Arboricultural Impact Assessment (AIA)

Land Off Cob Kiln Lane

Urmston

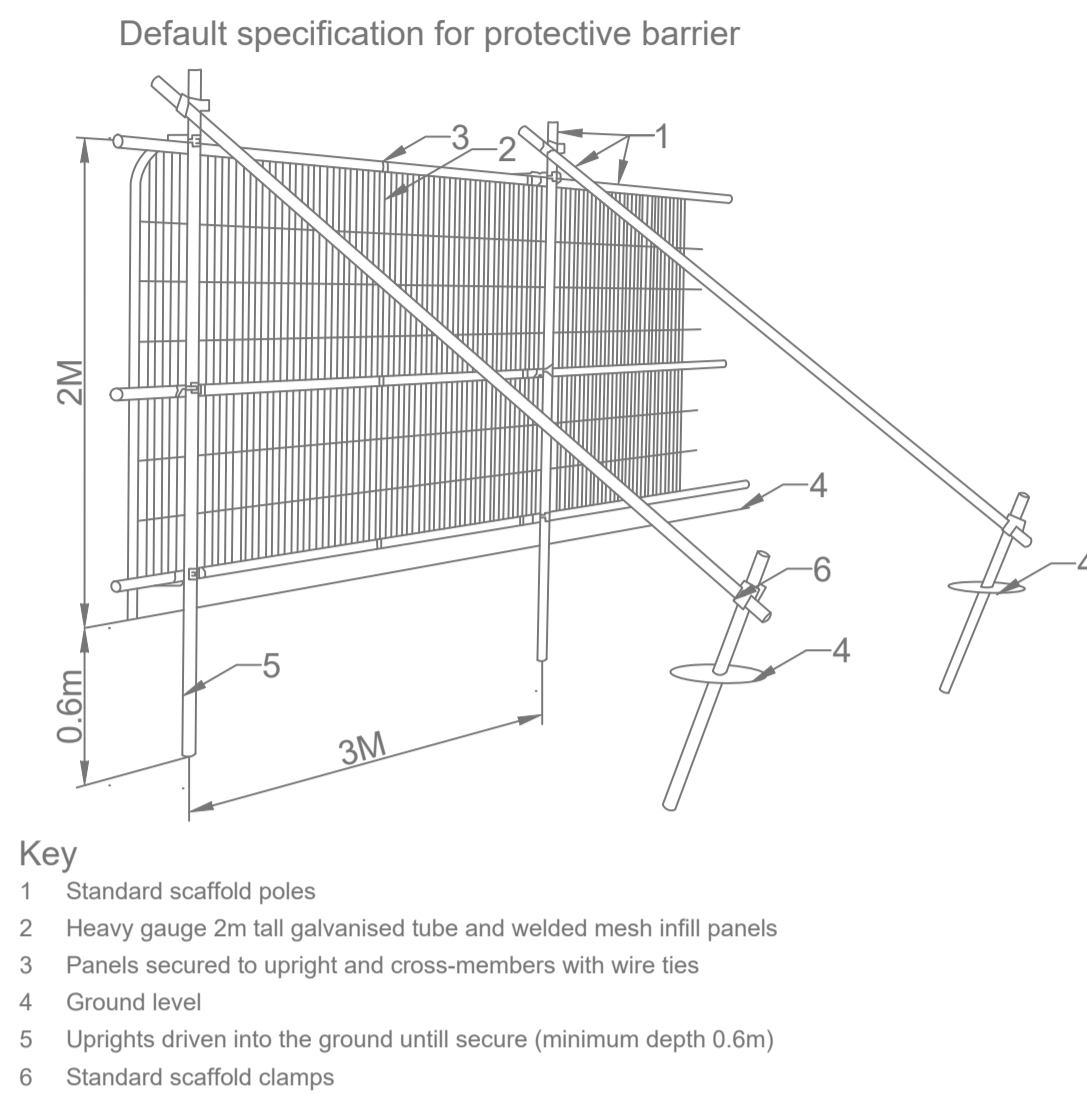
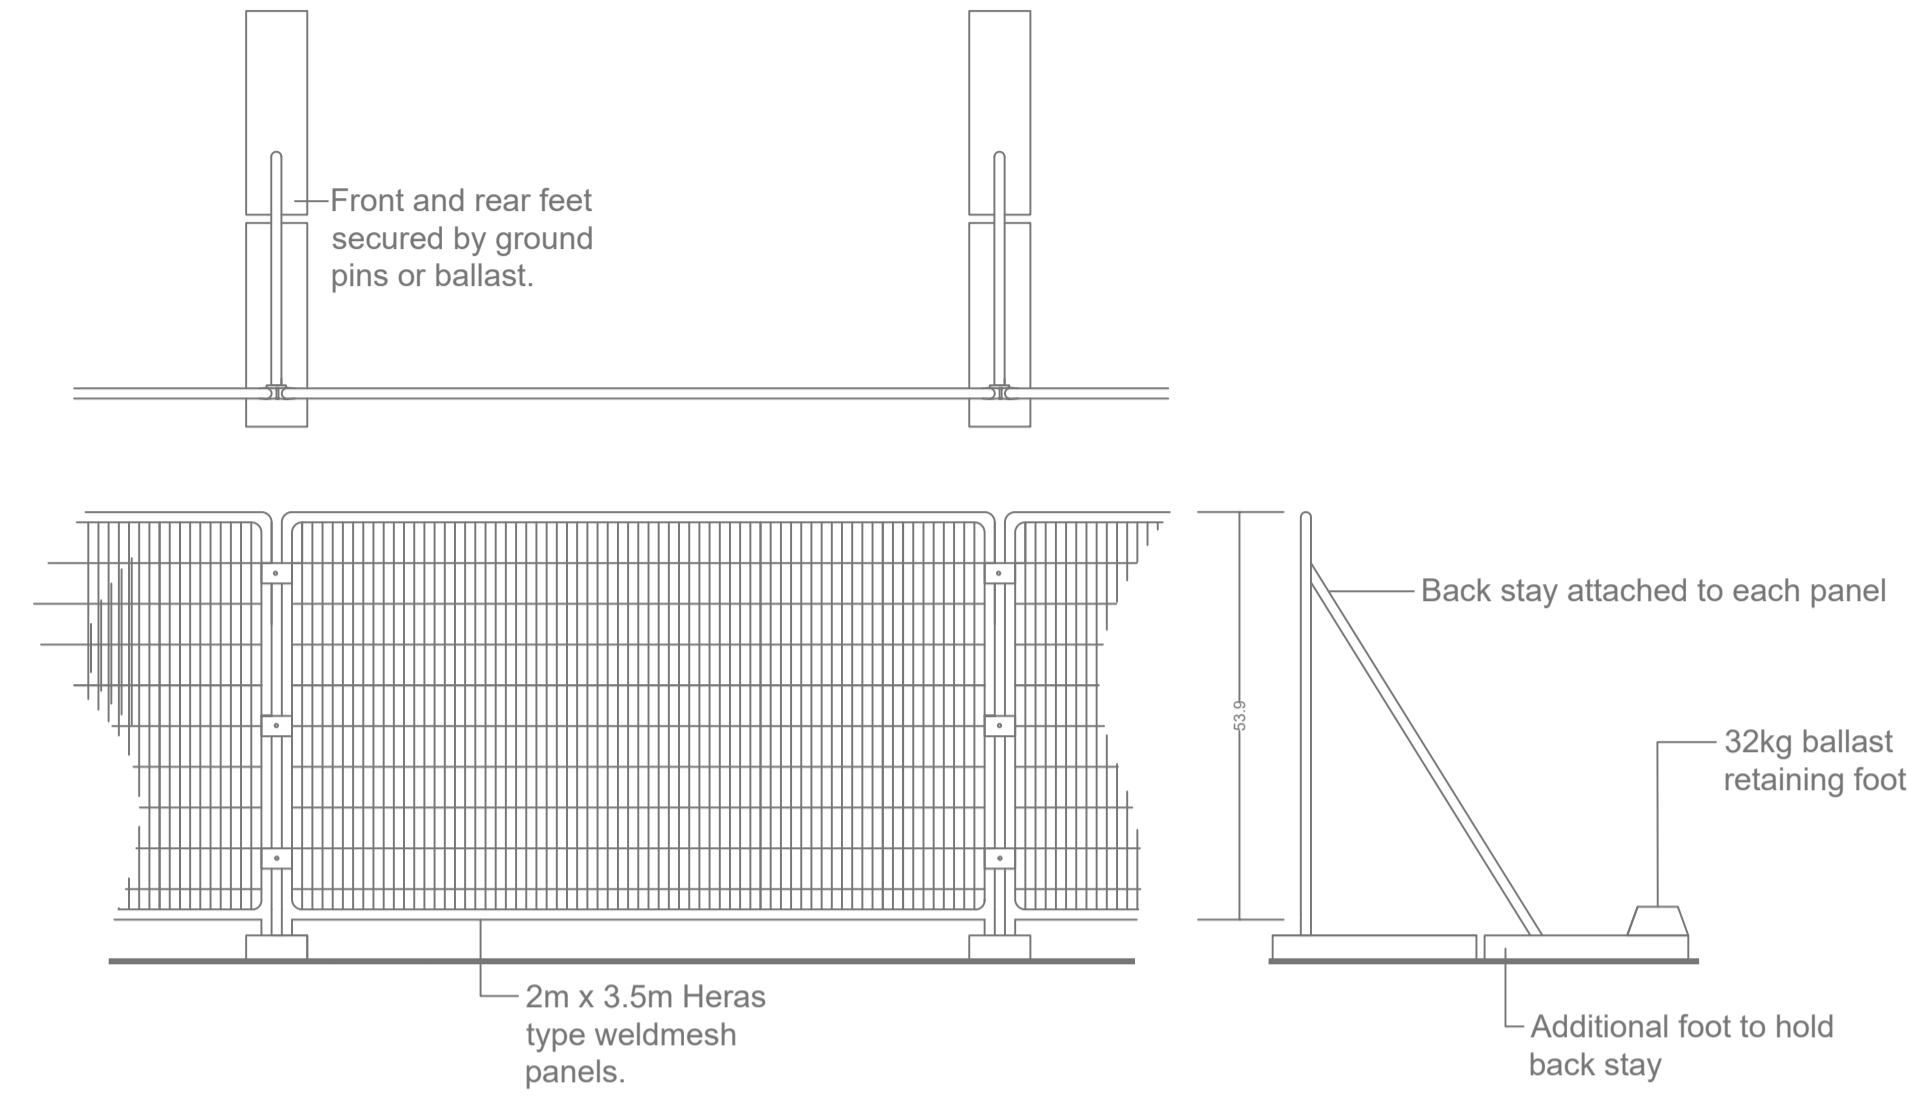
Insert 1: Tree protective fencing specification

Back-stay support

4.6.3. The required specification for protective fencing is illustrated in the Tree Protection Plan (Insert 1).

4.6.4. The 'in-ground' system involves driving vertical scaffold poles approximately 0.6m into the ground onto which are affixed horizontal scaffold poles and bracing struts. 2m high anti-climb weldmesh panels are then wired to the scaffold framework. The vertical scaffold poles should be at a maximum of 3m apart.

4.6.5. No fixing shall be made to any tree and all possible precautions shall be taken to prevent damage to the tree roots when locating uprights.
