P O R T H M I S S E N F A R M H O U S E H E R I T A G E I M P A C T A S S E S S M E N T

June 2021

Proposed Alterations

Porthmissen Farmhouse
Trevone, Padstow

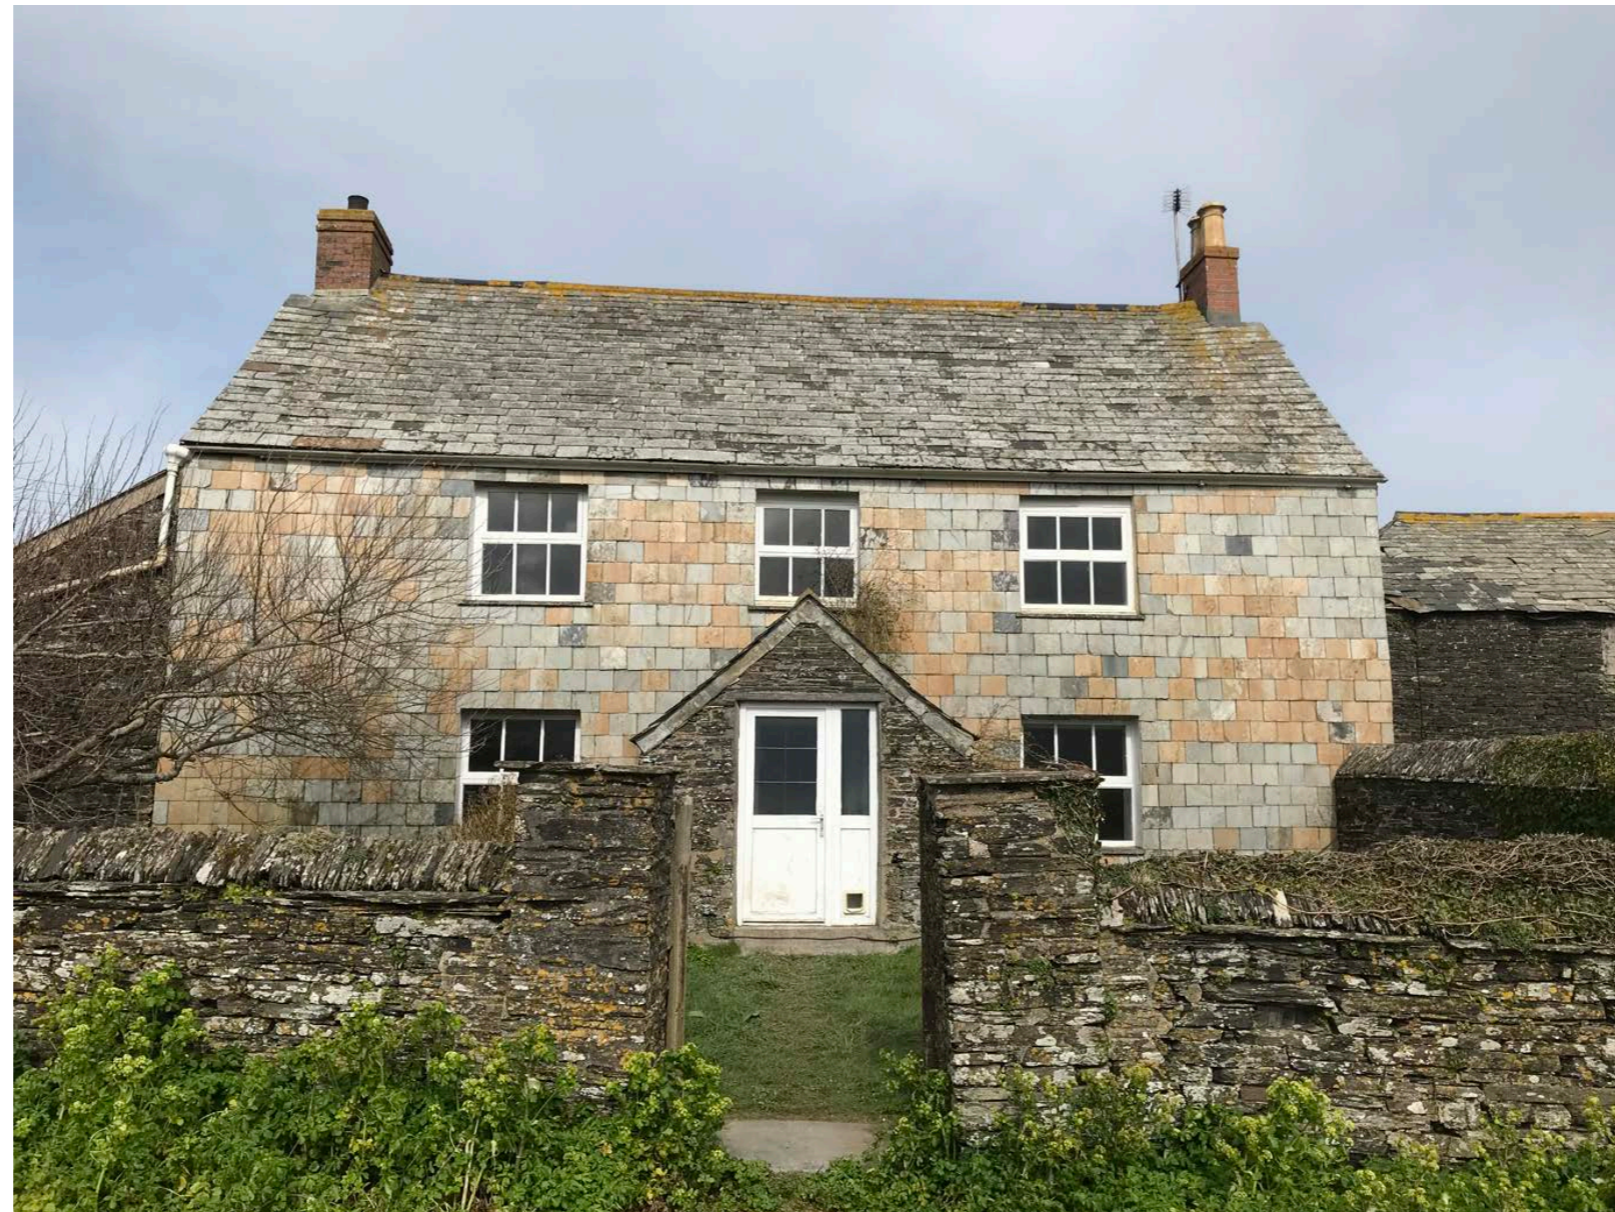
South Elevation

The main/south elevation is the most prominent elevation of the dwelling, overlooking Porthmissen Beach and Trevone Bay.

The main elevation is characterised by uniform natural slate hanging surrounding squat 3 over 3 casement timber windows, painted white., with slate cills and cement arrises.

The roof slope is in natural rag slate with brick chimneys to each gable, topped with black clayware ridge tiles.

Guttering is in ogee section cast iron, falling to hopper and downpipe at the south-west corner.

Main entrance is via a stone porch with double pitched roof, in slate with slate barge and upvc door and side panel.

The roof shows signs of movement and slipped slates. The chimney stacks appear more uniform and are likely to have been added/rebuilt in the near past.

The window styles do not appear sympathetic to the age of the dwelling.

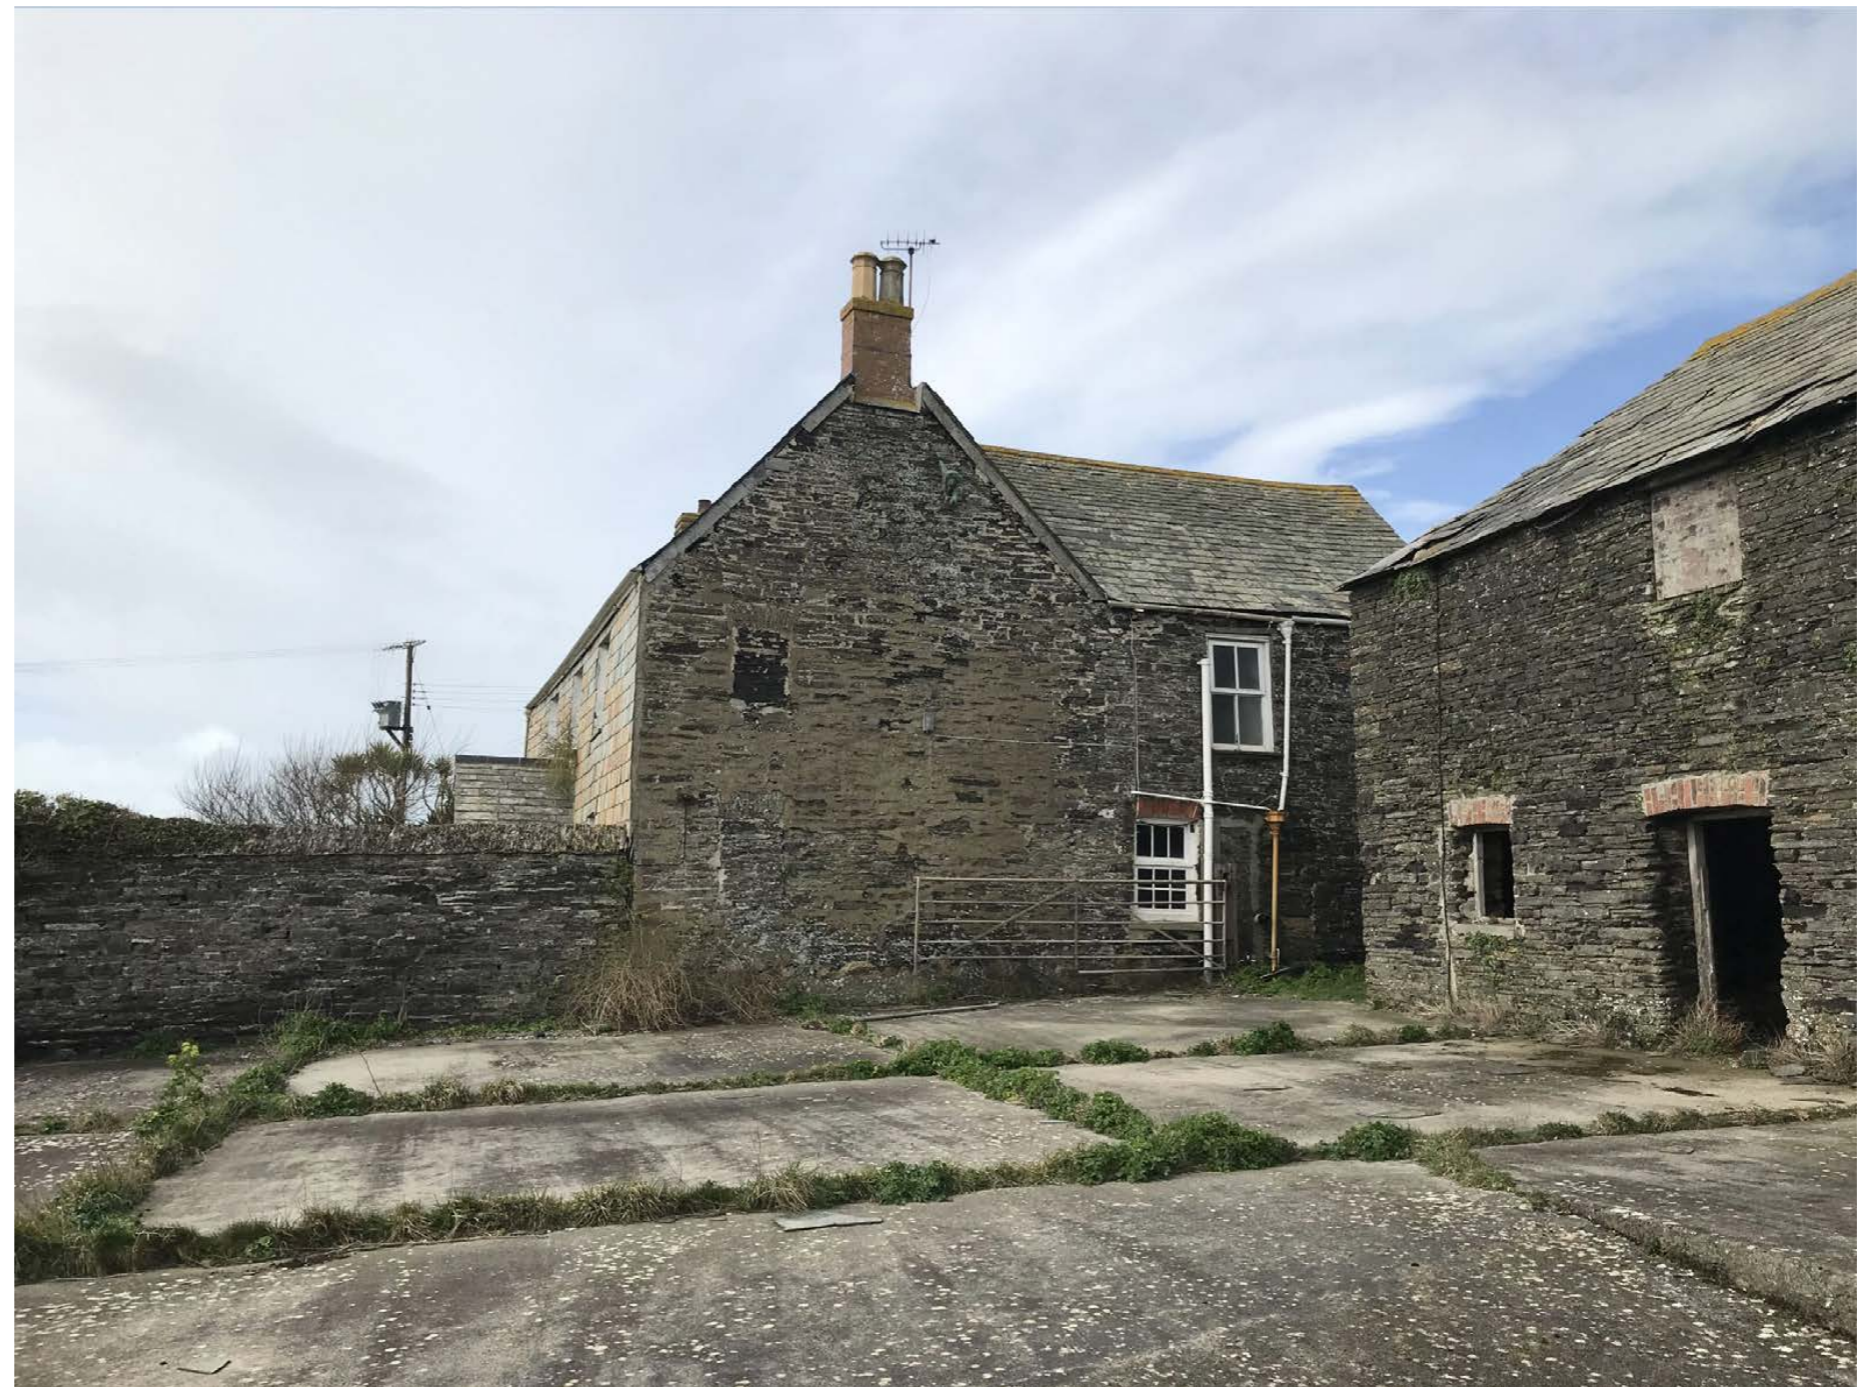
East Elevation

The eastern elevation is retained in exposed stonework with gable end to main portion of the dwelling, with north-east wing beyond.

The east elevation is characterised by evidence of two small openings near the south-east corner of two windows, now blocked in stone.

The lower and upper blocked windows indicate original curved stone lintel over. The walling shows evidence of original lime based mortar pointing, with areas of cement overlay, likely in an attempt to address water ingress/damp issues.

The gable end is finished in nailed slate barge, with some sections missing.

The jointing of the stonework suggests the north-east wing was added at a later date given the straight vertical jointing.

Two windows are present to this elevation, one timber casement at low level to the pantry/kitchen with red brick arched lintel and slate cill, 3 panes over 6 below. To the immediate right hand side, evidence of blocked openings are defined by a change in stone weathering.

Above a simple timber 2 over 2 timber casement window above.

Various untidy paraphernalia such as external lights and wiring, SVP piping to bathroom, cast iron hoppers and downpipes mixed with plastic guttering, plus boiler outlets at low level.

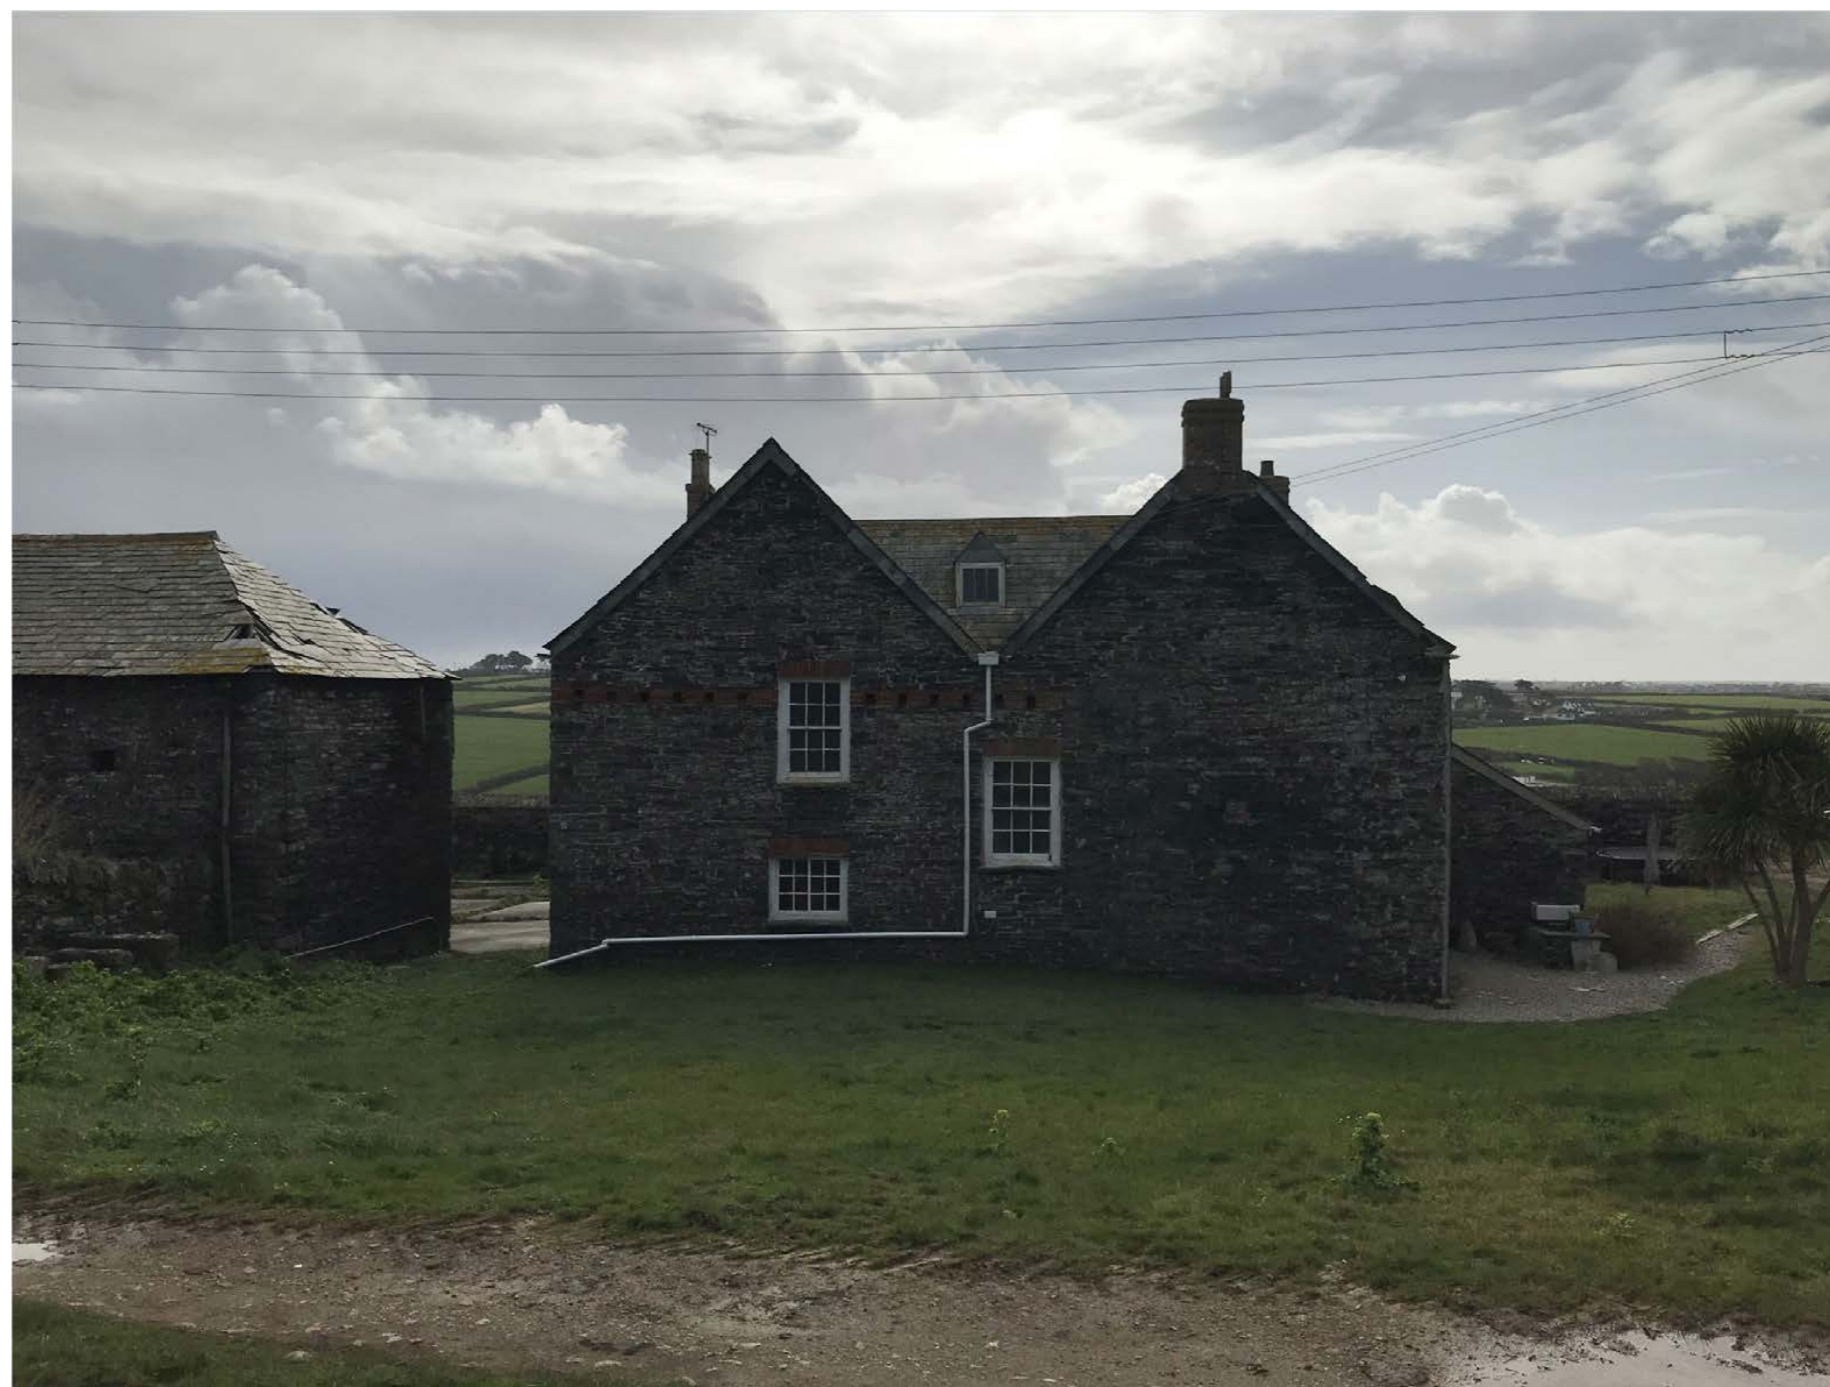
North Elevation

The north elevation is in natural stone, characterised by the steep pitched double gable arrangement, with central roof valley with dormer to roof space visible.

Barges are in nailed slate, with brick chimney to north-west gable end. Rainwater emitting from the central valley is taken by a upvc hopper and downpipes to the north-east corner of the building.

A timber sliding sash, six over six window with arched brick lintel and slate cill, sits at the half landing stage to the internal stairs.

The right hand side of this window aligns with a vertical slot in the stonework which suggests that the current arrangement was not constructed at the same time. The walling to the north-west gable is darker and rougher in construction.

The north-east gable contains two windows, the lower being a horizontal 6 by 6 sliding sash with traditional 6 over 6 sash above.

Of further interest is the 3 course brick band intersecting the upper window, with uniform holes.

The presence of these details suggests the arrangement of the building to the rear of the original building has altered over time.

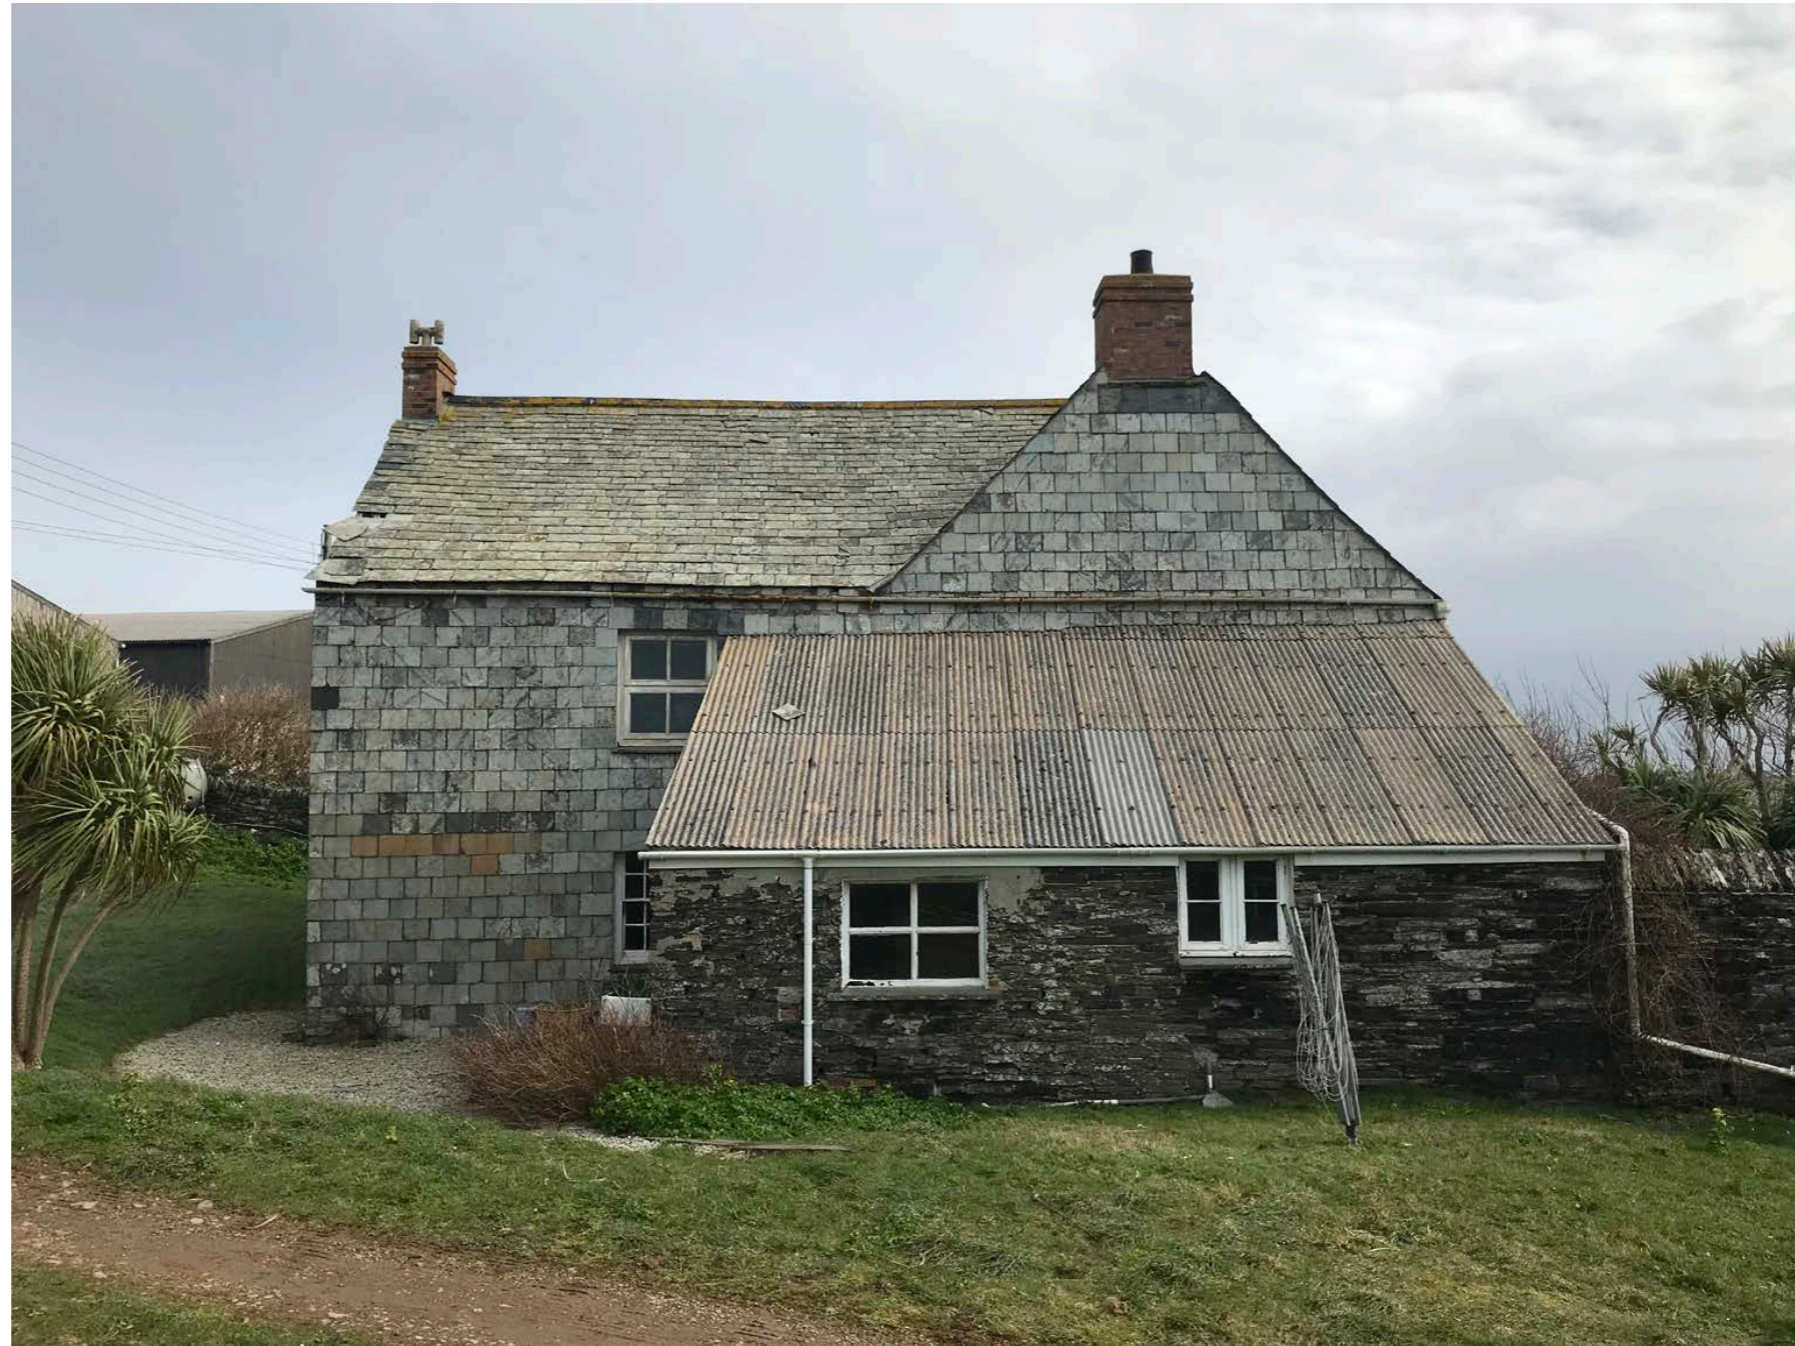
West Elevation

The west elevation, like the south, being one of two most exposed elevations is finished in natural slate hanging, partially hidden by the lean-to building at the south-west end.

The lean-to is in stone construction with corrugated roof covering. The roofing sits just below the eaves line.

Rainwater goods are a mix of white and grey upvc.

Two windows are present with the lean-to, high level facing west, of varying sizes and styles.

The back entrance stable door in timber, painted white, abuts the main building and is accessed from the north.

At the junction with the lean to, two windows are present on the west elevation. The ground floor window is white painted timber sash, 8 over 8 panes with slate cill. The upper window is a 2 over 2 timber casement, again, painted white with slate cill.

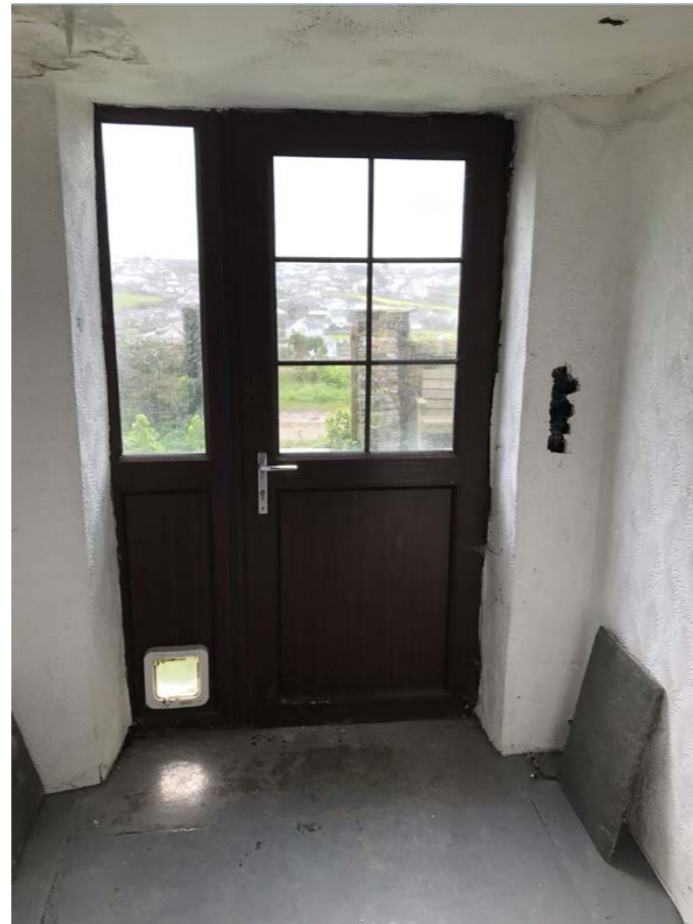
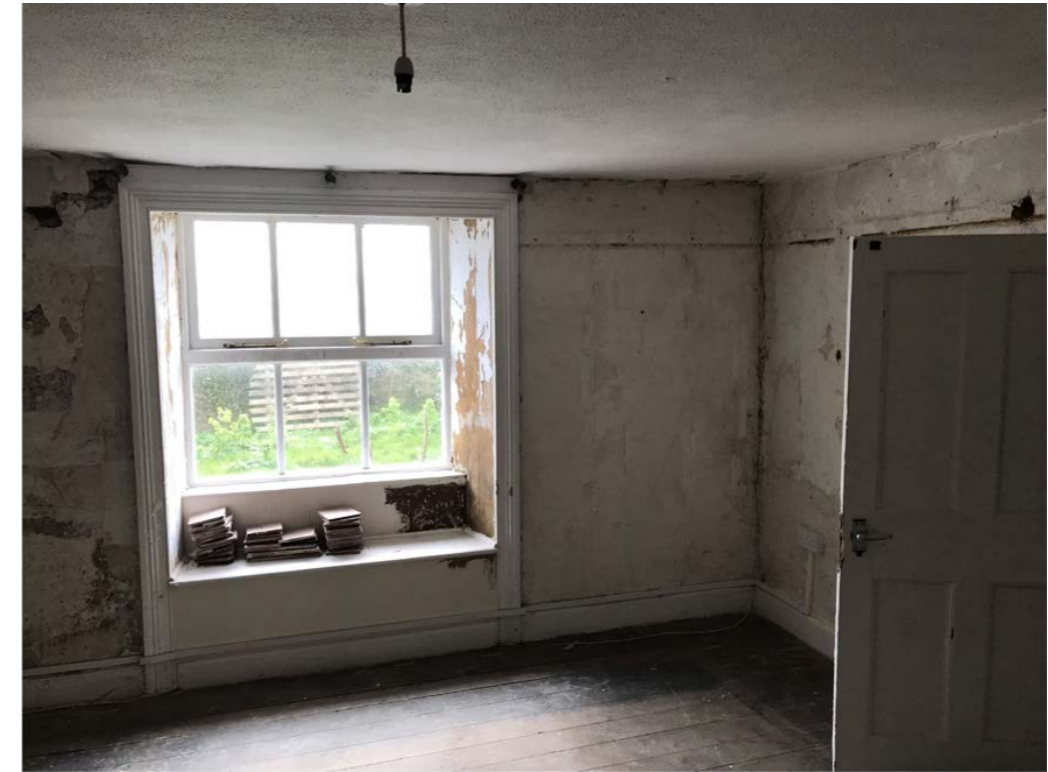
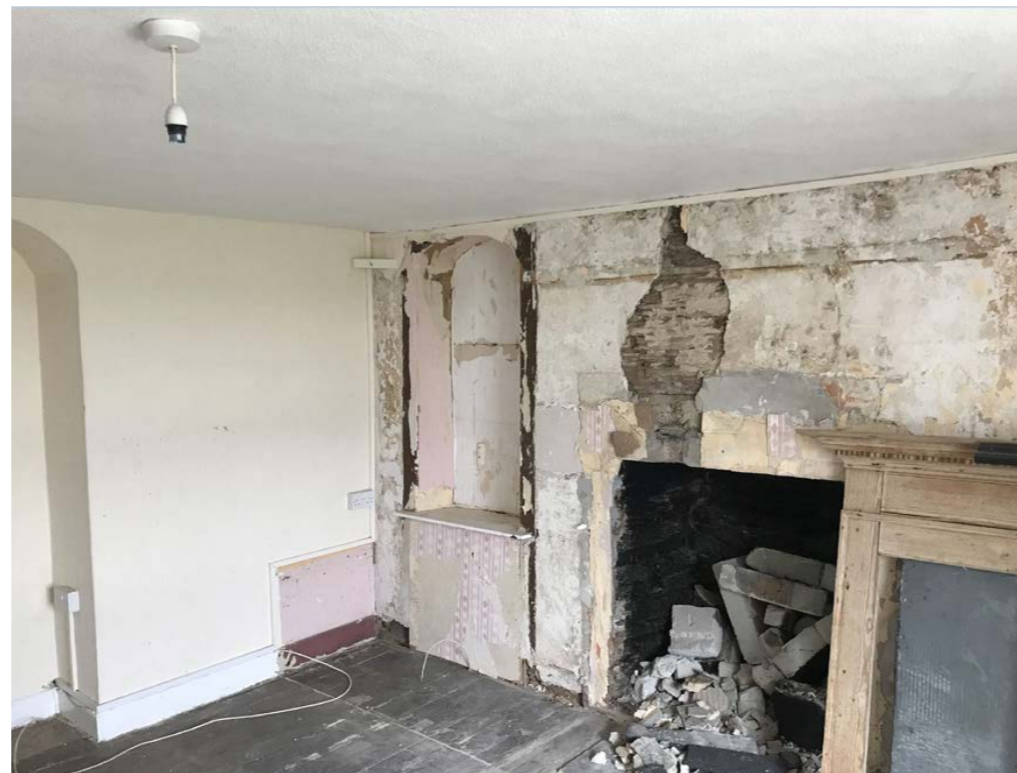
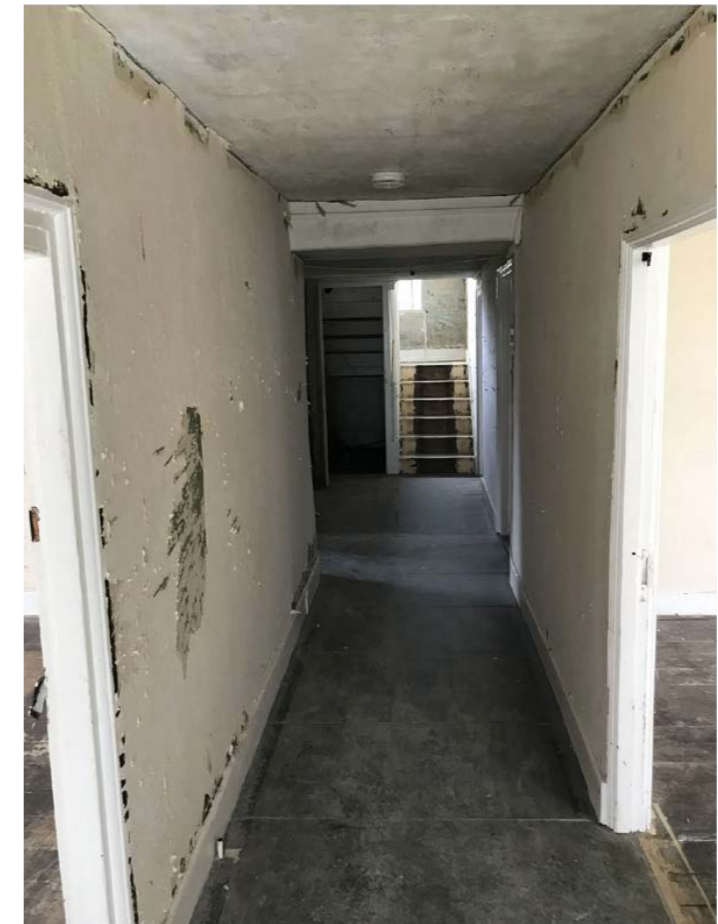
Ground Floor

The southern section of the building is based on a traditional double room plan with central corridor. Access is via the stone porch with small lobby.

Both rooms have stone surrounded fire places, with windows facing south. Internally, there is evidence that the external window cill has been raised on both windows.

Floors are in bare timber with walls showing various layers of wallpaper, paint and render in varying degrees of deterioration. Skirting boards are in painted timber and small decorative coving to plastered ceilings.

The hall is in natural slate, again with timber skirtings. The hall leads to the stairwell. To the immediate right is the pantry/kitchen area, with rough slate flooring.

To the other side of the hall way is likely to be the original kitchen, as it links via a serving hatch to the room to the south, suggesting an original opening in this location.

A fire place and large side cupboard sits at the northern end. The western wall has the back door access and side window adjacent.

From the side door, the lean to is adjacent, separated into two spaces, with exposed roof timber visible.

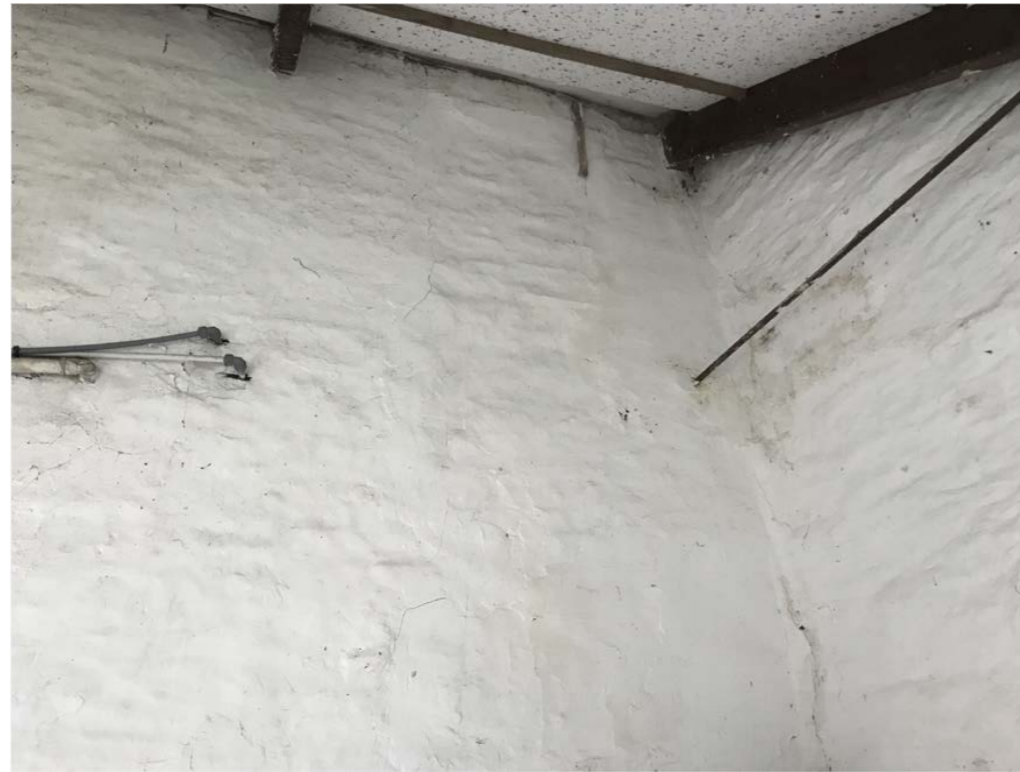
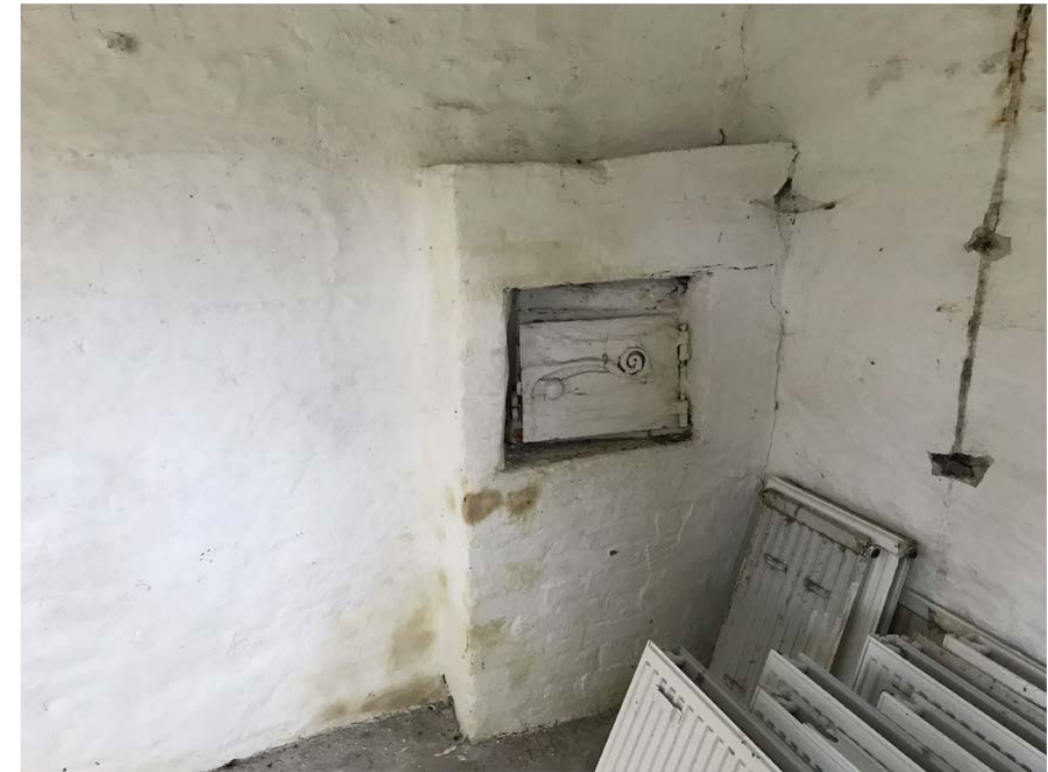
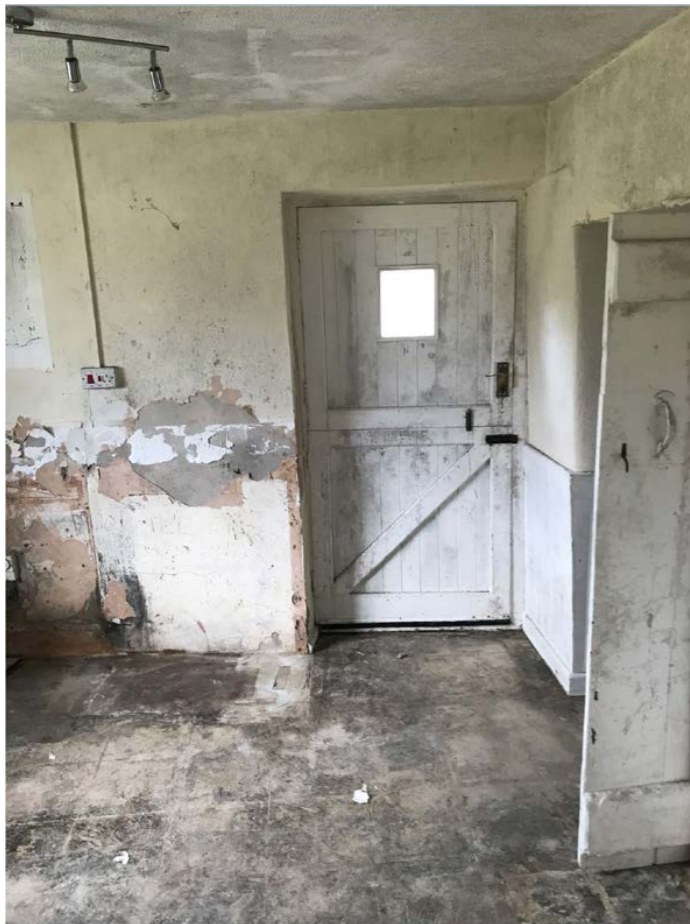
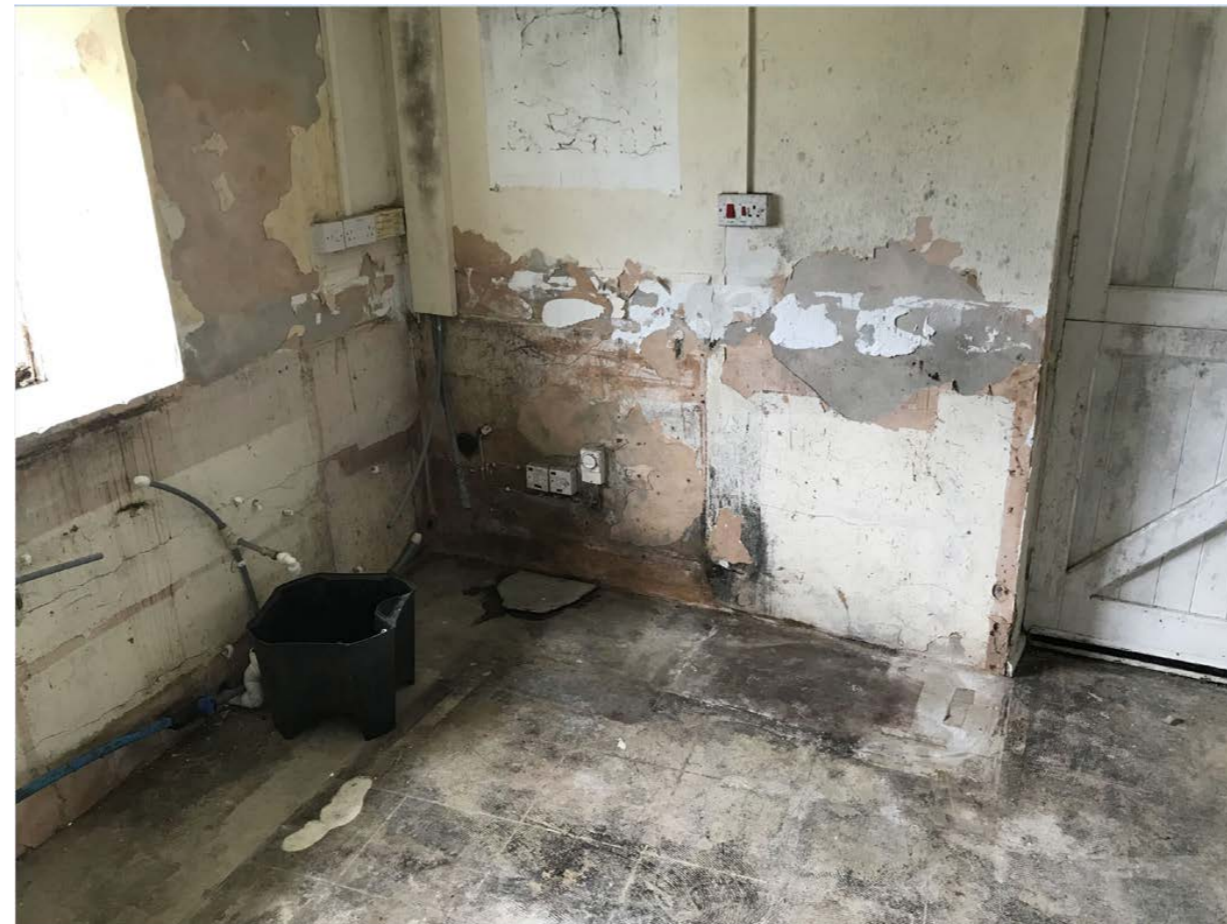
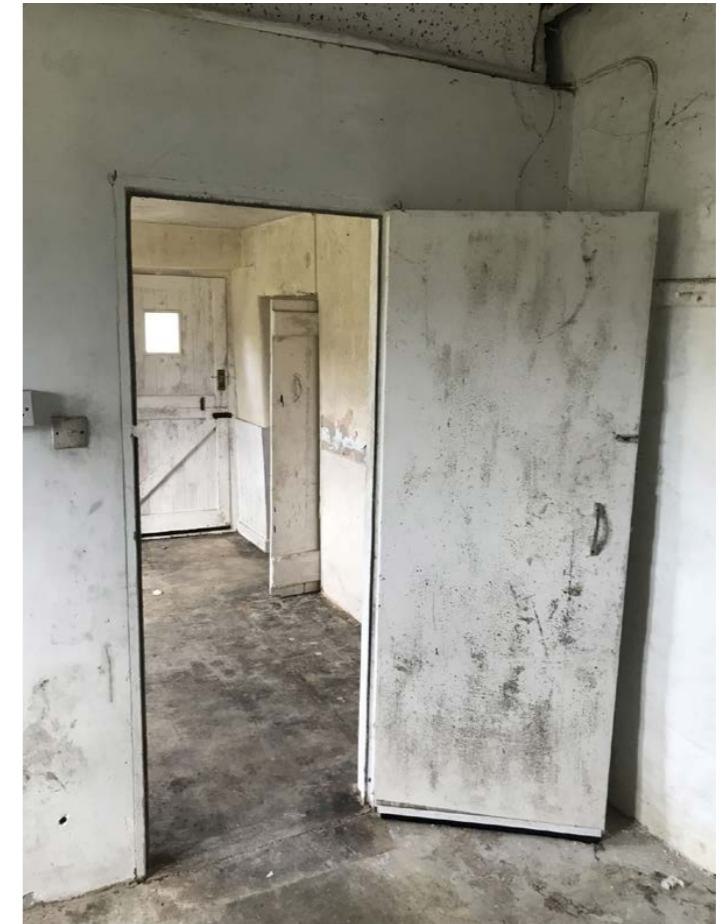
Photos show the interior of the existing lean to with will become rear entrance and utility spaces. The first photo shows blocked original window opening to be reinstated and roof pitch lowered.

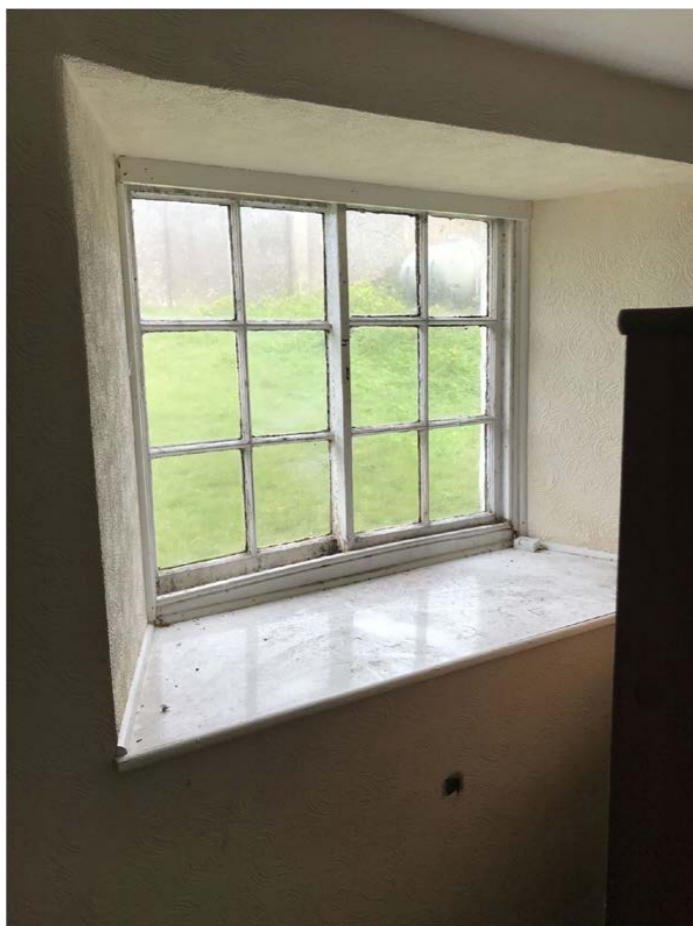
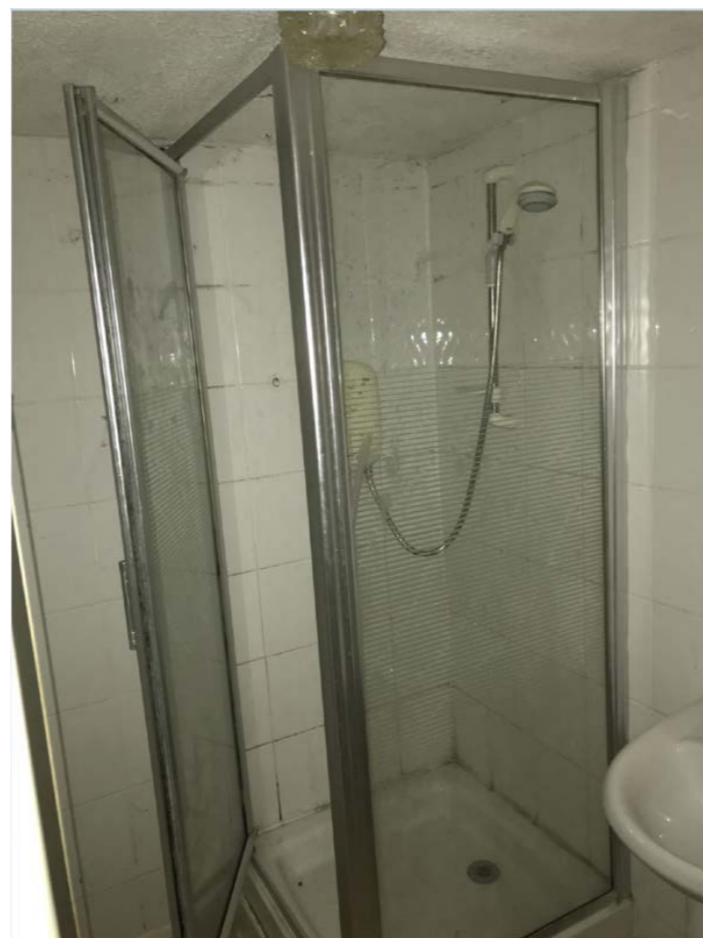
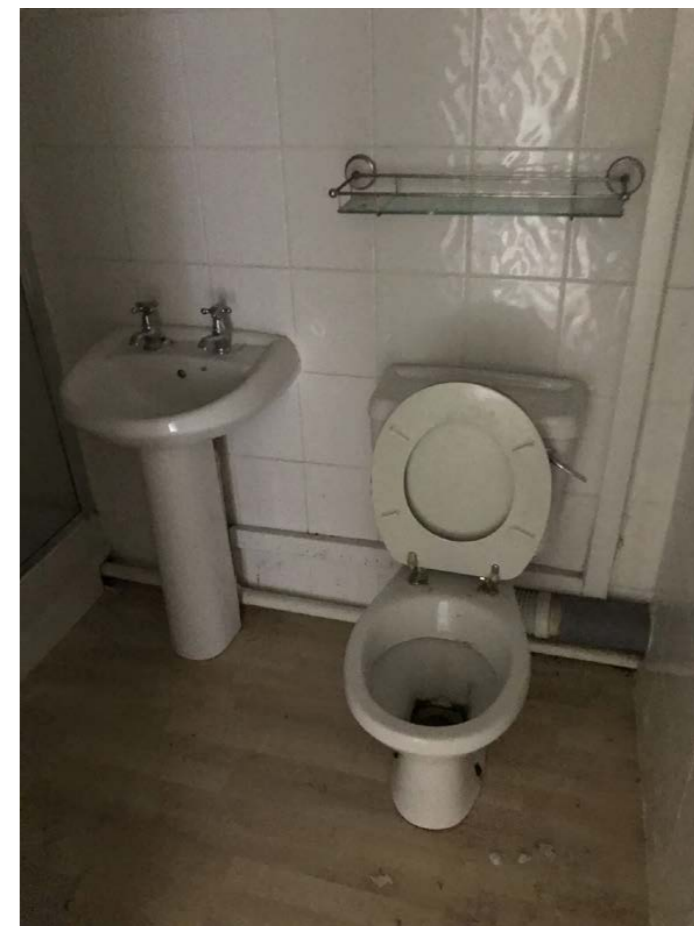
Photos of modern bathroom arrangement at ground floor with horizontal sliding sash window to be replaced with deeper vertical sash window and lowered window cill.

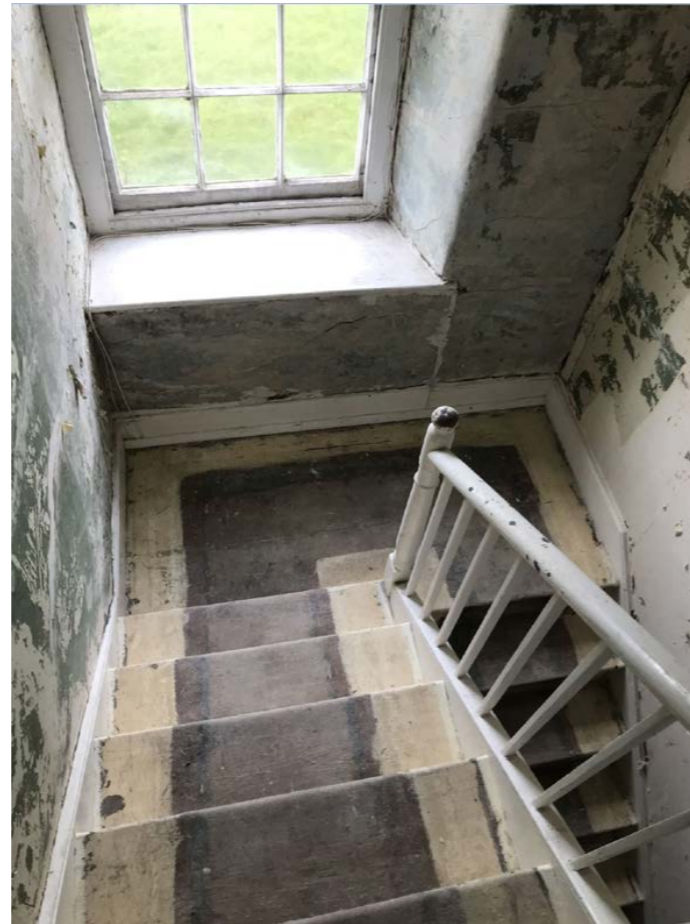
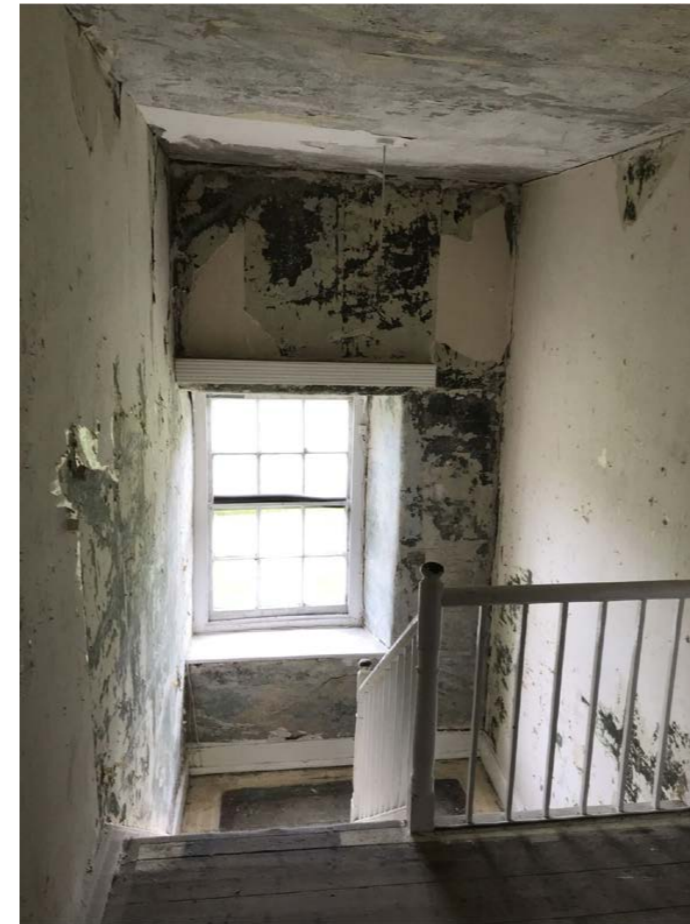
First Floor

The first floor is accessed by the main timber staircase, with half landing and sash window facing north.

The stairs leads to a central landing. To the immediate left is the rear north-east corner bedroom, with family bathroom adjacent with sash window looking east towards the courtyard.

To the immediate right, bedroom with sash window facing west towards the coast. The wall between the bedroom and landing is in part stud work with recess for storage. The fire place from below carries up through the room, with cupboard recess to the north-west corner.

At the southern end of the dwelling, the space is split into three spaces. In this area the floor level is raised by 110mm across a single step.

Centrally, a small box-room overlooks the porch entrance to the south, with larger bedrooms either side. The south-west corner bedroom has a sash window facing south and recessed cupboard to south-west corner.

The south-east corner bedroom also has a sash window with lower internal cill and recess to south-east corner aligning with blocked window opening externally.
