P O R T H M I S S E N F A R M H O U S E H E R I T A G E I M P A C T A S S E S S M E N T

June 2021

Proposed Alterations

Porthmissen Farmhouse
Trevone, Padstow

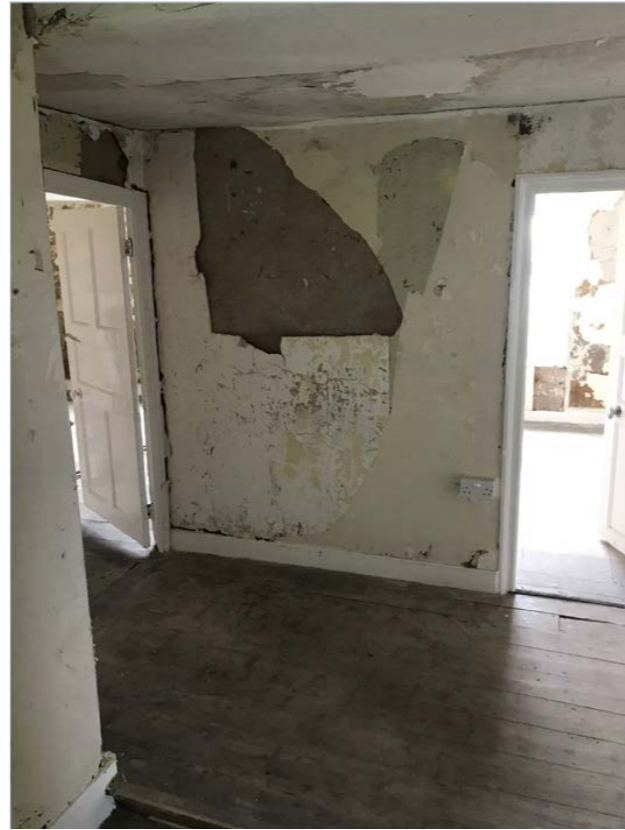
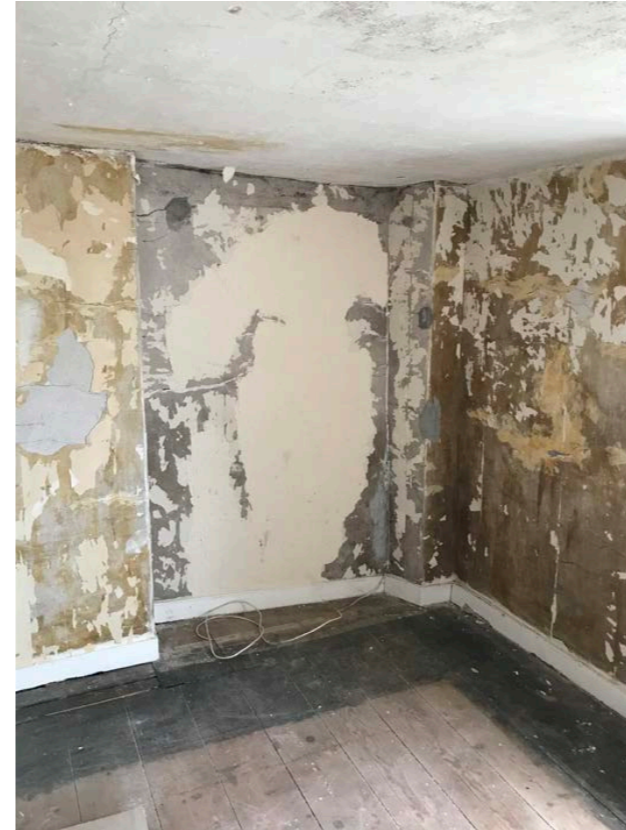
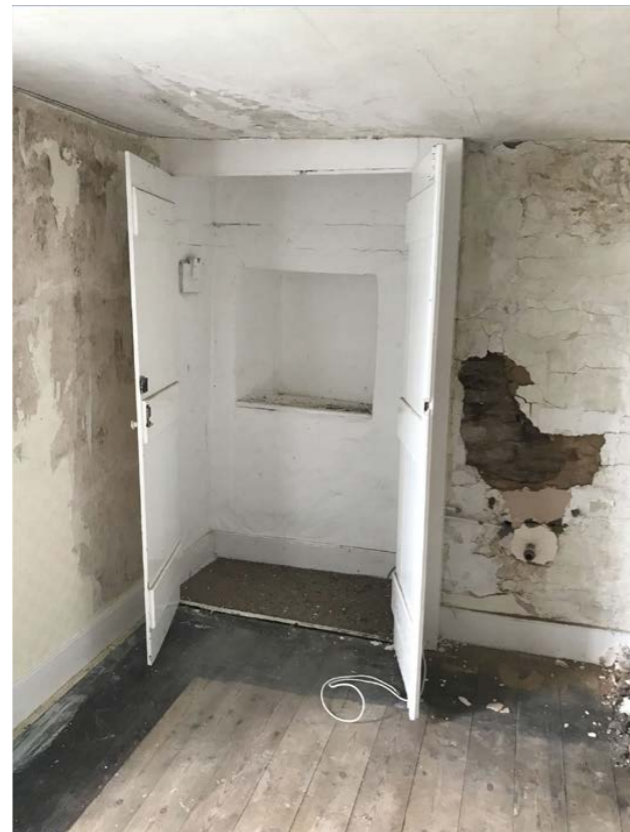
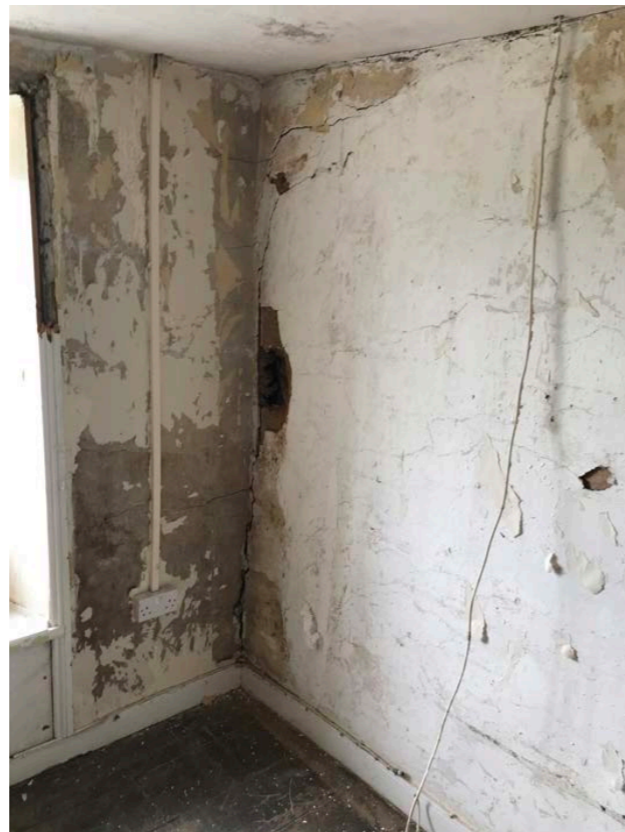
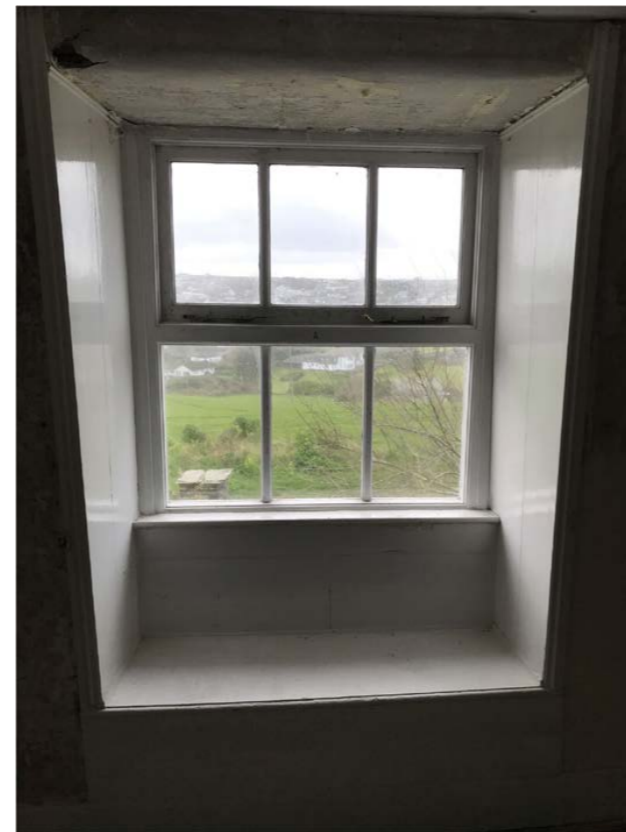
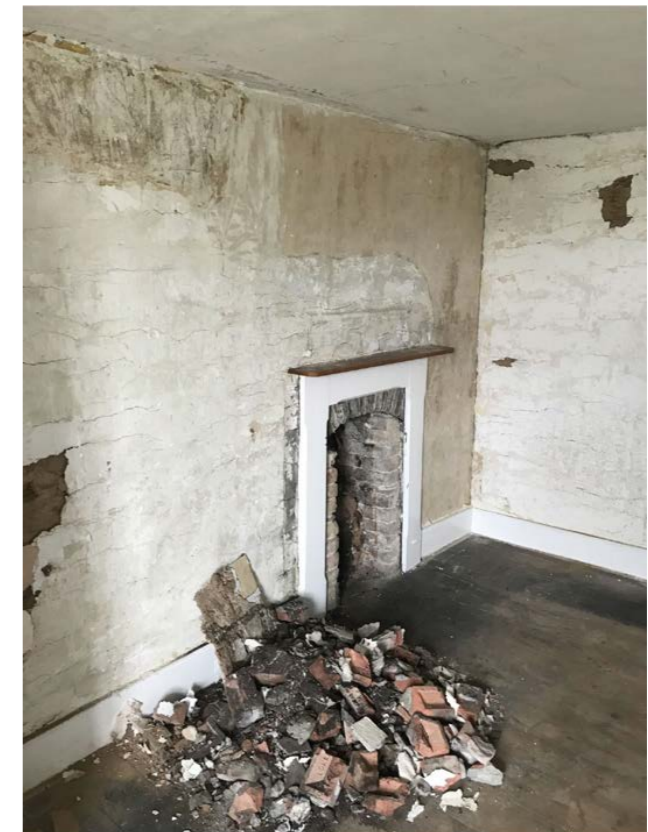
Photos show the existing landing and front bedrooms accessed from it, with timber floors to be retained and original fireplace openings.

Bottom left photo shows the original window reveal open to be reinstated to the upper south-west corner of the building.

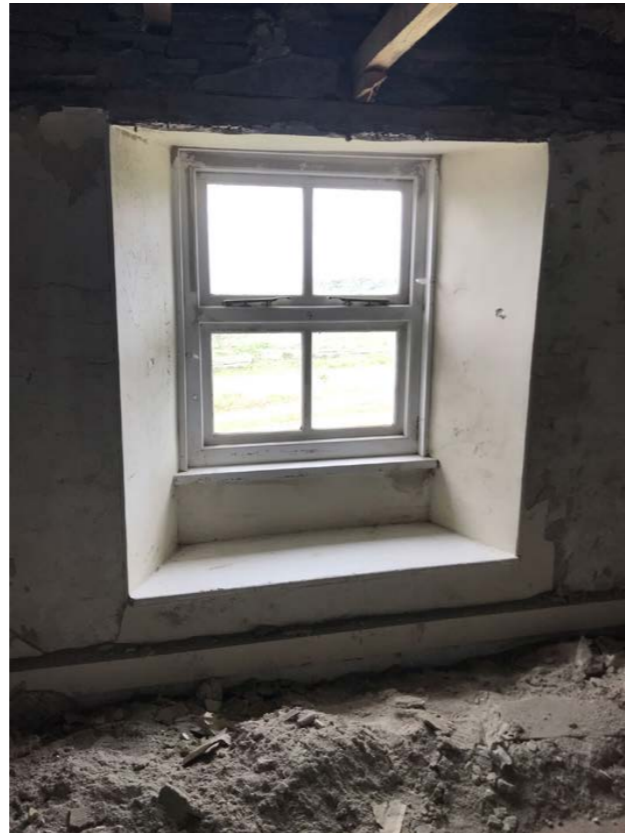
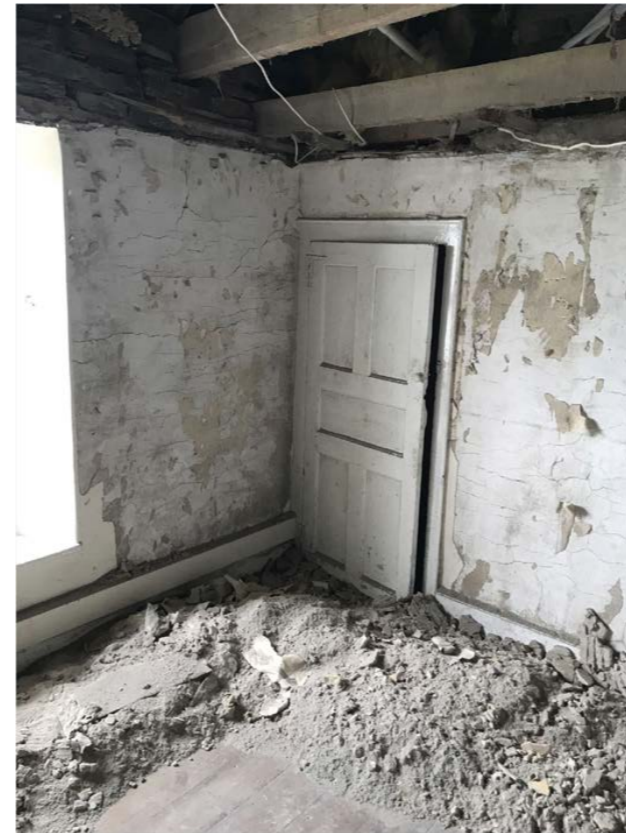
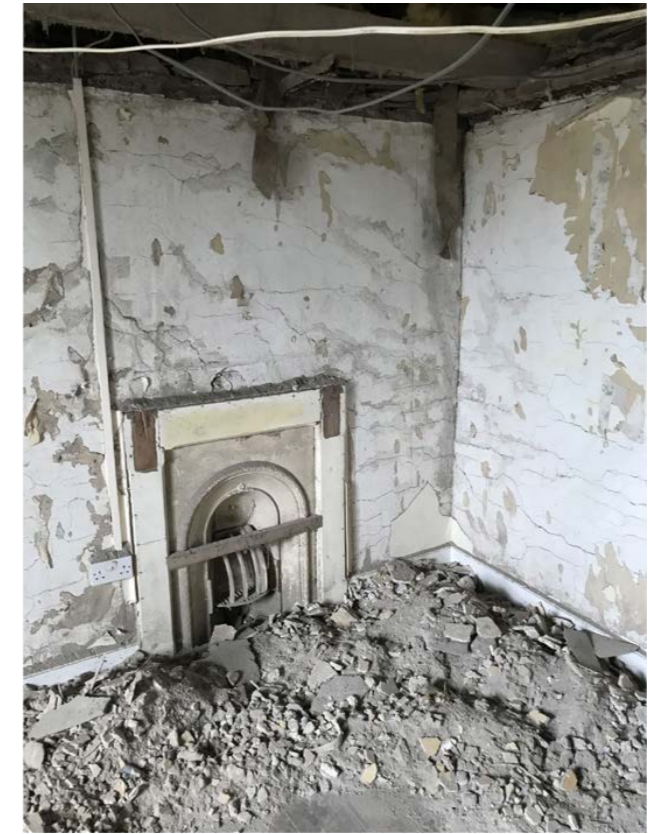
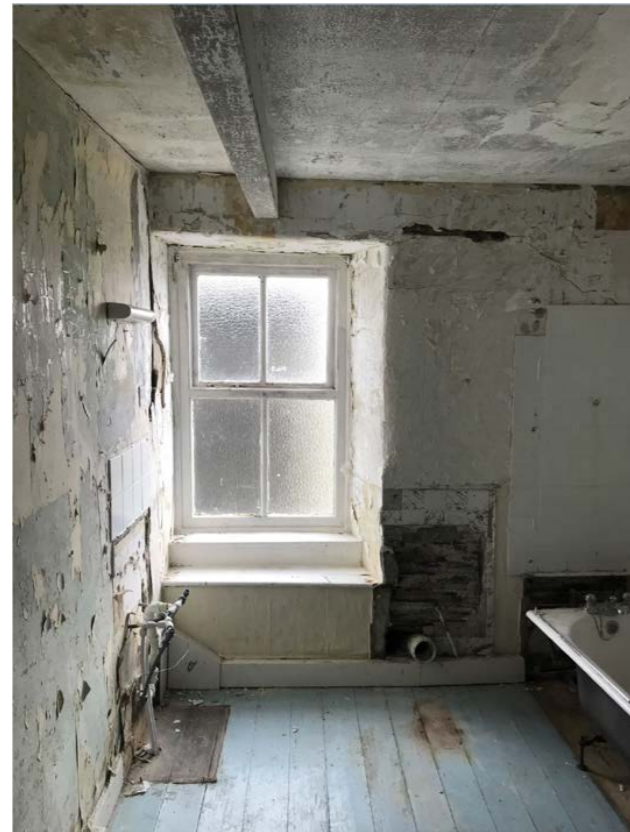
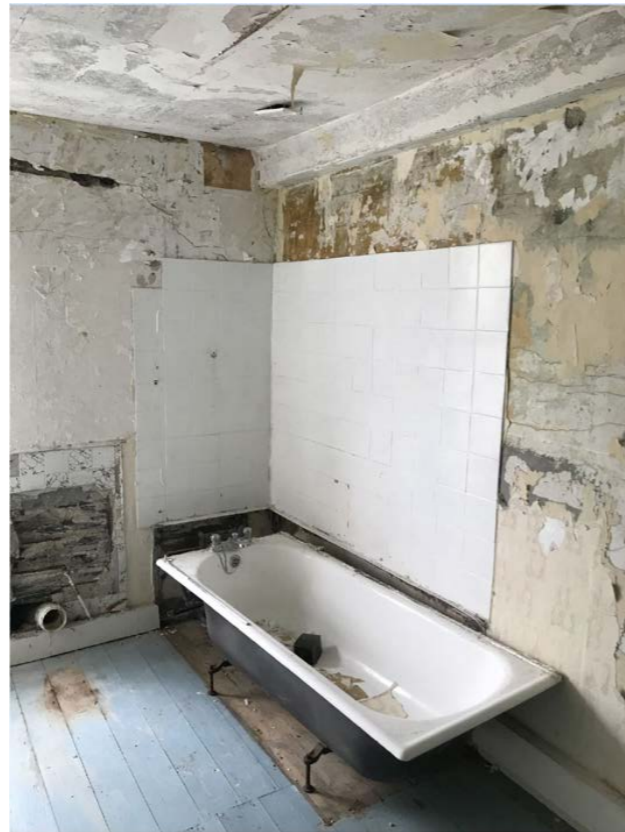
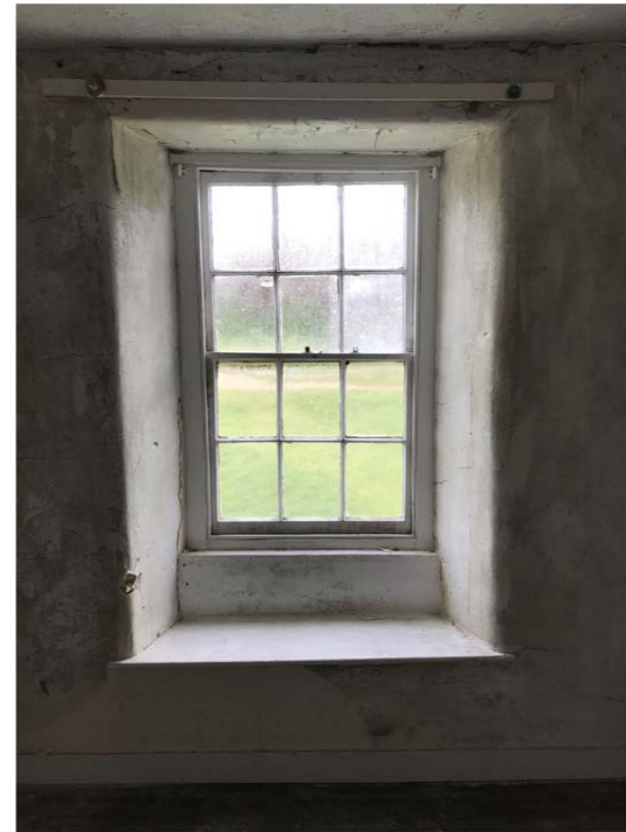
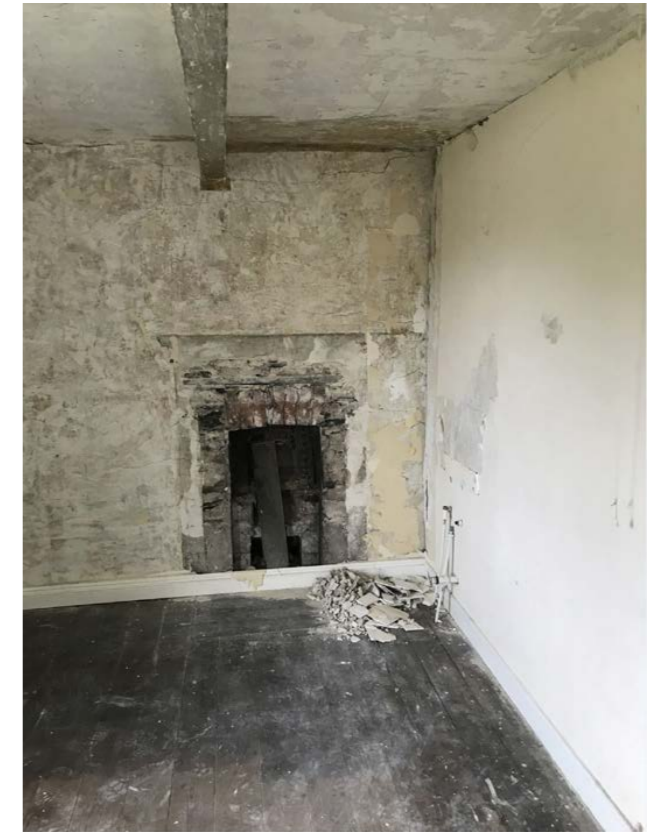
Photos show the rear bedroom spaces and family bathroom, including for fireplaces and varying window styles.

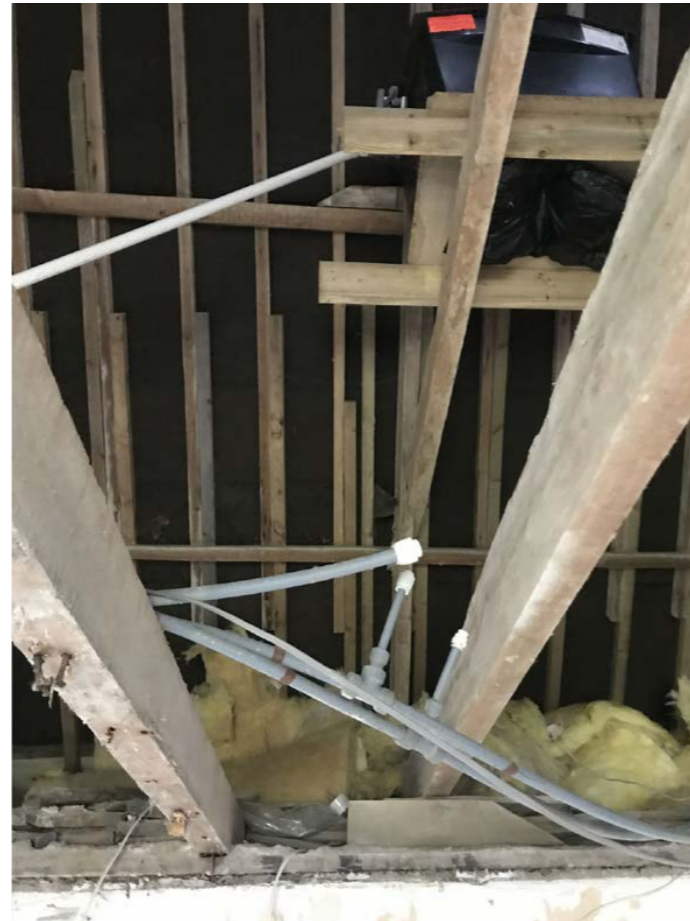
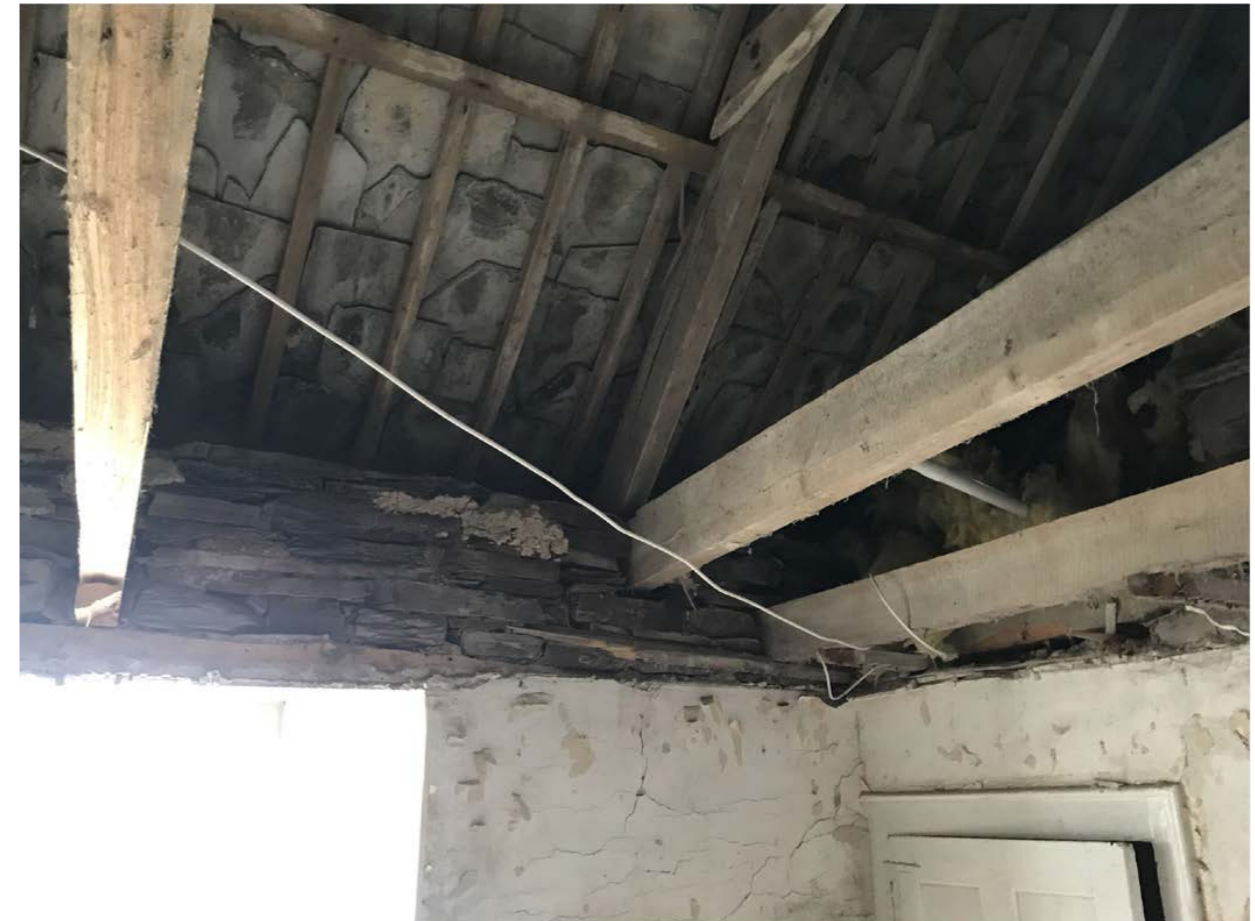
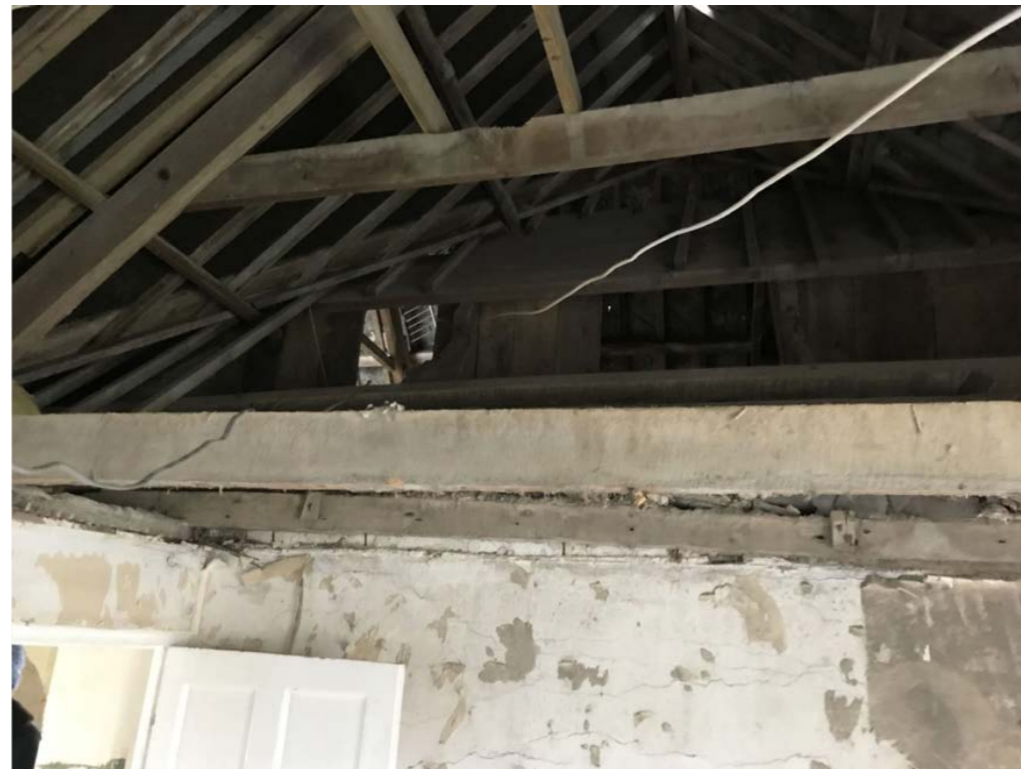
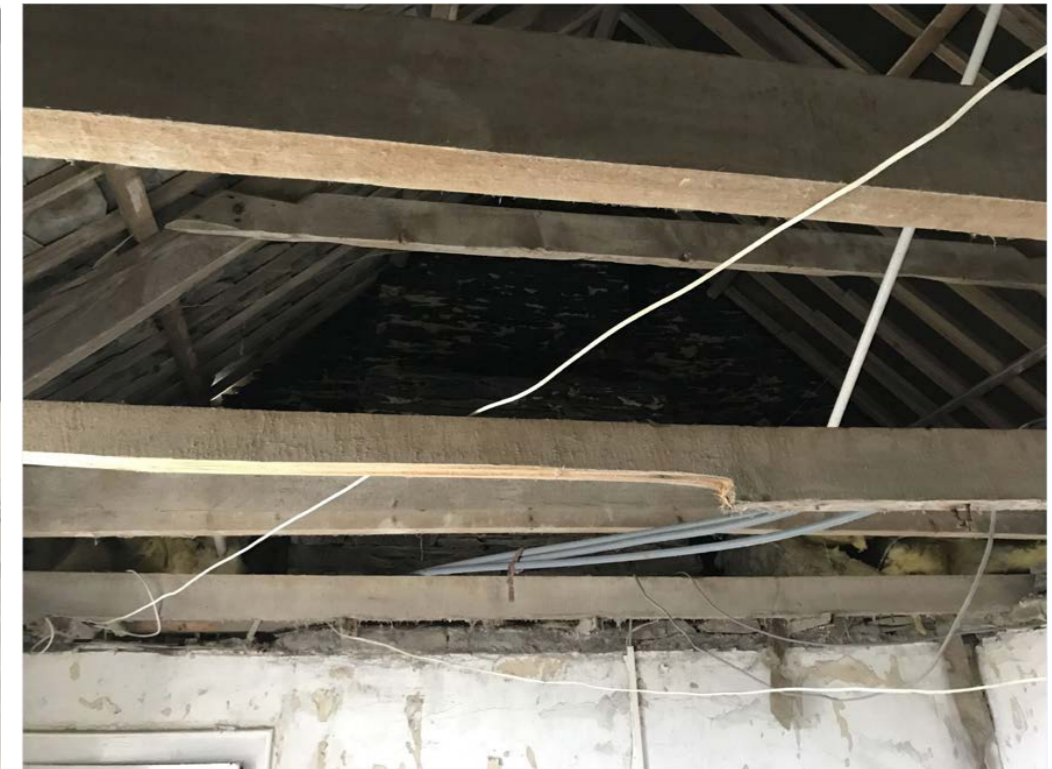
Roof Void

At present, not all of the roof void is exposed or available to view. Areas of roof are exposed in the north-west bedroom at first floor where the ceiling has previously failed.

Internal photos show sections of breather membrane and fibre glass insulation adjacent to the lead valley gutter.

The underside of the west and south facing roof slopes show the roof construction being rag slate on timber battens fixed to purlins on principle raised tie trusses.

Additional timber joists are visible, likely as a later addition to strengthen the roof structure.

From the north-west corner bedroom looking south into the roof void, there is evidence of redundant roof structures following the line of the north facing slope, reinforcing the suggestion that the rear sections of the building are later additions.

The missing section of ceiling reveals the internal wall render on the natural slate stone, with the fireplace recessing to the ridge.
