**Proposed Development at  
Mayberry Garden Centre  
Old Shoreham Road  
Portslade**

**Combined Geotechnical and  
Quantitative Ground Contamination Risk Assessment**

**Project Reference: P14899**

**Report Reference: R14559**

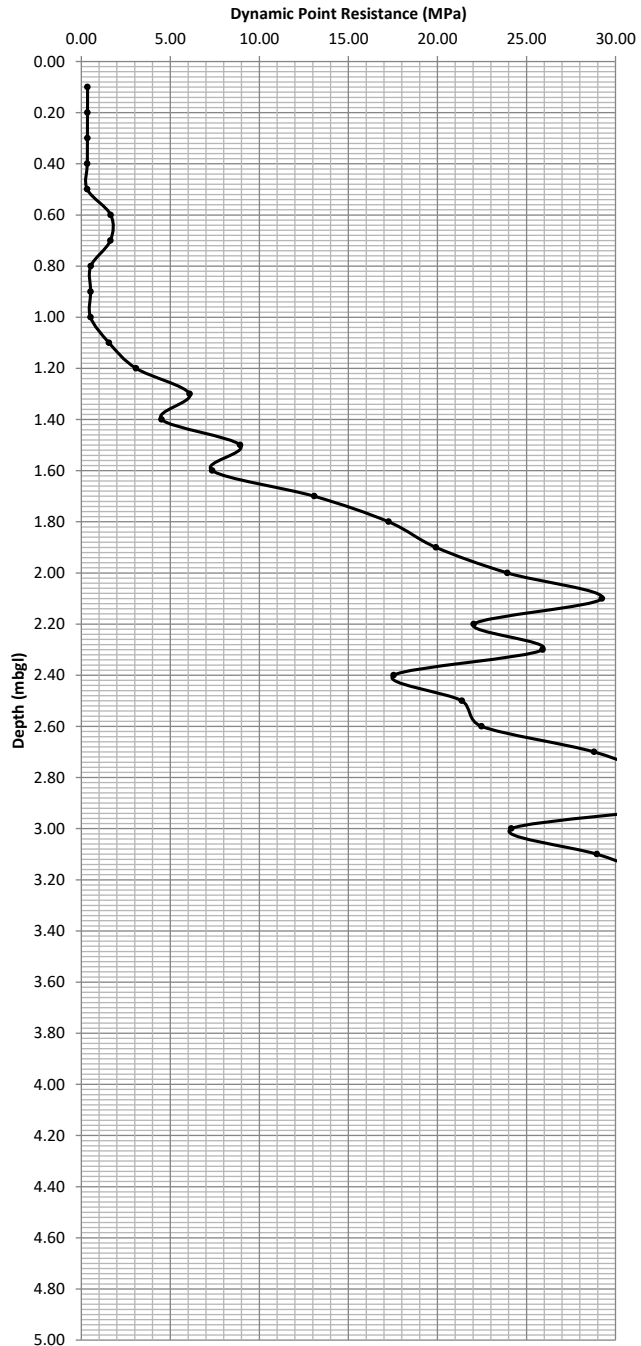
Notes:  
No further progress below 3.30m depth - hammer bouncing.

Cone penetrometer tests undertaken to establish the California bearing ratio (CBR) of the in-situ soils indicated CBR values ranging between 2% and >50% but typically in the range 2% to 6% in the underlying Head and derived made ground at the time of the investigation. It is noted that CBR values are, in part, dependent on the moisture content of the tested soils and are consequently subject to seasonal variation.

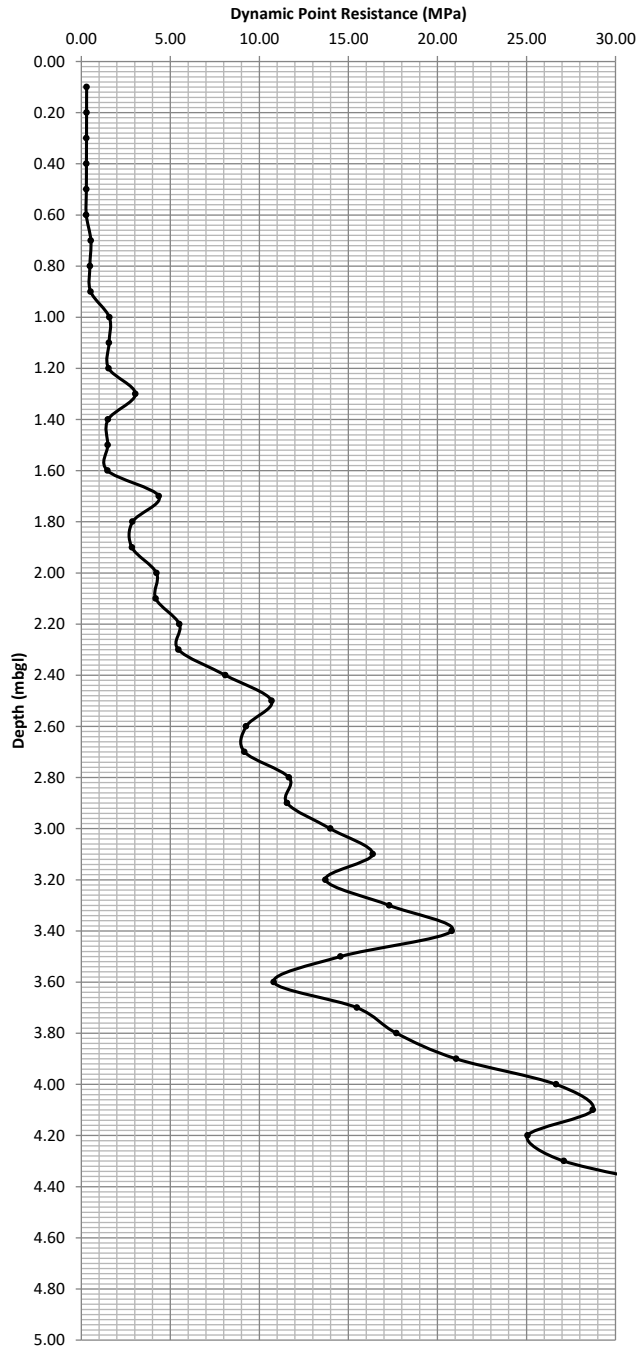
Notes:  
No further progress below 4.40m depth - hammer bouncing.

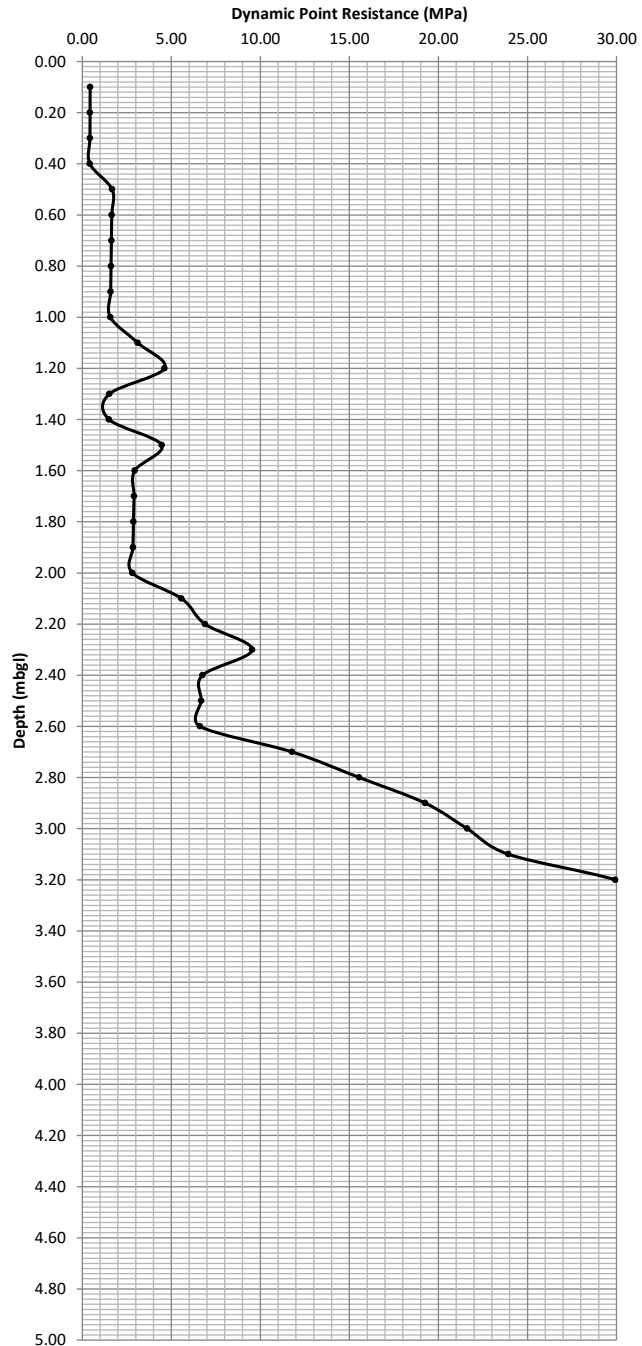
Notes:  
No further progress below 3.40m depth - hammer bouncing.

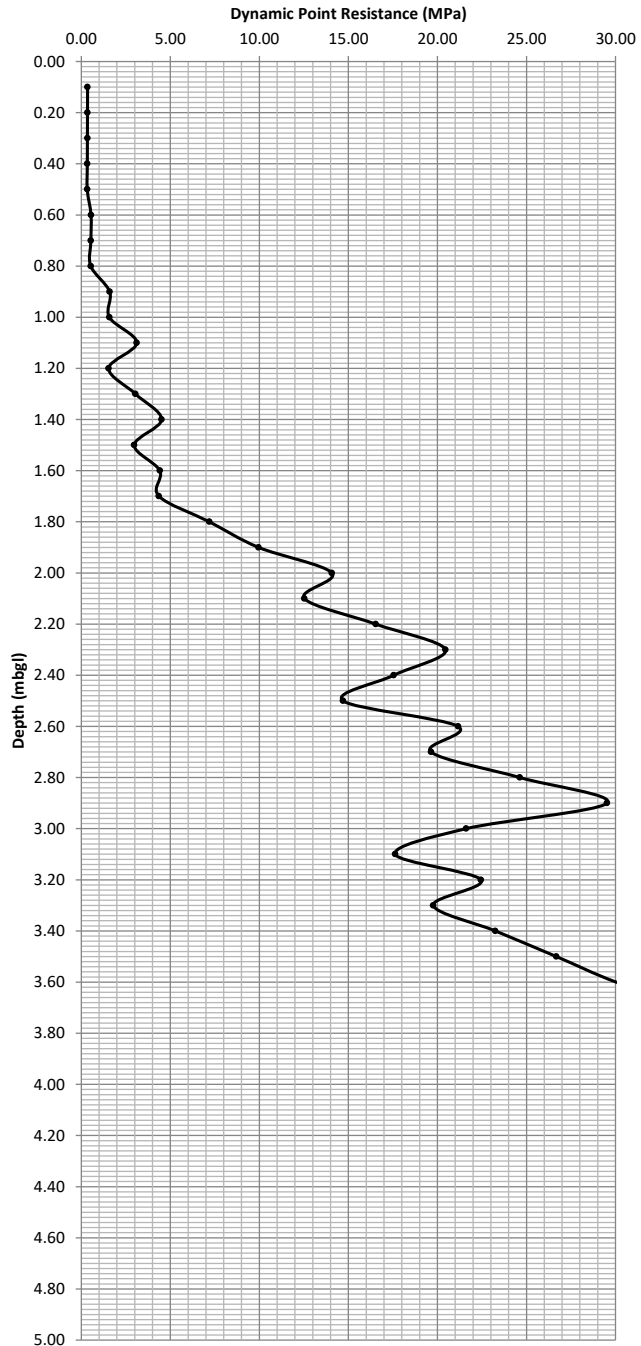
Notes:  
No further progress below 3.90m depth - hammer bouncing.

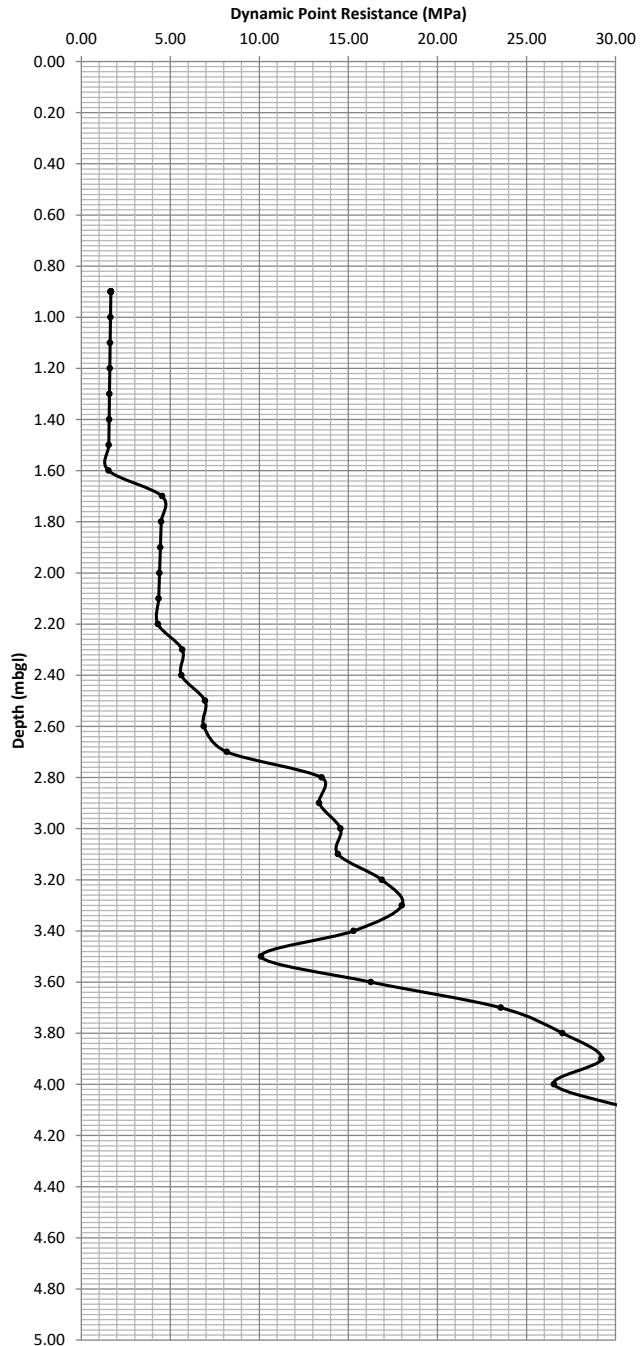
Notes:  
No further progress below 4.30m depth - hammer bouncing.

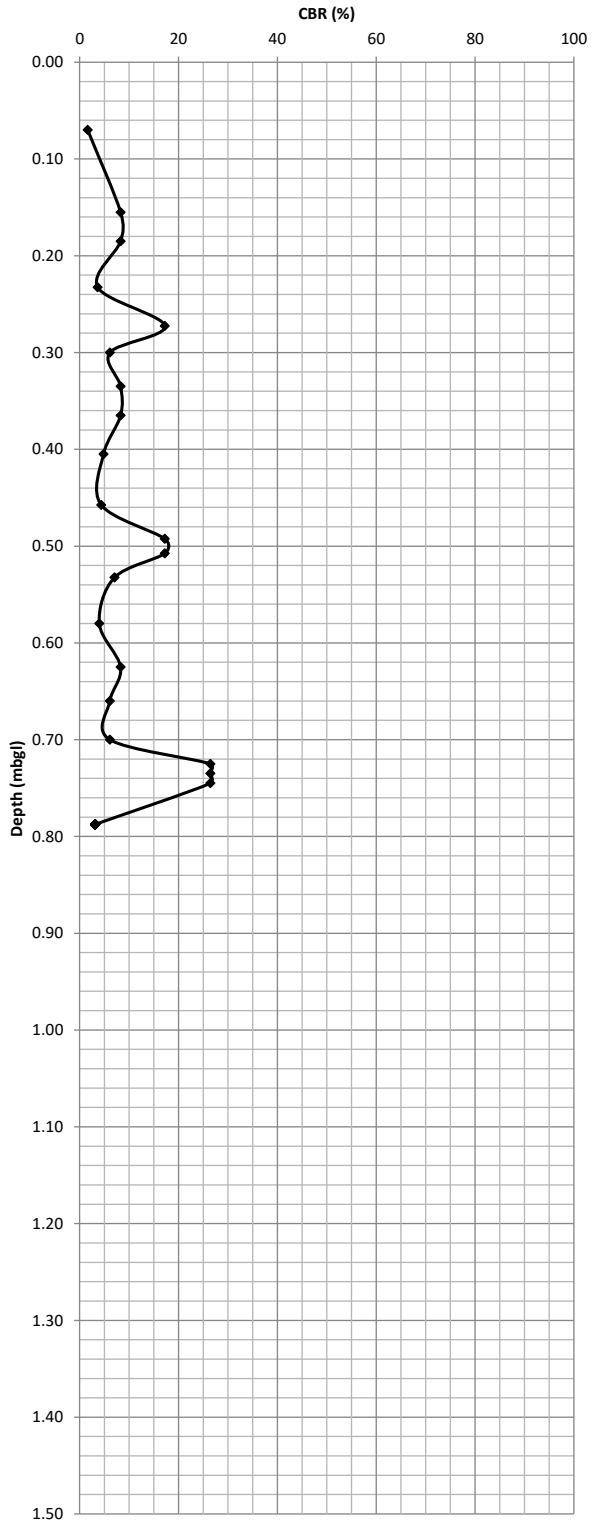
**Notes:** CBR Value calculated in accordance with the TRRL equation given in TRL Road Note 8.
