## Emergence Survey Report – Bats Nesting Birds/Barn Owl

<b>Site Location</b>	St. Marys Croft, The Green, Dungworth, Bradfield, Sheffield, South Yorkshire, S6 6HE
<b>Document reference</b>	CE1605  <i>This document should be read in conjunction with the Preliminary Roost Assessment for bats completed on the 6<sup>th</sup> October 2020 by ARBTECH</i>
<b>Date of survey</b>	Emergence Survey – 9 <sup>th</sup> May 2021 Emergence Survey – 24 <sup>th</sup> May 2021 Emergence Survey – 28 <sup>th</sup> June 2021
<b>Report by</b>	Garry Smith – Senior Ecologist  Signature:  Tel:  Email: <a href="mailto:info@chaseecology.co.uk">info@chaseecology.co.uk</a>

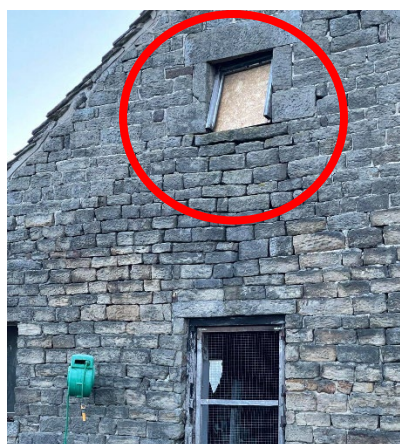
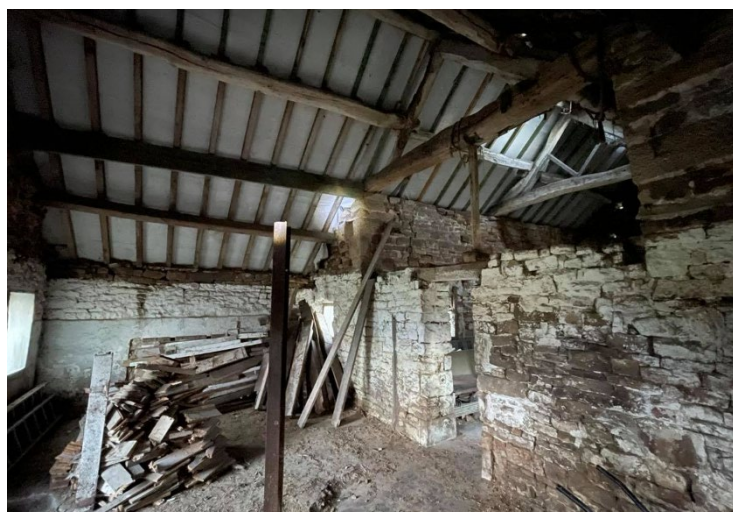
During the survey visit on the 24<sup>th</sup> May 2021 it was identified that the first floor opening within the East facing gable had been blocked up and the internal 1<sup>st</sup> floor joists & coverings had been removed as per below images.

If Barn Owl had still been active within the structure this would have likely caused access disturbance. In addition the removal of the 1<sup>st</sup> floor has opened up additional natural lighting within the roof void areas

The building has demonstrated confirmed activity from Barn Owl during an internal assessment in October 2020. It was identified in May 2021 that the only suitable access point for Barn Owl had been blocked off which may have prevented any continued roosting within if active.

It is confirmed that prior to any further development taking place a Barn owl inspection must be carried out (24 hours prior) by a suitably experienced ecologist to confirm no disturbance would be offered to said species.

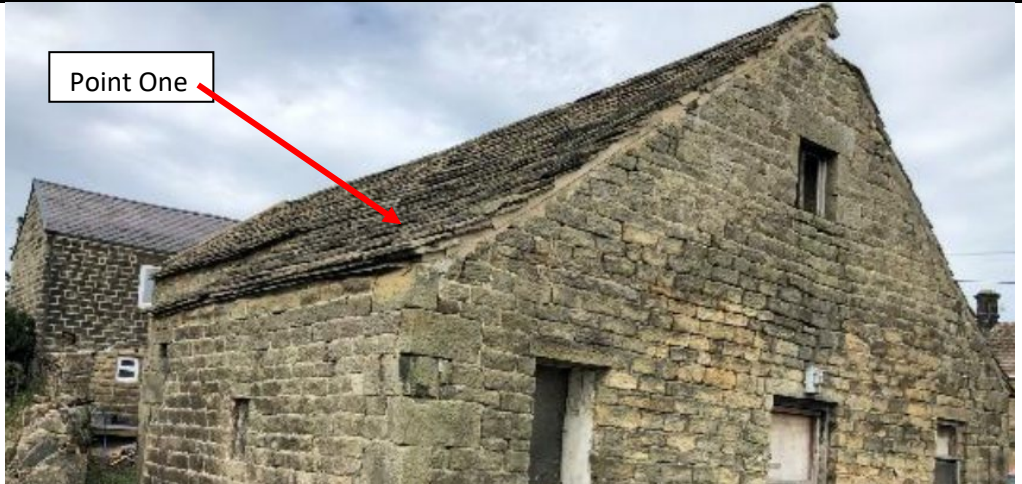
Any other information including photographs of emergence points

Point	Time	Species	Activity
One	04:29	Common Pipistrelle	1 x bat emerged into rear South facing roof coverings as per below image.

Species	Activity
Common Pipistrelle	2 x bats foraging around the building and field to the rear for up to 15 minutes during mid stages of survey. 1 x bat foraging around the rear of site and across roof coverings prior to emerging into the building (Point1) at 04:29.
Soprano Pipistrelle	1 x commuting pass during mid stages of survey, no visual.
Brown Long-eared	1 x brief foraging during early stages of survey, no visual.

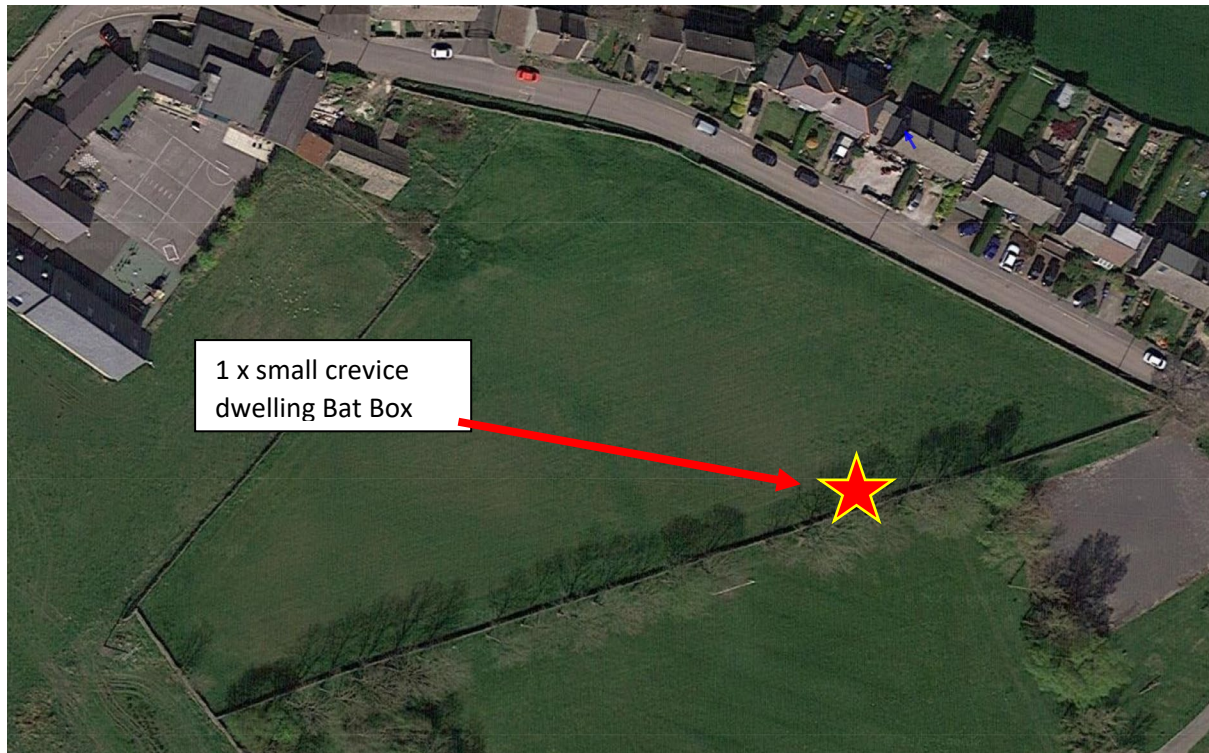
## Bat box location within the site

- One small crevice dwelling bat box will be installed within the site and remain as a permanent fixture. This selected box will form part of the mitigation licence and will be installed by the ecologist on the day of the mitigation works.

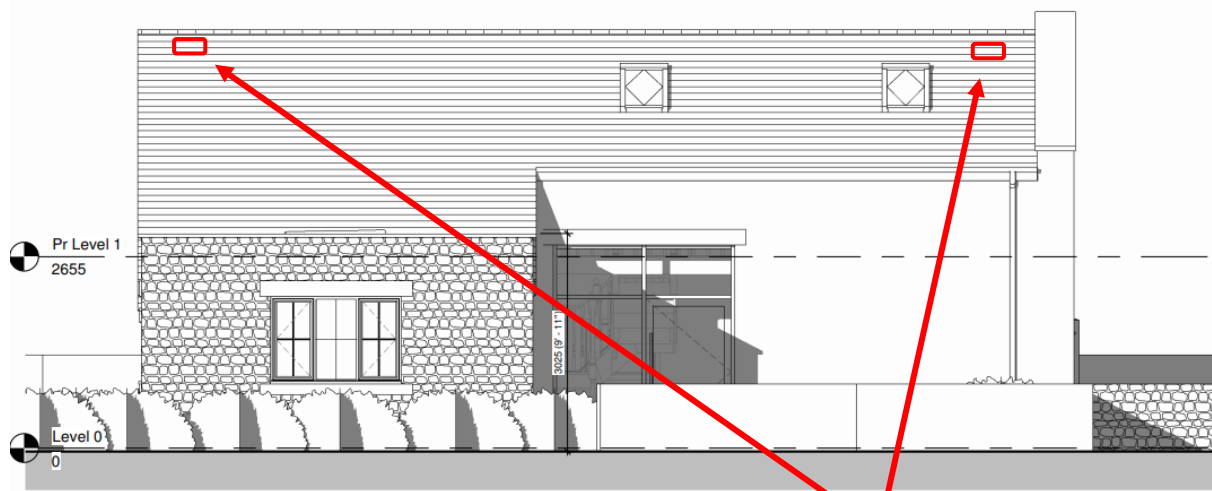
2 **Proposed Front (North) Elevation**  
1 : 50

Four bat access tiles will be introduced within the new roof coverings (two North & two South) to offer continued roosting features commonly used by crevice dwelling bats such as Common Pipistrelle.

Bat Access tile

It is confirmed that a felt membrane covering **MUST** be used during the construction of the new roof coverings during development as breathable roof membrane

coverings have been demonstrated to offer danger to bats and not recommended for use on such development works.

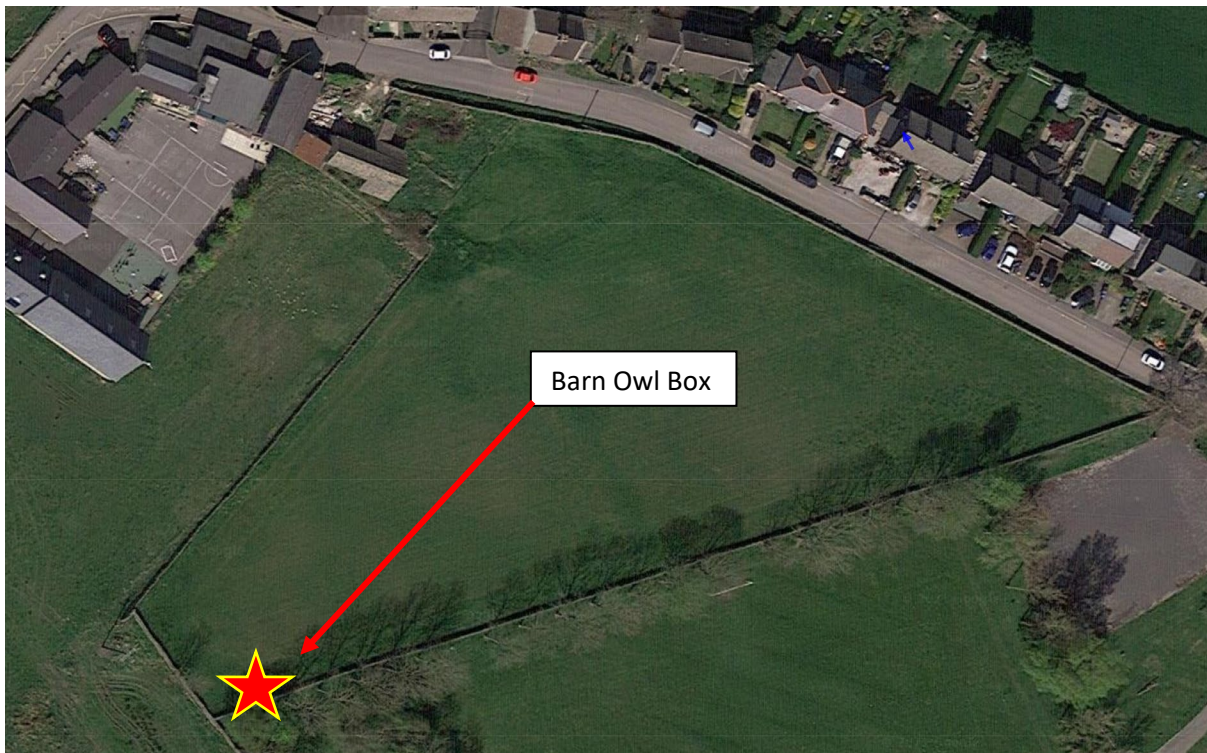
As the proposed development will likely offer an impact to Barn Owl with a loss in roosting habitat. It has been agreed that a barn owl box (Post mounted) will be introduced within the site and maintained by the client for no less than 10 years.
