Conservation Area Character Appraisal and Management Plan

Droxford

November 2015

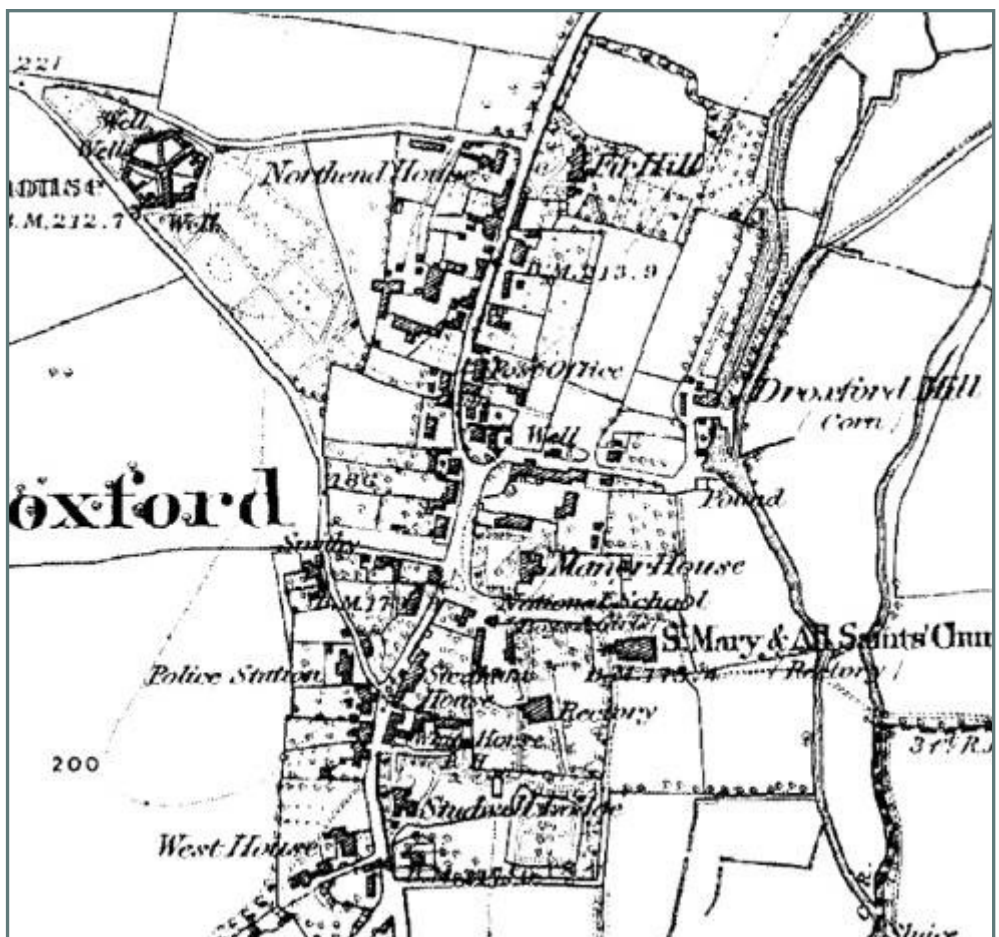
Figure 4: OS 1:10,500 map of 1872

3.9 The Tithe Map of the village dates to the 1840s (figure 5) and OS First Edition for Droxford was published in 1872. (figure 4) They clearly show the historic core and extent of the settlement. Later maps show incremental expansion, predominantly towards the west. The river forms a natural barrier to development to the east. Interestingly, there has only been limited development extending the linear form of the settlement to the north or south.

4.8 The historic OS mapping (Figures 4, 6 and 7) shows Droxford as a regular row on the west and north-east sides of the High Street. In these areas, the property plots are laid at right angles to the road, resembling a mediaeval burgage arrangement. If this interpretation is correct, Police Station Lane could represent the remnant of a back lane serving the properties on the west side of High Street.

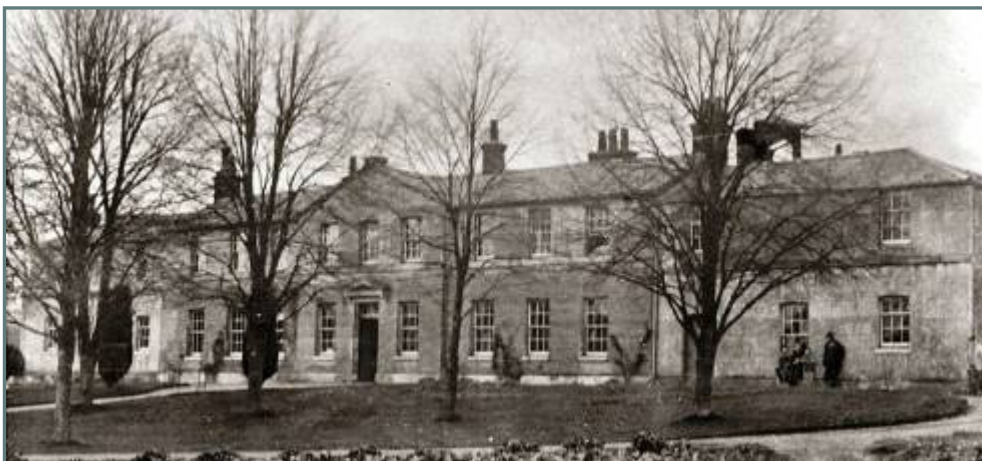
Figure 8: Historic photograph of the Union Workhouse.

3.13 Droxford was something of an administrative centre for the surrounding area. A Union Workhouse was built in 1836-7, serving the village and ten other parishes. The building was designed by a local architect, Sampson Kempthorne, and followed his model hexagonal plan. It was demolished in the 1980s but a memory of it survives in the name of Union Lane. The village was also the location of a petty sessions (magistrates) court and was provided with a court house, attached to the police station, in 1858. It was also the seat of Droxford Rural District Council, created by the Local Government Act of 1894 and abolished in 1974.

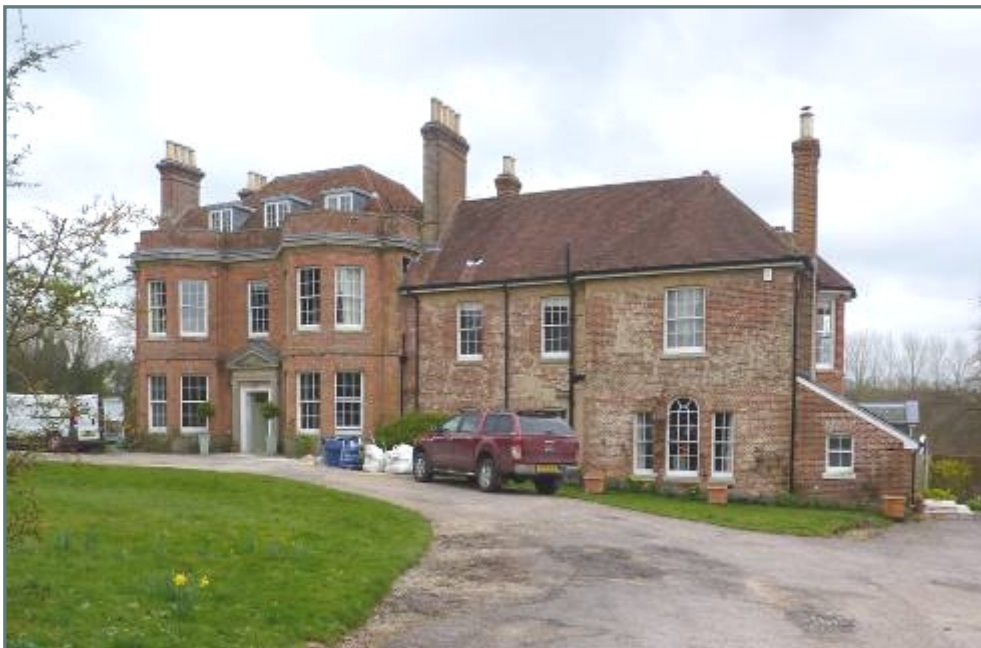
Figure 9: **Fir Hill**: mid 18th century in origins, with mid 19th century extension. Grade II listed.

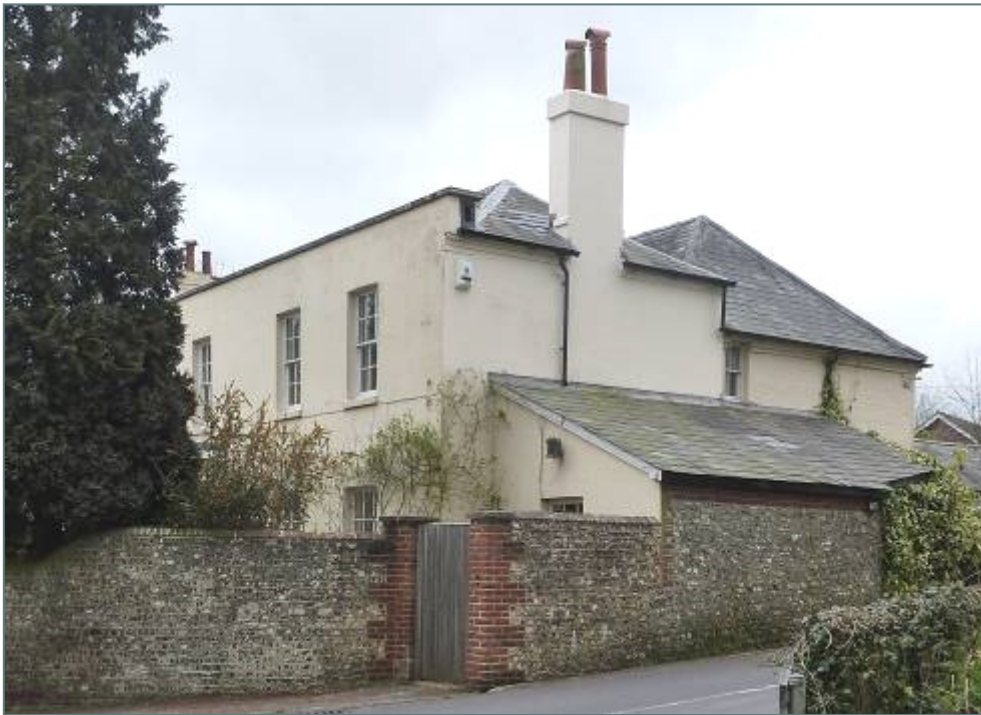
Figure 11: **Northend House:** late 18th & early 19th century in date. Grade II listed.

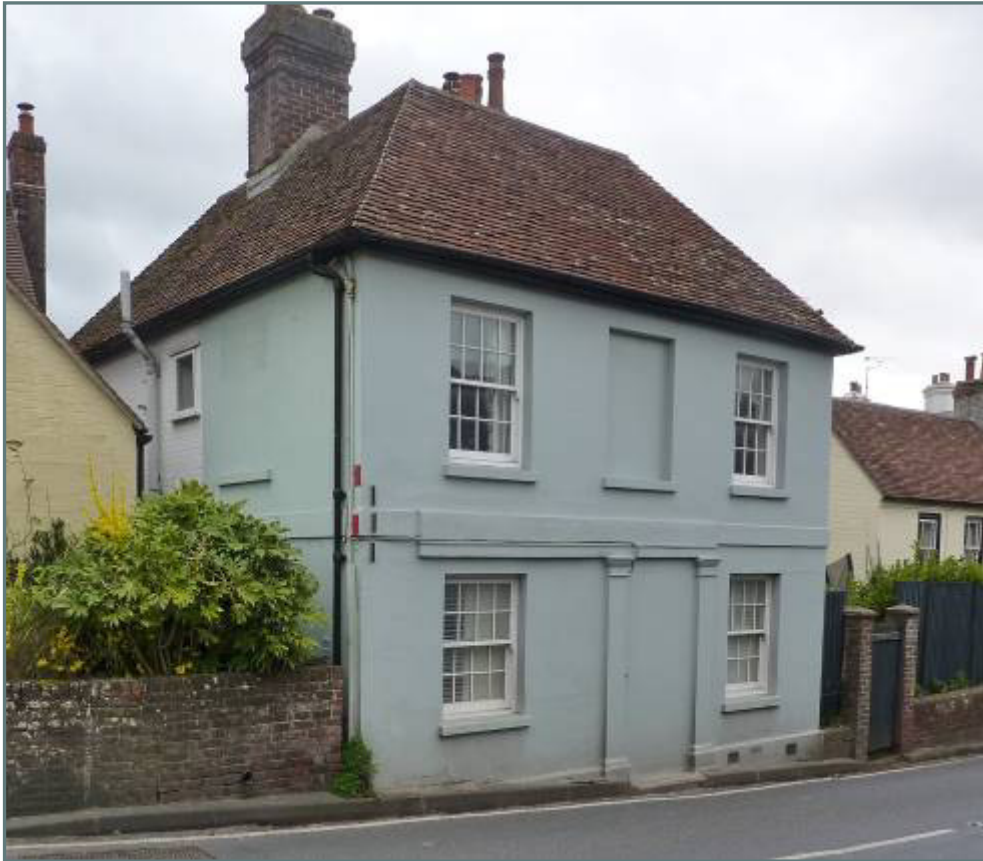
Figure 20: **The Old Post House.** The pilasters, blocked door and mutilated cornice are the remnants of an earlier shopfront.

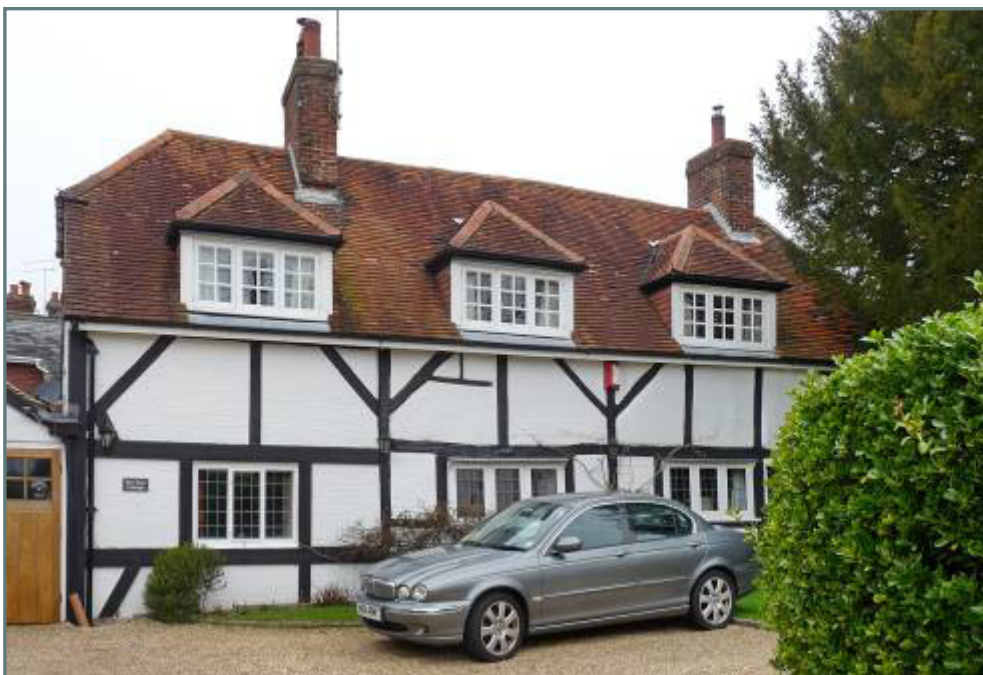
Figure 21: **Yew Tree Cottage, High Street:** c1600 timber frame with c1800 timber framed extensions. Grade II listed.

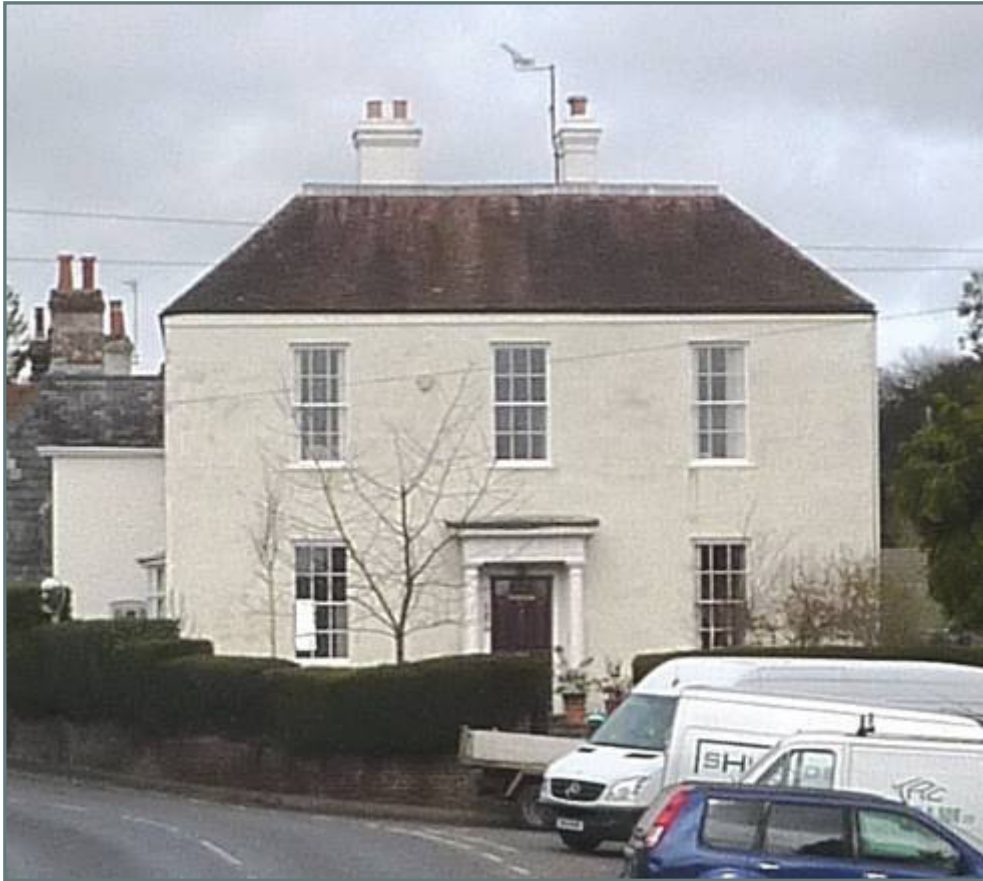
Figures 24 and 25: **Meon House**, The Square: late 18th century. Grade II listed, with group value.

The house sits in a prominent position at the core of the village, emphasised by its elevated position and the way in which the main road aligns on it before sweeping up and to the west of the house.

4.23 About half way along the main road stands *Meon House* (Figure 24 and 25), which is given great prominence by its elevated position and the way in which

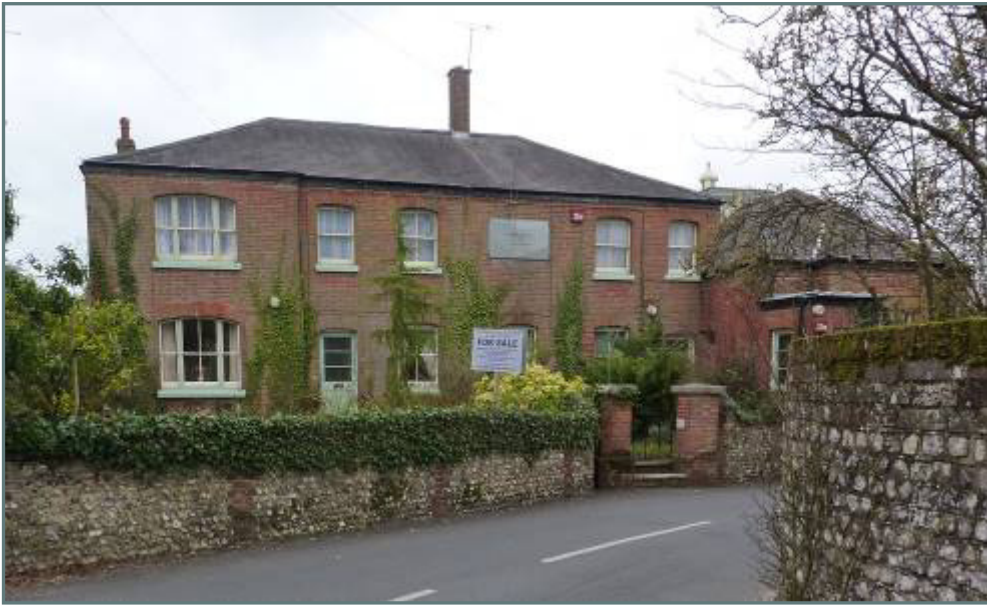
Figure 47: **Former Police Station and Court House** of 1858, Police Station Lane. Not currently included within the Conservation Area, but an extension is recommended. Identified as 'Locally Listed Buildings' in the Management Plan

6.7 A third addition to the west side of the Conservation Area is proposed at the southern end of Police Station Lane, covering the Police Station and Court House as well as other broadly contemporaneous buildings which share an architectural palette (figure 47). These are high quality, little altered mid-Victorian buildings in their own right and retain some evidential value as survivals from the time when Droxford was the location of a petty sessions (magistrates) court. The inclusion of the older *Dove Cottage* to the north is also recommended.

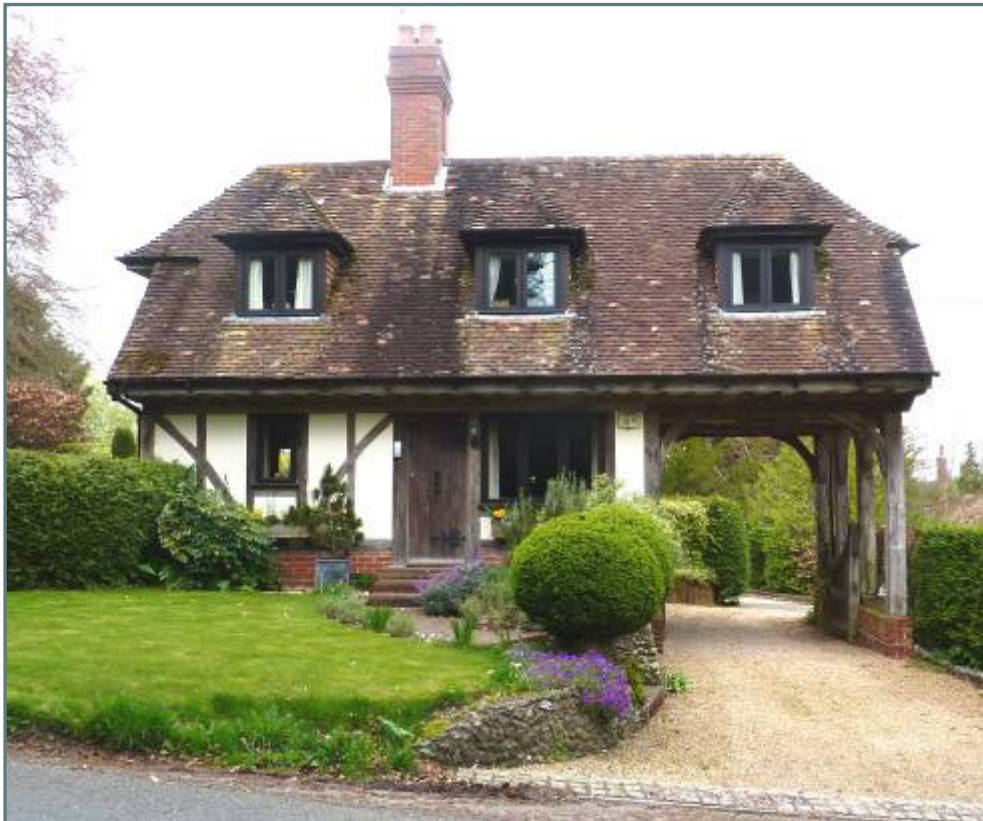
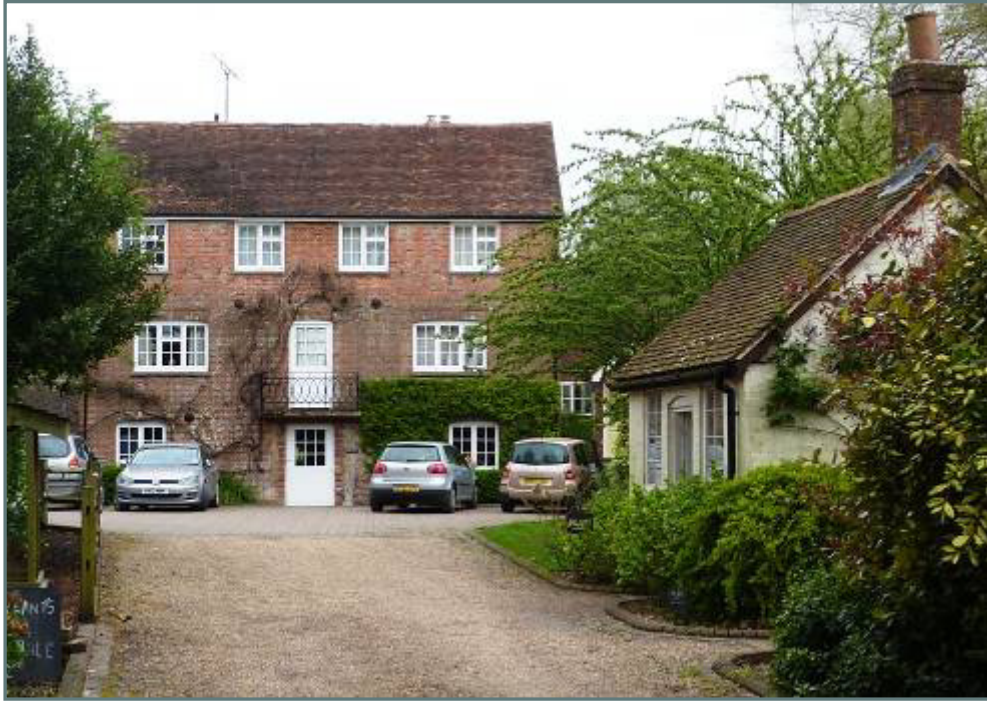
Figure 53: **The Mill** (above) and end of the mill race (below). The main mill building has been identified as a Locally Listed Building

4.26 Other notable groups of buildings are those associated with the Mill (Figure 53), which is recommended for selection as a Locally Listed building, and the collection of mid 19th century buildings on Police Station Lane associated with the administration of justice; the Police Station, the Court House and some associated housing, which all share stylistic characteristics (Figure 47).

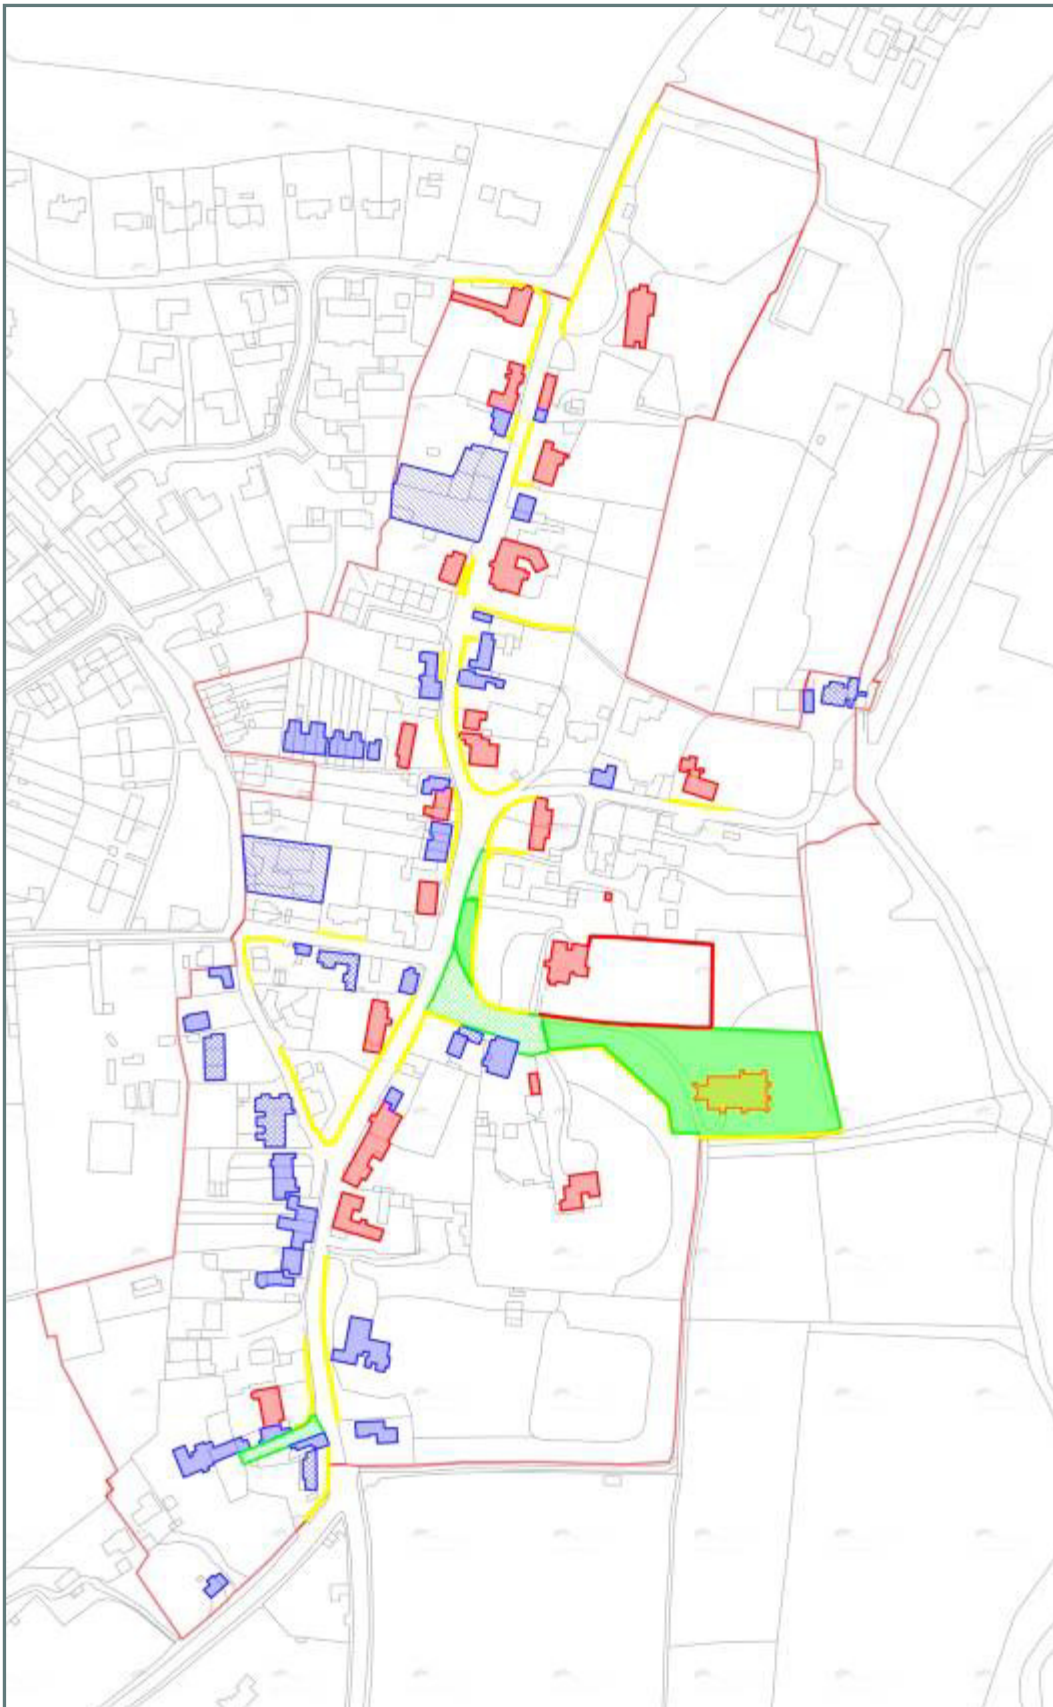
The extensions to the Conservation Area boundary were approved by the National Park's Planning Committee on 12 November 2015 and the revised map below shows the new boundary
