Our Ref: YEX2198

**Ref: Pulborough Garden Centre, Stopham Road, Pulborough, RH20 1DS**

### Soakaway Tests

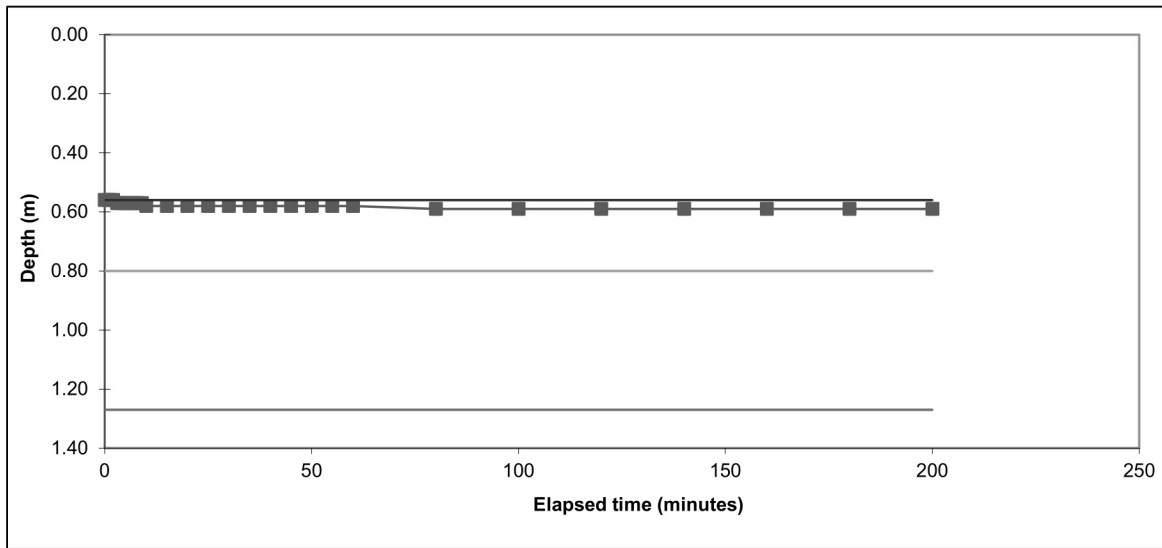
<b>Client:</b>	British Garden Centres Group	<b>TP1</b>
<b>Site:</b>	Pulborough Garden Centre

Trial Pit No:	TP1	Test No:	1	Date:	20/05/2021
Length (m):	1.400	Datum Height:		0.00 m agl	
Width (m):	0.30	Granular infill:	None		
Depth (m):	1.50	Porosity of infill:	1	(assumed)

Elapsed time (minutes)	Water Depth (m below datum)	Elapsed time (minutes)	Water Depth (m below datum)
0	0.560	30	0.580
1	0.560	35	0.580
2	0.560	40	0.580
3	0.570	45	0.580
4	0.570	50	0.580
5	0.570	55	0.580
6	0.570	60	0.580
7	0.570	80	0.590
8	0.570	100	0.590
9	0.570	120	0.590
10	0.580	140	0.590
15	0.580	160	0.590
20	0.580	180	0.590
25	0.580	200	0.590

Start water depth for analysis (mbgl)	0.56	Elapsed time (mins):	#N/A
75% effective depth (mbgl):	0.80		
50% effective depth (mbgl):	1.03	Elapsed time (mins):	#N/A
25% effective depth (mbgl):	1.27		
Base of soakage zone (mbgl):	1.50		
Volume outflow between 75% and 25% effective depth (m <sup>3</sup> ):			
Mean surface area of outflow (m <sup>2</sup> ):		2.02	
(side area at 50% effective depth + base area)			
Time for outflow between 75% and 25% effective depth (mins):

<b>Soil infiltration rate (m/s):</b>	<b>Test incomplete as 25% effective depth not achieved. Unable to reliably determine soil infiltration rate.</b>
--------------------------------------	--

WS	Soakage Area Dimensions (m)	Depth (m)	Soil Description (Base of TP)	Infiltration Rate (m/sec)	Drainage Characteristics
TP01 test1	1.40 x 0.30	1.50	Orangish brown sandy CLAY. Sand is fine - medium.	N/A	Practically Impermeable
TP02 test1	1.20 x 0.30	1.50	Orangish brown sandy CLAY. Sand is fine - medium.	N/A	Practically Impermeable
TP03 test1	1.10 x 0.30	1.50	Orangish brown sandy CLAY. Sand is fine - medium.	N/A	Practically Impermeable

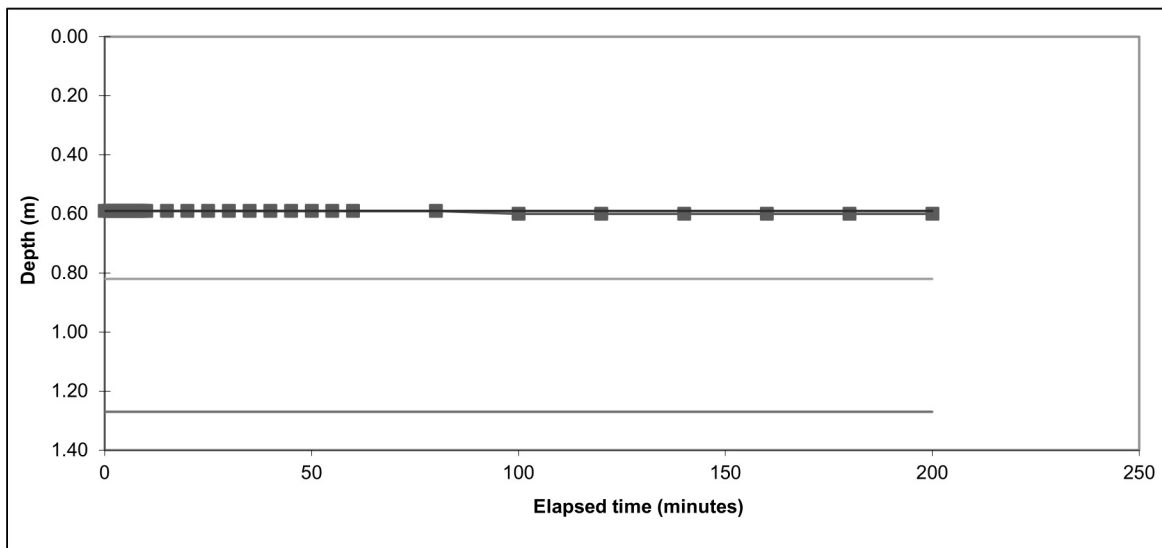
<b>Client:</b>	British Garden Centres Group	<b>TP2</b>
<b>Site:</b>	Pulborough Garden Centre

Trial Pit No:	TP2	Test No:	1	Date:	20/05/2021
Length (m):	1.200	Datum Height:		0.00 m agl	
Width (m):	0.30	Granular infill:	None		
Depth (m):	1.50	Porosity of infill:	1	(assumed)

Elapsed time (minutes)	Water Depth (m below datum)	Elapsed time (minutes)	Water Depth (m below datum)
0	0.590	30	0.590
1	0.590	35	0.590
2	0.590	40	0.590
3	0.590	45	0.590
4	0.590	50	0.590
5	0.590	55	0.590
6	0.590	60	0.590
7	0.590	80	0.590
8	0.590	100	0.600
9	0.590	120	0.600
10	0.590	140	0.600
15	0.590	160	0.600
20	0.590	180	0.600
25	0.590	200	0.600

Start water depth for analysis (mbgl)	0.59	Elapsed time (mins):	#N/A
75% effective depth (mbgl):	0.82		
50% effective depth (mbgl):	1.05	Elapsed time (mins):	#N/A
25% effective depth (mbgl):	1.27		
Base of soakage zone (mbgl):	1.50

Volume outflow between 75% and 25% effective depth (m<sup>3</sup>):  
 Mean surface area of outflow (m<sup>2</sup>): 1.71  
 (side area at 50% effective depth + base area)  
 Time for outflow between 75% and 25% effective depth (mins):

<b>Soil infiltration rate (m/s):</b>	<b>Test incomplete as 25% effective depth not achieved. Unable to reliably determine soil infiltration rate.</b>
--------------------------------------	--

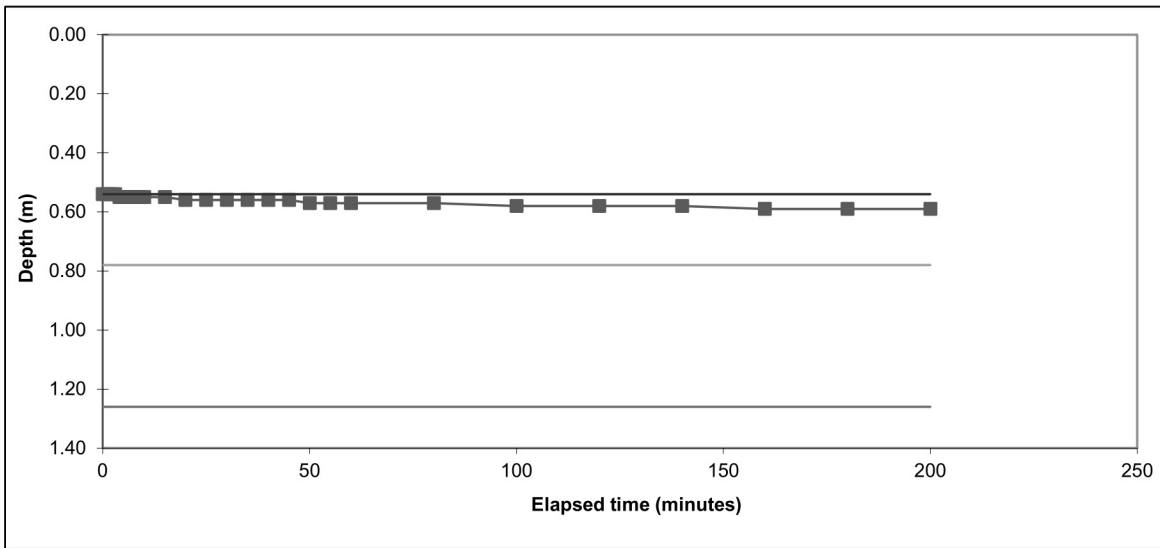
<b>Client:</b>	British Garden Centres Group	<b>TP3</b>
<b>Site:</b>	Pulborough Garden Centre

Trial Pit No:	TP3	Test No:	1	Date:	20/05/2021
Length (m):	1.100	Datum Height:		0.00 m agl	
Width (m):	0.30	Granular infill:	None		
Depth (m):	1.50	Porosity of infill:	1	(assumed)

Elapsed time (minutes)	Water Depth (m below datum)	Elapsed time (minutes)	Water Depth (m below datum)
0	0.540	30	0.560
1	0.540	35	0.560
2	0.540	40	0.560
3	0.540	45	0.560
4	0.550	50	0.570
5	0.550	55	0.570
6	0.550	60	0.570
7	0.550	80	0.570
8	0.550	100	0.580
9	0.550	120	0.580
10	0.550	140	0.580
15	0.550	160	0.590
20	0.560	180	0.590
25	0.560	200	0.590

Start water depth for analysis (mbgl)	0.54		
75% effective depth (mbgl):	0.78	Elapsed time (mins):	#N/A
50% effective depth (mbgl):	1.02		
25% effective depth (mbgl):	1.26	Elapsed time (mins):	#N/A
Base of soakage zone (mbgl):	1.50		
Volume outflow between 75% and 25% effective depth (m <sup>3</sup> ):			
Mean surface area of outflow (m <sup>2</sup> ):		1.67	
(side area at 50% effective depth + base area)			
Time for outflow between 75% and 25% effective depth (mins):

<b>Soil infiltration rate (m/s):</b>	<b>Test incomplete as 25% effective depth not achieved. Unable to reliably determine soil infiltration rate.</b>
--------------------------------------	--

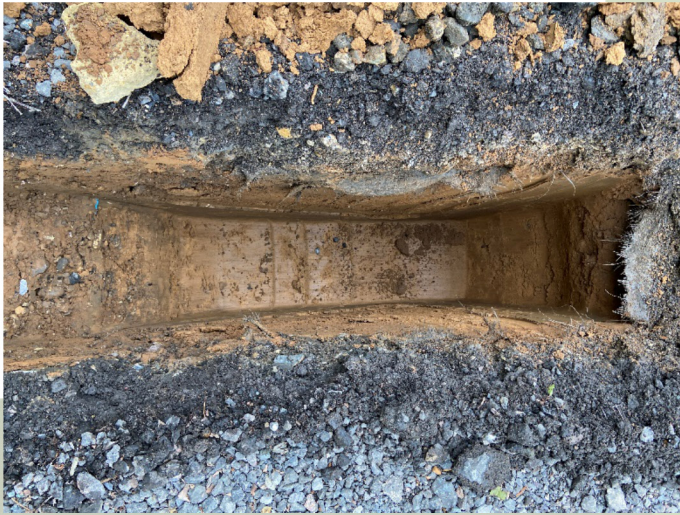
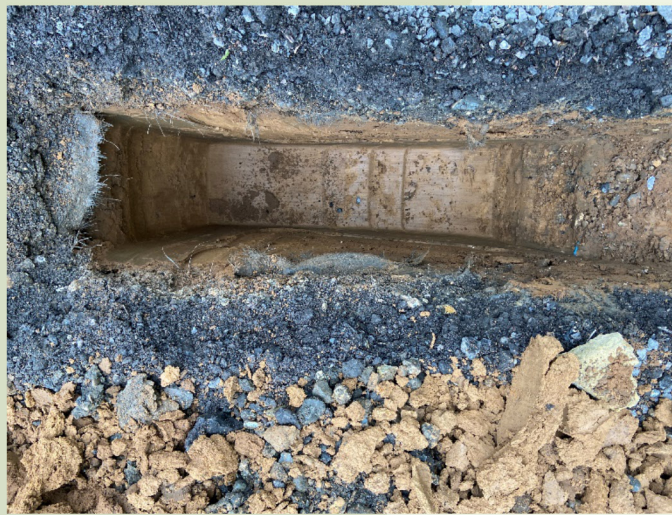
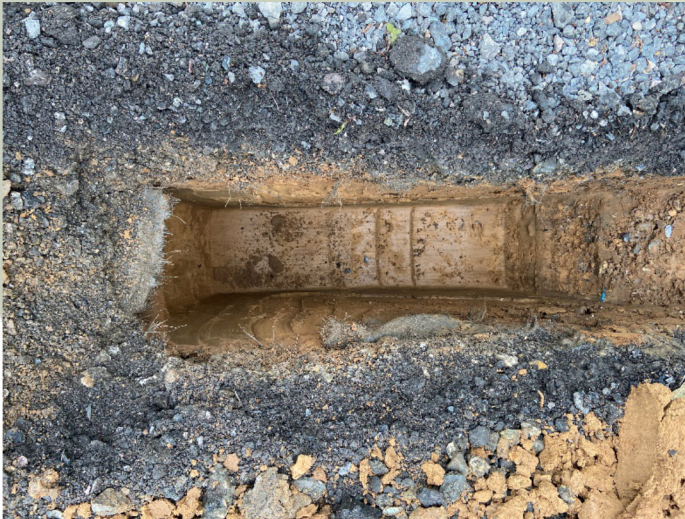
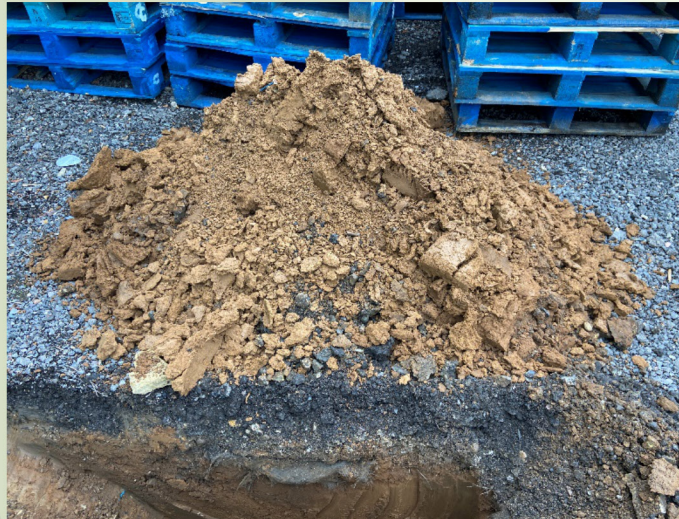
E. TP2

Stratum depth (m)	Sample Depth		Sample Type	GW	Install Details	LITHOLOGY
	From m	To m				
0.00					NONE	MADE GROUND. Black sandy GRAVEL. Sand is fine - medium. Gravel is medium - coarse, angular of asphalt fragments.
0.20						MADE GROUND. Brown sandy ,gravelly CLAY. Sand is fine - medium. Gravel is medium - coarse, angular of brick fragments and mixed lithology.
0.30						Orangish brown sandy CLAY. Sand is fine - medium.
-						
-						
-						
-						
-						
-						
-						
1.50						End of TP2

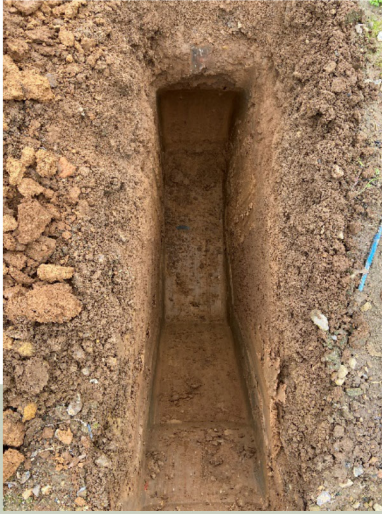
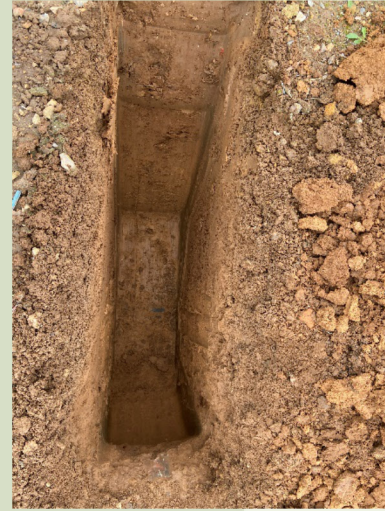
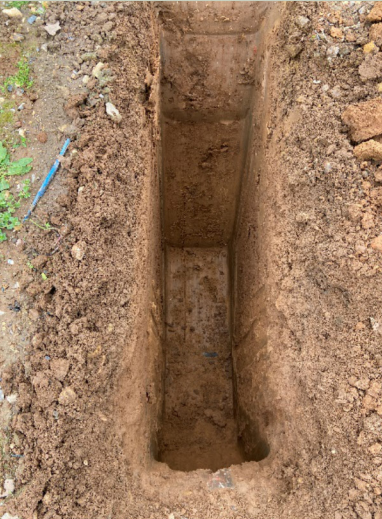
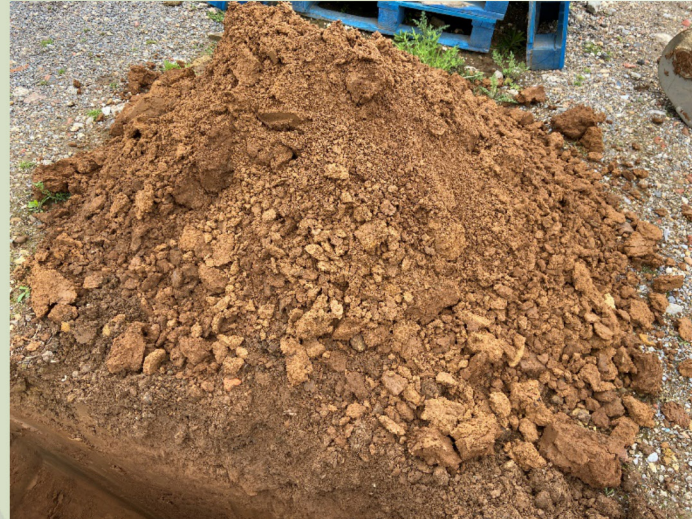
I. TP3

Stratum depth (m)	Sample Depth		Sample Type	GW	Install Details	LITHOLOGY	
	From m	To m					
0.00					NONE	MADE GROUND. Light brown gravelly, clayey SAND. Sand is fine - medium. Gravel is medium - coarse, angular of brick and concrete fragments and mixed lithology.	
0.30						Orangish brown sandy CLAY. Sand is fine - medium.	
1.50						End of TP3
