**Tregarth 8 Maes Trannon
Trefeglwys, SY17 5PS**

Proposed extension

Bat Survey

25 June 2021

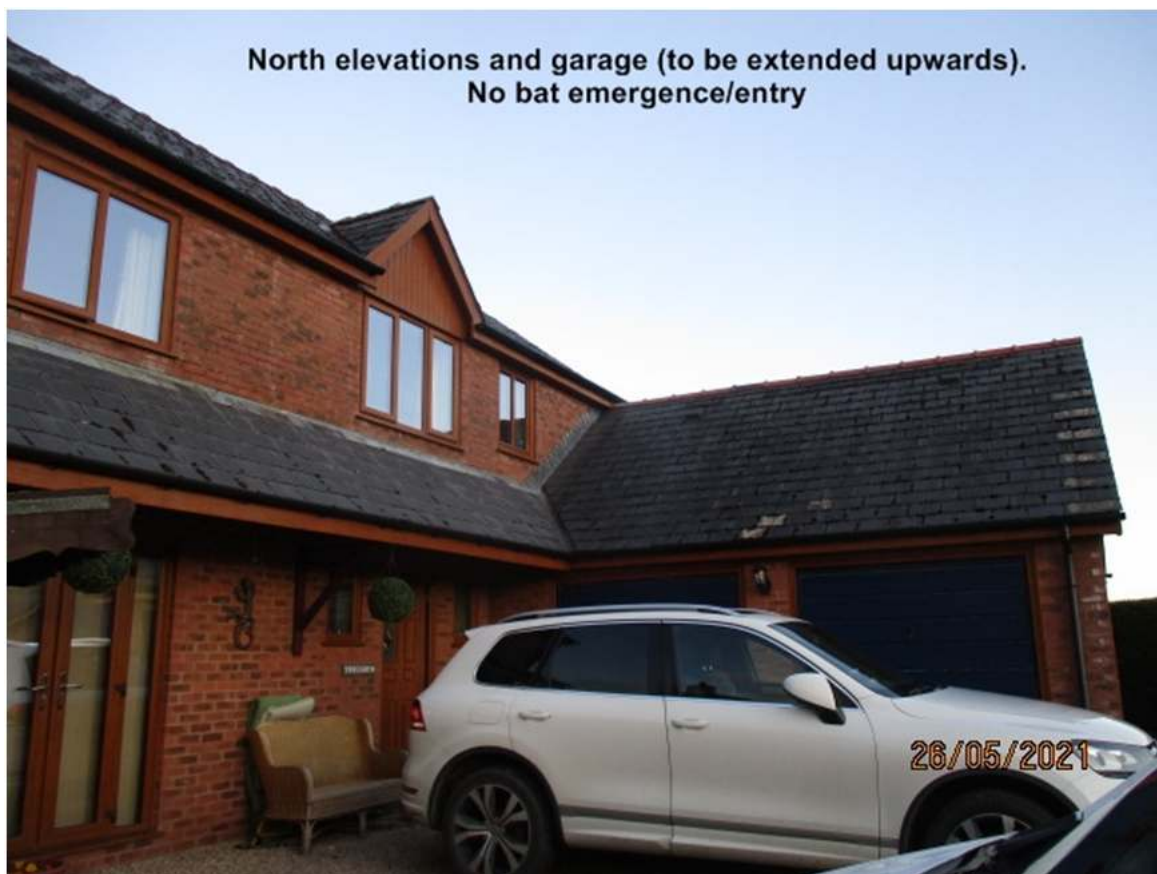
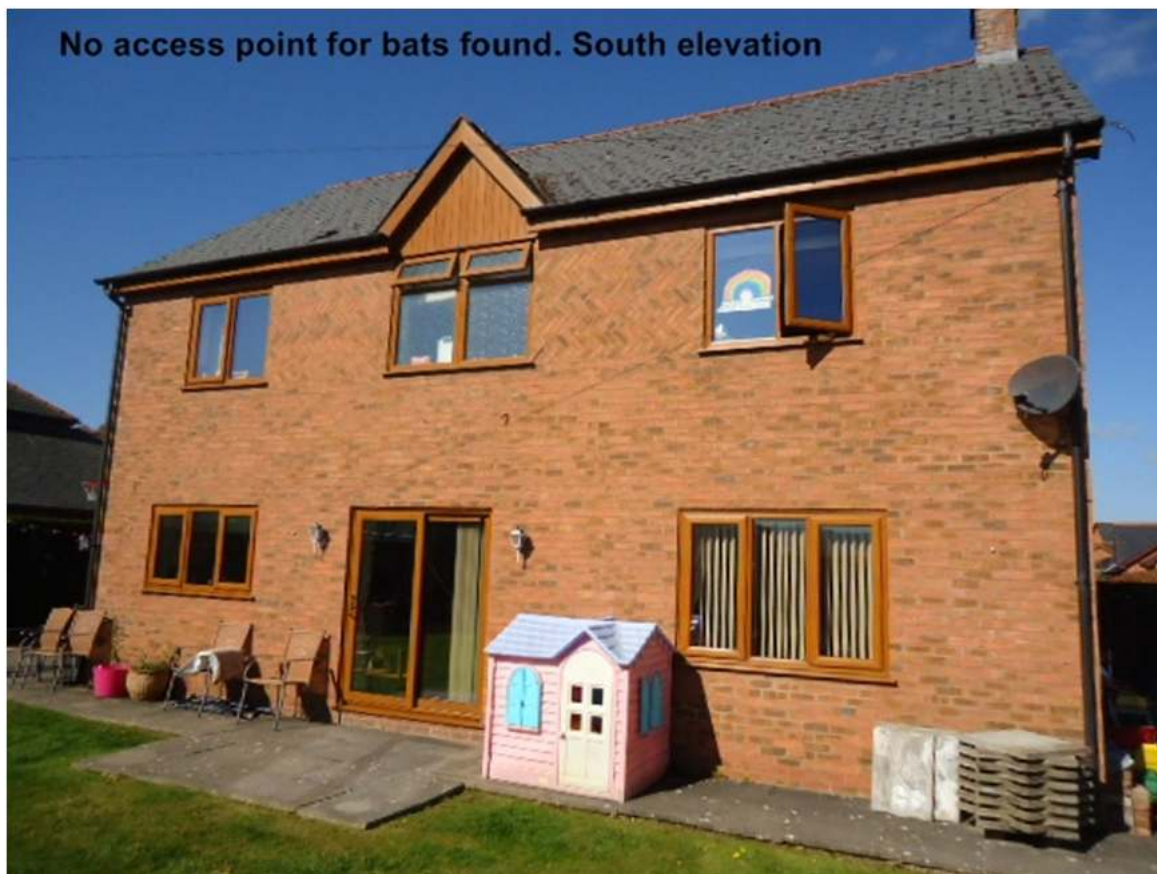
Around the building there few potential access points for bats with no gaps evident anywhere except at the tops of the East and West gable under the barge boards.

There were few obvious accesses into the building for bats, however there were small gaps under barge boards especially at the apex of the east and west gables.

**West gable and garage (to be extended upwards).
No bat emergence/entry**

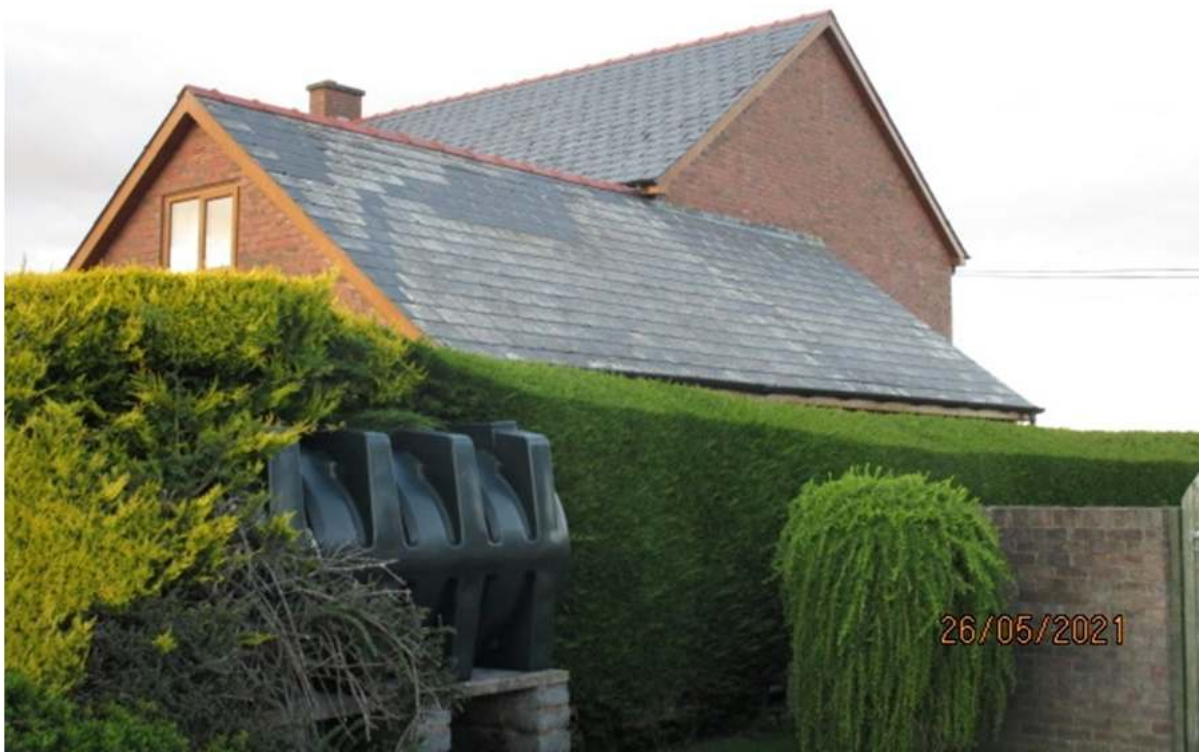
**East gable
No bat emergence/entry**
