ENVISION AESC UK BATTERY PLANT

TRANSPORT STATEMENT

IDENTIFICATION TABLE		
Client/Project owner	Envision AESC	
Project	Envision AESC UK Battery Plant	
Study	Transport Statement	
Date	15/07/2021	
Reference number	SYS_ENVISION_GB01T21B34_001

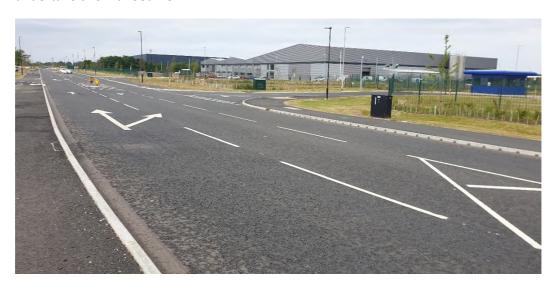
The drawings show the provision of a new right turning lane will be provided to access the new development. The right turning lane shown is approximately 55m long and appears to overlap the right turning lane for the existing access located to the east of the new site access (See photo below of existing right turn). The drawings do not show the exiting right turning lane or how the new road markings will be tied into the existing road markings. In addition, HGVs were observed pulling into the central hatching to access the existing right turn lane. If the road markings are not correctly provided this will increase the risk of vehicles entering both right turning lanes too early increasing the risk of side swipe and/or head-on collisions.

It is recommended that the drawings show how the new road markings will tie in with the existing road markings to ensure a safe layout is provided at the start of both right turning lanes and that auto-tracking is undertaken to demonstrate that large vehicles can safely undertake this manoeuvre.
