62 DURHAM ROAD, SUNDERLAND (LAND AT REAR) DESK BASED STUDY PLUS+ (PHASE 1) REPORT

*Report Ref 17019a/b
20 February 2017*

62 Durham Road, Sunderland (Land at Rear) Desk Based Study (Phase 1) Report

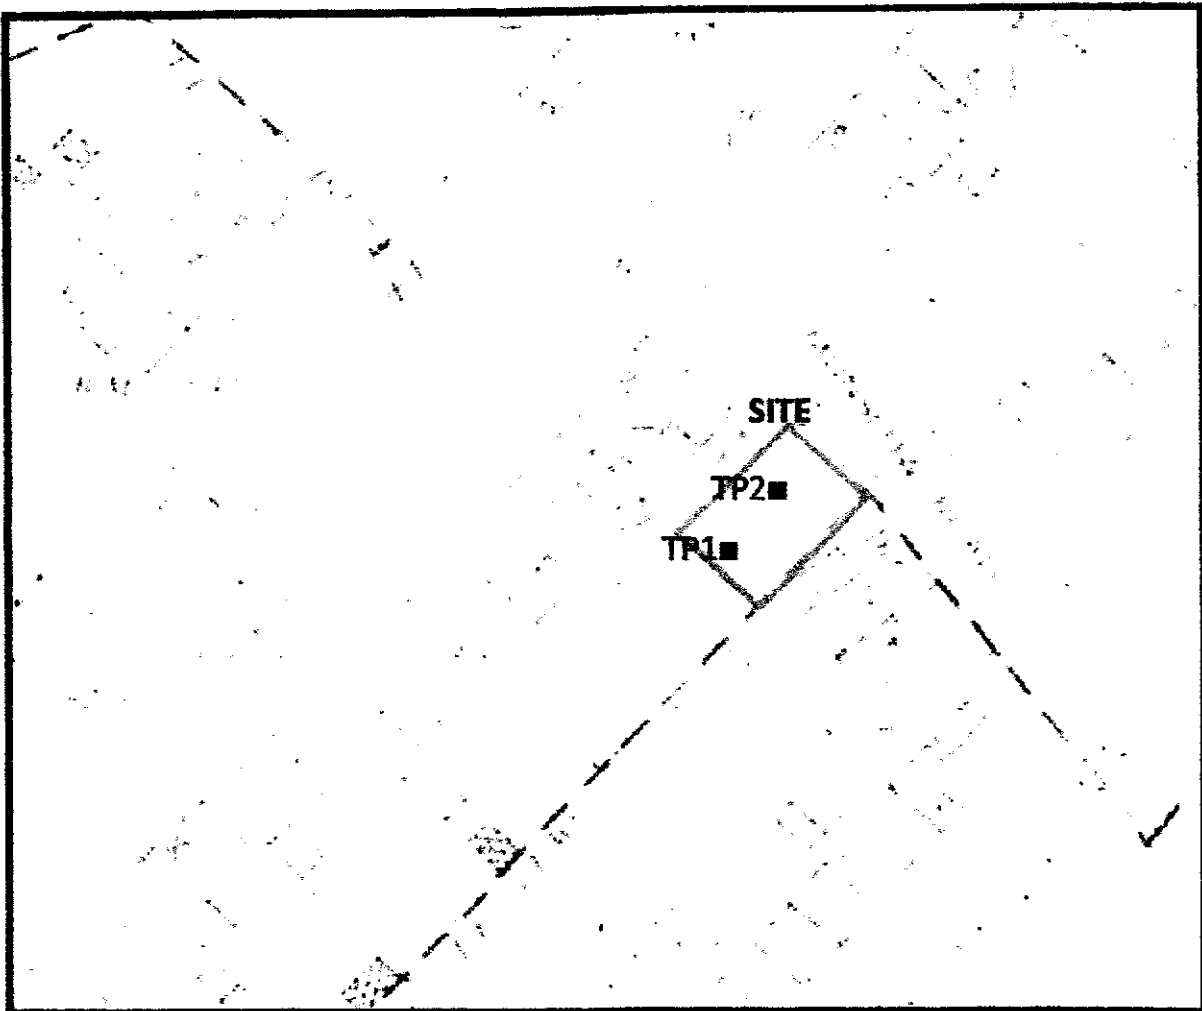
62 DURHAM ROAD (LAND AT REAR), SUNDERLAND SITE PLAN SHOWING AUGER HOLES

(NOT TO SCALE / DO NOT SCALE OFF PLAN)
For locations see coordinates in report text

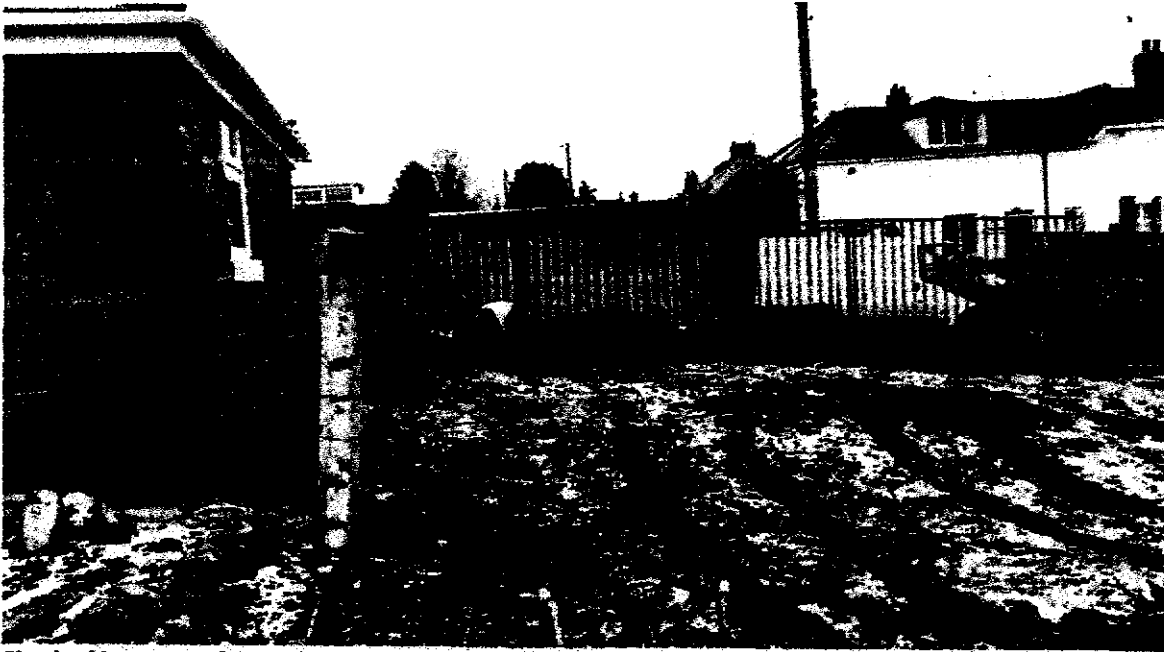
Site looking toward Munslow Road (Westward)

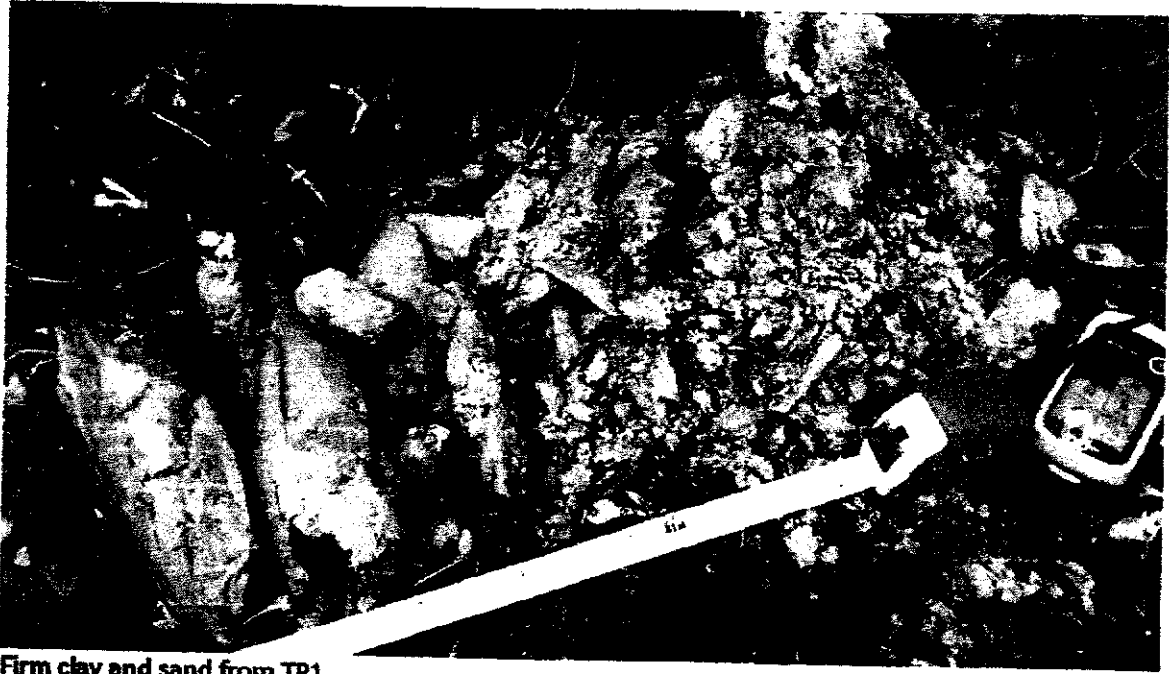
0-0.3m Dark grey black and grey brown topsoil type
0.3-1m Brown very sandy clay/clayey sand
1-1.2 Stiff dark brown clay

Firm clay and sand from TP1
