**Barrington Downs Farm Barns, Barrington Downs,  
near Aldsworth, Cheltenham,  
Gloucestershire GL54 3PT**

**Bat Survey Report**

**September 2020**

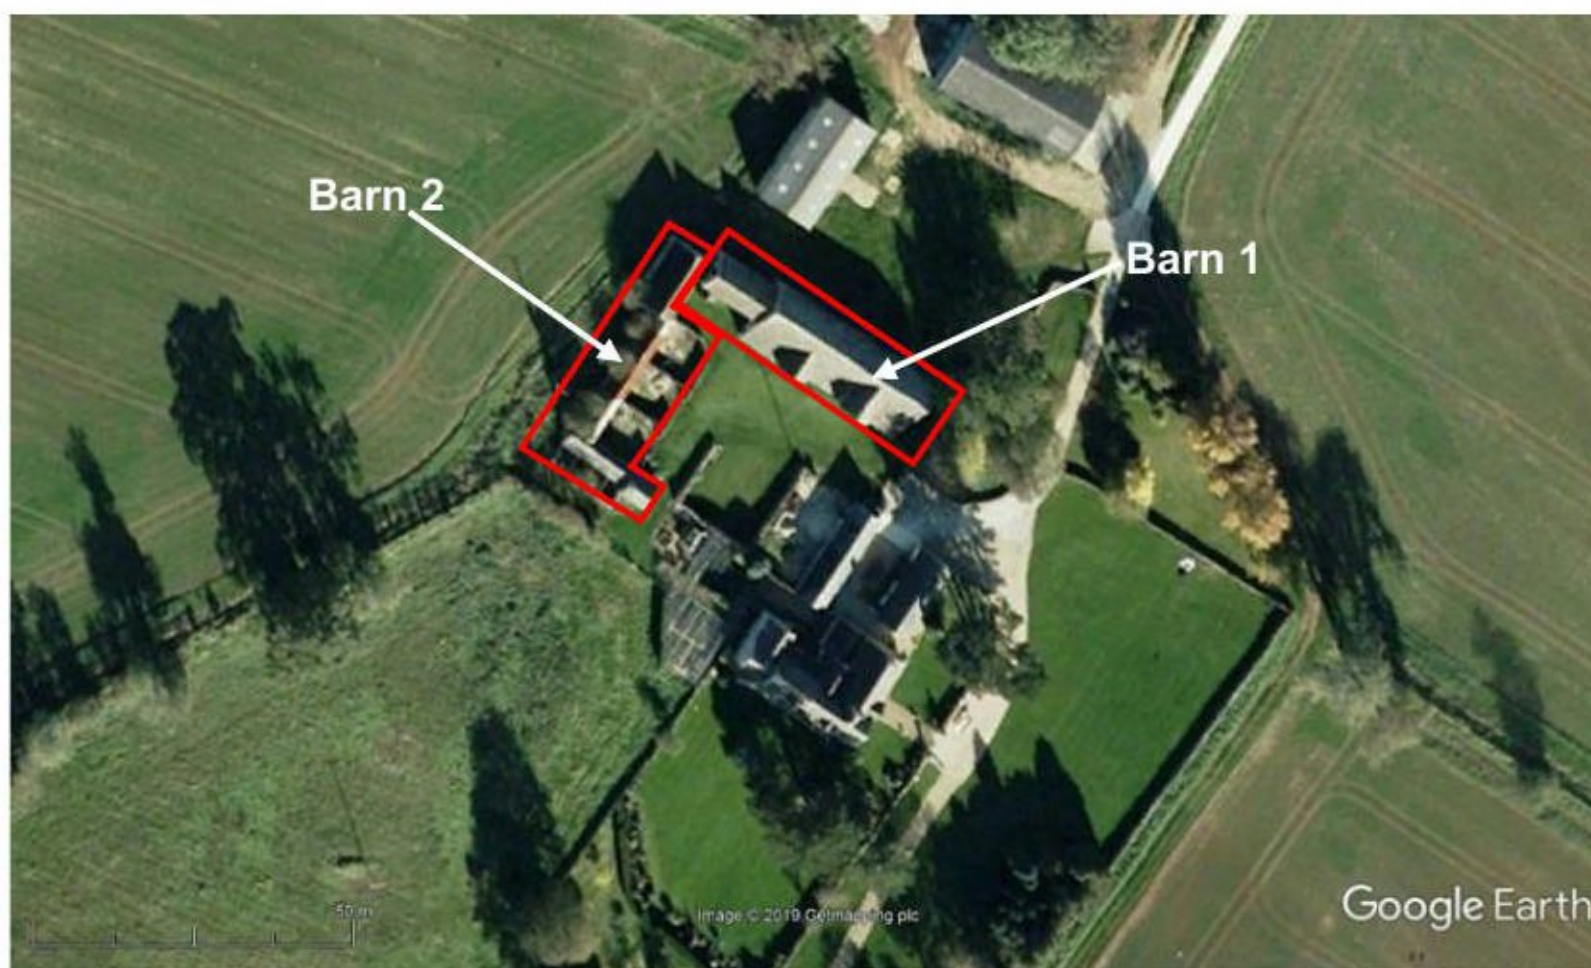
Figure 1. Aerial photograph showing the location of Barn 1 and Barn 2.

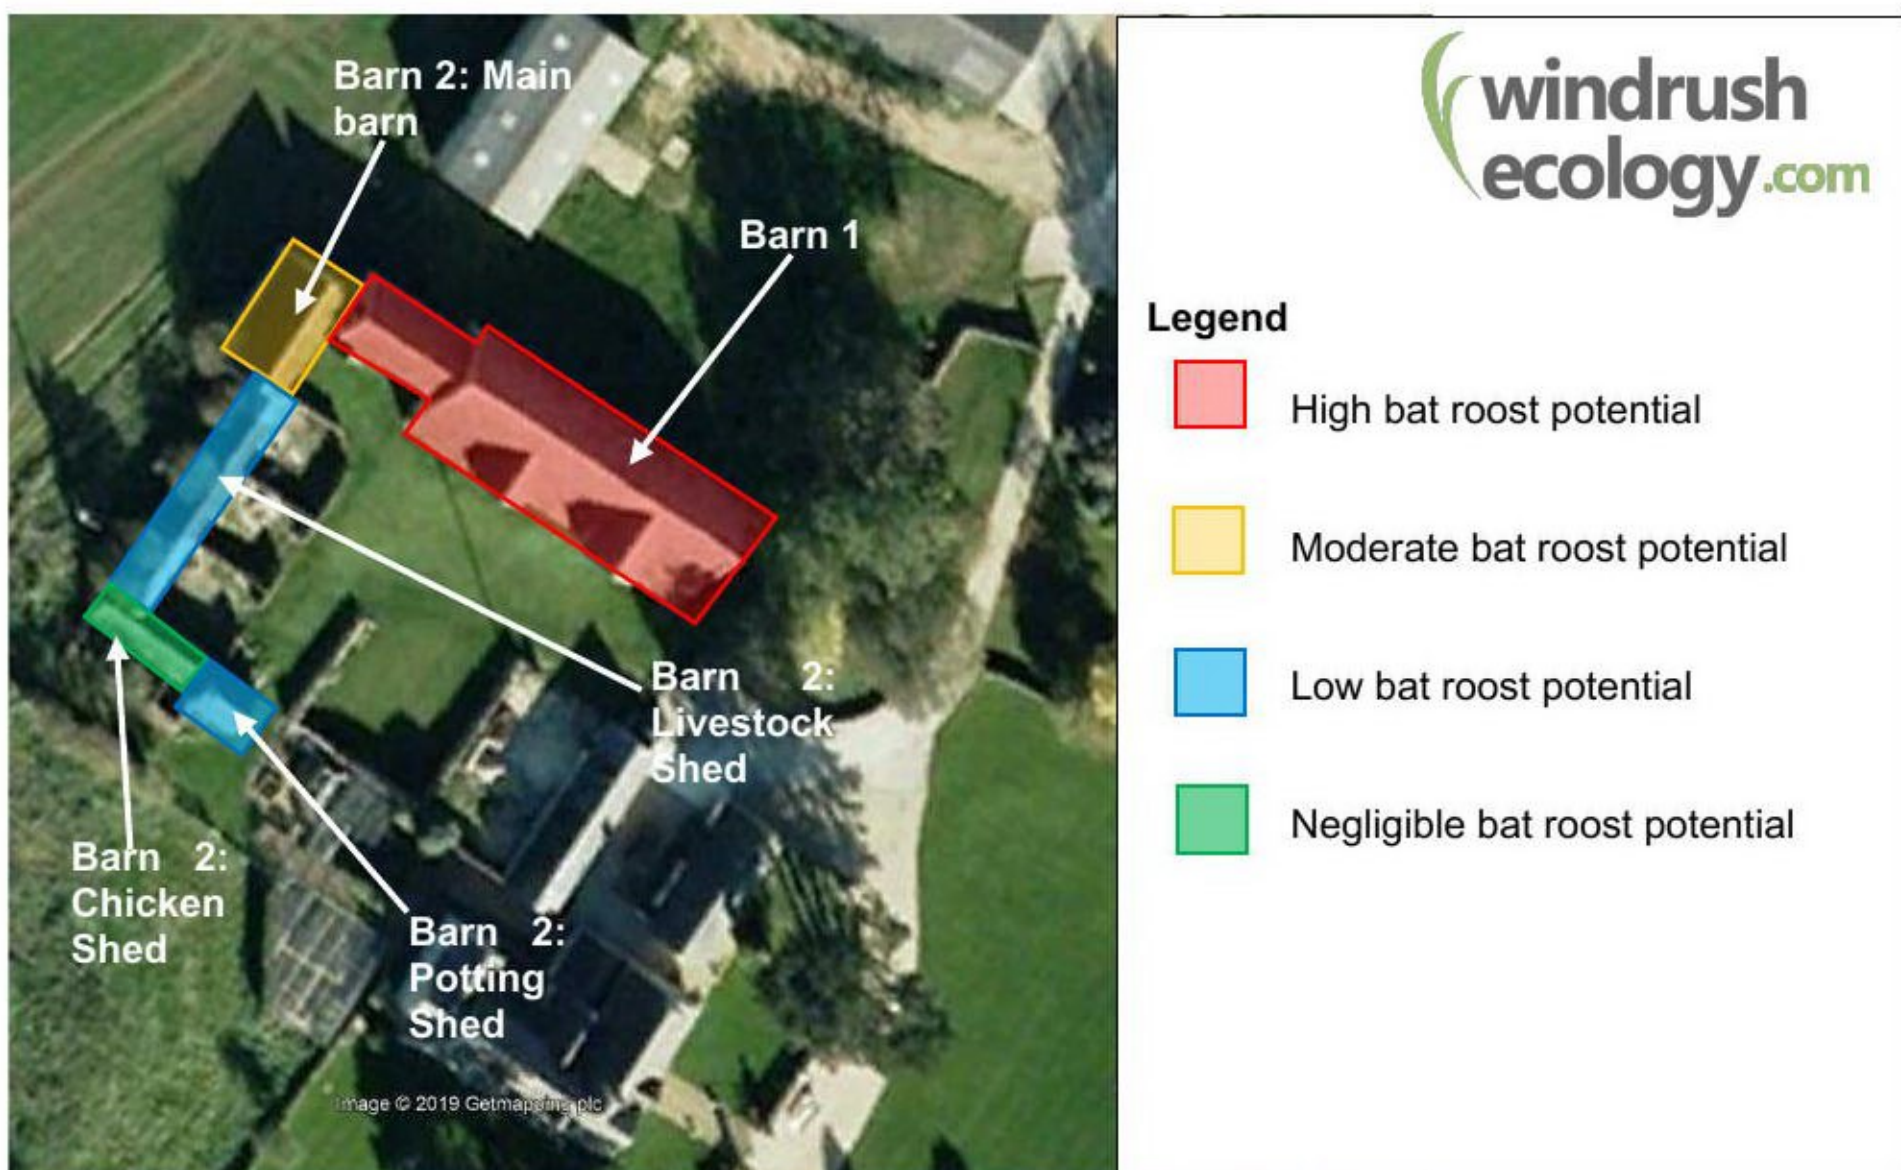
Figure 2. Plan showing the bat roost potential of the sections of the barns and the reference used for each section.

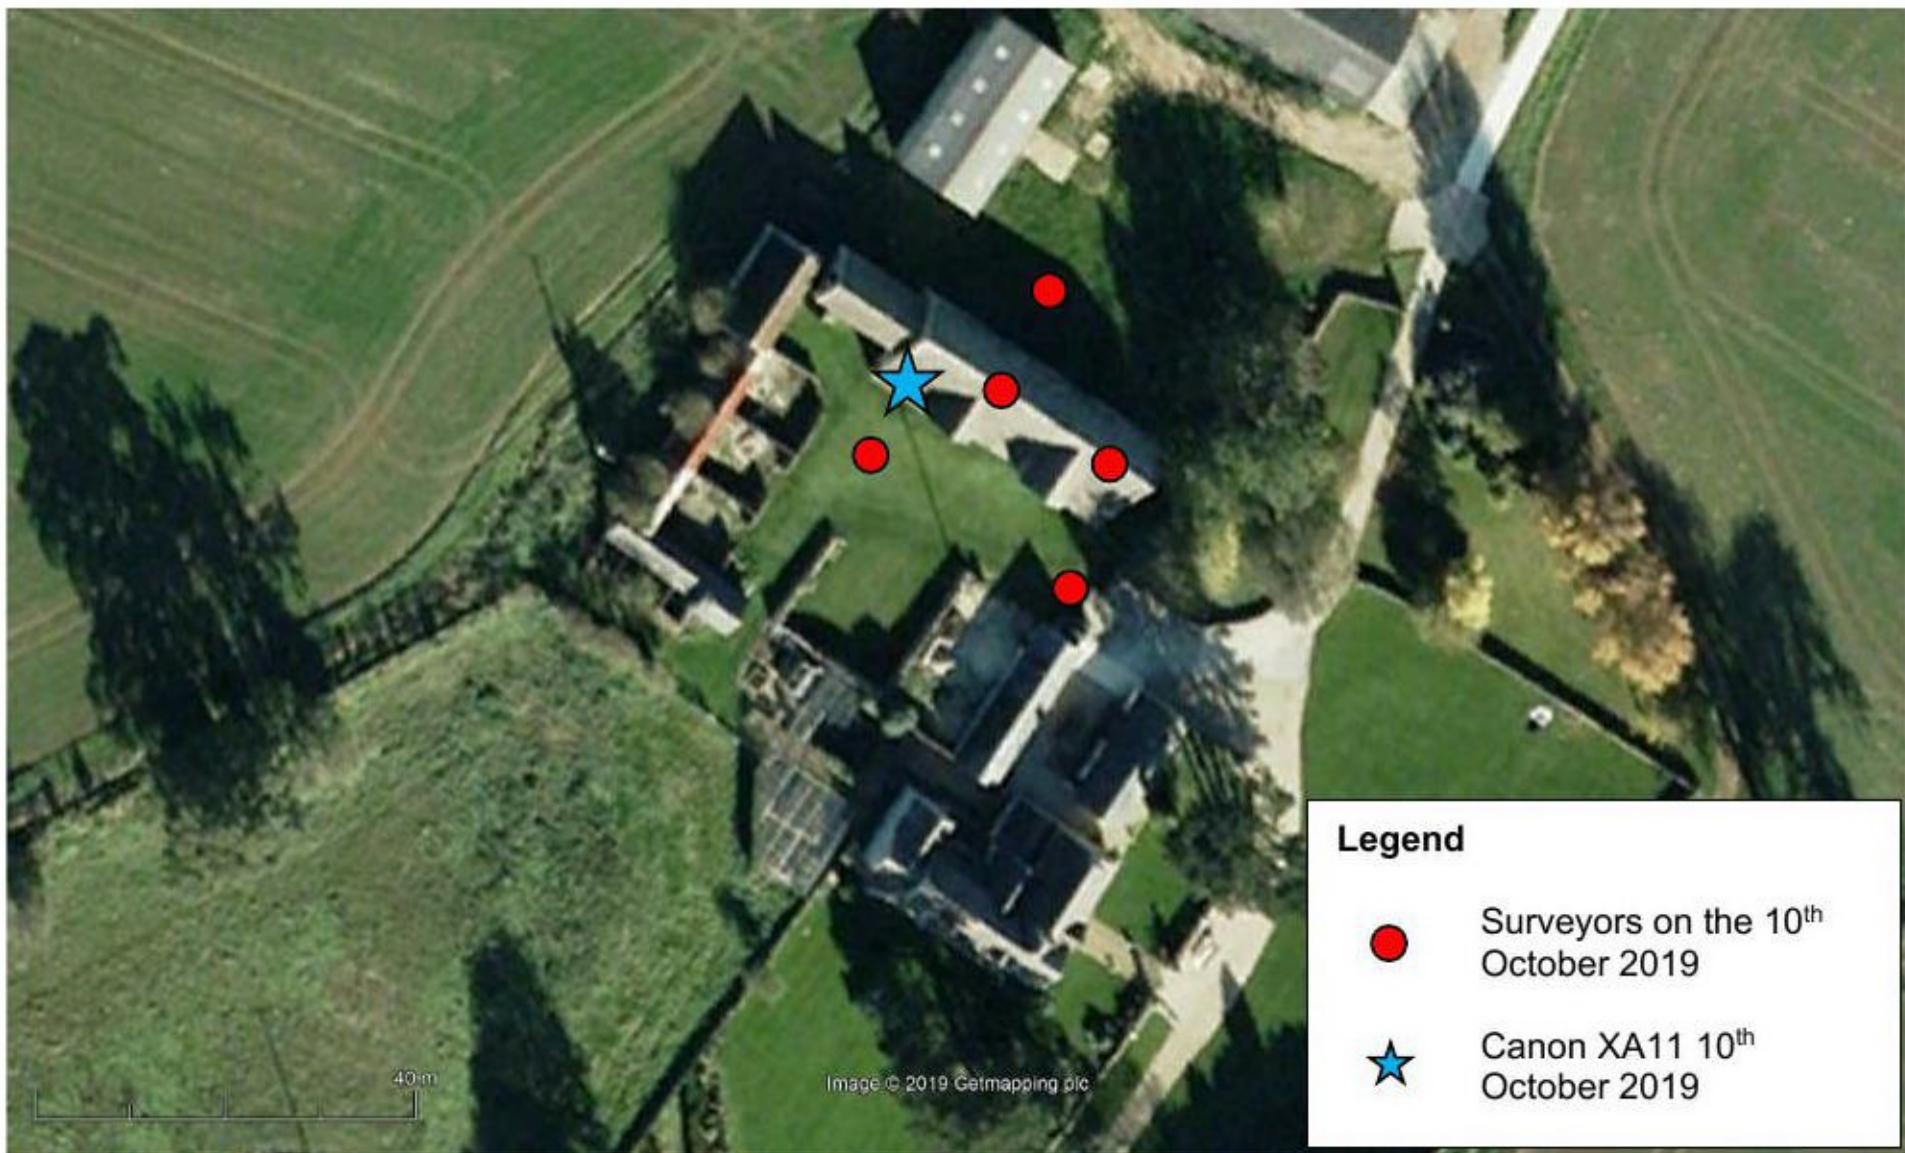
Figure 4. Aerial photograph showing the position of the surveyors during the dusk emergence surveys at Barrington Downs Farm Barns on the 10<sup>th</sup> October 2019 (Barn 1).

The surveyors were positioned as to be able to identify use of the barn, with a particular emphasis on the use by brown long-eared bats and whether they emerged from the building. An infra-red camera (Cannon XA11) was placed within the south-west lean-to extension which previous surveys had shown to be the key area for the swarming brown long-eared bats; as to cause as little disturbance as possible. The surveyors were equipped with Echometer Touch bat detectors to listen to and record bat calls. Figure 4 shows the location of the surveyors and the infra-red camera.

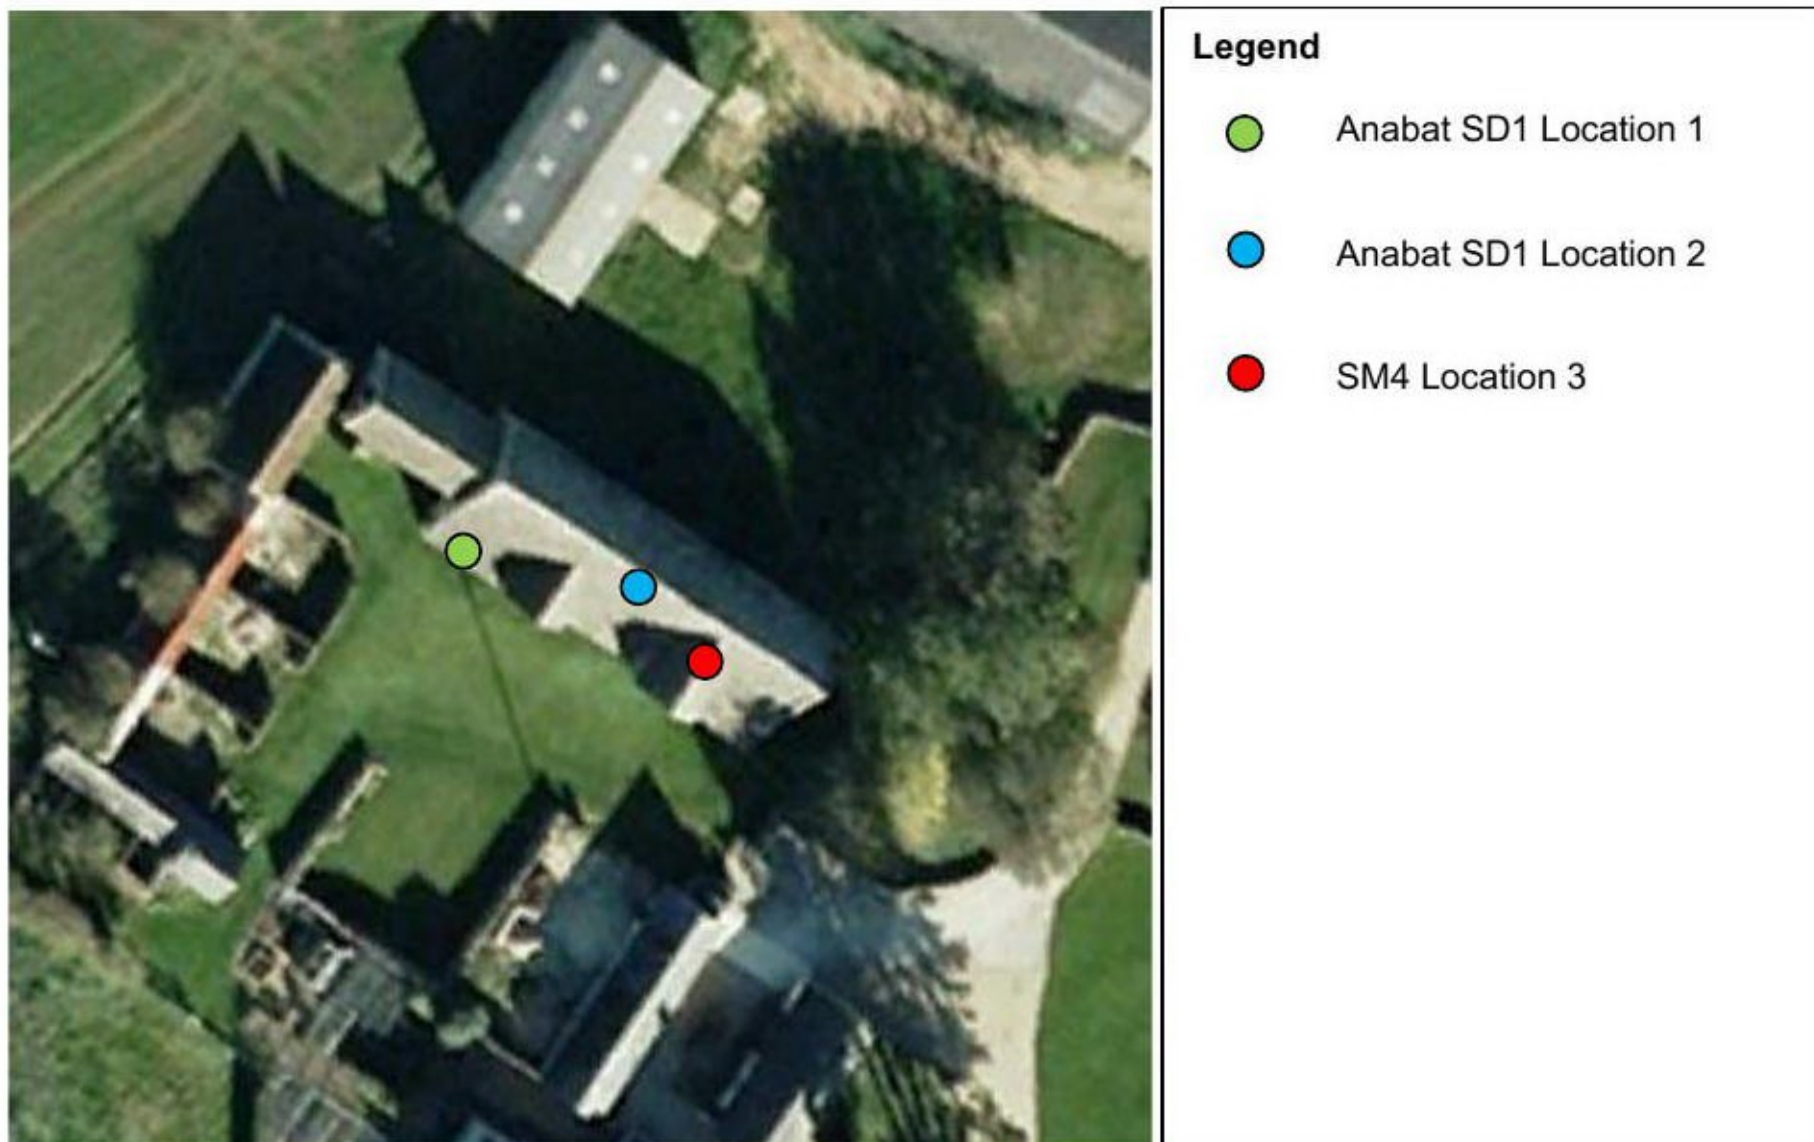
Figure 5. Aerial photograph showing the location of the SM4 and Anabat SD1 bat detectors at Barrington Downs Farm Barns (Barn 1) between the 9<sup>th</sup> of December 2019 and 11<sup>th</sup> February 2020.

White sheets were placed over the floor in all four rooms, where roosting bats have been identified within Barn 1, during the winter months in order to collect any bat droppings that may be left by bats that are using the barn during the winter period. Any bat droppings that were collected were sent off for DNA analysis.

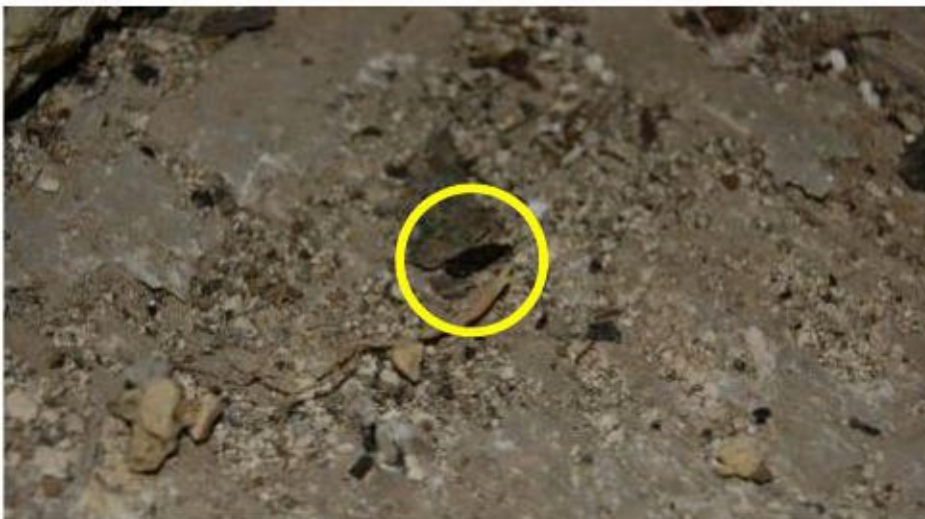
Figure 4. Photograph showing a pipistrelle bat dropping below a crevice in the doorway of the pigeon loft (outlined in yellow).

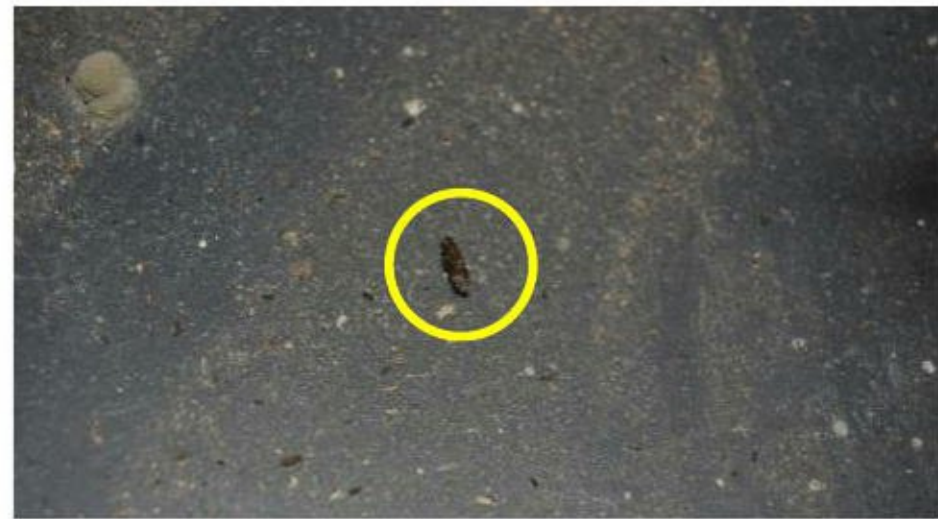
- The second location was within the south-eastern most lean-to (along the south-western elevation), where bat droppings from two species were identified. Small numbers of widely scattered bat droppings (5 bat droppings) were found on the floor and over a stored pool table. There was no pattern of accumulation and the bat droppings are characteristic in size and shape of the pipistrelle bat (see Figure 5). Three of the pipistrelle bat droppings appeared to be fresh, the remainder were old, dating from previous active seasons. One old bat dropping found on the pool table is characteristic in shape and size of the brown long-eared bat, in that it is 'knobbly' in appearance having three distinguishable parts (see Figure 6). In addition to the bat droppings, small loose accumulations of moth and butterfly wings were noted on the floor of the lean-to. In total, approximately 15-20 wings were noted in the lean-to. They were predominantly small tortoiseshell butterfly wings *Aglais urticae*, with a small number of yellow underwing moth wings *Noctuca pronuba* (see Figure 7).

Figure 5. Photograph showing a pipistrelle bat dropping within the south-east lean-to (outlined in yellow).

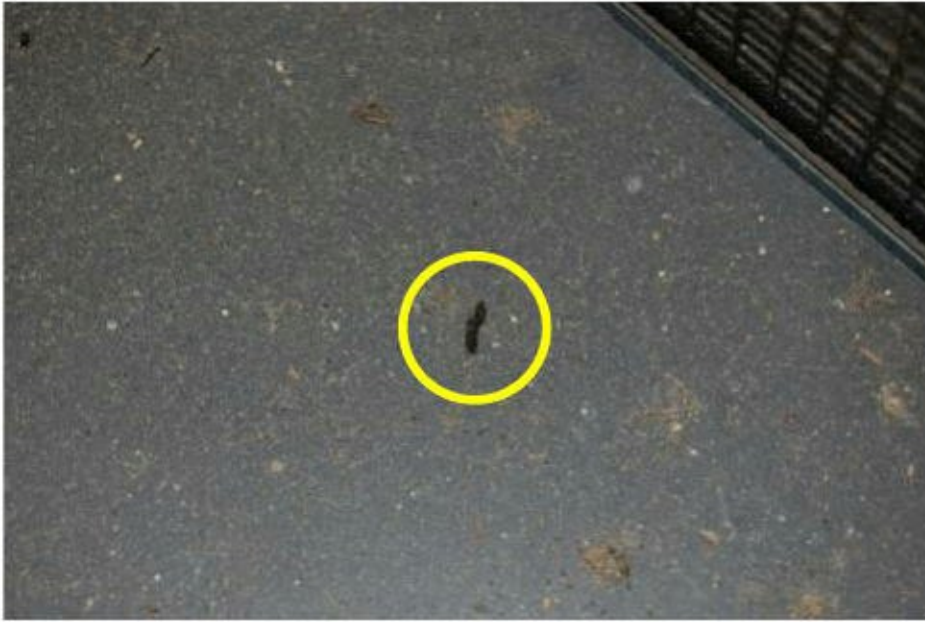
Figure 6. Photograph of a brown long-eared bat dropping within the south-east lean-to (outlined in yellow).

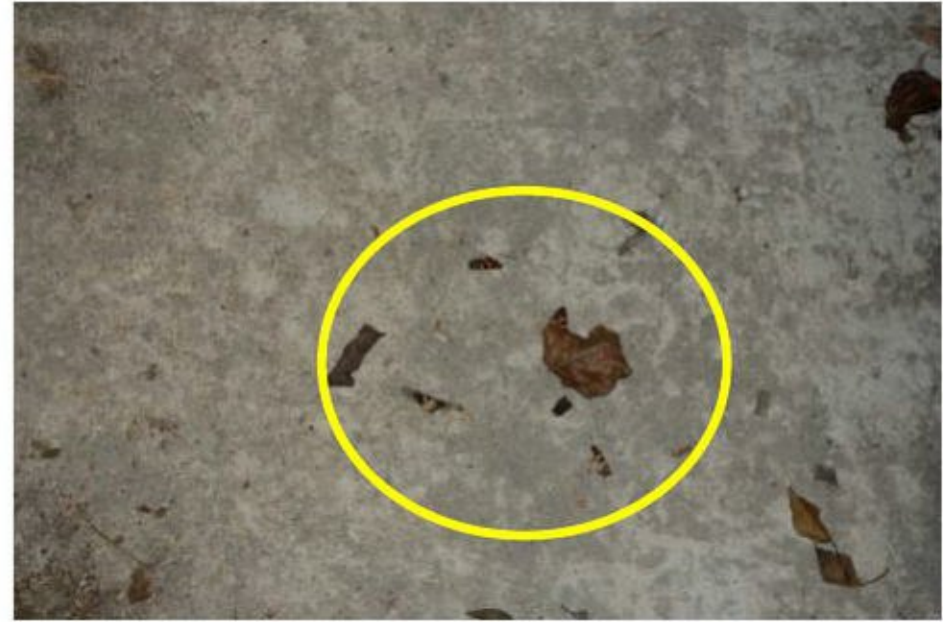
Figure 7. Photograph showing part of one of the small accumulations of butterfly wings (outlined in yellow).

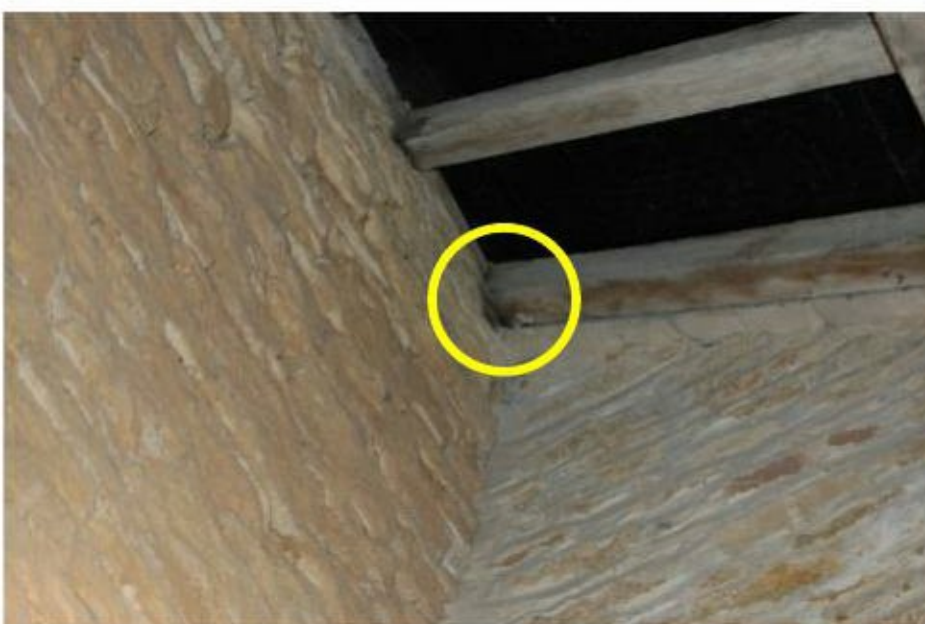
- An accumulation of approximately 30-40 bat droppings was observed below a crevice within the north-west lean-to. The crevice is located to north-eastern corner of the lean-to, at the apex of the roof and fur-staining can be seen around the roost site (see Figure 8). The bat droppings are characteristic in size and shape of the serotine bat, being thick and blunt, shiny and some droppings forming 'rugby-ball' shapes with droppings being formed from a mixture of one, two and three parts. All bat droppings are fresh, dark, black and shiny, with some being 'tacky'. The bat droppings have been confirmed (via DNA analysis) as belonging to the serotine bat; please see Appendix 4 for DNA analysis results.

Figure 8. Photograph of the crevice used by a serotine bat as a day roost (outlined in yellow). This location may also be used by brown long-eared bats.

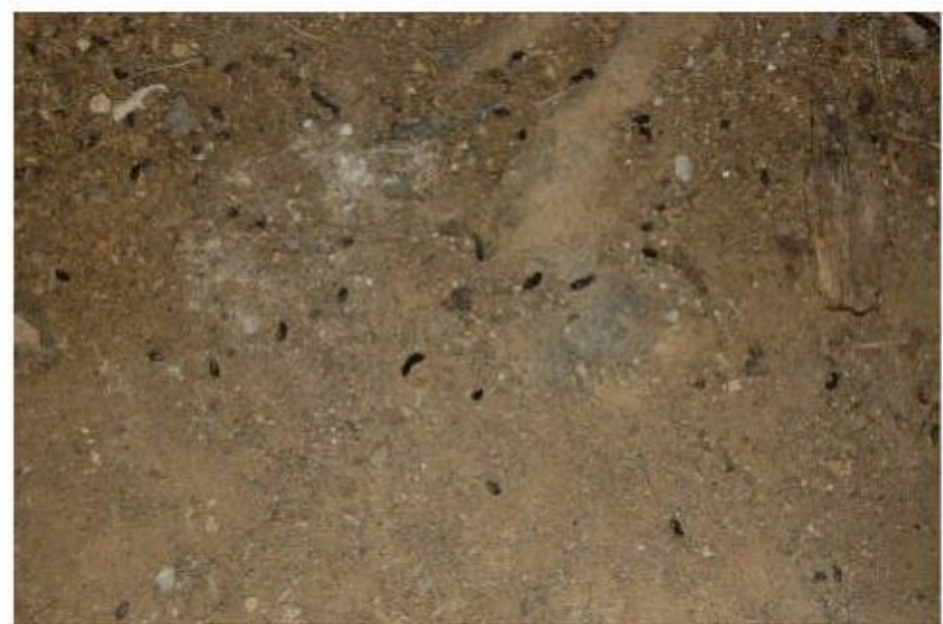
Figure 9. Photograph showing a wide view of the accumulation of serotine bat droppings within the north-west lean-to (further serotine droppings outside the view of the camera shot).

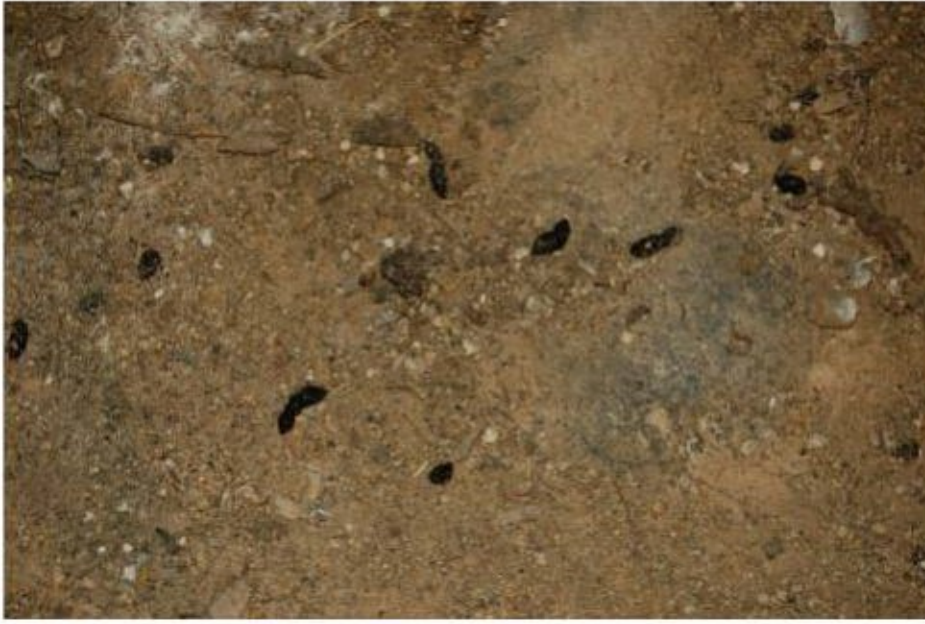
Figure 10. Photograph showing a close up of the serotine bat droppings within the north-west lean-to.

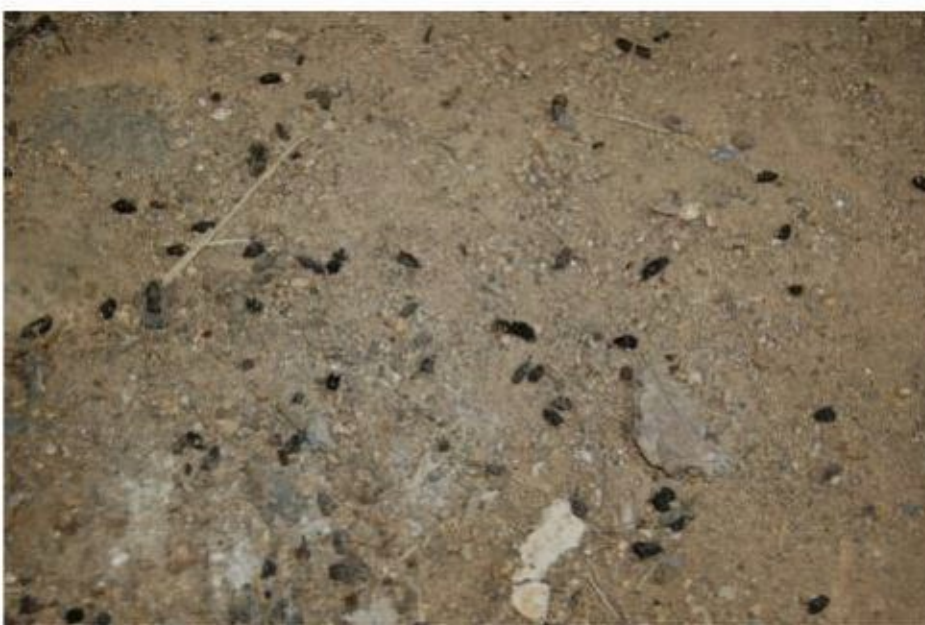
- Additional fresh serotine bat droppings (approximately 40 droppings) were noted in the same location as that identified on the 31<sup>st</sup> July 2019.

Figure 11. Photograph of the accumulation of serotine bat droppings; further serotine droppings have been deposited since the last survey (undertaken on the 31<sup>st</sup> July 2019).

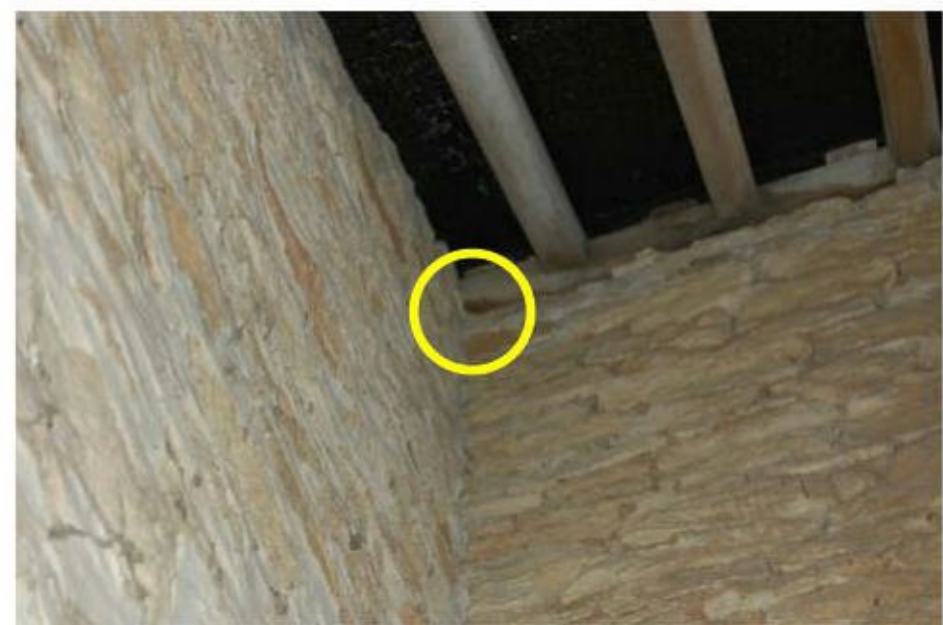
- A further small accumulation of bat droppings was noted to the north-west corner of the lean-to below a crevice that contains fur-staining around it. Approximately 15 bat droppings that are characteristic in size and shape of the brown long-eared bat were observed on the floor below the crevice. The brown long-eared bat droppings are fresh, dating from the current active season. A small number of moth wings were also seen in this location.

Figure 12. The crevice around which there is fur staining and a number of brown long-eared bat droppings and moth wings were found below.

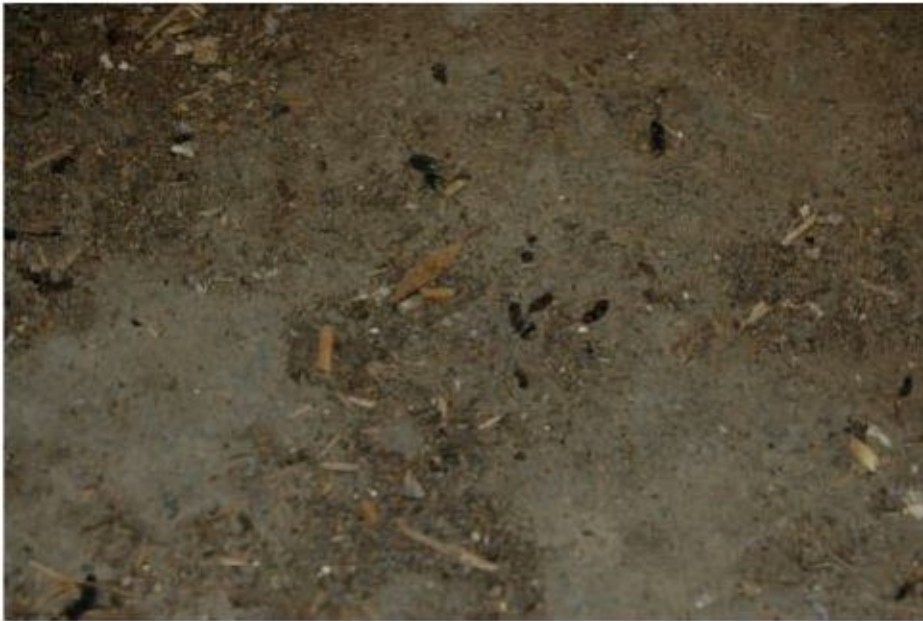
Figure 13. Photograph showing the brown long-eared bat droppings below a crevice to the north-west corner of the north-west lean-to.

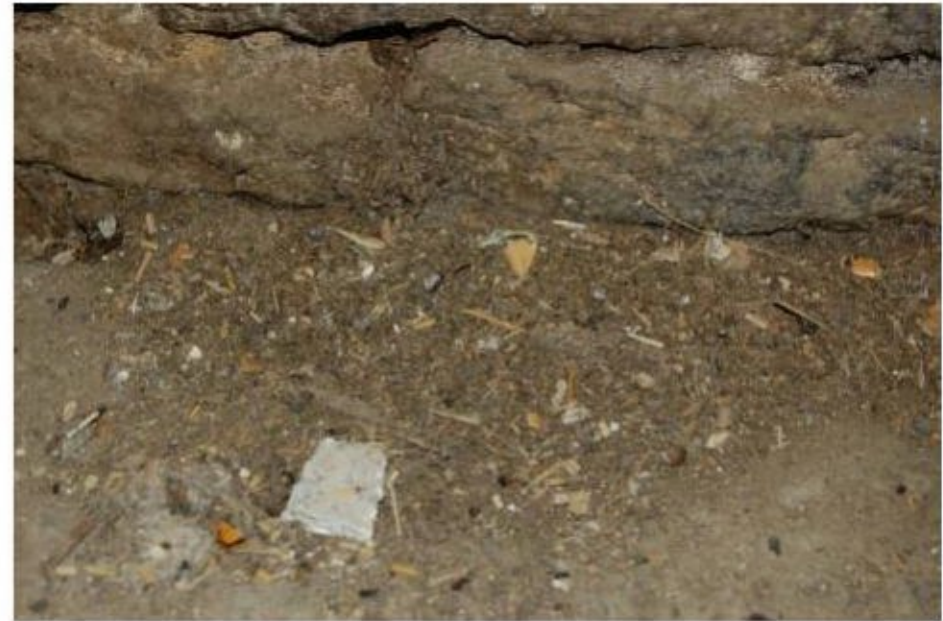
Figure 14. Photograph of the moth wings and brown long-eared bat droppings.

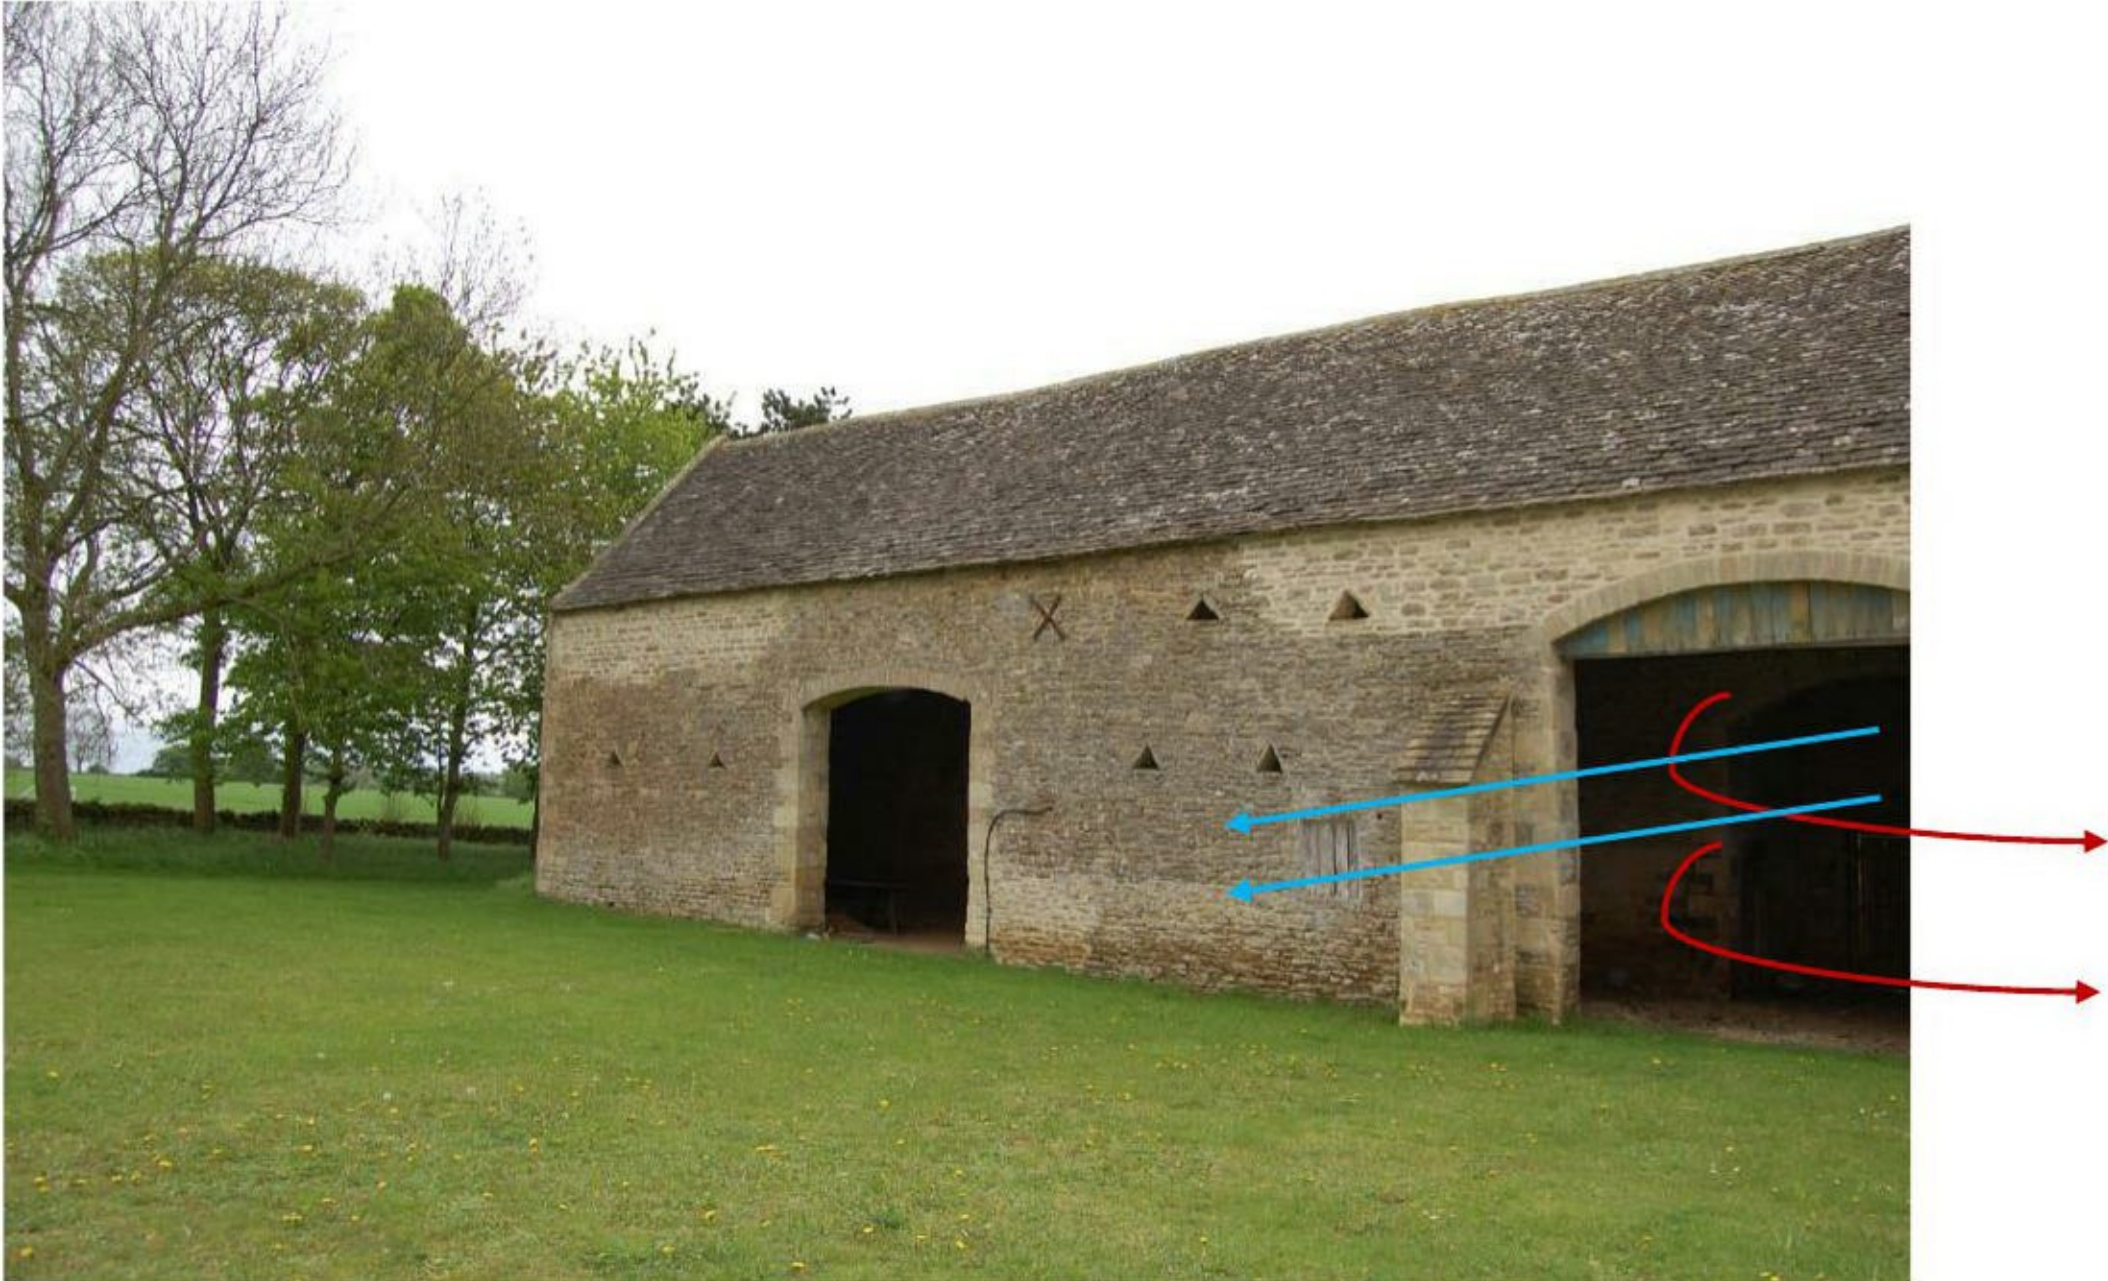
Figure 15. Photograph showing the emergence points of two common pipistrelle bats (red arrows) and two brown long-eared bats (blue arrows). 31<sup>st</sup> July 2019.

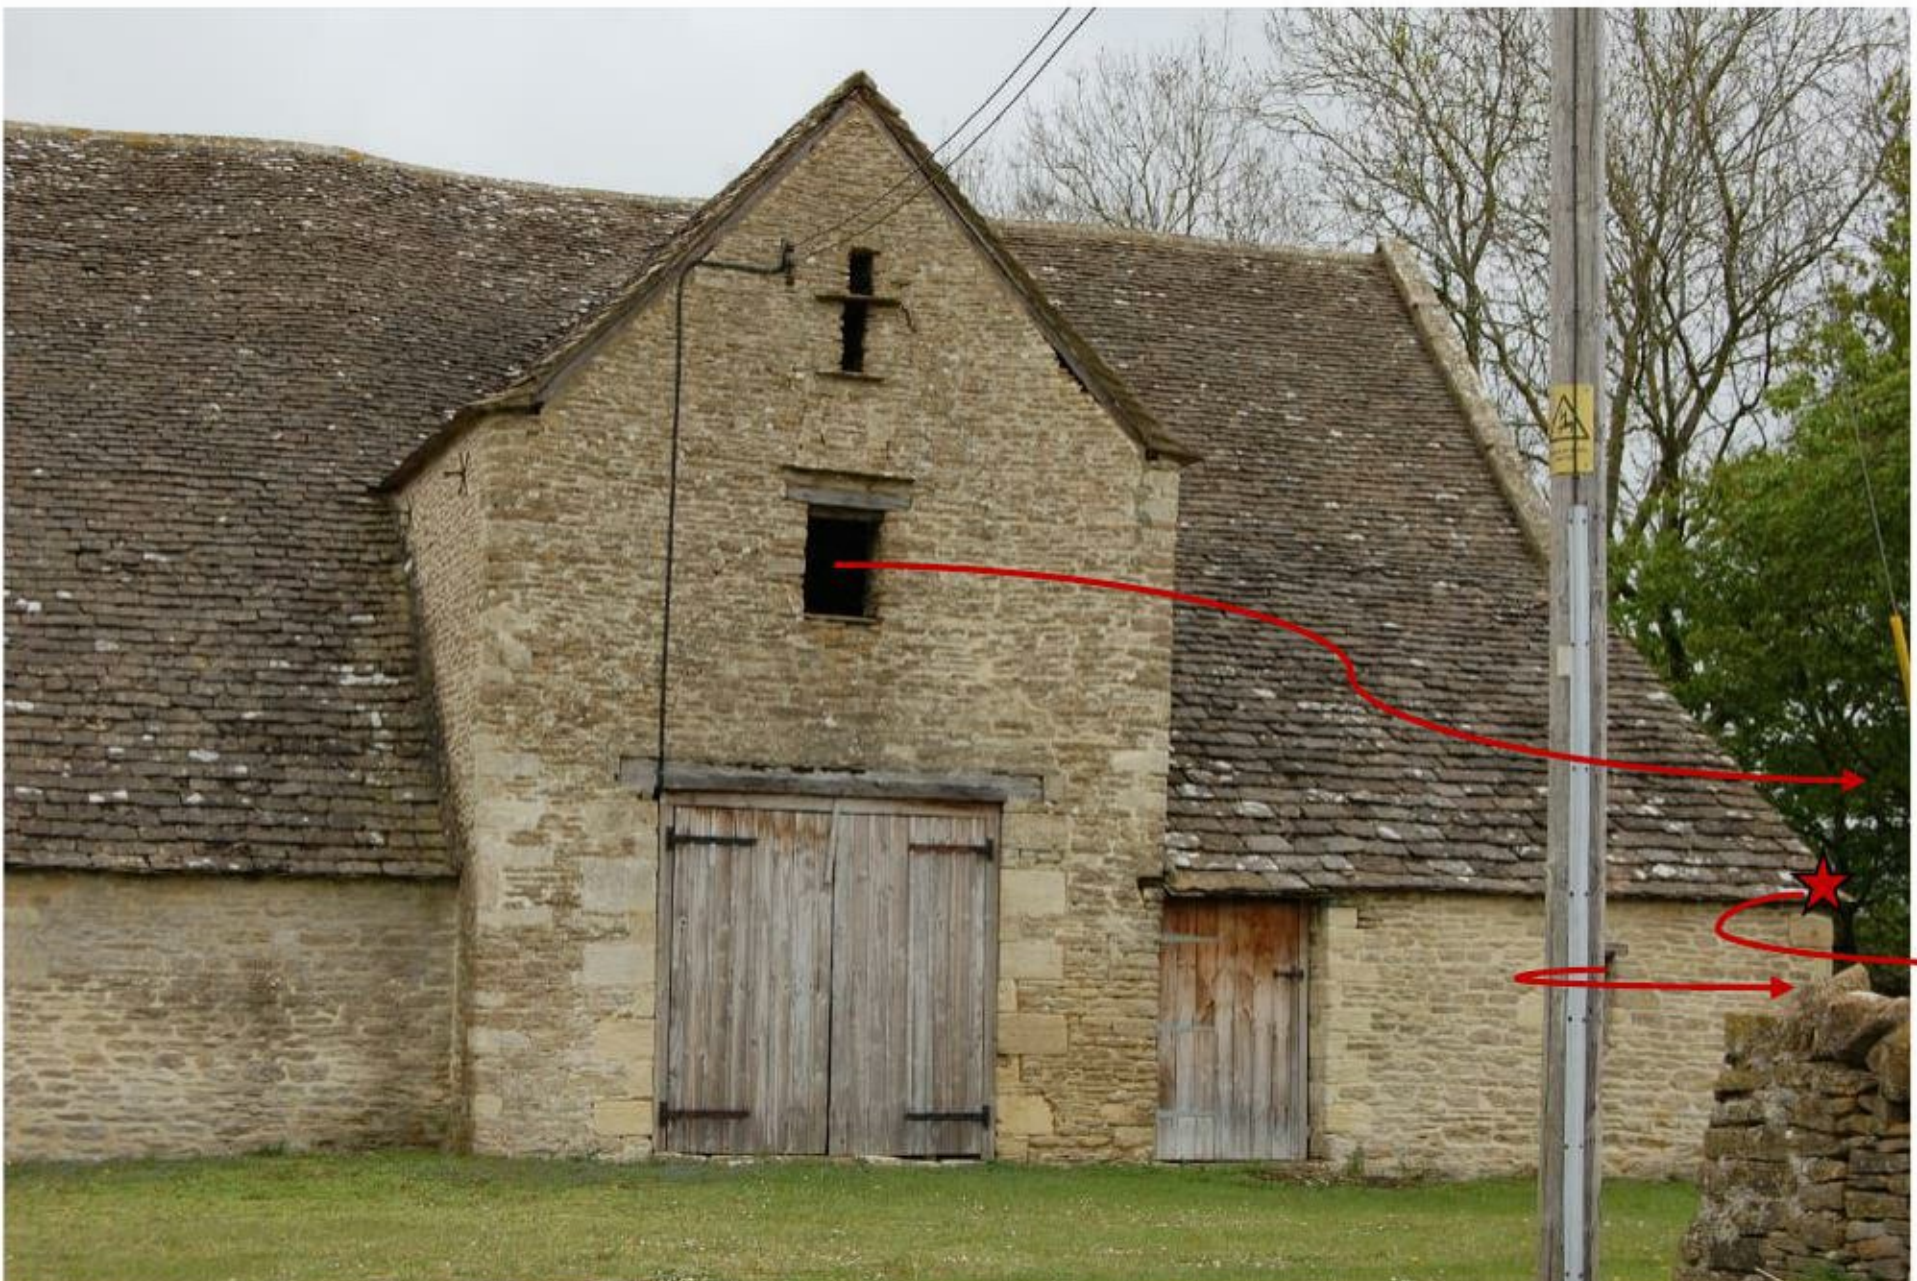
Figure 16. Photograph showing the roost locations (red stars) and emergence points (red arrows) of three of the common pipistrelle bats. 31<sup>st</sup> July 2019.
