**Barrington Downs Farm Barns, Barrington Downs,  
near Aldsworth, Cheltenham,  
Gloucestershire GL54 3PT**

**Bat Survey Report**

**September 2020**

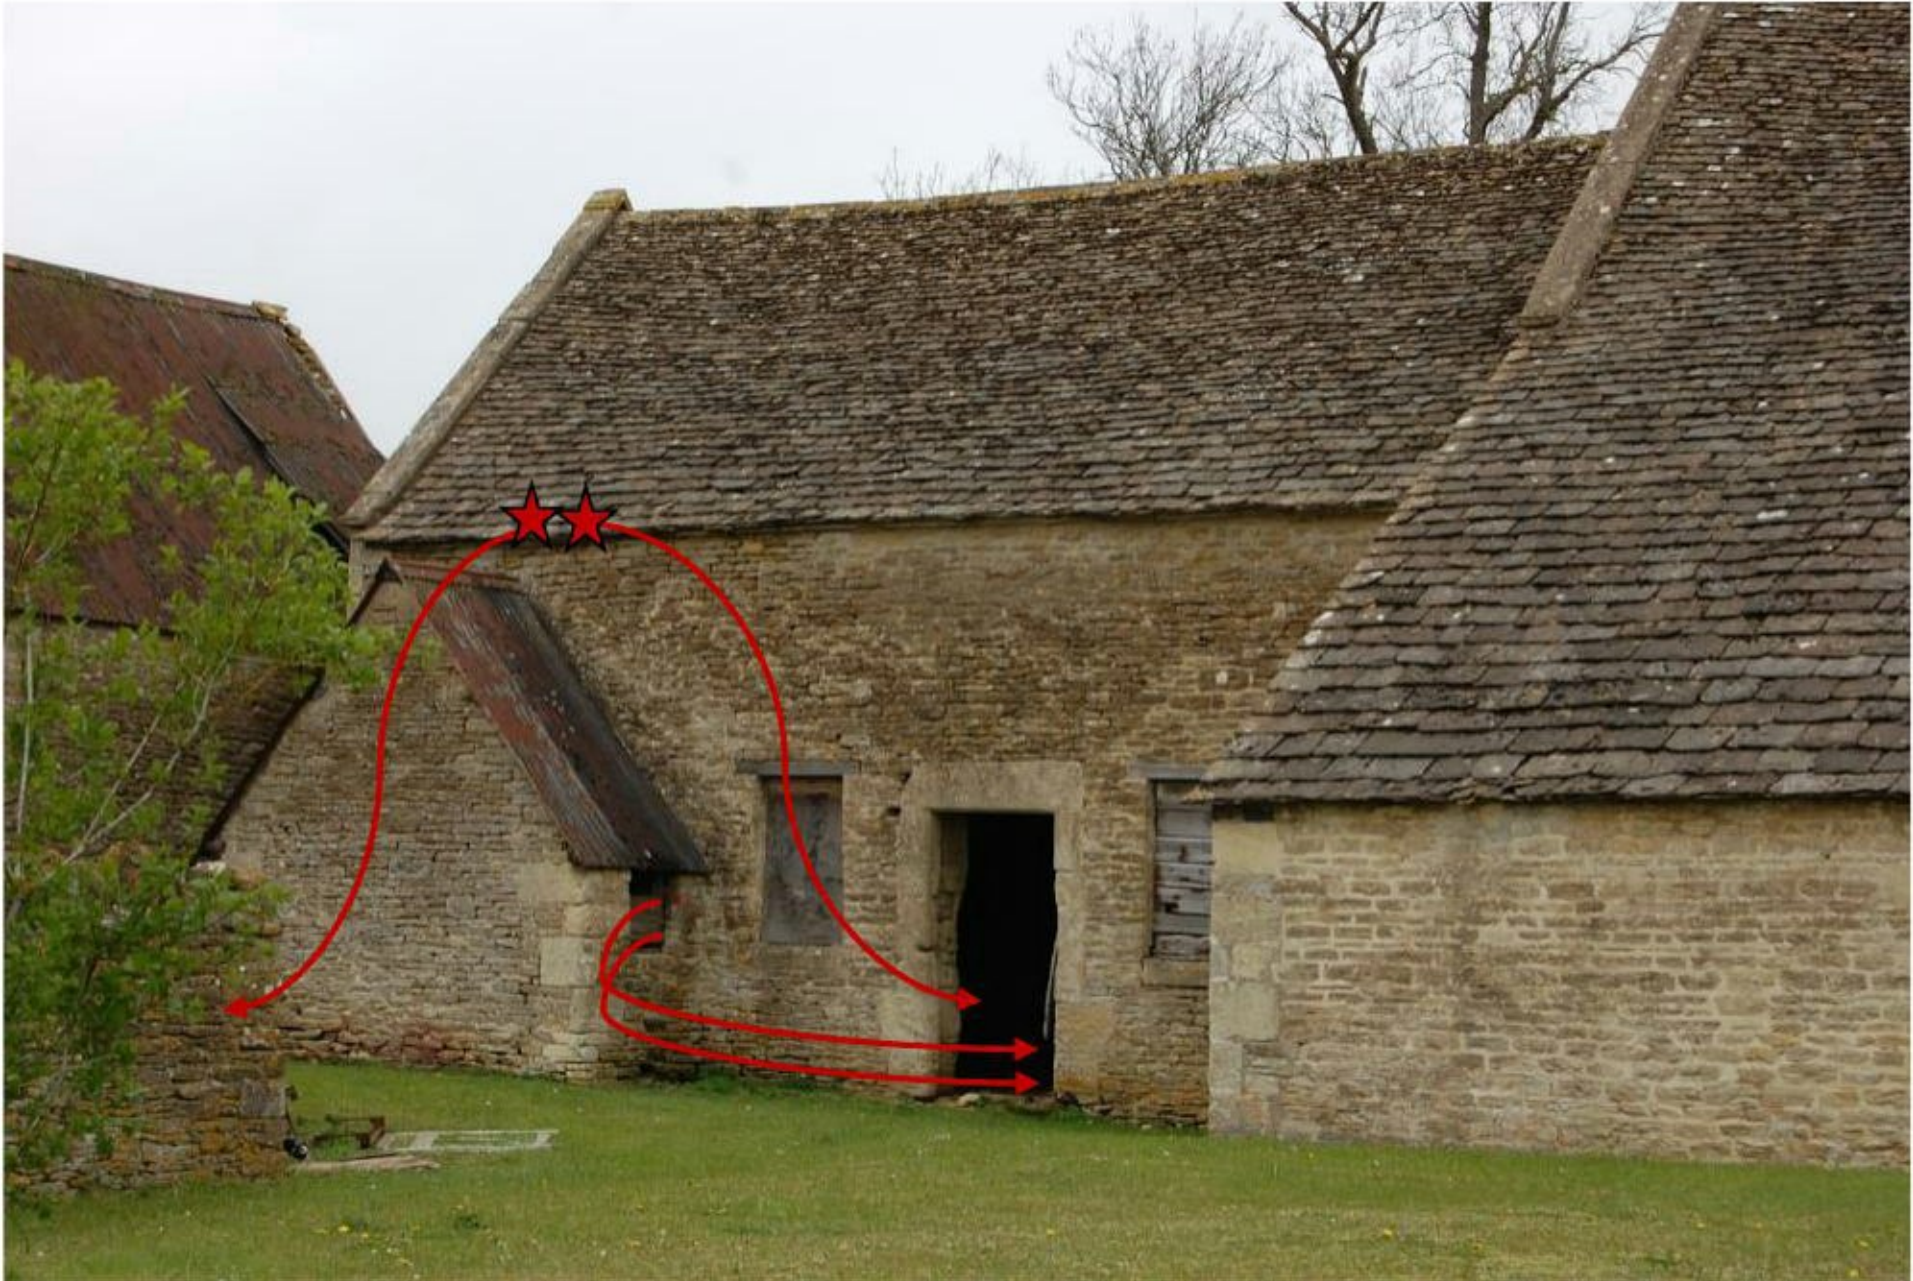
Figure 17. Photograph showing the roost locations (red stars) and emergence points (red arrows) of four of the common pipistrelle bats. 31<sup>st</sup> July 2019.

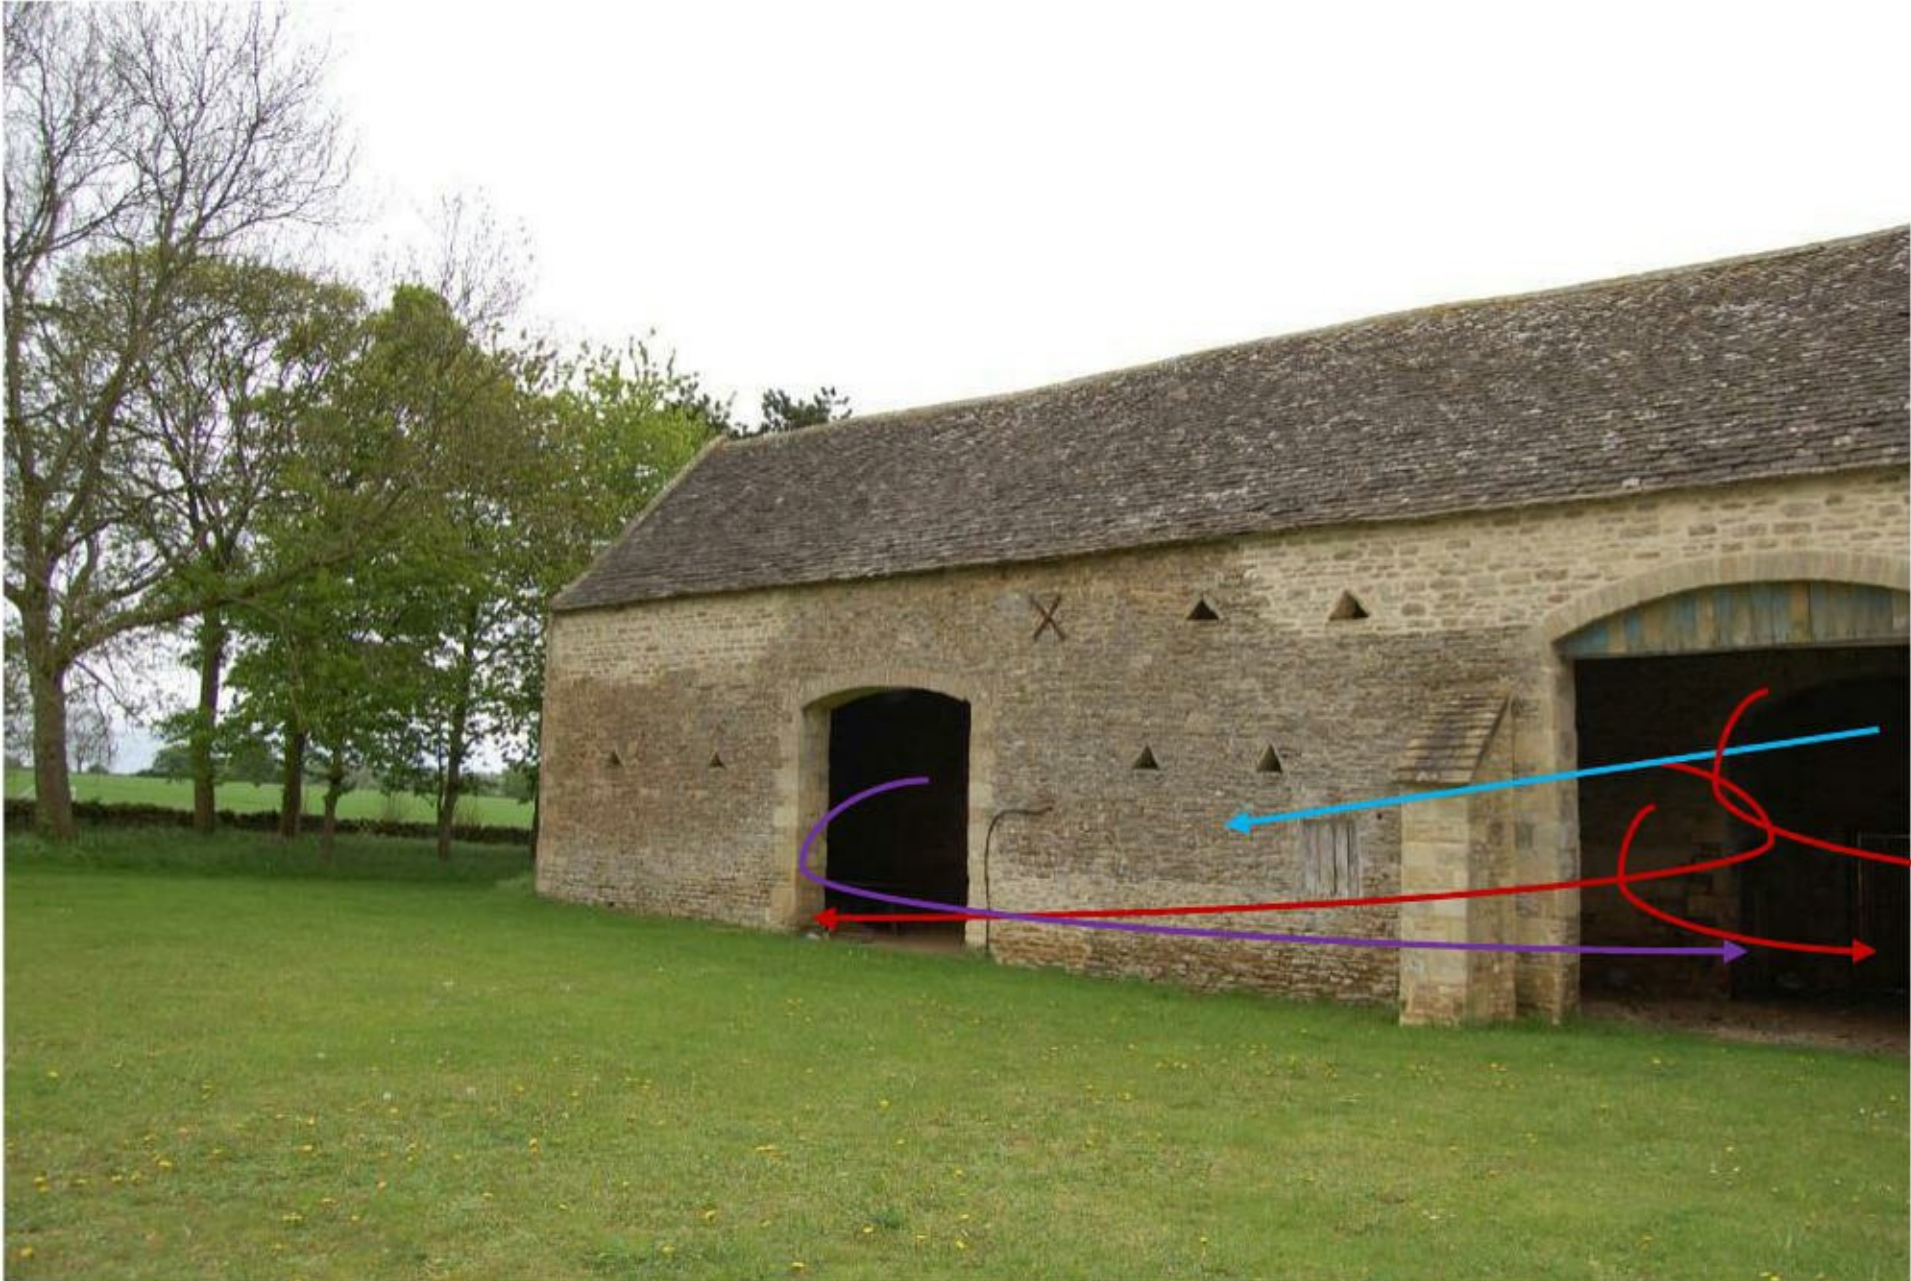
Figure 18. Photograph showing the emergence points of two common pipistrelle bats (red arrows), one brown long-eared bat (blue arrow) and a serotine bat (purple arrow). 4<sup>th</sup> September 2019.

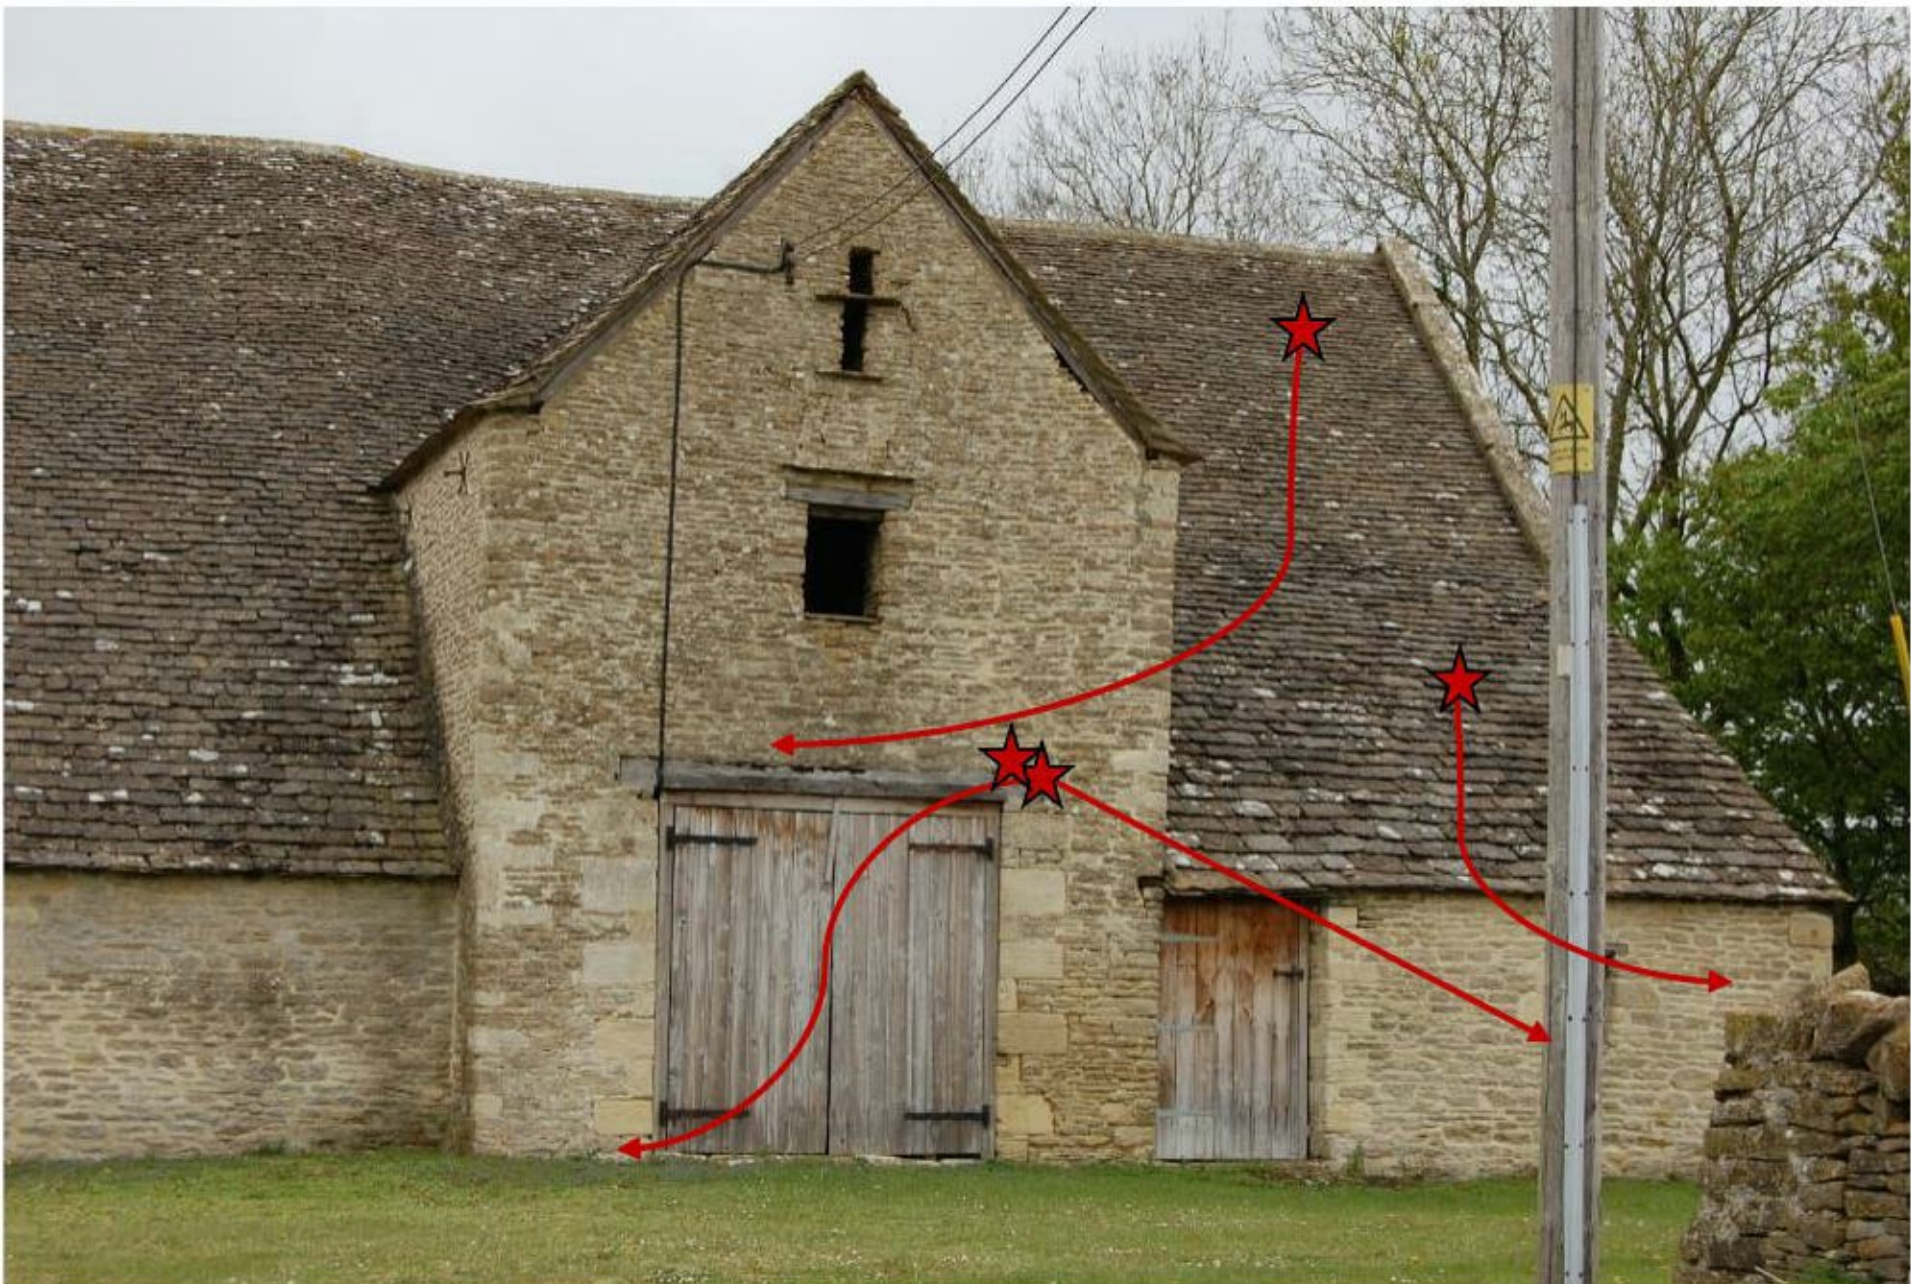
Figure 19. Photograph showing the roost locations (red stars) and direction of flight (red arrows) of four of the common pipistrelle bats. 4<sup>th</sup> September 2019.

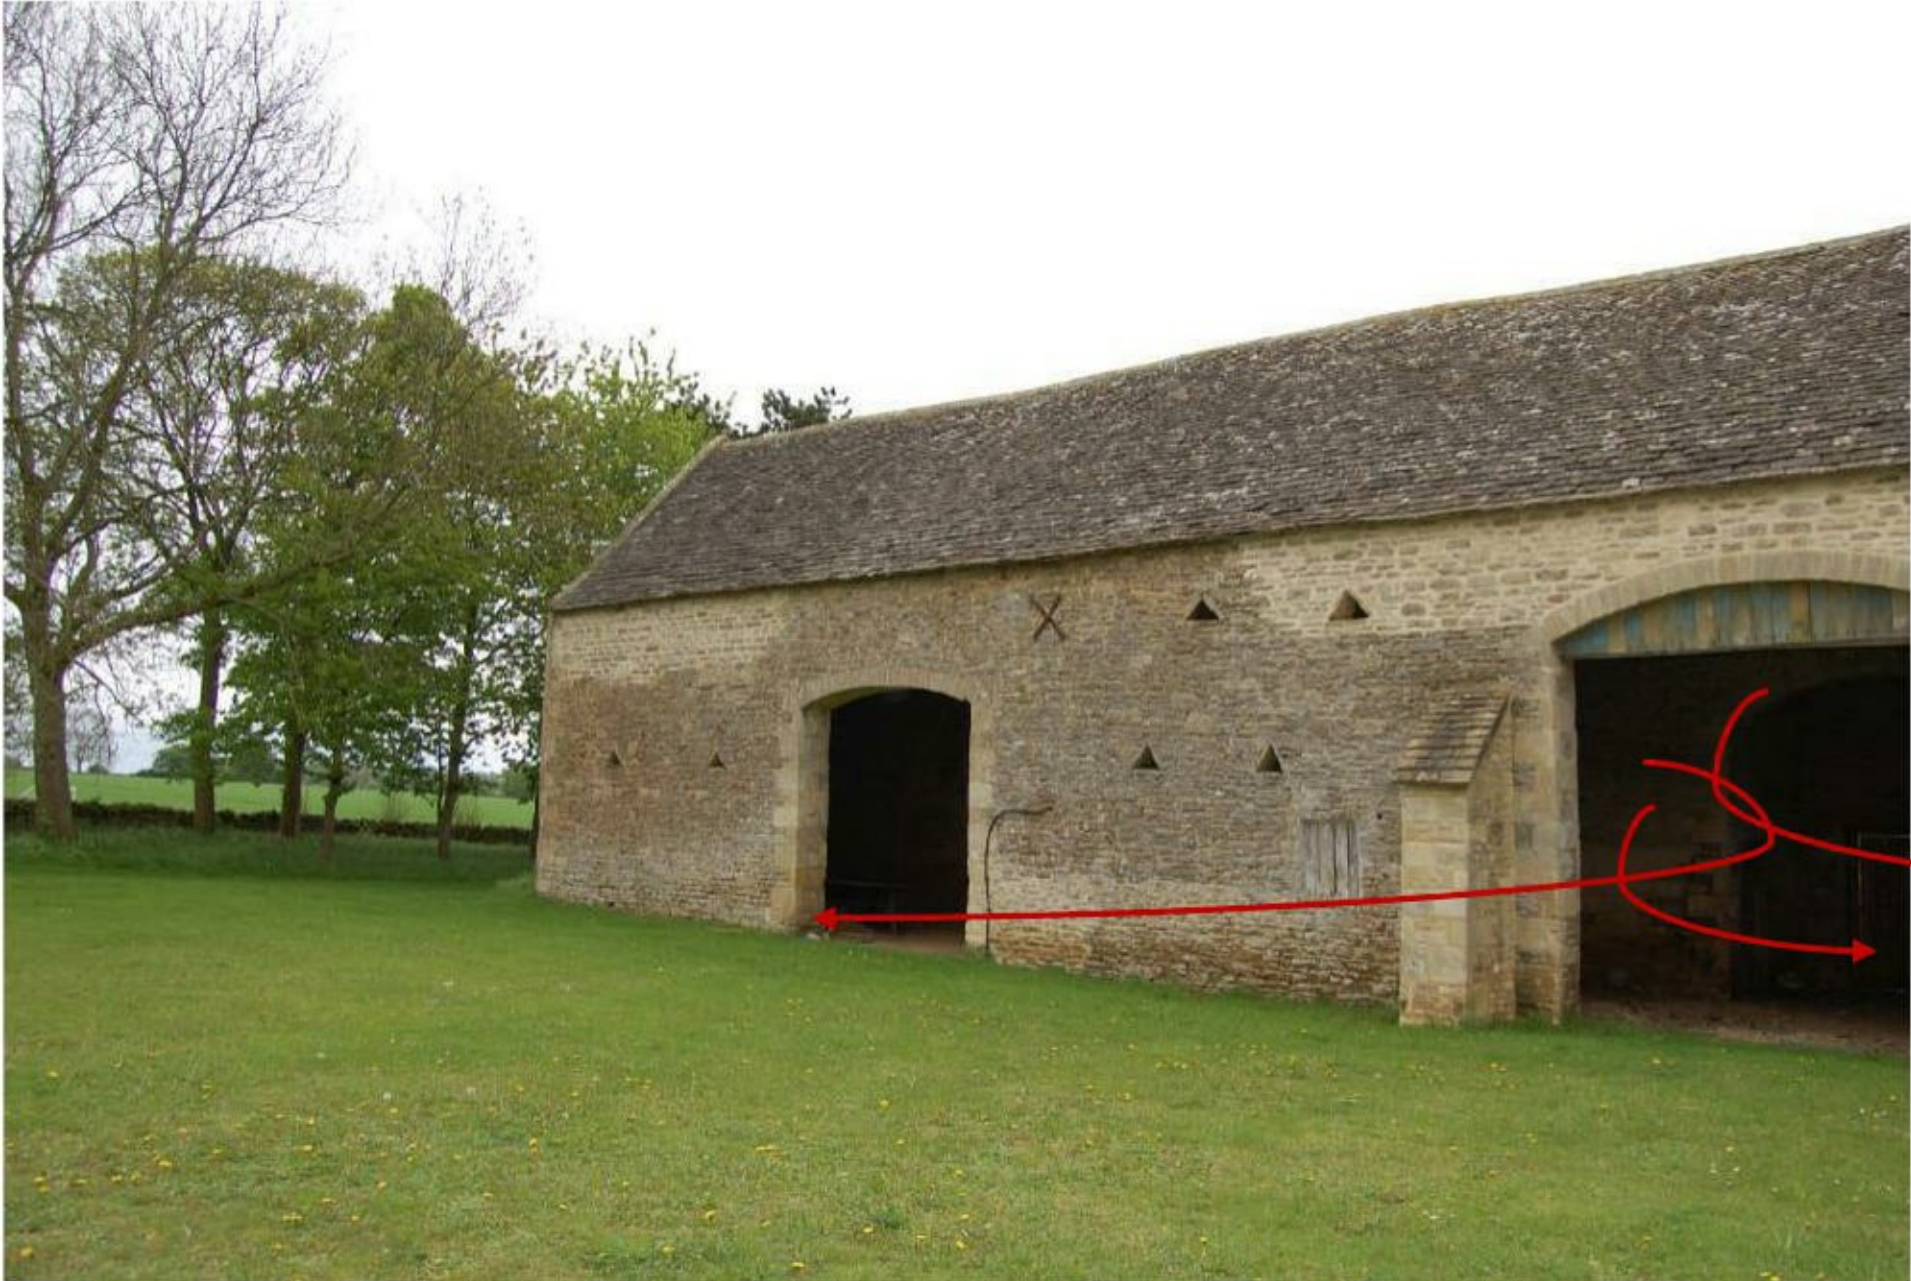
Figure 20. Photograph showing the emergence points of three common pipistrelle bats (red arrows). 12<sup>th</sup> September 2019

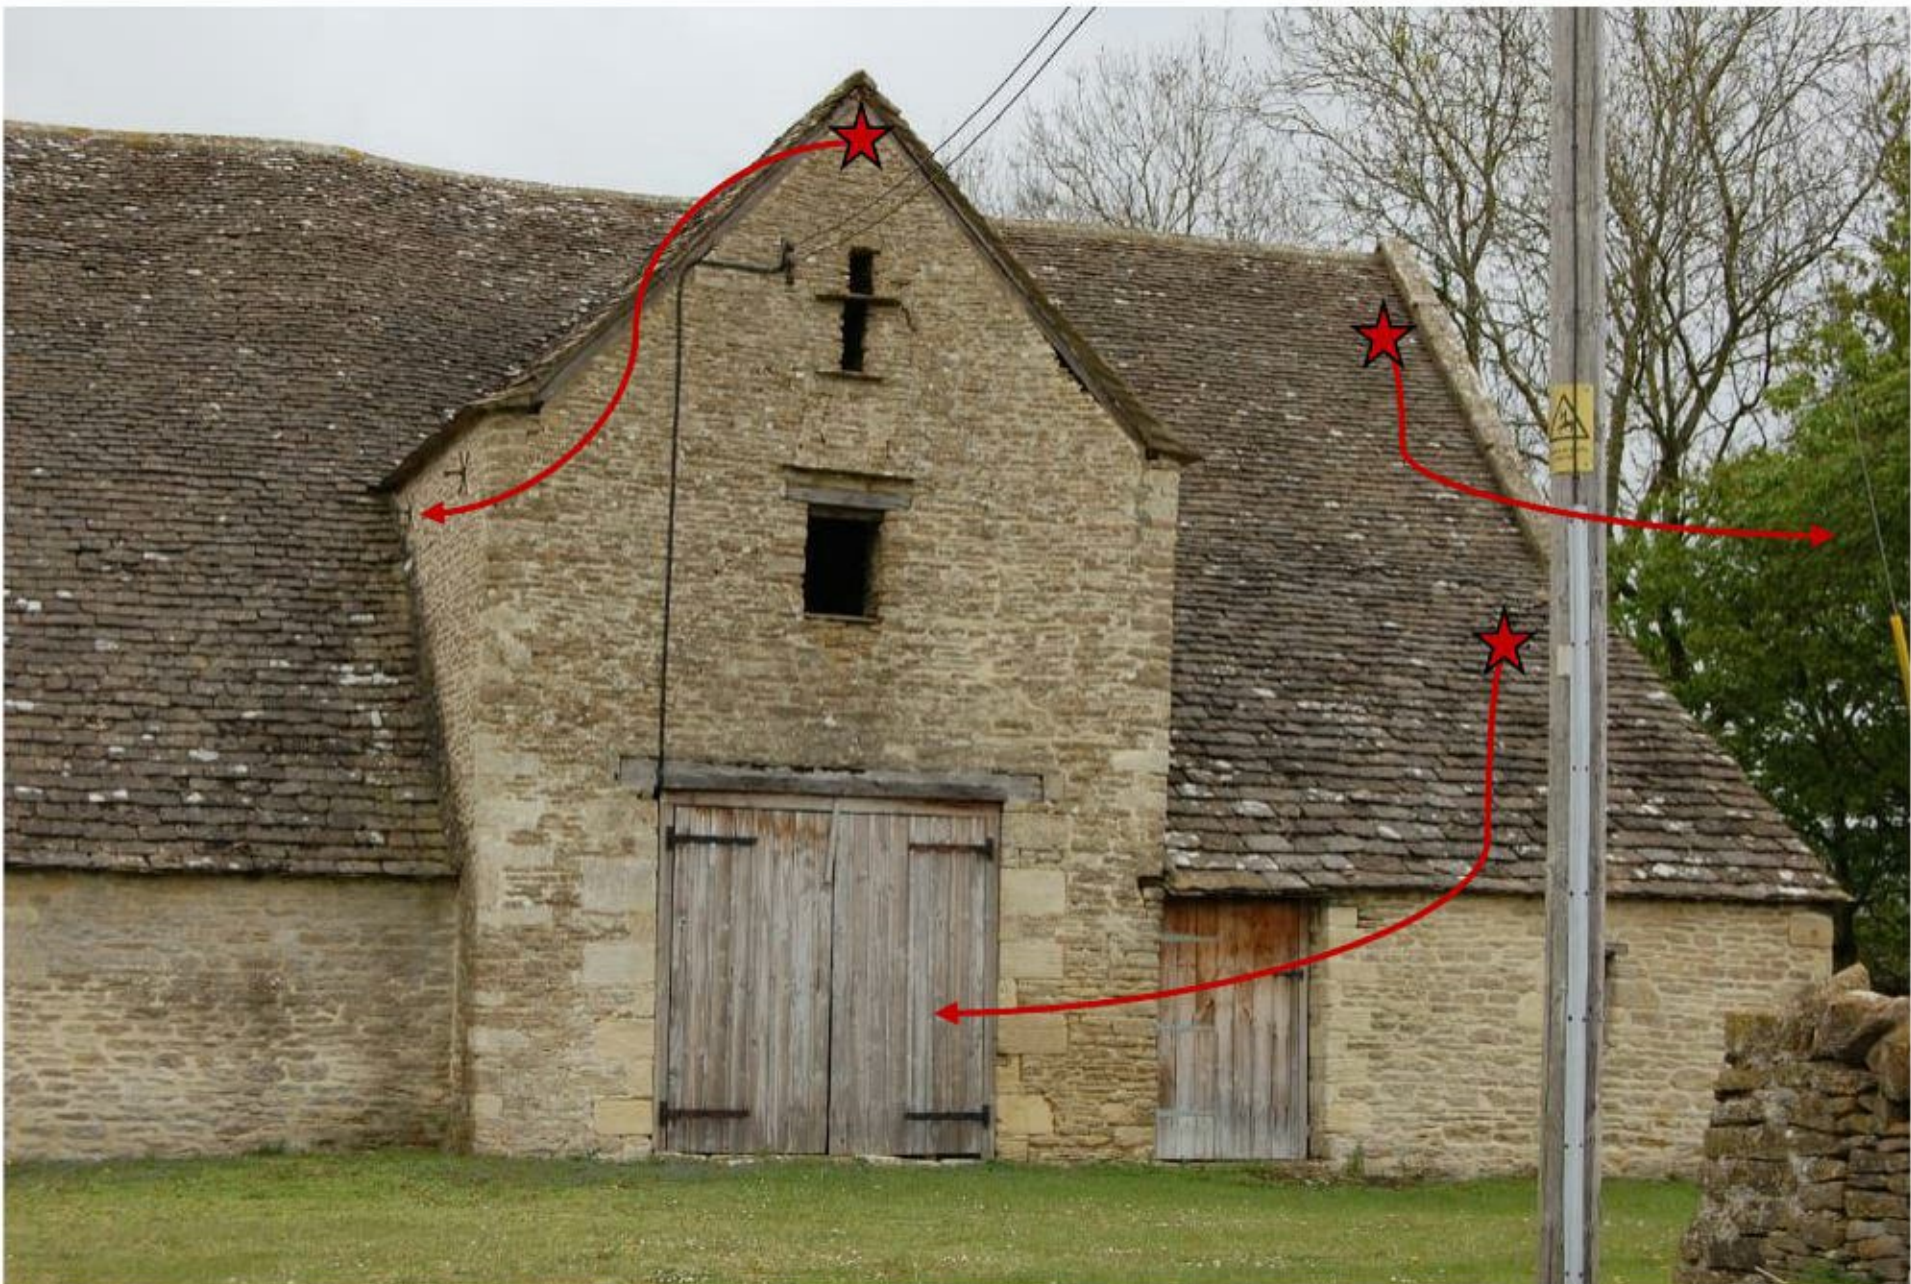
Figure 21. Photograph showing the roost locations (red stars) and direction of flight (red arrows) of three common pipistrelle bats. 12<sup>th</sup> September 2019.

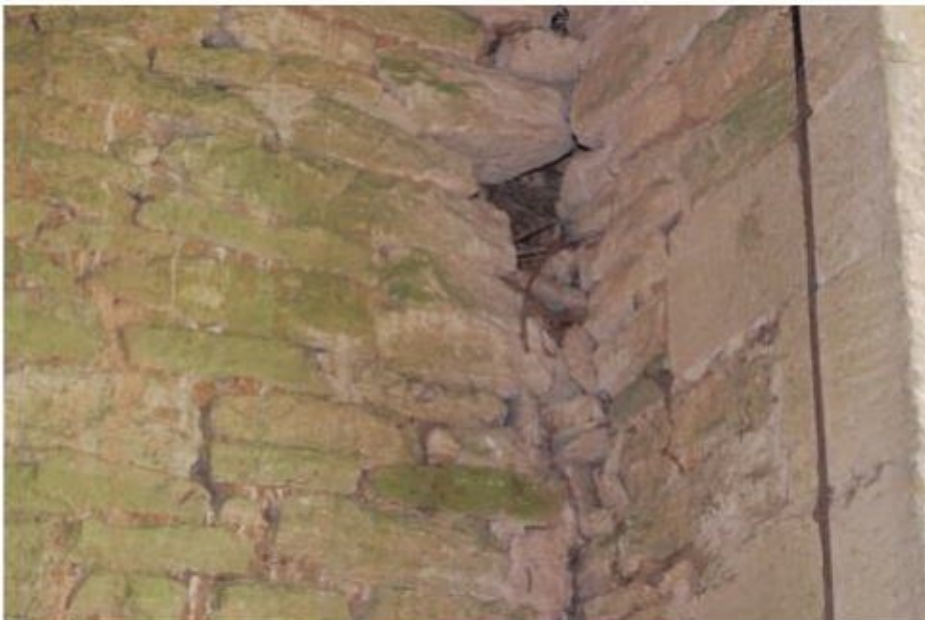
Figure 22. Photograph showing a jackdaw nest within a crevice in Barn 1. South-eastern room of main barn.

It is recommended that two jackdaw nest boxes are erected on nearby trees. The nest boxes should be sited a minimum of 3m above ground and should be in a quiet, secluded area with a clear flight path to the entrance.

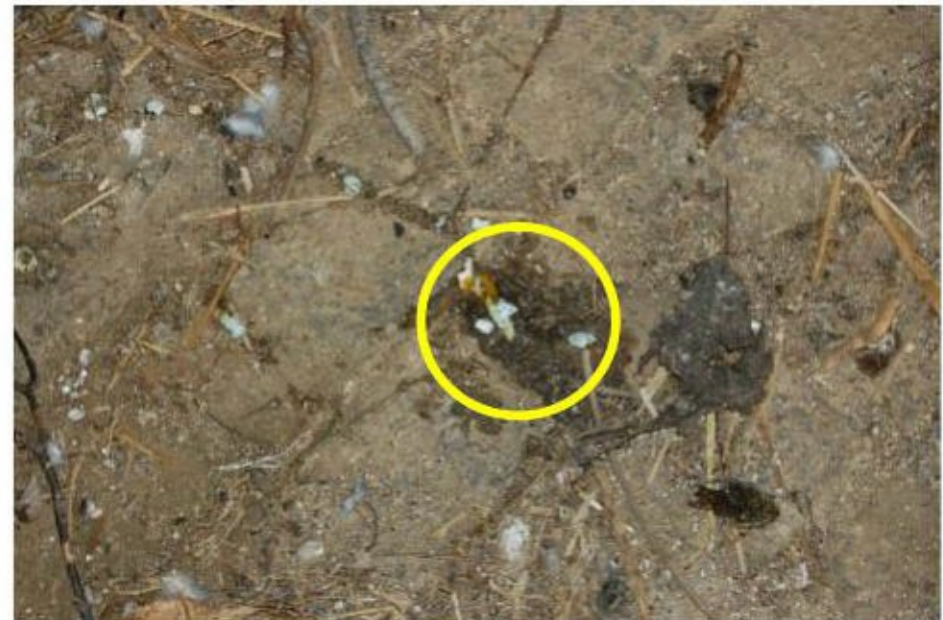
Figure 23. Broken jackdaw egg shell (outlined in yellow). South-eastern room of main barn.

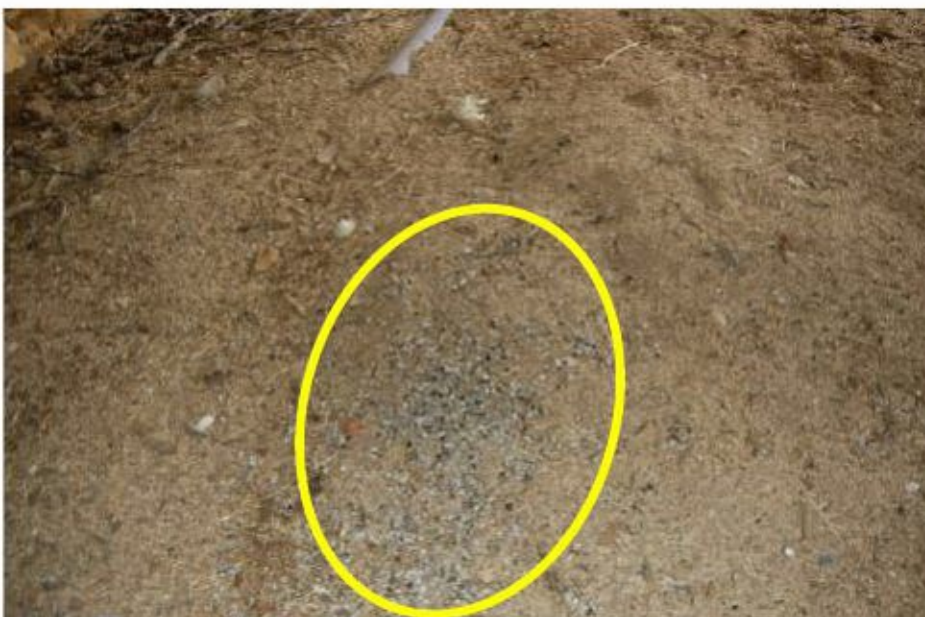
Figure 24. Photograph showing concentration of pigeon droppings. South-eastern room of main barn.

No specific mitigation is recommended for the loss of an inactive wren's nest or the loss of likely feral pigeon nest sites.

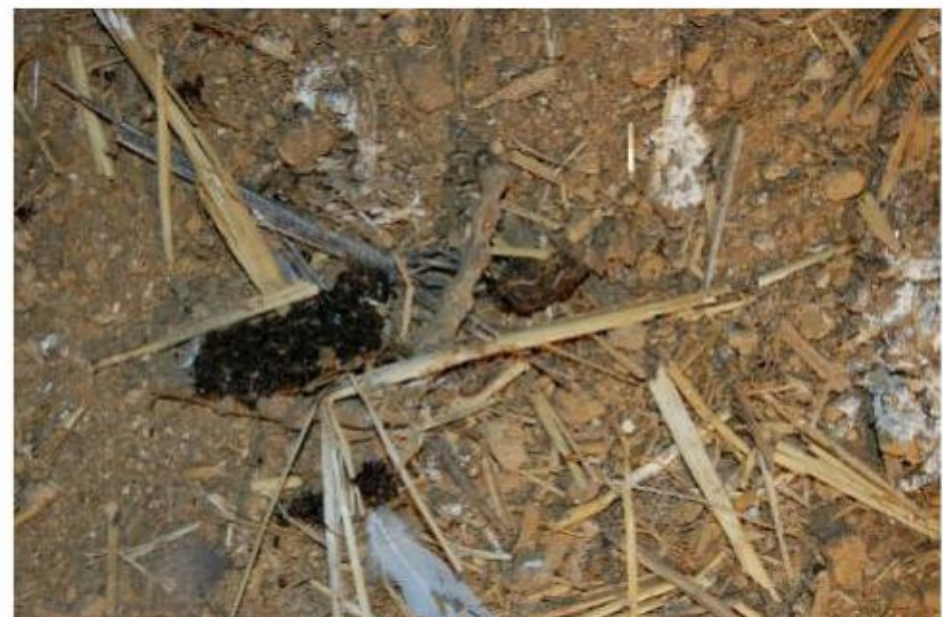
Figure 25. Photograph of one of the little owl pellets within Barn 1. South-eastern room of main barn.

It is recommended that the loss of the perching sites used by little owls and barn owls is compensated for through the erection of a little owl nest box on a nearby tree and barn owl nest box on the exterior of the converted barn.

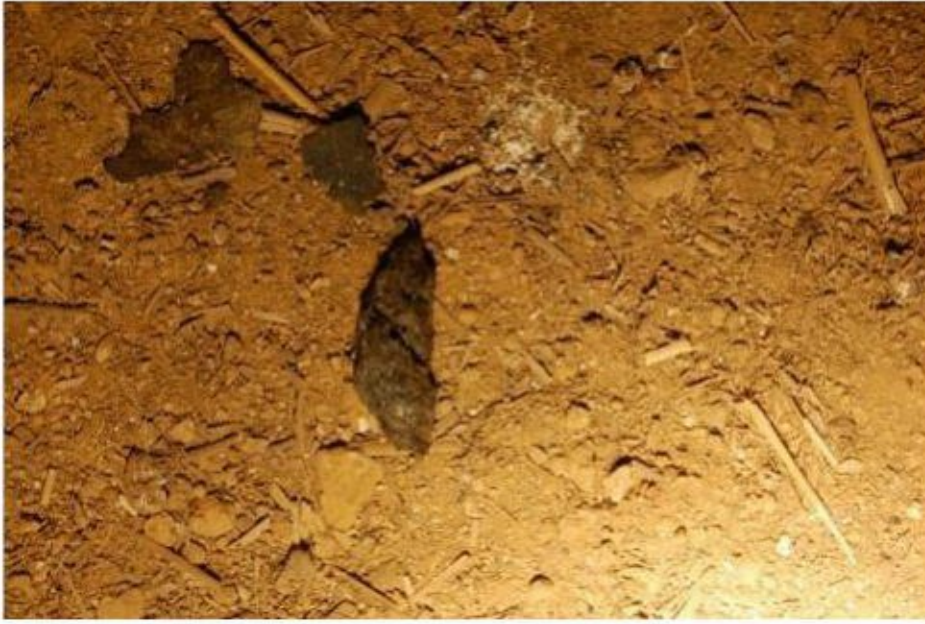
Figure 26. Old barn owl pellets noted within Barn 1. South-eastern room of main barn.

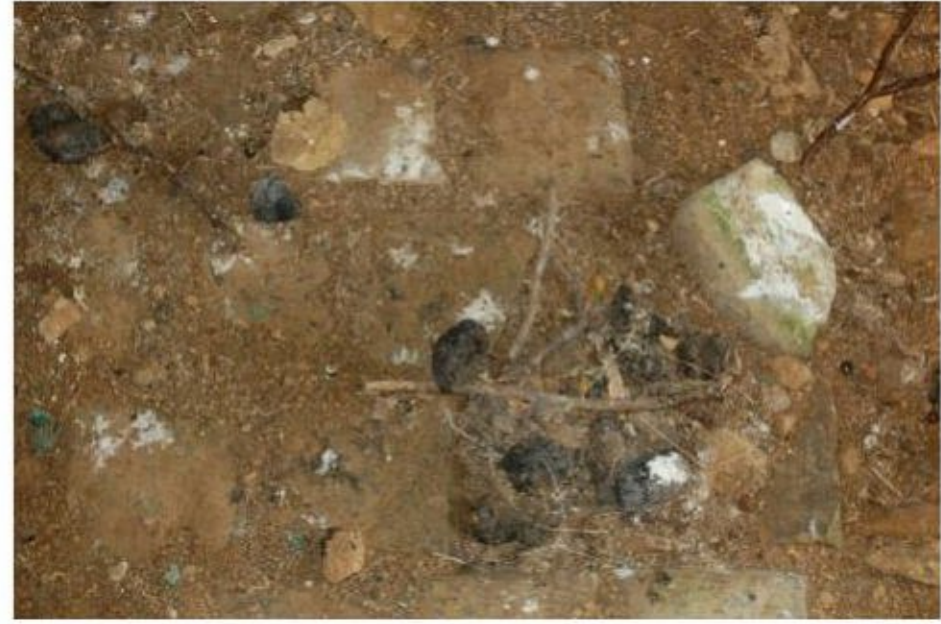
Figure 27. Small accumulation of old barn owl pellets found in the north-west extension of the barn.

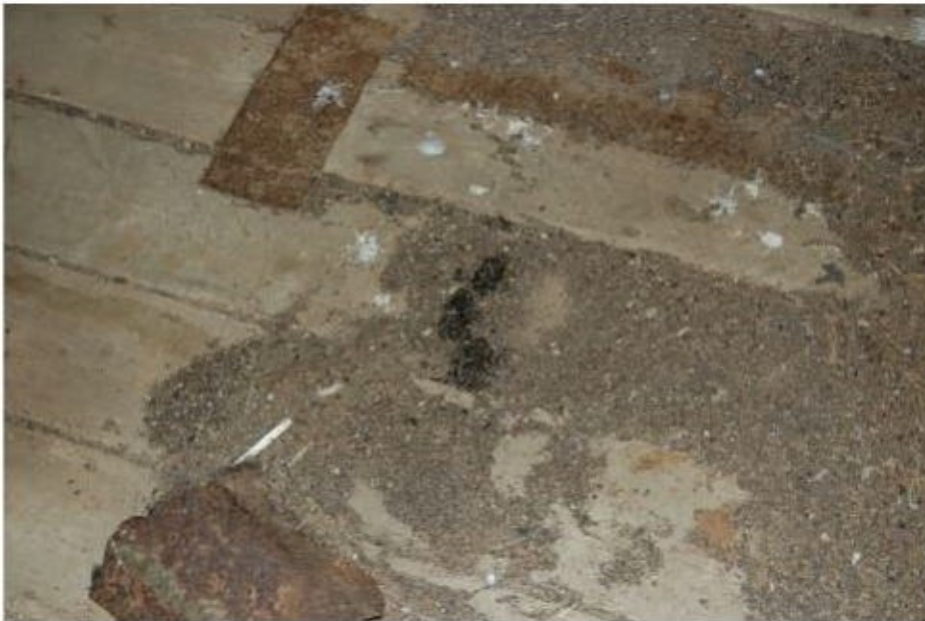
Species	Location of nest/perch	Notes
Little owl	<b>Barn 2 (main barn, upper floor).</b> Perch site.	<p>No evidence of nesting little owls within Barn 2 was identified during the surveys. A large number of little owl pellets were observed on the upper floor of Barn 2 (main barn). Approximately 120 little owl pellets were recorded over the floor; the main concentration was to the centre of the space; with some pellets widely scattered to the edges of the upper room. Where the little owl pellets are concentrated, there is also a patch of disintegrated pellets. The majority of the pellets are old, with approximately 20% being fresh.</p> <p>White-wash (owl droppings) was noted over the floor and some of the cross beams.</p> <p>A little owl was seen perching on top of Barn 2 at 21:55 for a few moments during the survey on the 31<sup>st</sup> July 2019. No further sightings of little owls were made.</p> <p>The upper room of Barn 2 (main barn) is used as a perch site by a little. The perch is active.</p>

Figure 28. Little owl pellets and material that appears to be disintegrated pellets; noted in the upper room of Barn 2 (main barn).

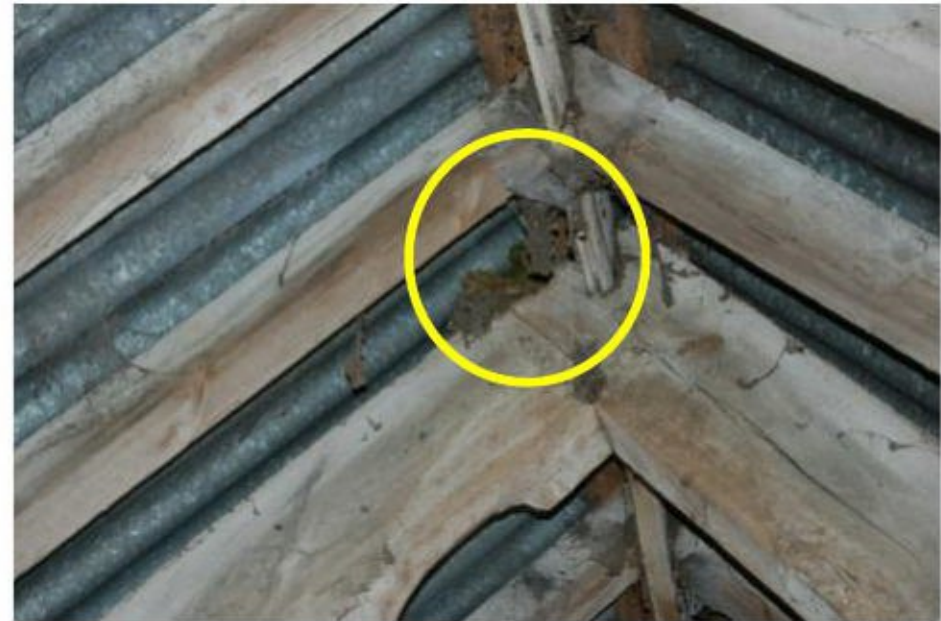
Wren	<b>Barn 2 (livestock shed).</b> Nest site.	An inactive wrens' nest was observed within the livestock shed. The nest had been built at the apex of the roof towards the south-western end of the barn, between the ridge board and the beams. The nest was inactive at the time of the survey.

Figure 29. Wren's nest within the livestock shed (outlined in yellow).

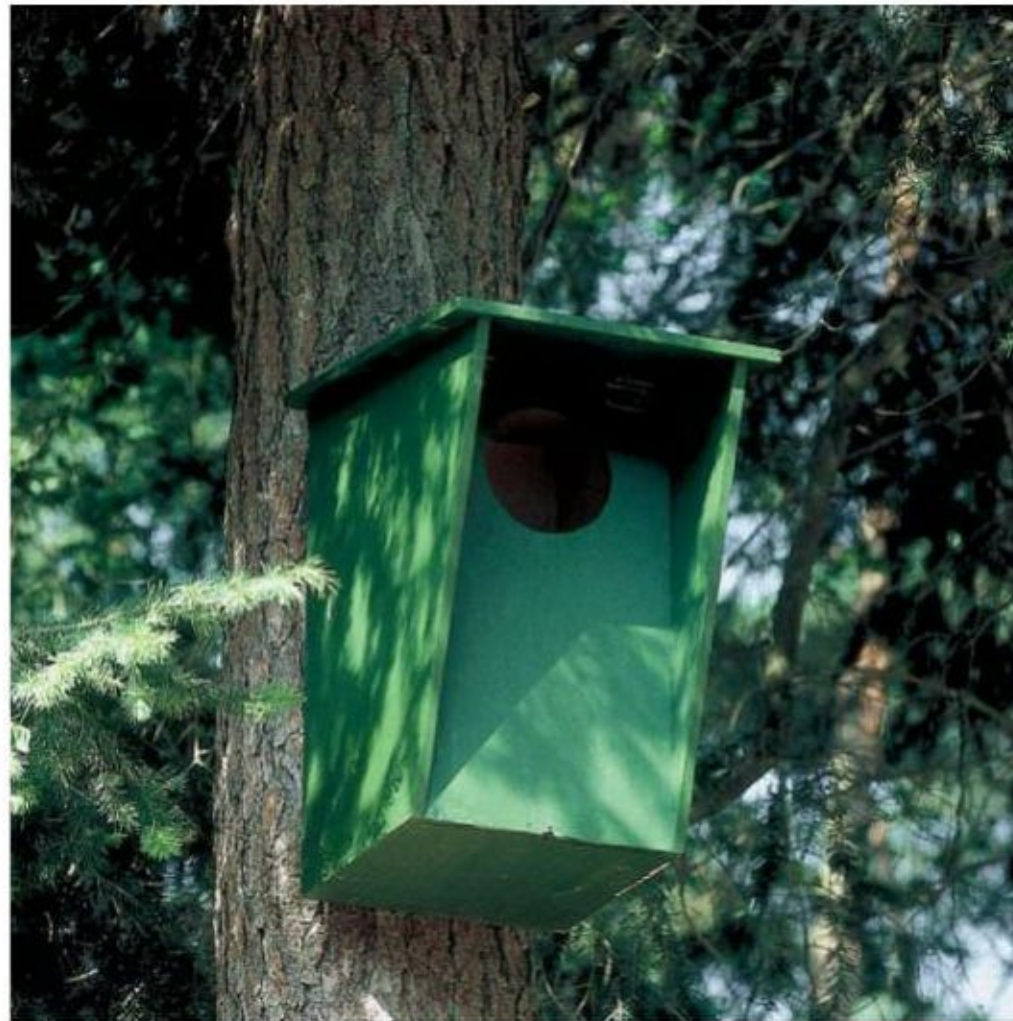
Figure 31. A jackdaw nest box mounted in a tree. This box is also suitable for tawny owls and stock doves.

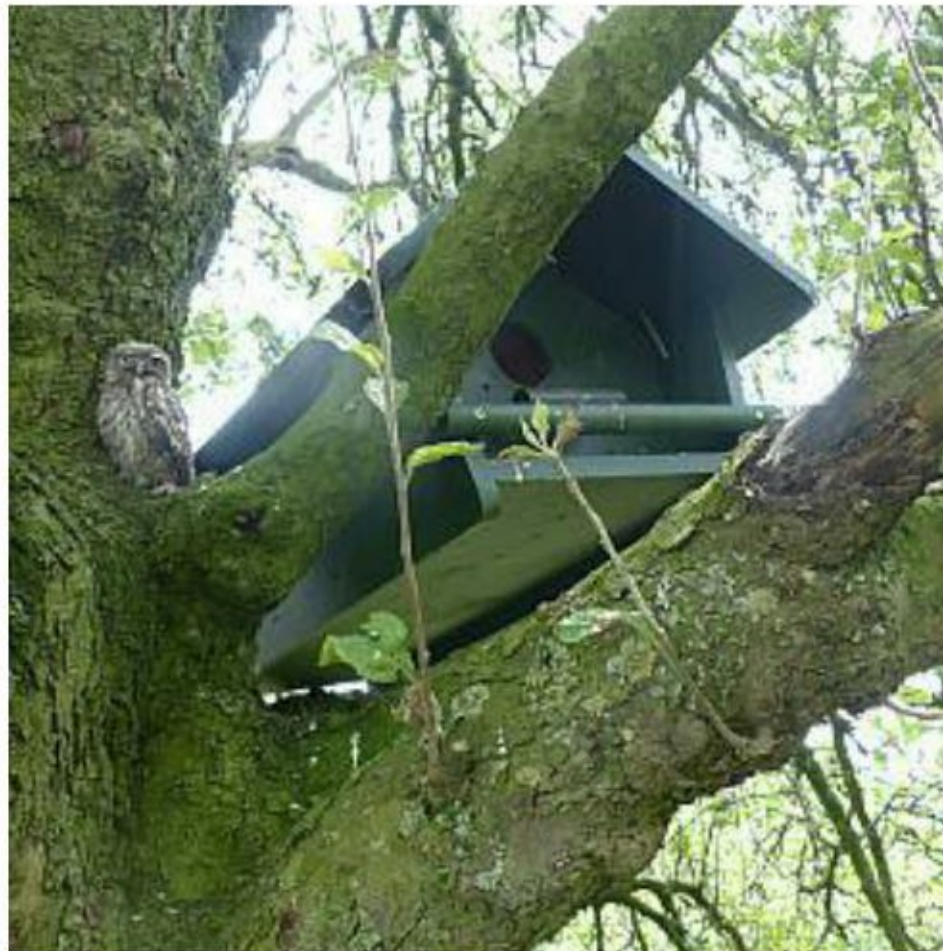
*Figure 32. A little owl nest box mounted in a tree.*

The little owl nest box should be situated at a height of 3 - 5 metres above the ground on an isolated tree. Preferred locations are in farmland, parks, golf courses or any area which has a good mix of grass, hedge and copse. The box should be lined with wood chips or shredded bark which will protect the eggs. Avoid using soil or sawdust as this will clog up the drainage holes.

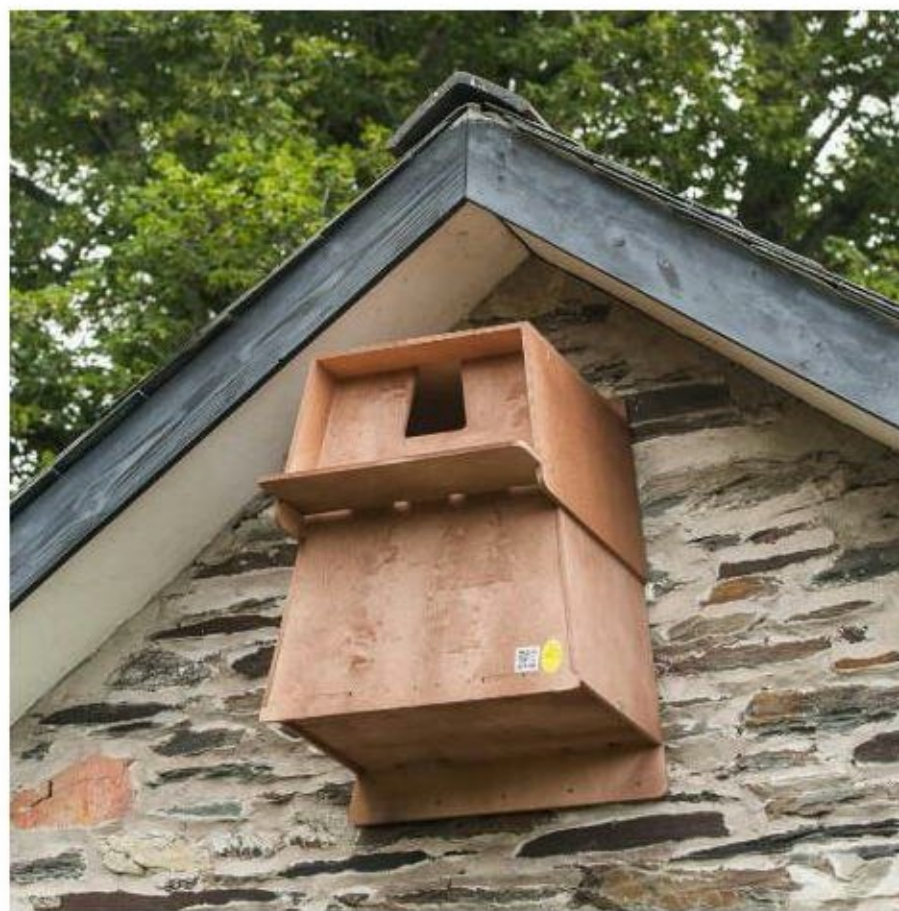
*Figure 33. A barn owl nest box mounted on a building*

The barn owl nest box should be erected as high as possible on the north-east gable end of Barn 2. Alternatively, the box could be erected on a tree or pole within the landholding of the property. The box will provide a potential nest site for barn owls, as well as a place to rest and perch.

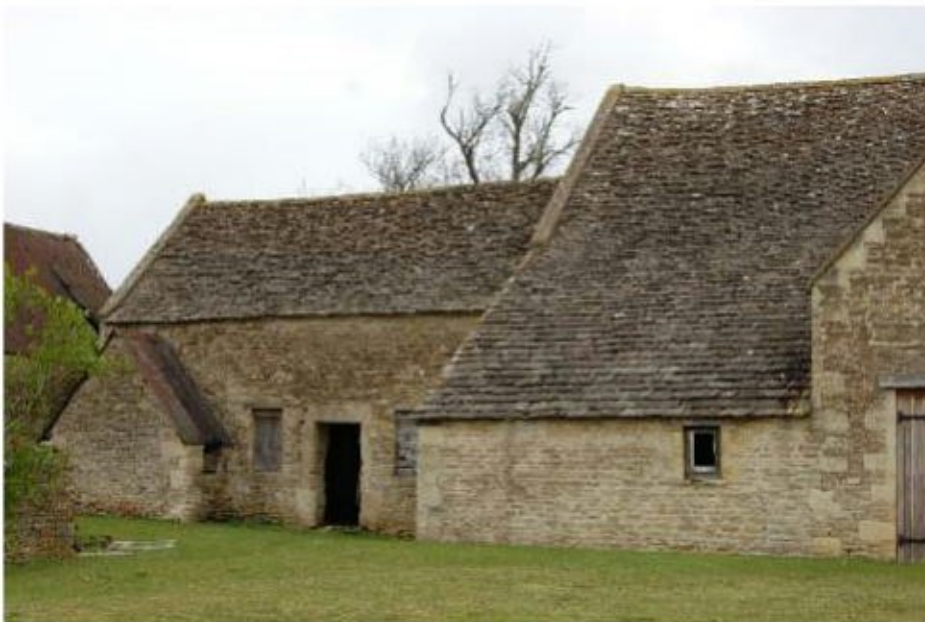
Photograph 5. The north-west section of the south-west elevation of Barn 1. Photograph shows the extension and north-western lean-to (main swarming site)

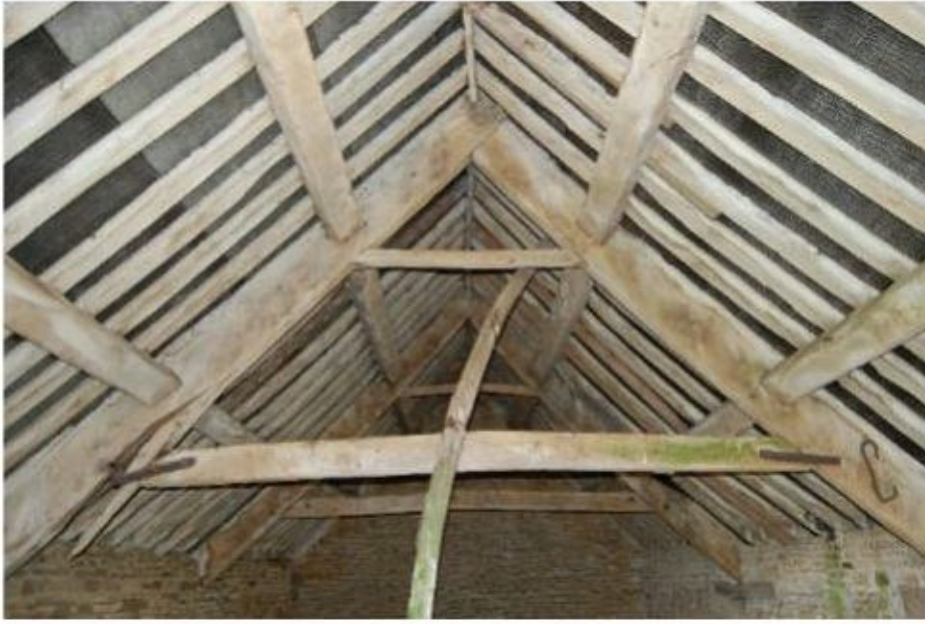
Photograph 7. The interior of the north-west extension of Barn 2, taken from the mezzanine floor looking south-east.

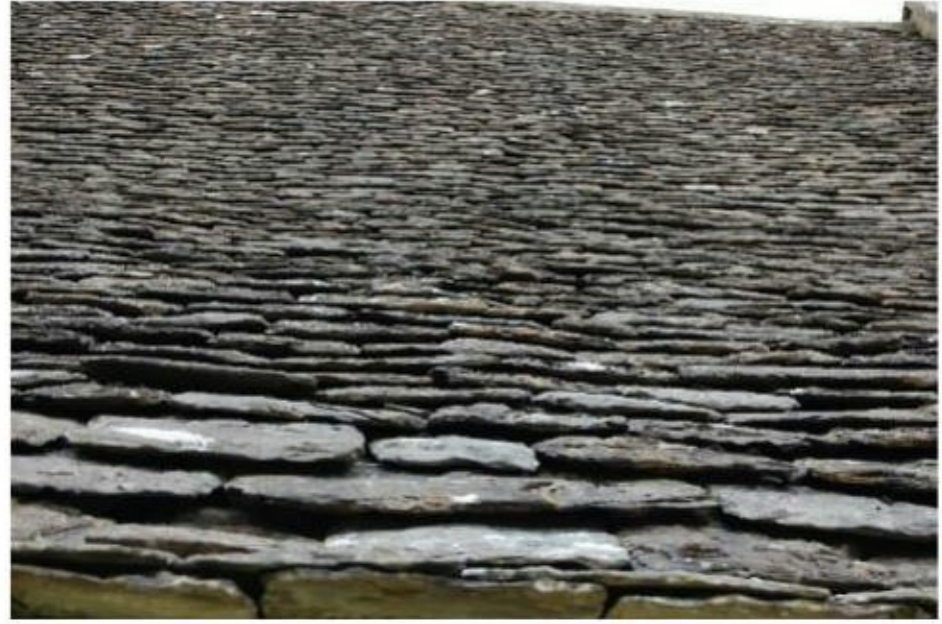
Photograph 8. Photograph showing the naturally occurring gaps below the stone roof tiles of Barn 1.
