**Barrington Downs Farm Barns, Barrington Downs,  
near Aldsworth, Cheltenham,  
Gloucestershire GL54 3PT**

**Bat Survey Report**

**September 2020**

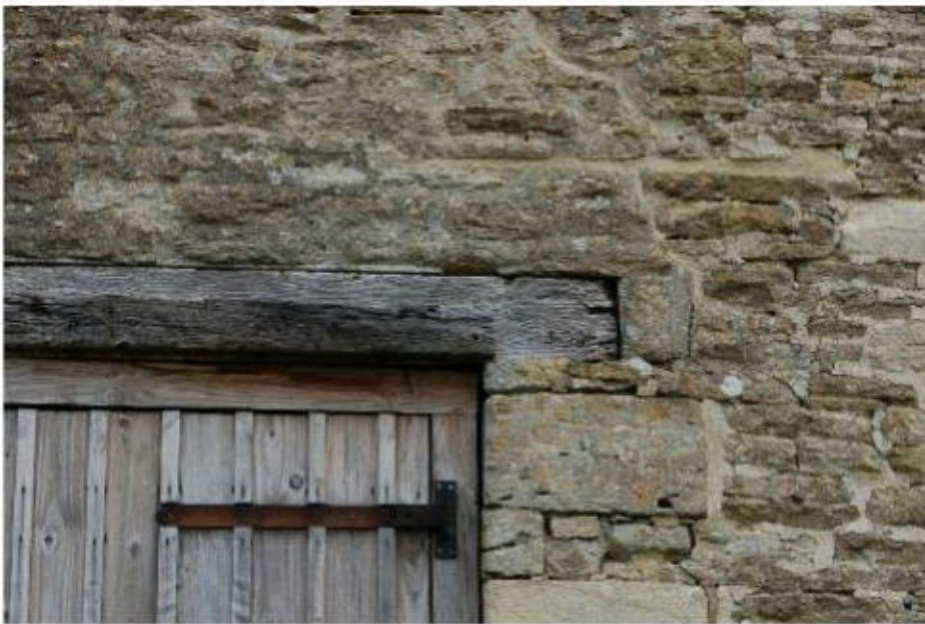
Photograph 9. Photograph showing one of the crevice features above the wooden lintel. Two common pipistrelles roost within this feature.

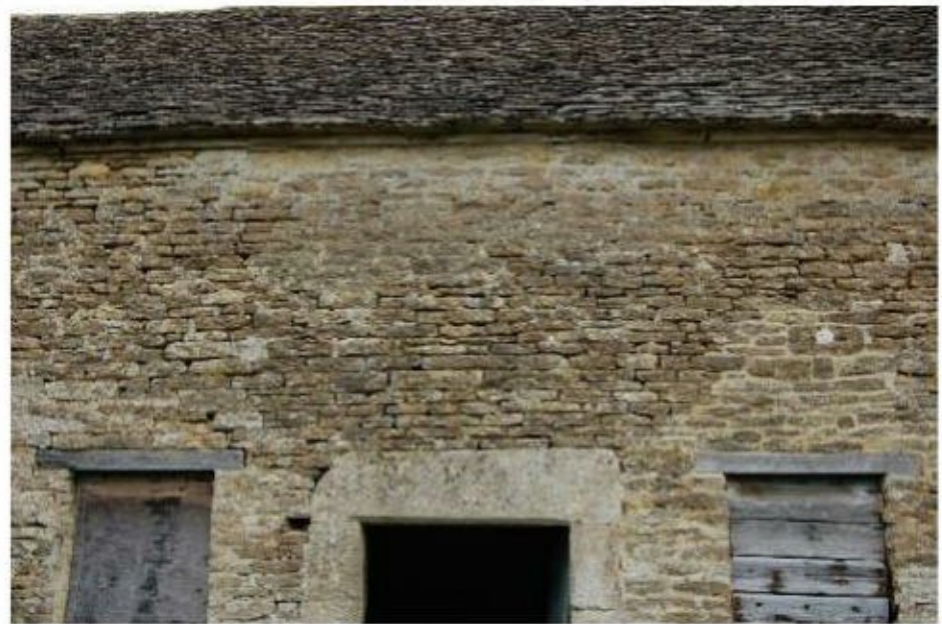
Photograph 10. Photograph showing external crevices between the stonework.

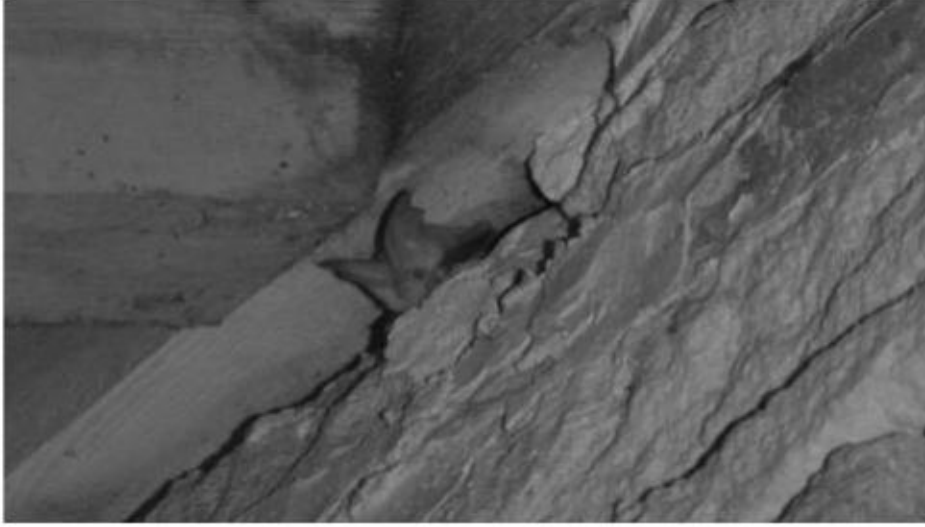
Photograph 19. Photograph showing one of the brown long-eared bats within the south-western lean-to at the apex of the wall; within the crevices used for roosting.

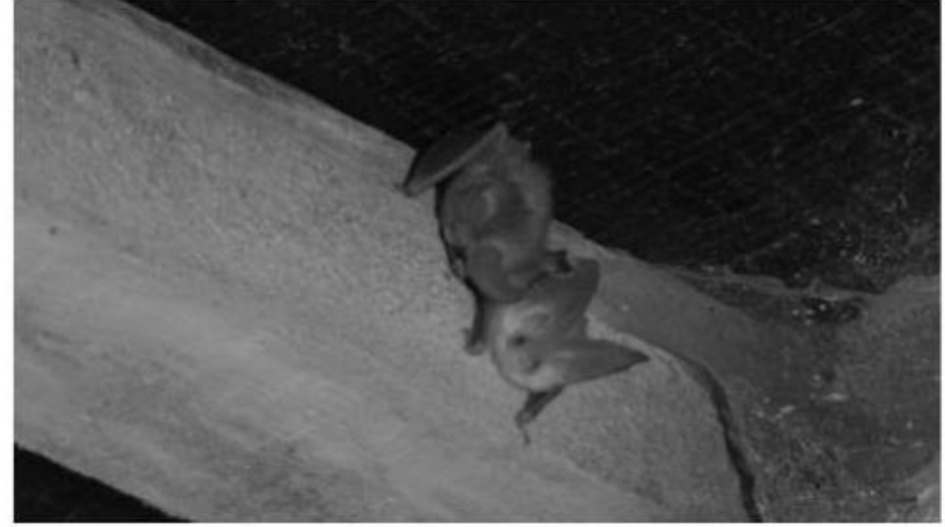
Photograph 20. Photograph showing two of the brown long-eared bats on a wooden beam towards the apex of the south-western lean-to extension.
