**Barrington Downs Farm**

Historic Building Report for Samuel Morse

April 2021

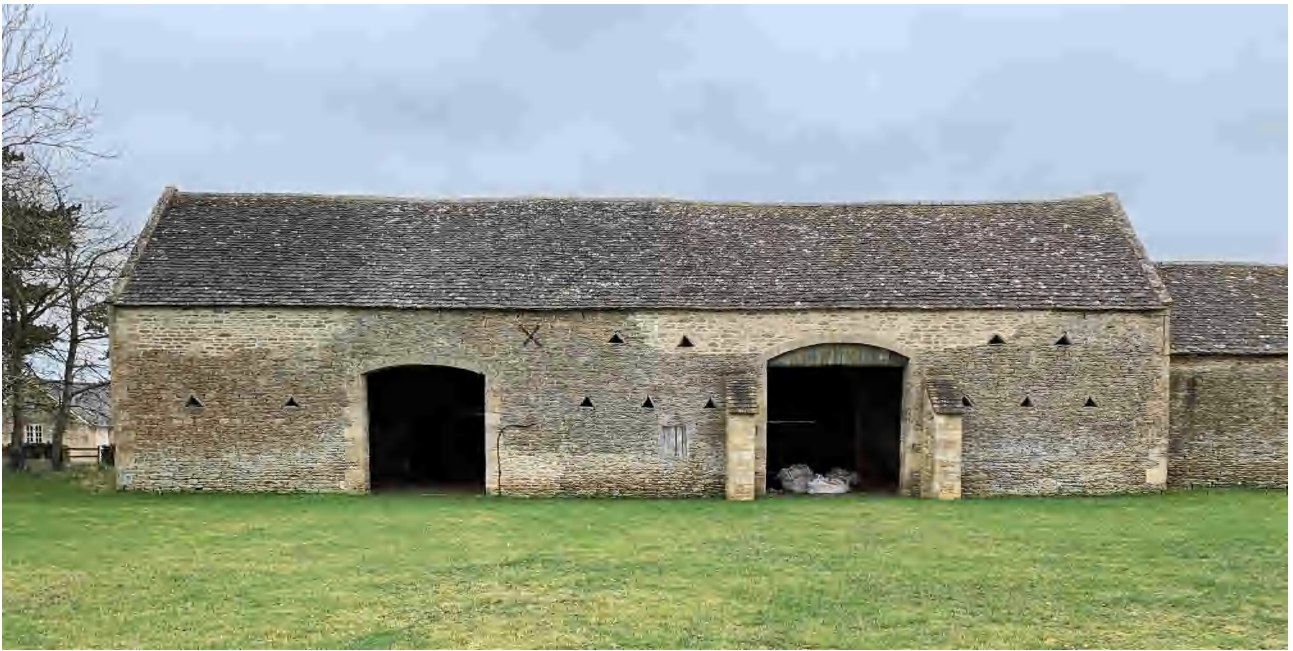
The barn is constructed of limestone rubble, and is visible on its north, east and south sides. The north side has large doorways with segmental arches to each of the two internal volumes **[Plate 3.1]**. The taller western doorway, to the threshing barn, has a timber spandrel panel within the arch, in the soffit of which are large holes for the original harr-hung doors (now removed) **[Plate 3.2]**. Marks on the soffit of the arch show where a similar panel has been removed from the east doorway. Each doorway has dressed stone jambs and voussoirs, and there are also dressed stone quoins on the corners, at each end of the elevation. There are a number of triangular ventilation holes in the north elevation: five to each side of the threshing floor in the western part of the barn, and two to the east of the door in the eastern part of the building. At each end the gable-end wall rises above the roof, and is capped with flat coping. Areas of fresh mortar show parts of the masonry that were repaired in 2011. The two buttresses on either side of the western door were built at this time, using reused stone from an unknown source.

3.1 Building A, north elevation (DIA).

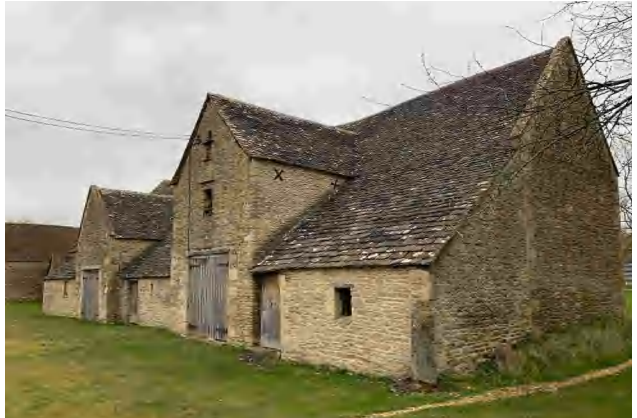
3.4 Building A, south elevation, from the south east (DIA).

The south side of the building has a lower eaves line, owing to the outshuts to either side of and between the two porches **[Plates 3.4-3.5a]**. The western porch has dressed stone door jambs and quoins, and has gable details exactly the same as the east elevation of the original building: it is almost certainly part of the primary phase, and appears to be unaltered. The double doors are modern. The eastern porch is not only taller but different in detail. It does not have dressed quoins, and its roof overhangs the gable. There is a rectangular window above the double doors and above that a slit opening to a pigeon loft, with slate landing perches. The detail differences in the eastern porch suggest that it was a later addition

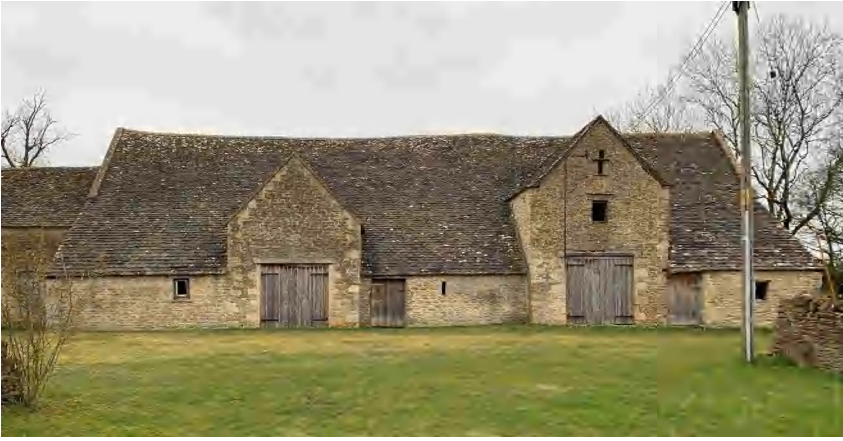
**3.5** Building A, south elevation (DIA).

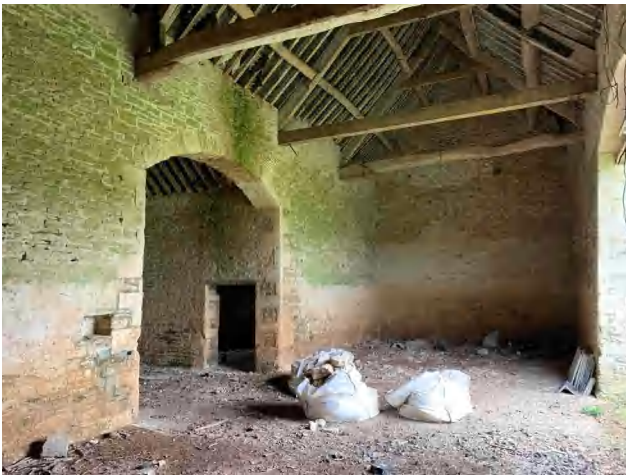
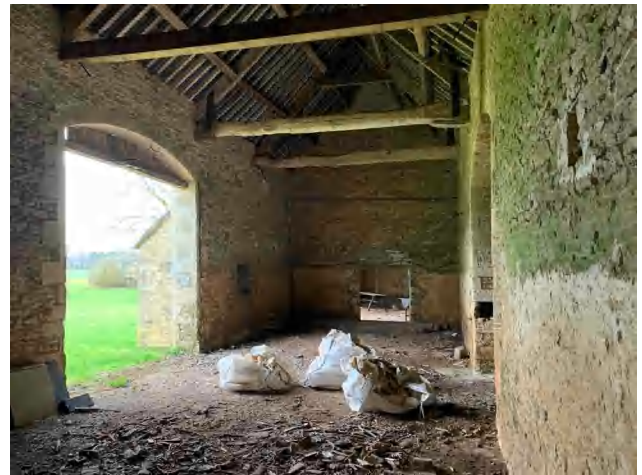
The western part of the building is a threshing barn of five bays, with a central threshing floor and storage bays to each side **[Plates 3.8-3.9]**. The walls are of rubble limestone, with the remains of lime plaster on the lower parts of the wall, between floor and head height. The wall between the eastern and western parts of the barn extends to the apex of the roof and is part of the primary structure. The doorway at the bottom of this wall, beneath a lintel made from redundant railway sleepers, is a 20<sup>th</sup> century insertion. The south wall is pierced by a number of ventilation holes. These holes appear as triangles on the exterior of the buildings, but are square within. The window on the north wall to the east of the porch is probably not an original feature, but was likely inserted in the 19<sup>th</sup> century. The floor to the storage bays is rammed earth, while the threshing floor is of blue brick, now quite degraded – probably a 19<sup>th</sup> or early 20<sup>th</sup> century replacement for the original floor. It has a collar and tie beam truss roof of elm, with two rows of threaded purlins **[Plate 3.10]**. While largely original, the roof was repaired using metal plates, new rafters and one new tie beam in 2011. On the south side of the space an arch, with dressed stone jambs and voussoirs, identical to that on the north side, gives on to the unceiled porch. On both sides of the porch there are doorways, leading into the later outshuts. Both doorways are conceivably parts of the primary structure, with jambs that are structurally integral with those of the main archway. If they are primary, however, they must originally have been exterior doors. The eastern doorway has the initials 'BB' and the date 1783 scribed into one of the jamb stones: this may be the date of the doorway's insertion and (therefore, probably) the date of the central outshut **[Plates 3.11-3.12]**. Immediately beneath this stone is a candle niche: one of several in the building. There is another round the corner, on the south wall of the main space. There are some graffiti in this area, commonly found in such buildings: 'tally' marks and interlocking 'V's.

**3.8** Building A - the western part, from the north east (DIA)

**3.9** Building A - the western part, from the south west (DIA).

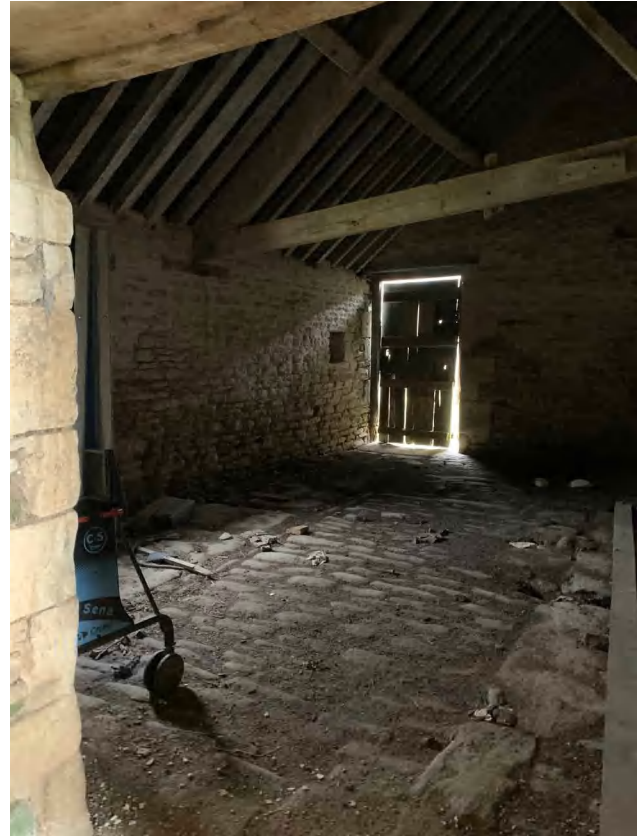
The western outshut has a cobblestone floor, and a softwood roof structure, indicative of a later 19<sup>th</sup>-century date **[Plate 3.22]**. The central outshut has a modern concrete floor, and an elm roof. It is accessed by a late 18<sup>th</sup> or early 19<sup>th</sup> century plank and batten softwood door. The eastern outshut is accessed externally, through the door in the southern elevation, and could not be inspected.

**3.22** Building A, western outshut, from the north east (DIA).

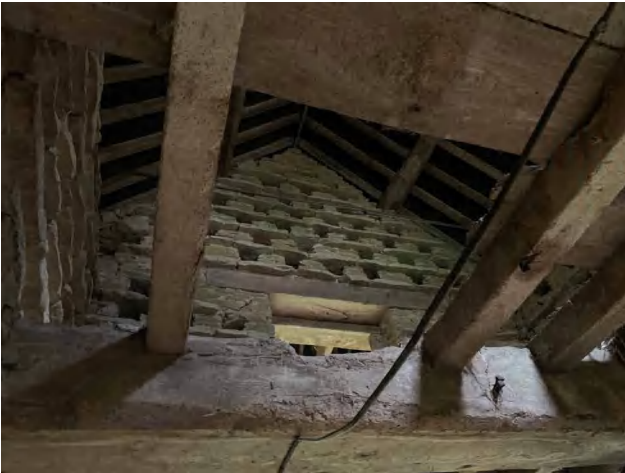
The opening into the porch on the south side does not have any of the structural niceties that characterise the arched opening in the south side of the western part of the barn, and elsewhere **[Plate 3.18]**. Specifically, there are no dressed quoins on the eastern corner. This invites the suspicion that prior to the construction of the porch there was a blank wall on the south side. The porch is accessed through an opening with a timber lintel at its head, and is ceiled to create a pigeon loft in its upper part. The floor of the porch is stone flags, probably dating from its construction **[Plate 3.19]**. The top left hand jamb stone of the doorway contains the scribed initials 'I (J) B' and, beneath, the name 'John Gray' and the date 1777 **[Plate 3.20]**. If this stone is not reused it gives a possible date for addition of the porch and pigeon loft. At the upper level the pigeon loft is accessed through the barn wall via a doorway, the frame of which survives (the door has gone). Inside, the walls have numerous nesting boxes built into them **[Plate 3.21]**.

**3.21** Building A, east end. View up from ground level into the pigeon house, showing nest boxes built into the gable wall (DIA).

Opening to pigeon loft relocated: very harmful. Unlikely that the important features of the pigeon loft could be adequately preserved with the proposed use as a bathroom.	The scheme has been changed such that the pigeon loft and its openings will all be retained.
Glazed link between main barn and the attached smaller barn or stable: highly incongruous and very visually intrusive.	This has been omitted.
Infilling of a presumed historic doorway is also noted as harmful. An internal link would be appropriate.	The alterations to the doorway have been omitted and an internal link proposed.
New first-floor opening (stable): large and sits within an important area of blank walling. Falls in uncomfortable proximity to the historic openings below, and very much compromises the historic character of this elevation.	This opening has been redesigned and now consists of two much smaller vertically proportioned openings.

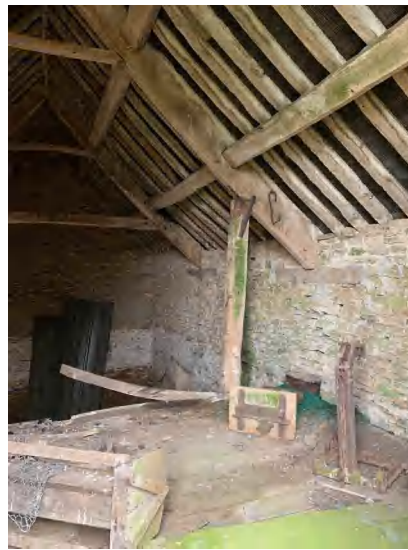
The hayloft above is accessed through a doorway from the tallet steps outside **[Plate 3.36]**. There are carved images of horses on the northern jamb **[Plate 3.37]**. The boarded floor within extends half way down the building – on the right the opening to the southern projection is visible **[Plate 3.38]**. The well-made roof has collar trusses and two rows of threaded purlins. The deep principals have a pegged mortice and tenon joint at their apex, and the rafters meet at a ridge board **[Plate 3.39]**. This roof is constructed entirely of oak, and appears to retain all its original timber, albeit the south-western principal has broken at its joint with the collar, allowing the collar to fall away. The short upper collars are nailed in, and are probably a later modification.

**3.36** The hayloft of Building B, looking south east from the doorway (DIA).

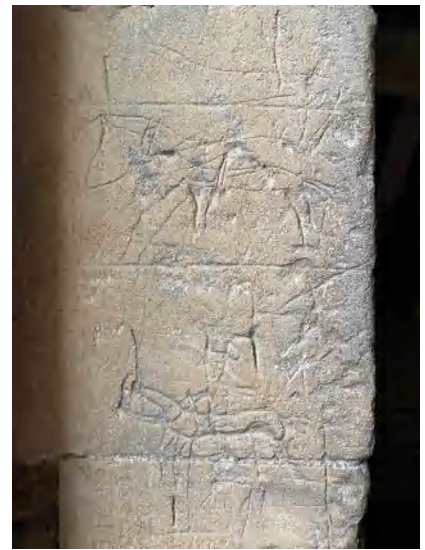
**3.37** Graffiti of horses on the jamb of the door to the hayloft in Building B (DIA).

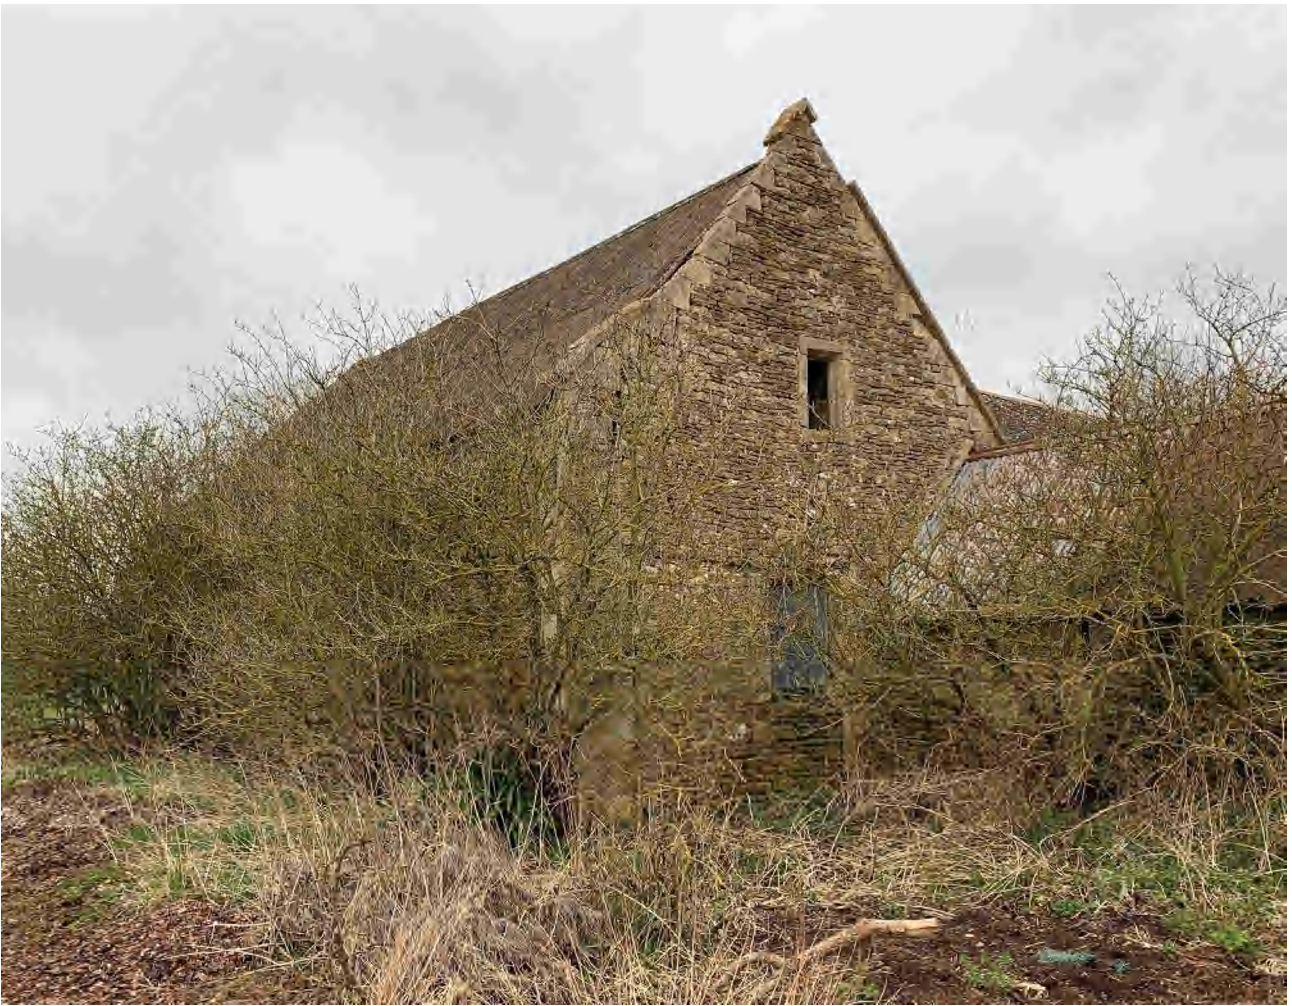
**3.40** The south elevation of Building C, from the south west (DIA).

The former granary, which is suffering from cracking and movement, would be carefully repaired. The existing openings would be glazed, with doors hung externally. The former cart entrance in the end gable elevation would be opened and glazed.

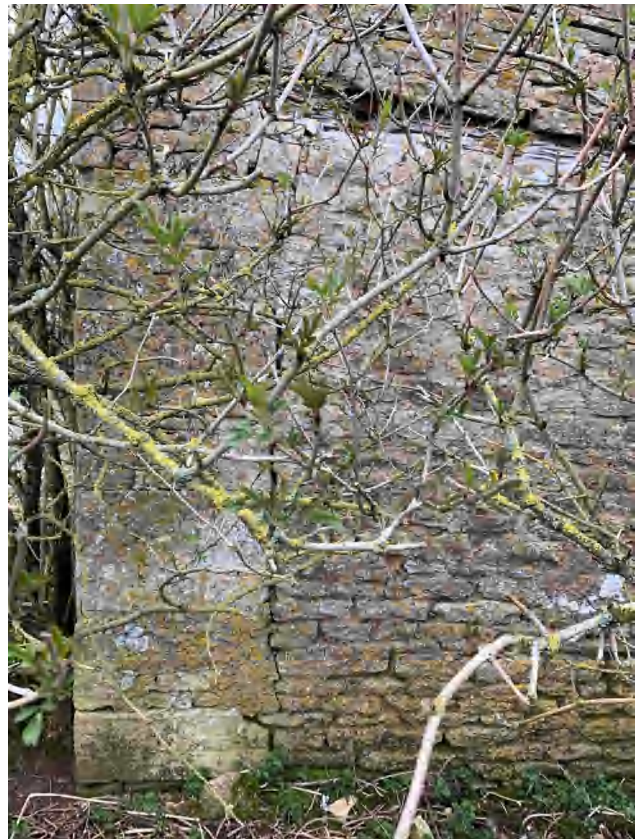
**3.43** Straight joint and lintel showing the former extent of the doorway (left side) in the south elevation of Building C (DIA).

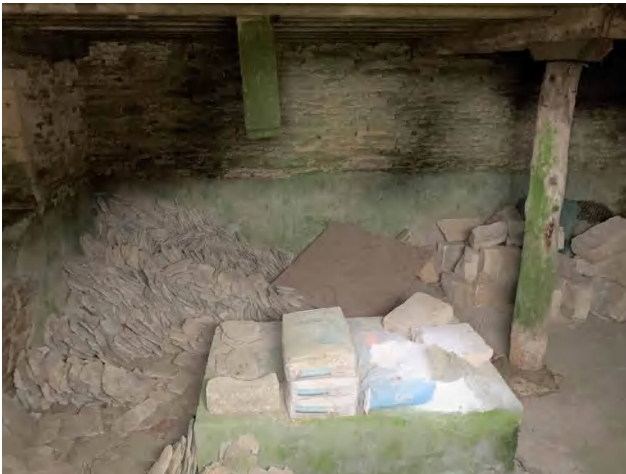
The ground floor of the building could not be inspected internally, except through a small gap at the top of the door **[Plate 3.51]**. The timber framework of the ceiling appears to be original, but two unconverted timber Samson posts beneath the transverse beams are almost certainly later additions. Upstairs, the 'original collar and tie beam trusses' noted in the list description are no longer present (or were never here to begin with; see below for other inaccuracies in the listing). The current corrugated steel roof is supported on a lightweight softwood collar truss roof structure of the late 20<sup>th</sup> century **[Plate 3.52]**. It is unlikely, however, that the original roof had tie beams, as these would have been a serious impediment to the use of the loft. The list description is also incorrect in describing this small building as having been of five bays, and must – as far as it relates to this building – be taken with a pinch of salt.

A chute running from the loft to the ground-floor space, and the remains of wall finishes in the loft space suggest that the building may have functioned as a granary. The large doors at north and south ends would (prior to the insertion of the Samson posts) have allowed a cart to be driven in at one end, loaded, and driven out through the other. The lower part of the building may have been used as a cartshed – the adjacent field was recorded in the tithe apportionment survey as 'Cart House Garden'.

**3.51** View into the ground floor of Building C from the gap above the door in the east elevation. The chute is in the centre, and the reveal of the window in the south elevation is on the left (DIA).

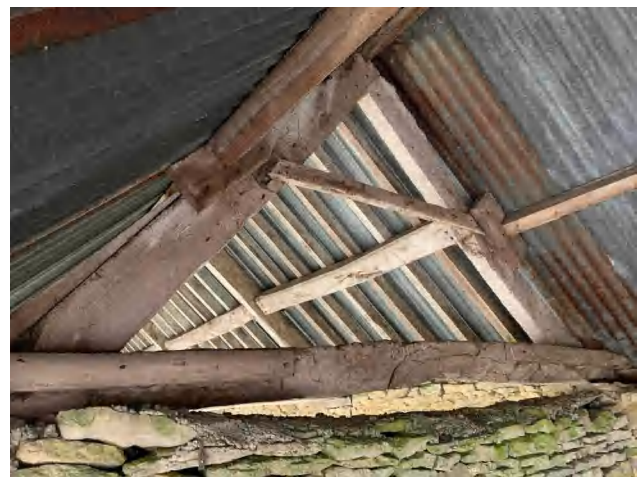
The roof comprises seven tiebeam trusses, but only the three in the southern part of the range are complete, with their original chamfered purlins and rafters **[Plate 3.58]**. In the central part of the range the roof and its supporting posts are later 20<sup>th</sup> century, and the same is true of the northernmost section. Between the two, however, one original truss (with the assembly mark 'III' clearly visible) sits above the dividing wall **[Plates 3.59-3.61]**. This wall is a 20<sup>th</sup> century block- and brickwork construction, while the southern division is the rubblestone original.

**3.58** The roof of Building D, looking south from the central part into the southern three bays (DIA).

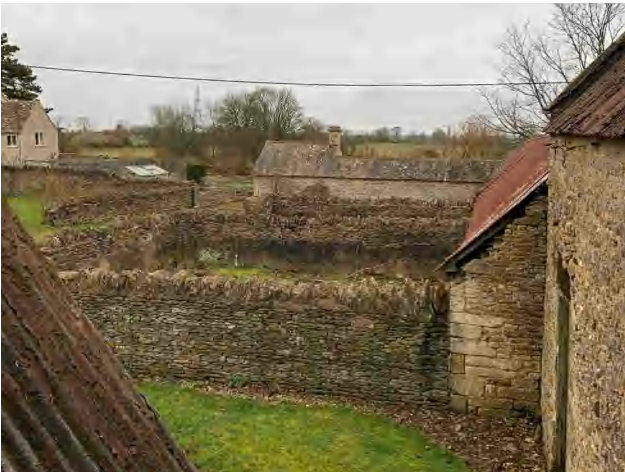
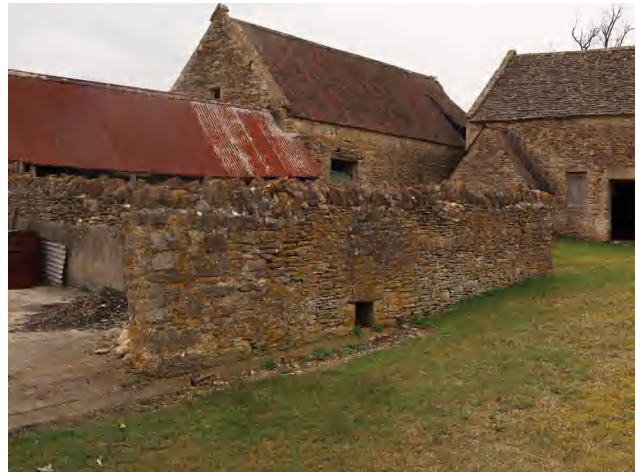
Projecting eastwards from the building are three undateable, but historic drystone walls, creating a separate stock enclosure in front of each section of the building **[Plates 3.62-3.63]**.

**3.62** The enclosures in front of Building C, from the north (DIA).

**3.63** The northern part of the enclosures, from the south east (DIA).

Stone tallet steps: apparent proposed demolition is very concerning.	The steps will not be demolished.
Need for greater understanding of the existing material in the adjacent barn	This has been provided in this report.
Openings in smaller barn should be repaired if necessary but not 'straightened up' or changed in proportion.	Noted and scheme altered accordingly.
Proposed demolition of shelter shed is very concerning. Greater analysis of its timber structures should be provided.	The scheme has been altered so that the shelter sheds will be retained and converted to additional guest bedrooms.
Level of intervention wholly unacceptable, as the form, features and character of this part of the building are not respected.	The scheme has been changed to ensure the form, features and character of the buildings are all respected.
Proposed removal of stock pen enclosures is unacceptably harmful to the historic integrity and character of the farm complex.	The scheme has been altered so that the stock pen enclosures would be retained.
