**2020 Updated Bat Survey Report for
former Pentecostal Chapel, Aston Magna,
Gloucestershire, GL56 9QQ**

Cotswold Wildlife Surveys

20th January 2011 and 15th & 23rd July, 9th August & 11th September 2020

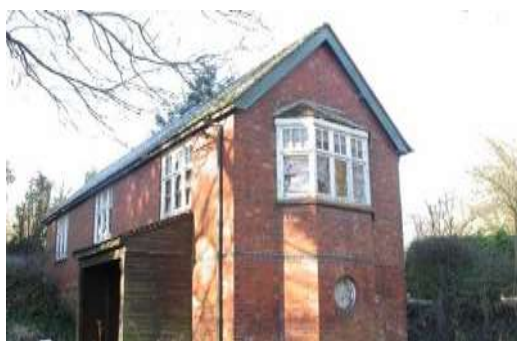
Fig. 1 Chapel – S & E elevations

The site comprised a detached brick building with a pitched tile roof (Fig. 1). Constructed on the side of a slope, there were two main rooms at upper floor level and a basement below (Fig. 2).

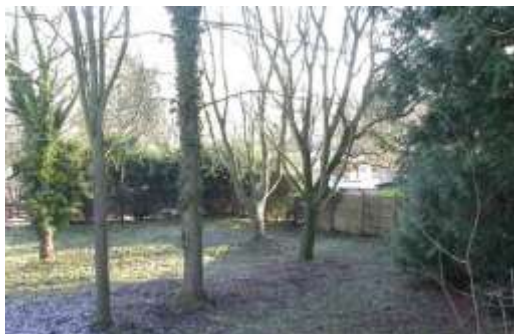
Fig. 3 Lightly wooded garden of chapel

The chapel sat within its own grounds, these lightly wooded with no shrubs or field layer (Fig. 3). To the west there were neighbouring houses, to the south and east Batsford Timber yard, and to the north a large block of broadleaved woodland.

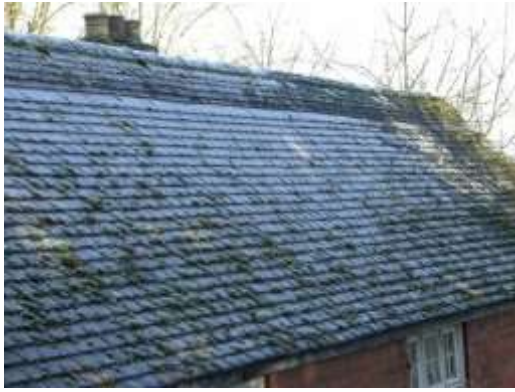
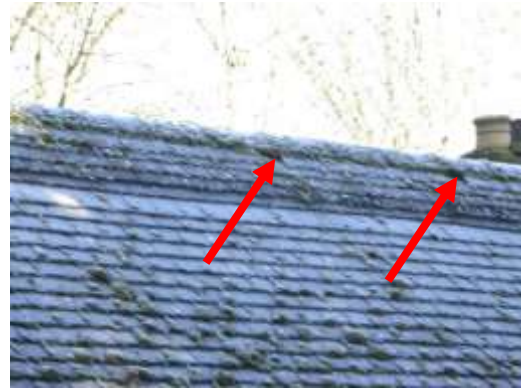
Figs. 5 & 6 Roof of chapel and missing tiles (arrowed)

The roof of the former chapel had been replaced several years previously, and it was in good condition (Fig. 5), with the ridge intact and sealed except for five missing tiles spread out along south roof slope (Fig. 6 – arrowed).

The lead flashing around the chimney was tightly moulded and all the remaining tiles were closely overlapping.

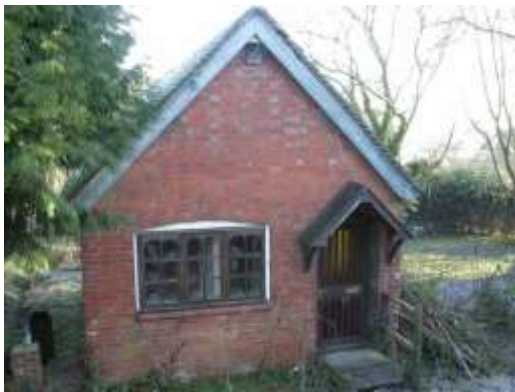
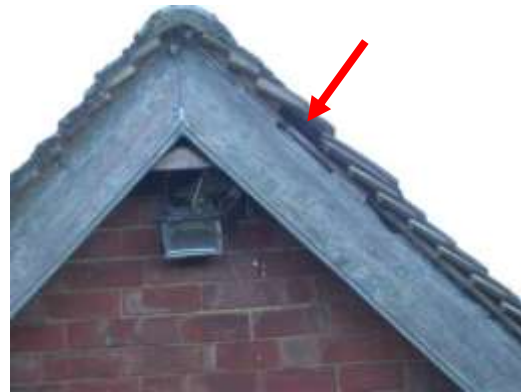
Figs. 7 & 8 West gable end showing barge boards and cavity in roof end

The gable ends were finished with timber barge boards (Figs. 7-10), behind which the ends of the tile batons were exposed.

At the east gable end the spaces between the batons were sealed with cement, but at the west end, there were gaps between many of the batons on the south side (the north side being sealed), as well as a large cavity in the end of the roof (Fig. 8 – arrowed). The hole was free of cobwebs and opened directly into the roof void.

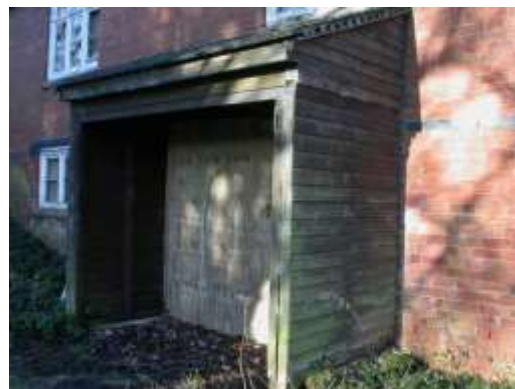
Fig. 12 Temporary porch

On the south elevation there was a temporary timber porch covering the basement doors (Fig. 12). The latter were boarded over and there was no access to the inside of the chapel.

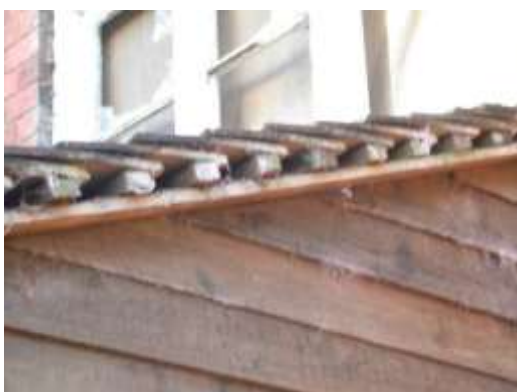
Fig. 13 Porch roof end

The porch had a sloping tiled roof, the ends of which were open, providing multiple roost sites for bats (Fig. 13).

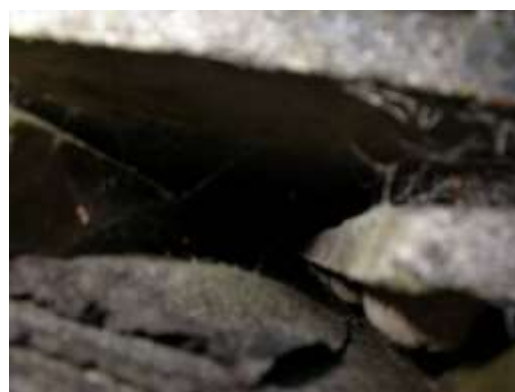
Fig. 14 Holes cobwebbed and dusty

Each gap was carefully examined with an endoscope, but all were cobwebbed over and no evidence of bats was found (Fig. 14).

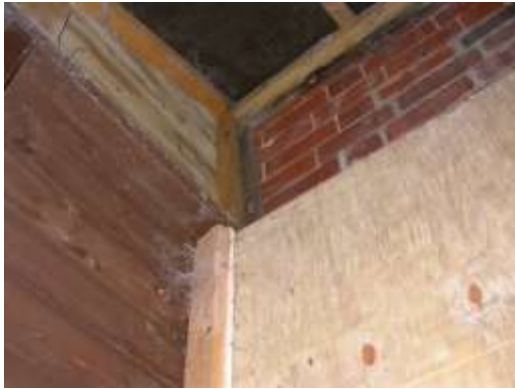
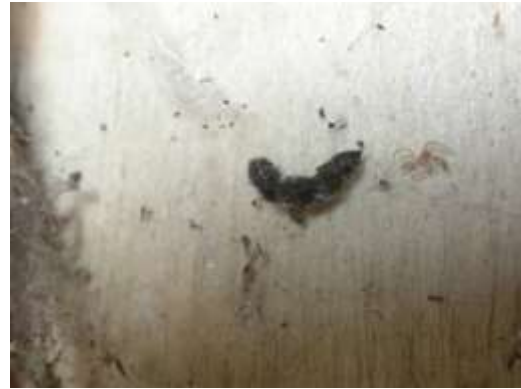
In the top left hand corner of the porch (Fig. 15), c6 Brown Long-eared Bat droppings were noted, all caught in cobwebs on the timberwork (Fig. 16).

Fig. 15 Porch interior

Fig. 16 Brown Long-eared Bat dropping

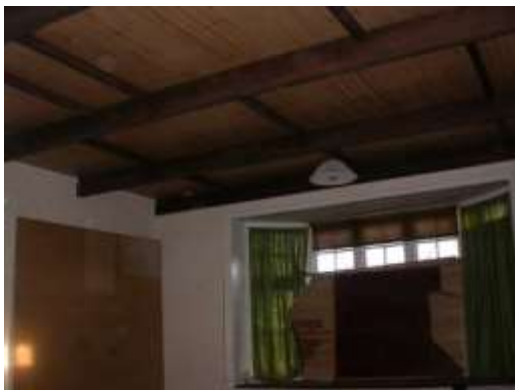
Fig. 17 Eastern meeting room

Internally there was an upper floor divided into two meeting rooms, a small entrance lobby and a tiny kitchen. The ceiling of the eastern meeting room (Fig. 17) was lower than the main room, and there was no loft hatch.

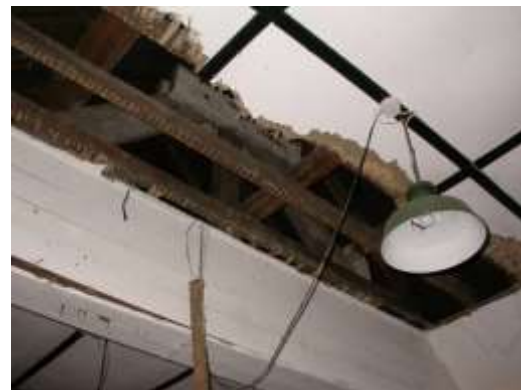
Fig. 18 Hole in ceiling of western room

No hatch was present in the main room either, but part of the ceiling had been removed in September 2010 to examine the underside of the roof (Fig. 18).

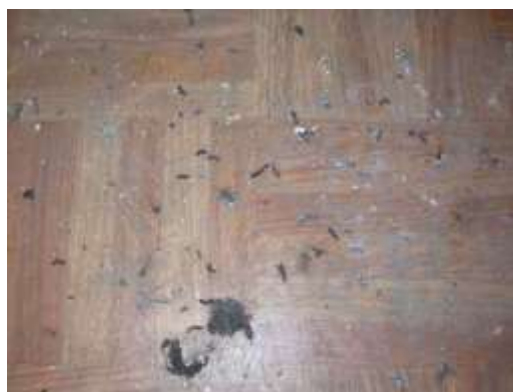
Fig. 19 Cluster of Brown Long-eared Bat droppings below hole in ceiling

On the floor below the hole a small, loose cluster of c30 Brown Long-eared Bat droppings were found, these evidently deposited by a bat roosting since September 2010 (Fig. 19).

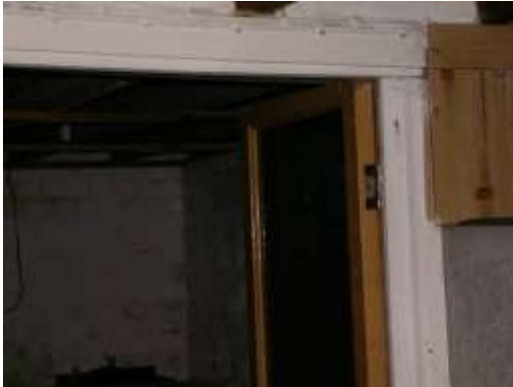
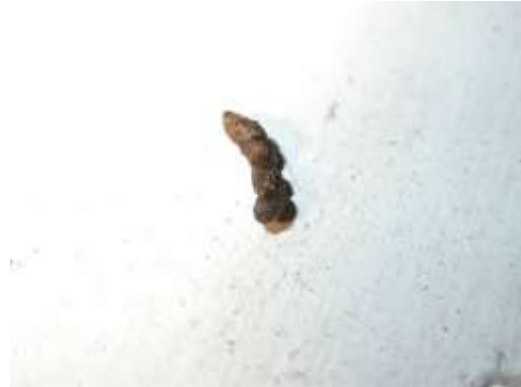
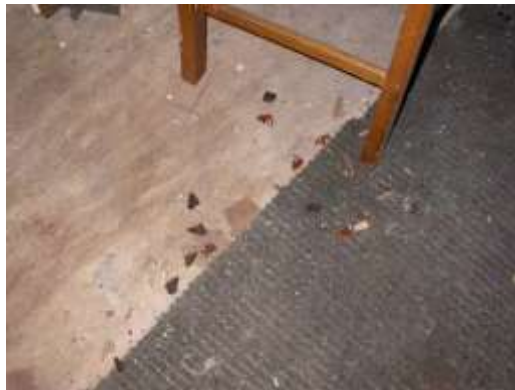
In the corner of the eastern meeting room there was an opening leading to the basement (lower ground floor) via a space-saver staircase. Scattered around the two basement rooms (Fig. 20), were c20 Brown Long-eared Bat droppings (Fig. 21) and several moth and butterfly wings (Fig. 22), these presumed to be bat feeding remains.

Fig. 20 Basement room

Fig. 21 Brown Long-eared Bat dropping

Fig. 22 Butterfly wings

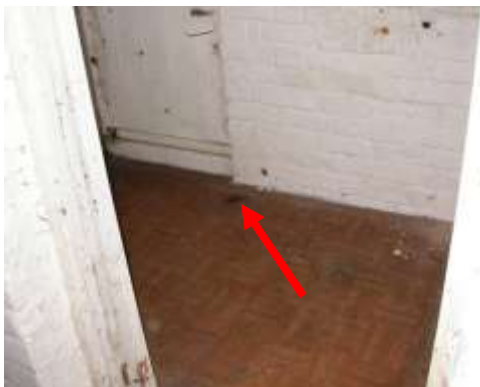
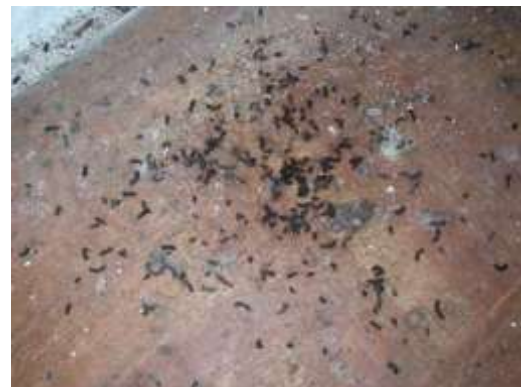
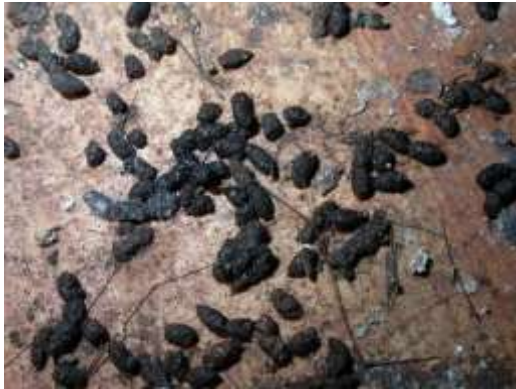
In the basement lobby (Fig. 23), more bat droppings were discovered (arrowed).

These were in a tight cluster consisting of about 100 Lesser Horseshoe Bat droppings (Figs. 24 and 25), all slightly swollen due to the damp conditions. The bat had evidently roosted on a wall-mounted light fitting (Fig. 26).

The location of the Lesser Horseshoe Bat droppings found in 2011 was also typical, although the droppings were slightly swollen in size due to the damp conditions (bat droppings are hygroscopic and swell up when moist).

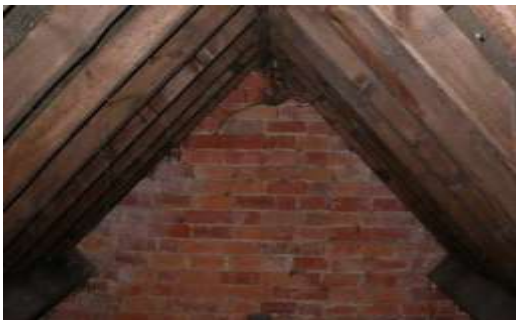
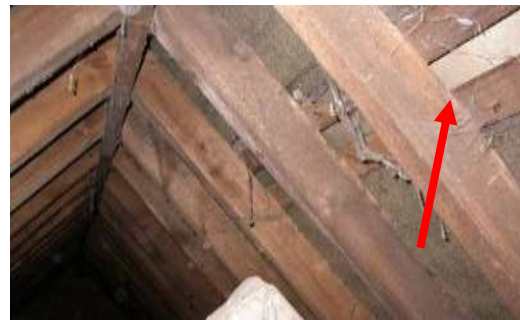
Figs. 27 & 28 Roof void with horizontal gap in felt (arrowed)

There was a single roof void measuring approximately 1.6 m high and running the full length and width of the building (Fig. 27). It was lined with bitumen felt, except for a horizontal gap about two thirds of the way up the south slope (Fig. 28 – arrowed). This connected with a gap in the western roof end and provided ventilation to the void. There were no other sources of light penetration.

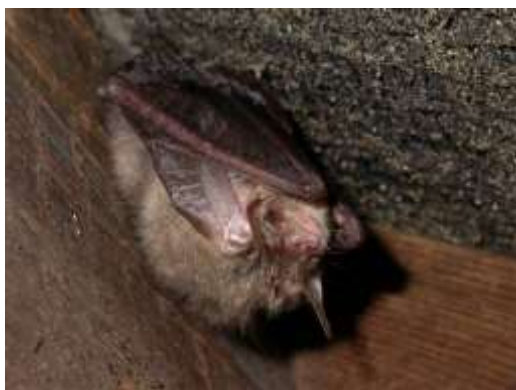
Fig. 29 Hibernating Brown Long-eared Bat

The timbers were relatively lightly cobwebbed, and about halfway along the void a hibernating adult Brown Long-eared Bat was found (Fig. 29).

It was initially thought that the bat may have used the chapel as a transitory autumn roost, but it was subsequently found hibernating in the roof void, wedged in against a rafter and the ridge board.

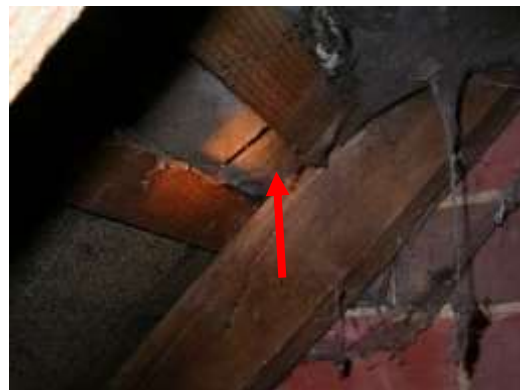
Fig. 30 Bat entry point

The bat entry point was obviously through a wide, uncobwebbed gap in the west gable end (Fig. 30 – arrowed). This corresponded to the cavity noted in the roof end from outside.

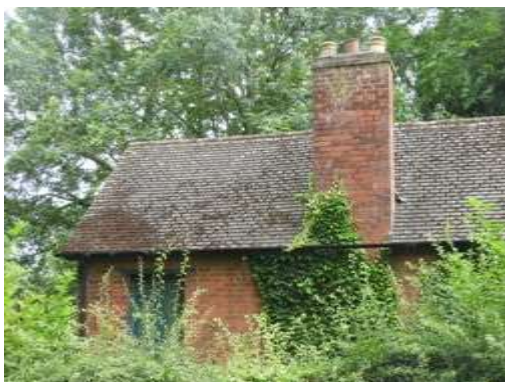
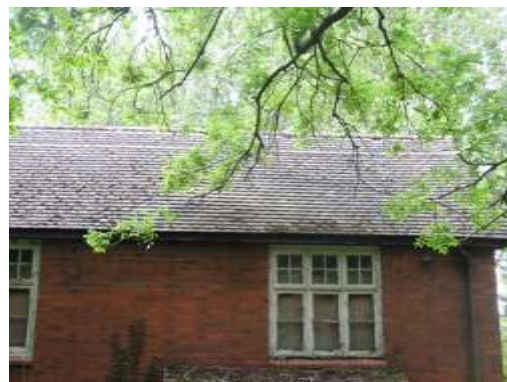
Figs. 31 & 32 Ridge and roof tiles to both front (L) and rear (R)

The ridge still was intact, and the gaps observed in the previous survey were covered with moss.

All the roof tiles were closely overlapping and the lead flashing around the chimney was tightly moulded (Figs. 31 and 32).

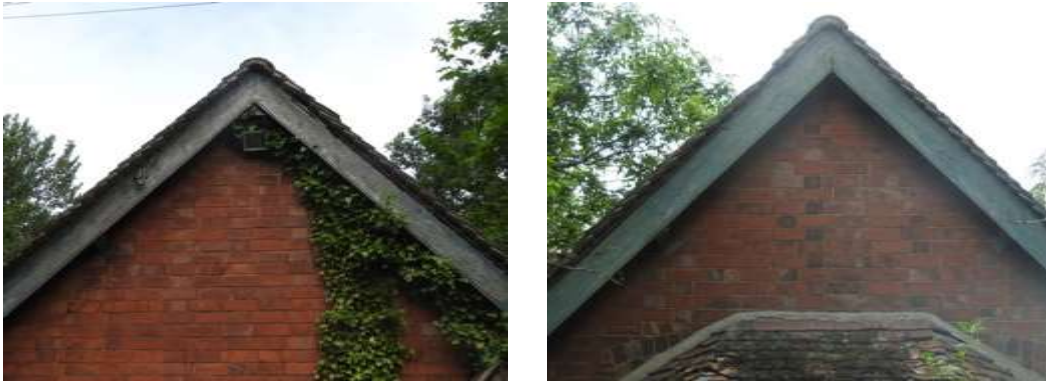
Figs. 33 & 34 Gable ends – with west gable gaps (L) and sealed east gable (R)

As found on the previous survey, on the east gable end the spaces between the batons were sealed with cement, but at the west end, there were gaps between many of the batons on the south slope (the north side being sealed) (Figs. 33 and 34).

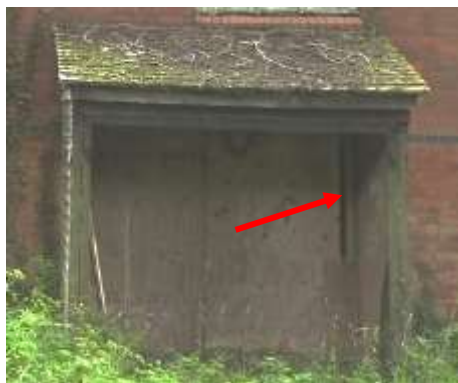
Fig. 35 Gap to the side of the lower entrance door

The brickwork was sound throughout and the window casements and doorframes were tightly fitting. A 10 cm gap was observed between the door and the doorframe of the entrance door on the lower floor (Fig. 35 – arrowed). No evidence of bat activity was found around the outside of the building.

Although the main roost site in the roof void will be retained, there will be no access from it to the rest of the building. A purpose-built entrance will therefore be provided in the south facing roof slope.

Timing of works will also be critical, as the roost is not to be disturbed between mid-April and the end of October. As such the roof void will be fully isolated from the rooms below, with the new entrance created before the boarding gap is closed up.

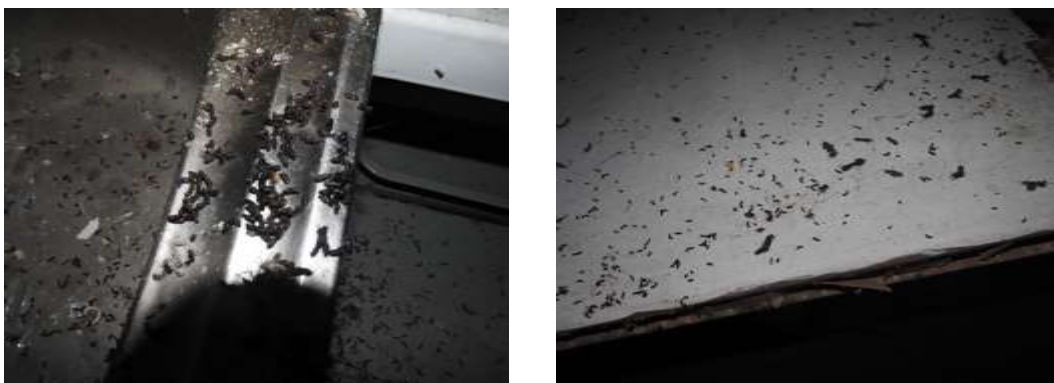
Figs. 36 & 37 Lesser Horseshoe Bat droppings

Internally the layout of the building was the same. On the floors of both the upper and lower levels, hundreds of Lesser Horseshoe Bat droppings were found and a check of the roof void revealed at least 35 Lesser Horseshoe Bats at roost (Figs. 36-38).

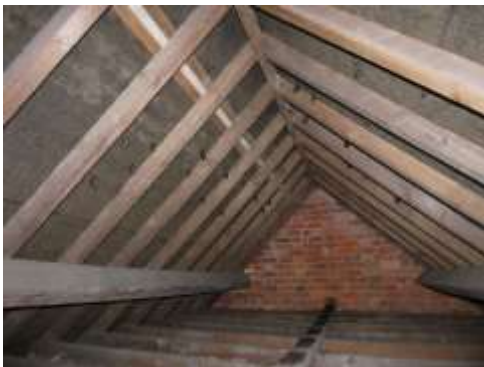
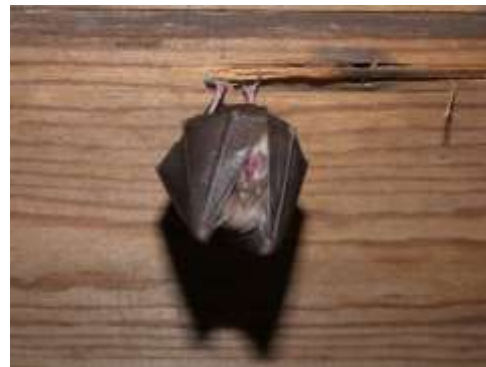
Figs. 39 & 40 A total of 48 Lesser Horseshoe Bats at roost

A second inspection was carried out on 11th September 2020 to specifically count the Lesser Horseshoes. A total of 48 animals were noted, these a mixture of adults and juveniles. Most were roosting in the roof void (Fig. 39), but a couple were found in the basement rooms (Fig. 40). The entrance through the boarding gap led into these rooms.

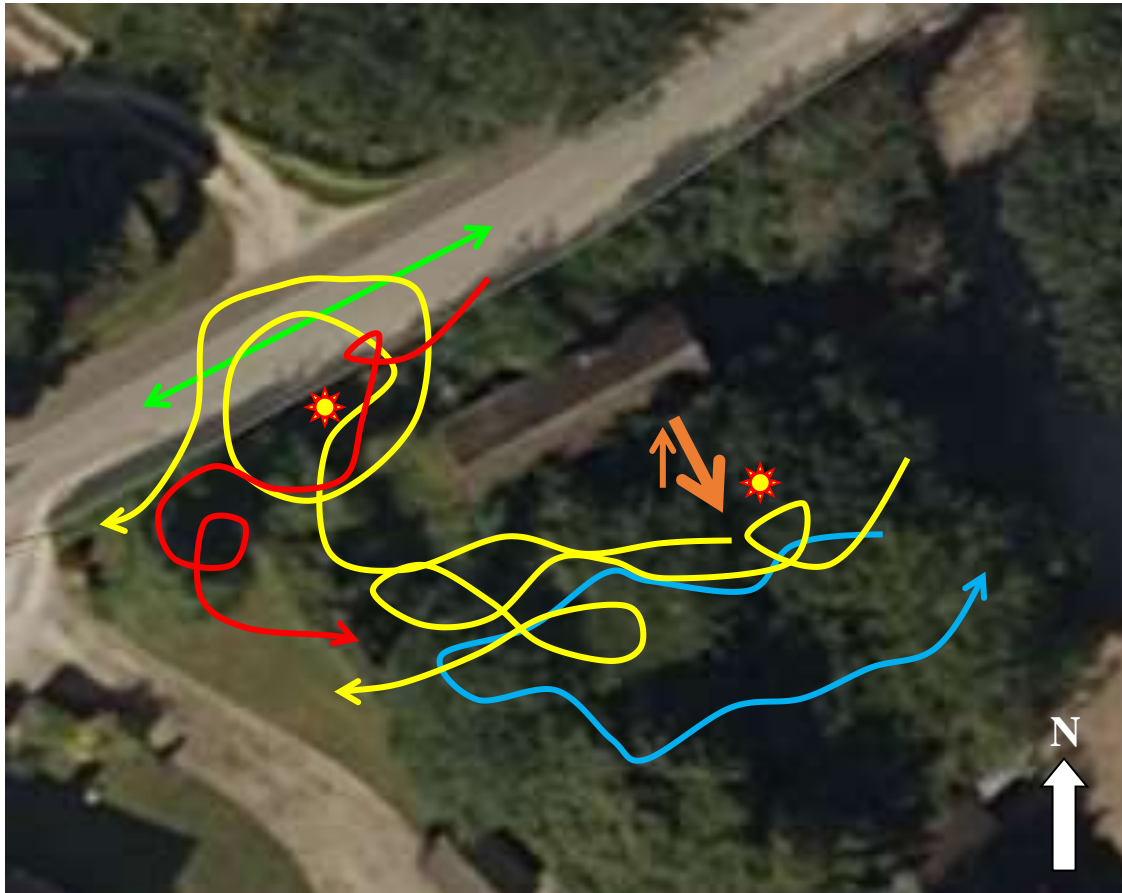
Plan 1 Bat flight paths at 1st emergence on 23rd July 2020

Small numbers of Common and Soprano Pipistrelles flew around the site, but none were observed to emerge from the building. A Noctule was recorded flying up and down the road and a Whiskered/Brandt's flew around the rear of the site. 21 Lesser Horseshoes Bats emerged from the building through the gap in the boarding in the lower floor. 3 Lesser Horseshoe Bats were noted returning to building through the same gap.

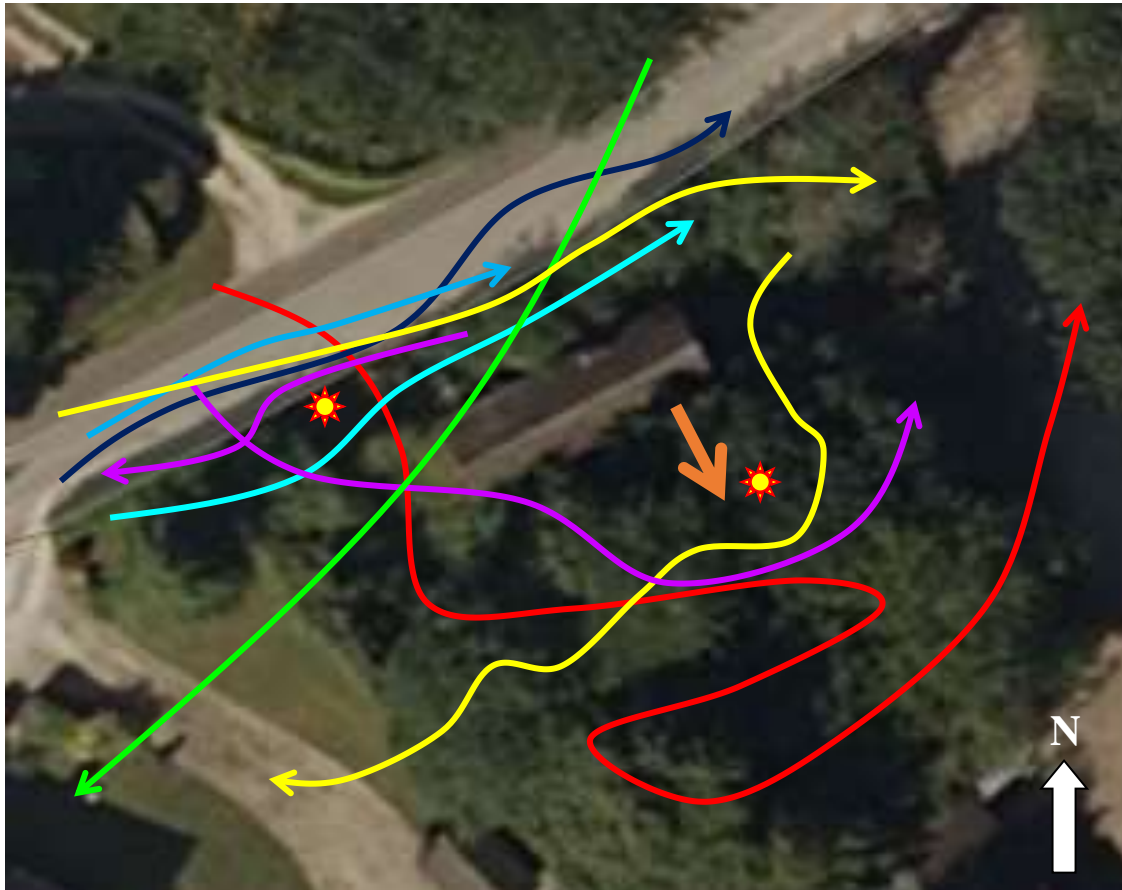
Plan 2 Bat flight paths at emergence on 9th August 2019

21:44	Daubenton's Bat flew past again
21:45	Brown Long-eared Bat detected briefly
22:15	Intermittent Lesser Horseshoe and pipistrelle activity and survey ended

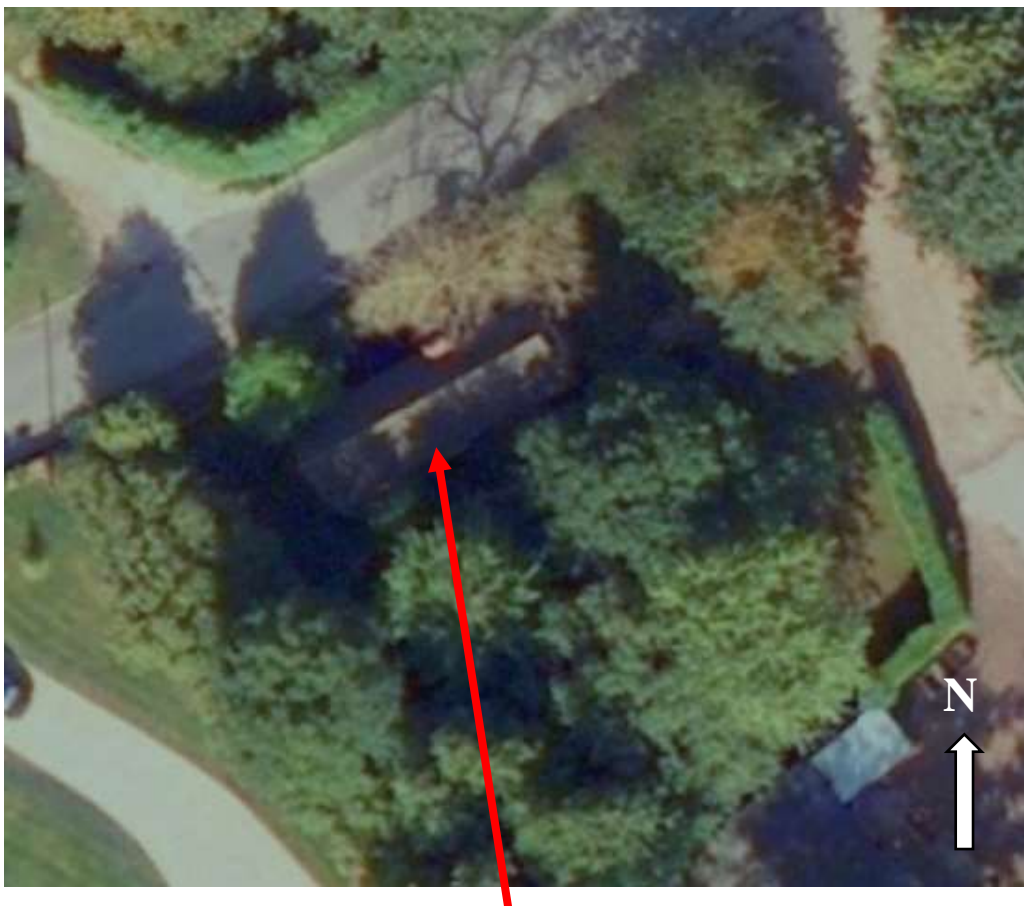
Appendix 2: Site plan

The layout of the site is shown in Appendix 2.
