Bat survey report for Ty Ucha, Glascwm, Meifod, Powys, SY22 5LU

Oakwood Ecology

Ty Ucha, Glascwm, Meifod, Powys, SY22 5LU

September 2020

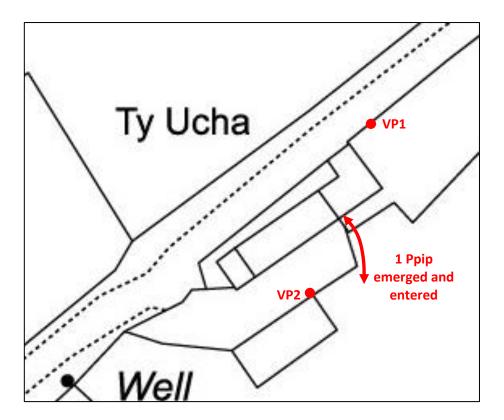
Figure 5. Map showing the location of the vantage points used, and the roost access point observed during the activity surveys (also see photographs in **Appendix 1**).

4.2.10 Over the two activity surveys, a total of two common pipistrelles (one per survey, highly likely to be the same bat) were recorded using one roost access points (Figure 6). No consistent flight-lines were recorded around the house, although the lesser horseshoe bat was following the hedgerow between the house and the adjacent road.

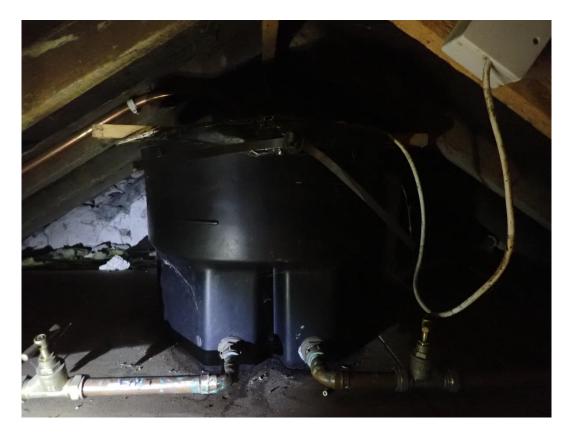
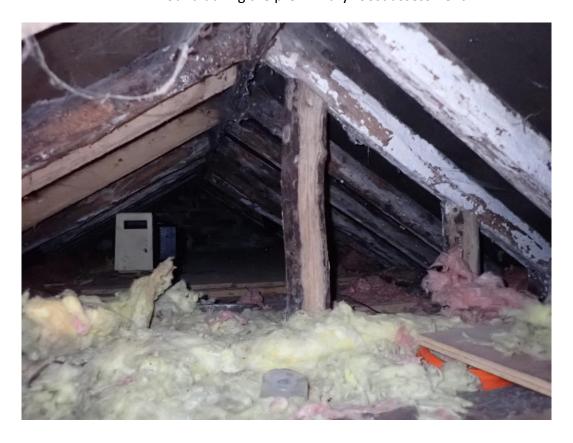
Photo's 3 & 4. Views of the loft inside the house. No evidence of roosting bats was found during the preliminary roost assessment.

- 4.2.6 In terms of potential to support bats, all the walls have intact pointing, the slates and ridge tiles were all tightly fitted, with no potential bat access points. The open eaves were covered by wire mesh that is impenetrable to bats, and the render and mortar on the gable walls extends right up to the barge boards / end rafters, effectively excluding bats from the batten space and internal parts of the roof. No evidence of bats was found inside the loft, or anywhere else on the property.

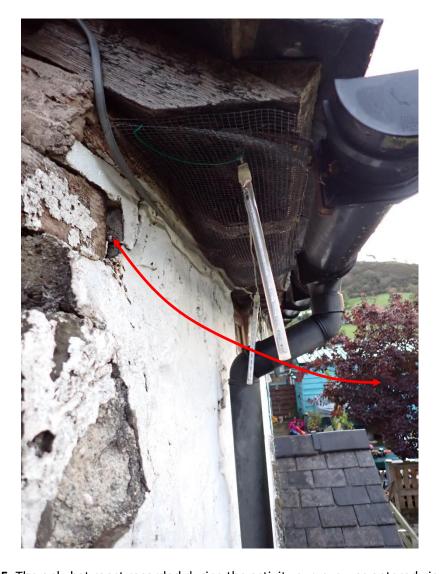
Photo 5. The only bat roost recorded during the activity surveys was entered via a hole between a piece of redundant timber and the stone wall.

- 4.2.7 There was a gap in the mortar around an exposed timber on the south corner, and some gaps under the leadwork around the chimney on the north end.

- 4.3.1 The single roost was occupied by a solitary bat and is considered to be a day roost occupied by a solitary male or non-breeding female; no obvious maternity roosts were recorded.
- 4.3.2 It is likely that the access point leads directly into a small crevice between the timber (which is a severed piece of the wall plate of the barn that used to be attached to the house) and the surrounding stone wall.
- 4.3.3 There was no artificial lighting directly illuminating the roost access point.

- 6.2.3 The construction of the extension at Ty Ucha will necessitate the destruction of the bat roost contained within the house. The loss of this roost will be compensated for by the provision of new purpose-made roosts, and the negative impact of this loss, and the possibility of harm and/or disturbance to the bats, can be mitigated by the following recommendations (based on guidance given in Mitchell-Jones, 2004):

- The existing roost will be dismantled gently by hand. The ECoW will be on hand to deal with any bats that are found, and these will be captured and detained during daylight hours in a suitable container, to be released at the point of capture at dusk on the same day. The current roost will be made unsuitable in one day so that the bat cannot return to it. In general, the guidelines presented in the 'Rescue and Collection' section of the Bat Care Guidelines (Miller, 2016) will be followed for the care of any captured bats.

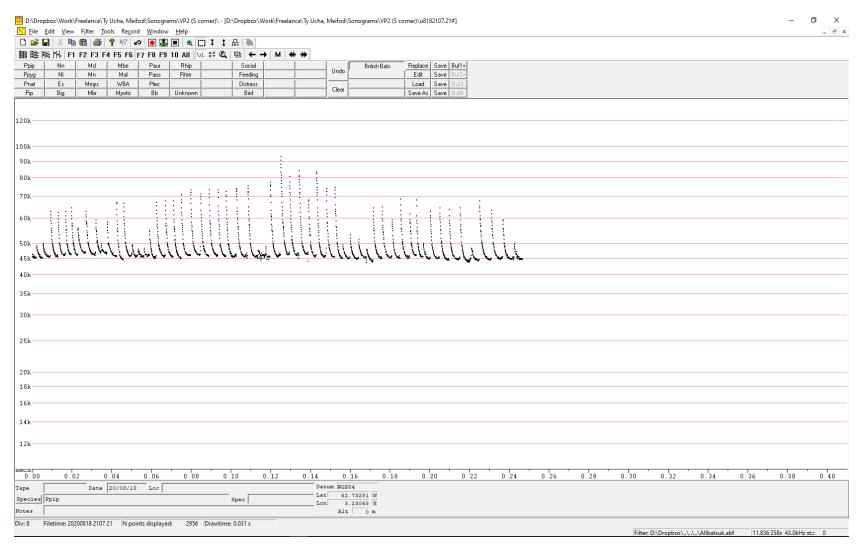
Figure 7. Screenshot of a sonogram, with frequency on the vertical axis and time along the horizontal axis. The hockey stick shaped calls are diagnostic of all pipistrelle species, and the flatter (qCF) part of the call at around 45 kHz indicates a common pipistrelle (expansion scale: F7, compressed to remove spaces between calls, filtered to remove non-bat noise).

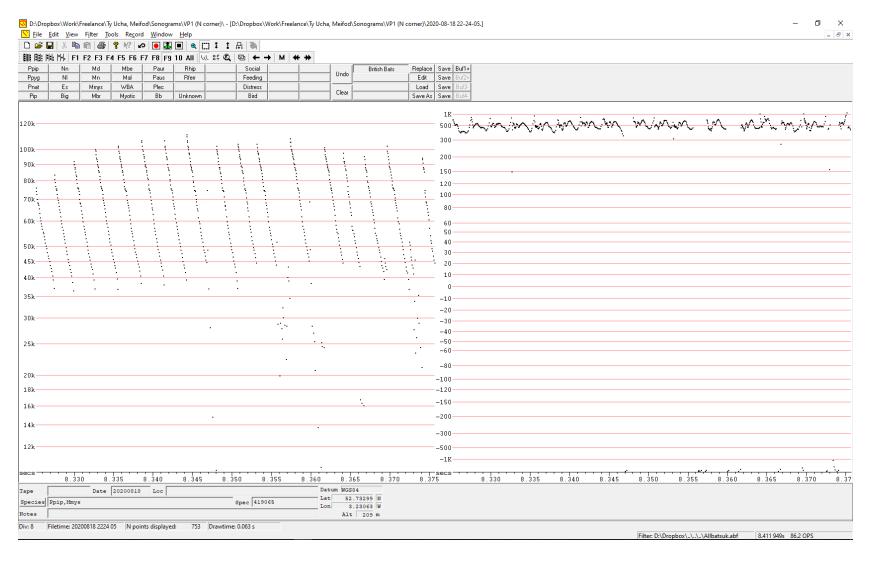
Figure 9. Sonogram of a whiskered Bat. The near-vertical (FM) sweeps on the left-hand side are indicative of a Myotis species; the split-screen on the right-hand side is an analysis of the rate of change in frequency (slope) of the corresponding calls on the left-hand side. A slope between 300 and 1000 octaves per second with many small-scale kinks indicates the likely species. (F9, compressed, filtered).
