GROUND INVESTIGATION RYBROOK, HANDY CROSS, HIGH WYCOMBE

Carried Out For: DEALERSHIP DEVELOPMENTS LIMITED

June 2021

Report Reference: 20008J-02

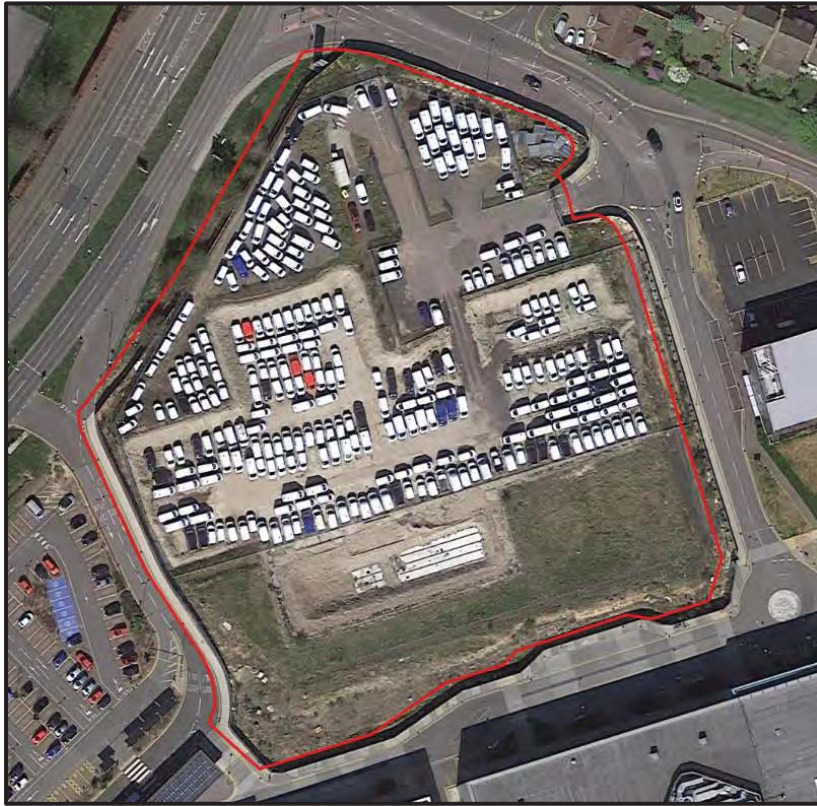
Figure 1 **Site Aerial Photograph**

An aerial photograph of the current site layout is shown in Figure 1 overleaf.

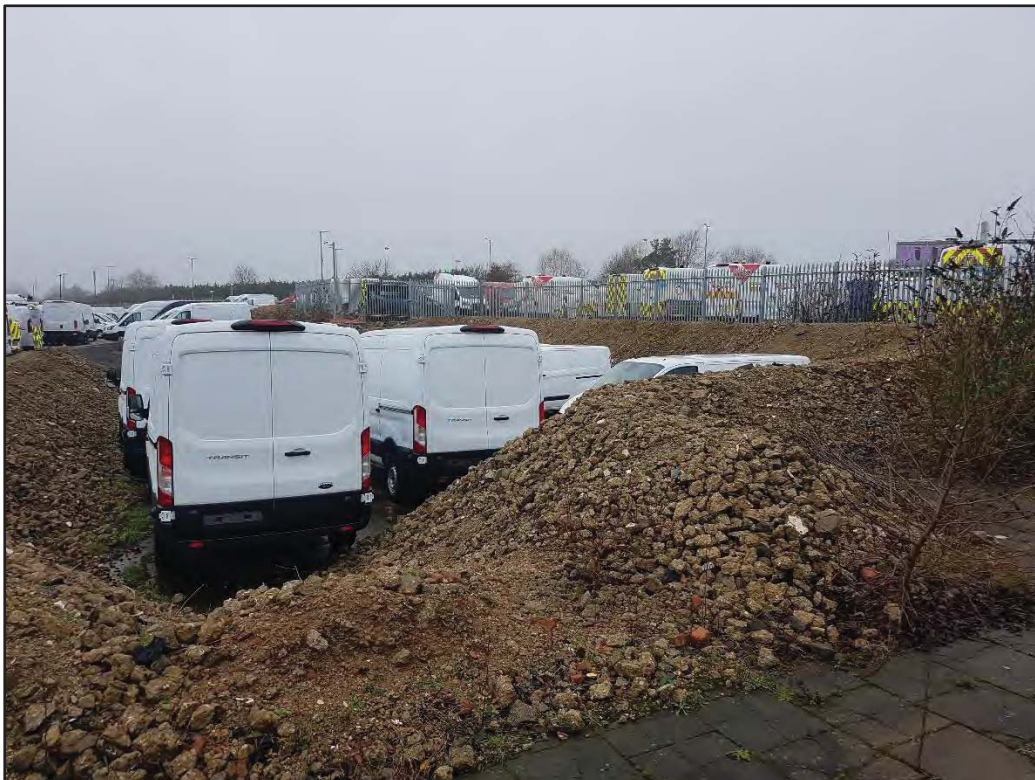
Plate 2 East of northern site looking northwest

Note: lowest elevation part of the northern area of the site in the foreground with the mid elevation in the distance.

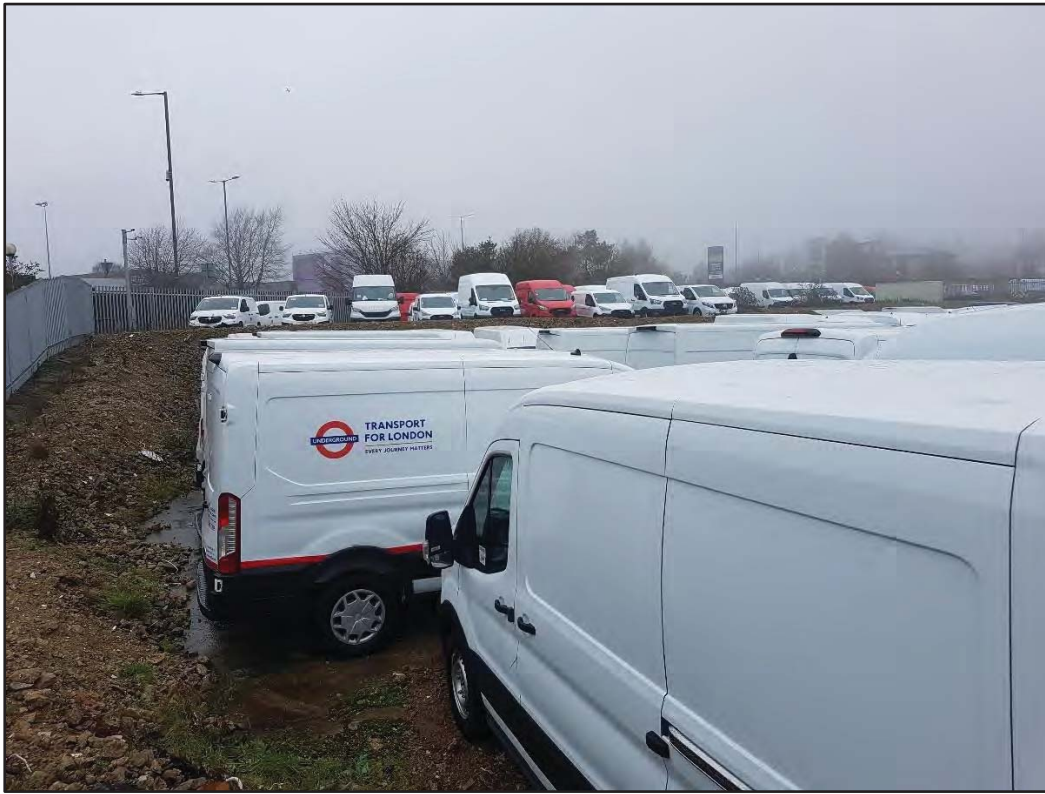
Plate 5 West of northern area looking north

Note: Highest elevation part of the northern area of the site in the background with the mid elevation in the foreground.

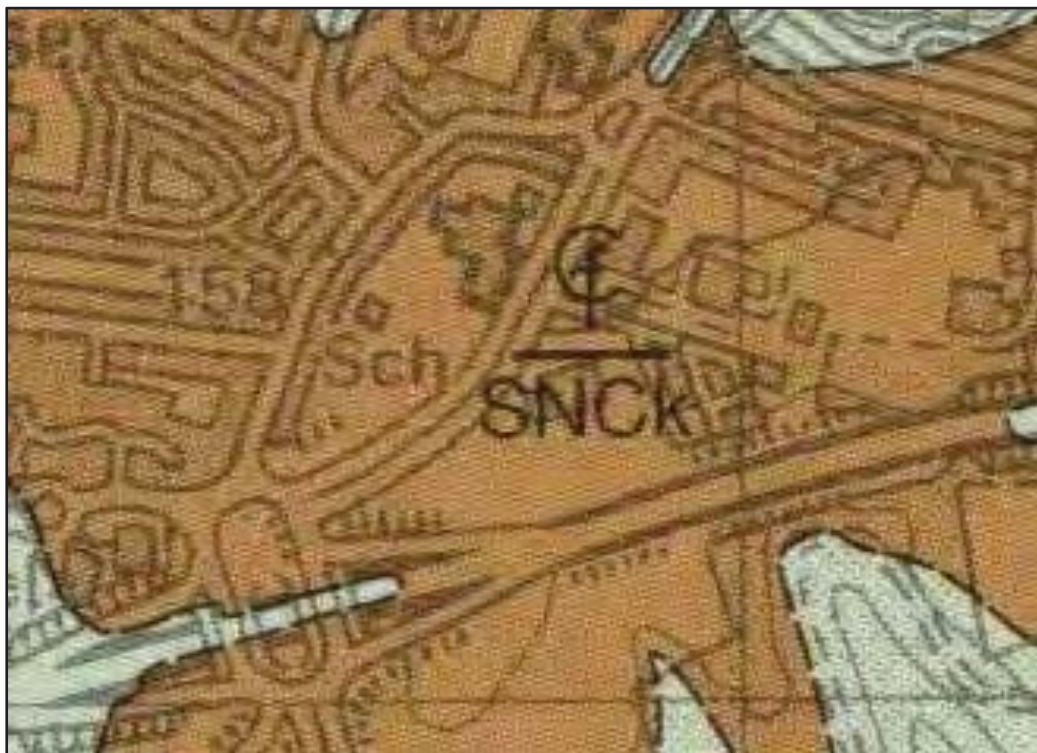
Figure 3 Site Geology

No records of artificial or Made Ground have been found within this site area. However it is known that Made Ground is likely due to the presence of a former sports centre and evidence from the site walkover.

There are no records of faults or landslips within 500m of the study site.

Clay with Flints

Seaford Chalk
Formation And
Newhaven Chalk
Formation

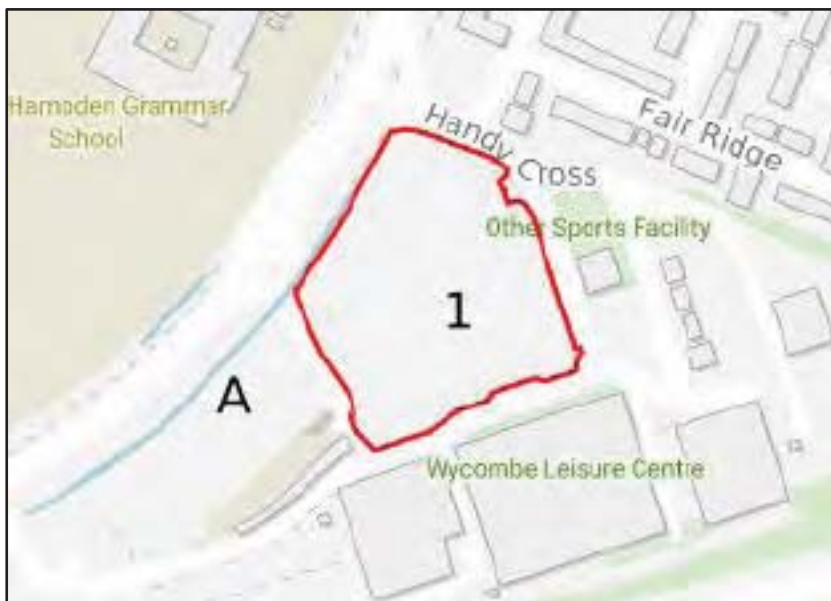
Figure 4 Surface water map

The nearest watercourse to the site is an inland river 2 m NW to the site, followed by another inland river 50 m W as seen in Figure 4 below. These appear to relate to local surface water drainage.

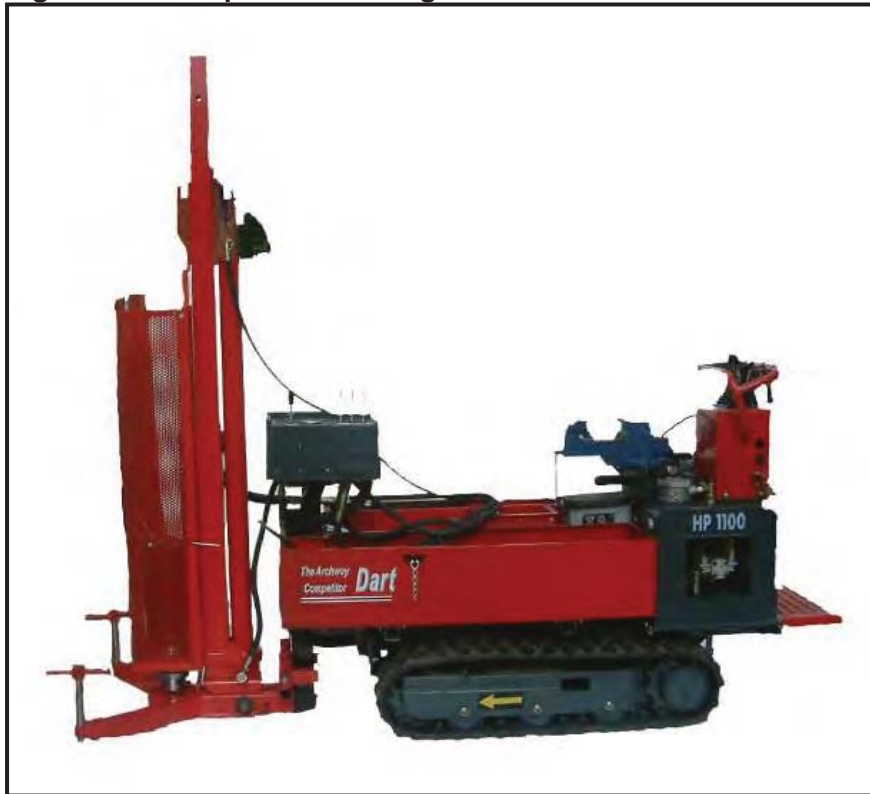
Figure C2: Competitor Dart Rig

If carried out the locations of the Dynamic continuous sampling boreholes are shown on the exploratory hole location plan. They are put down using a Competitor Dart Drilling rig (Figure C2).

The sampling is progressed by driving a hollow steel tube with a plastic inner liner into the ground. Both cohesive and granular soils are “wedged” into the tubing, relying on the friction between the soil and liner to retain the sample on withdrawal of the tubing. Sample can be lost, particularly in loose granular soils if frictional resistance is not sufficient. The technique can be used in the absence of casing in cohesive soils, although the diameter of tubing is progressively reduced from 101 mm, through 92, 79, 70, 57 and 47 mm dia to ensure that frictional resistance on the sides of the sampling tubing does not exceed the capacity of the equipment to pull the tubing from the hole. Small diameter 115 mm diameter casing can be driven simultaneously with the sampling tube in soft or loose soils to a maximum depth of around 7 m. Standard penetration testing and recovery of “undisturbed” samples is possible in the correct conditions.
