**PHASE I AND PHASE II GEO-ENVIRONMENTAL SITE
ASSESSMENT**

**Kilbuck Lane
Haydock
St. Helens**

**Report Ref: 12-639-r02
Date Issued: October 2018**

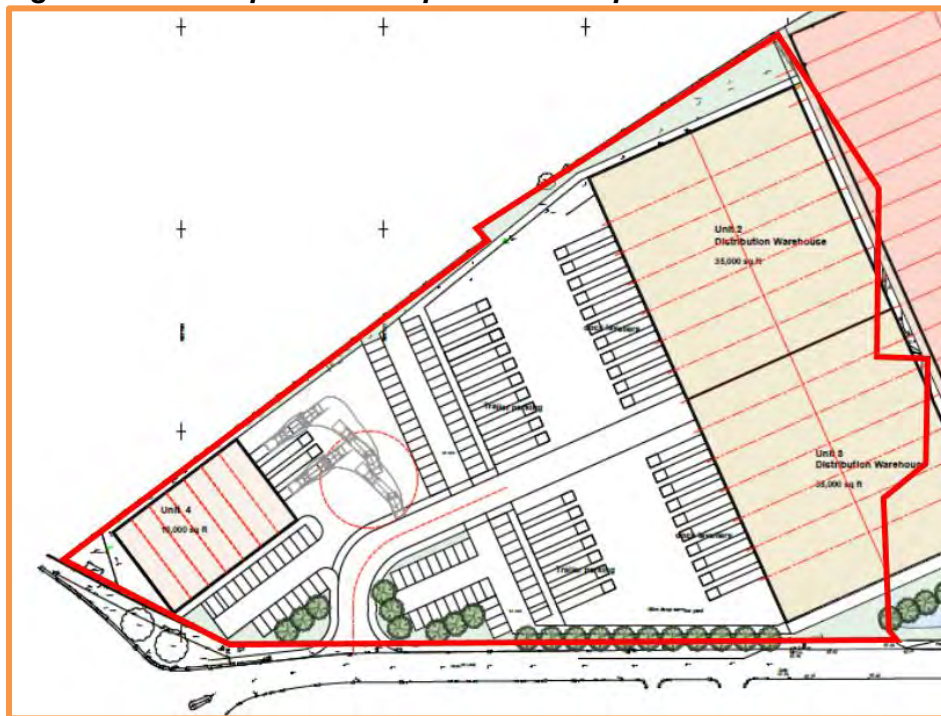
Figure 1.1 Snapshot of Proposed Development

A snapshot of the proposed development layout is indicated in Figure 1.1:

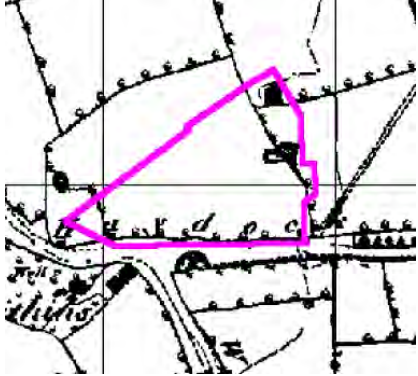
MAP EDITION	HISTORICAL LAND USE	HISTORICAL MAP EXCERPT
<p>1849 1:10,560</p>	<p>The site is agricultural land, with hedge rows intersecting the north east and south corners. Three ponds are present in the north east of the site.</p> <p>A road lines the southern boundary of the site.</p>

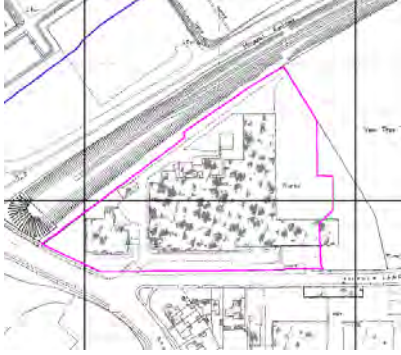
MAP EDITION	HISTORICAL LAND USE	HISTORICAL MAP EXCERPT
<p>1977 – 1985 1:1,250</p>	<p>The tanks are no longer marked.</p>

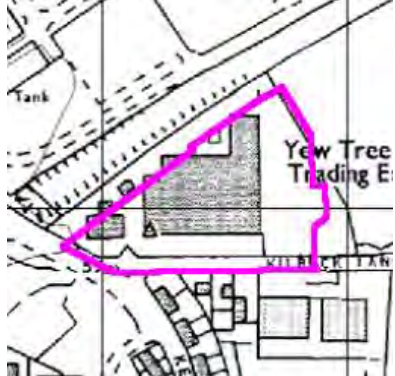
<p>1995 1:10,000</p>	<p>No significant changes.</p>

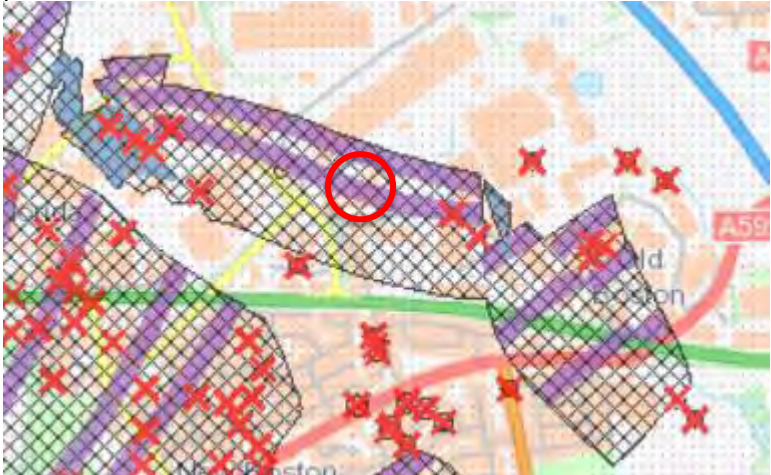
<p>Coal Authority Interactive Map</p>	<p>The Coal Authority Interactive Map indicates the presence of three mine entries within influencing distance of the property, the closest approximately 170m east of the site. The site is within a development high risk area, with two coal outcrops beneath the site.</p>

<p>British Geological Survey Mapping</p>	<p>The 1:10,000 geological mapping for the area notes the Higher Florida (or Pemberton Five Foot Mine) coal seam is present across the centre area of the site, traversing from north west to south East; with the Lower Florida (or Bickershaw Seven Foot Mine) coal seam present just north east of the site boundary, running parallel to the Pemberton Five Foot coal seam. The coal seams are shown to be dipping in a southerly direction beneath the site. There are two unspecified boreholes located adjacent to the south-eastern corner of the site and circa. 136m east of the site. Furthermore, a mine shaft is located circa. 166m south-east of the site.</p>

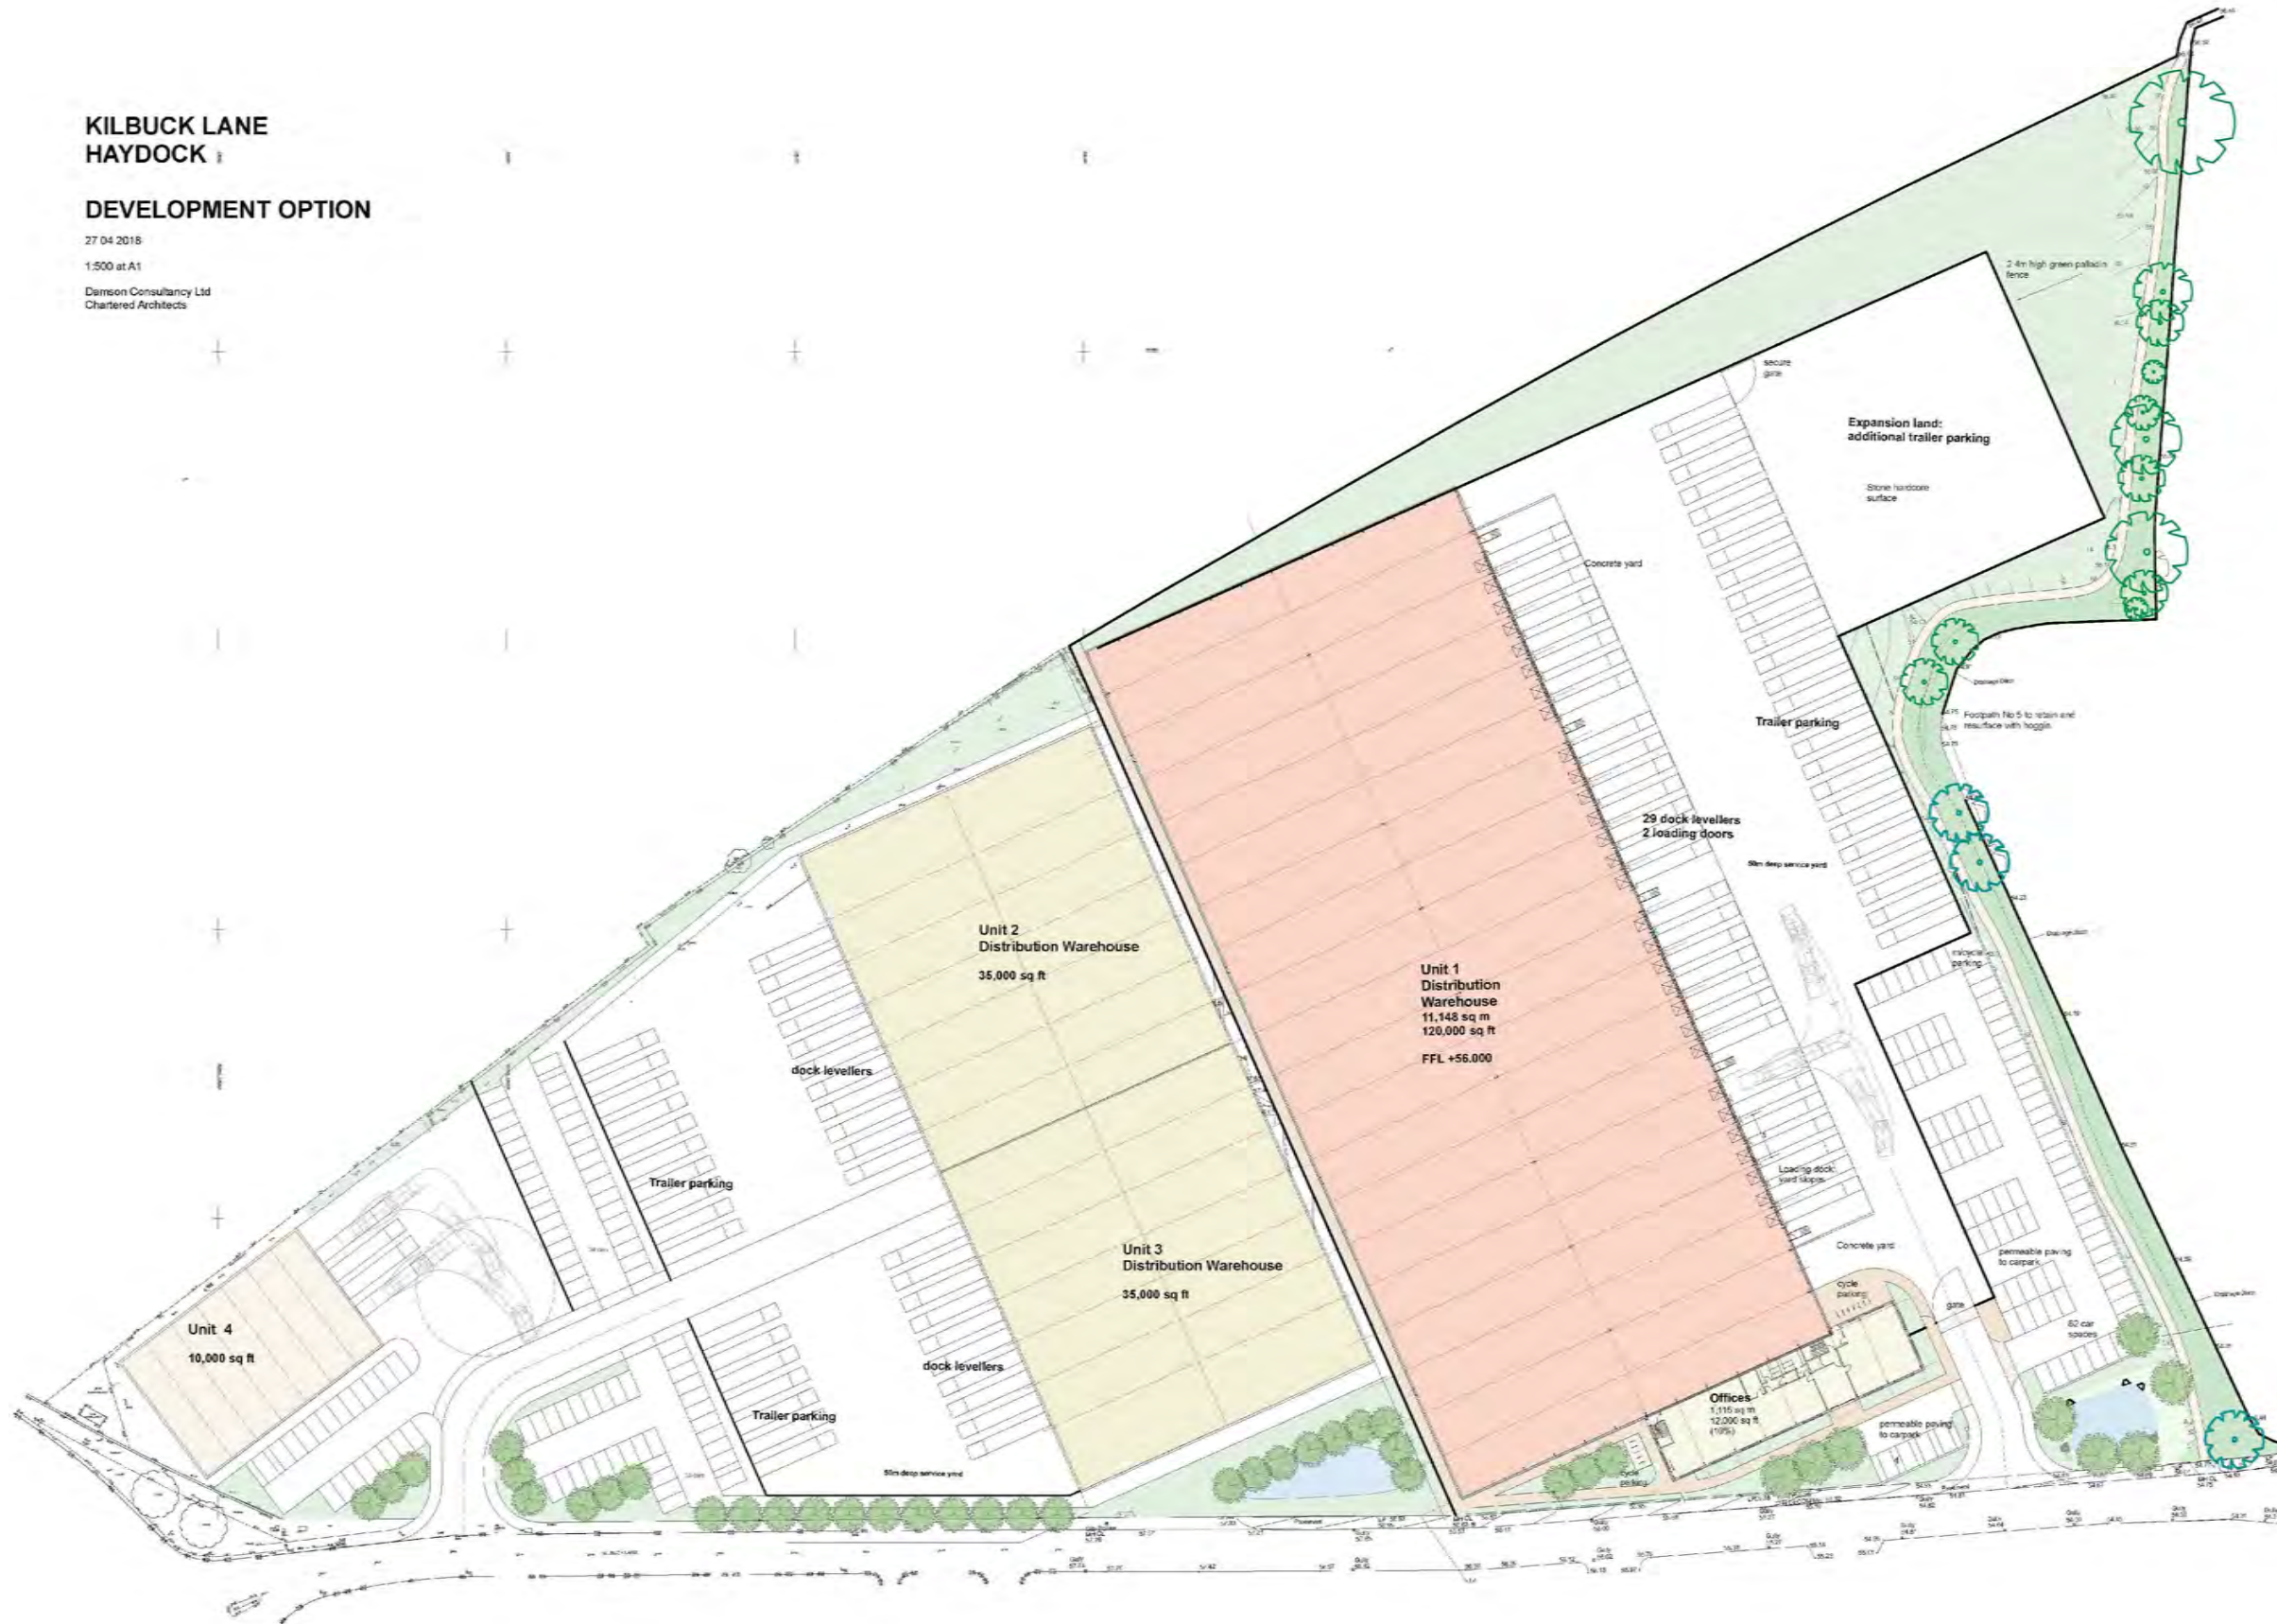
DEVELOPMENT OPTION

27.04.2018
1:500 at A1
Damson Consultancy Ltd
Chartered Architects

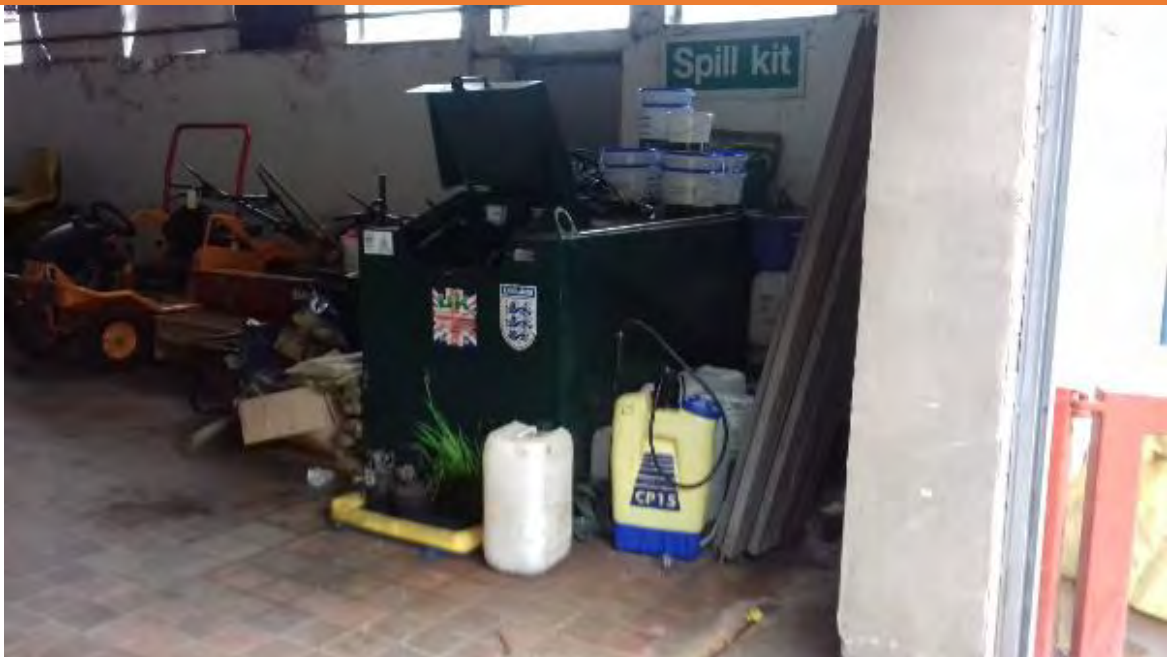
PLATE 2: DIESEL STORAGE TANK

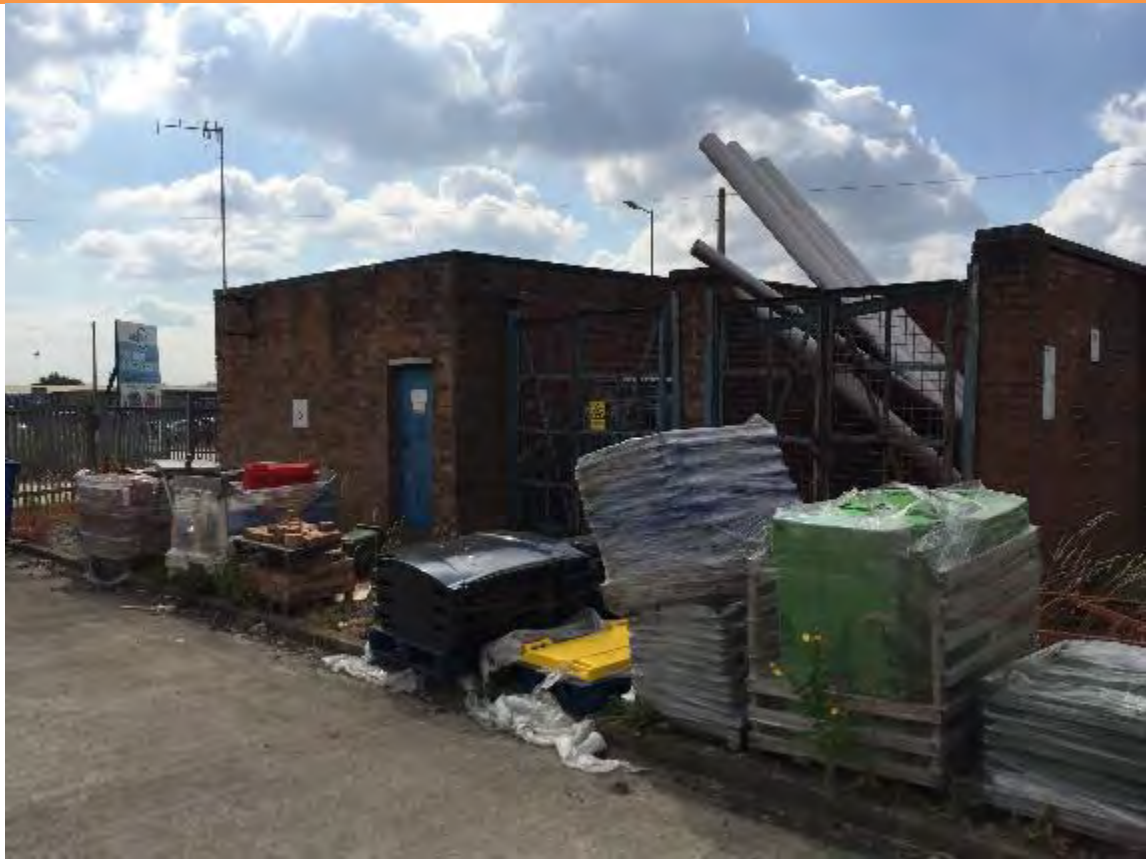
PLATE 3: ELECTRICITY SUBSTAION IN SOUTH-EAST OF SITE

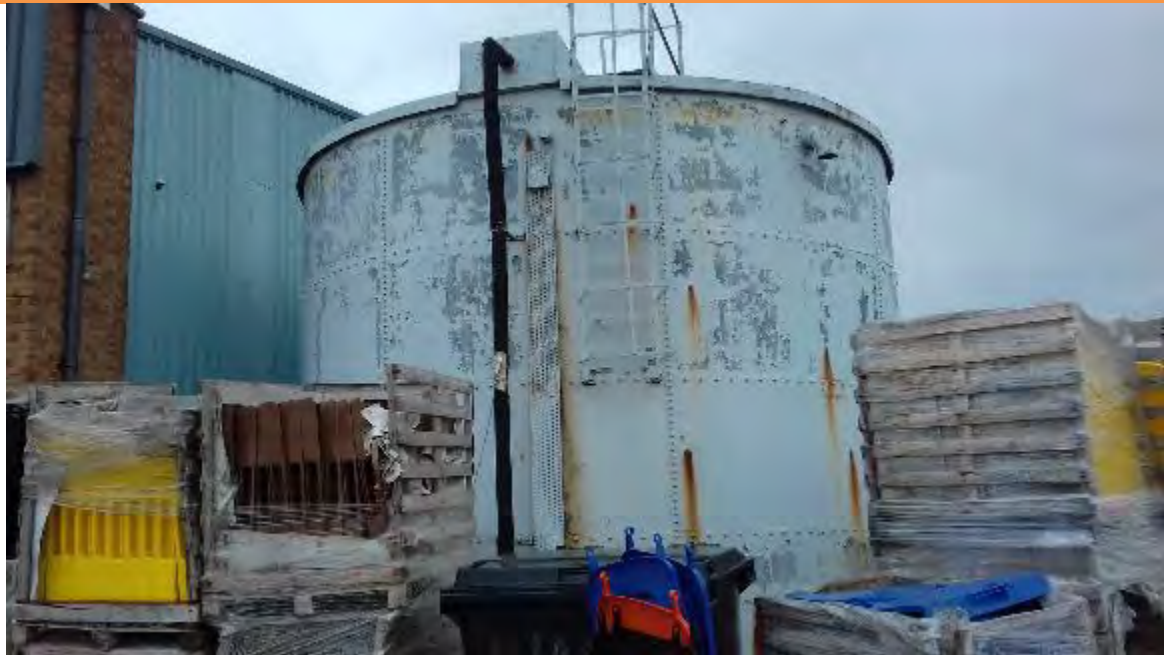
PLATE 13: WATER STORAGE TANK

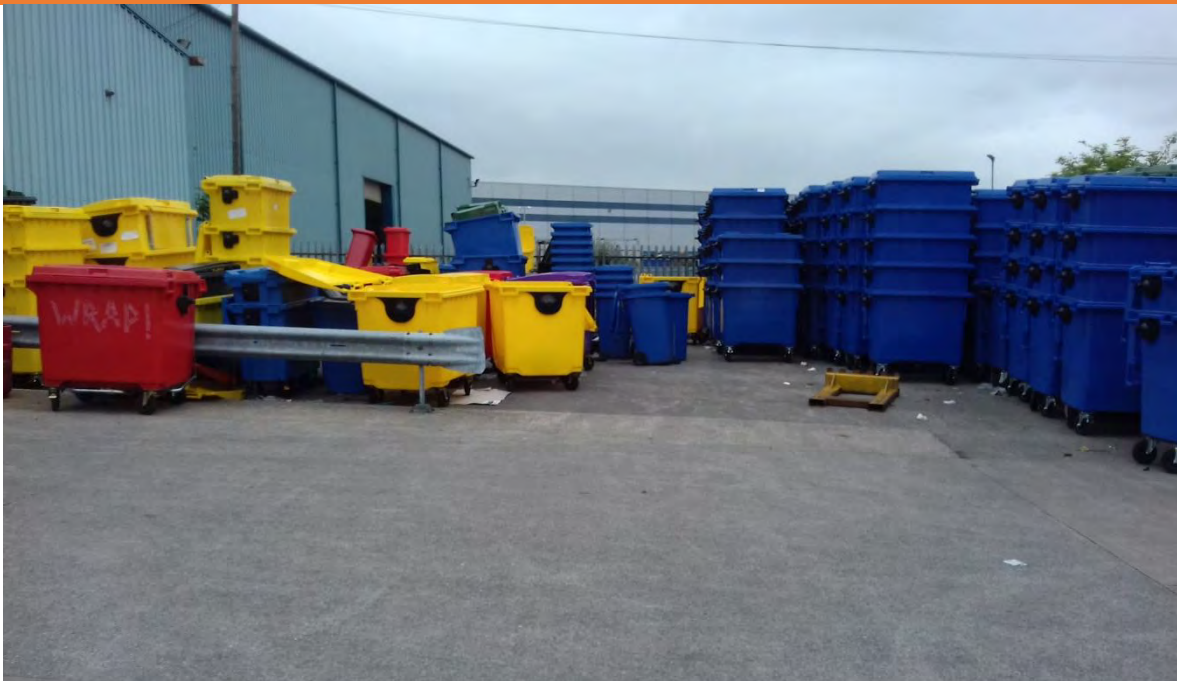
PLATE 14: BIN STORAGE IN EAST OF SITE

Polychlorinated Biphenyls (PCBs)	<p>An electricity substation is present along the southern boundary of the site in the south-east of the site, which may contain PCBs.</p>
Waste Storage	<p>Waste storage was generally observed to be stored appropriately and no significant areas of potential environmental concern were noted. However, access to the bus depot was not permitted during the site walkover, therefore substantial waste storage will require confirmation.</p>
Utilities	<p>A formal drainage survey has not been completed, however a review of online records has indicated the presence of utilities within Kilbuck Lane, with an electricity feed into the Electricity Substation located along the south-eastern boundary, and a gas feed into the gas governor located in the west of the site. These services are then distributed throughout the site.</p>
