EXTENDED PHASE 1 HABITAT SURVEY AND BAT RISK ASSESSMENT

St Johns Nursery, Clacton-on-Sea, Essex, CO16 8BP

E3 Design

May 2018

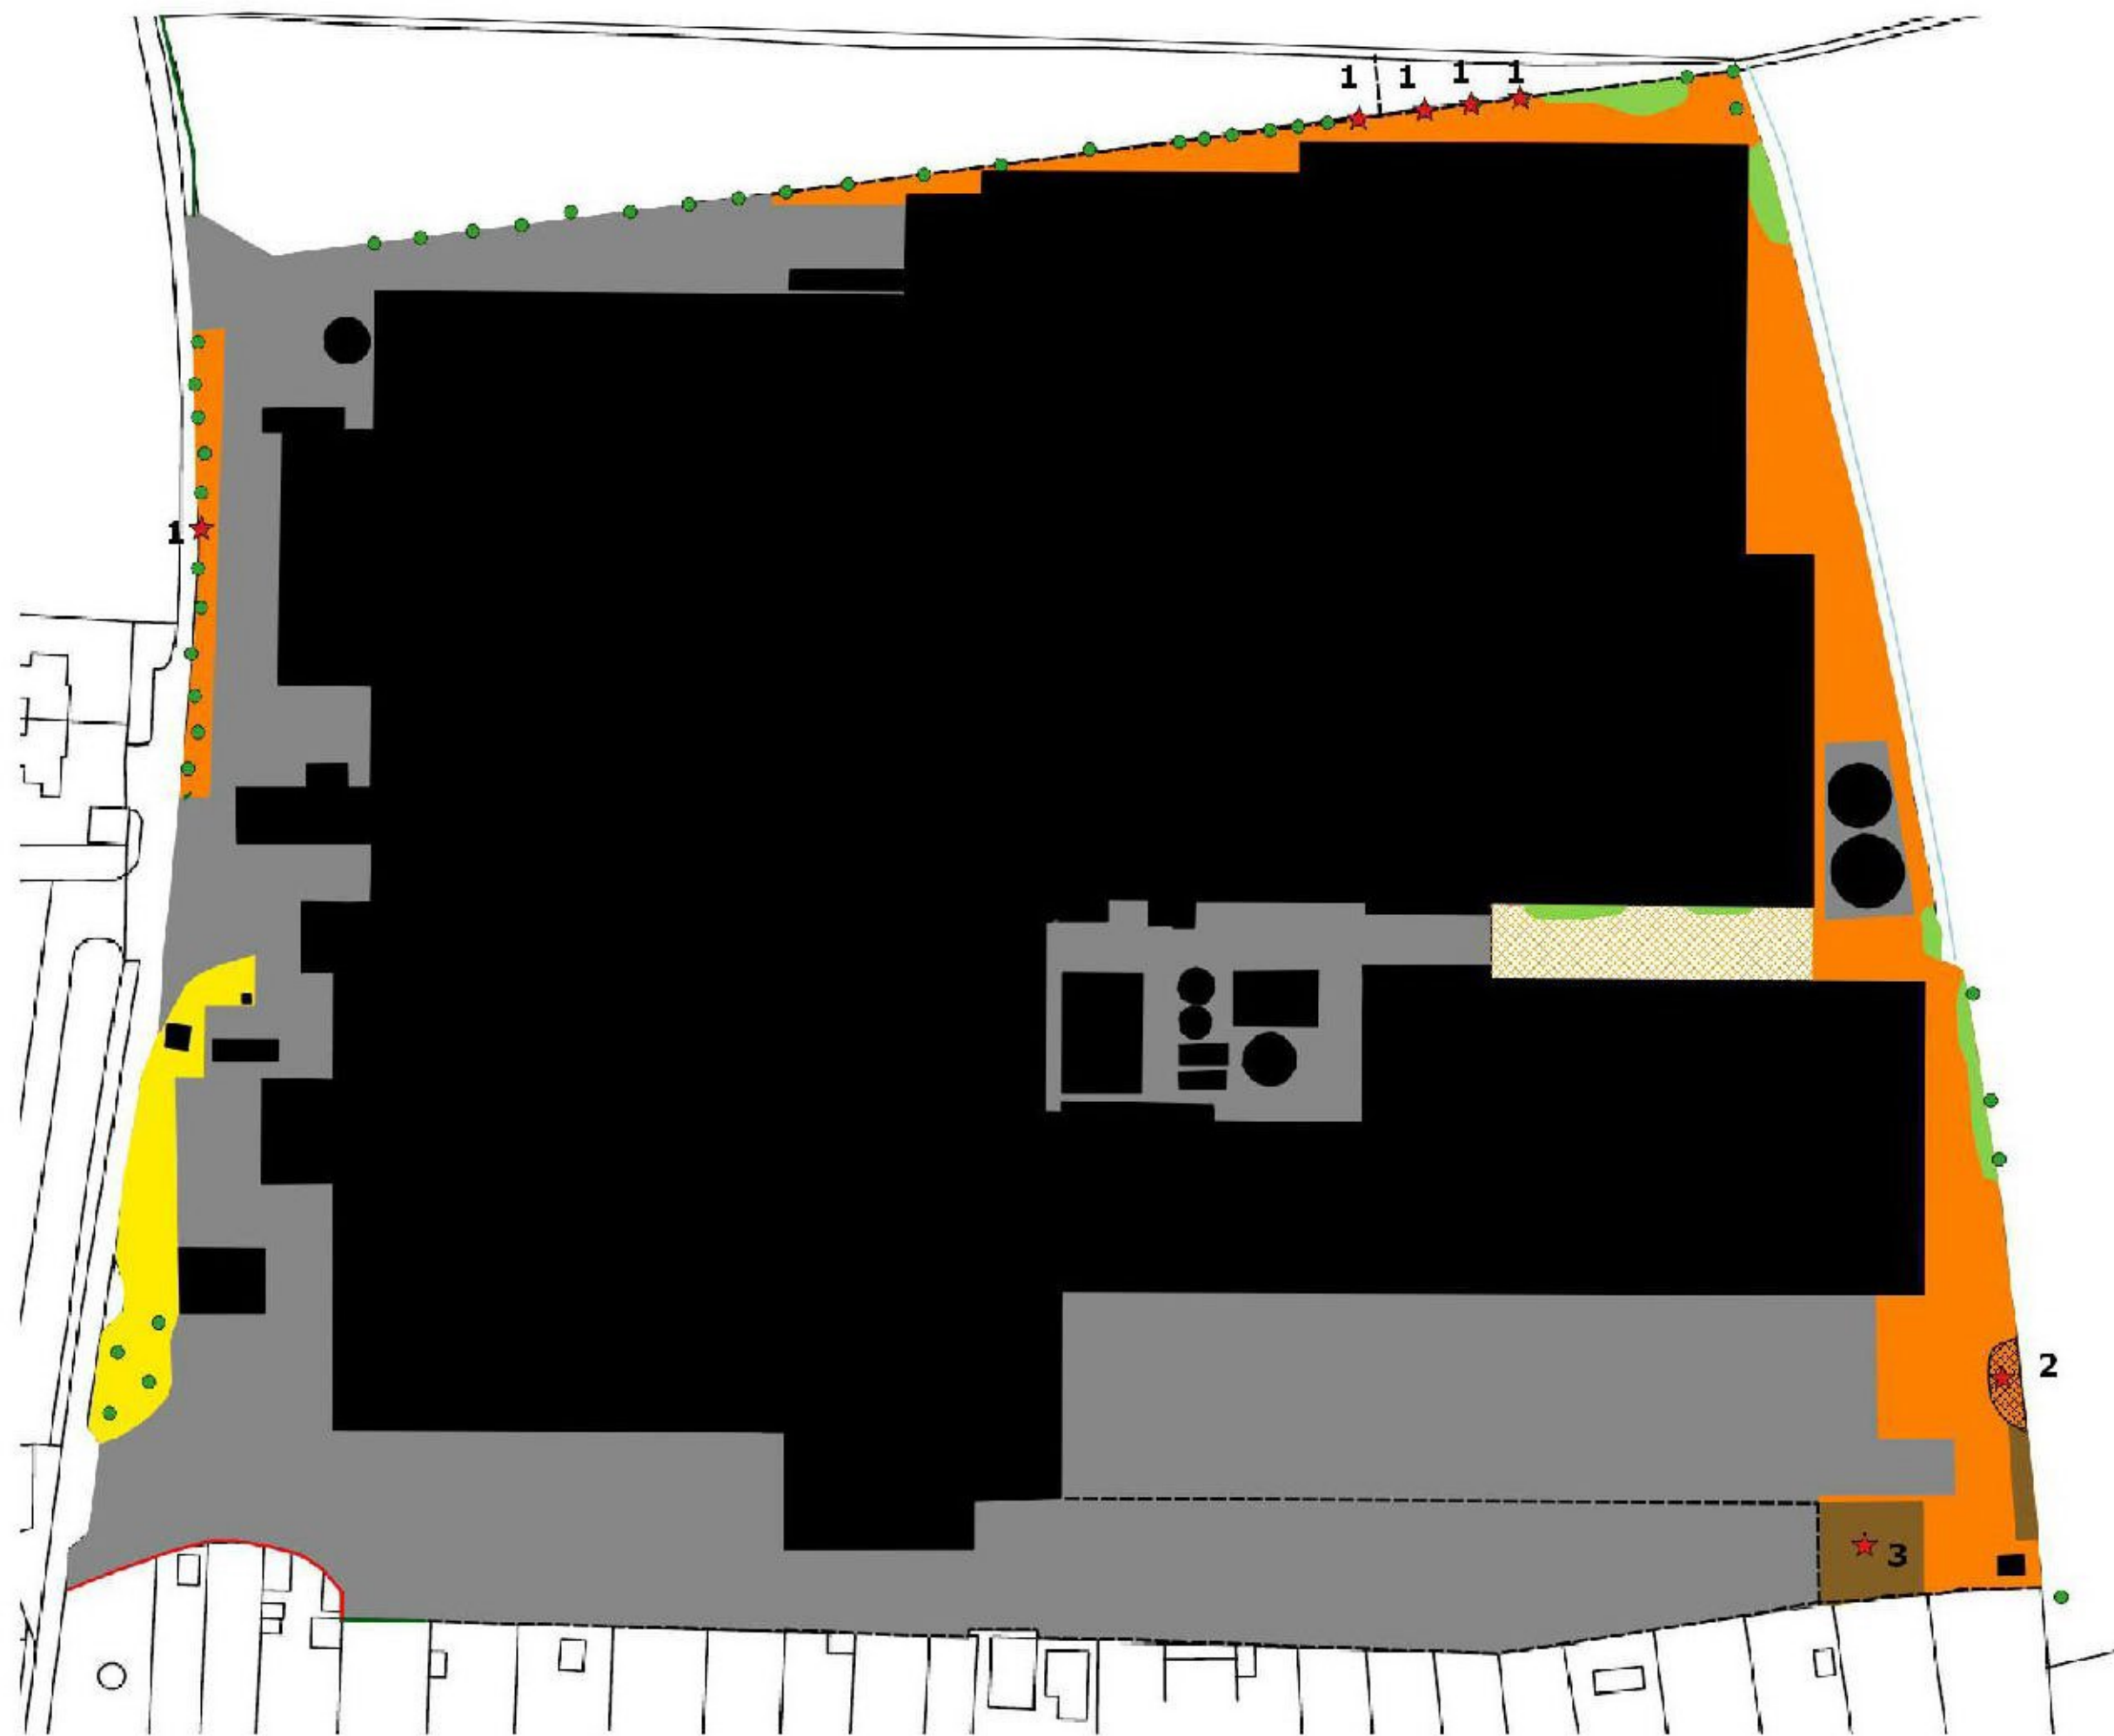
Project	St Johns Nursery, Clacton-on-Sea
Title	Habitat Map
Client	Mr Dave Caruso
Date	16th March 2018
Ref	Figure 3

Twelve main habitat categories were identified within the area under the Phase 1 system of habitat description. These were:

Appendix A shows the habitat map for the site whilst Appendix B gives selected photographs.

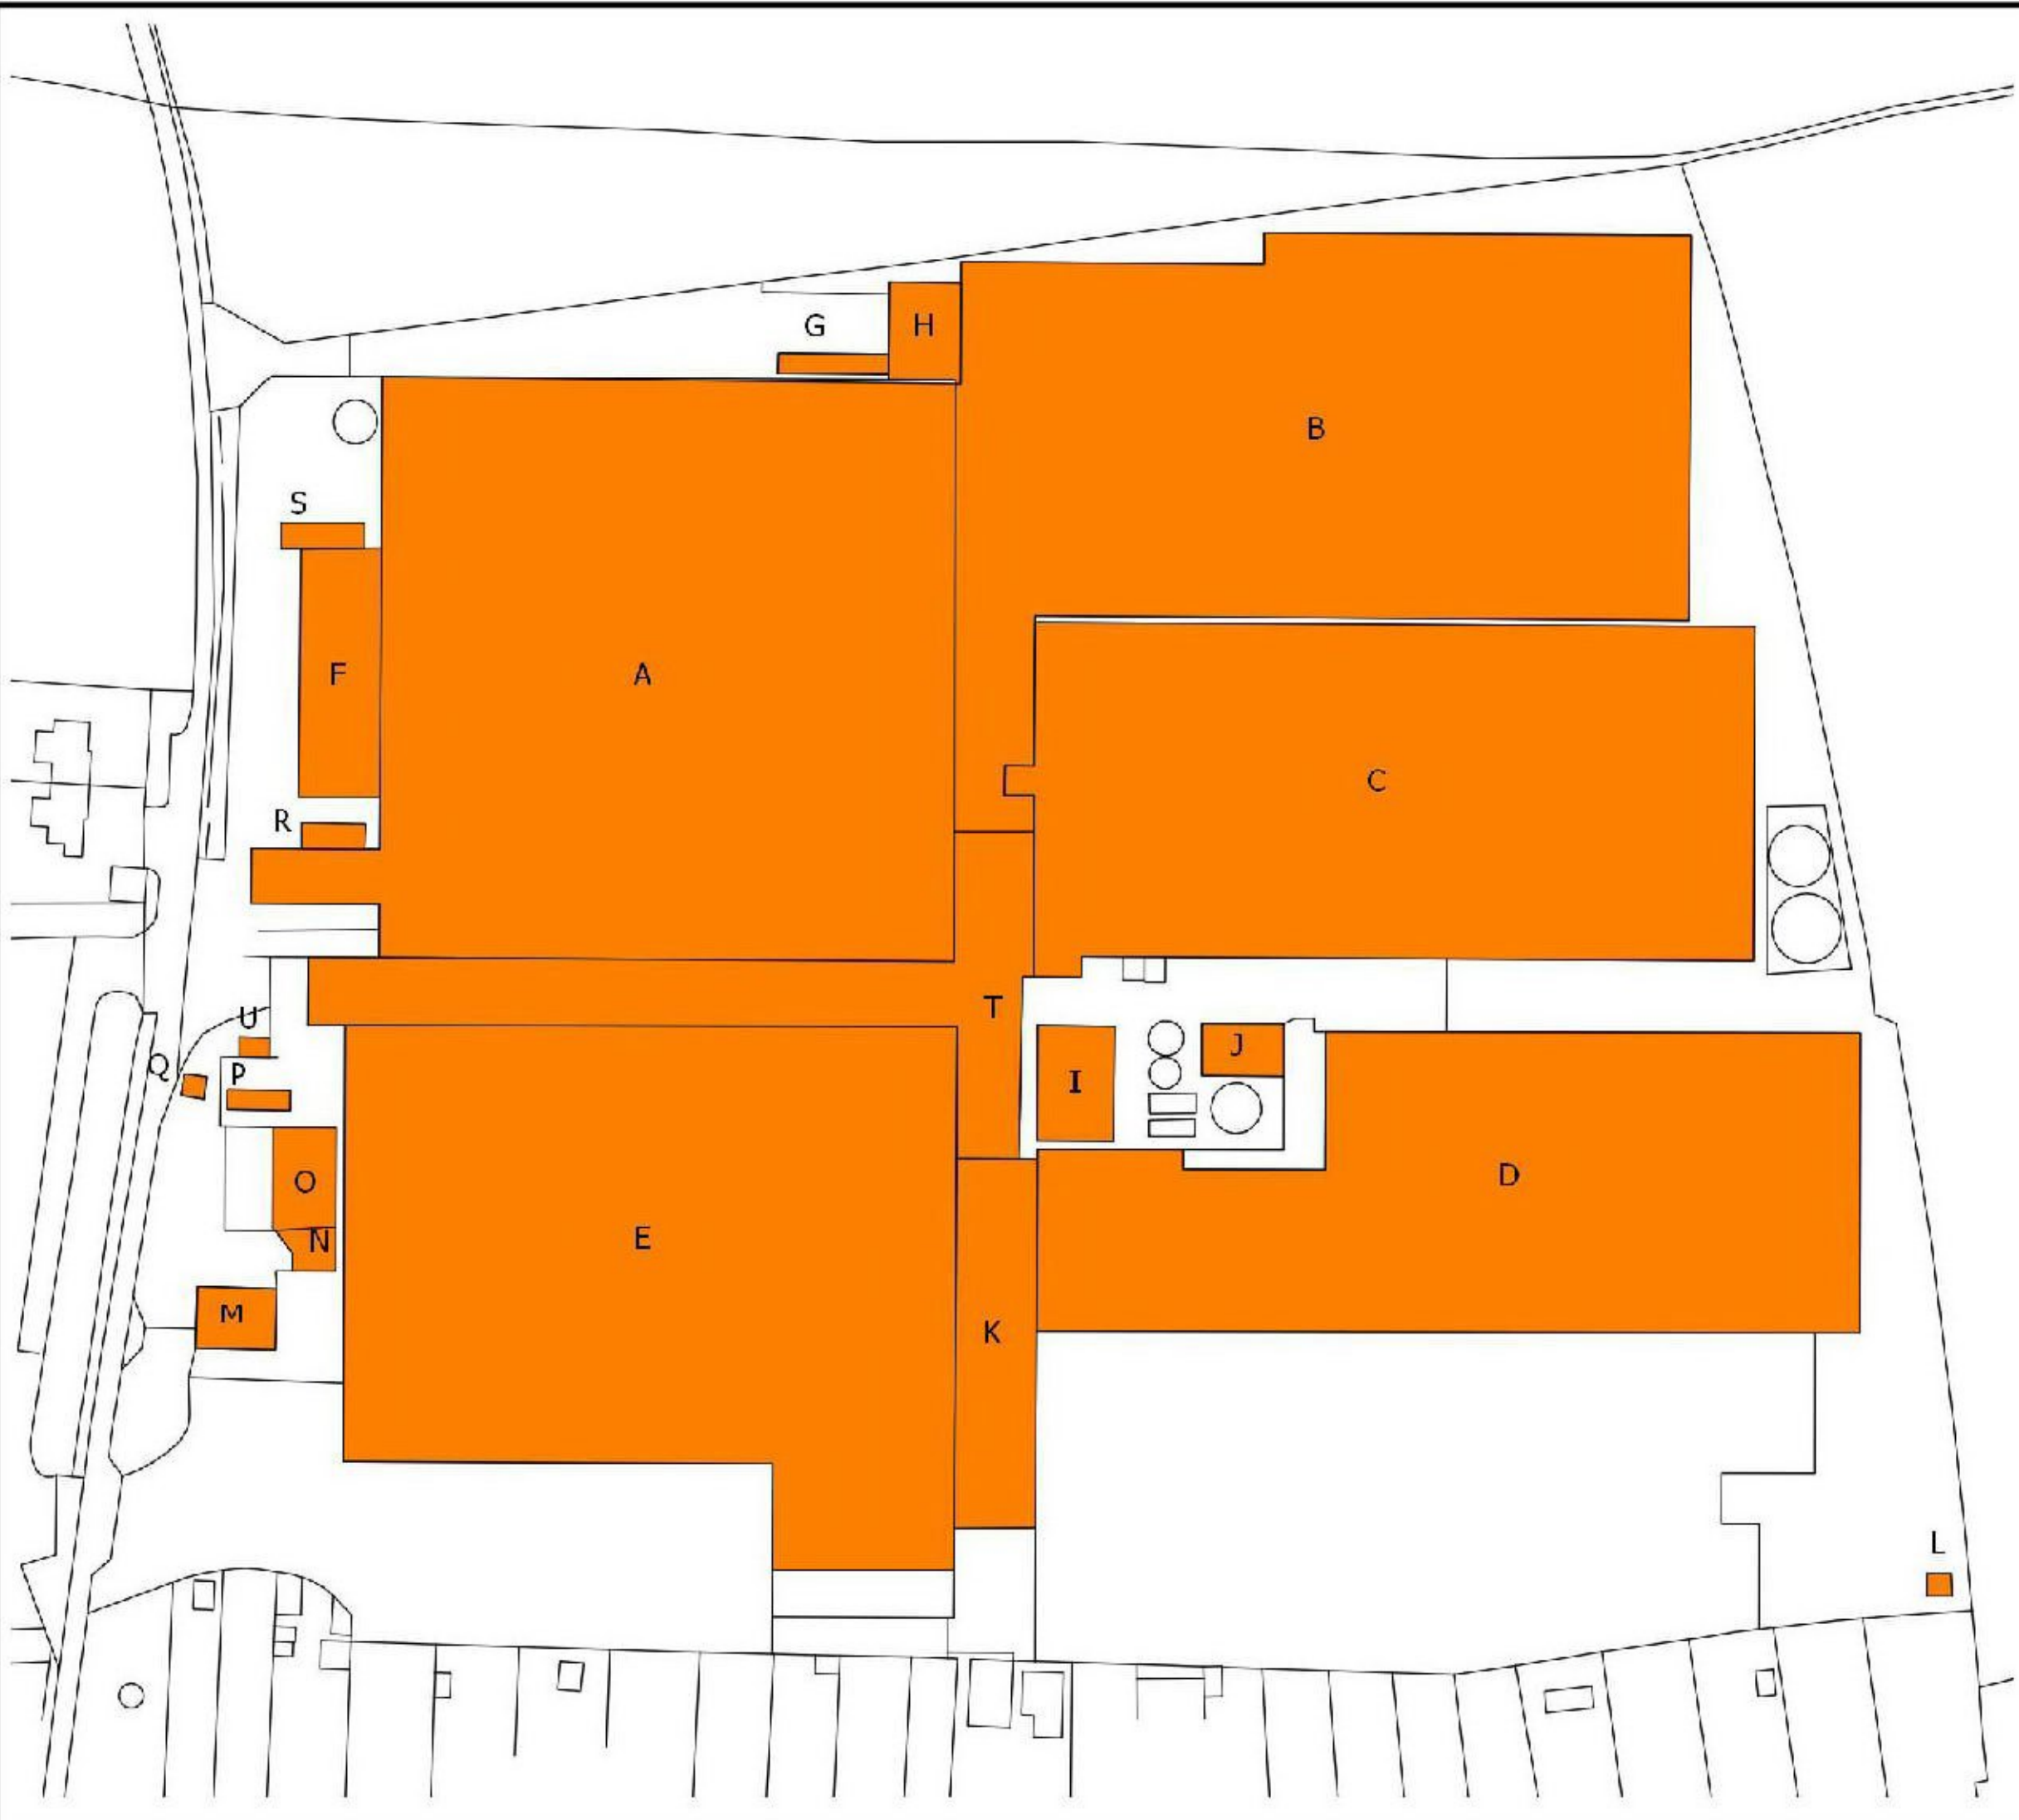
Legend
 Building Reference

Based upon the building features recorded during the external assessment, building reference E, I, J, M, N and O along with three trees were assessed as having low potential to contain roosting bats. Therefore a single nocturnal survey is recommended to be carried out on each of the above buildings and trees between May and September during the active season for bats.

Building Code (Figure 3, Appendix A)	Building construction details	Structural features present						Other structural features of note	Potential bat access and roosting points	Internal features	Evidence
		Gables	Barge boards	Soffit Boards	Fascia Boards	Flashing	Roof void				
A	Single- storey, glass roofed greenhouse type building with some side walls composed of corrugated sheet materials.	✓	X	X	X	X	X	None noted	None noted	Single open space, glass roof and sides, used mostly for storage	None noted.
B	As for Building A above	✓	X	X	X	X	X	None noted.	None noted	Single open space, glass roof and sides, used mostly for growing plants	None noted.
C	As for Building A above	✓	X	X	X	X	X	None noted.	None noted.	Single open space, glass roof and sides, used mostly for growing plants	None noted.

The nocturnal survey requirement is determined through reference to the recommended bat survey guidance (BCT, 2016) and based upon the assessed potential of the surveyed buildings to contain roosting bats. Following this guidance, one nocturnal surveys should be conducted on the buildings and trees above during the bat activity season (May-September) in order to gain a satisfactory understanding of how they are utilised by bats, and their importance to local bat populations.

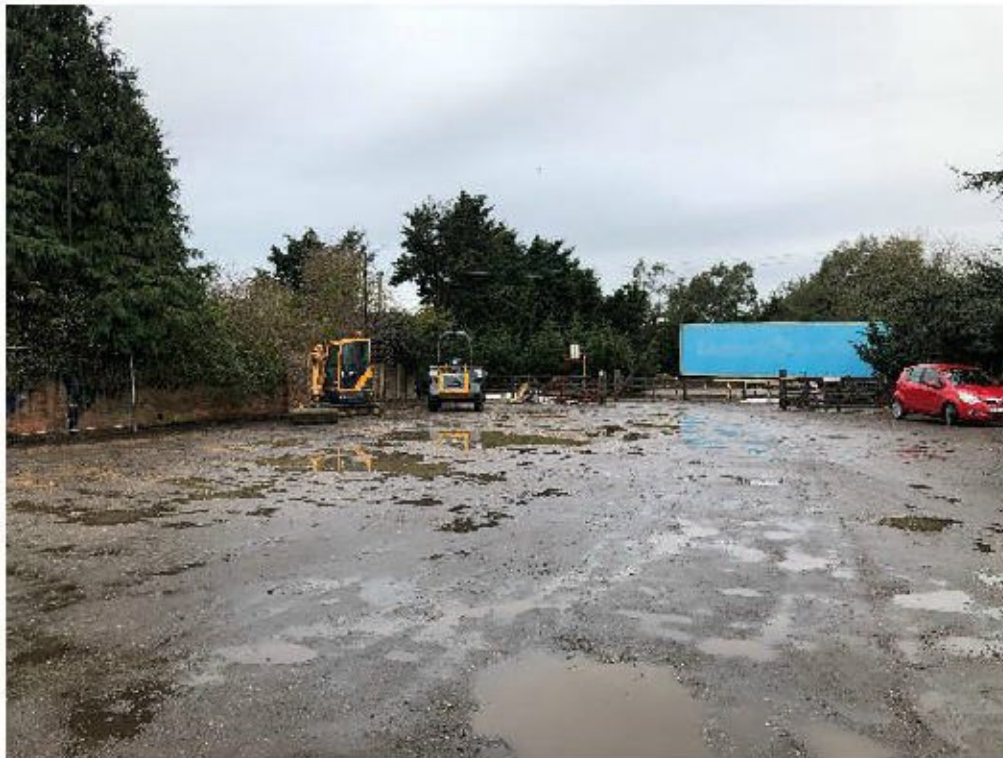
Hardstanding is present on site as tarmac access roads and car parks. There are also areas of concrete between the glasshouses and where glasshouses have been dismantled which merges in with Semi Improved grassland in places. Hard standing holds negligible ecological value.

Photograph 1 Hardstanding present on site.

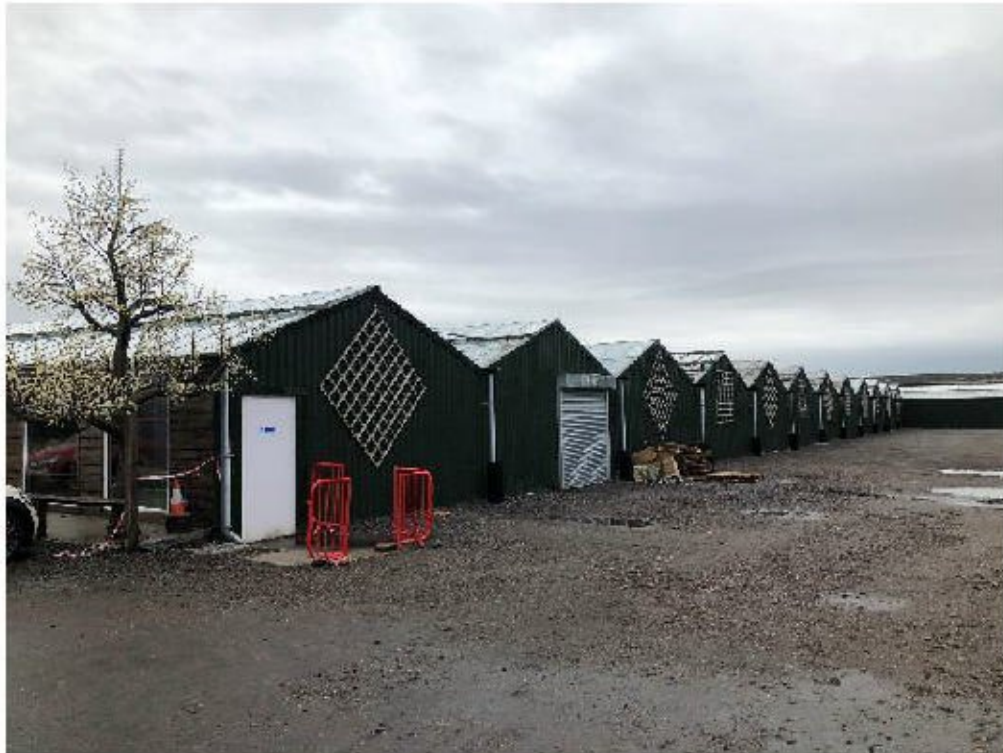
Photograph 2 Car park and building reference E

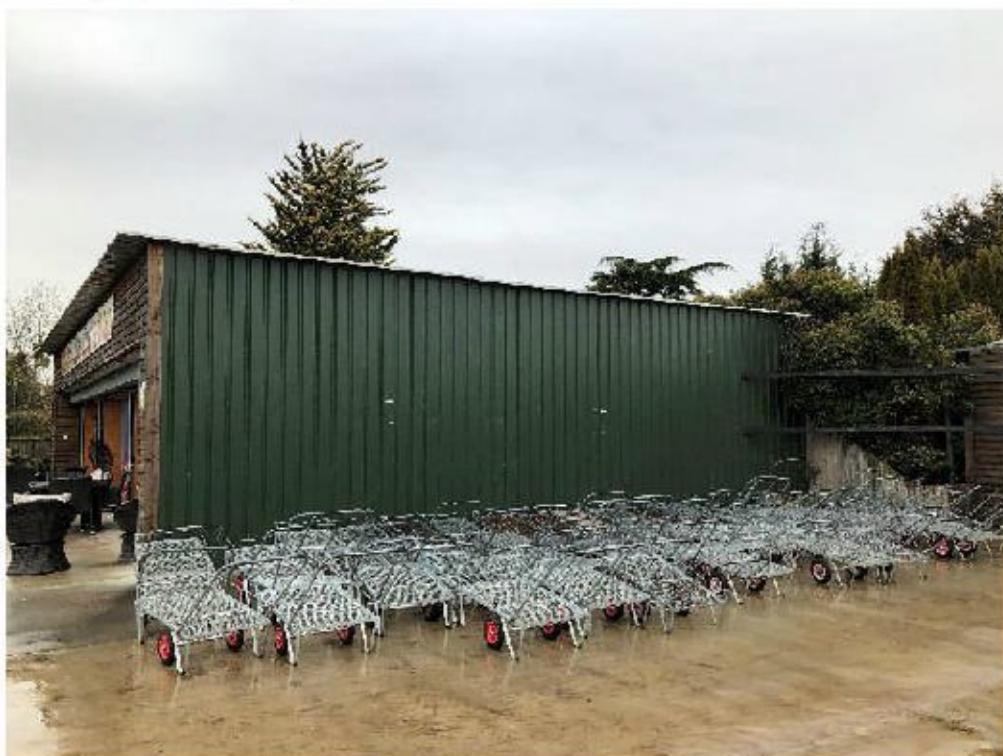
Photograph 4 Building reference M

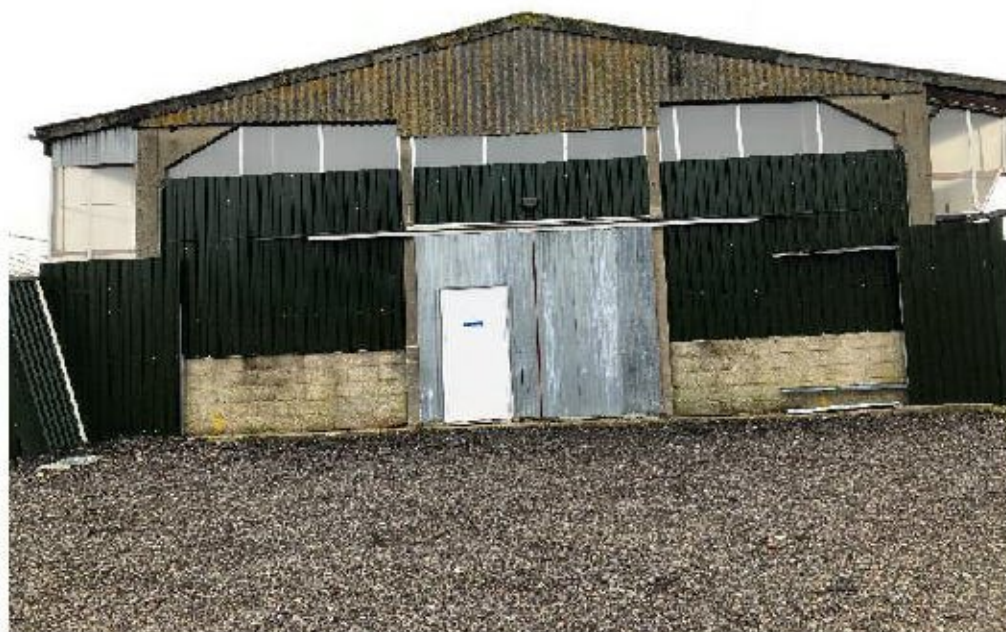
K	Breeze block construction with corrugated asbestos roof. southern elevation with plastic panelling in places. Wooden window frames.	✓	✓	X	✓	X	X	None noted	Under asbestos panelling at southern end.	None noted	None noted

Photograph 7 South elevation of building reference K.

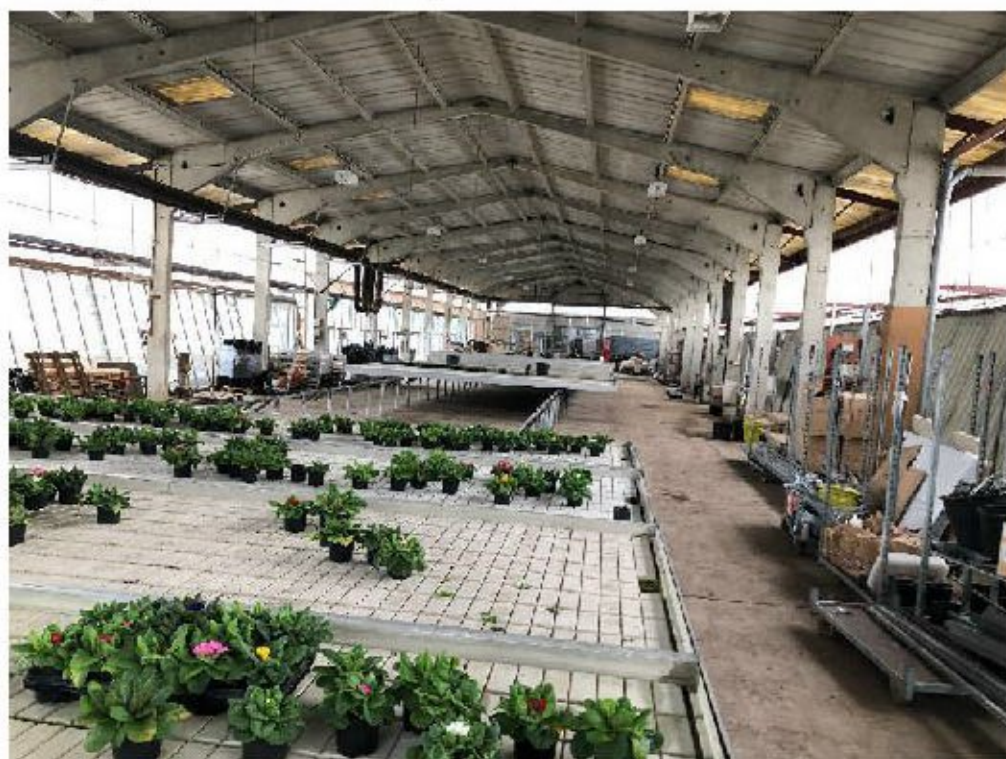
Photograph 8 Interior of building reference K.

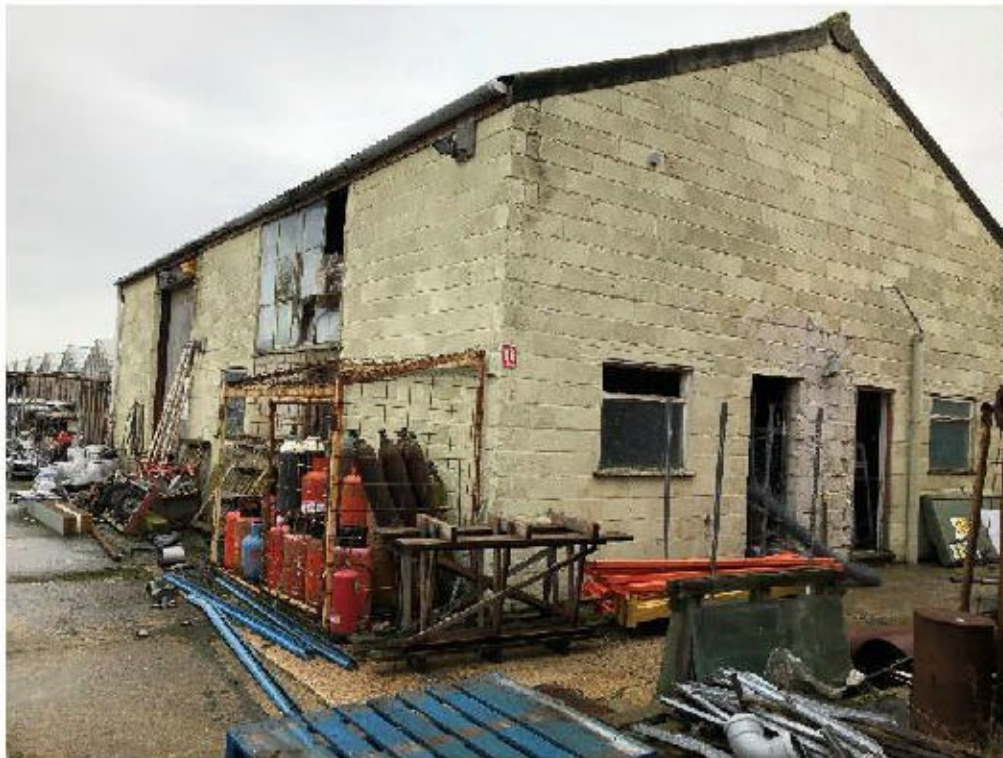
Photograph 9 Building reference J

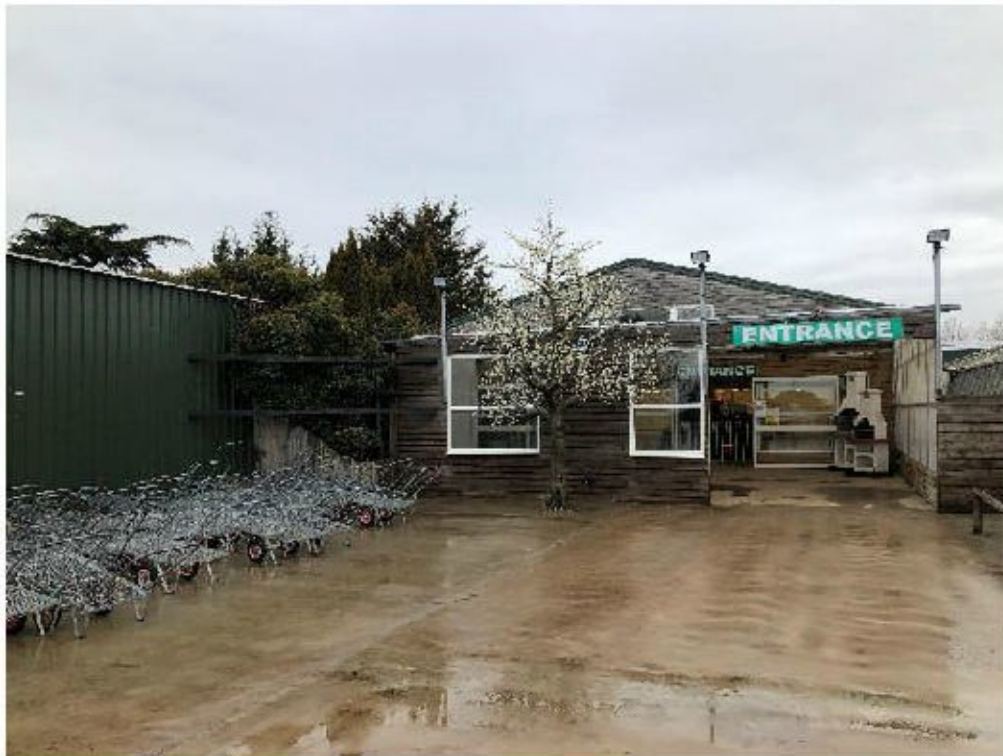
Photograph 15 Building reference M showing wooden panelling

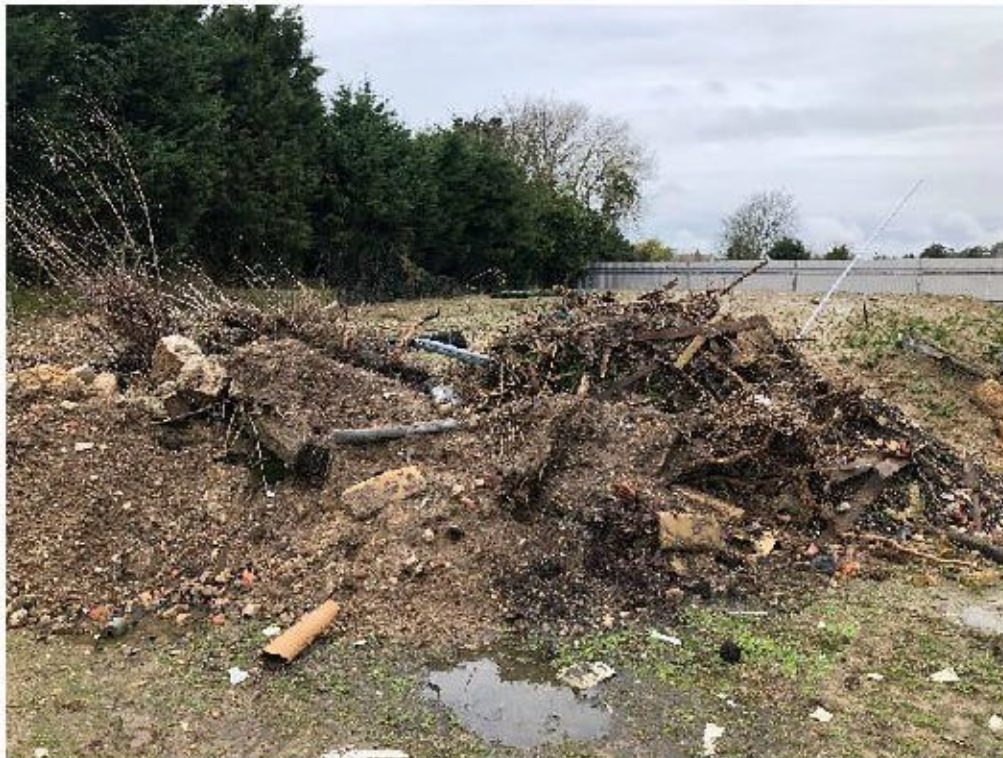
Photograph 17 Potential reptile habitat

Reptiles – There are habitats on site that provide opportunities for reptiles to bask and shelter. Although no reptile records were presented from EWT, local records of lizards, slow worm and grass snake are present (pers. Comm., site workers, 2018). It is therefore recommended that further reptile surveys be carried out on this site.
