Bat Scoping and Emergence Interim Report

Redwood, Penshurst Road

Project No: P3808

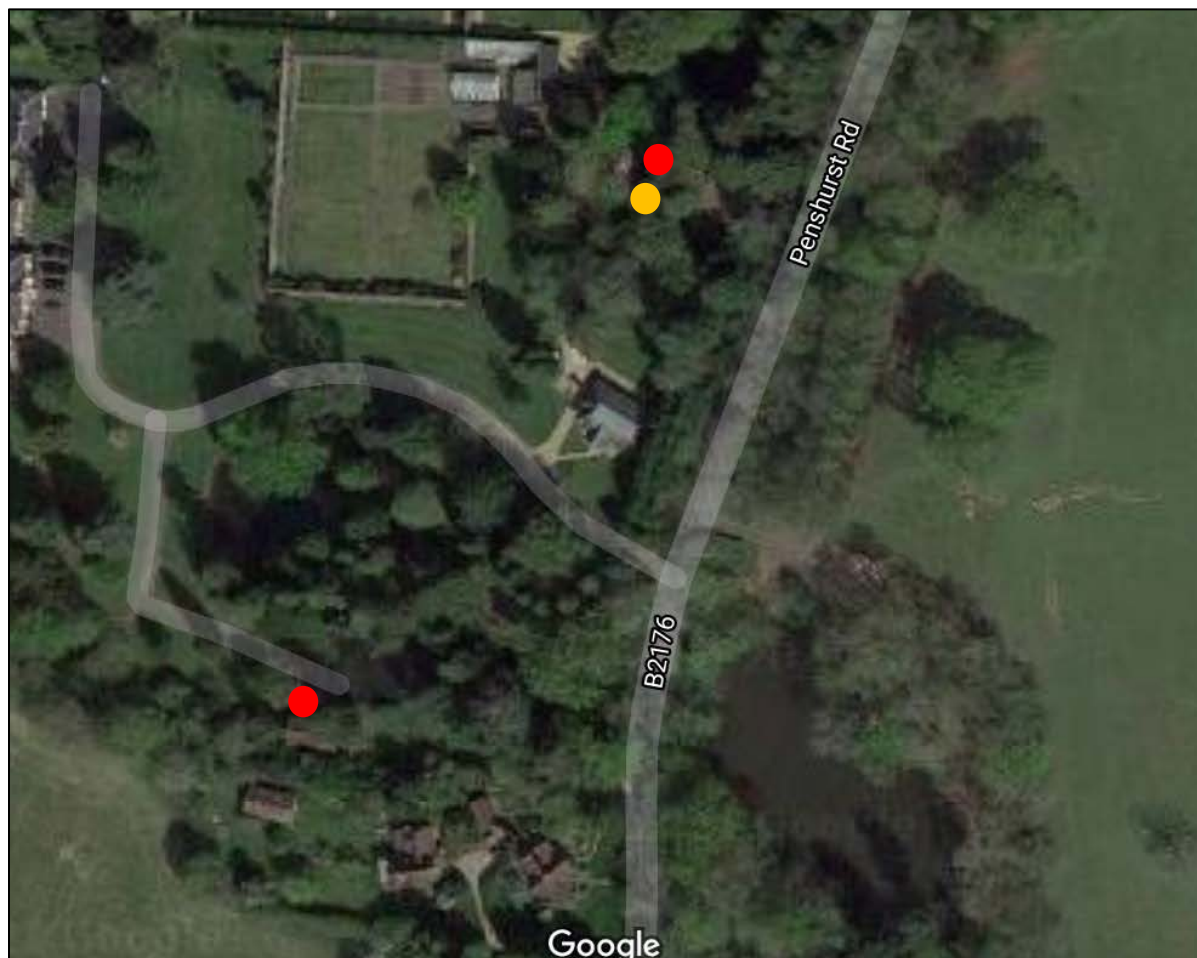
Figure 3. An aerial image of the site, showing the positions of surveyors (red dots) night vision camera (yellow dot). Images produced courtesy of Google maps (Map data ©2021 Google).

The surveys focused upon the clay peg roof tiles using two surveyors and one night vision camera positioned according to Figure 3. From these positions, surveyors could see almost all features potentially suitable for roosting bats that were identified during the initial bat scoping survey.

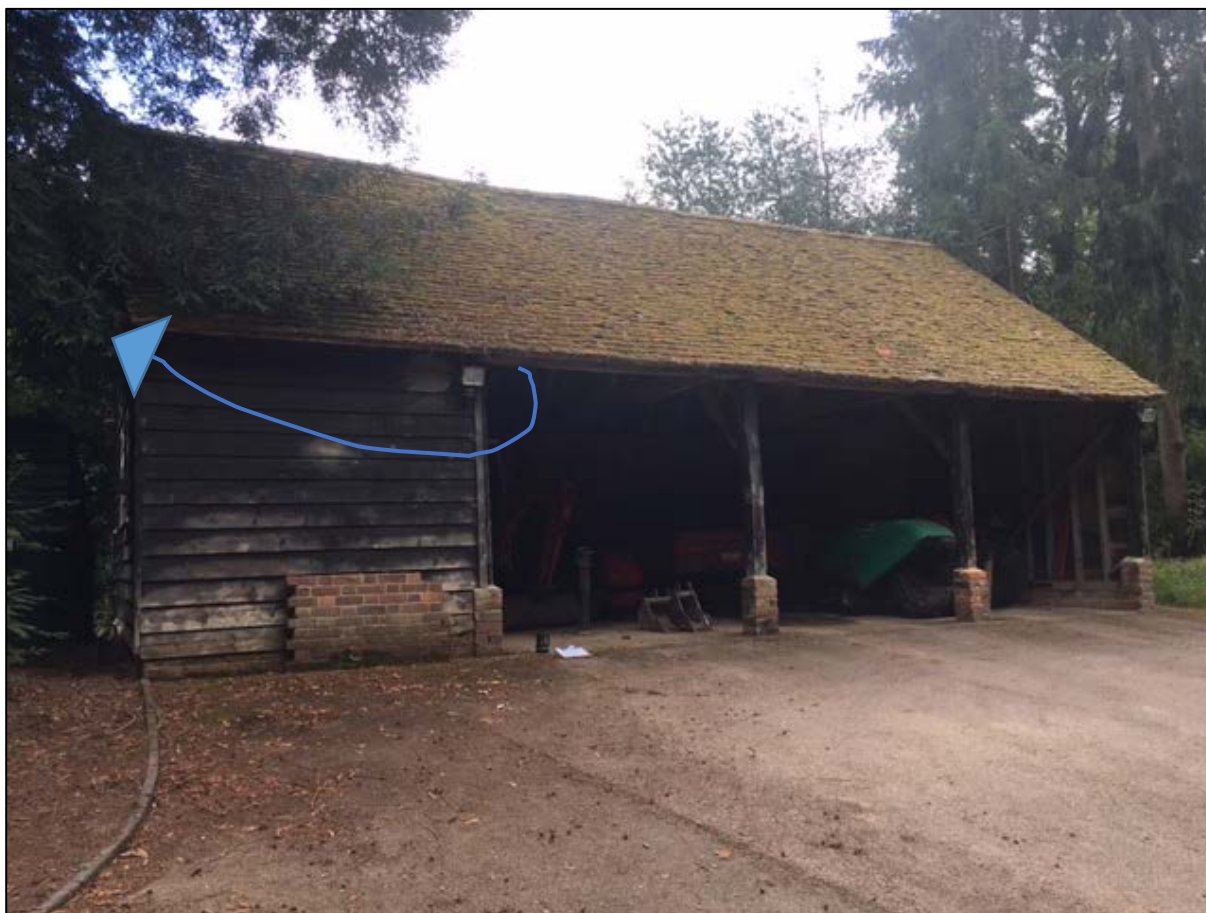
Two emergences were recorded from the building. Both were Brown long-eared bat *Plecotus auratus* from the open sided barn (B1), the first was one hour and 7 minutes after sunset followed by a second 2 minutes later flying out from the open sides of the barn along the northern aspect (photograph 1). The vast majority of activity was from foraging soprano and common pipistrelles, *Pipistrelles pipistrellus* and *P. pygmaeus* that had emerged elsewhere. The first bat recorded was a soprano pipistrelle 2 minutes after sunset foraging over the canopy of the stable block (B1), this continued intermittently for 13 minutes. The first soprano pipistrelle to be seen at the open sided barn arrived from the west and flew around the barn in a single pass 17 minutes after sunset. Common pipistrelle was recorded around both buildings intermittently during the early dusk period. It then went quiet at both buildings until a Noctule *Nyctalus noctula* was heard passing by just over half an hour after sunset. The survey produced two records of *Myotis spp.* one over each building, the first was 39 minutes after sunset passing by the open sided barn, the next followed 29 minutes later foraging past the stable block just after a visit from a foraging common pipistrelle.

Photograph 1. Image showing the location of an emerging brown long-eared bat from a from the open side of the barn at 21:14 on the 24th August 2020 (blue arrow).

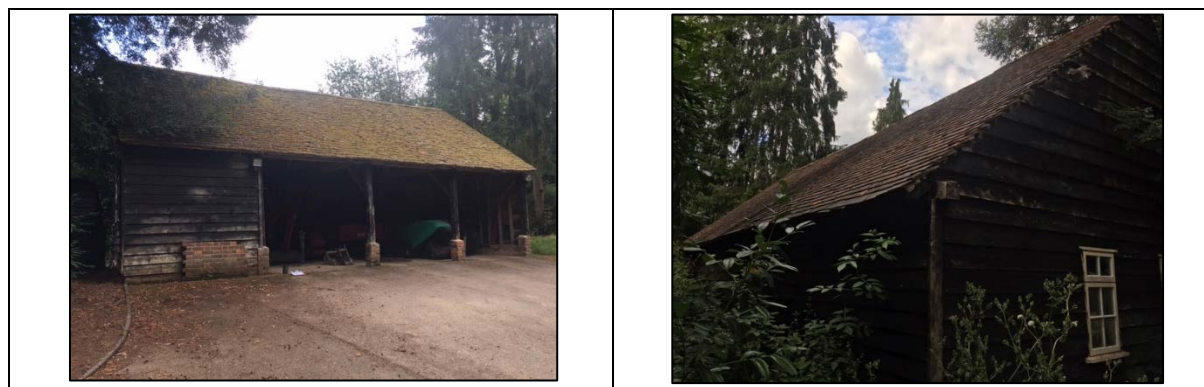
The first building assessed comprises an open sided single storey timber-framed barn used for storage of vehicles and equipment. It has a single pitch roof measuring approximately 10m (l), 5m (w) (photograph 2). The roof is constructed from clay pegged tiles, some of which are damaged or lifted creating suitable roosting habitat for crevice roosting bats. There is a small store room on the eastern aspect illuminated by natural light from one window on the eastern gable end (photograph 3). The roof is lined with bitumen felt; there is a small hole in the lining, potentially providing access to the space between the lining and the roof tiles for bats. There is no enclosed loft space, although the ceiling of the small store room provides a mezzanine level above, and the building has no insulation. Three quarters

Photograph 2: view of northern aspect Open sided barn on hardstanding

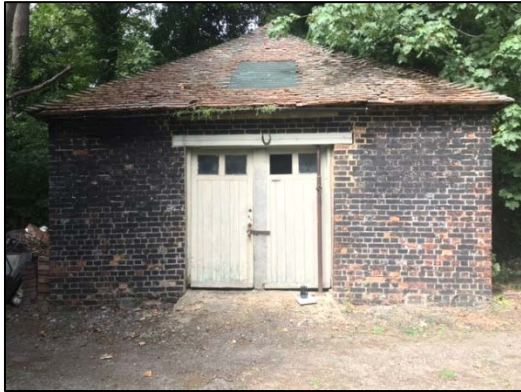
Visibility during emergence surveys at both buildings was limited by the overhead tree canopy, which reduces light and contrast making observation of flying bats difficult. The rear of the open-sided barn was inaccessible due to dense vegetation growth along the property boundary. (Photograph 3).

Photograph 3. View of south east corner of open barn illustrating the only window and the roof.

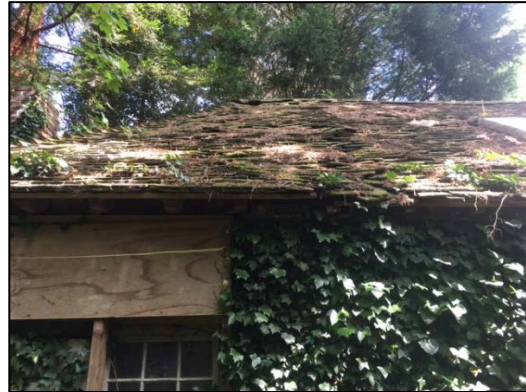
The second building comprises a single storey brick stable block building, now disused and falling into disrepair. It is approximately 15m (l), 8m(w), with a single pitched roof and a double barn door on the southern aspect (photograph 4). The clay peg-tiled roof is cluttered by encroached vegetation, there are many damaged and lifted tiles around all aspects providing potential crevices for roosting bats (photograph 5) and an area of missing tiles (approx. 1m (w) 2m (l) allowing access into the interior (photograph 6). There is no enclosed loft space, the interior of the roof is constructed from a timber frame, littered with cobwebbing, and there is no roof lining or insulation in the ceiling (photograph 7).

Photograph 4. The southern aspect of the stable with the double timber stable doors, show the gaps underneath the lifted roof tiles and the patch of missing tiles.

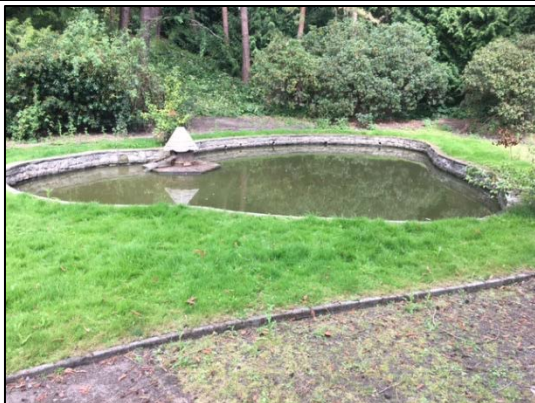
Photograph 8. Duck pond to the north of the stable block

There is a small ornamental duck pond to the north of the open-sided barn. However this pond has vertical sides, supports no aquatic vegetation and has very poor water quality due to the influence of ducks. It is considered unlikely to support Great Crested Newts (photograph 8). The area around the front of the open-sided barn are dominated by hard standing and frequently mown amenity lawn. These habitats have very low ecological value and unlikely to support reptiles or amphibians. The dense scrub

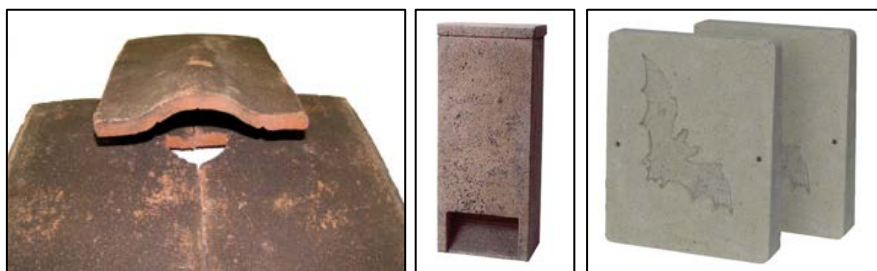
Figure 6a (left), 5b (centre) & 5c (right). Left - Bat Access Tile Set, Centre - 2FR Schwegler Bat Tube, Right - 2FE Schwegler Wall-Mounted bat shelters.

The proposed development represents an opportunity for biodiversity enhancements for bats, and the developer is encouraged to consider incorporating an enclosed loft space dedicated to roosting bats, and/or integral bat roosting opportunities into the building fabric such as Bat Access Tiles or internal voids/access points for bats, such as Schwegler 2FR bat tubes and 2FE Schwegler Wall-Mounted bat shelters (see Figure 6a-c below) into the architects design.
