Phase I Geo-Environmental Risk Assessment
Land at Christon Bank Farm, Northumberland

Reference: 190502.R.001

Status: Version 1.0

Date: May 2019

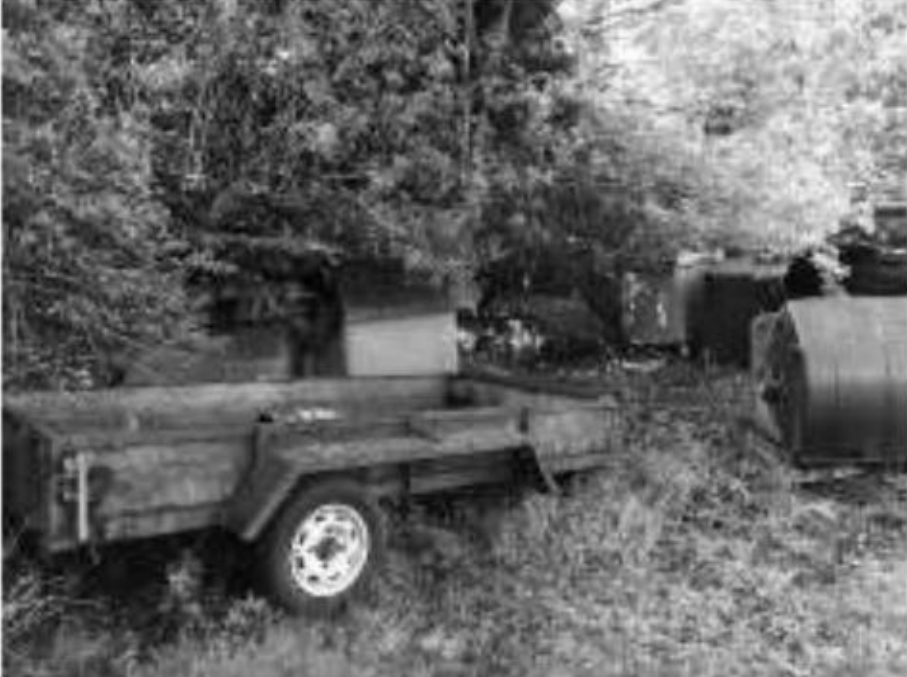
Photograph Number	Photograph Description	Photograph
2.	To the south west of the structure, disused industrial plastic waste bins and a trailer is present within the soft landscaping.

During the site walkover, an abandoned car, industrial plastic waste bins and tyres were identified at the site. This should be cleared up as part of good housekeeping. During site redevelopment demolition type wastes, which may include ACM's may be generated which will require disposal. Any asbestos impacted waste should be assumed to be hazardous unless proven otherwise.

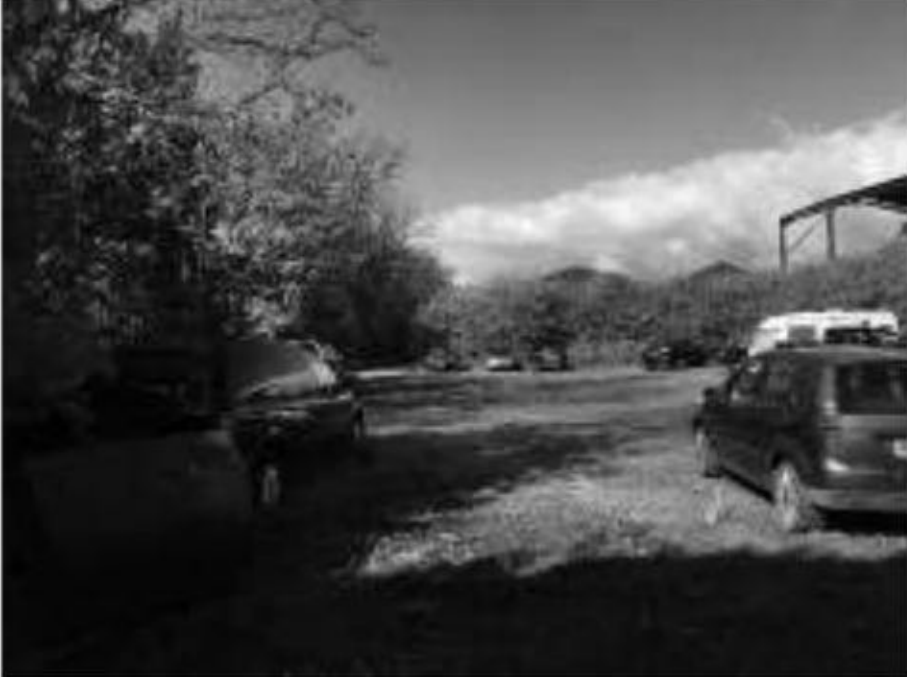
3.	To the west of the site, a car park surfaced in GSB with discrete grassed areas can be seen. The western entrance and site exit are visible centrally in the background.

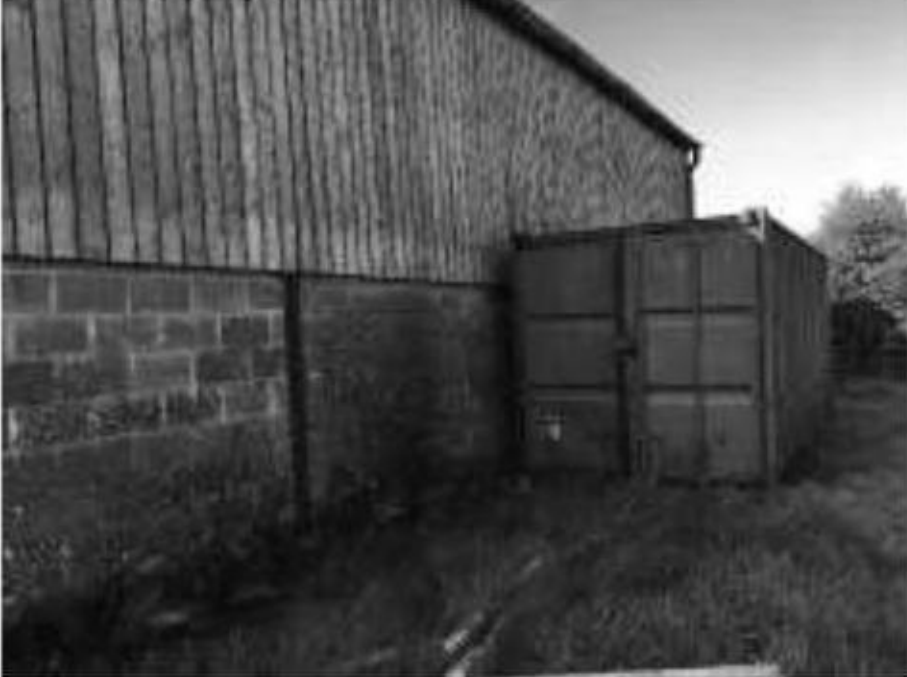
4.	Adjacent to the northern boundary of the structure, a shipping container was present, used as storage for wooden beams, metal railings and plastic bucket/bollards.

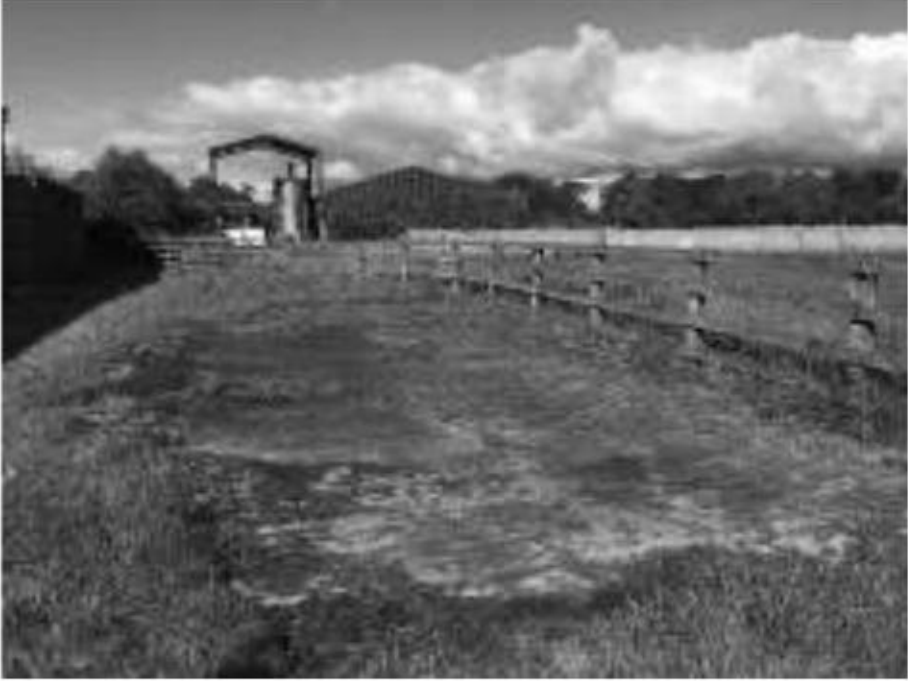
Photograph Number	Photograph Description	Photograph
5.	A concrete slab can be seen adjacent to the northern boundary within a grassed area.

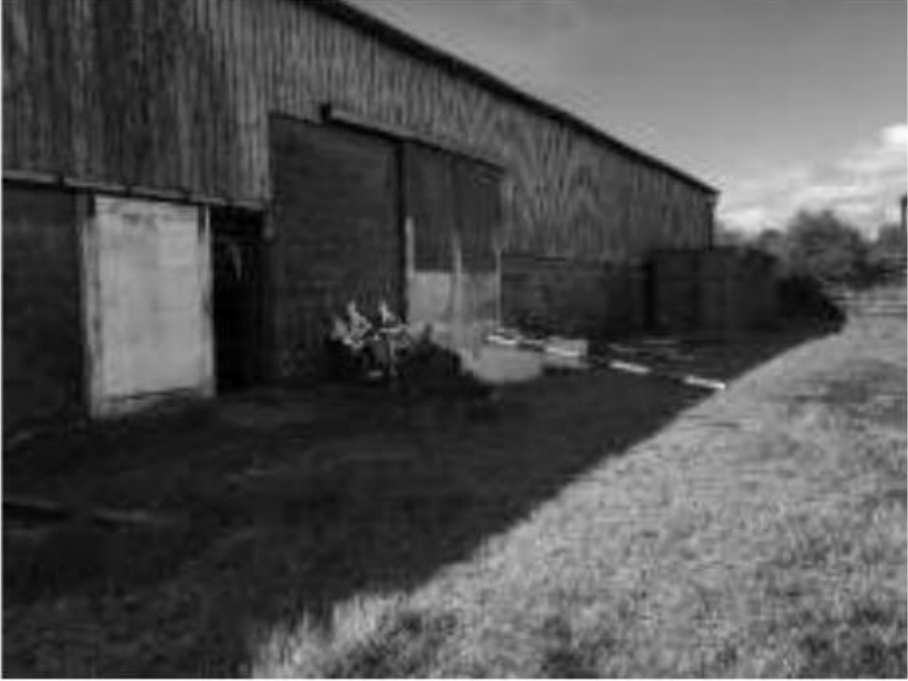
6.	Along the northern boundary of the structure, materials associated with the equestrian nature of the site can be seen against the northern wall of the structure.

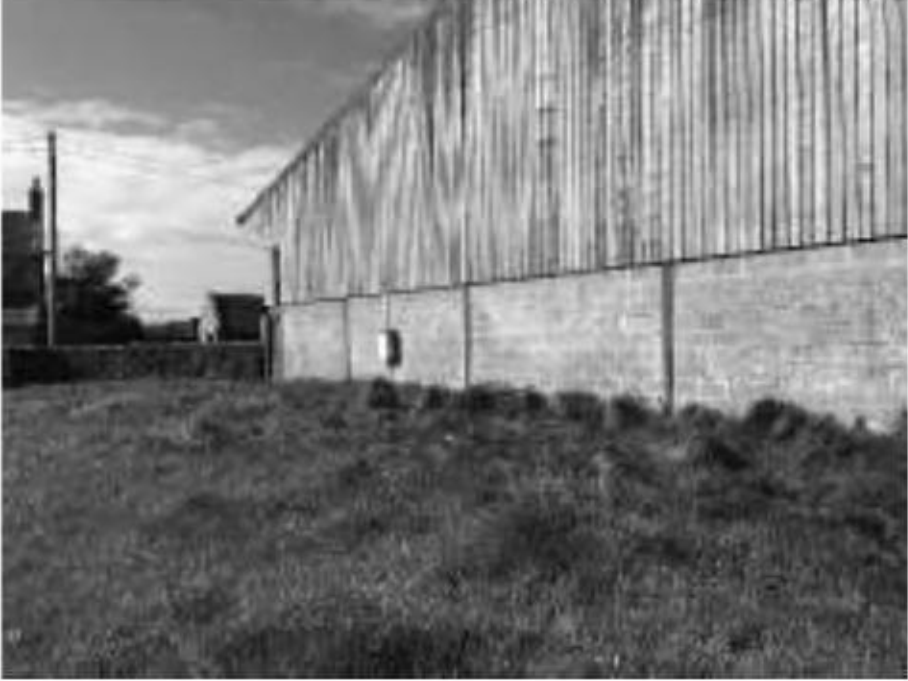
7.	View across the grass covered eastern area of the site. The construction of the eastern elevation of the barn from brick and steel portal frame can be seen. An electricity box is present centrally on the eastern elevation.

As part of the redevelopment of the site, which will involve the disturbance or demolition of the barn, it is recommended that a Refurbishment and Demolition asbestos survey is carried out and the information provided to the contractors undertaking the work.
