## GROUND INVESTIGATION REPORT

Starlings, Milton Road, Harwich, Essex

Tendring District Council

Project no: 60275

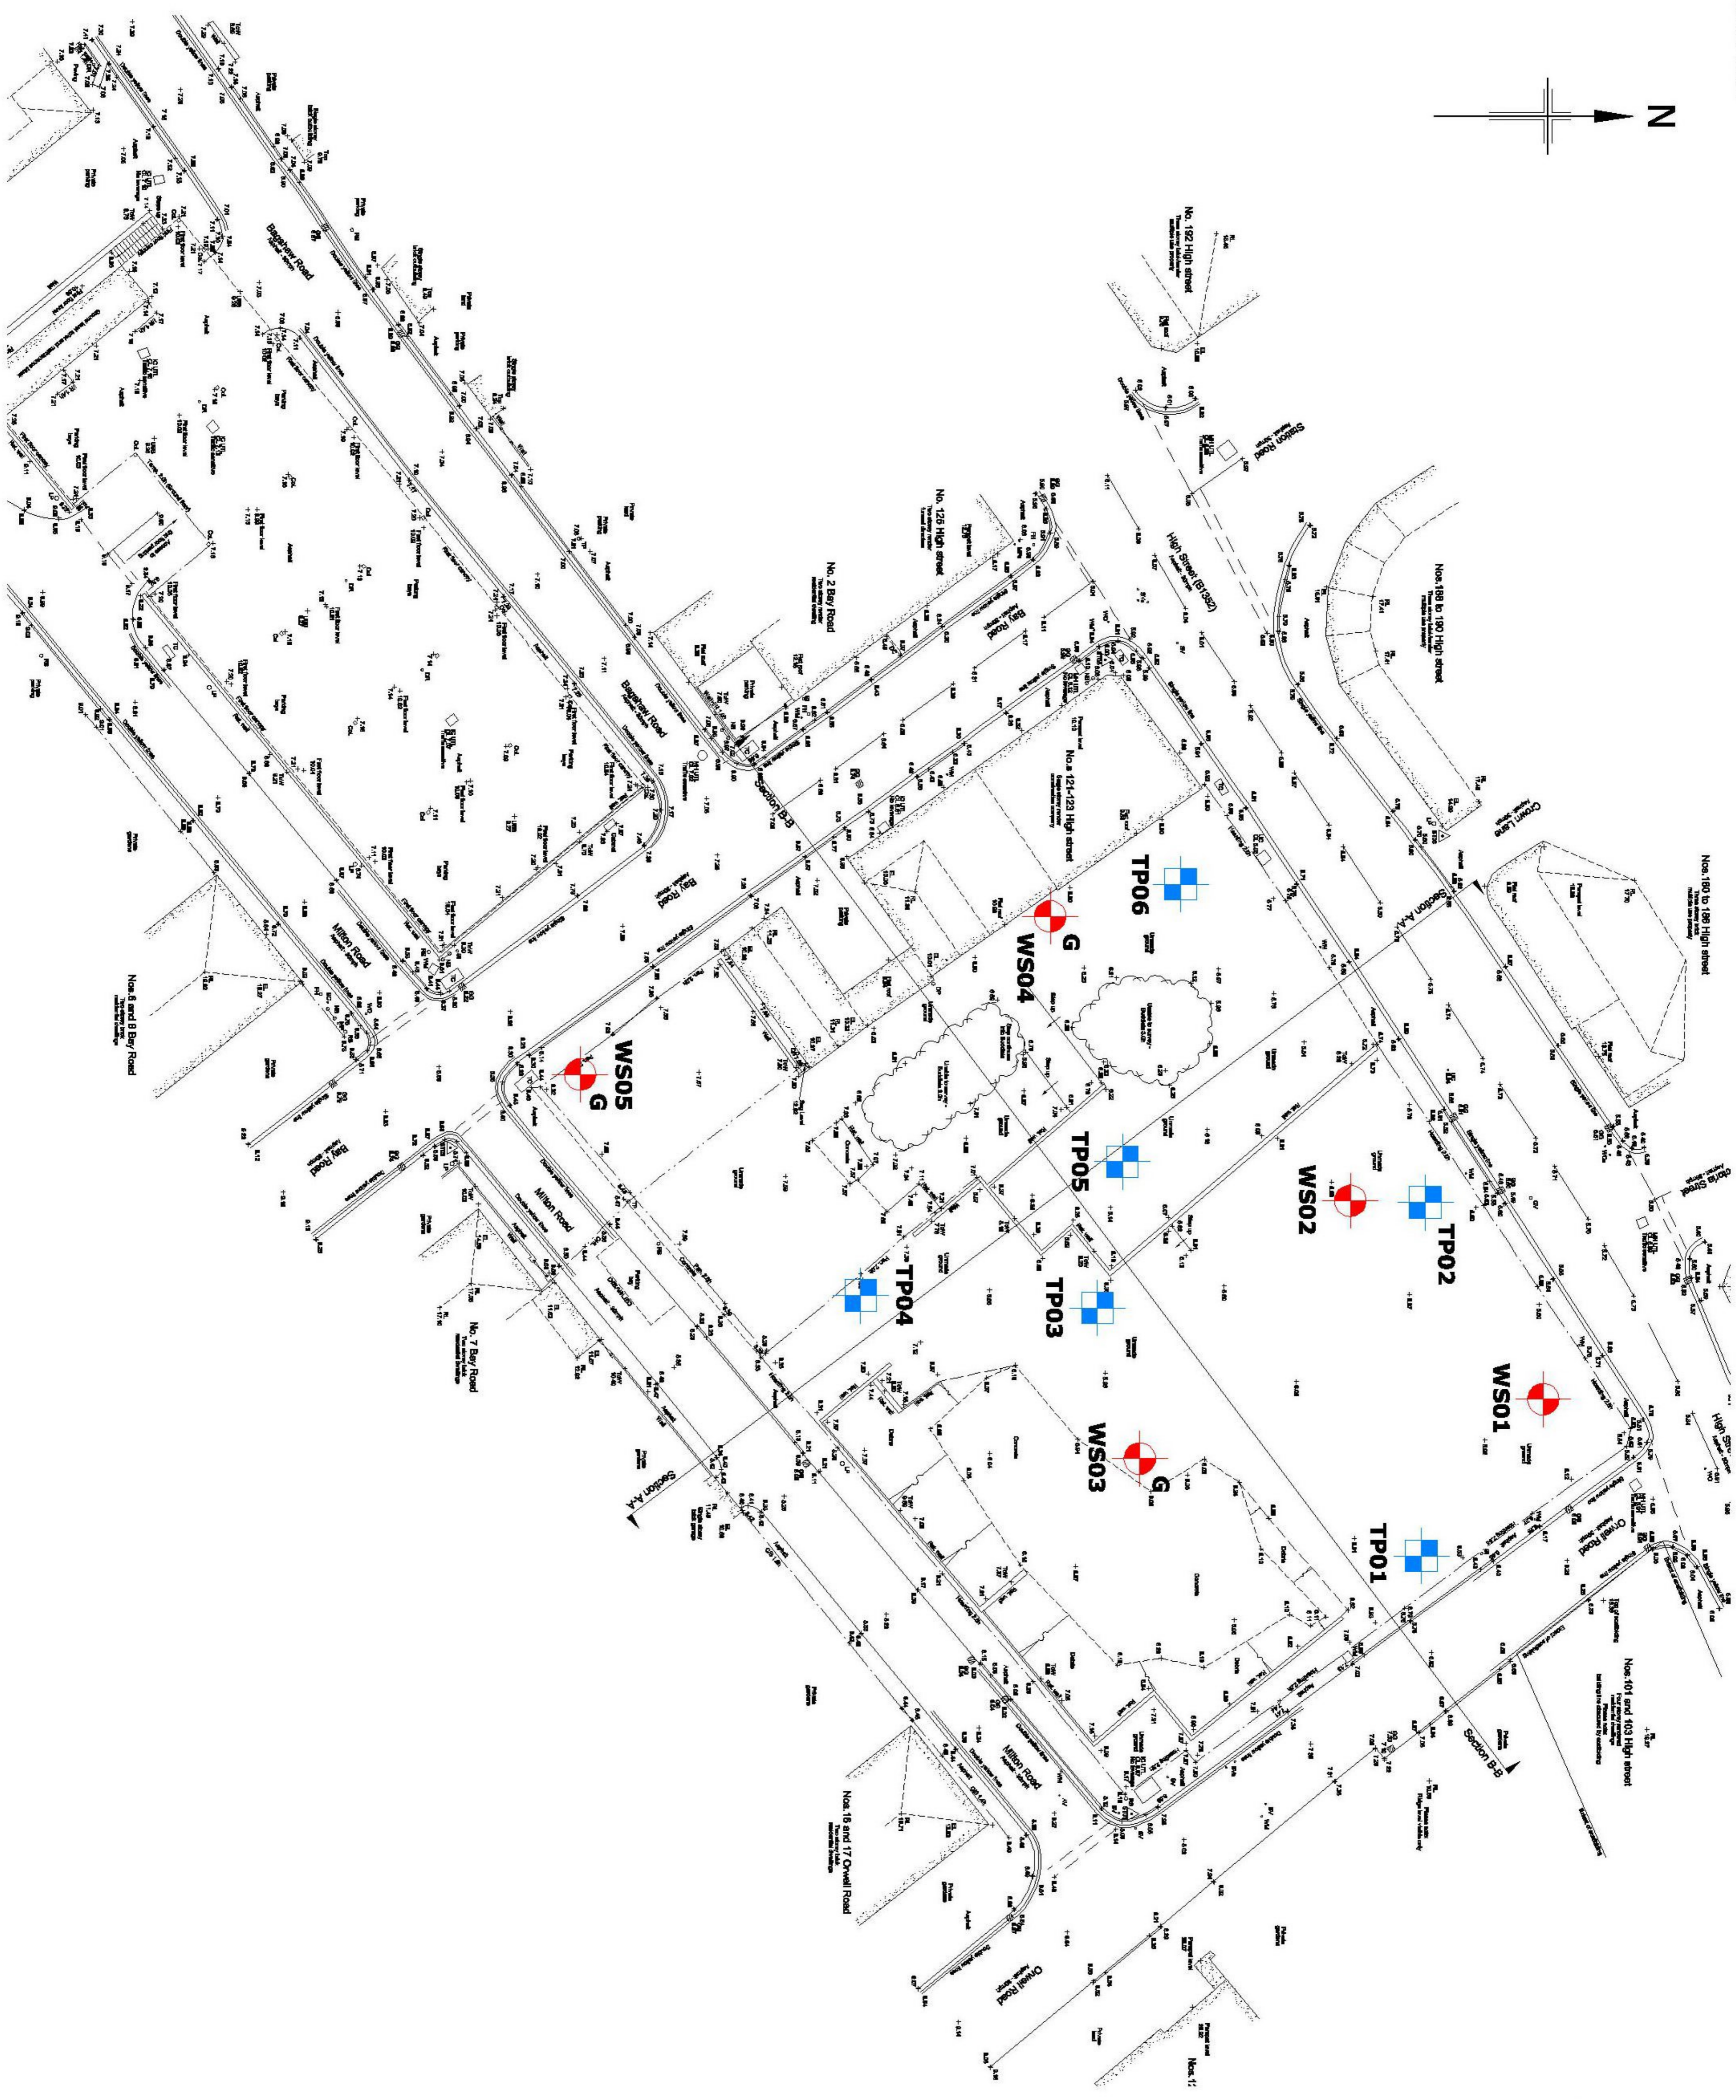
Drawing No. **60275/G/FIG02**

- KEY**
- : WINDLESS SAMPLER BOREHOLE
  - : TRIAL PIT
  - : MONITORING WELL INSTALLED

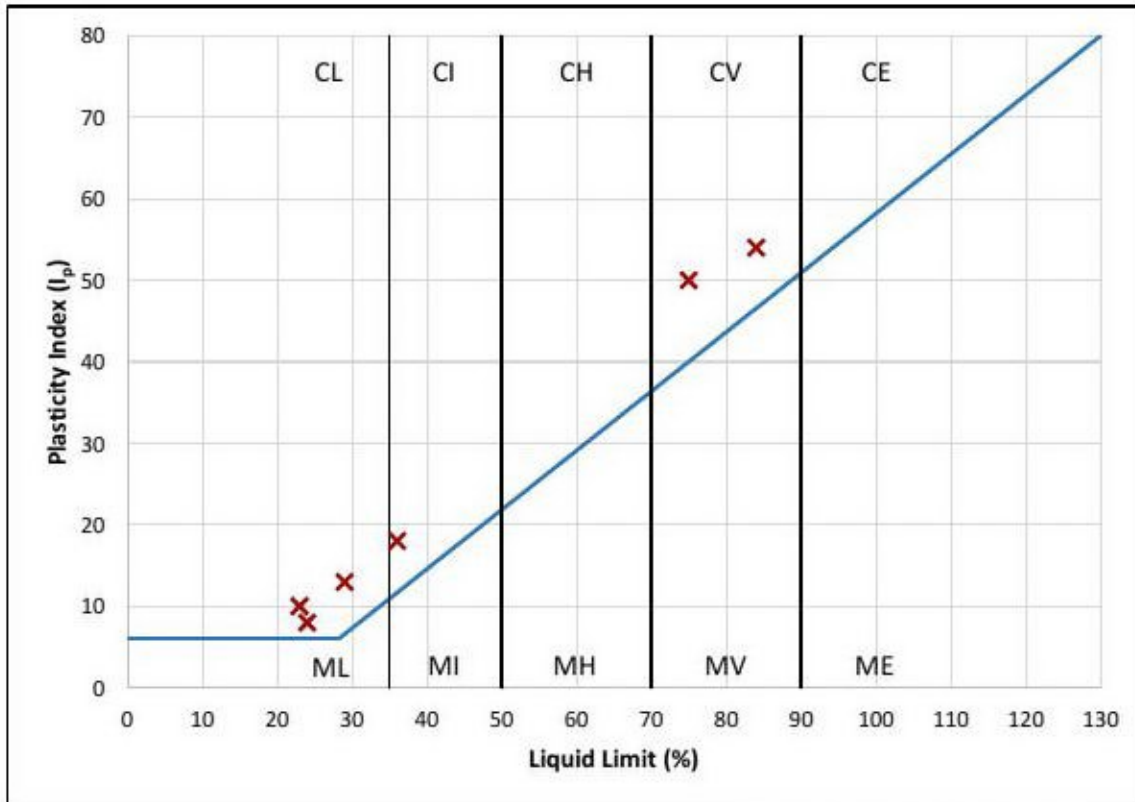
## PLOT OF PLASTICITY INDEX AGAINST LIQUID LIMIT USING CASAGRANDE CLASSIFICATION CHART

Plasticity Chart BS5930: 2015: Figure 8

High	NHBC Volume Change Potential
Medium	
Low

Interim advice note 73106, Revision 1 (2009) provides recommendations for design CBR values on the basis of soil plasticity. The recorded plasticity index of the Head Deposits ranged from 8% to 18%. Therefore, a CBR value of 3% is recommended for the preliminary design of thin road pavements where the Head Deposits are present at formation level. Thin pavement construction is defined as a depth to subgrade of 300mm.

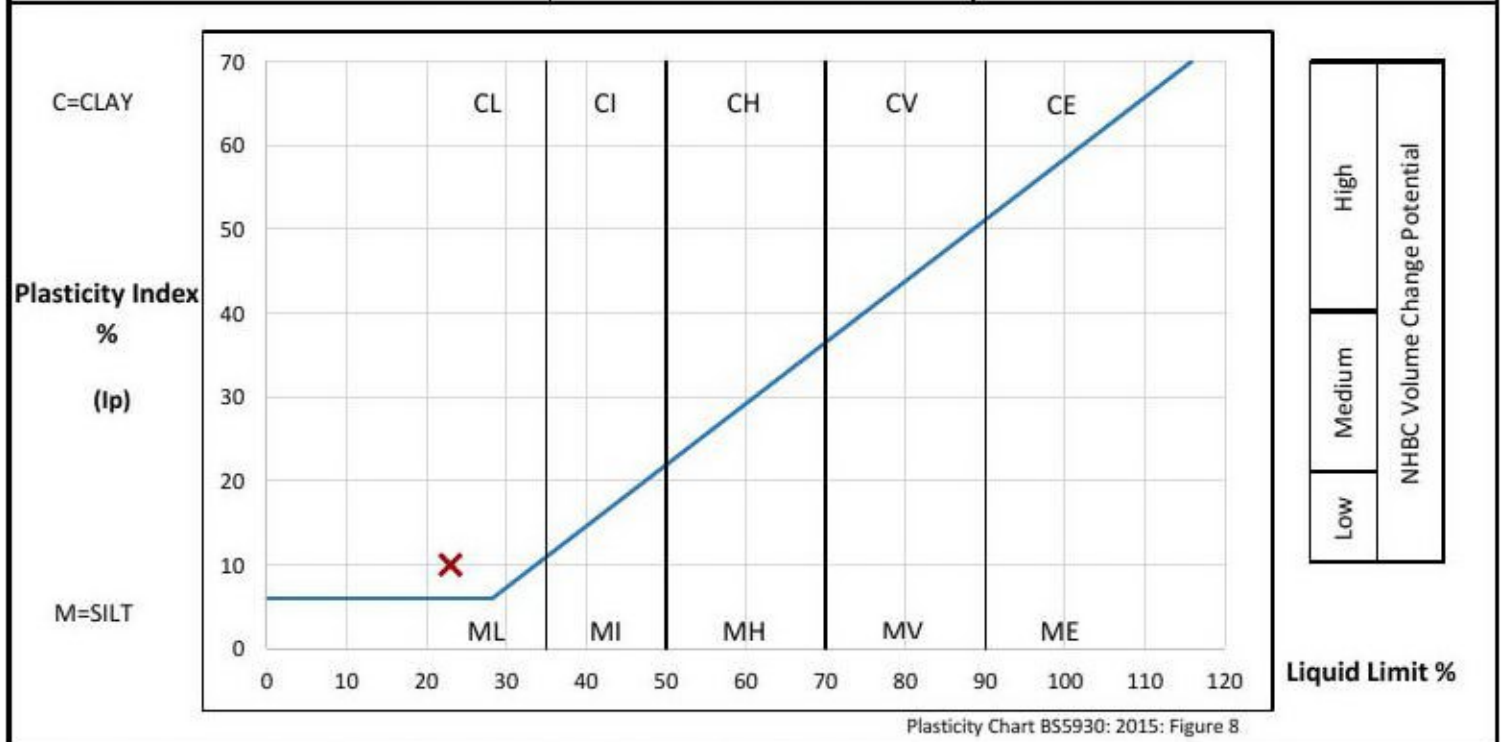
Borehole / Pit No.	Depth m	Sample		Water Content (W) %	Description	Remarks
		Type	Reference			
TP06	1.60	D	2	9.3	Friable yellowish brown slightly gravelly sandy silty CLAY with occasional recently active roots. Gravel is fine to coarse angular to subangular brick, chert, concrete, and ceramic fragments.

<b>PREPARATION</b>			Liquid Limit	23 %	
Method of preparation			Wet sieved over 0.425mm sieve	Plastic Limit	13 %
Sample retained 0.425mm sieve	(Measured)	7 %	Plasticity Index	10 %	
Corrected water content for material passing 0.425mm			10.0 %	Liquidity Index	-0.37
Sample retained 2mm sieve	(Measured)	3 %	NHBC Modified (I'p)	9 %	
Curing time	73 hrs	Clay Content	Not analysed	Derived Activity	Not analysed

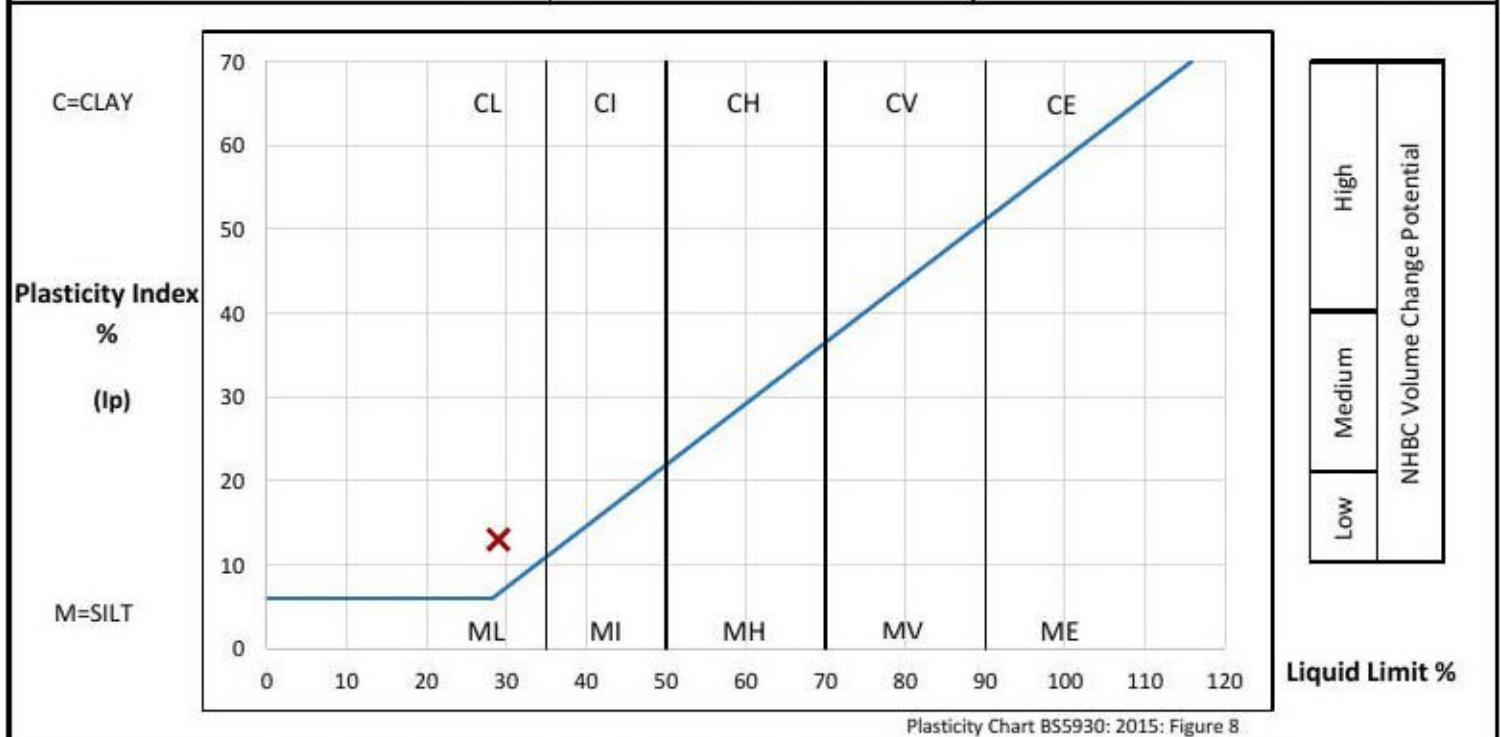
Borehole / Pit No.	Depth m	Sample		Water Content (W) %	Description	Remarks
		Type	Reference			
WS01	2.10 - 2.20	D	3	<b>17.8</b>	Firm yellowish brown slightly gravelly sandy silty CLAY with occasional greyish brown mottling, and rare recently active roots. Gravel is fine to medium angular to subrounded chert, and quartzite, and rare brick.

<b>PREPARATION</b>			Liquid Limit	<b>29 %</b>	
Method of preparation			<b>Wet sieved over 0.425mm sieve</b>	Plastic Limit	<b>16 %</b>
Sample retained 0.425mm sieve	(Measured)	<b>11 %</b>	Plasticity Index	<b>13 %</b>	
Corrected water content for material passing 0.425mm			<b>20.0 %</b>	Liquidity Index	<b>0.14</b>
Sample retained 2mm sieve	(Measured)	<b>4 %</b>	NHBC Modified (I'p)	<b>12 %</b>	
Curing time	<b>75 hrs</b>	Clay Content	<b>Not analysed</b>	Derived Activity	<b>Not analysed</b>

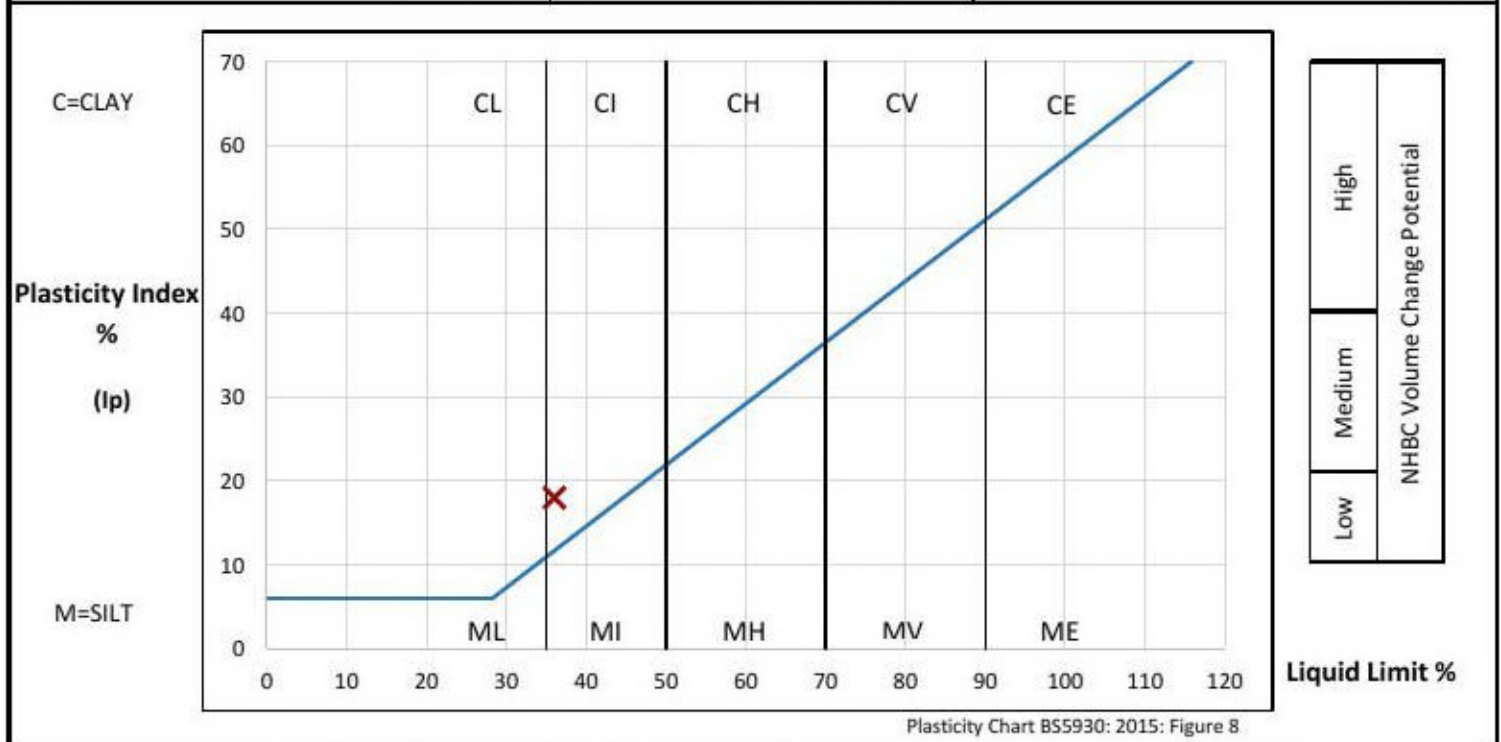
Borehole / Pit No.	Depth m	Sample		Water Content (W) %	Description	Remarks
		Type	Reference			
WS02	1.40 - 1.50	D	2	25.1	Soft yellowish brown sandy silty CLAY. Sand is fine.

<b>PREPARATION</b>			Liquid Limit	36 %	
Method of preparation			From natural	Plastic Limit	18 %
Sample retained 0.425mm sieve	(Assumed)	0 %	Plasticity Index	18 %	
Corrected water content for material passing 0.425mm			Liquidity Index	0.39	
Sample retained 2mm sieve	(Assumed)	0 %	NHBC Modified (I'p)	n/a	
Curing time	100 hrs	Clay Content	Not analysed	Derived Activity	Not analysed

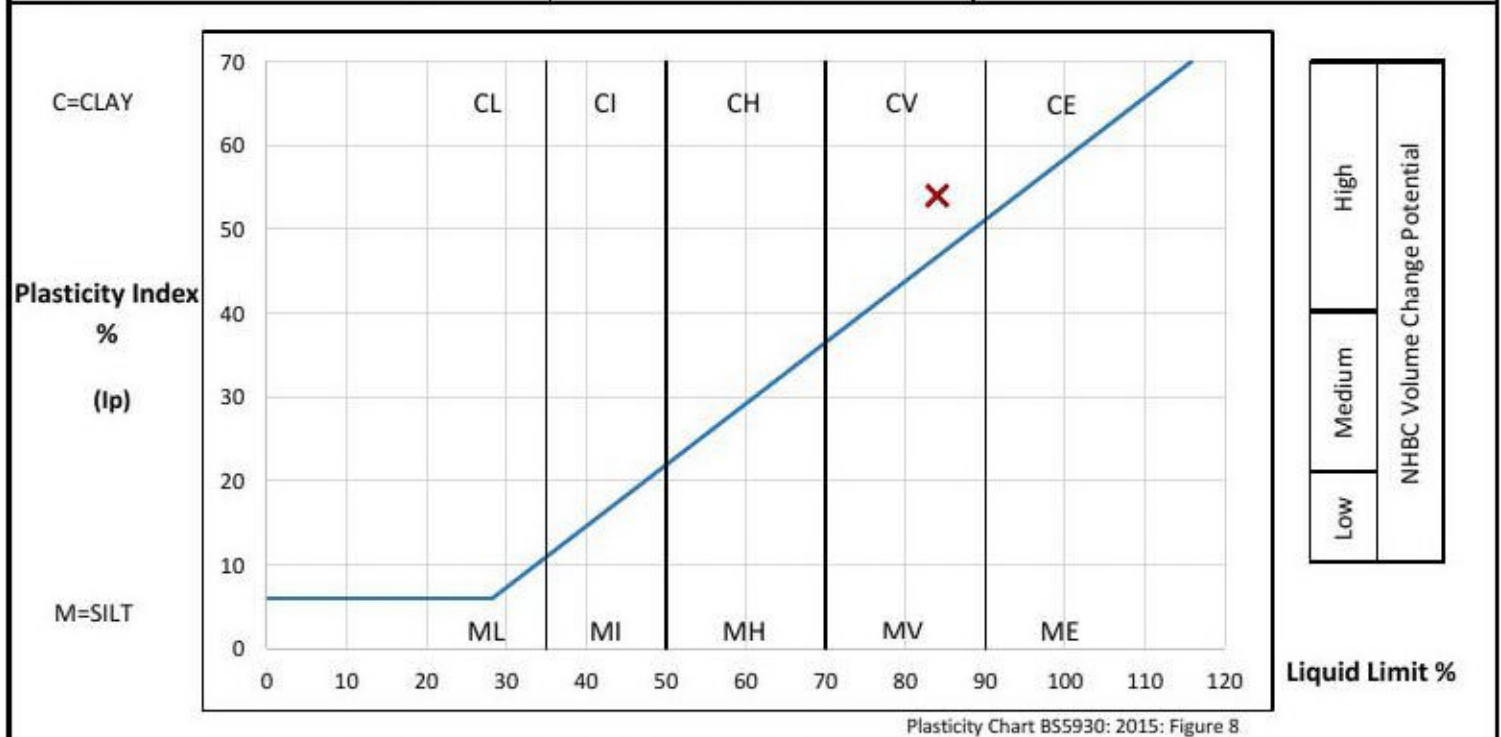
Borehole / Pit No.	Depth m	Sample		Water Content (W) %	Description	Remarks
		Type	Reference			
WS03	2.30	D	3	42.5	Firm yellowish brown CLAY with rare bluish grey mottling, rare orange silt partings, and decayed roots.

<b>PREPARATION</b>			Liquid Limit	84 %	
Method of preparation		From natural	Plastic Limit	30 %	
Sample retained 0.425mm sieve	(Assumed)	0 %	Plasticity Index	54 %	
Corrected water content for material passing 0.425mm			Liquidity Index	0.23	
Sample retained 2mm sieve	(Assumed)	0 %	NHBC Modified (I'p)	n/a	
Curing time	24 hrs	Clay Content	Not analysed	Derived Activity	Not analysed

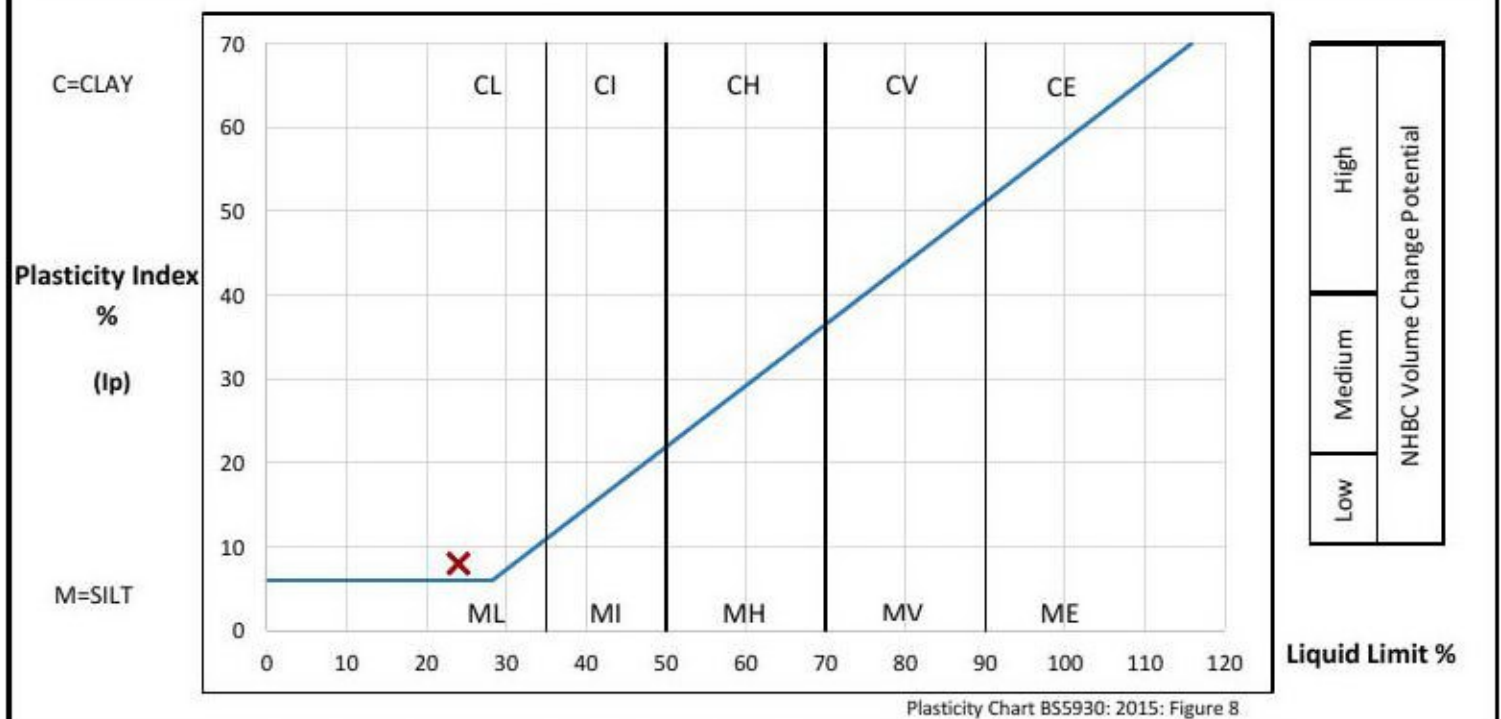
Borehole / Pit No.	Depth m	Sample		Water Content (W) %	Description	Remarks
		Type	Reference			
WS04	1.70 - 1.80	D	3	18.0	Soft yellowish brown sandy silty CLAY with occasional recently active roots. Sand is fine to medium.

<b>PREPARATION</b>			Liquid Limit	24 %	
Method of preparation		From natural	Plastic Limit	16 %	
Sample retained 0.425mm sieve	(Assumed)	0 %	Plasticity Index	8 %	
Corrected water content for material passing 0.425mm			Liquidity Index	0.26	
Sample retained 2mm sieve	(Assumed)	0 %	NHBC Modified (I'p)	n/a	
Curing time	26 hrs	Clay Content	Not analysed	Derived Activity	Not analysed

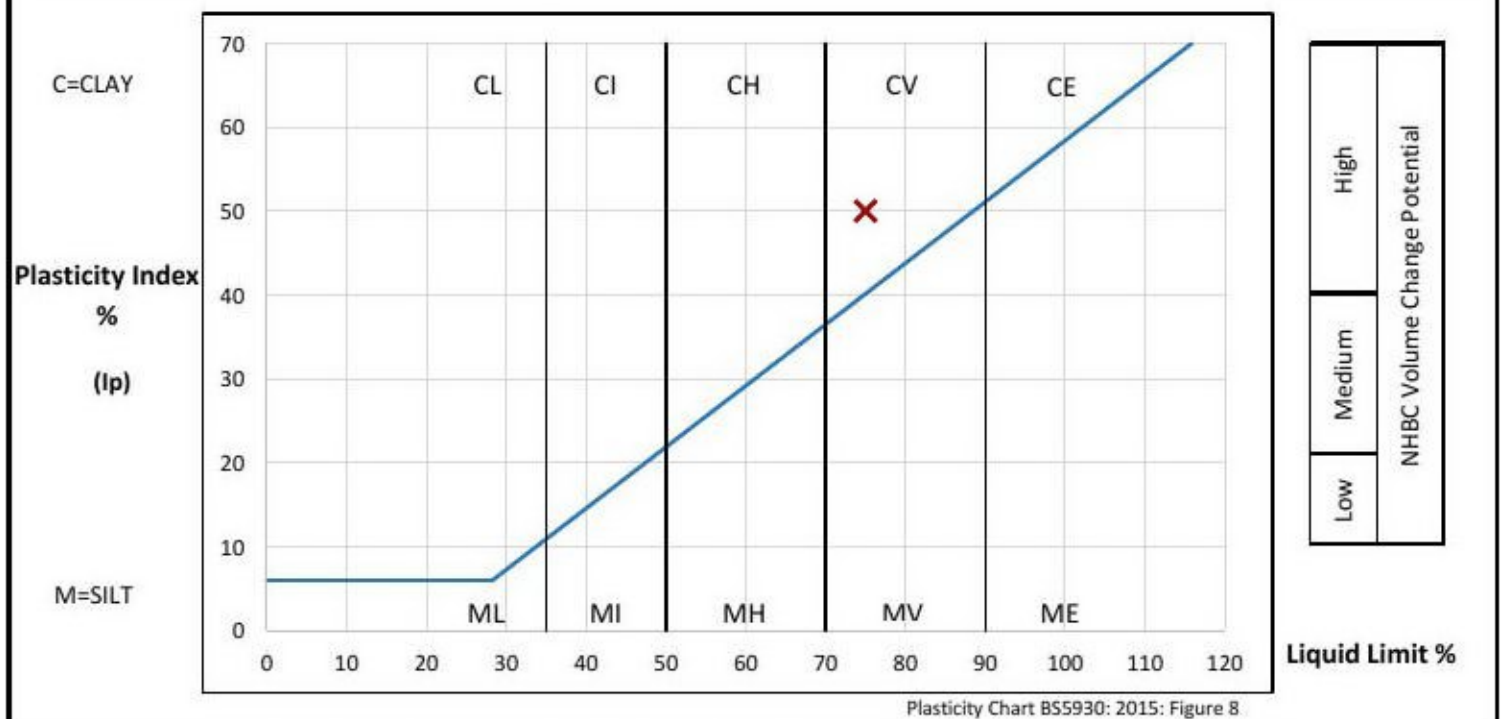
Borehole / Pit No.	Depth m	Sample		Water Content (W) %	Description	Remarks
		Type	Reference			
WS05	1.80 - 1.90	D	2	38.4	Soft olive yellow CLAY with occasional bluish grey and orange mottling, rare recently active roots, and fine chert gravel.

<b>PREPARATION</b>			Liquid Limit	75 %	
Method of preparation	From natural/gravel picked out by hand		Plastic Limit	25 %	
Sample retained 0.425mm sieve	(Assumed)	0 %	Plasticity Index	50 %	
Corrected water content for material passing 0.425mm			Liquidity Index	0.27	
Sample retained 2mm sieve	(Assumed)	<1 %	NHBC Modified (I'p)	n/a	
Curing time	25 hrs	Clay Content	Not analysed	Derived Activity	Not analysed
