Richard Jackson
Engineering Consultants

REMEDIATION METHOD STATEMENT

Starlings, Milton Road, Harwich, Essex

Project no: 60275

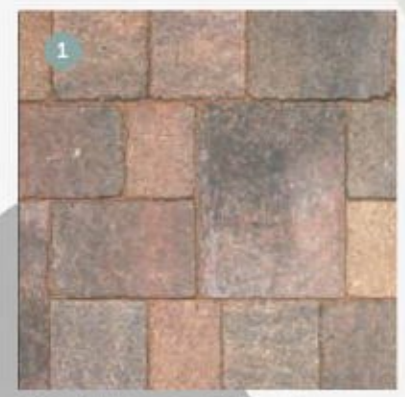
1 Marshall drivesett Tegula Traditional block paving

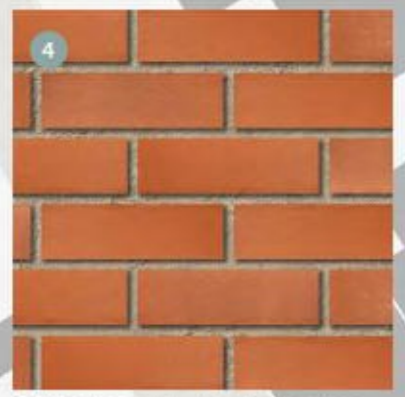
4 Retaining wall - Ibstock Class B red 65mm perforated engineering brick

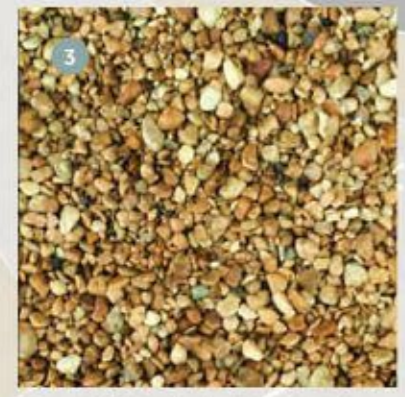
3 Gravel/Shingle (min 10mm) trench to boundary with existing

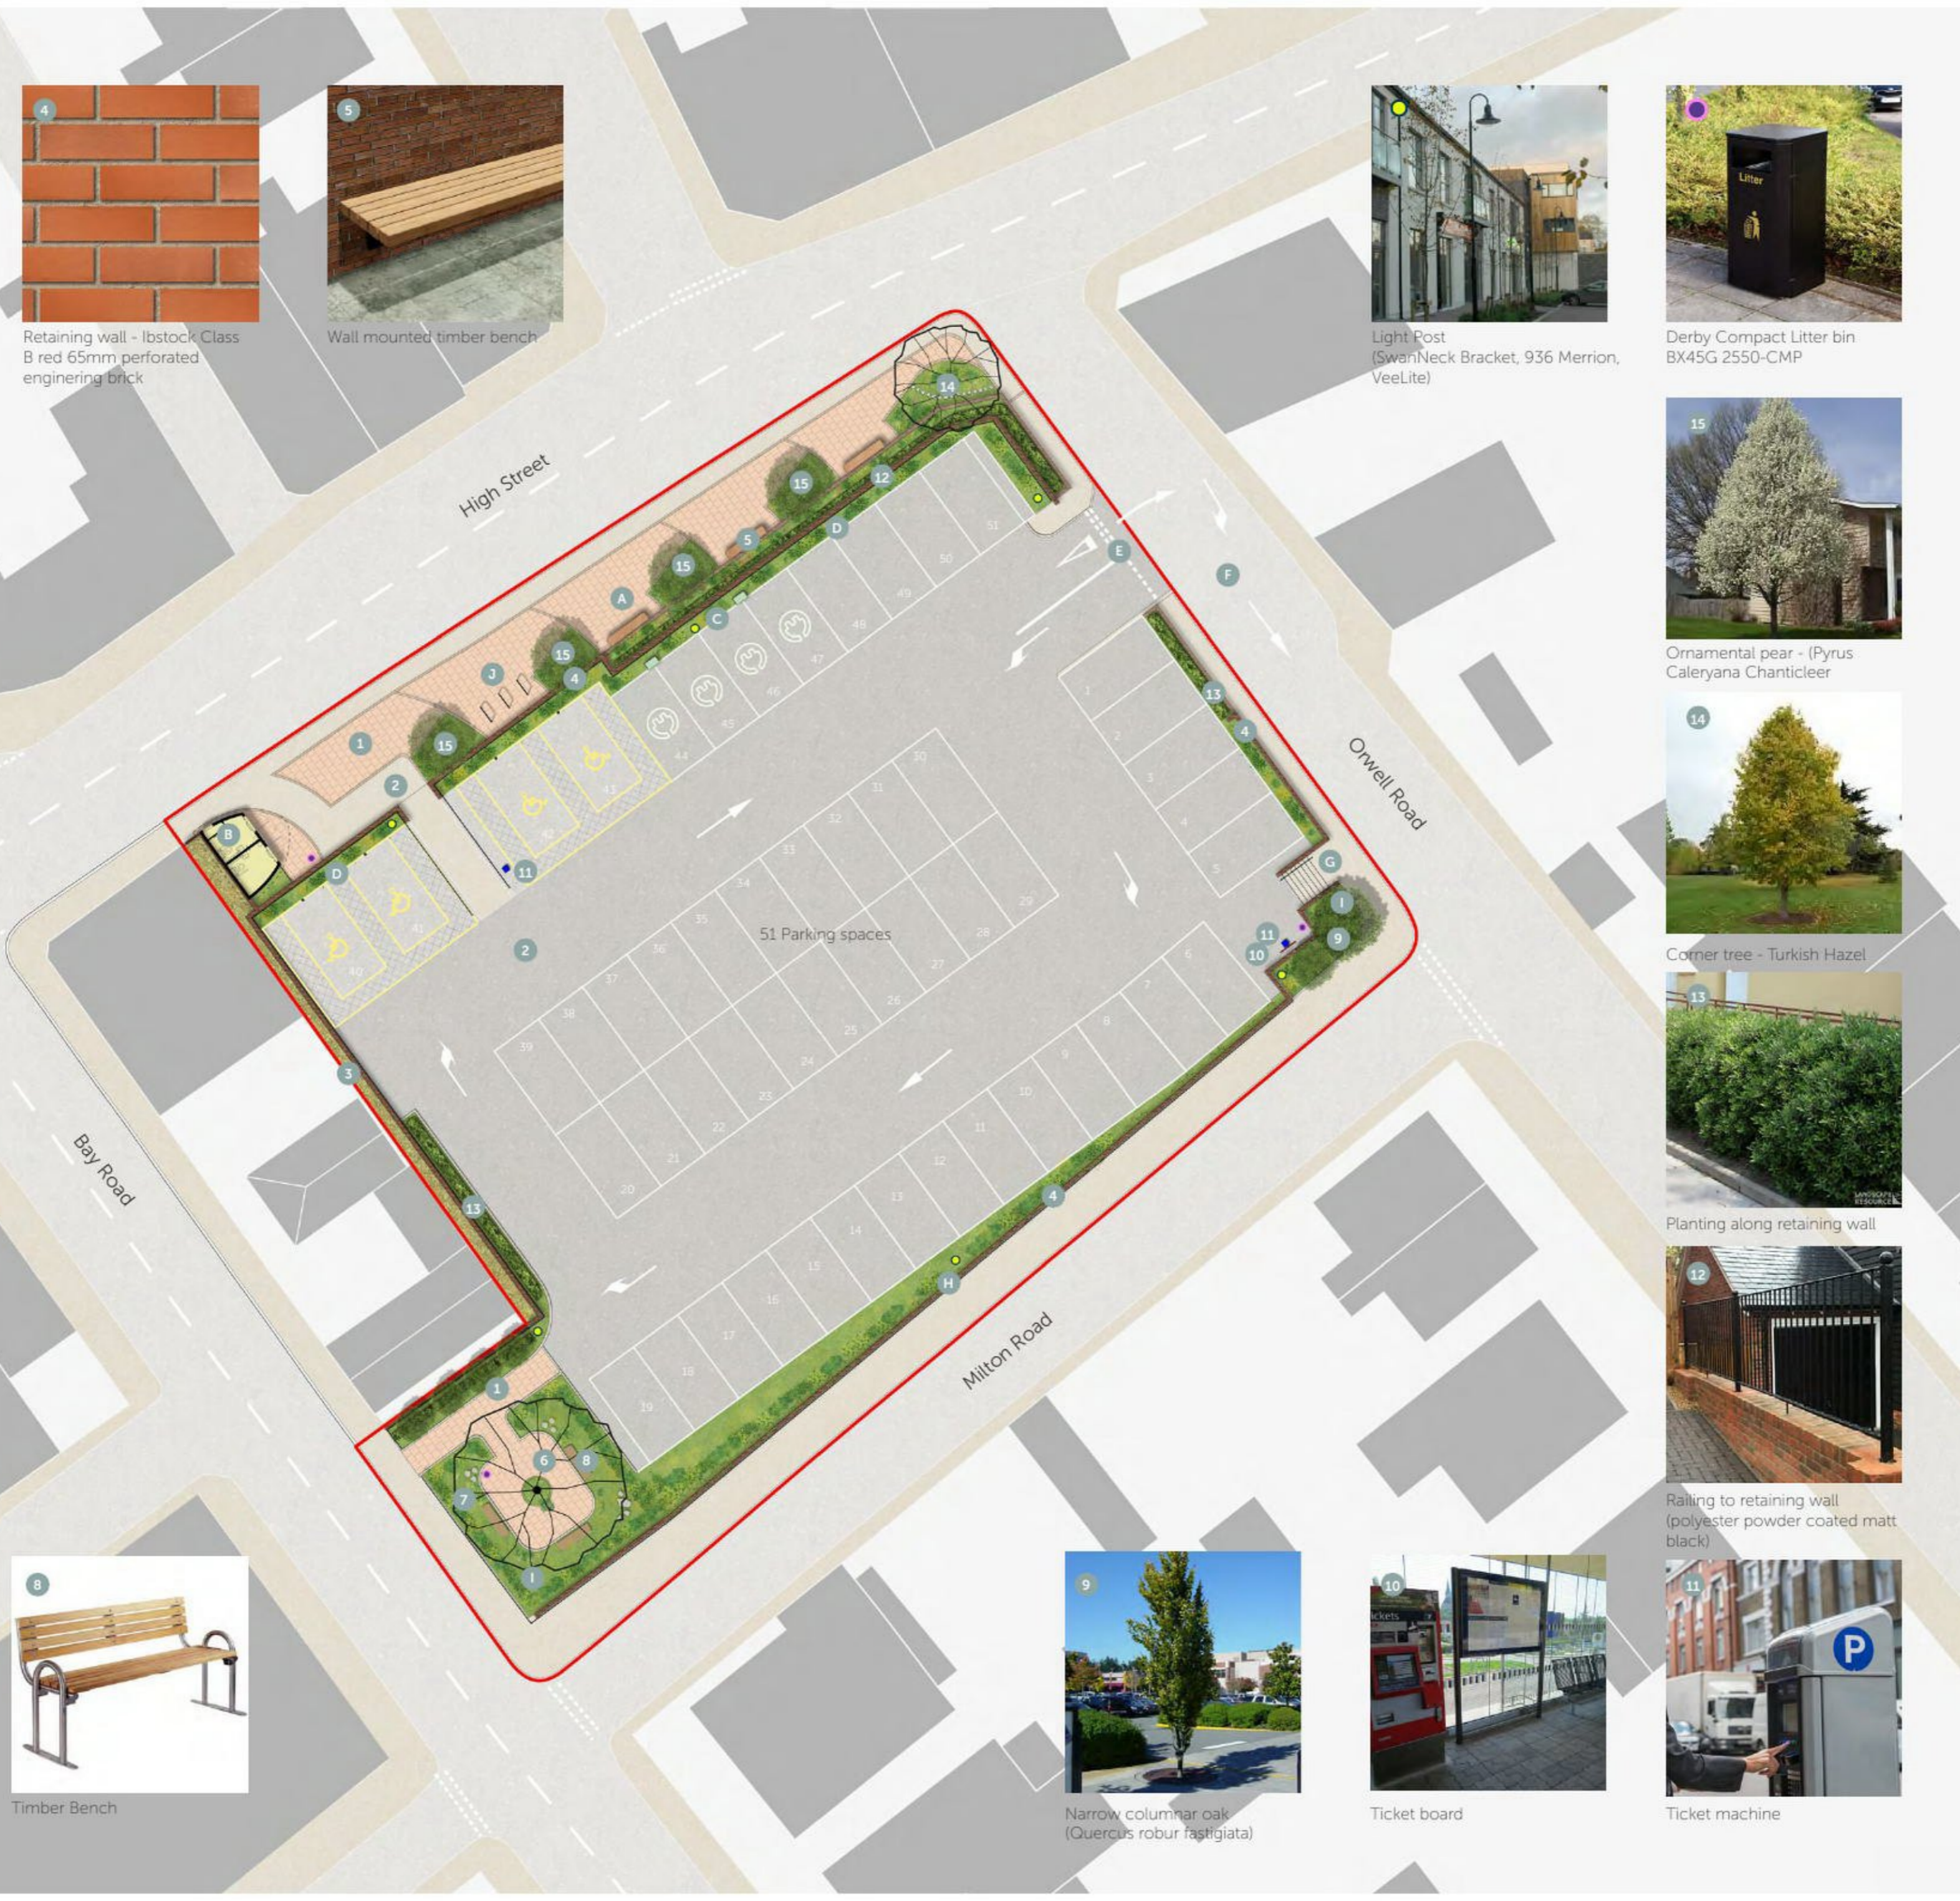
Drawing No.	Revision
60275/C/06	-

* FURTHER DETAILS OF THE LEVEL STRATEGY CAN BE FOUND IN RICHARD JACKSONS ENGINEERING ASSESSMENT REPORT.
- THE CUT AND FILL HAS BEEN BASED UPON A REDUCED FORMATION LEVEL OF THE CAR PARKING AREA, 500mm REDUCED FROM PROPOSED FINISHED LEVEL TO ACCOMMODATE CONSTRUCTION BUILD UP. THICK THICKNESS SHOULD BE QUALIFIED THROUGH THE DETAILED DESIGN PROCESS.

- IT SHOULD BE NOTED THAT THE EXISTING LEVELS ARE BASED UPON WHAT WAS RECORDED ON SITE AND DO NOT ALLOW FOR THE CLEARANCE OF DEBRIS OR PILED MATERIAL WHICH MAY NEED TO BE DISPOSED OF PRIOR TO THE WORKS. FOR COMPLETENESS AND A MORE ACCURATE REPRESENTATION OF THE CUT AND FILL A FURTHER ASSESSMENT SHOULD BE UNDERTAKEN FOLLOWING SITE CLEARANCE.
