## **BAT SURVEY REPORT**

Field House Farm  
Main Road  
Asselby  
East Riding of Yorkshire  
DN14 7HE

Reference no: CE0997

Curtis Ecology

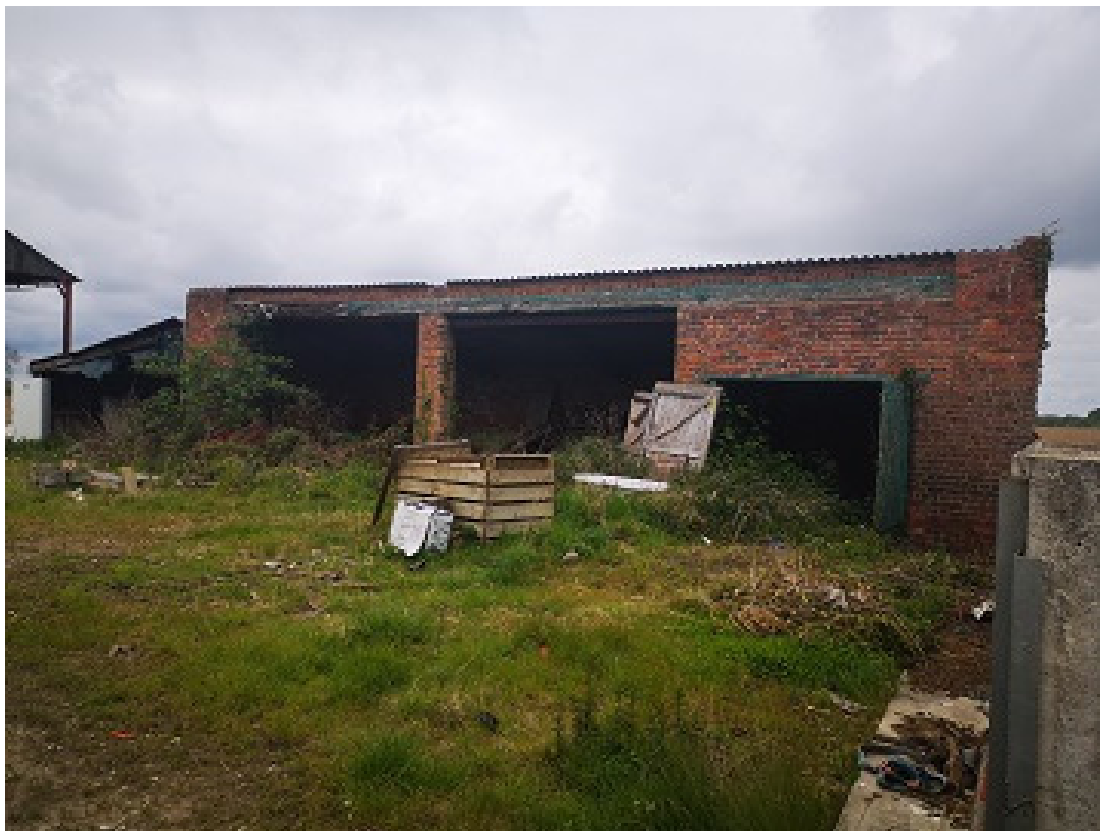
Plate1. Looking towards the eastern elevation of Building 1.

Building 1 is a single storey mono-pitched building with open arches to the east elevation, constructed from solid brick with a corrugated asbestos sheet roof covering. The solid brick walls were in reasonable condition, no deep holes were noted within the brickwork apart from several places along the eastern elevation between the timber lintels and surrounding brickwork over the open arches wall. The roof structure is comprised of timber beams spanned between the brick pillars and the western brick wall, with timber purlins and timber boarding above, to which the corrugated Asbestos sheets are attached. The roof was in reasonable condition with a small area of damaged roofing sheet noted in the centre above the eastern eave. The corrugations along both elevations are sealed with mortar, which was in good condition, the internal walls were mostly in reasonable condition, however cracks between the bricks were noted in the north east corner. On the southern gable is a small timber framed mono pitched outbuilding which was covered with corrugated tin sheeting along the walls and the roof. There was no roofing felt or boarding out of this roof or external walls. There was no historical evidence of bat habitation.

- Gaps above timber lintels on the east elevation
- Cracks between bricks internally

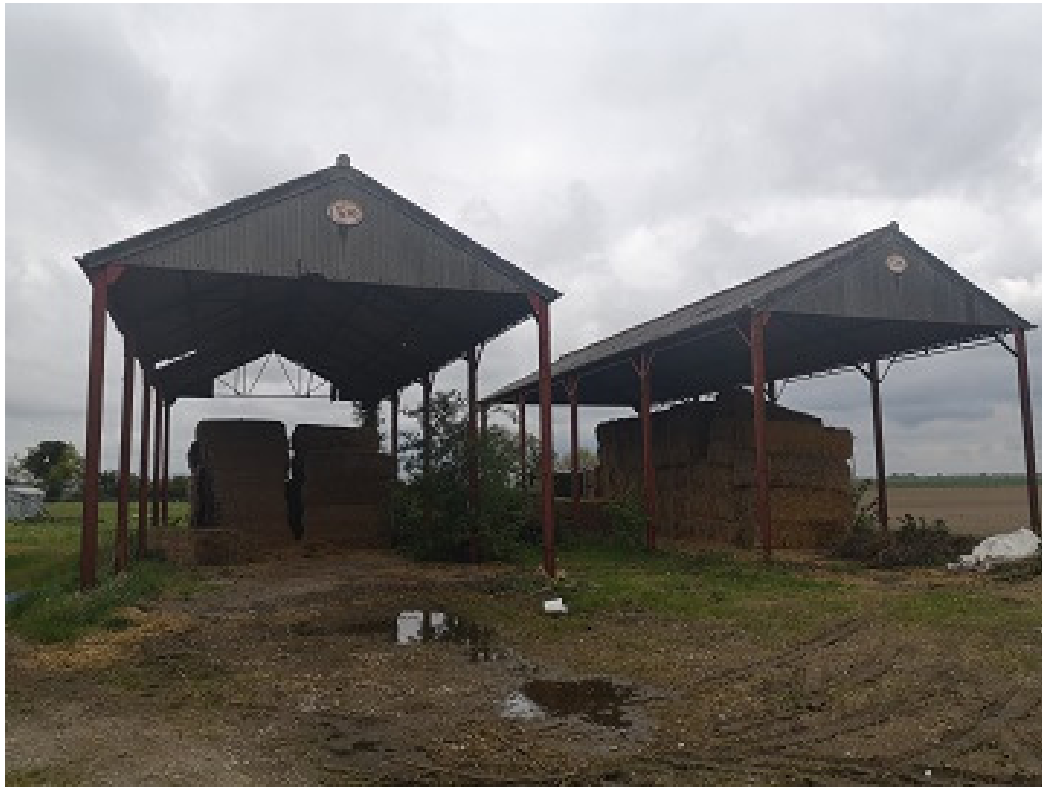
Plate 3. Looking toward the north gables of Buildings 2 & 3.

Two General purpose straw sheds are located in the south west corner of the site. The buildings are constructed with RSJ stations to which are fixed the angle iron box roof trusses, above which are angle iron purlins to which the Big 6 fibre cement roofing sheets are fixed. The gables are covered down to eaves level with standard corrugated fibre cement sheeting on both elevations. There are several damaged roof sheets present on both buildings as well as some damage to the gable end sheets. From the observations made both these buildings have been assessed at this stage as having Negligible potential for bat habitation.

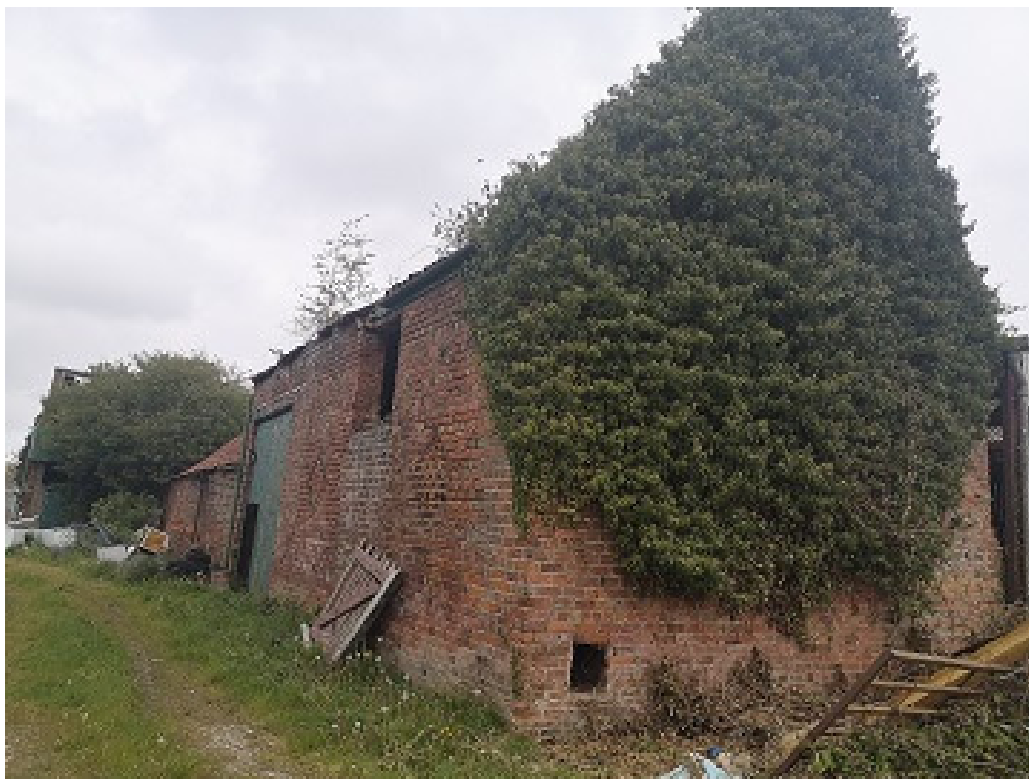
Plate 5. Looking north along the western elevation and south gable of Building 4

Building 4 is a two-storey barn constructed with solid brick walls and a pan tiled roof covering. The walls have superficial decay of both the bricks and mortar lines on all elevations, although the majority of the south gable is covered in Common ivy *Hedera helix*. Cylindrical clay ventilation pipes were noted on the lower level of the east and west elevations and at eaves level on the north gable. There are several deep holes within the mortar lines especially noted on the west elevation just below eaves level and above the timber doors. The timber doors are in poor condition with gaps being present between the door frames and surrounding brickwork. Internally the walls are in reasonable condition with only occasional deep holes noted within the brickwork and around a proportion of the roof trusses where they are let into the wall. The lower part of the north gable is open which facilitates internal entry into the adjoining Building 5. The roof structure consists of timber King post roof trusses, with timber purlins, rafters, and a central ridge board, however there is no roofing felt or under drawing present throughout this building. There are numerous lifted, slipped and missing pantiles and holes are present within the bedding mortar of the ridge line.

- Holes in mortar lines above timber lintels and surrounding doors
- Holes in mortar lines at eaves level externally.
- Numerous lifted/slipped/missing pantiles
- Holes in bedding mortar under ridge tiles.

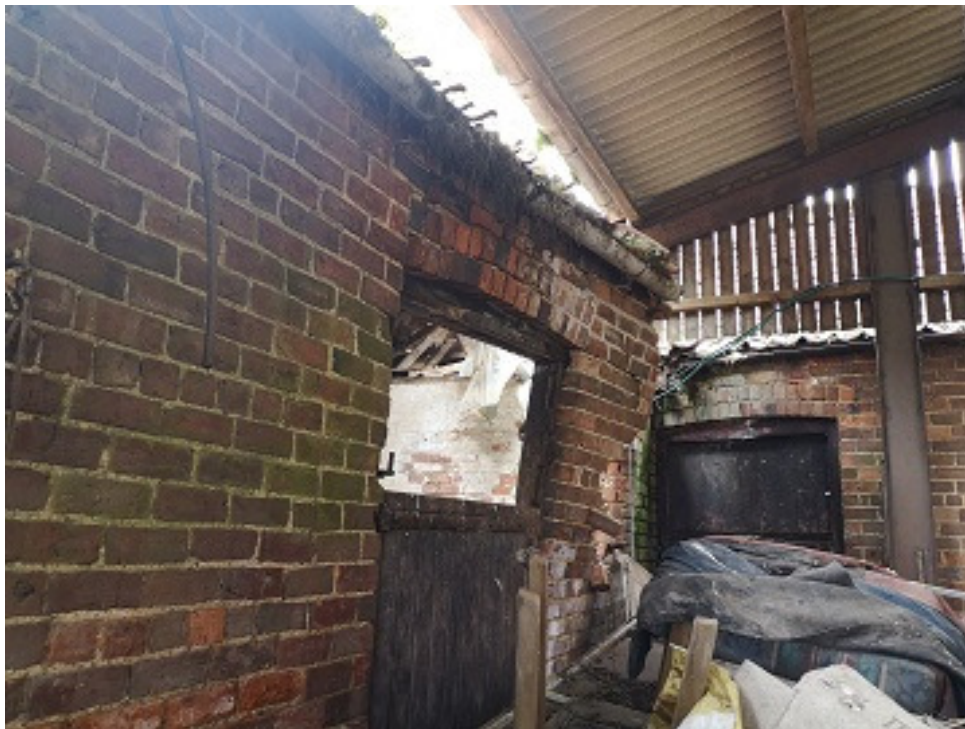
Plate 7. The eastern elevation of Building 5 viewed from within Building 8, with collapsing wall.

A single storey solid brick barn with a red pantile roof covering. The brick walls have several age related holes/cracks to all elevations, the wall to the north west corner has cracked and started to collapse meaning access could not be gained into the stables. The timber stable type doors and timber window frames found in the eastern elevation are generally in a moderate condition. There are gaps however between the door and window frames and the surrounding brickwork.

The roof is supported upon A framed roof trusses with timber purlins, rafters and a central ridge board, with no roofing felt being present throughout this building. There are numerous missing pantiles, mainly on the eastern roof aspect and towards the northern end of the roof, along with lifted and slipped tiles on both roof aspects. There are also holes within the bedding mortar along the ridge line.

- Gaps between timber frames and surrounding brickwork
- Unable to gain access due to wall collapse.
- Holes/cracks in mortar lines.

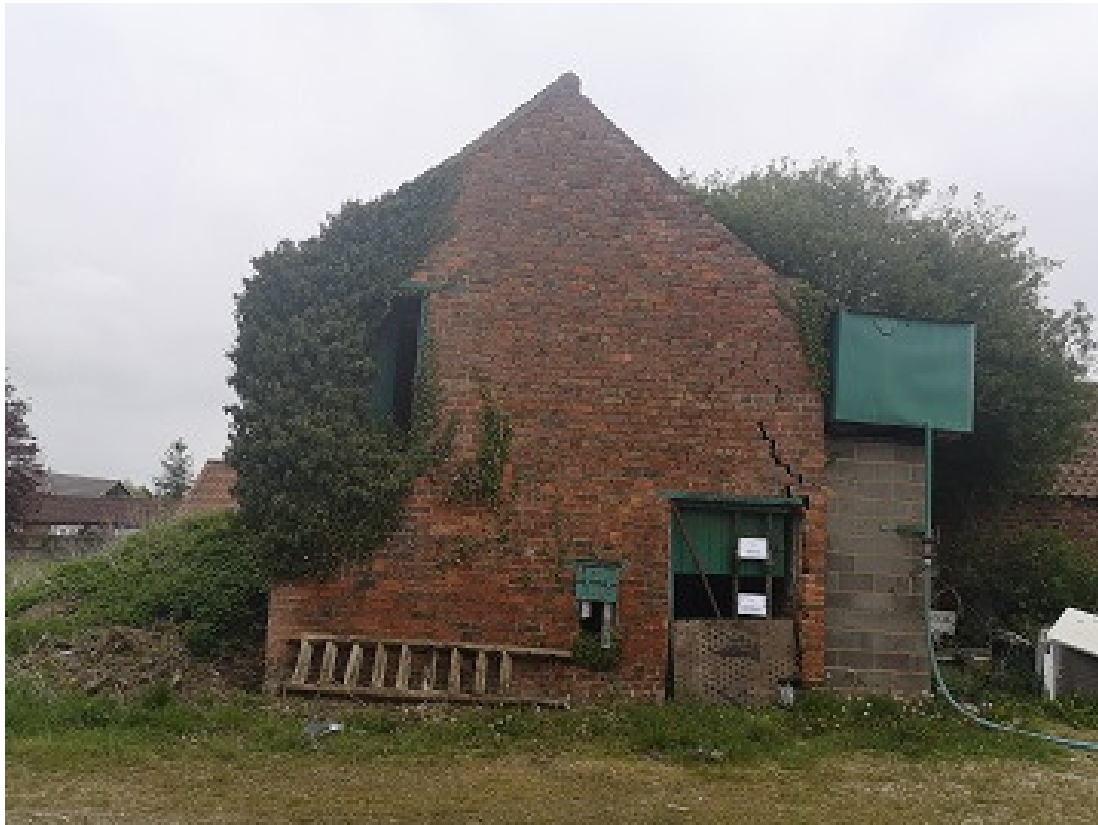
Plate 8. Looking towards the western gable of Building 6.

There are numerous lifted, slipped and missing pantiles, especially at the most eastern and western ends where the northern side of the roof has partially collapsed in. There were holes noted within the bedding mortar along both ridge lines and the verge on the western gable has large areas of missing mortar.

- Gaps/cracks in external walls on all elevations
- Missing mortar along both sides of the ridge
- Unable to gain access internally

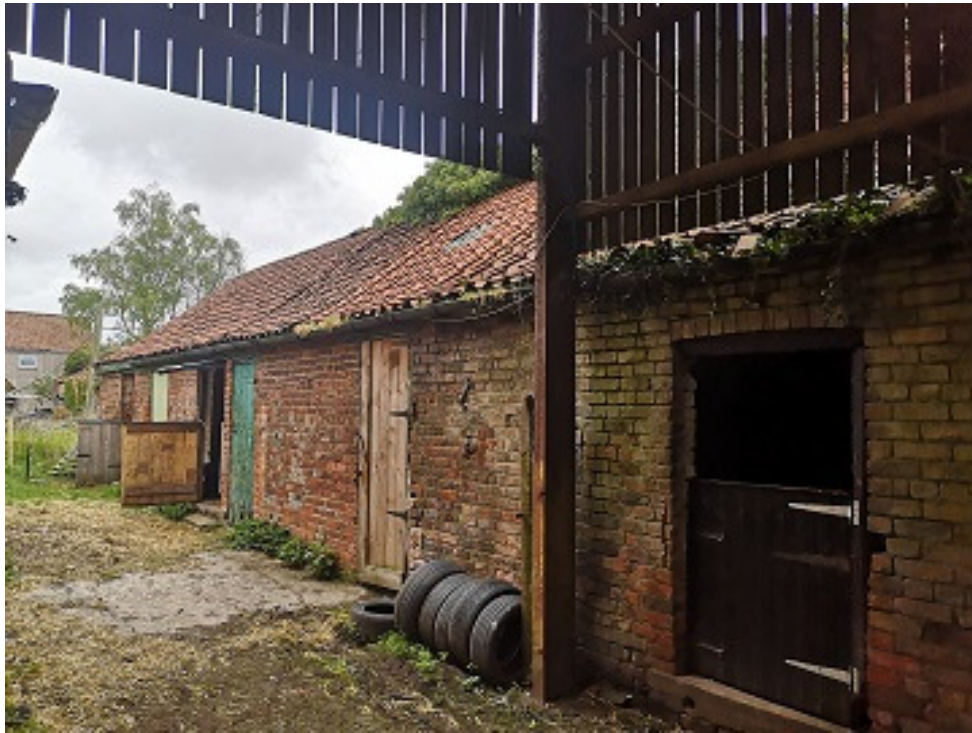
Plate 10. Looking north from the open doorway in Building 8 along the west elevation of Building 7

Building 7 is a single storey former stables and tack room constructed from solid brick with a pantile roof covering. Externally the brick walls were in moderate condition with only slight superficial decay noted. There were six timber framed doors to the west elevation with gaps of varying sizes noted between the frames and the surrounding brick walls. Timber fascia boards on both the west and east elevation had gaps behind where the timber had bowed over time. Internally the walls had been painted white, there were varying degrees of age related decay, resulting in some cracks/holes within the mortar lines.

- Lifted/Slipped pantiles
- Gaps between timber frames and behind fascia boards

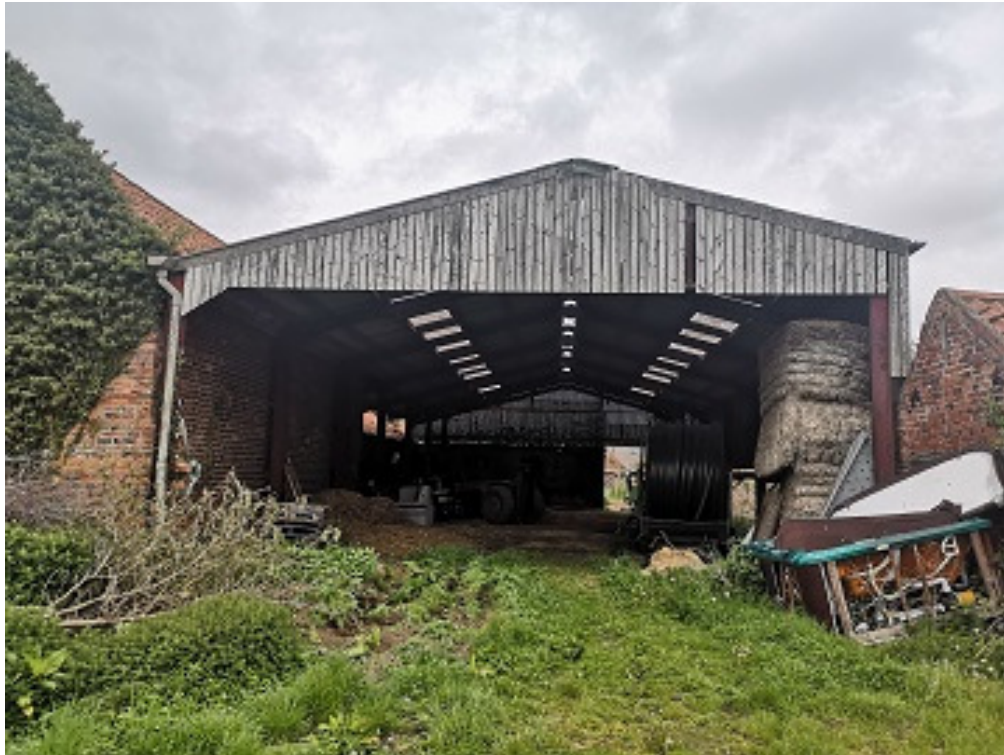
Plate 13. The south gable of Building 8, with Building 10 seen to the right of the photograph and part of Building 4 to the left.

A general purpose building which covers the former central fold yard area. Constructed with a steel portal frame with the roof being covered with Big 6 corrugated sheeting. The ridge line is open and a series of evenly spaced Perspex roof lights are found along both roof aspects. The southern gable down to eaves level is covered with Yorkshire boarding below which this gable is open. The north gable and eastern elevation are both covered with Yorkshire boarding down to the eaves height of the adjacent traditional buildings. There are occasional gaps between the Yorkshire boarding and preformed barge boards on both gables. The interior is again light and draughty with no historical evidence of bat habitation. Due to the gaps noted between the Yorkshire boarding and barge boards on the gables this building has been assessed as having Low potential for bat habitation.

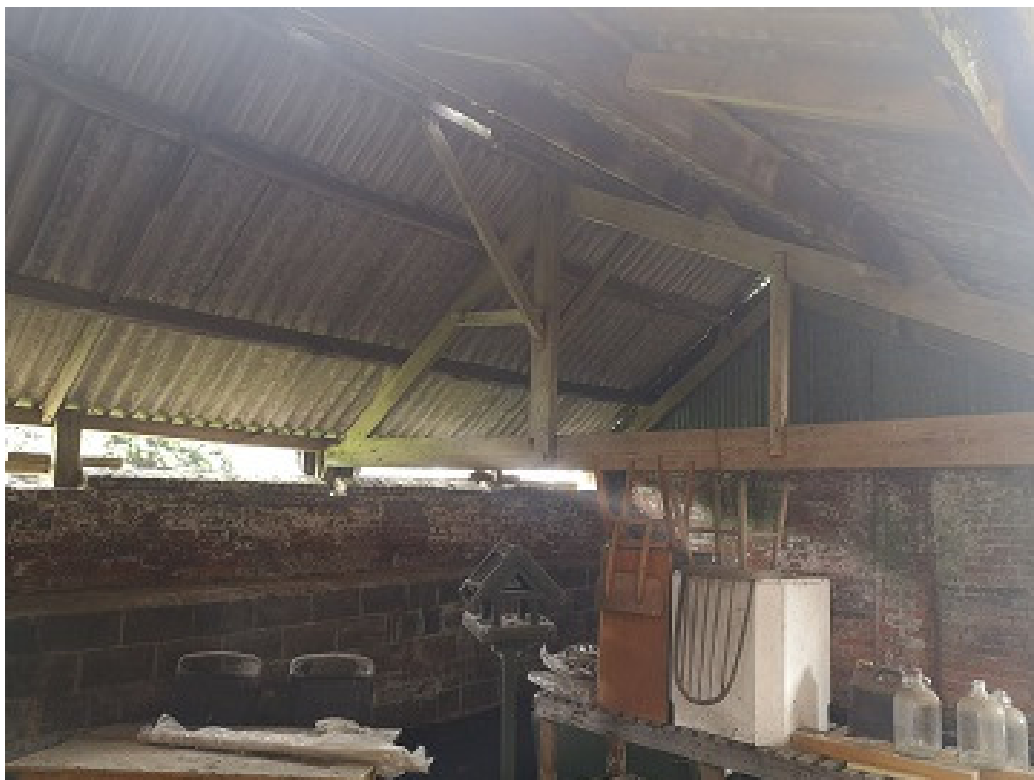
Plate 15. Looking east into Building 9 from the interior of Building 8.

A single storey outbuilding with an open front into Building 8. The walls are predominantly solid brick, with the eastern elevation having a 225mm block wall up to around 1.5m which extends up a further 60 cm with solid brick, above which with elevation is open up to the eaves of the roof. All of the walls have superficial decay of the brickwork with no deep holes noted. The roof is formed by A framed roof trusses and timber purlins to which the roof covering of corrugated asbestos sheeting is affixed to. The western elevation is open into Building 8 and the roof on this side of the building is supported upon timber beams which in turn are fixed to the stantions of Building 8. The interior was light and draughty and there was no historical evidence of bat habitation. As a result of the observations made at this stage building 9 has been assessed as having Negligible potential for bat habitation.

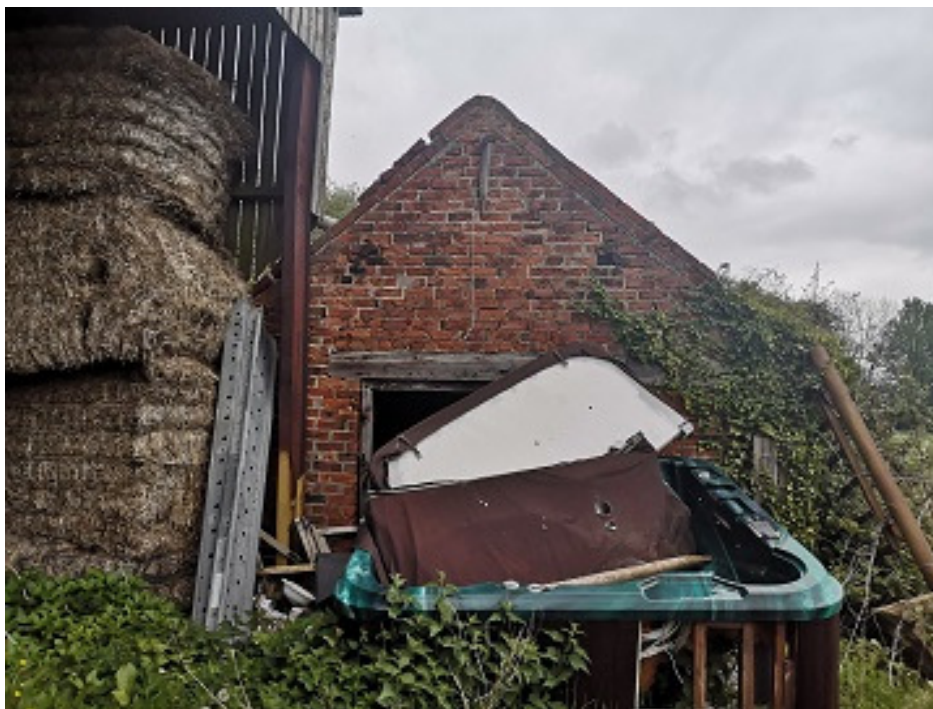
Plate 16. The west gable of Building 10.

The east gable and a large proportion of the south elevation and roof were covered by Common ivy. Holes were noted on the west elevation between bricks due to age related decay of the mortar lines. A timber framed doorway at the west elevation was noted to have gaps of varying degrees between the timber frame and surrounding brickwork.

- Holes in brickwork an mortar lines
- Access could not be gained internally

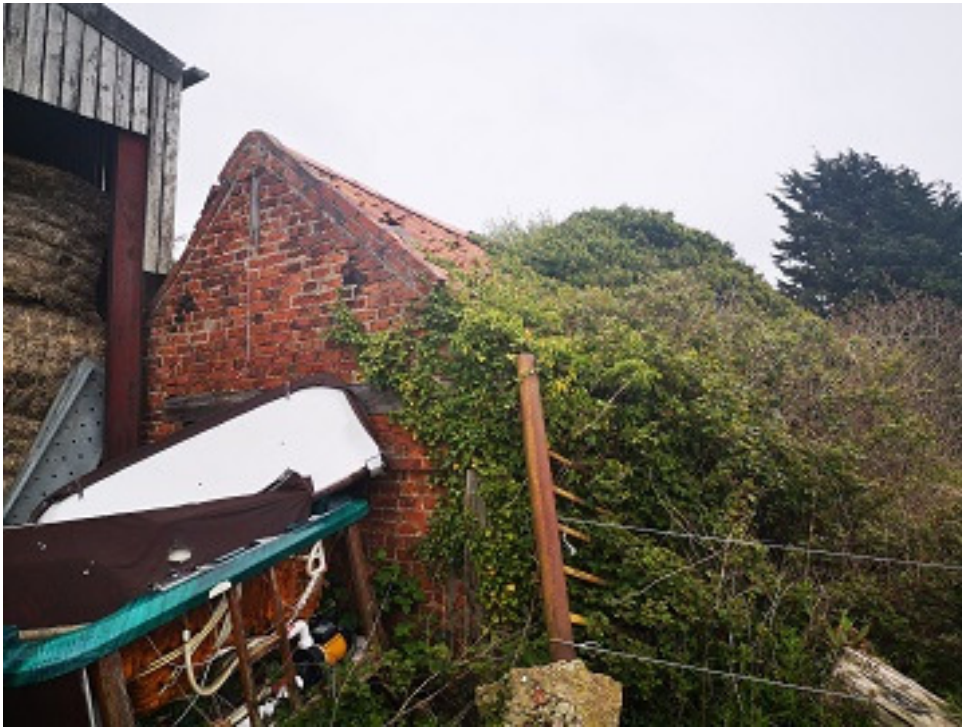
Plate 17. Common Ivy covering the east & south elevations as well as the majority of the roof.

The roof covering of red pantiles was in a poor condition with numerous missing tiles on both roof aspects.

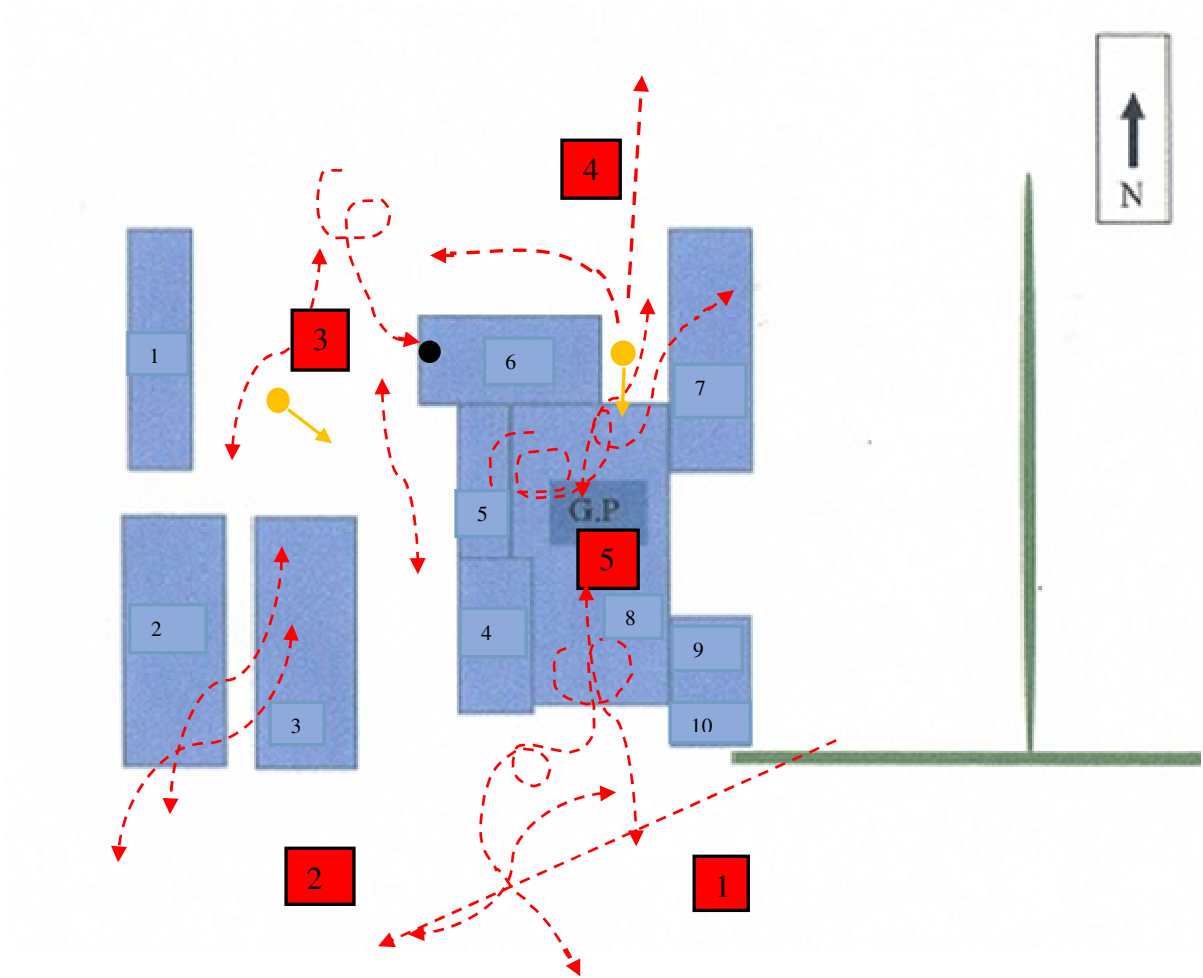
Dawn bat activity plan 10<sup>th</sup> July 2021

3	04.23 – 04.27	1 Common pipistrelle foraged along west gable of B6, before entering a day roost in a crack above the door @ 04.27hrs
	05.10	Survey End

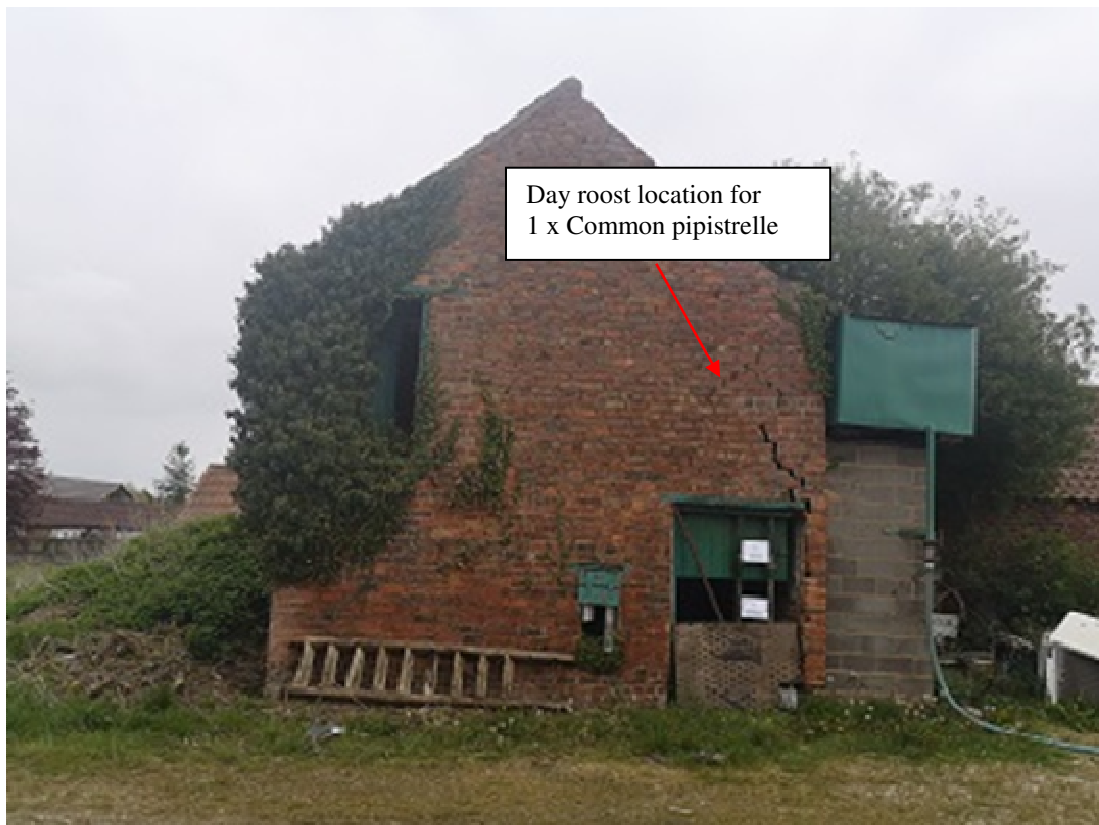
Plate 18. Shows location of day roost in west gable of Building 6

During the dawn/re-entry survey of the 10<sup>th</sup> July 2021 one Common pipistrelle *Pipistrellus pipistrellus* was seen to re-enter a day roost in a crack above the door in the western gable of Building 6 at 04:27 hrs.

On the dusk/emergence survey on the 26<sup>th</sup> July 2021, one Common Pipistrelle *pipistrellus pipistrellus* was seen to emerge from a day roost in a crack above the door in the western gable of Building 6 at 22.25 hrs before re- entering at 22.31 hrs. At 22:40 hrs the Common pipistrelle *Pipistrellus pipistrellus* re-emerged from the same roost location.

Without suitable mitigation the conversion/demolition of Building 6 would result in both the short and long term destruction of one identified day roost for one Common pipistrelle *Pipistrellus pipistrellus*.

- 7.1.4. The identified day roost located in the west gable of Building 6 will require sealing prior to the conversion/demolition work being undertaken. Therefore at this juncture it is proposed that a one way excluder device is fitted over the existing exit points and left in place for a minimum of five consecutive nights in suitable weather condition for bat activity and not during the hibernation period generally considered to be between November to March.

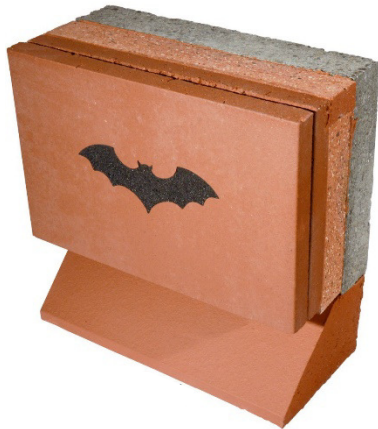
### Ibstock Bat Box 'C'

The Enclosed Bat Box 'C' from Ibstock is designed for the pipistrelle bat. It is ideal for new builds as it can be integrated directly into the brickwork to produce a discrete but attractive home for bats.

The inside of the box is designed to create several roosting zones which are ideal for crevice dwelling bats such as the pipistrelle. The bottom entrance means that no maintenance is required as droppings will simply fall out the bottom.
