# HERITAGE IMPACT ASSESSMENT

17 Hollyhock Cottage, Down Ampney

Assessment of the internal principal features which contribute to the grade II listing of no.17 Hollyhock Cottage, Down Ampney.

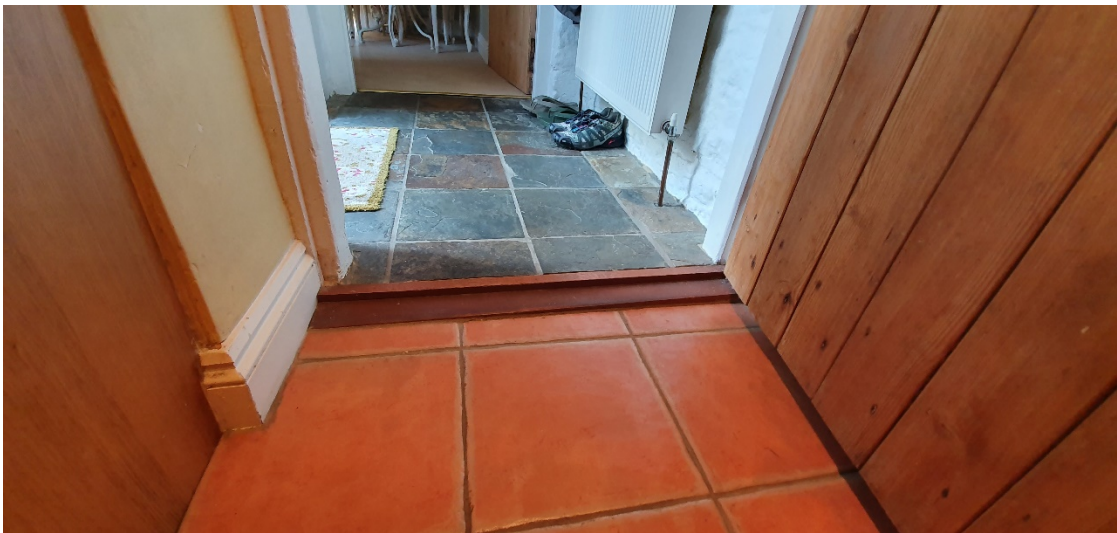
- 3.1. The proposed development would result in the existing kitchen arrangement changing. The proposal seeks to remove the existing subfloor, lowering the kitchen to the infill / foundation layer. This would change the finished floor level (FFL) from 85.42m to 84.99m, which would require 430mm of existing floor to be removed to meet the proposed floor level.
- 3.2. The existing kitchen floor is covered with tiling up to the kitchen units, with the remaining floor being left exposed allowing access to the subfloor. The existing kitchen floor is shown in Photograph 1 below:

*Photograph 1: Kitchen Floor Materials*

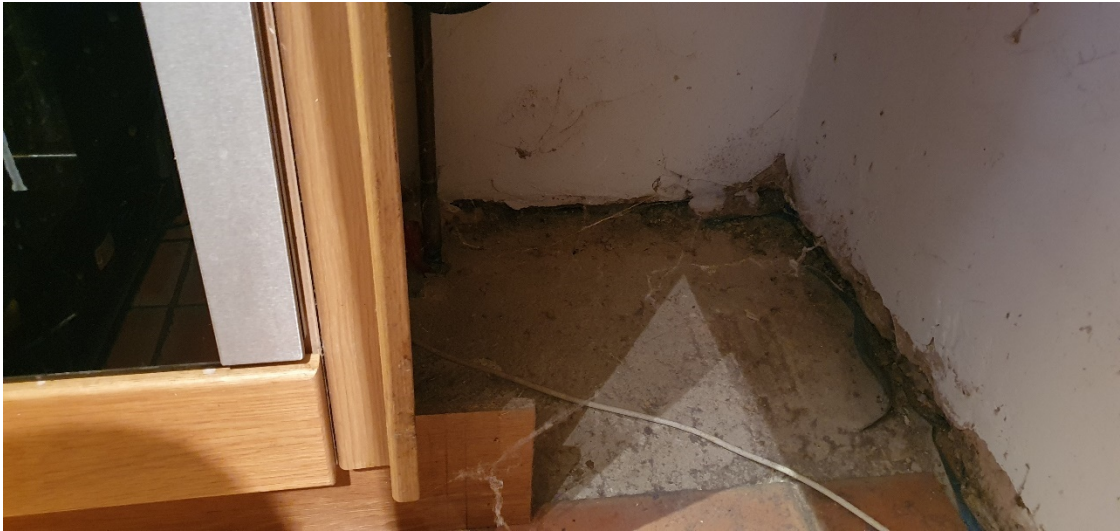
- 3.3. The DAS notes that the kitchen section of the property was subject to a renovation which included replacing the roof structure in 1985. As part of these renovation works the original kitchen floor was removed and replaced with a concrete sub-floor with modern style tiling to the finished floor. The subfloor can be seen in Photograph 2 below:

*Photograph 2: Concrete Subfloor Exposed under Kitchen Units*

- 3.4. The concrete subfloor was laid in 1985 and reflects modern practices. It is considered the removal of the section of the floor would not impact upon the heritage significance of the Grade II listing. Furthermore, due to the time when the floor was laid it is highly unlikely any archaeological interest is contained within the subfloor which would warrant the need to maintain the floor in its current condition.

- 5.1. The HIA has assessed the identified internal principal features within the listed building which would be impacted by the proposed development. In regards to the kitchen floor, the tiles are of modern construction and have no significance to the listing. The subfloor is of a concrete construction and was installed during the 1985 renovation to the property. Consequently, it is also considered the subfloor has no significance to the listing of the property.

- 5.2. The proposed development would result in lowering the kitchen floor by 430mm, removing all the concrete subfloor. This would result in the foundations or infill layer being exposed with a shallower subfloor and floor coverings placed over the foundation / infill layer. It is difficult to determine the significance of the lower levels of floor construction without disruptive exploratory works. However, the proposal does not include changes to these floor levels. Therefore, it is recommended during the construction of this phase of the proposal a qualified professional is on-site to oversee the works to identify any potential heritage significance which would require further consideration upon removing the subfloor.

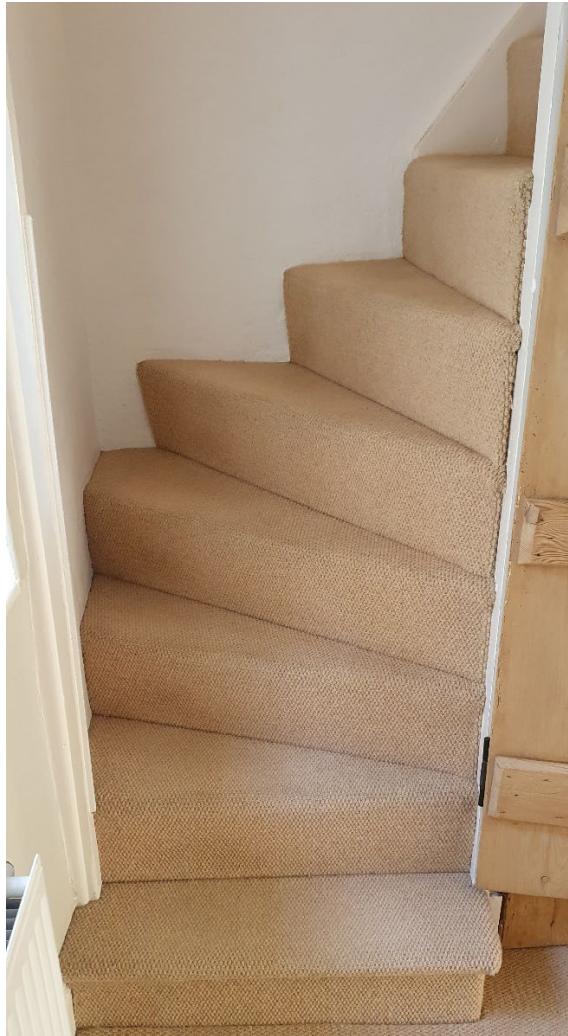
- 4.3. The staircase in no.17 Hollyhock Cottage is a winder style stair of timber construction. A winder staircase is where a section of the steps is narrowed at one end for turning a corner, Photograph 3 shows the staircase found in no.17 Hollyhock Cottage with the winder steps centred around the newel post which forms part of the doorframe entrance to the staircase.

*Photograph 3: Winder Staircase at no.17 Hollyhock Cottage*

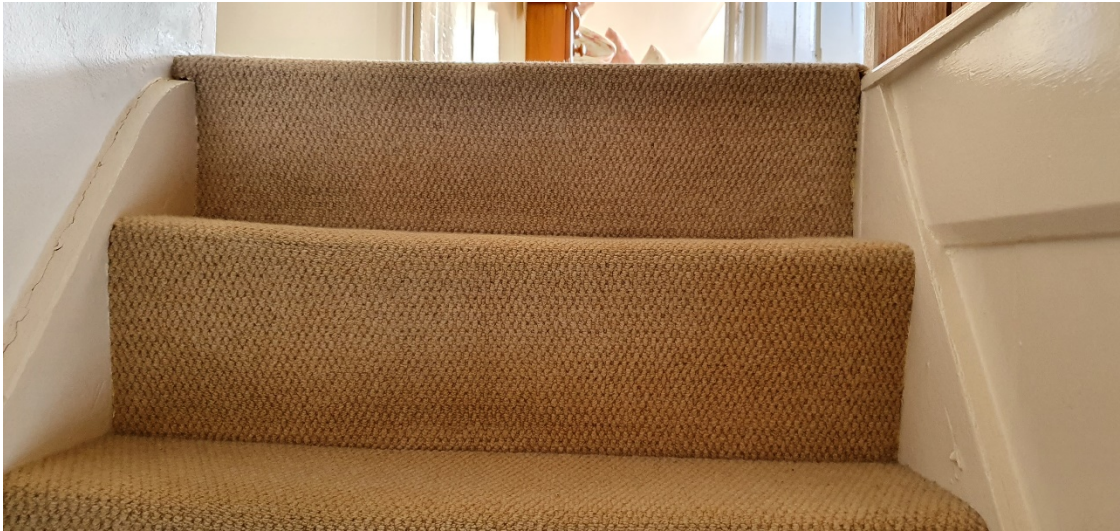
- 4.4. The staircase is designed as a close string stair with the sloping pieces which support the ends of the steps which are known as strings containing grooves to accommodate each step enclosing the ends of the step. Photograph 4 & 5 shows the strings from above and below. This type of design in staircases is not restricted to the time period and the components required to construct this type of stair are still used in modern stair construction.

*Photograph 4: Stair Strings Visible above the Stairs (to match skirting height)*

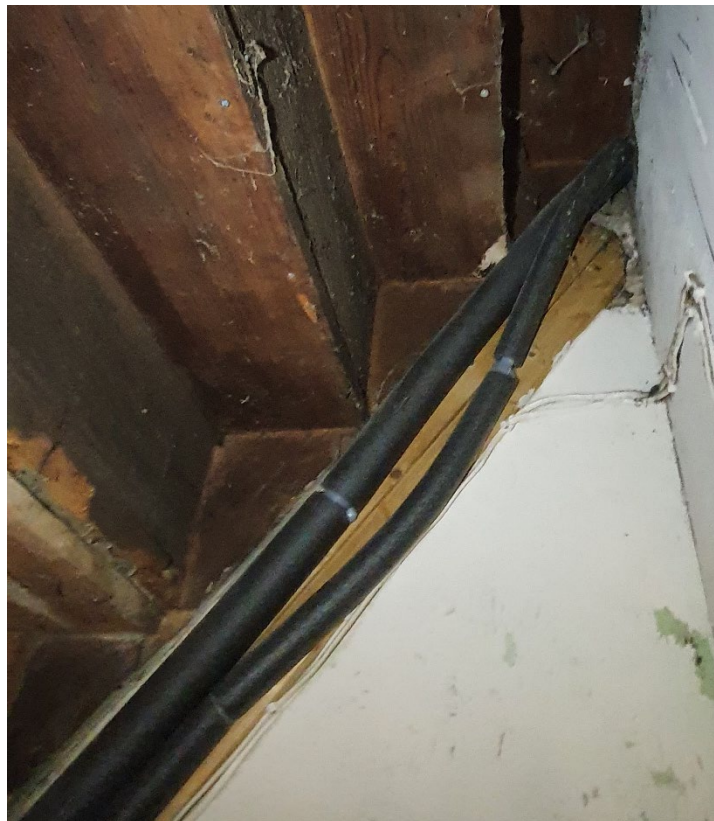
*Photograph 5: Stair String Below Stairs*

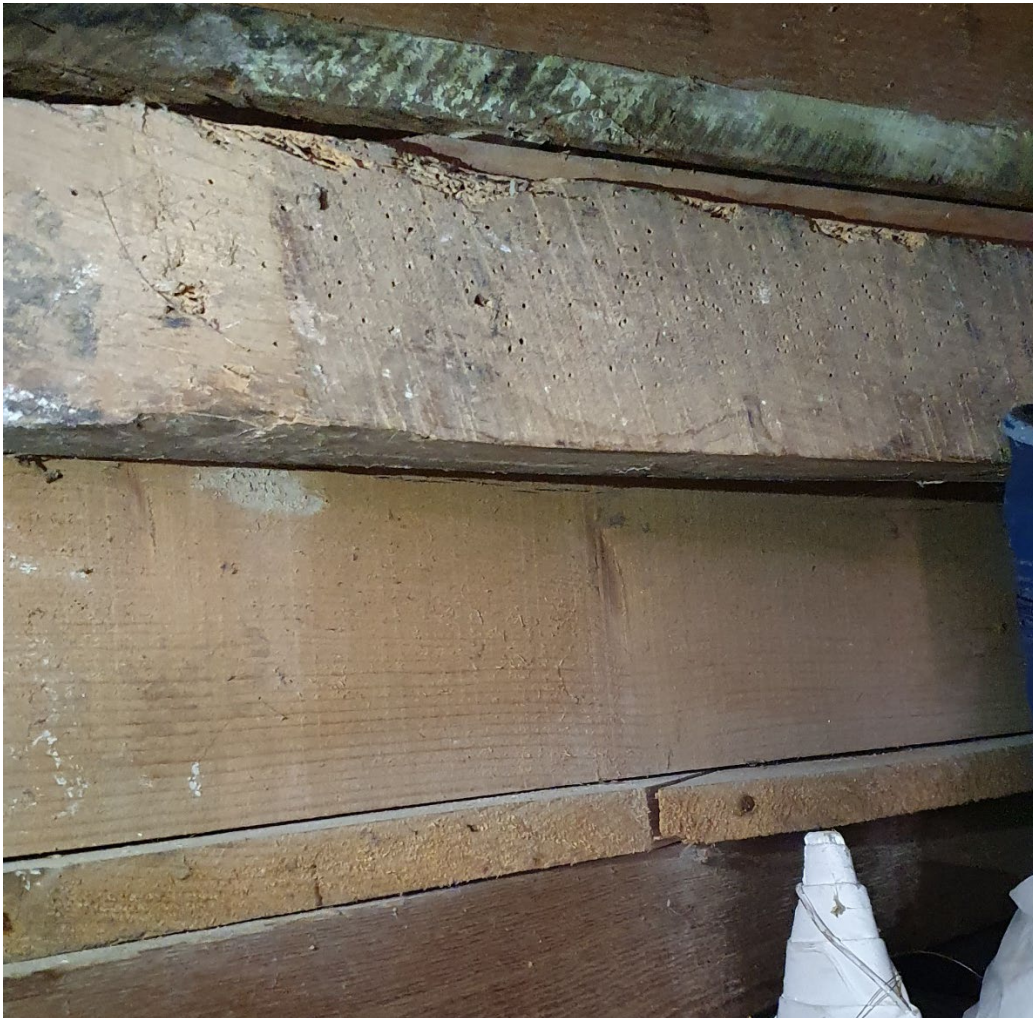
- 4.5. However, the staircase does have additional support from timbers placed below the flyers called rough strings and the winder steps are supported by rough pieces called bearers as shown in Photograph 6. The bearers of the winder steps are joined to the newel post which forms the entrance way to the staircase, the upper string of stairs is also supported by this newel post (Photograph 7 refers).

*Photograph 6: Bearers Supporting the Winder Steps*

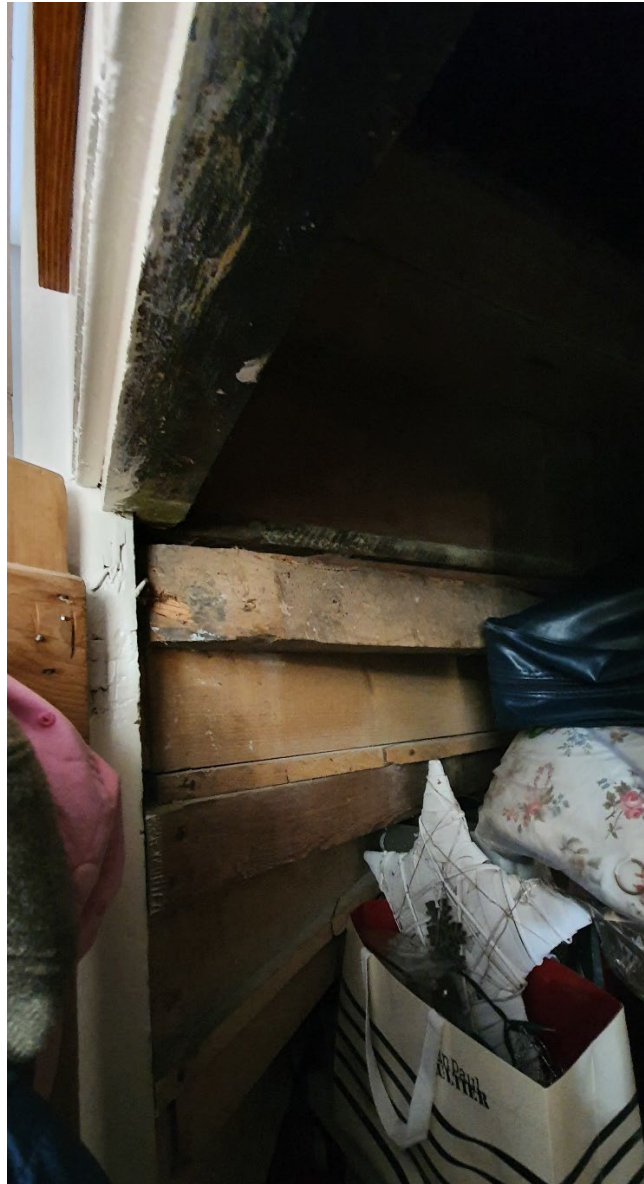
*Photograph 7: Bearers and String attached to Newel Post (which forms the doorframe to the entrance to the staircase)*

- 4.6. The newel post forming part of the doorway entrance to the staircase is unusual, but the use of doors to stairs is not representative of the Georgian period. Therefore, it is considered this design feature does not contribute to the archaeological or historic interest of the Grade II listing. However, it is considered the design of the staircase would have some architectural interest due to the conscious design implemented by the original tradesman that constructed the staircase.

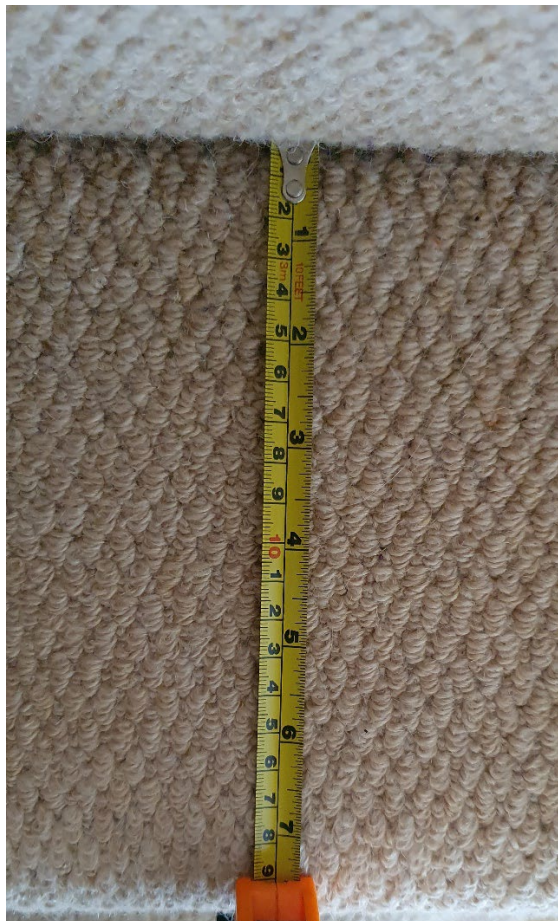
- 4.7. The staircase is steep in nature and has shallow treads to each step and high risers. The steepness of the stairway and shallow steps is due to the limited space within the main element of the property. This is a reasonably unique feature of the property which is dictated by the form of the building and would contribute to the architectural interest of the listing. Although the staircase would not comply with current building regulations, the design of the staircase is not specific to the time of its construction in the mid to late 1700s. This is evidenced by the stairway not following the typical construction practices of the time as demonstrated in Quattro Libri Book 1 (translated

in 1738, Isaac Ware) which states “The steps ought not to be made higher than six inches of a foot; and if they are made lower, particularly in long continued stairs, it will make them the more easy because the rising one’s self the foot will be less tired; but they must never be made lower than four inches ; the breadth of the steps ought not be made less than one foot, nor more than one and a half” (Palladio, Quattro Libri Bk1, 1570: trans. Isaac Ware, 1738). Additionally, the New Practical Builder publication identified specifications for common stairs stating “the breadth of common stairs is from nine to twelve inches.” (Peter Nicholson, The New Practical Builder, 1823). In the context of stair construction of this period, the term breadth refers to the depth of the stair. Photograph 8 shows the depth of the stairs being 7 ½ inches which is below the standard stair specification for the time period. The height of the riser is approximately 9 inches high which also beyond the typical height of a stair for the period. Consequently, it is considered reasonable to conclude the staircase was designed to fit the specific aperture in the building to join the different levels together. This does contribute to an element of architectural interest to the staircase due to its deviation from construction standards of the time, however, it does not contribute to the historic or archaeological interest of the building.

*Photograph 8: Depth of Stair Tread*

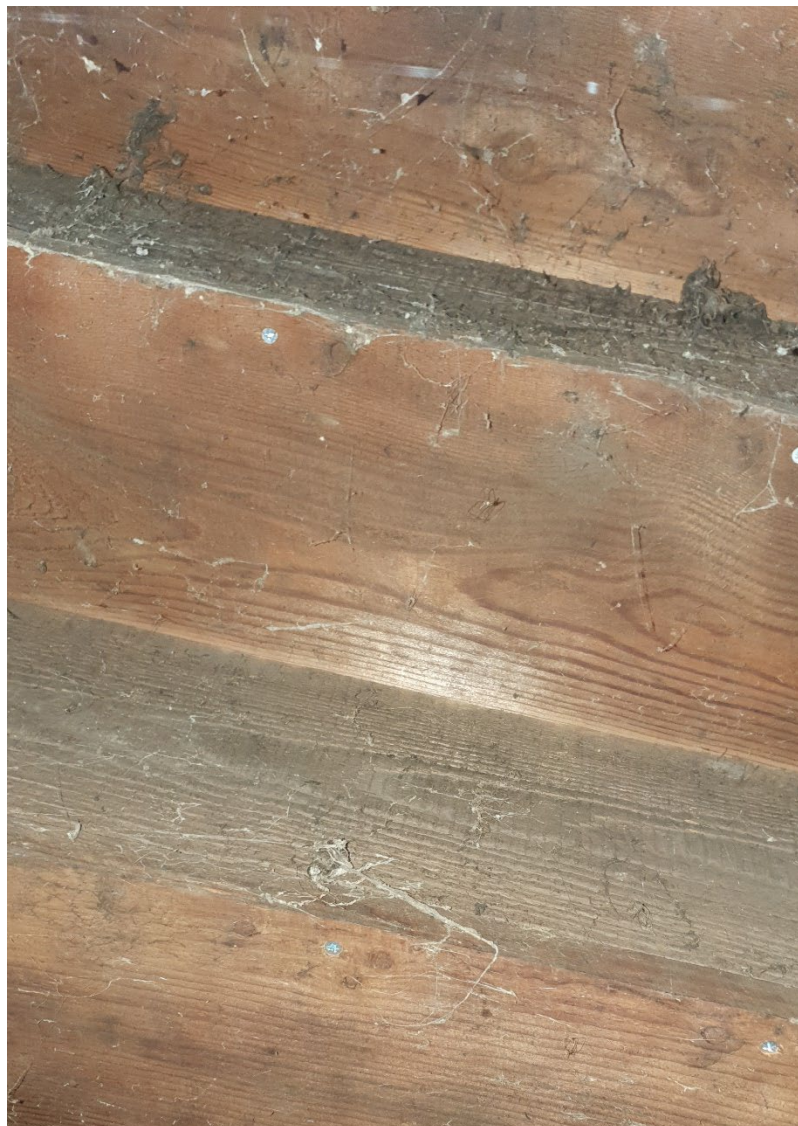
- 4.9. The modest construction of the staircase demonstrates that the property was not built for those of high social status within Georgian society and reflects the nature of the property as a typical estate cottage used to house working families attached to the wider estate. The pine construction adds some historical interest to the Grade II listing helping to demonstrate the type of person the building was constructed for, although this is evident in the wider construction of the building. Therefore, it is considered only minor weight can be given to the use of pine in the staircase in contributing to the heritage significance of the property. Photograph 9 shows an element of the original staircase. However, modern screws have been used to reinforce the structure detracting from the overall historical construction.

*Photograph 9: Original Pine Staircase (note modern fastenings reinforcing the structure)*

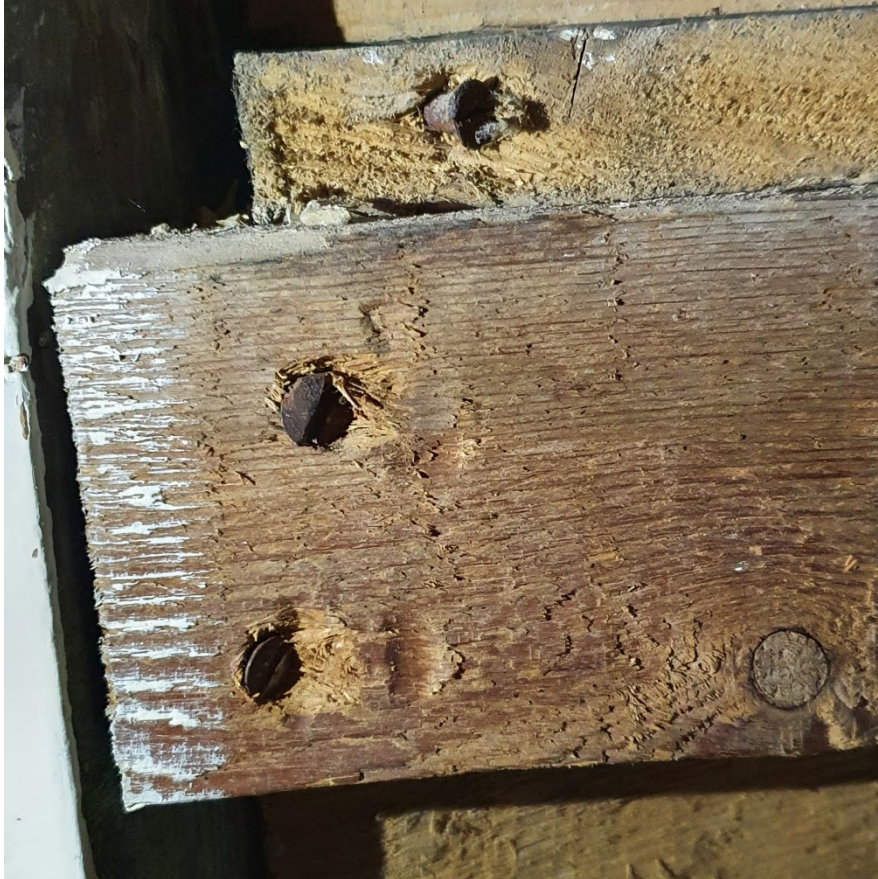
- 4.10. The stair construction also includes various fasteners ranging from round headed nails to Philips-head screws. Photograph 10 shows an example of the different style fasteners found in the stair construction within the property.

*Photograph 10: Example of Different Fasteners in the Step Bearer*

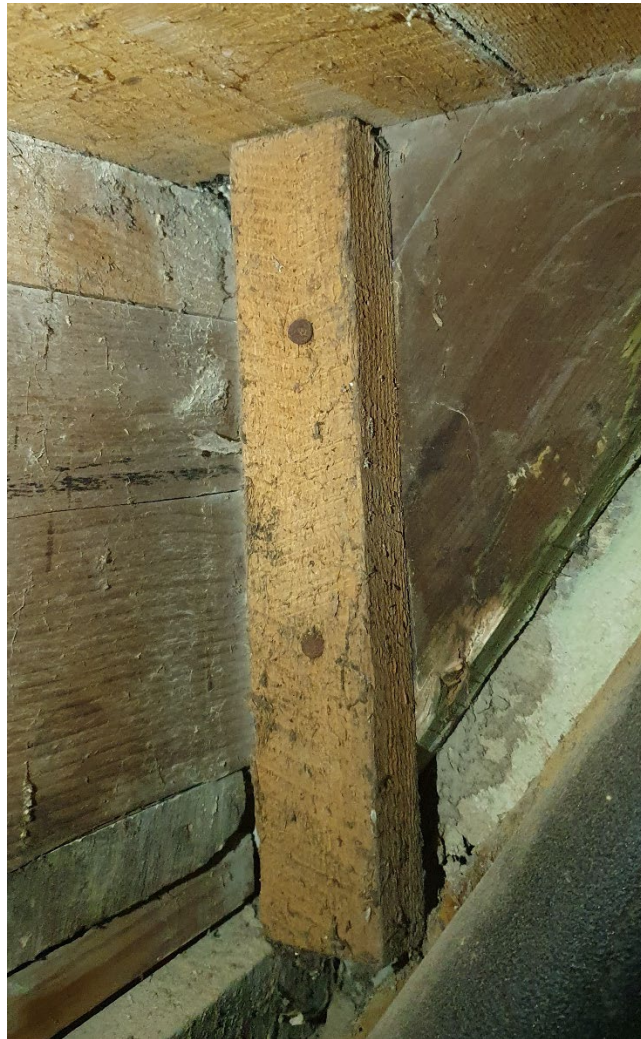
- 4.11. It is clear from the different use of fasteners that the staircase has been subject to a number of reinforcements since its original construction. Based on the type of fasteners used and the type of wood used to reinforce the stair structure these have taken place during the 1900s to early 2000s. These amendments to the original staircase structure have not been undertaken sympathetically to the original staircase construction. Photograph 11 shows an unsympathetic addition to the original staircase which has been fastened using modern fixings and using a different type of wood to the original staircase which detracts from the original construction. In terms of archaeological interest, the materials used in the construction of the staircase were common during the period and there are numerous examples of fastenings from this time period, consequently it is considered little weight can be given to the significance of the fastening materials used in the staircase contributing to the overall heritage significance of the property. Additionally, rough strings have been replaced with different types of wood which has resulted in the loss of part of the original structure (Photograph 12 refers).

*Photograph 11: Example of Unsympathetic Addition to the Staircase Construction*

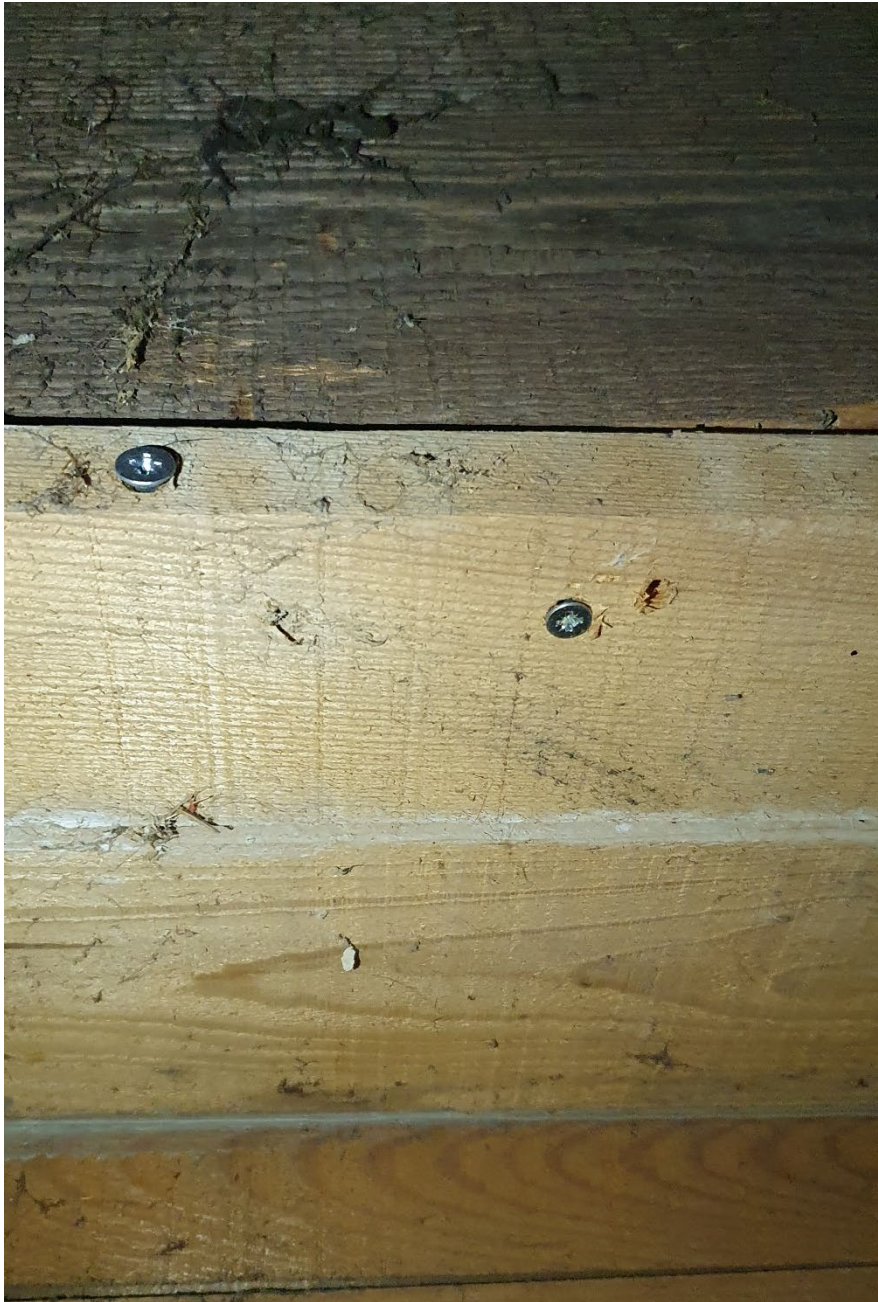
Photograph 12: Replacement Rough String
