Dyffryn Barn
Llanwrthwl
Llandrindod
LD1 6NP

An Ecological Survey
Report By:

Client	MS J Tyler
Project Name	Dyffryn Barn, Llanwrthwl, Llandrindod LD1 6NP
Report Title	An Ecological Survey Report
File Reference	BAT11920

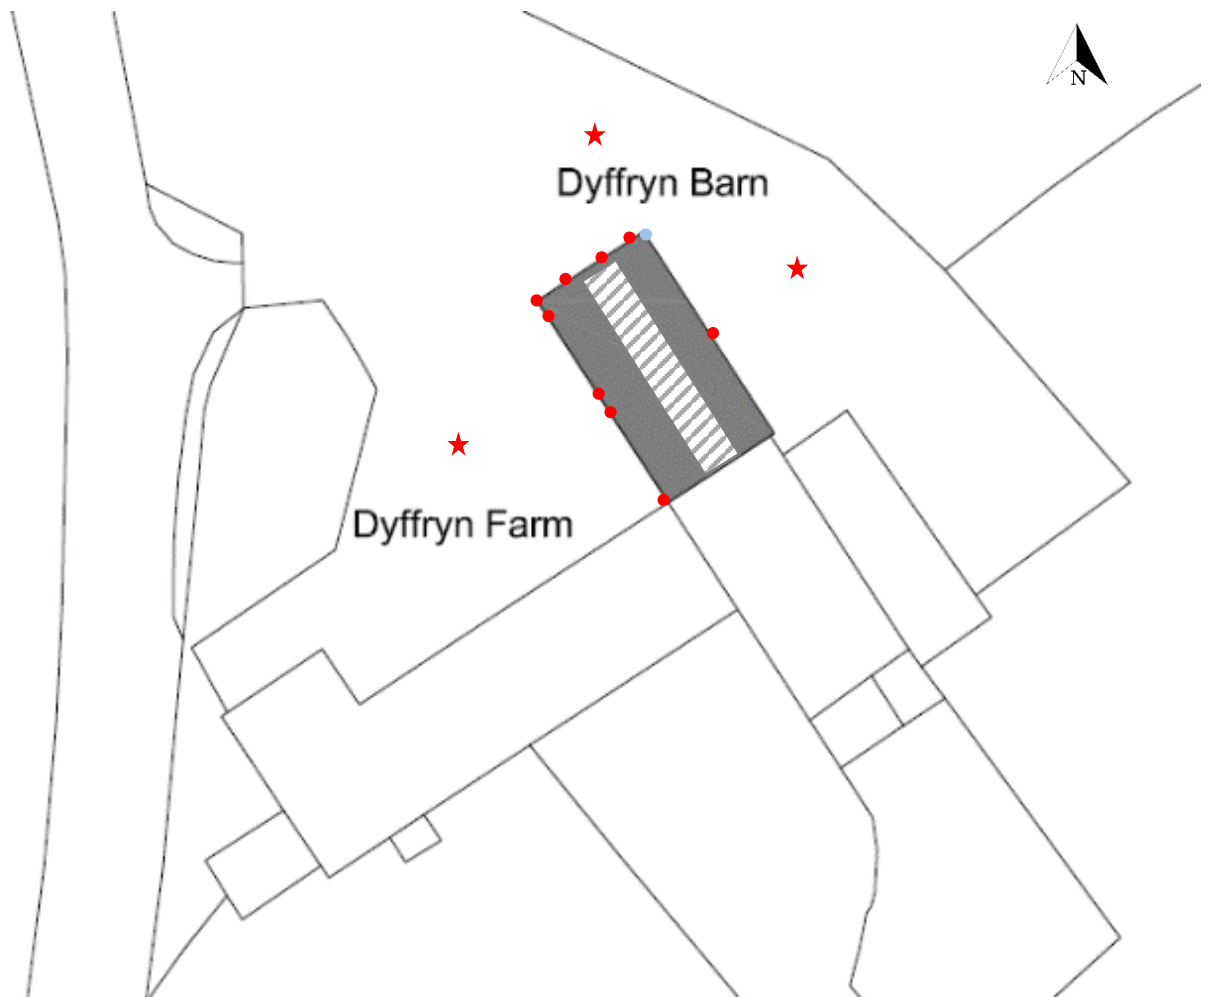
Figure 3: Building layout and evidence of bats and birds

Droppings recorded:	<i>Circa</i> 200 fresh droppings at north end wall, and <i>circa</i> 200 fresh droppings near loft hatch, identified as pipistrelle and also brown long-eared Under the line of the ridge several thousand old droppings, pale grey in colour.

- ★ = position of observers
- = Evidence of birds
- ▨ = area of bat droppings
- = bat exit/entry points

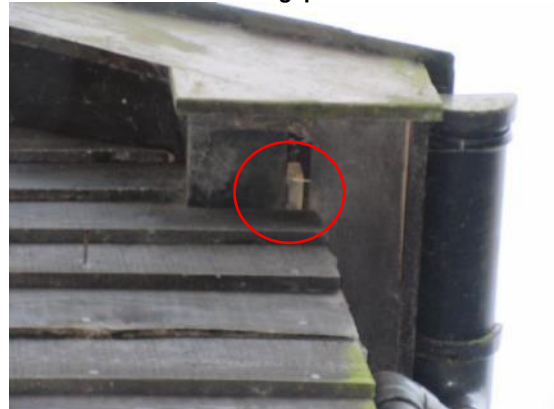
Plate 4: North-west corner gap

Time (24 Hour Clock)	Species (Common Name)	Recording No.	Observed Activity
19.28 hours	Pipistrelle	-	Emerged at north-west corner (see Plate 4)
19.45 hours	Common pipistrelle	1 NI	Emerged at north-west corner (see Plate 4)

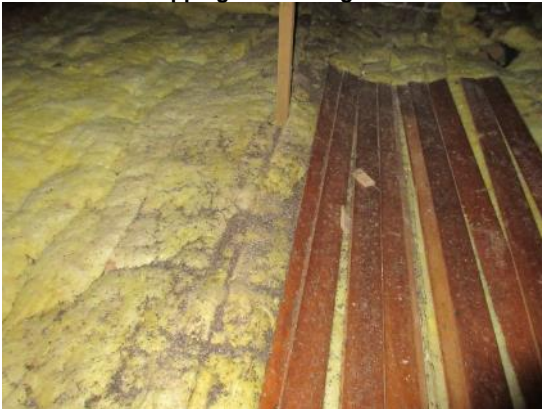
Plate 13: Bat droppings below ridge line

- 8.3 Inside the loft, no live bats were found, but abundant evidence for the presence of bats was noted. A large quantity of bat droppings extend along the full length of the loft below the ridge line, with several areas showing a more marked concentration of droppings. A large proportion of the droppings look to be old and grey. Some fresh droppings were examined and it was apparent that pipistrelle and brown long-eared bats are present in the roof structure. Fresh droppings were seen down the face of both end walls within the loft, especially at the north gable end. The colour and appearance of the droppings suggested that the number of animals roosting in Dyffryn Barn is not great, but there had been long-term presence of bats. Droppings close to the hatch were collected and examined but the droppings elsewhere in the loft were viewed from the distance as the weight bearing strength of the joists across the floor of the loft could not be determined with confidence.
