**BS 5837:2012 Tree Survey,  
Arboricultural Impact Assessment,  
Arboricultural Method Statement and  
Tree Protection Plan**

**At  
13 Hadley Grove,  
London EN5 4PH  
for  
Mr Dann**

**August 2021**

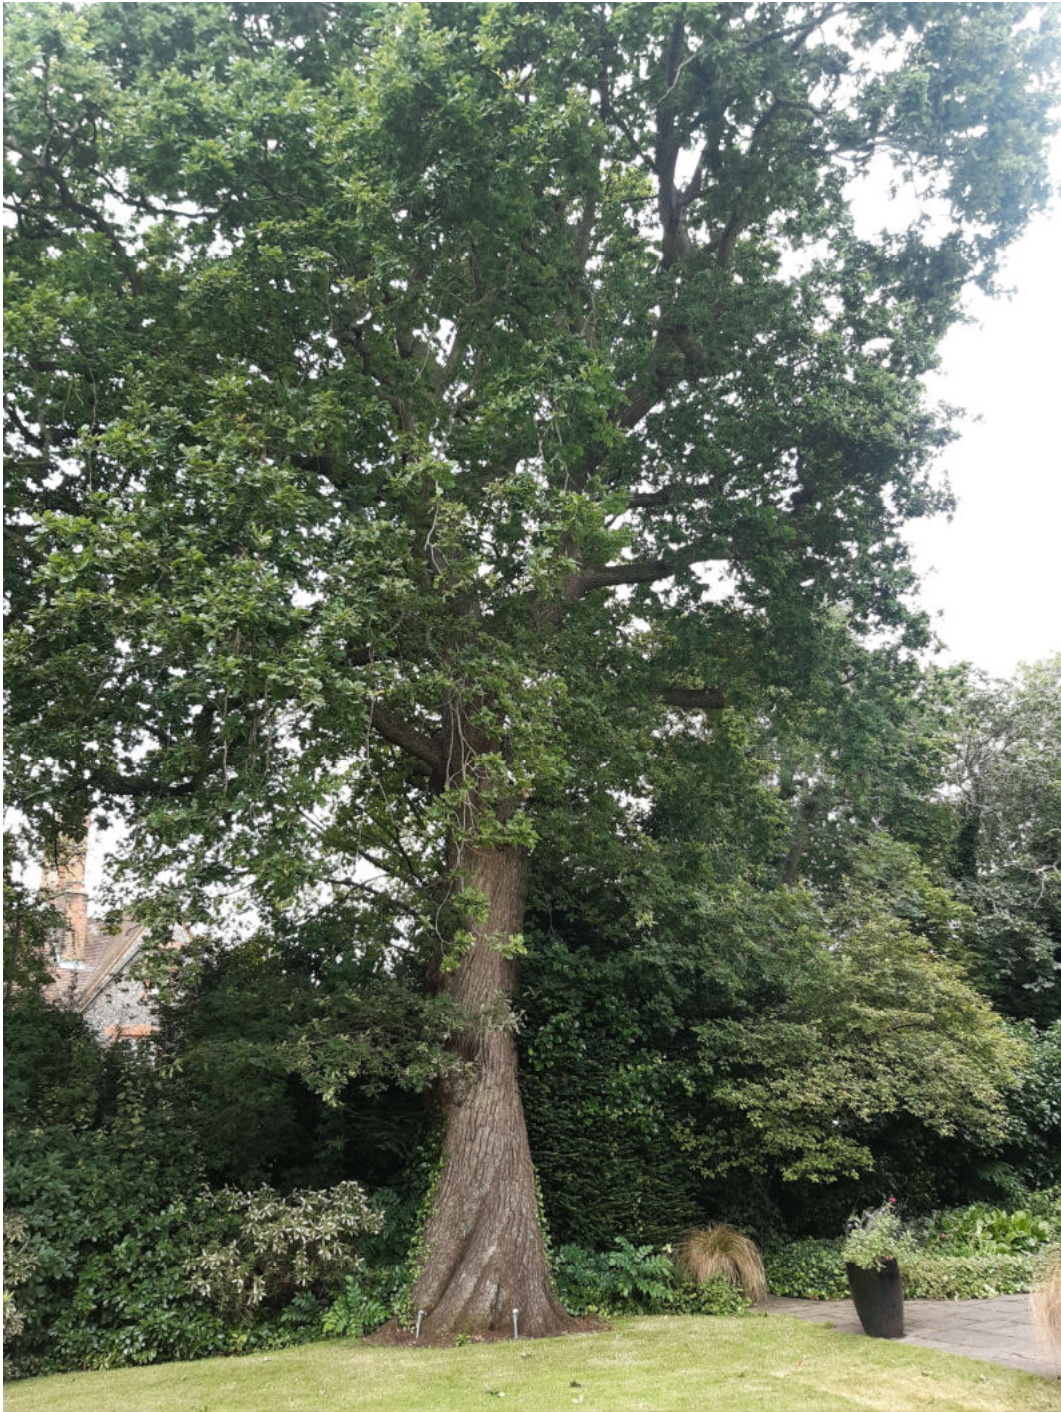
T1 - Oak

13. 13 Hadley Grove is a large, detached residential property with off street parking to the front and a substantial rear garden.
14. The rear garden is dominated by two mature Oak trees (T1 and T2). Both trees are in a good condition with no obvious external indications of weakness or decay.
15. The remainder of the garden is largely set to lawn with mature shrub borders along the southern, western and eastern boundaries.
16. The Cypress hedge at the south has been topped at approximately 4m and is heavily clothed in Ivy.
17. The only trees on the property realistically visible from a public thoroughfare are T1, T2 and G1.

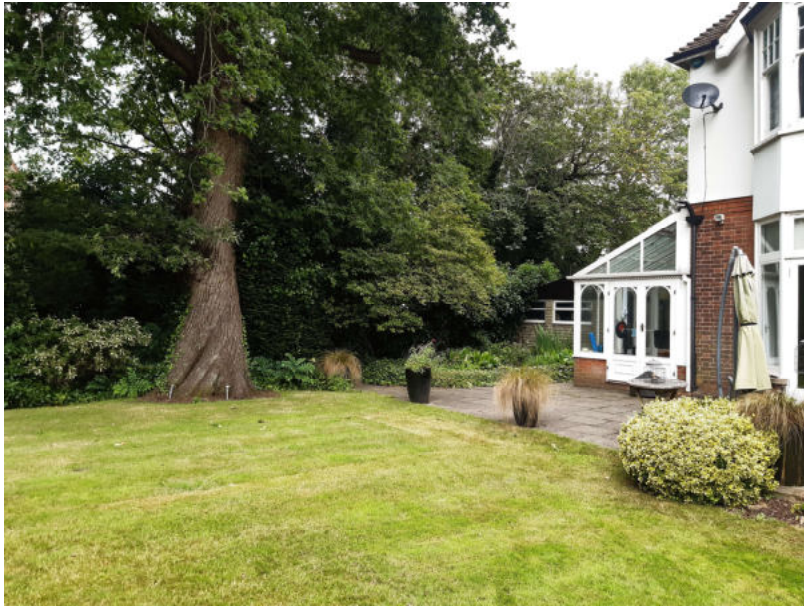
34. The spatial relationship between T1 and the new extension will mirror that of the existing. Therefore, any shading will be the same as being currently experienced by the residents.

**T1 in relation to property**

55. The patio area shall be retained during the construction of the rear extension to provide additional ground protection for T1.

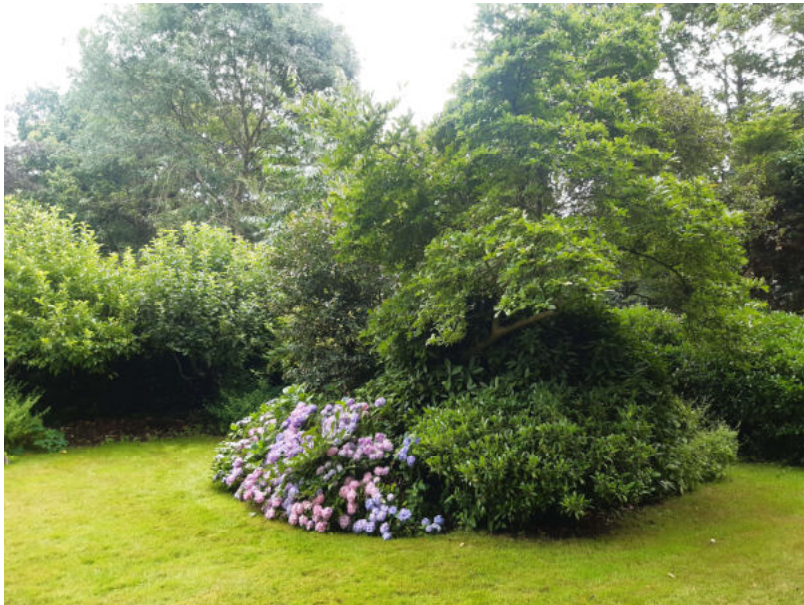
**T4 - Magnolia in foreground**

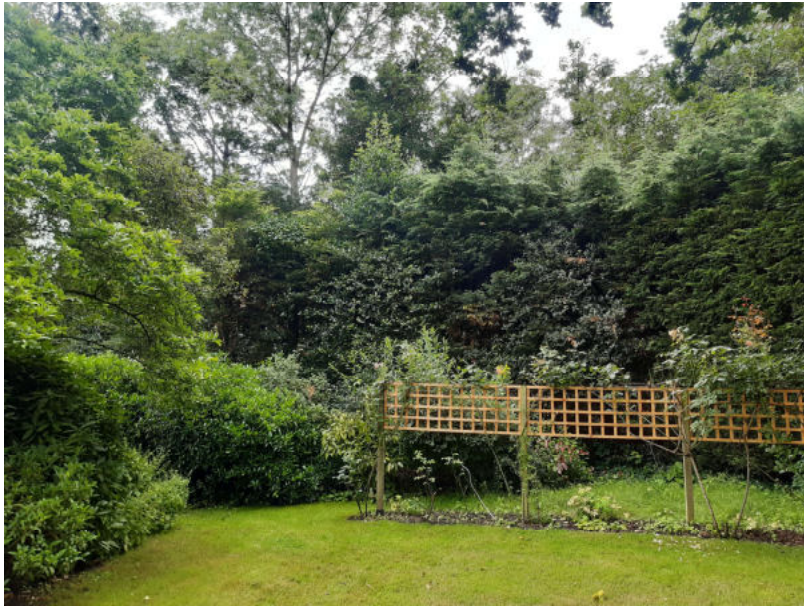
21. Only the first three stems in G1 are due to be removed (in addition to T3) as a direct result of the proposal. Consequently, there will be very little effect on the wider visual amenity.

**G1 - Cypress hedge**

37. I recommend that the following tree works are undertaken prior to commencement of the proposal;
- G1 & T3 - Fell and grind
  - T6 - Trim back overhanging branches by 1.5m
38. If required, it will be the responsibility of the tree contractor to ensure that all the necessary consents have been sought from the local authority.
39. Where stumps are to be removed within the RPA for any retained tree, grinding will be kept to a maximum depth of 100mm to enable soft landscaping works.

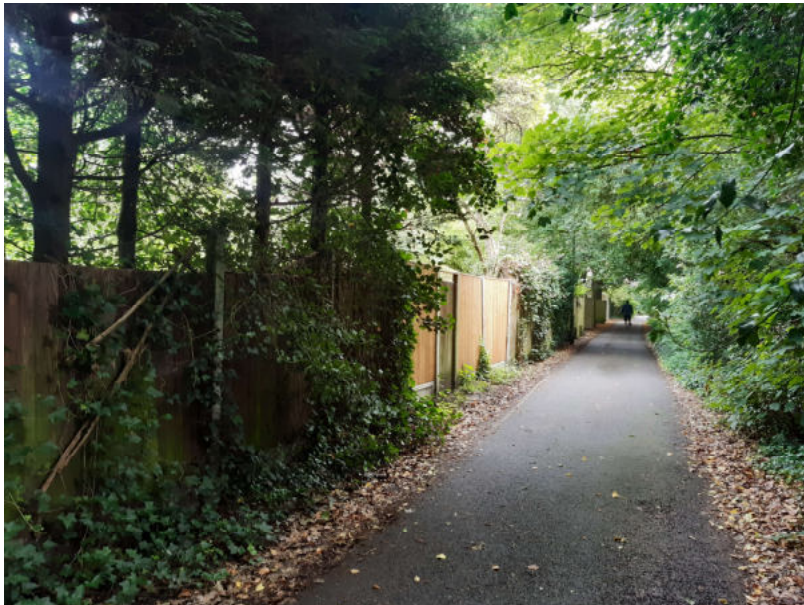
**Christ Church Lane (G1 on LHS)**

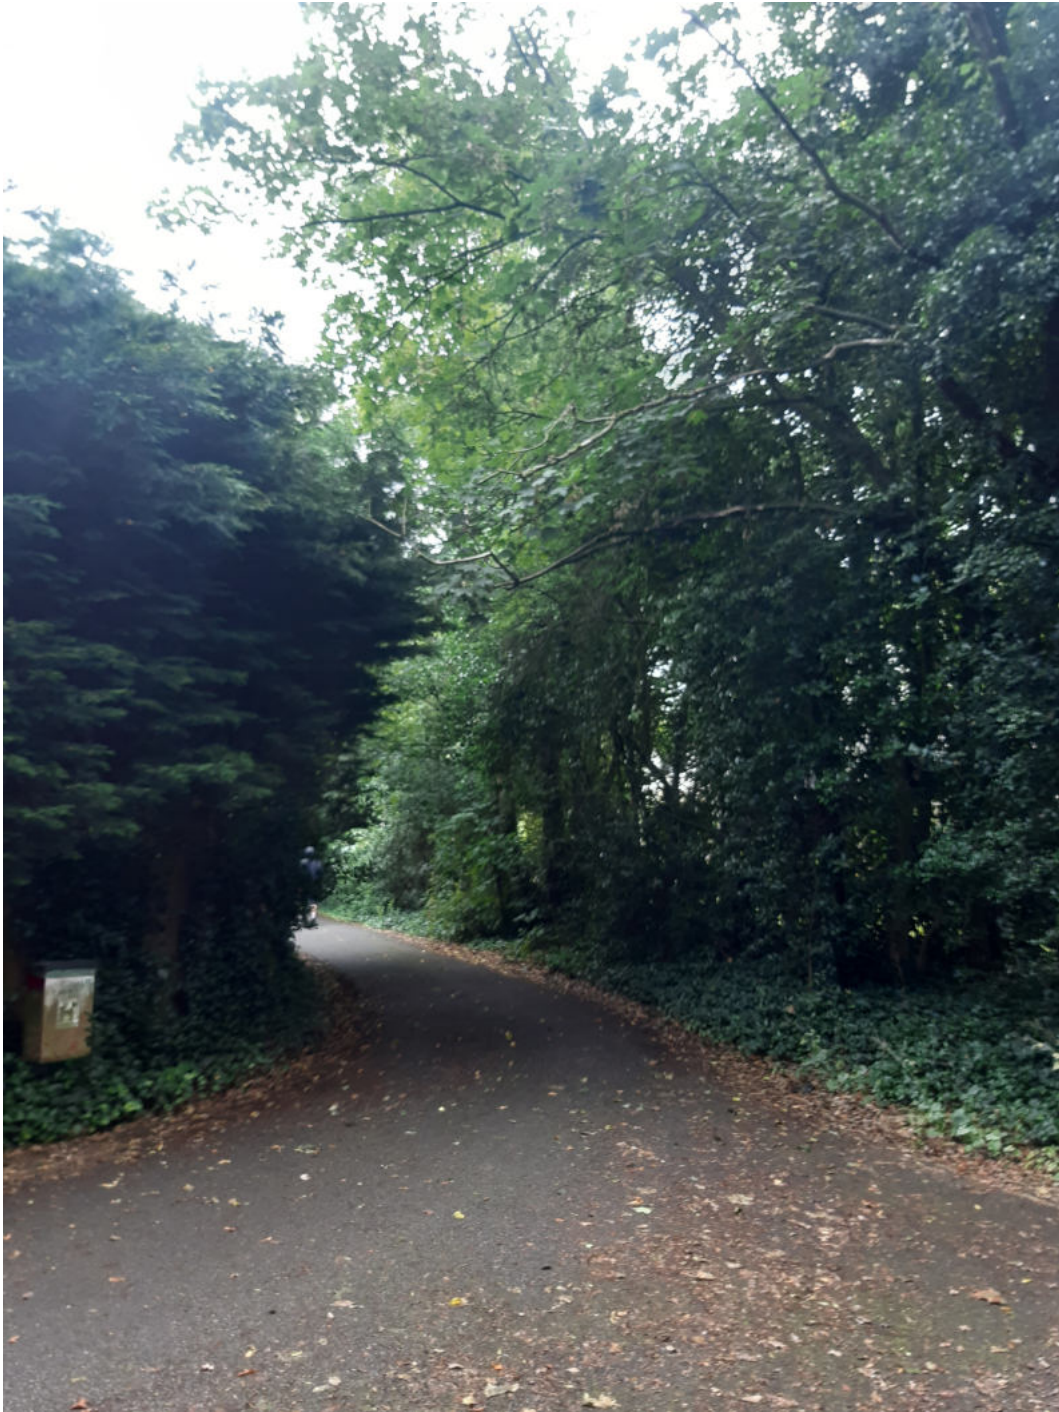
T7, T8 and T9 on the other side of Christ Church Lane
