Llantroft, Newcastle, Craven Arms, SY7 8PD

Bat Survey with Mitigation Plan

01 July 2021

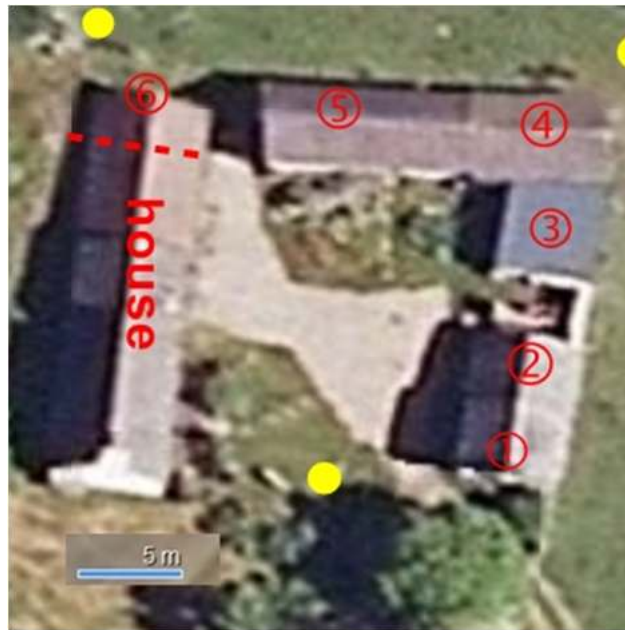
surveyor positions yellow.
building parts numbered

Llantroft
Outbuildings numbered as surveyed.
Shows farmhouse and other buildings behind to west too

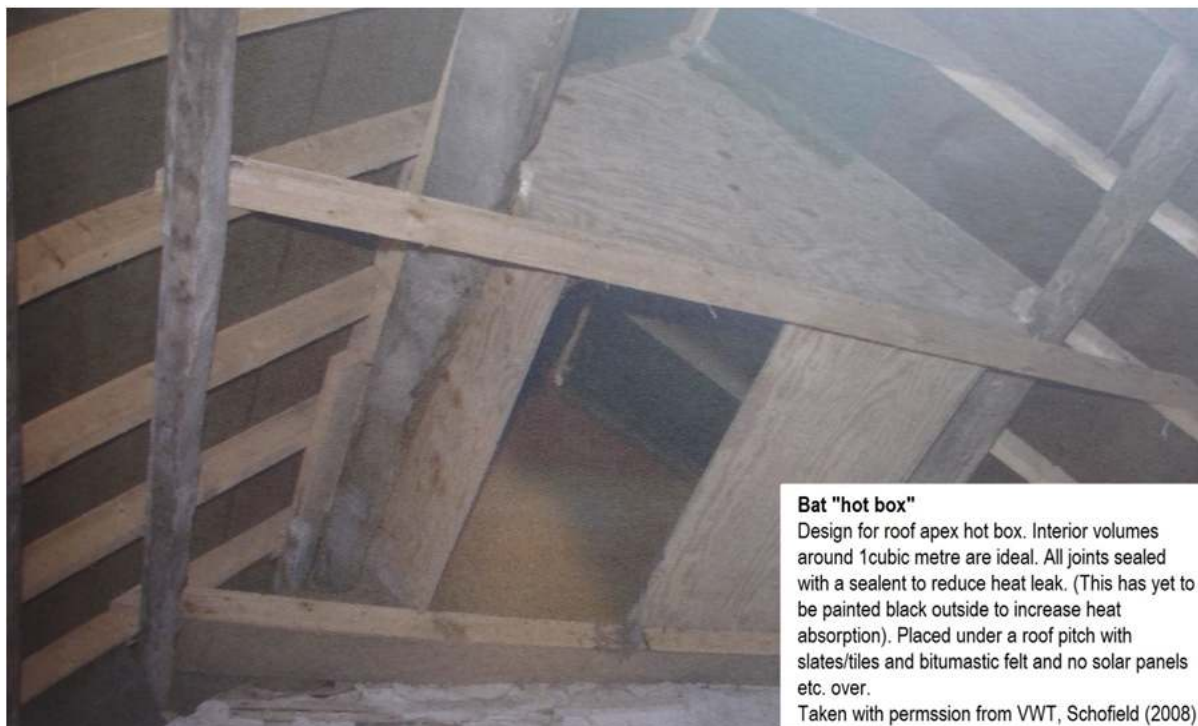
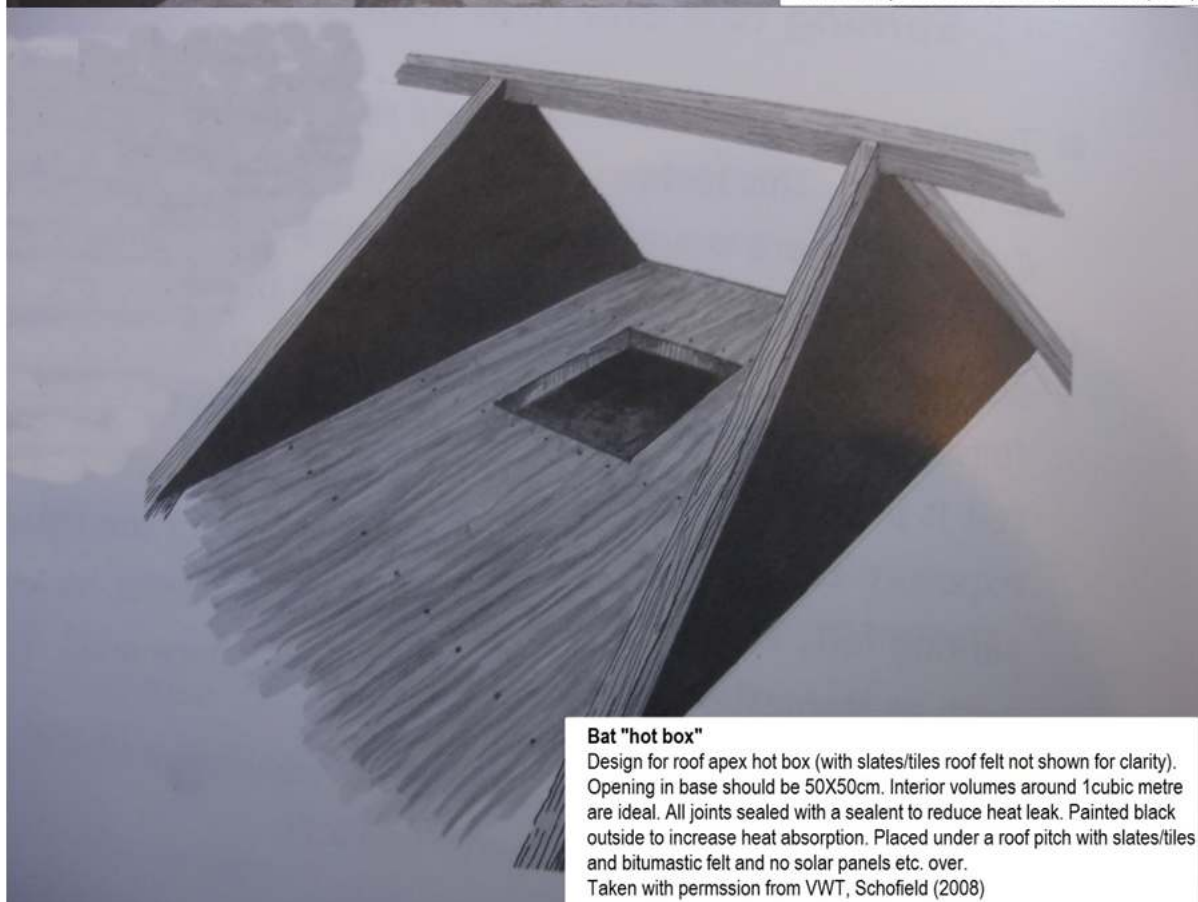
- VI. In the centre of the loft, a “hotbox “ will be constructed of sterling/OSB and untreated timber, to be approximately 2000mm long, and 1000mm deep, sealed with mastic at its joints, painted black on the outside with a bat access hatch through its “floor” of 450mm by 450mm. See illustrative photo of a hotbox installed and a drawing with roof and slates removed for clarity (below).

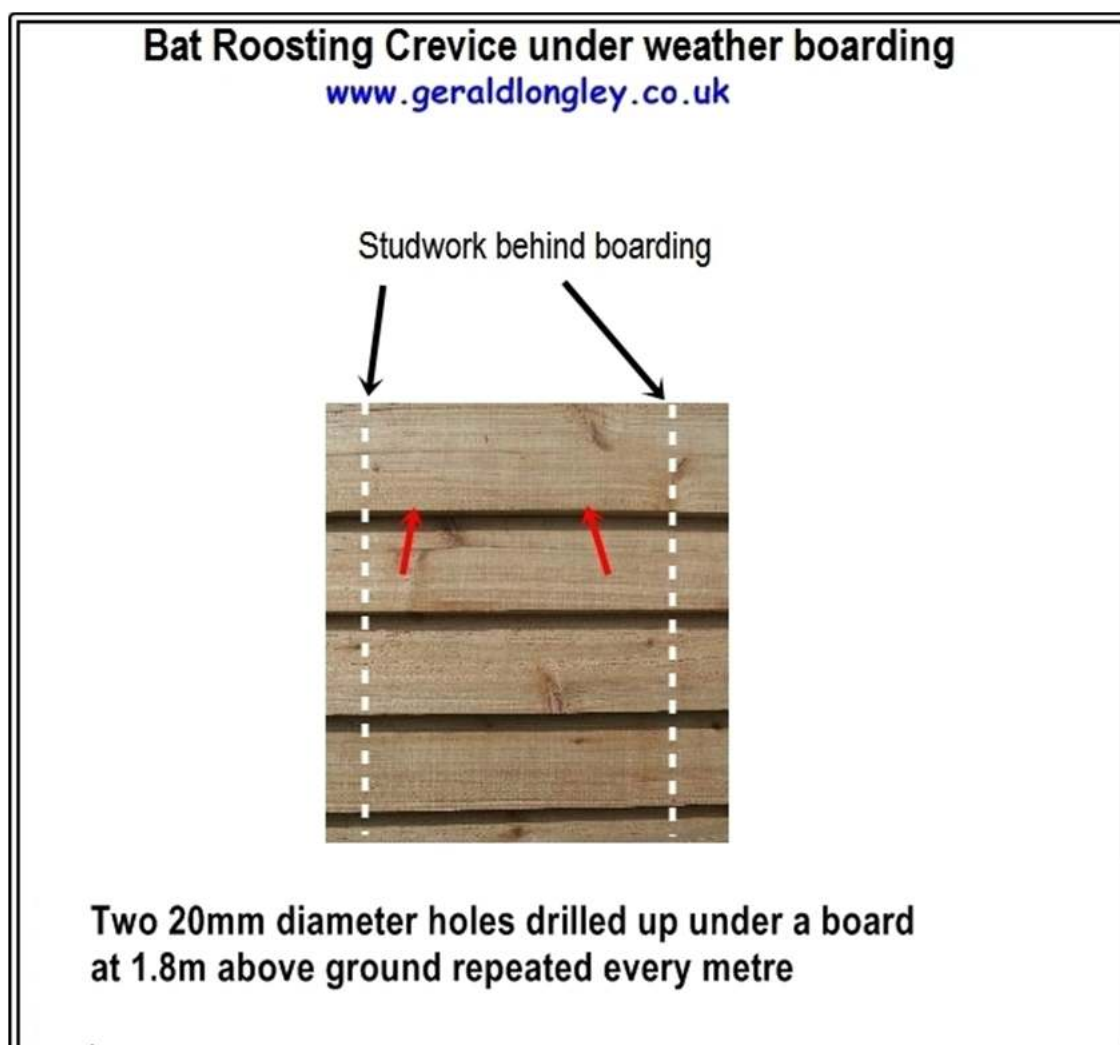
- IX. The horizontal exterior timber cladding on walls will have holes, 20mm in diameter, at approx. 1000mm spacing, drilled up vertically at the bottom edge of a cladding board, at approx. 1.7m from the ground on each elevation to allow access for bats behind the cladding into the cavities between battens. The timber walls will have an interior lining throughout of OSB boarding to provide the cavity for bats to roost in

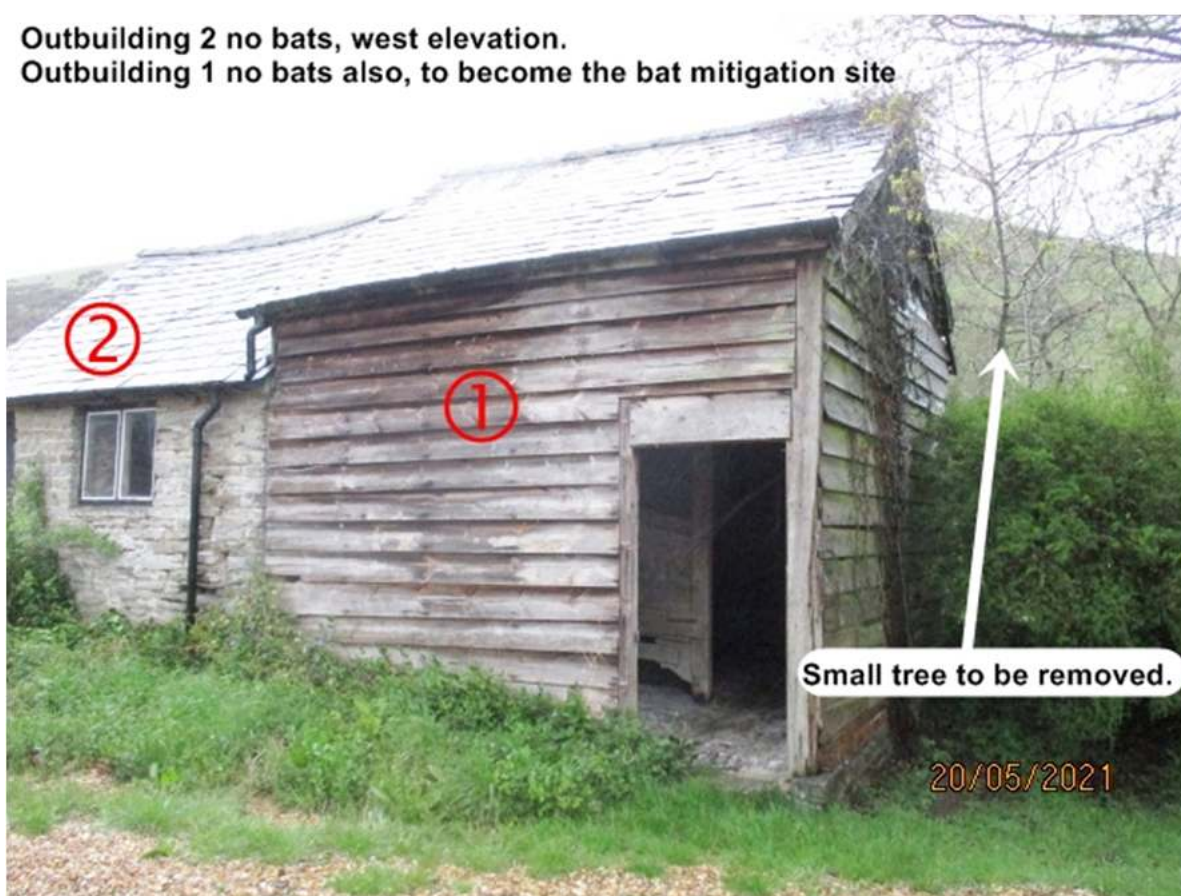
**Outbuilding 2 no bats, west elevation.
Outbuilding 1 no bats also, to become the bat mitigation site**

- I. A dedicated bat building will be made of Outbuilding 1 to provide bat roosting habitat to replace that in Outbuilding 4 including a ground level room and loft above. Outbuilding 1 has no conversion works planned. Bats will be excluded from Outbuilding 4 as part of the conversion works. Outbuilding 1 is large enough at around 5m square in plan and shall have all the design features listed below incorporated. This will provide the roosting and flying space essential for Natterer's, brown long-eared and lesser horseshoe bats. It must have a minimum apex height above its loft floor of 2.0m. It will have a load-bearing floor installed, designed for occasional access to monitor bats. There will be a secure, locked ground level door access to monitor bats.
