HEATH FARM HOUSE, SHAWBURY

April 2021

Level 3 Historic Building Record

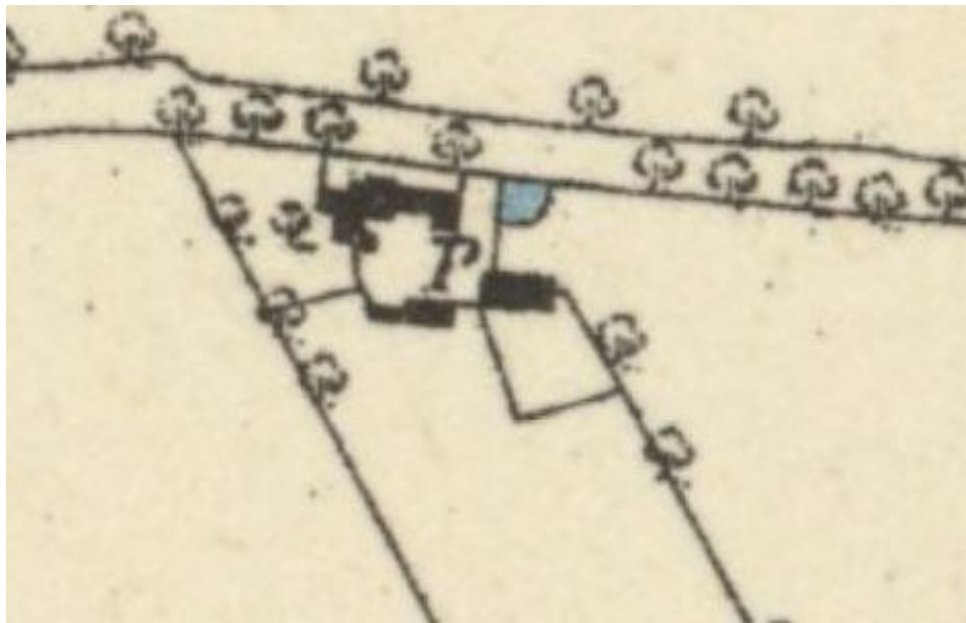
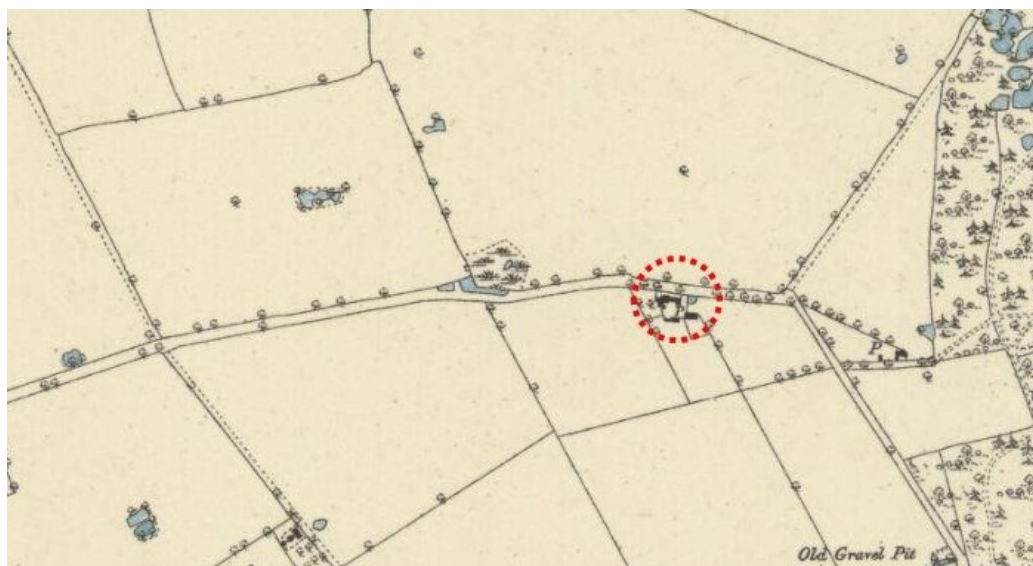
The 1884 six-inch OS map shows a similar arrangement to the 1881 map, however few differences are evident. The house appears to have been extended slightly at the southeast corner. Another possibility is that the stackyard has been turned into a structure. The wider setting of the farmhouse remains unchanged, and the farmhouse itself retains the east-west axis, fronting onto the unnamed lane to the north.

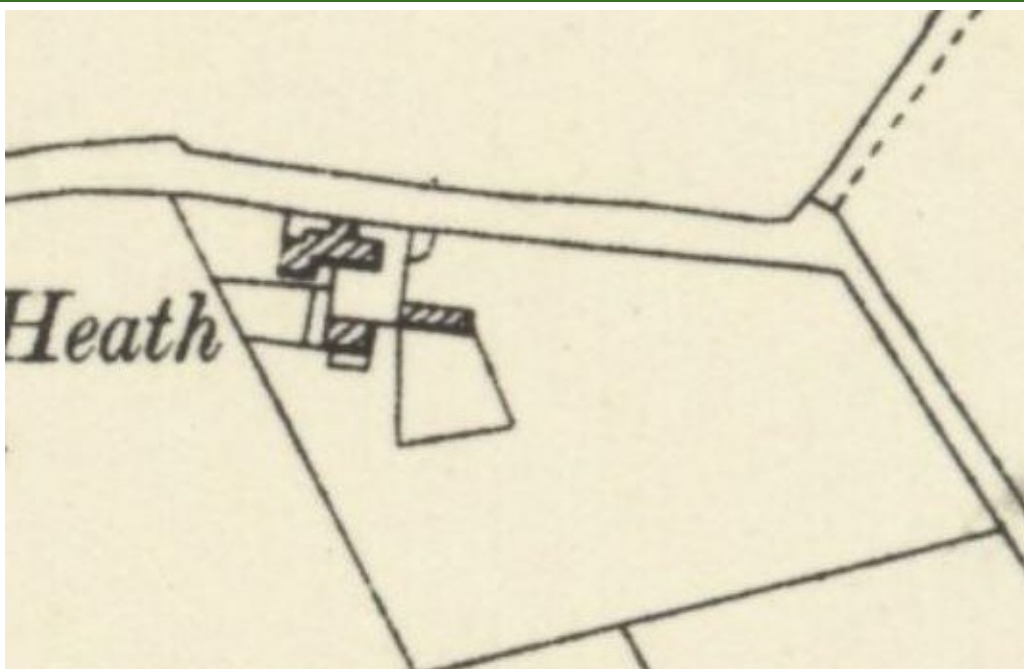
Figure 5. 1902 OS Map

The 1902 six-inch OS map below shows further changes. While the small extensions on the south and southwest corner of the farmhouse are still present, the structures immediately to the east have been partially removed. To the south-east the Granary retains its yard, though the field boundary respected by its eastern side has been removed. The collection of agricultural buildings forming the southern boundary of the loose yard formation of the site have been reduced, or possibly rebuilt, and the small orchard to the west of the farmhouse is no longer present.

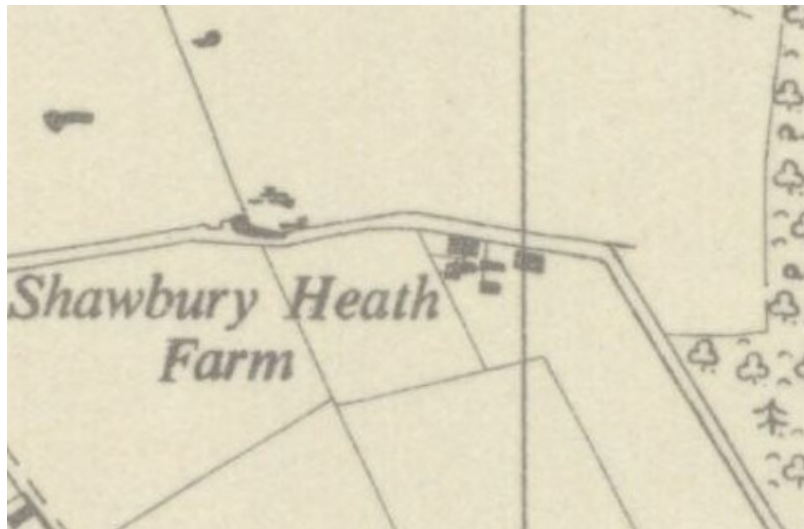
Figure 6. 1956 OS Map

The 1956 map below shows the house present in its garden, but the form of the structure is unclear due to the scale of the map. The Granary is present, along with another small structure to the south. The two structures appear to be connected by a path. A new building is present to the south of the house, where the modern garage stands.

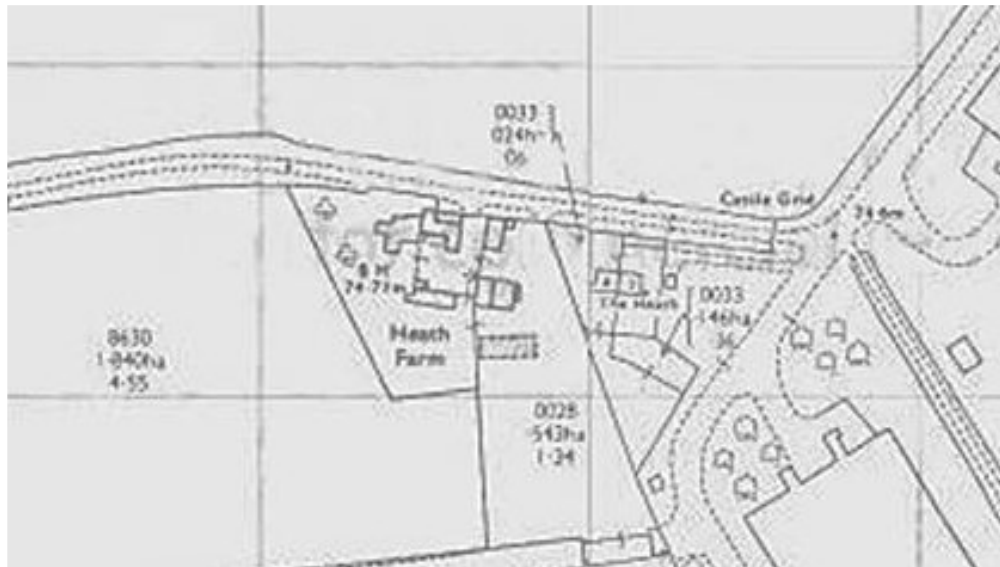
Figure 7. 1971 OS Map

The site is shown in more detail on the 1971 OS map. Here we can see that the farmhouse appears to have retained its plan form, the small structures to the south and southwest remain. The wider site as pictured in the 1971 OS map has undergone substantial changes. The arrangement of buildings at the northern end of site does not resemble any arrangements from previous or subsequent historic mapping. The principal change to this end of site is the addition of an irregular shaped structure abutting the eastern end of the farmhouse. This is clearly defined on the map as a separate structure in its own right rather than an extension of the farmhouse itself. To the south of the house stands a structure presumed to have originally been agricultural in nature. The original field boundary to the east of the granary has been reinstated, and the plot to the east of this boundary has undergone some development with the creation of The Heath.

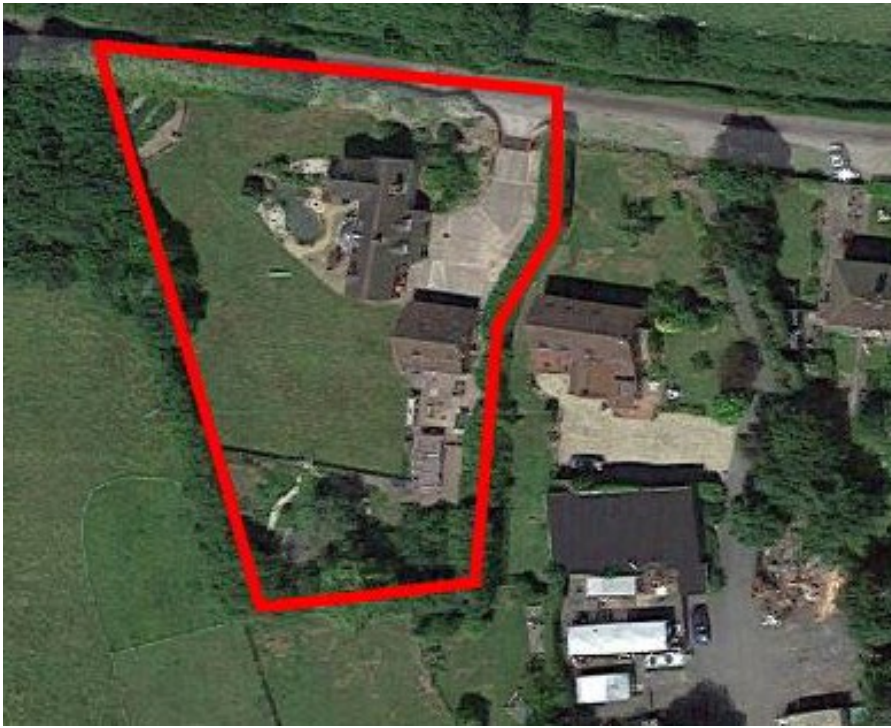
Figure 8. 2020 Google Maps Image

Present day photographs of the farmhouse show substantial changes between the 1971 OS map and the current structure. The structure abutting the eastern end of the farmhouse is no longer present. The south and southwestern extensions to the farmhouse have been demolished, and a new extension built to the south. This extension serves to rotate the axis of the building, giving the overall structure a north-south orientation. The current owner of the house states that the large southern extension was added sometime during the 1970s. In 2002, the line of the roof slope to the 1970s extension was extended and the dormer windows were added (planning ref: NS/02/00983/FUL). A conservatory was added to the western elevation of the farmhouse at some point before 2008, planning permission for the addition was granted in 2003 (ref NS/03/00015/FUL). The garage building to the south-east of the house was significantly enlarged in 2010.

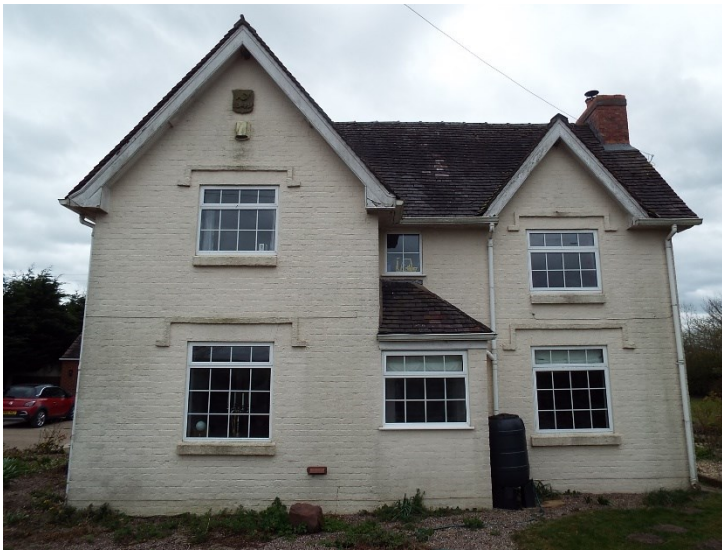
Figure 9. Ph 10. North elevation

The north elevation is part of the original 19th range and is the primary façade of the property (Figure 10). It retains elements of early Gothic style such as raised label moulds to the square windows and asymmetrical primary facade broken by gables. The elevation extends to three bays. There is a projecting gabled bay to the east with deep timber bargeboard and date stone to the gable which reads '1849 AVC' (Figure 11). To the ground floor and first floor are modern uPVC windows with upper opening casements, inserted into original window openings. The stone sill and stone label moulds remain.

To the centre is a single storey porch with hipped lean-to roof; the roof appears to be a later replacement. This porch is in the location of the former entrance, indicated by the line of a footpath leading to the property on the OS map dating to 1880. Also, to the interior, the remains of a small section of wall indicate the presence of the internal door leading in from the porch. To the first floor is a small, modern uPVC window.

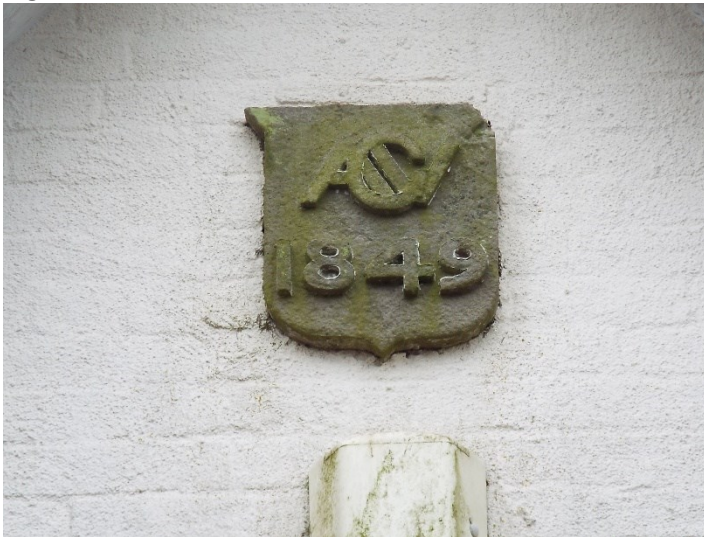
Figure 11. Ph 14. Date stone to north elevation

At the eastern end of the north elevation of the building, a datestone is set into the first floor of the house. The date on the stone is 1849, giving a mid-nineteenth century date for the construction of the original farmhouse. The relief on the datestone also includes the initials 'AVC'. Research of tithe and other early mapping of the surrounding area reveals the largest landowner in the vicinity at the time of construction to have been one 'Andrew Vincent Corbet'. It is therefore likely that this farm initially formed part of the Corbet Estate, and was constructed as a farmhouse for one of the Corbet's tenant farmers. Unfortunately, the tithe map of the Shawbury area terminates just to the north of the unnamed lane onto which the farmhouse originally fronted, so this conclusion remains speculative, though likely.

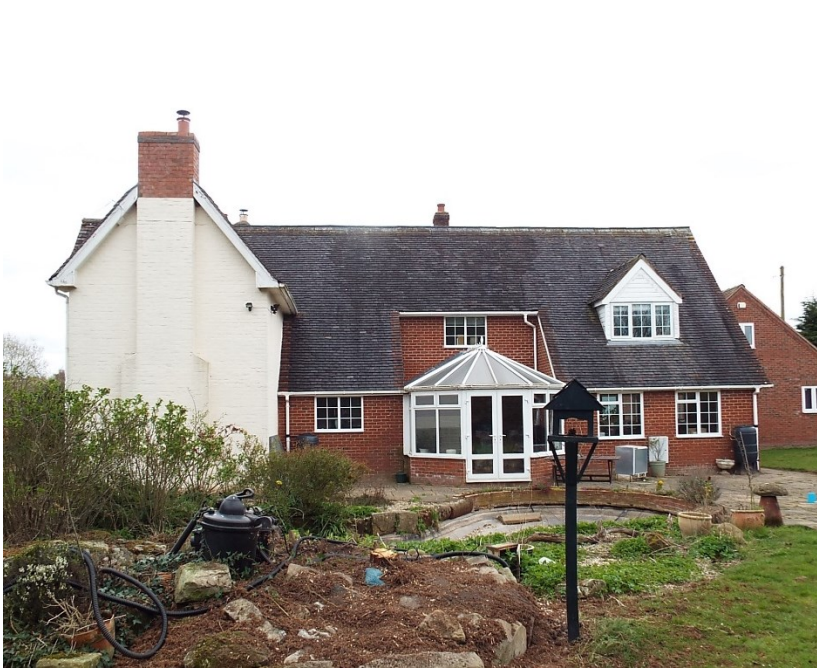
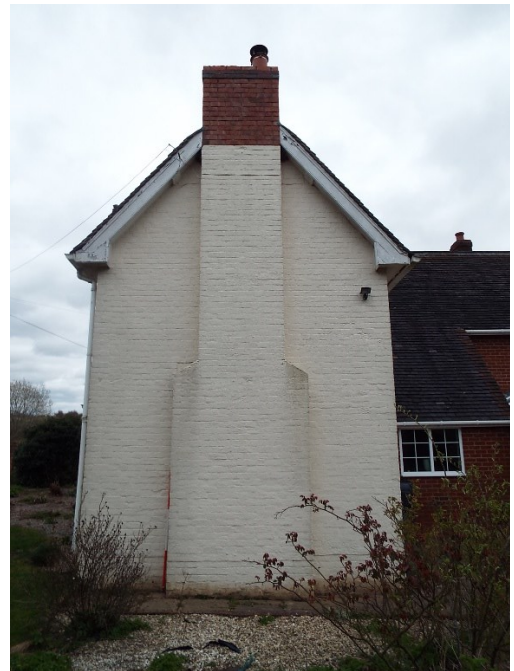
The west elevation is comprised of the west elevation of the 19th century range, and the west elevation of the 1970s extension including the conservatory (Figure 13). The west elevation of the 19th century range is the gable end with chimney stack. The upper section of the chimney stack shows near perfect red brick with no signs of weathering, indicating it has been re-built. This elevation is painted off white. To the 1970s extension, the elevation is red brick, with two sections of cat slide roof either side of the central conservatory. To the southern end a dormer window has been added.

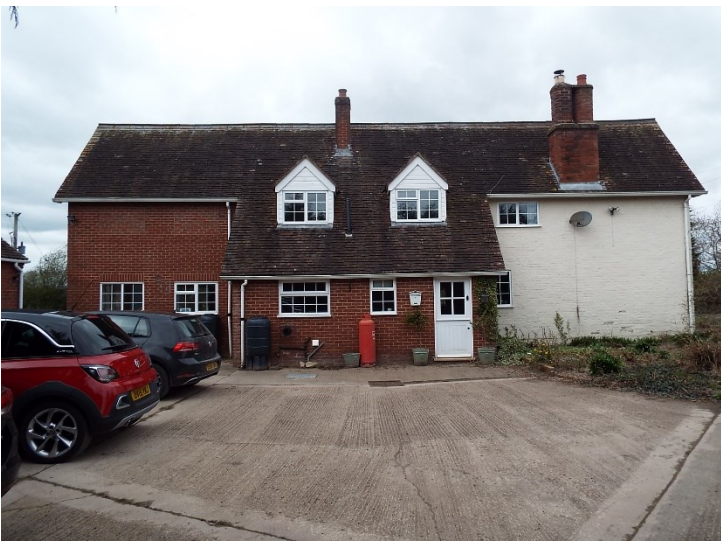
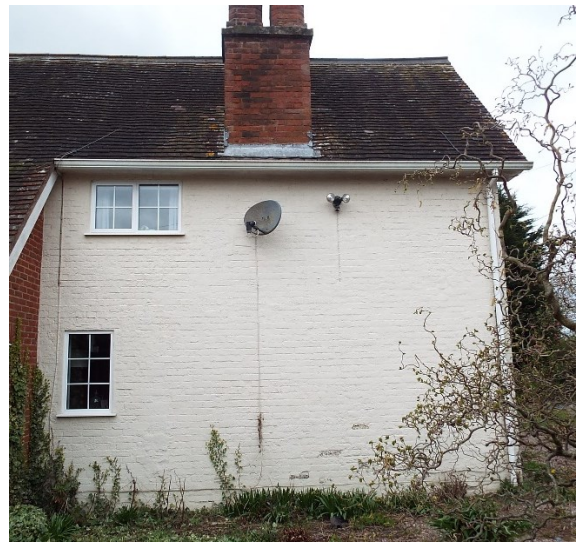
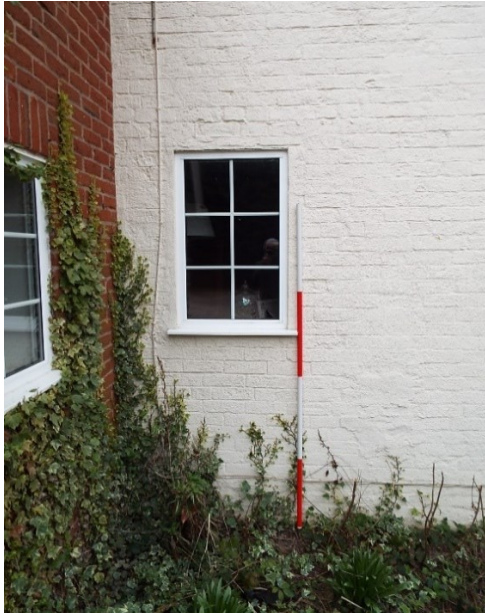
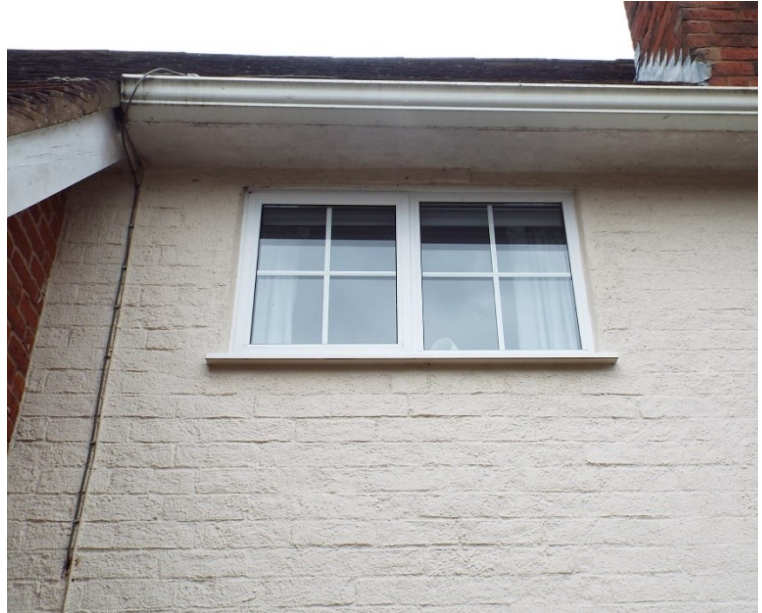
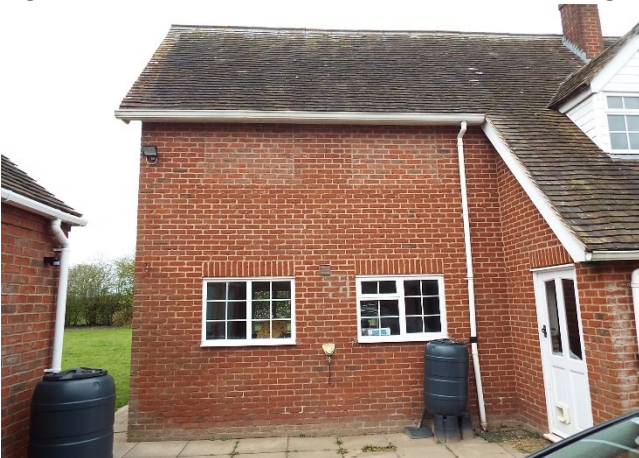
As with the west elevation, the east elevation is a combination of the 19th century range and the 1970s extension (Figures 15-19). The east elevation of the 19th century range is painted, with modern inserted windows to the ground and first floors. Areas of patch repair to the brickwork may be scars left behind by previous extensions to the elevation, as seen on the 19th century OS map, but as the elevation is painted it is difficult to assess. The 1970s extension is red brick with section of catslide roof to the north with two dormer windows. To the southern section there are two bricked up windows at first floor level. These were bricked up circa 2001.

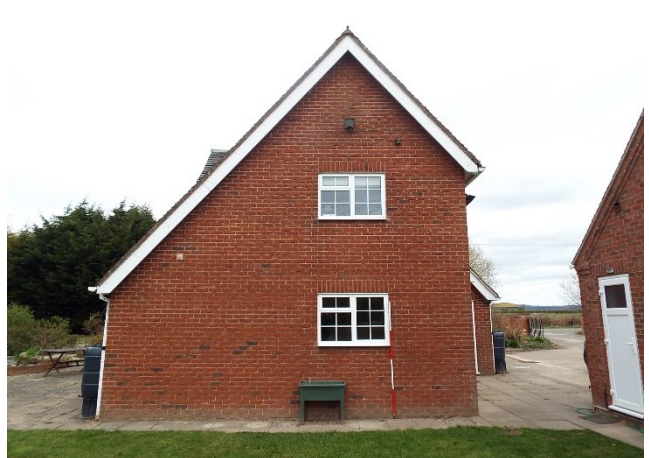
Figure 20. Ph 43. South elevation

The south elevation is comprised of the gable end of the 1970s range, red brick with uPVC windows to the ground and first floor (Figure 20).

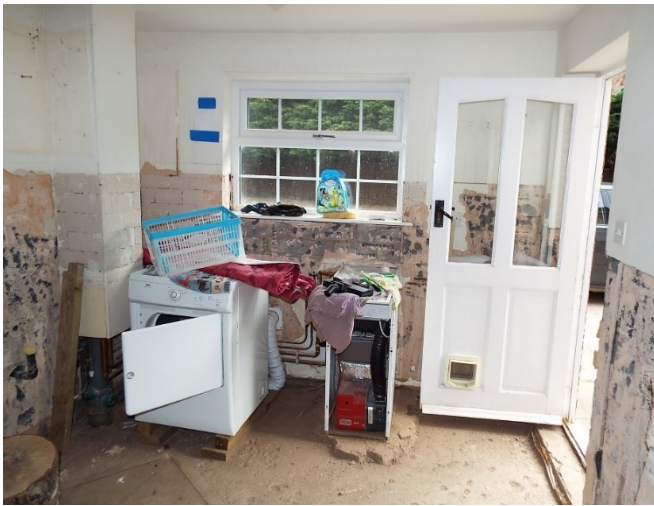
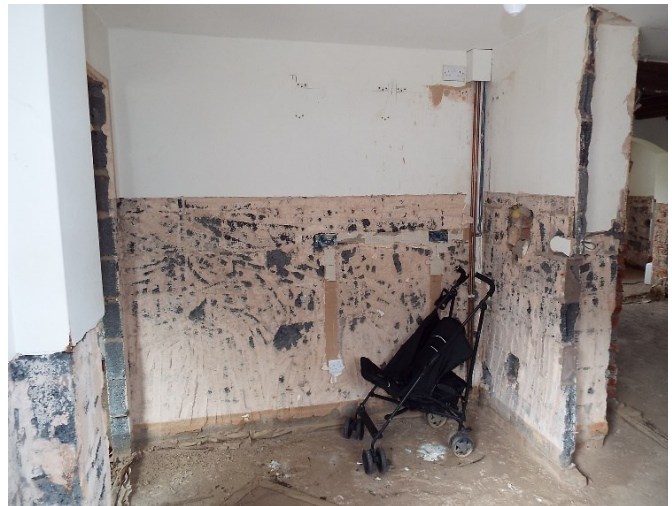
GF1 is situated to the southeast side of the property, in the 1970s extension (Figures 22, 23). The room is sub-rectangular in plan and used to provide a rear entrance and utility area. The room has been stripped out following damage by a flood. The walls are partially plastered and painted, and through the remaining plaster to the lower sections, the breeze block construction is visible. The floor is stripped back to the concrete.

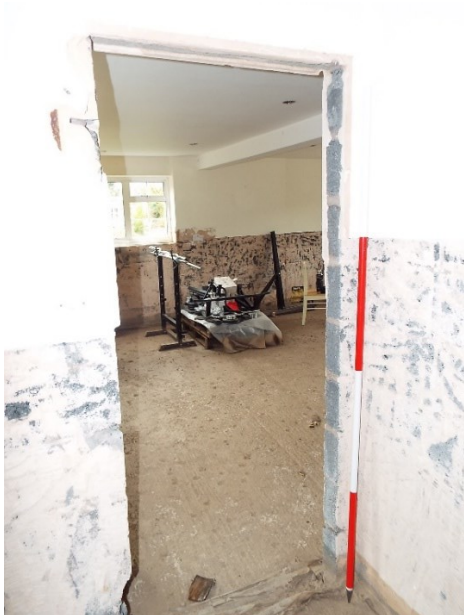
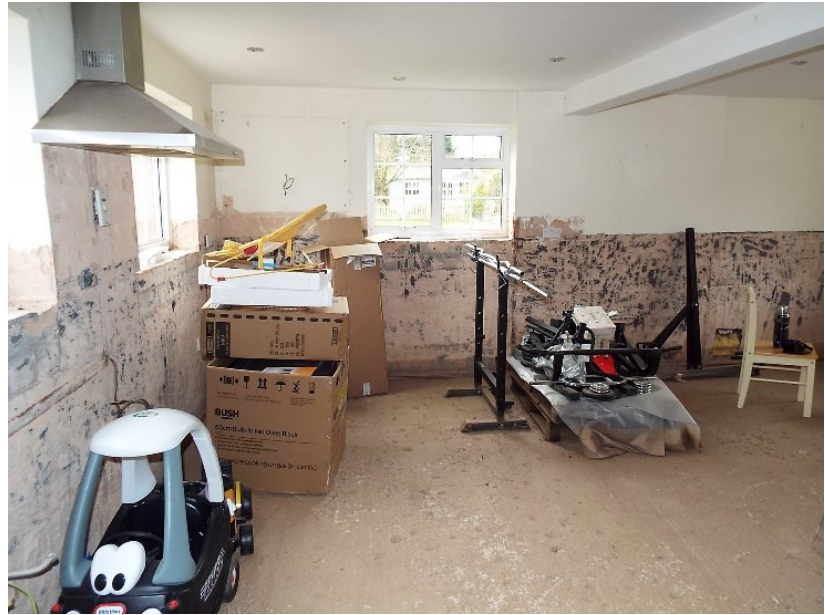
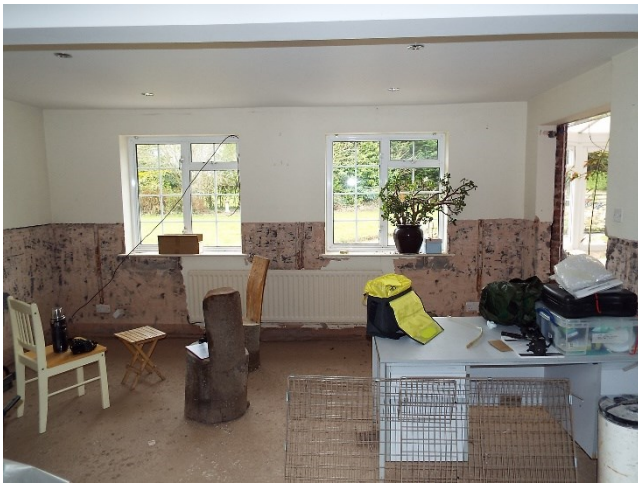
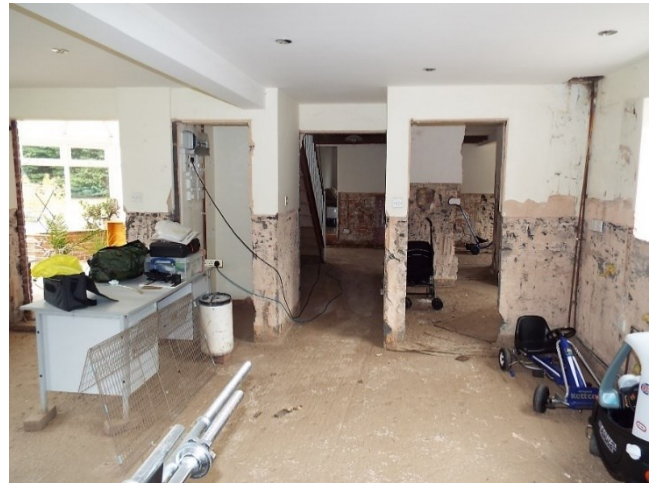
GF2 occupies the southern end of the 1970s extension (Figures 24, 25). The room was formerly a kitchen. It is sub-rectangular in plan with two doorways to the north wall, which lead to the conservatory and the hallway. As with GF1, it has been stripped out following damage by a flood. The walls are partially plastered and painted, and through the remaining plaster to the lower sections, the breeze block construction is visible. The floor is stripped back to the concrete.

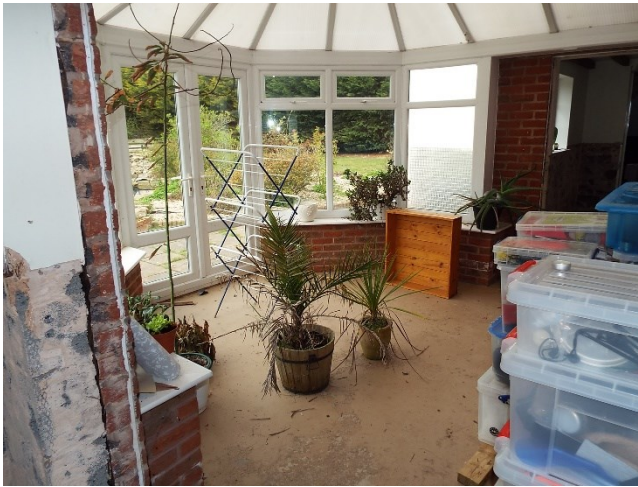
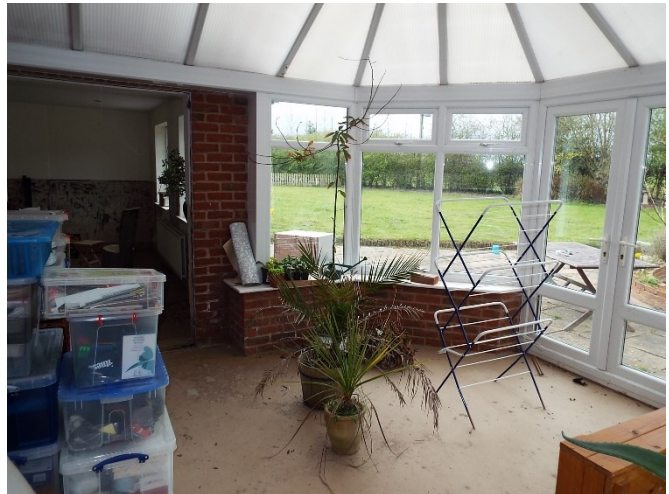
GF3 is the conservatory to the centre of the west side of the property. It is of red brick with uPVC windows, with corrugated plastic roof and double French doors that open onto the garden. It is accessed from the GF2 to the south and the hallway to the north.

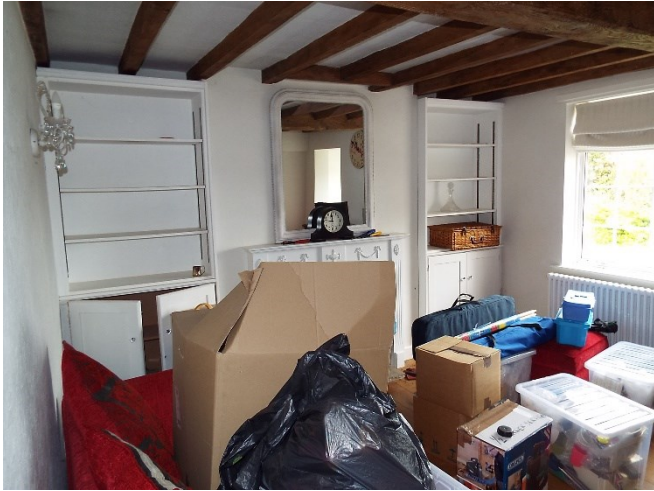
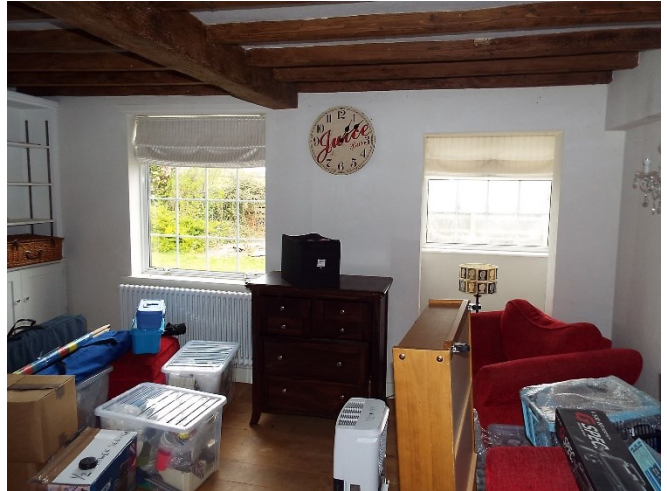
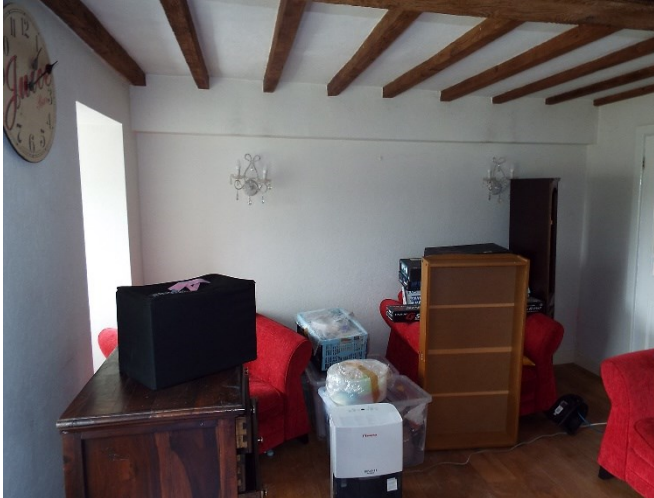
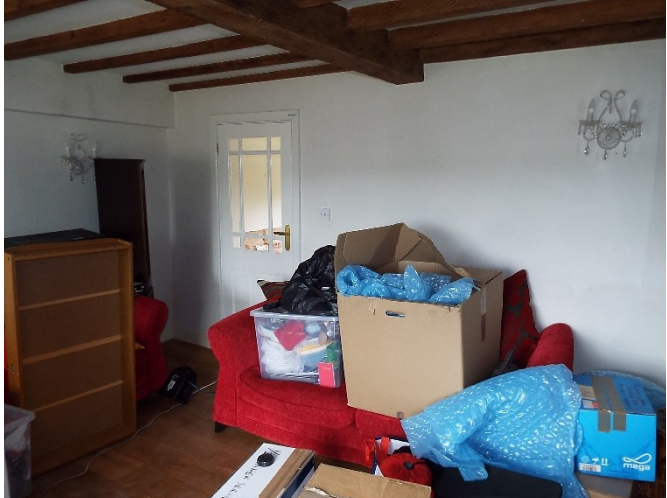
GF4 is occupied the west side of the 19th century north range (Figures 30,31). Historically a reception room, this room is sub-rectangular in plan with fireplace to the west wall and a small alcove to the north wall that may have been the position of a former porch. The walls are plastered and painted and the floor

retains what appear to be original timber boards. The brick fireplace remains, although the log burner and fire surround are modern additions. To the ceiling heavy timber beams remain (Figures 32,33).

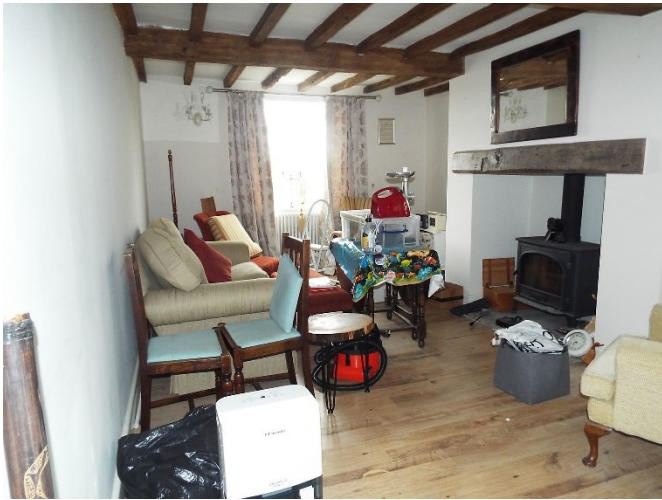
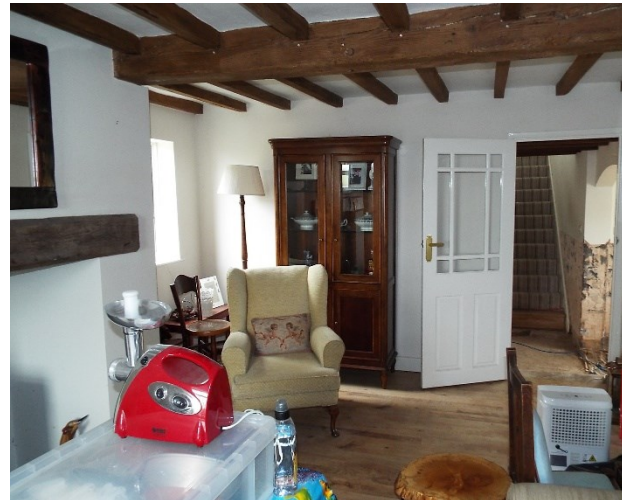
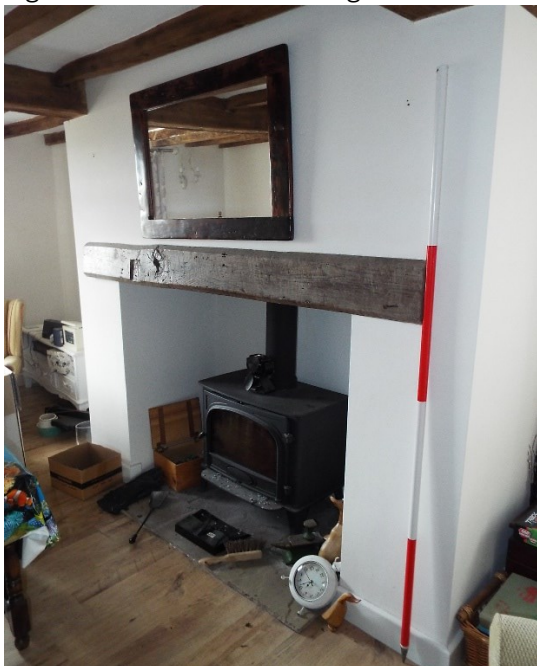
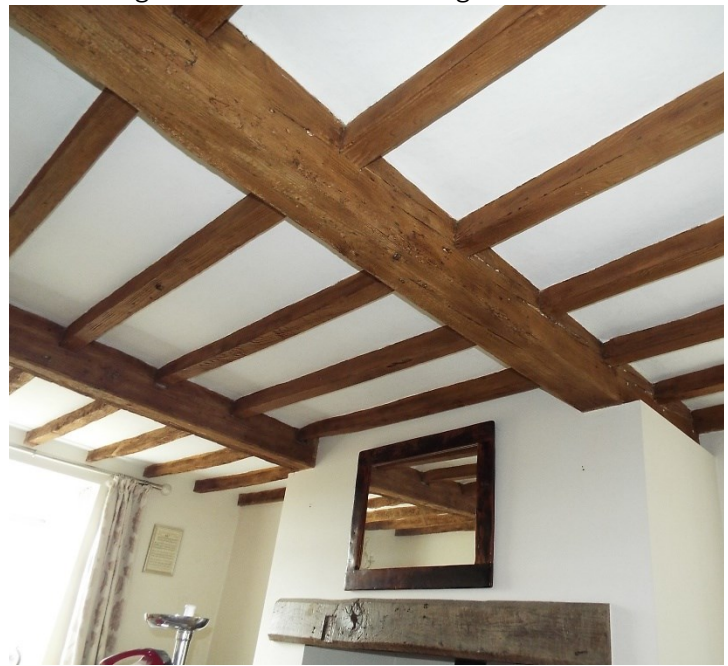
GF5 occupies the eastern half of the 19th century northern range and is historically a reception room of sub-rectangular plan form (Figures 34-37). This room retains a substantial fireplace to the eastern wall, with timber beam mantle and modern log burner. The floor is modern timber board. As with GF4, heavy timber beams remain to the ceiling.

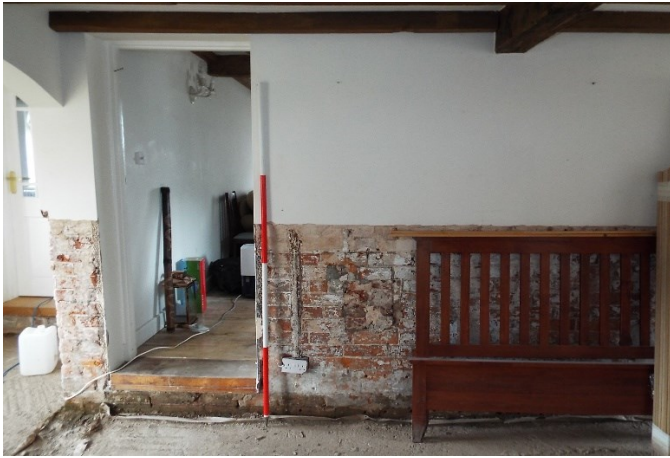
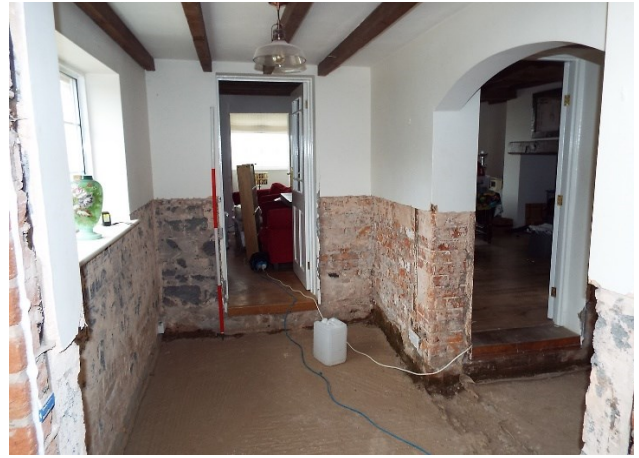
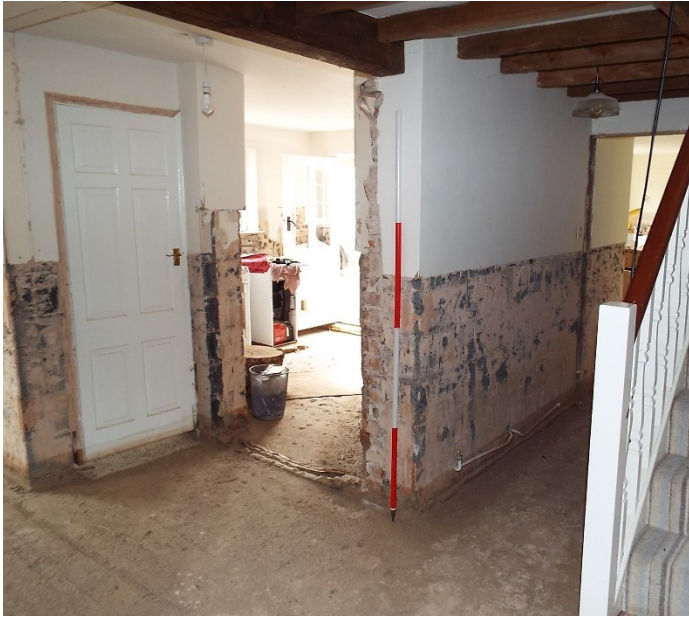
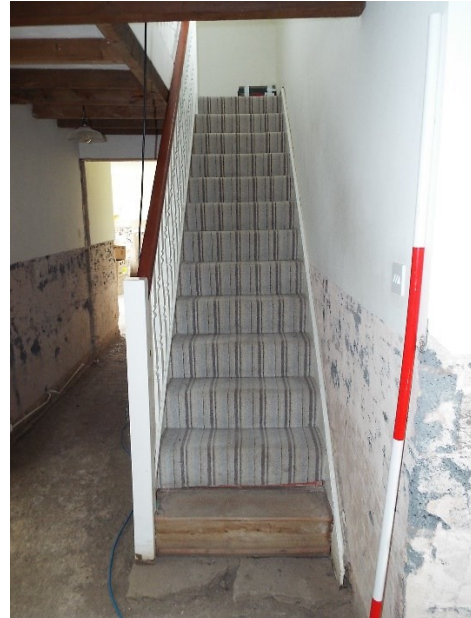
The hallway is to the south of G5 and extends southwards to GF2 (Figures 38-41). The northern section of the hallway is situated in between the 1970s extension and the 19th century range. To the southern wall of G5, the brickwork of the original house is visible, as is a later repair to the brickwork (Figure 38). The southern part of the hallway extends into the 1970s extension, with stairs to the west side that provide access to the first floor.

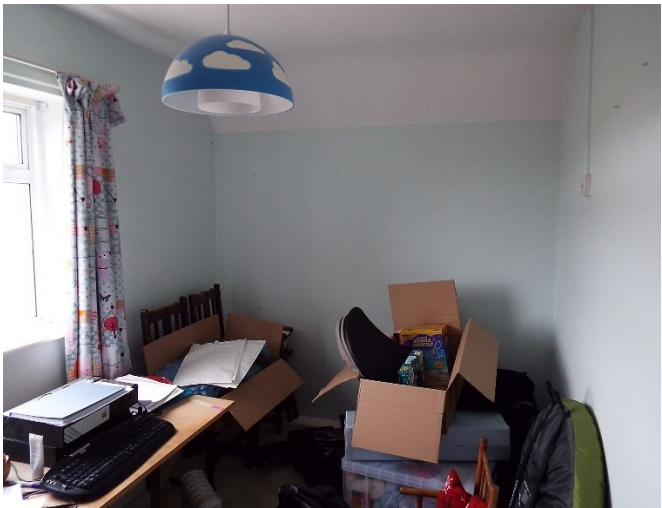
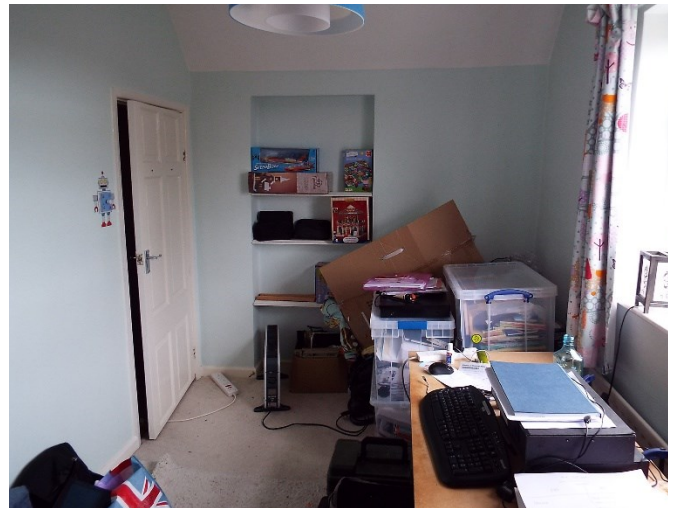
FF1 is situated to the northeast corner of the property, within the 19th century northern range. It appears to have been formed by the subdivision of a larger room comprised of FF1 and FF2, which have been altered to form a landing and two bedrooms with the insertion of a partition wall. This is likely to have been one of the primary bedrooms, indicated by its location and size. It was most recently in use as a bedroom. The room is rectangular in plan, with window to the north wall in the location of an original window opening. There is no fireplace to the room, as would be expected in a Victorian bedroom. The walls are plastered and painted, the floor is carpeted and there is little of historic interest.

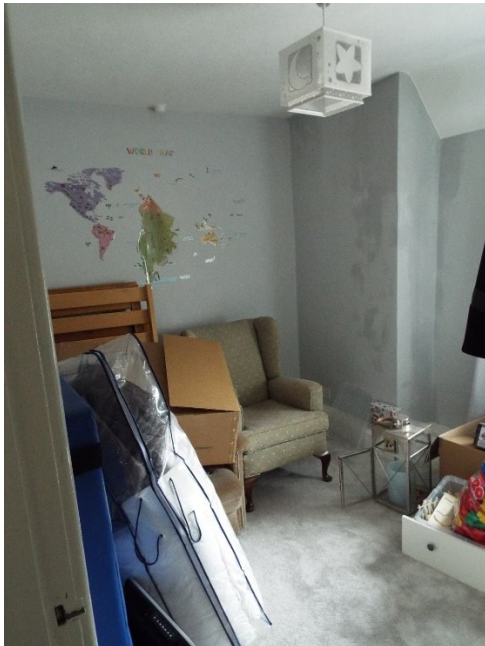
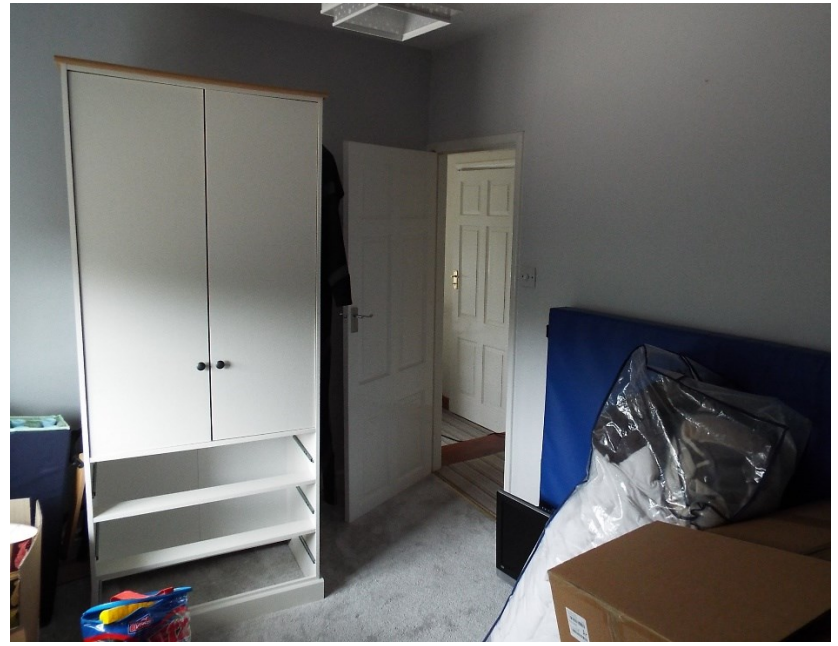
FF2 is situated to the southeast corner of the 19th century northern range and it appears to have originally formed a larger room with FF1 to the north. The room is rectangular in plan, most recently used as a bedroom. There is a later inserted window to the east wall, and the chimney breast remains to the northeast corner of the room. The walls are plastered and painted, and the floor is carpeted. The room retains little of historic interest.

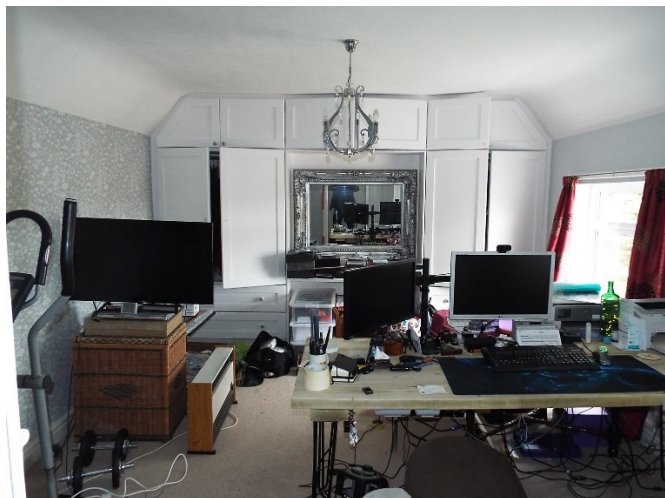
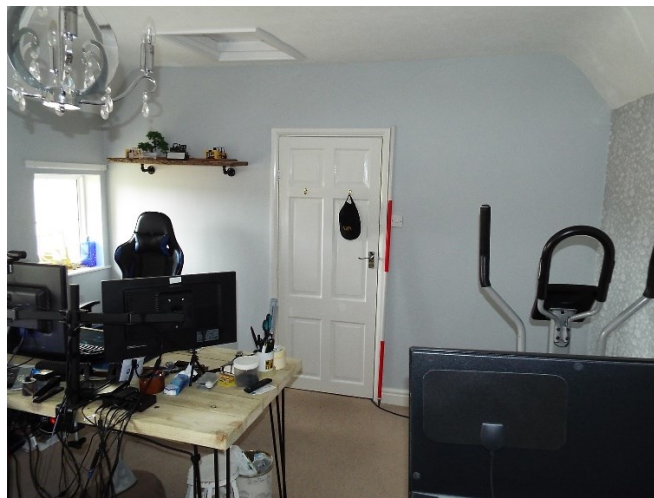
FF3 is situated to the west side of the 19th century northern range. It is sub-rectangular in plan, with chimney breast to the west wall and a modern window in the original window opening to the north wall. There is also a later inserted window to the east side of the north wall. Most recently used as a bedroom, the room is plastered and painted with carpet to the floor. There is a chimney breast west wall. This is likely to have been one of the primary bedrooms, indicated by its location and size.

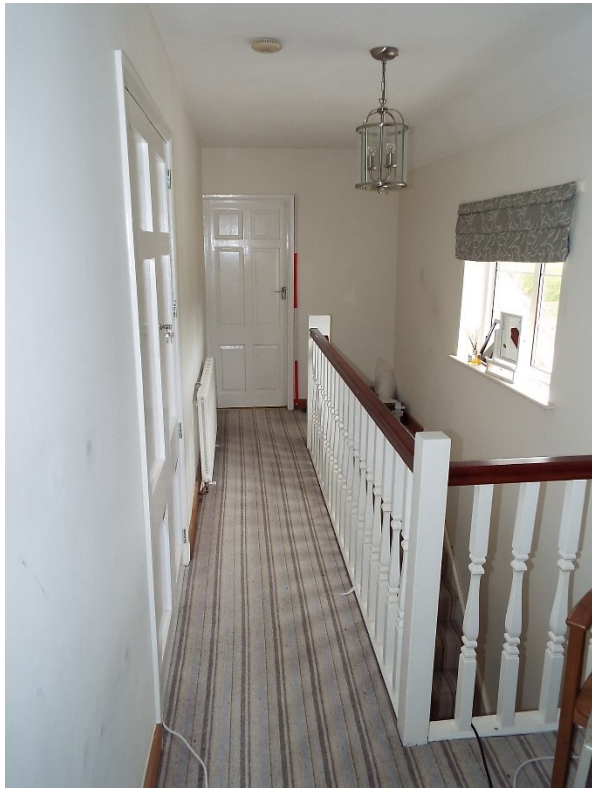
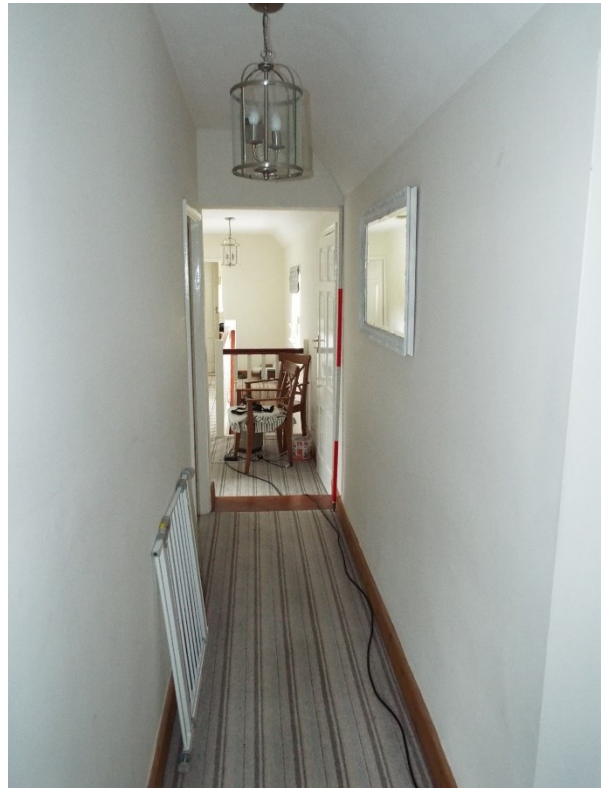
The upper landing is situated to the west of FF1 and FF2, extending along a north-south axis (Figures 49, 50). It was potentially formed at a later date with the insertion of a partition wall. It is at a slightly raised level, with shallow timber step in the location where the 1970s extension adjoins the 19th century range. The lower landing is to the centre of the 1970 extension. It extends along a north-south axis and provides access to a storage cupboard, bedrooms FF4 and FF6 to the east and bedroom FF5 to the south.

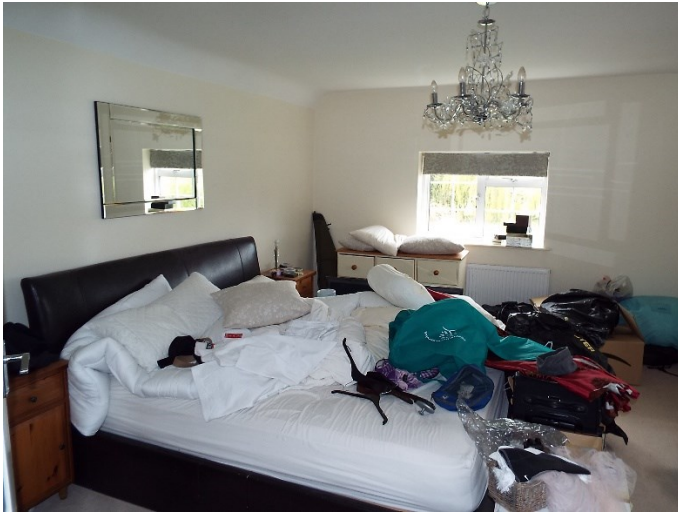
Figure 53. Ph 229. FF5 facing southwest

FF5 is a bedroom, which occupies the southern end of the 1970s extension. Square in plan form, with ensuite bathroom (FF6) to the northeast. The walls are plastered and painted, the floor is carpeted. There

is nothing of historic interest. FF6 is a modern ensuite in the 1970s extension. It contains a modern bathroom suite. The walls are plastered and painted with tiles around the bath and a tiled floor. There is nothing of historic interest.

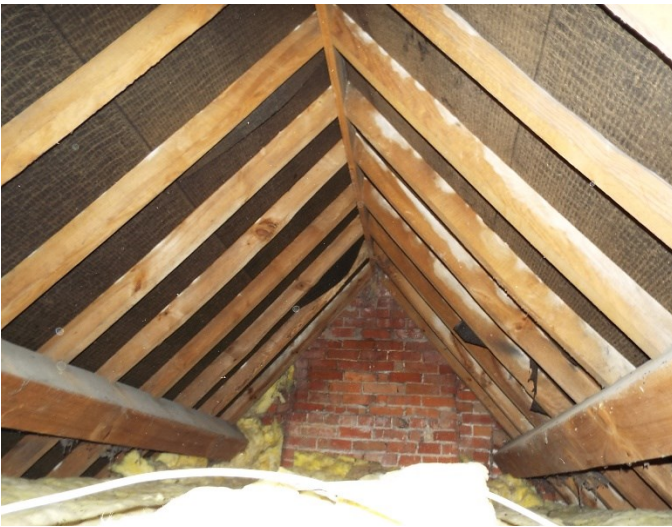
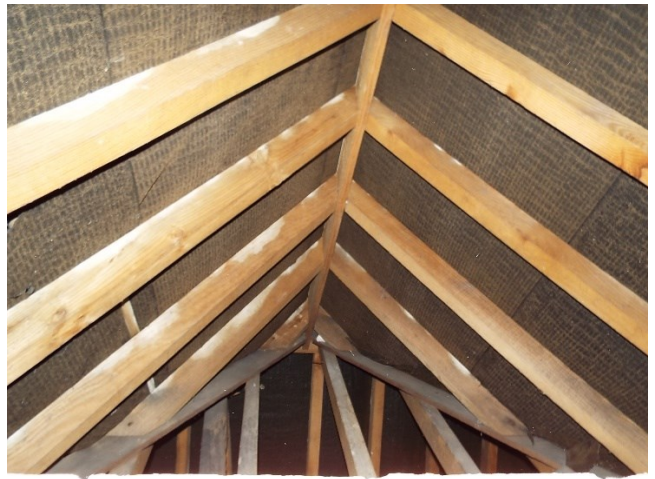
Only limited access to the roof structure was possible; a small section of the roof structure to the over FF3 was accessible and photographed. The timber rafters appeared to be 20th century, and the owner confirms that he thinks it was re-roofed after sustaining damage in the 20th century. The brickwork to the east may be original or partially original.

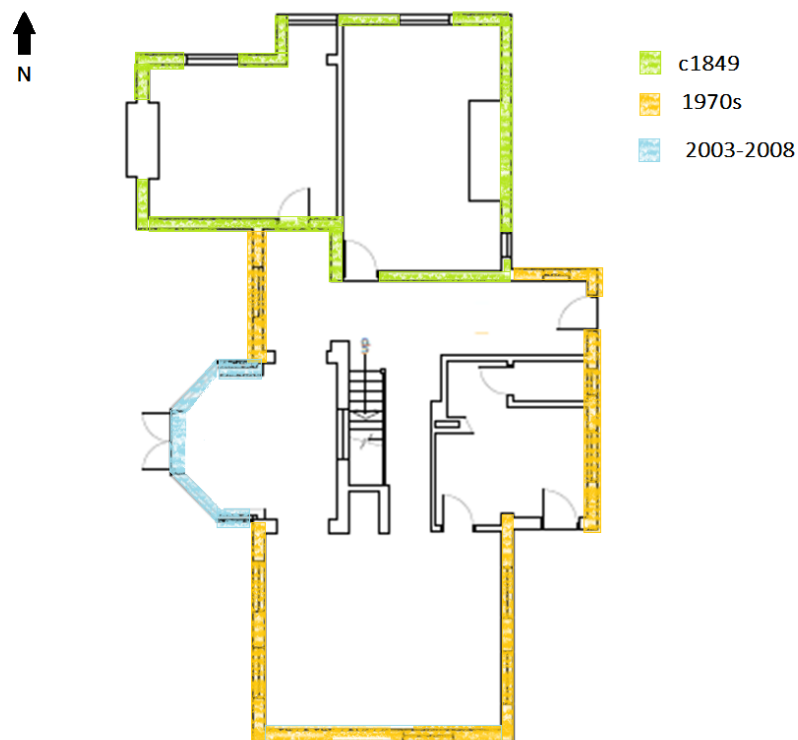
Figure 59. Phasing plan

Today, two phases of the structure remain, dating to the 19th and 20th centuries. The main fabric of the range to the north dates to the 19th century, presumably c 1849. Although it should be noted that the windows, roof structure and covering and possibly the chimney to the west elevation are 20th century additions.

To the south, the extension was added in the 1970s. In 2002 the line of the roof to the later extension was adjusted and dormer windows were added. The conservatory was added between 2003 and 2008.
