BAT & BIRD SURVEYS
Forge Farm, Bestwood Village

September 2020

Site Name:	Forge Farm
Document Number:	FFE-558-V1
Project:	Residential Development
Central OS Grid Reference:	SK 550 471

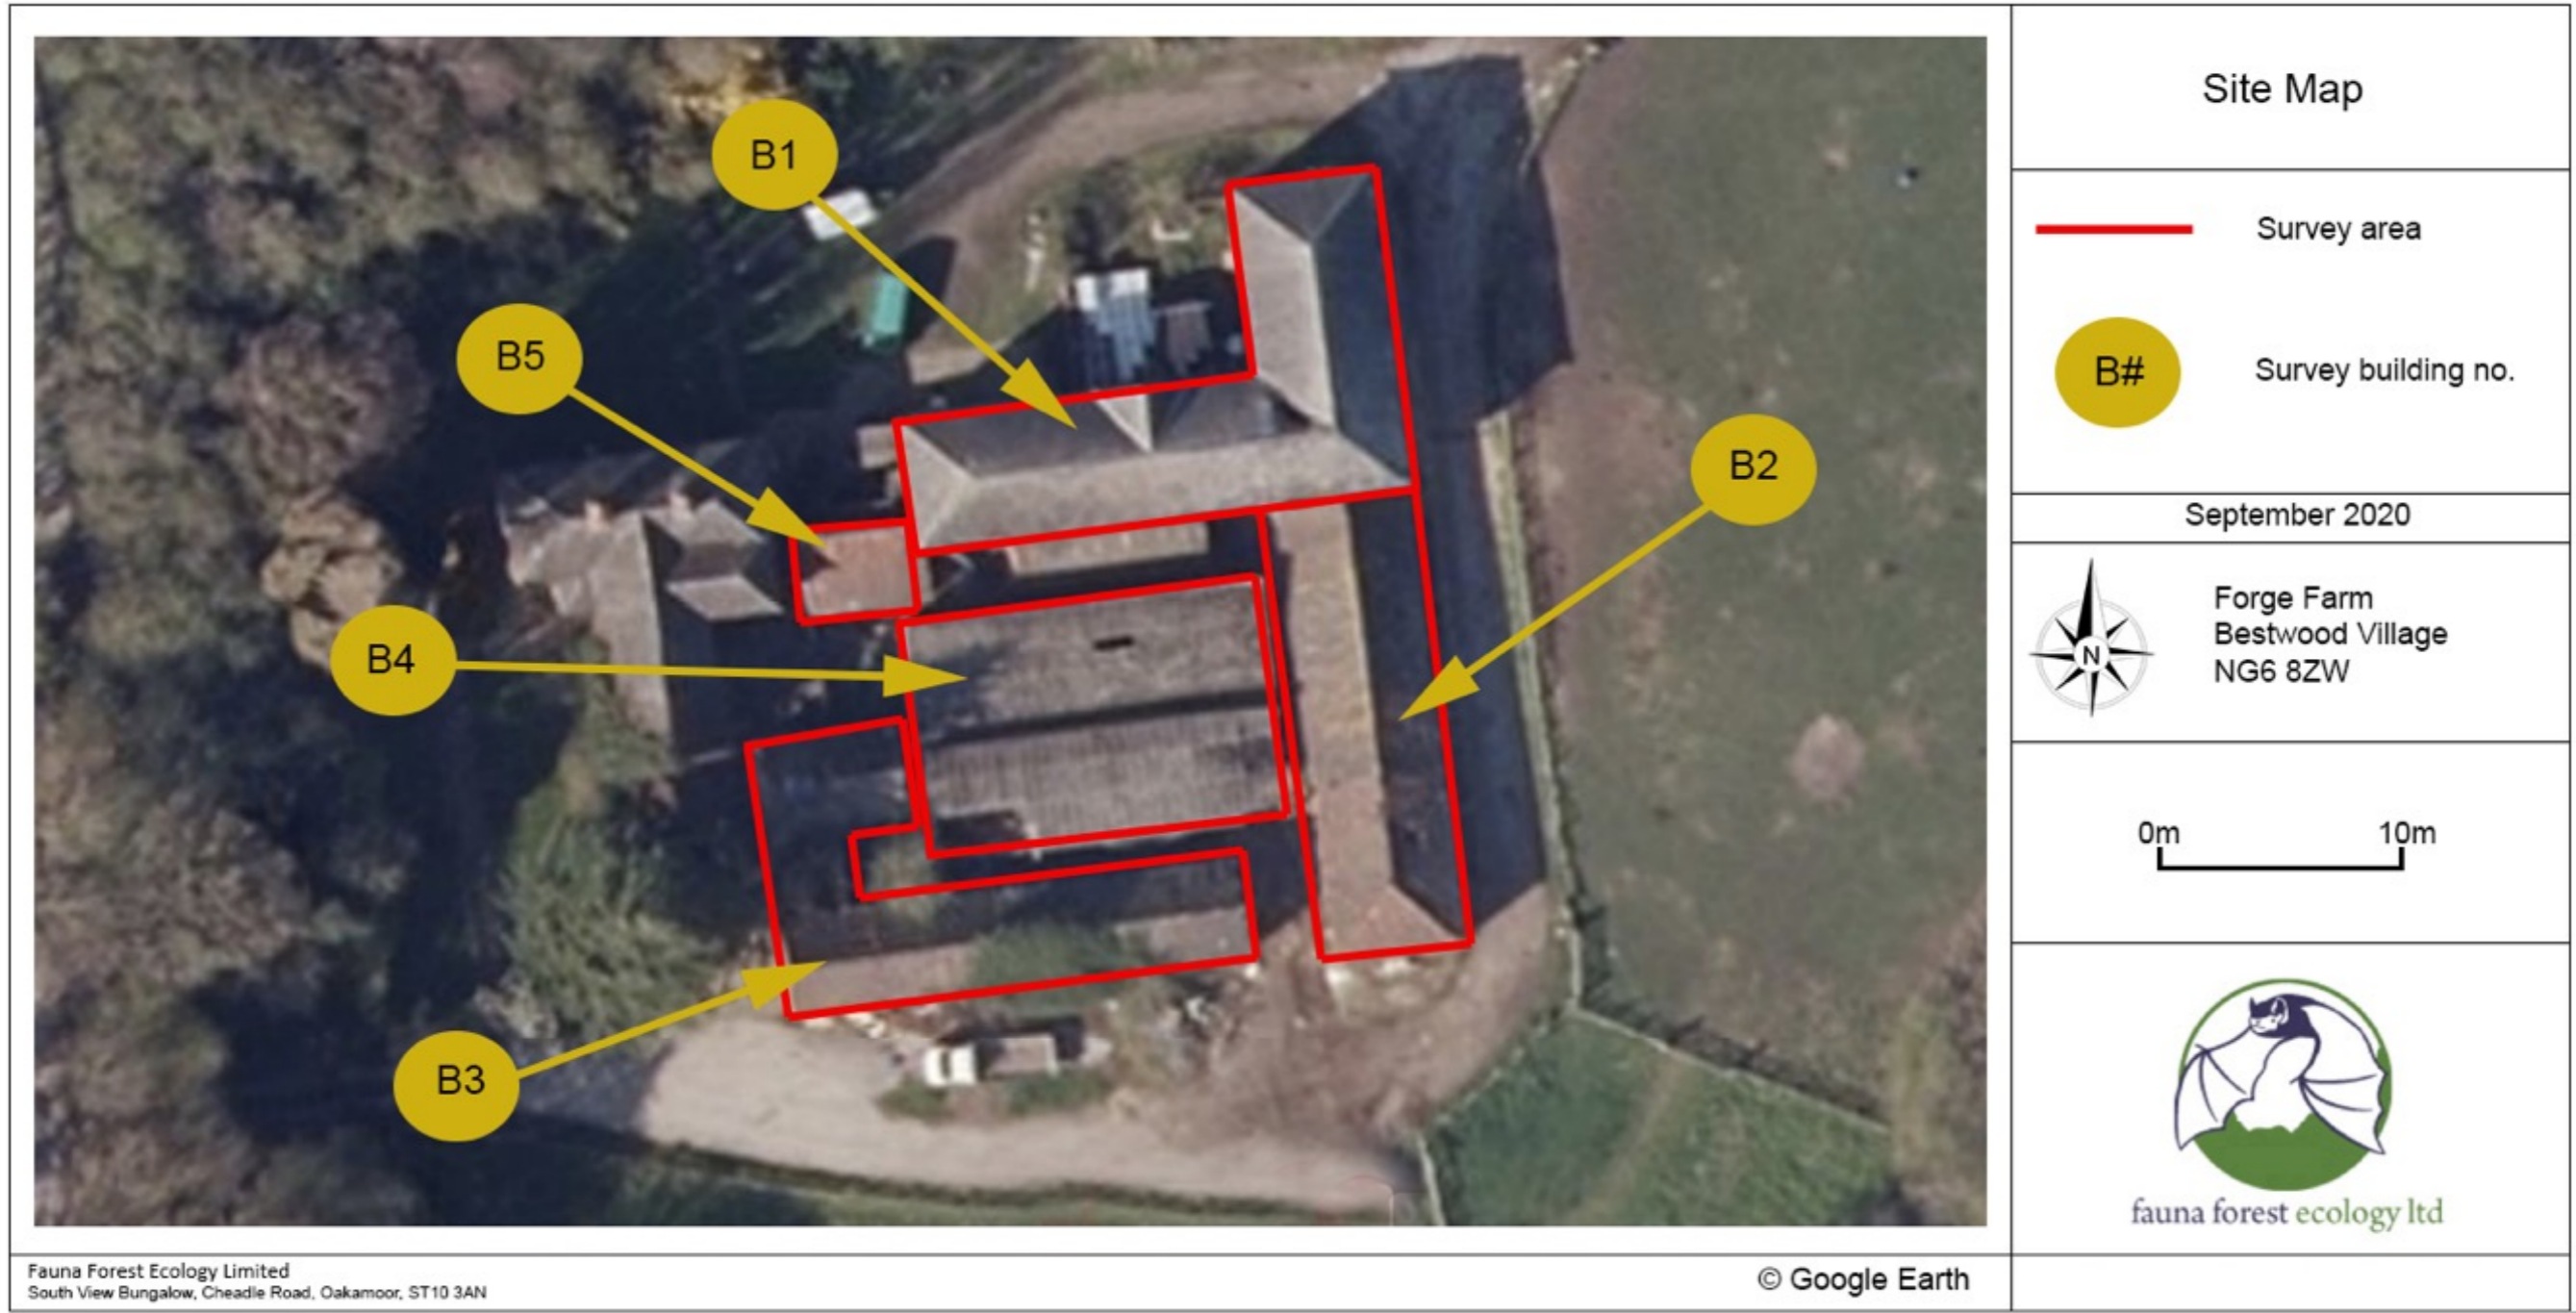
Figure 2: Site Map

- 1.4 The site comprises a farmhouse that is currently occupied, as well as a series of agricultural buildings, including barns, cow sheds and stables. The farmhouse is not part of the development. The survey buildings are referred to as B1, B2, B3, B4 and B5.

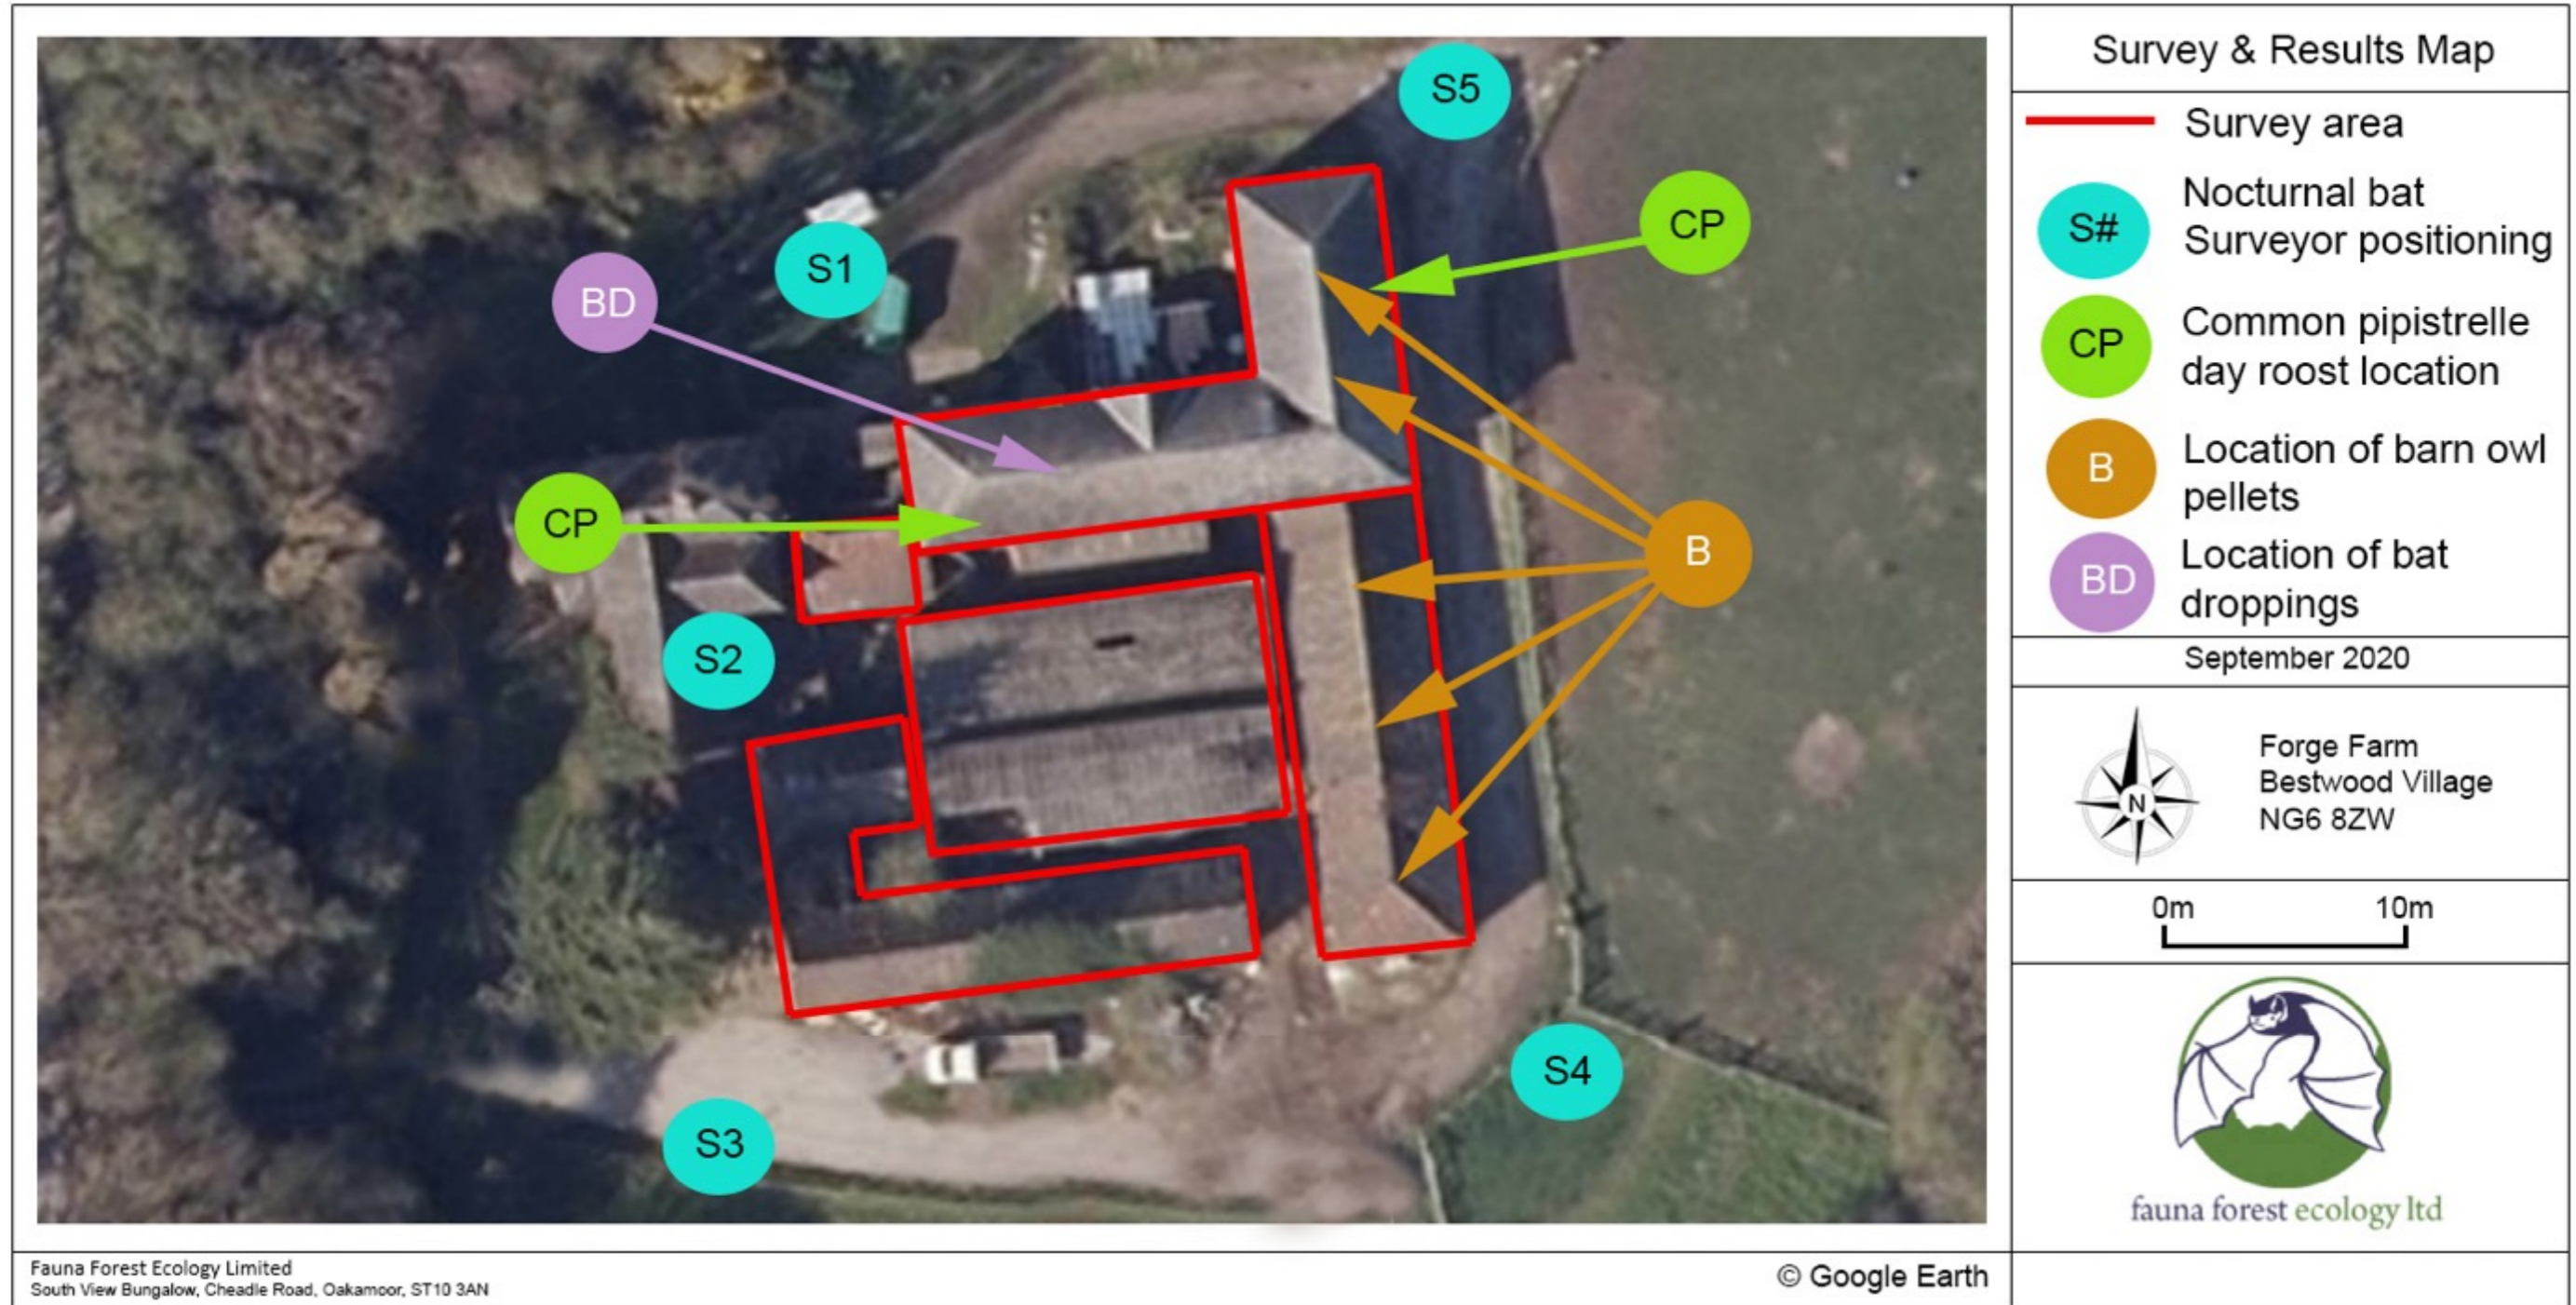
Figure 3: Survey & Results Map

- 3.5 Bat droppings and butterfly wing feeding concentrations were found on the second floor of B1 during both daytime site visits (Figure 3).

- 3.15 Barn owl pellets of various ages were found across the first-floor area of B1 as well as on the ground floor area of B2 (Figure 3). Based on their indicative characteristics (including their dark colour and soft moist texture), some pellets were considered to be fresh, and many others were thought to age from

3.21 Activity by bats was considerably lower in comparison with previous surveys. Periodic distant commuting common pipistrelle call registrations were logged. Although the bats were not seen, these calls were thought to be produced by individuals using the tree lines further beyond the southern site boundaries. One common pipistrelle was observed re-entering beneath a raised tile on the south facing roof pitch of B1 at 05:44 (Figure 3).

- 4.6 Over the course of the surveys, a total of two common pipistrelle day roosts were identified. They included a roost used by two individuals located on the south facing roof pitch of B1, and a roost used by one individual located on the east facing roof pitch of B1. No feeding behaviour by brown long-eared bats was observed during the surveys.

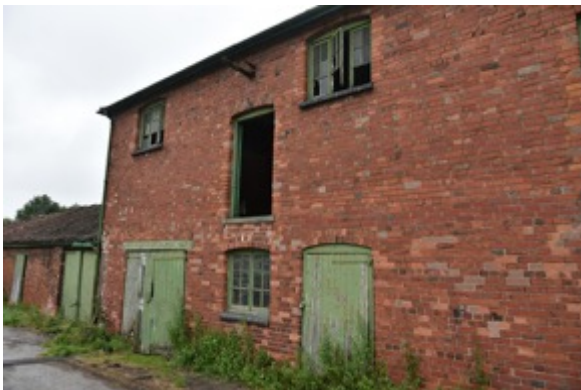
- 3.3 This is a brick-built building that is three stories in height with a timber-framed traditional hipped roof that is clad with clay tiles. There is a north-facing gable-type pitched roof built within the roof complex. The building is edged with plastic guttering and timber fascias, and the eaves are overhanging. The building is subdivided at ground level into multiple elements; mostly by brick partitioning walls. There are no cavity walls throughout, and the floors are all concrete at ground level. The timber ceiling joists are exposed and visible from ground level. The west-facing section's upper levels can be accessed by steps leading from the outside area near the farmhouse. Access to the east facing section that runs in a north – west direction can be achieved using ladders via a large open window at first floor level.

- 3.4 Multiple Potential Roosting Features (PRFs) were identified during the survey. They include gaps between the roof tiles, areas where the mortar has failed along the ridge, and other small niches between the fascia and eaves area. There are very many options for bats to enter the building, such as through broken windows, via raised and dislodged tiles, and also at eaves level.

Image 1: East facing side aspect of B1

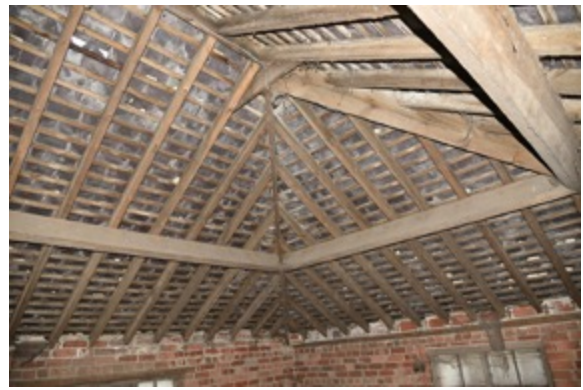
Image 2: Internal roof structure of B1

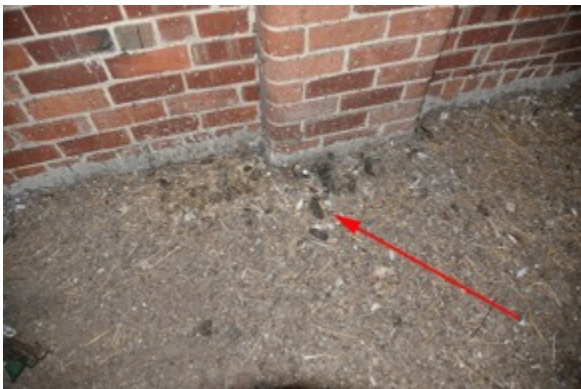
Image 3: Barn owl pellets in B1

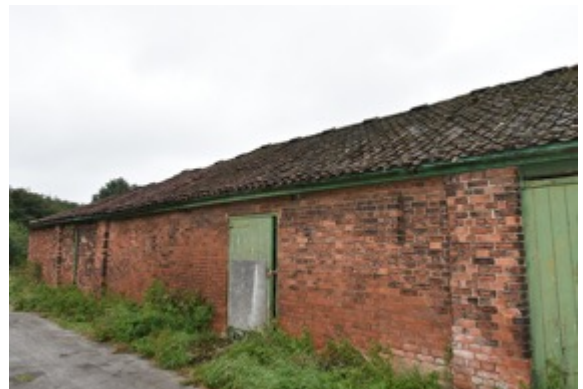
- 3.6 This is a rectangular-shaped brick building with a timber-framed traditional hipped roof that is clad with clay pantiles. The building is single storey in height and it is open to the elements with clear view up to the apex from ground level. It is edged with timber fascia and there is a series of ventilation gaps below eaves level. There is no cavity wall, no roofing felt, and there is a partitioning wall dividing the building into two separate elements.

- 3.7 The roof is in a poor state of repair with very many exposed gaps between the timbers. Numerous tiles are slipped, broken, and over time have become dislodged. These openings would provide ample access for bats to enter inside the building. Internally, several PRFs were observed. They include settlement cracks in the brickwork, crevices that have formed between roof timbers, as well as the many gaps between the tiles and roof timbers. Other suitable roosting features include exposed gaps above windows / lintels and openings beneath the ridge tiles where bedding mortar has failed.
- 3.8 No evidence of bat roosting was discovered in this building.

Image 4: East facing side aspect of B2

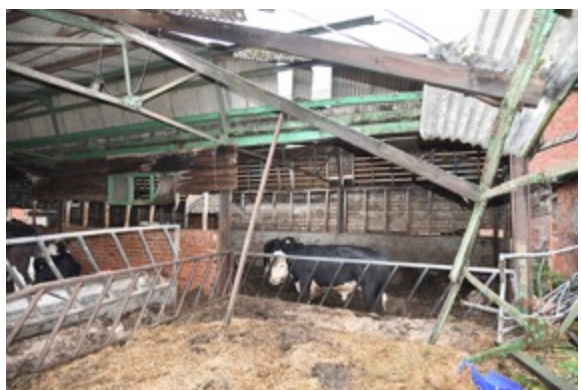
- 3.12 B4 consists of two steel-framed cow sheds that are clad over with corrugated roof sheeting. Cows were present during both daytime building inspections and the floor area was covered with detritus. These buildings lack suitable PRFs for bats and no evidence of bats was found during the surveys.

Image 5: B4 (cow sheds)

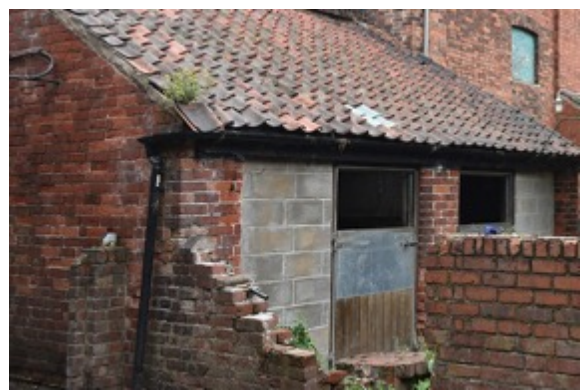
- 3.13 This is a small horse stable that was constructed using a mix of brick and concrete. The roof is mono-pitched, there is no roofing felt or cavity and it is clad with clay pantiles. The building is edged with plastic guttering and timber fascia, and the structure itself adjoins the western side of B1. Horses were present inside the building during the surveys.
- 3.14 Gaps between the clay pantiles provide suitable roosting opportunity for bats.

Image 6: B5 (horse stables)
