Report : Bat Dusk Emergence Surveys:  
Buildings at the Lord Hill Hotel,  
Abbey Foregate, Shrewsbury SY2 6AX

Reference : SYH/2401/20.1

Date : 25<sup>th</sup> October 2020

Proposed : Conversion with some demolition of modern extensions  
development

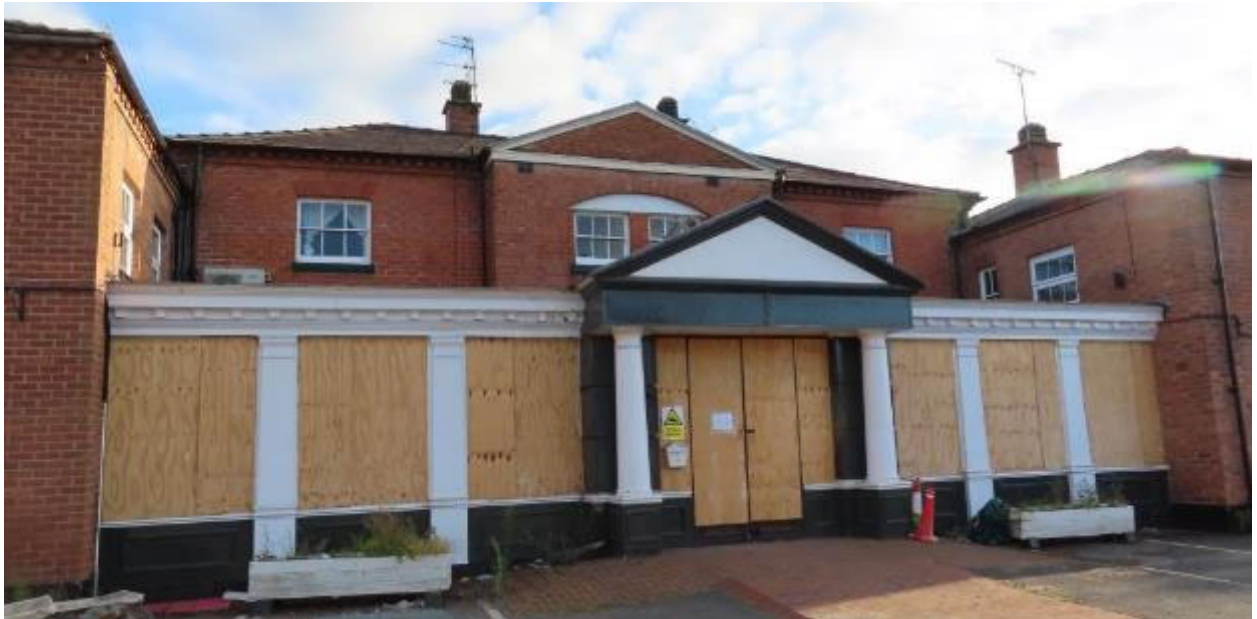
**Photograph 1.**

View of the central part of the Northeast elevation of the original part of the Lord Hill Hotel building.  
Looking southwest from northeast.

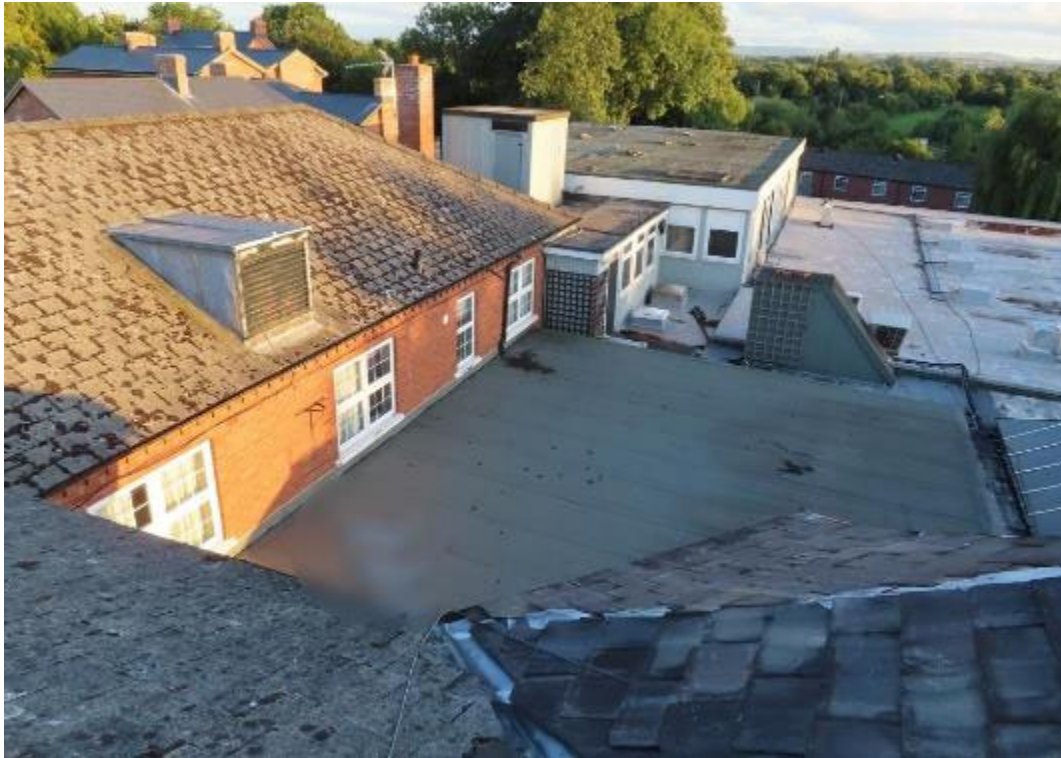
**Photograph 3.**

Left, lower centre and lower right: parts of the northeast-to-southwest and central roof structures of the original part of the Lord Hill Hotel building.

Mid-ground centre, upper centre and upper right: roof structures of modern-type extensions.

Looking south from north.

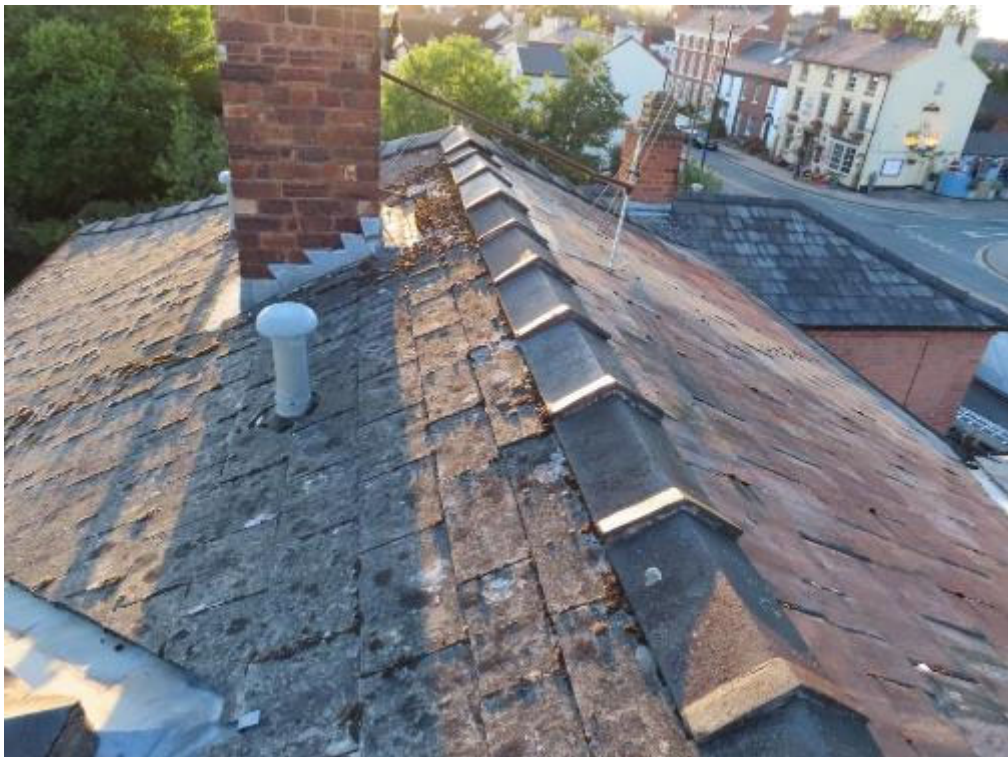
**Photograph 4.**

View of parts of the west roof structures of the original part of the Lord Hill Hotel building.

Looking northwest from southeast.

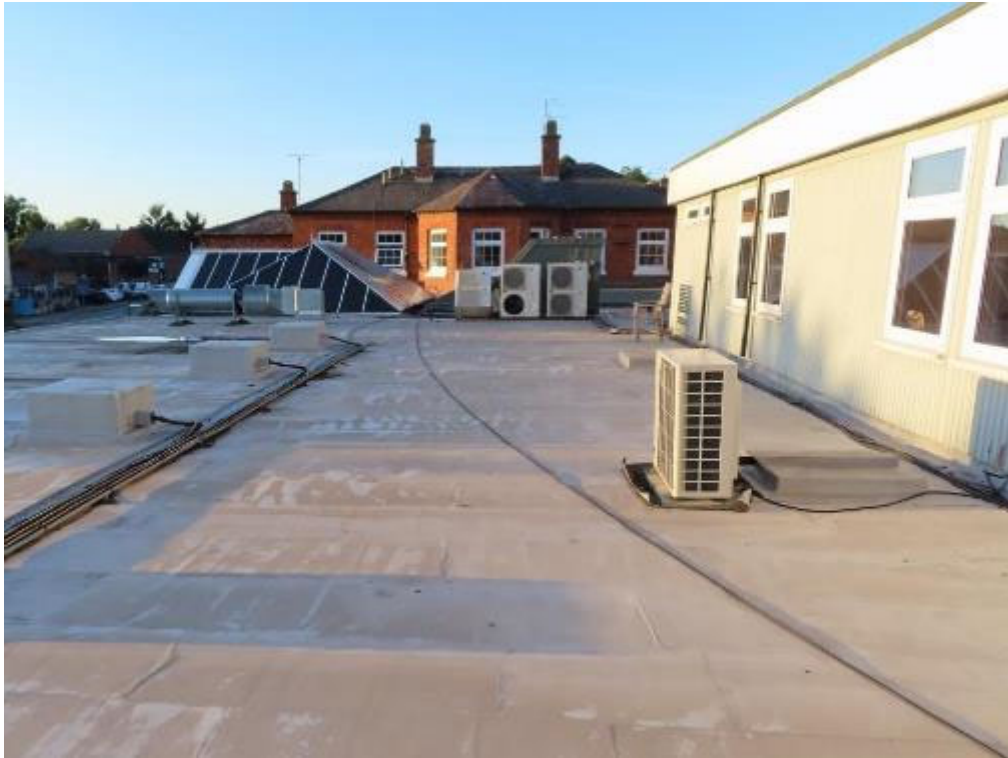
**Photograph 5.**

Lower: parts of the modern-type extensions.

Upper: part of the southwest elevation of the original part of the Lord Hill Hotel building.

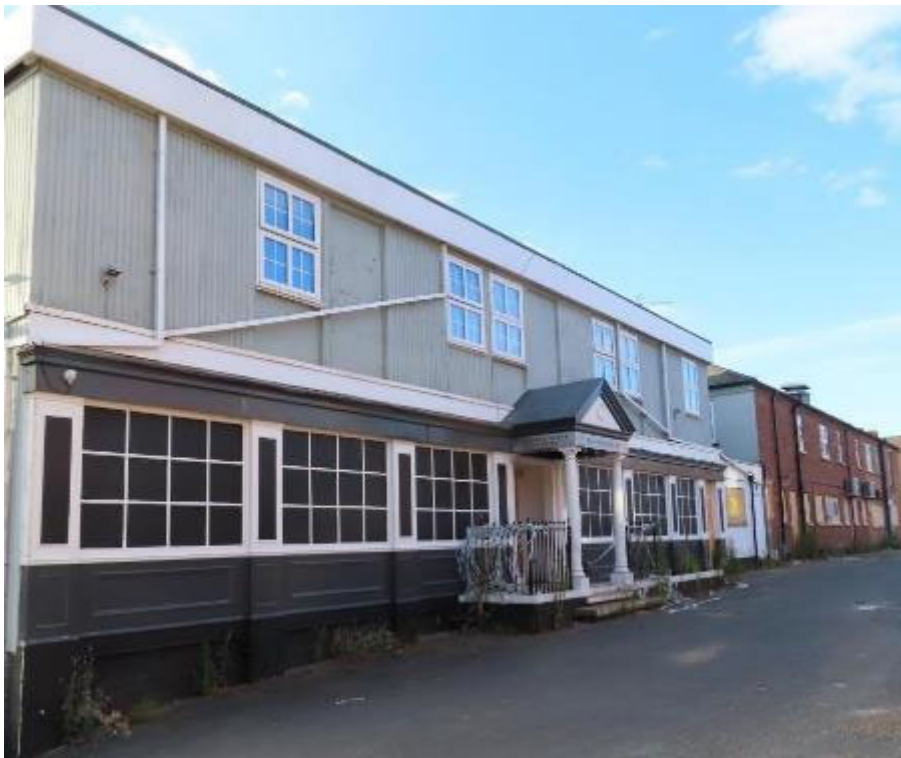
**Photograph 6.**

Left and centre: Southeast elevation of part of a modern-type extension.  
 Left: Southeast elevation of the original part of the Lord Hill Hotel building.  
 Looking north from south.

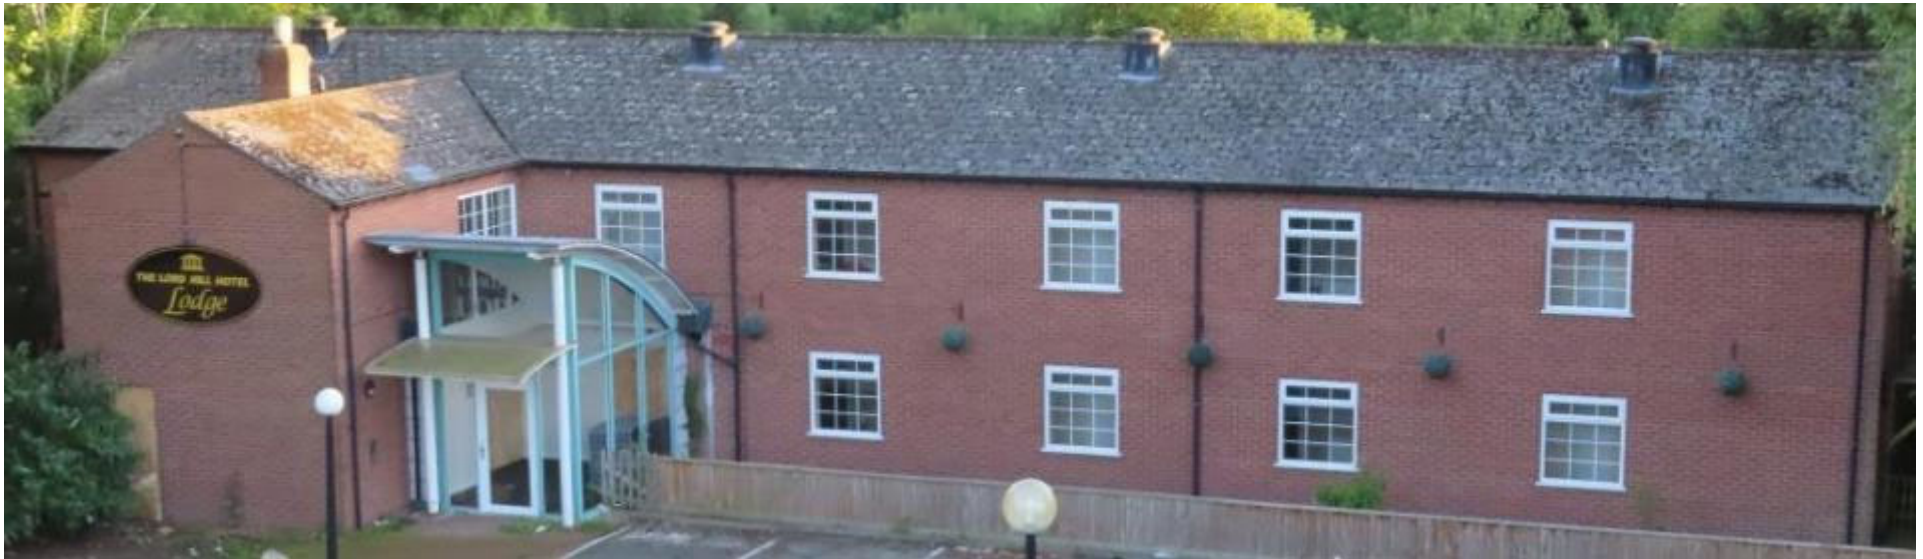
No physical evidence of bat was found, and no potential bat roost features were identified.

**Photograph 7.**  
North east elevation of the 'Lodge'.  
Looking south from north.
