# Intrusive Ground Investigation Report

18 Iron Bridge Close  
London  
NW10 0UF

E7119a

Environmental  
Management Solutions  
24<sup>th</sup> July 2017

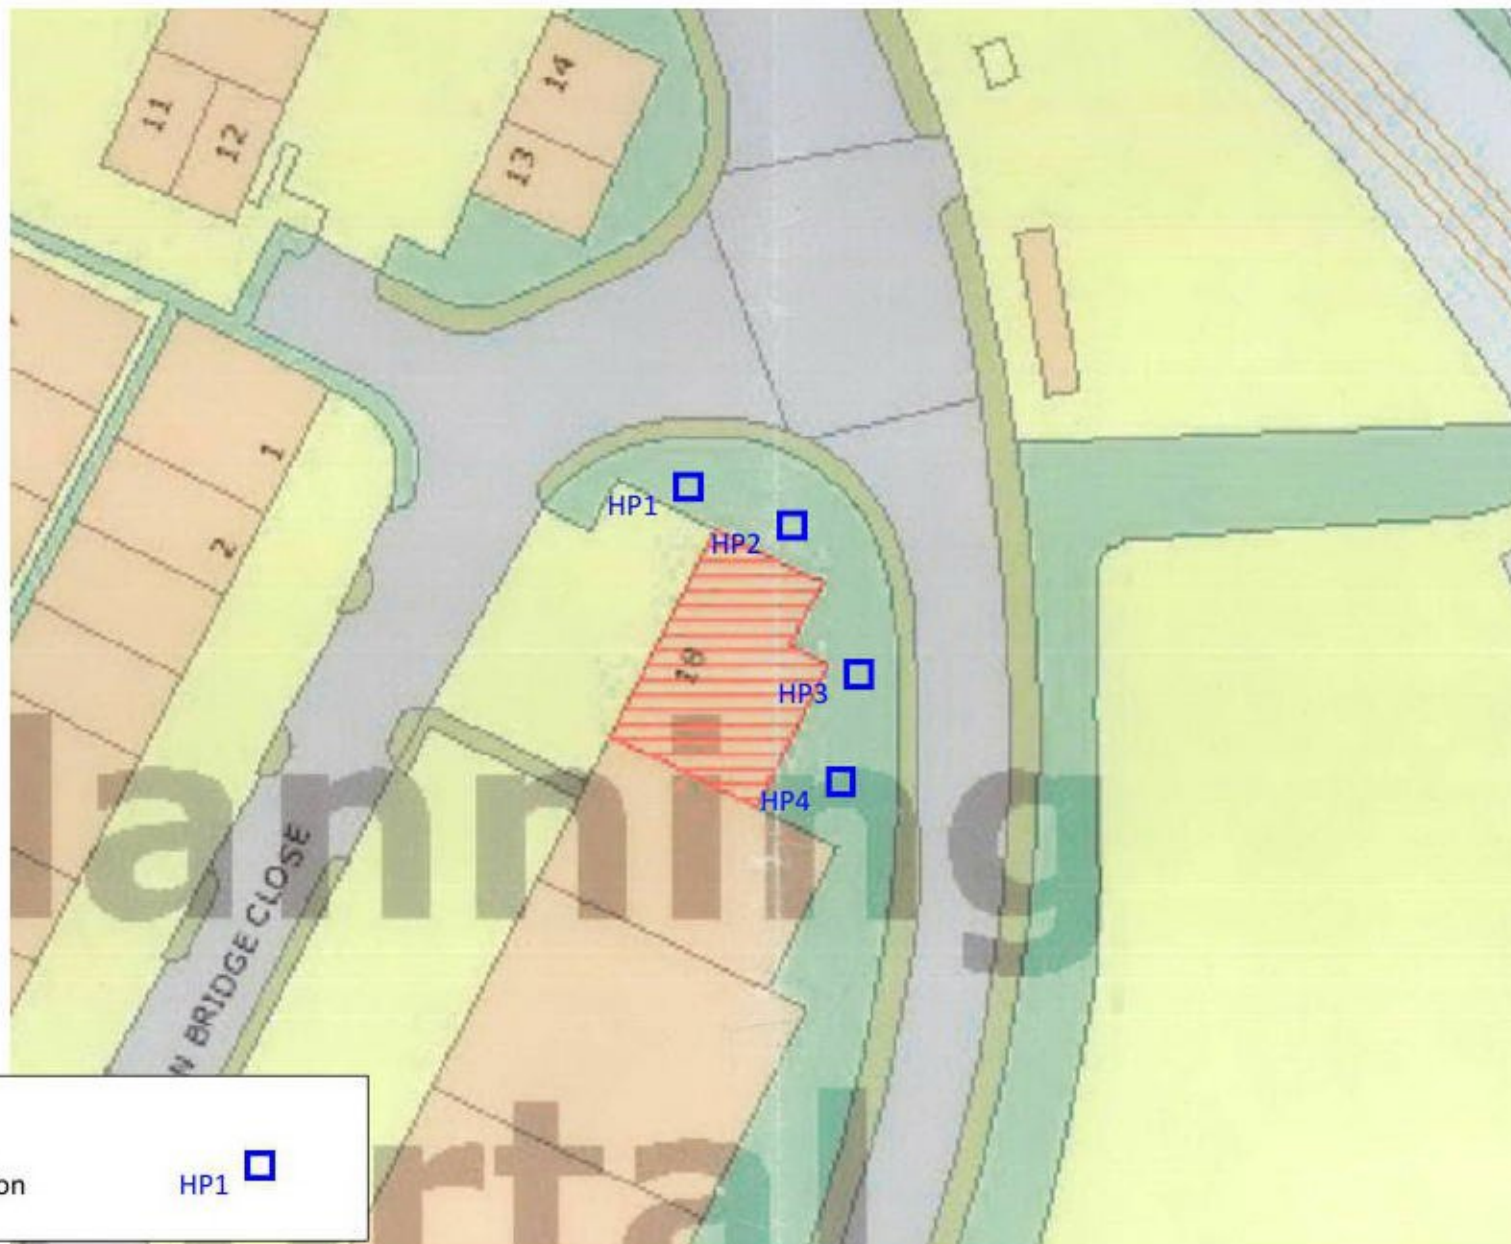
Exploratory Hole Location Plan

The locations of the trial pits are indicated on the exploratory hole location plan included as Appendix B.

Four hand excavated trial pits (HP1 to HP4) were excavated across the site on 4<sup>th</sup> July 2017. The trial pits were excavated to depths of between 0.80 m and 1.00 m.

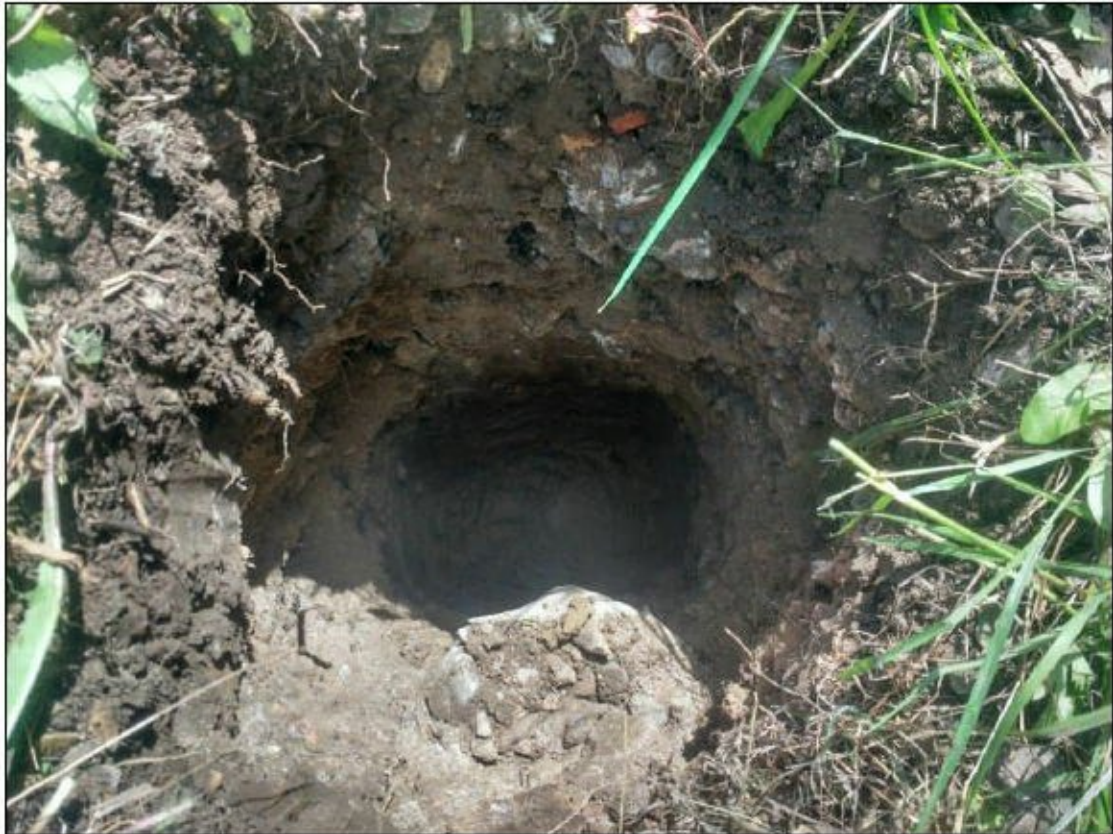
HP02 excavation

(0.15)	MADE GROUND: Brown silty gravelly fine sand occasional rootlets. Gravel is medium angular stone.		
			0.15

(0.25)	MADE GROUND: Light brown silty very gravelly fine sand. Occasional gravel-size concrete, fine gravel-size ash and cobble-size brick and concrete. Two pieces of thick plastic sheet.		
0.40								
0.70	D

(0.25)	MADE GROUND: Grey brown slightly gravelly clay with occasional gravel-size ash.		
		0.65

(0.15)	Stiff grey and orange-brown CLAY. (London Clay Formation)			
0.80

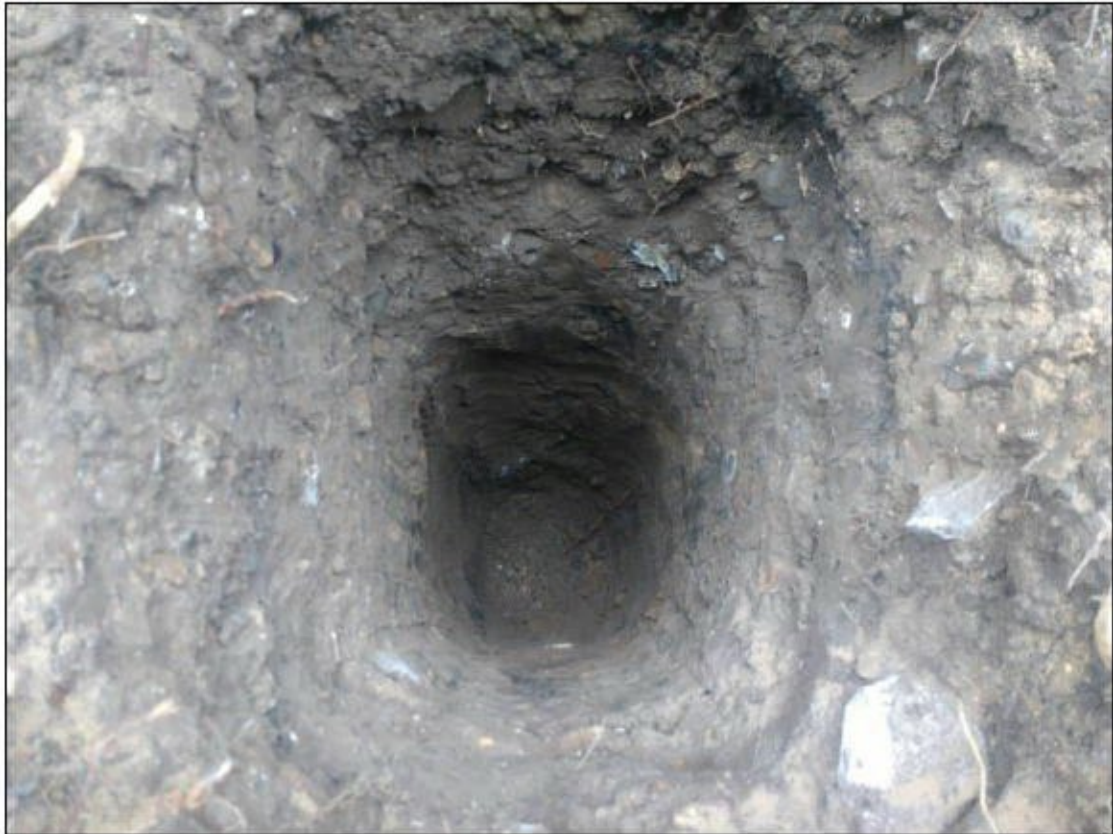
HP03 excavation

(0.05) 0.05	Concrete paving slab.

(0.05) 0.10	MADE GROUND: Yellow slightly gravelly medium sand. Gravel is fine sub-angular flint.

(0.30) 0.40	MADE GROUND: Brown silty slightly gravelly fine sand with occasional gravel-size ash, brick and concrete. Gravel is fine to medium sub-angular flint.

(0.35) 0.75	MADE GROUND: Dessicated brown very sandy slightly gravelly clay with rare gravel-size brick. Gravel is fine and medium sub-angular flint and rounded stone.		
0.80	D

(0.10) 0.85	Stiff yellow-brown slightly sandy slightly gravelly CLAY. Gravel is medium sub-angular flint and rounded stone.

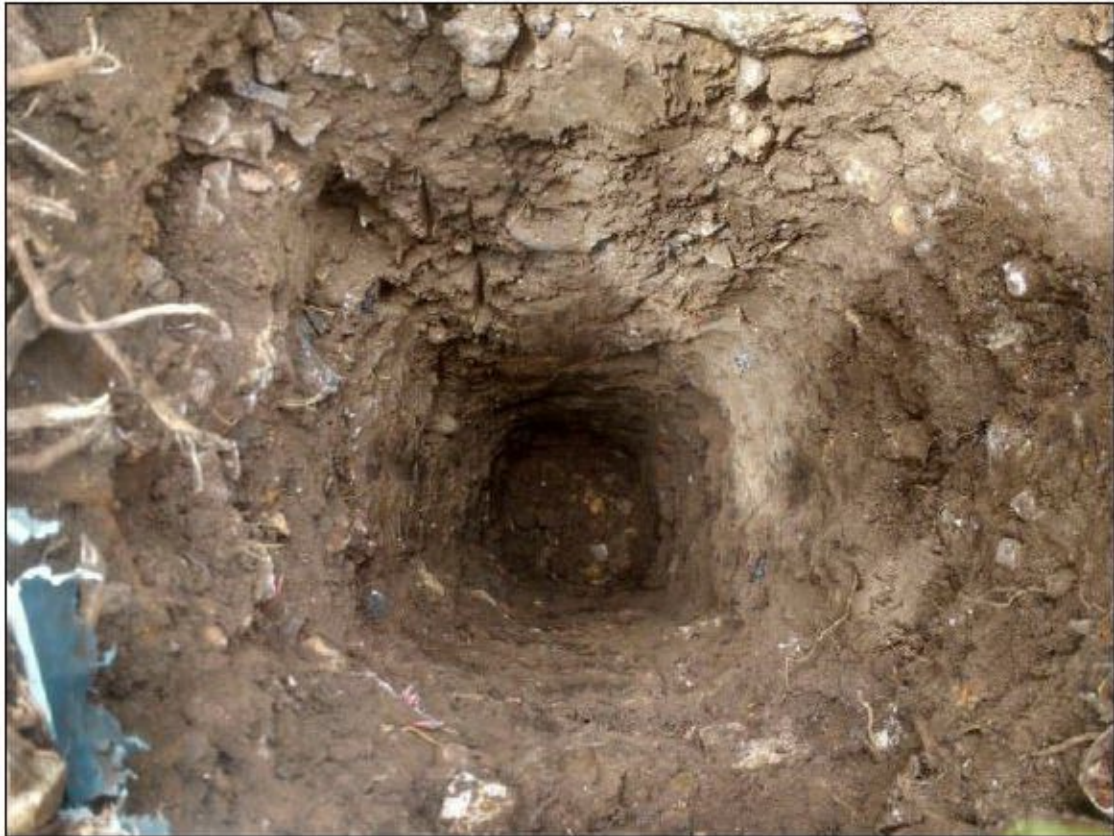
HP04 excavation

Strata considered to represent the London Clay Formation were encountered directly beneath the Made Ground and to the base of all trial pits except HP4 where the Made Ground was not fully penetrated.
