PRELIMINARY ROOST ASSESSMENT REPORT

Lodge Farm
Common Lane
High Catton
York
YO41 1EW

Reference no: CE0994

Title: Preliminary Roost Assessment Report

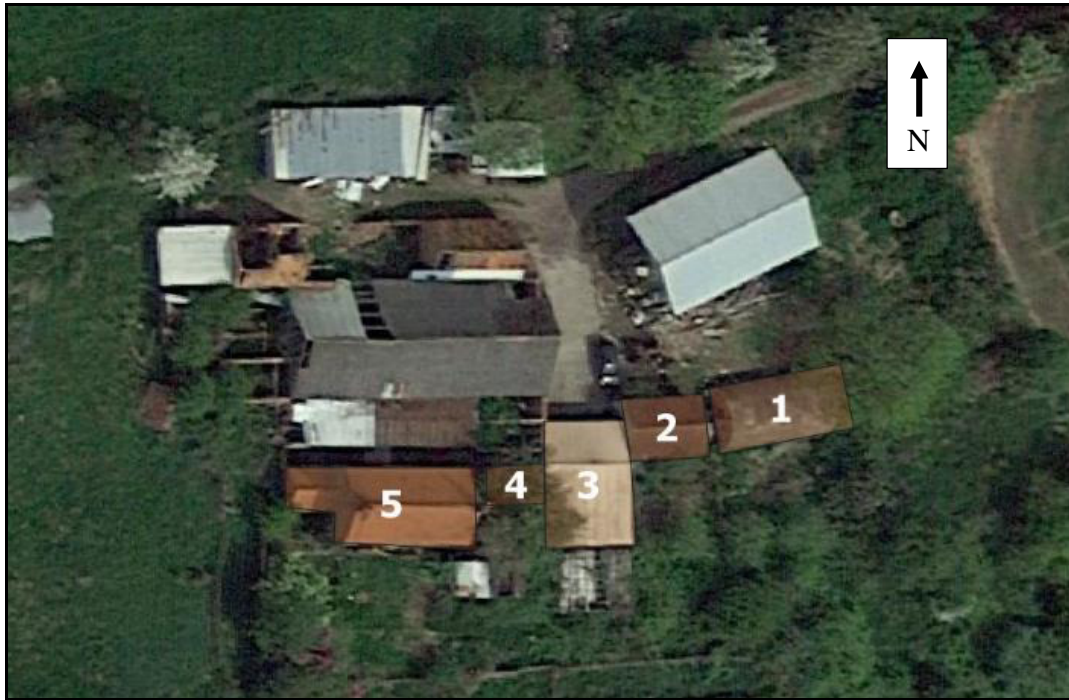
Figure 3. Site layout with the individual buildings numbered.

The study site consists of five buildings for the assessment, Buildings 1 and 5 are detached, whereas Buildings 2, 3 and 4 are connected by a central open fronted carport.

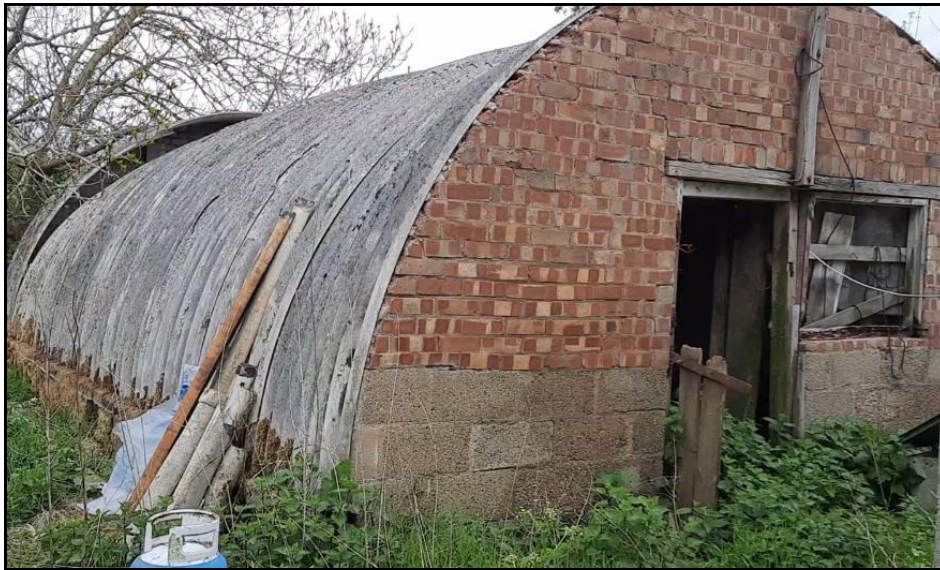
Building 1 is a former Nissen Hut which is in a poor state of repair, with the asbestos roof sheeting collapsing in on the building. The gables are constructed with a single skin brick construction. The western gable houses a rotten timber door frame and window with missing glass, offering gaps above the timber lintel. The verges between the asbestos sheeting and brick walls are not pointed and there are several cracks within each end wall, although the majority went right through the wall.

Plate 1 - Building 1 Western Gable.

From the observations made Building 1 was assessed as having Negligible to Low potential for bat habitation.

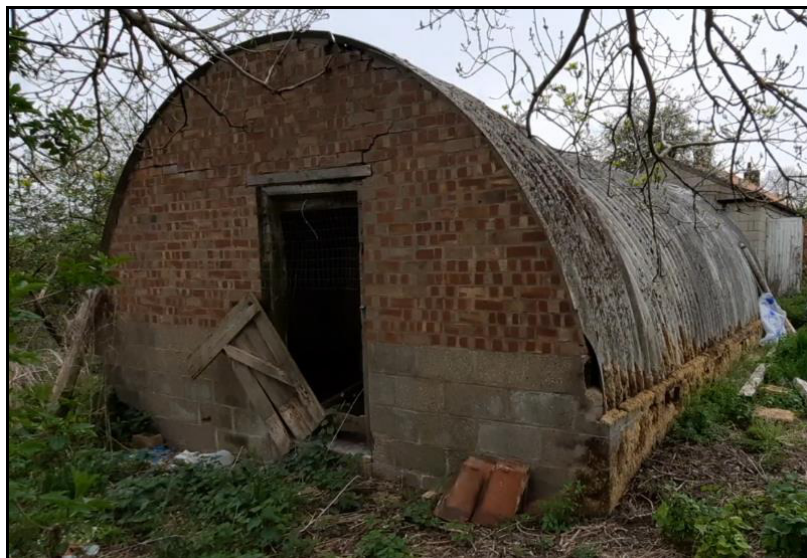
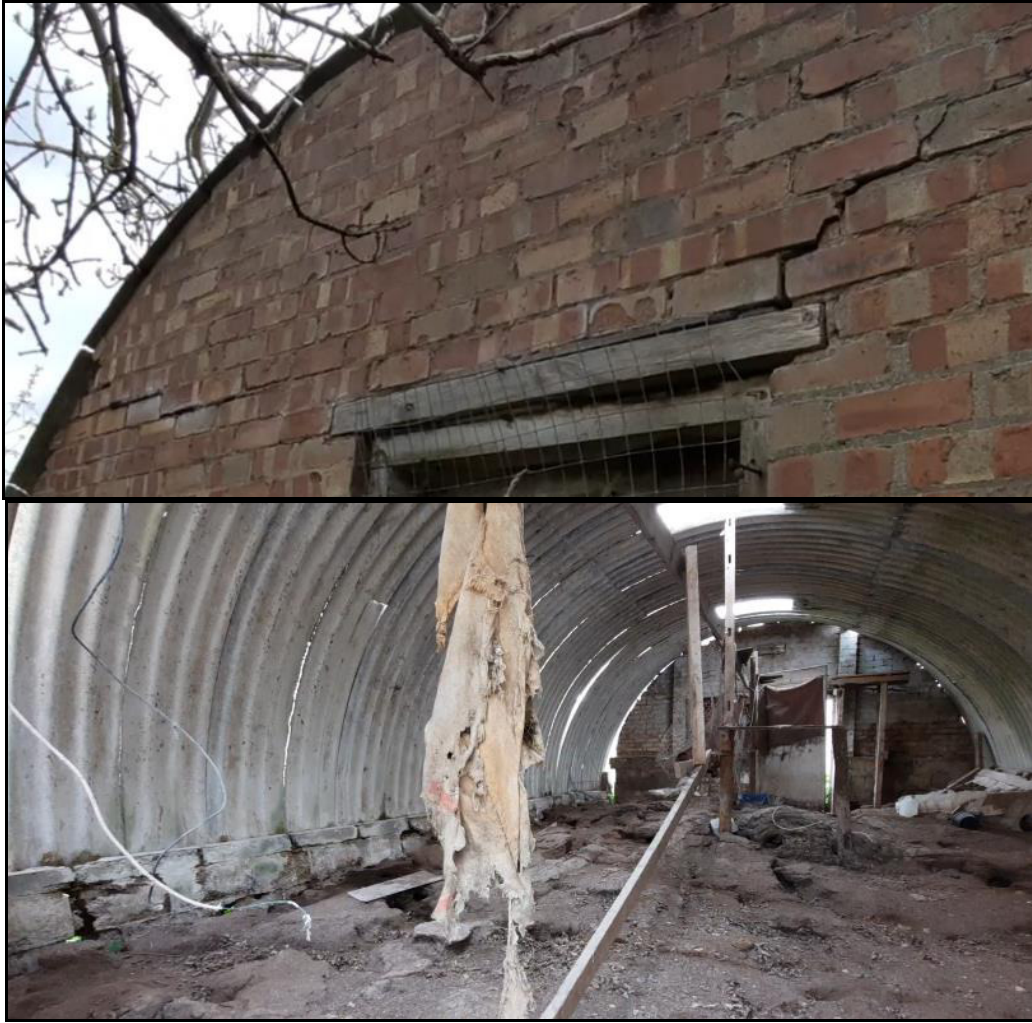
Plates 2a to c – Building 1 eastern gable with gap above the door frame, and the interior of the building.

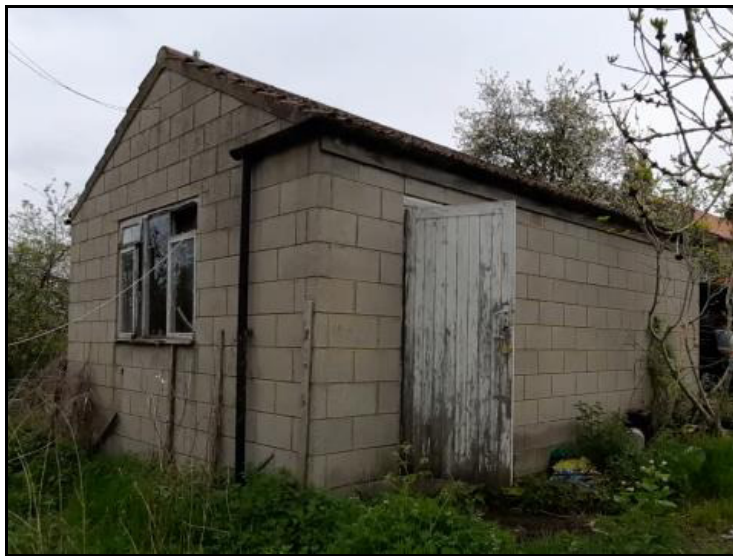
Plate 3 – Building 2 Eastern & north elevations showing broken glazing in the window allowing access into the interior.

There was no historical evidence of bat habitation at the time of the assessment and from the observations made Building 2 at this stage has been assessed as having Low potential for bat habitation.

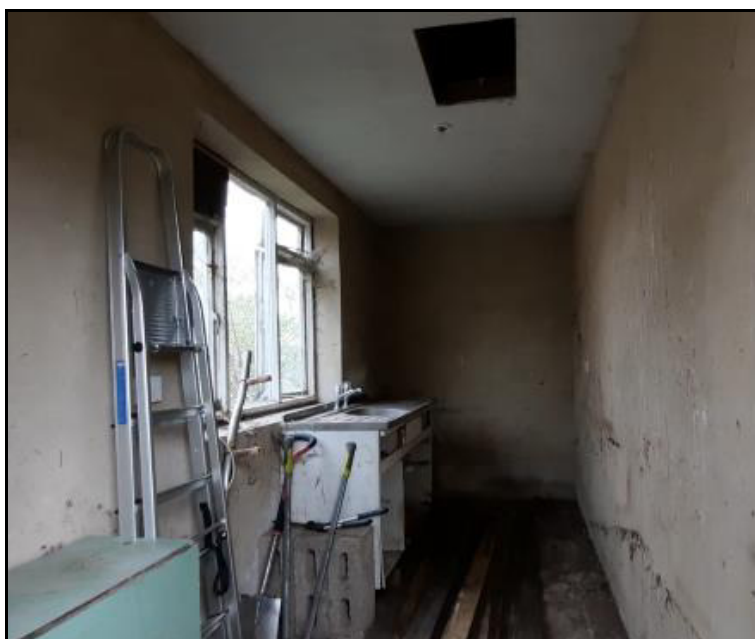
Plate 4 – Internal view on Building 2 showing the interior of the eastern room.

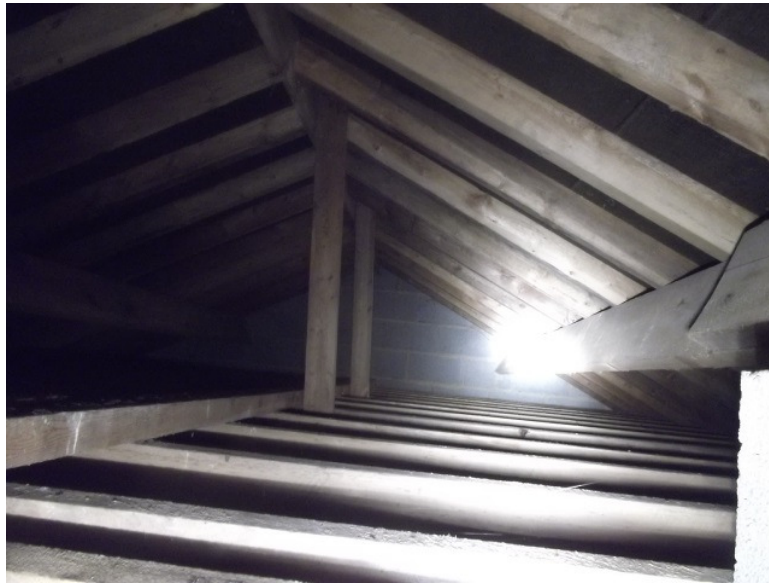
Plate 5 – Roof void which runs through over both rooms in Building 2.

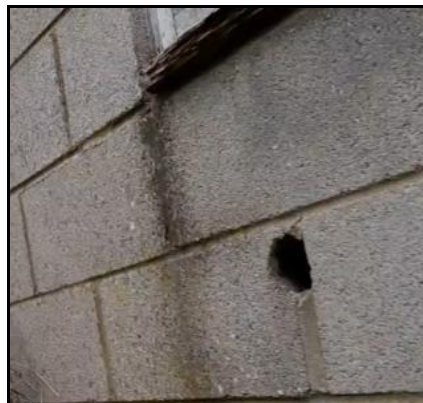
Plate 6 – Building 2 pipe hole allows access into the block wall cavity

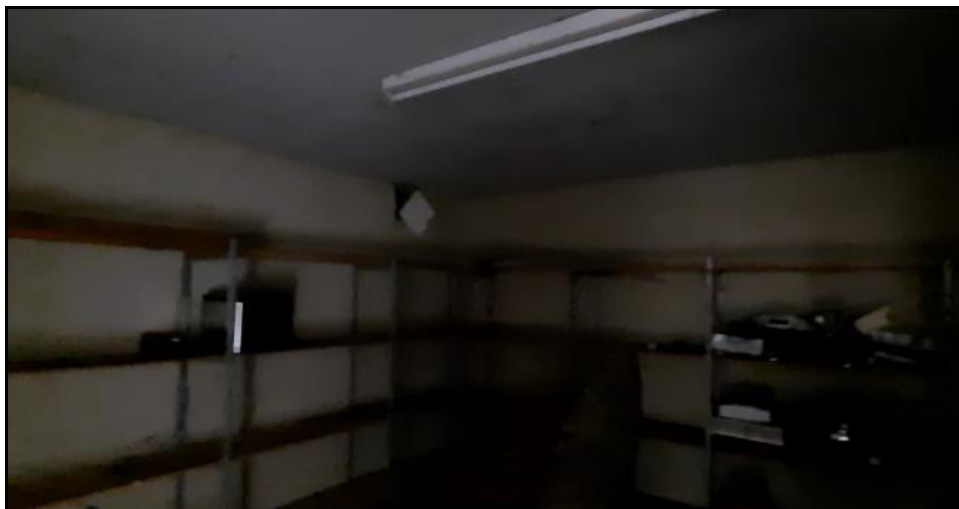
Photo 7 – Building 2 western room storage area showing the plasterboard ceiling.

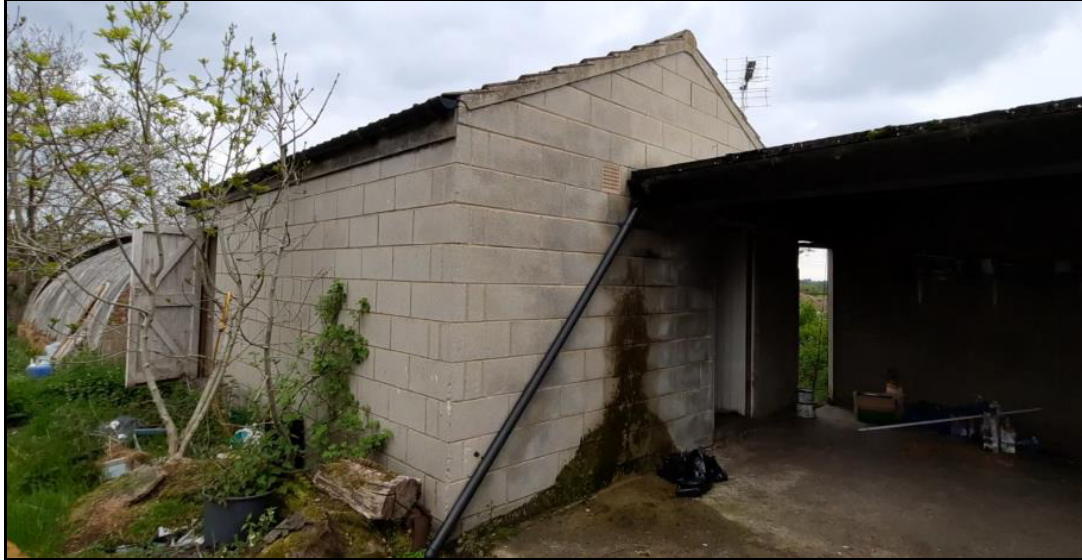
Plate 8 – Building 2 Western gable, the pointing on the verge is generally in good condition, apart from one area of missing pointing towards the ridgeline on the gable wall. The fascia boards are in good condition and well fitted to the blockwork, with no gaps noted. Also in the picture is the connecting carport that links Building 2, 3 and 4.

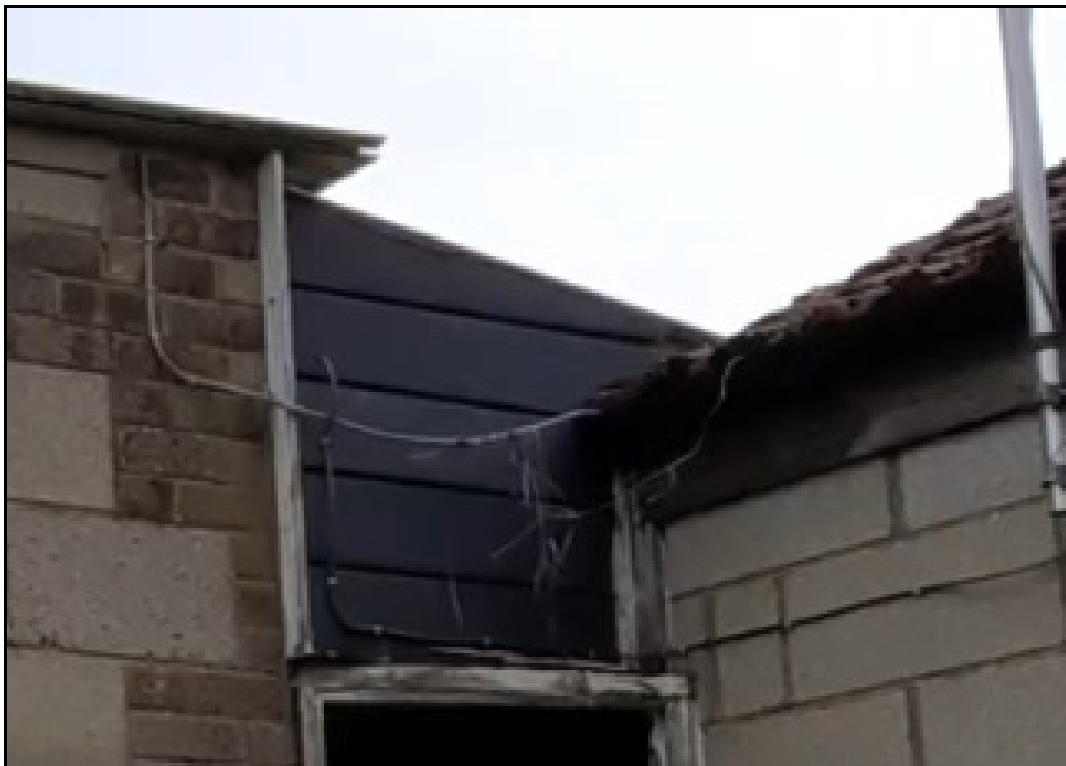
Photo 9 - The adjoining cladding for the carport is not pointed (screw fixed) with gaps to the under and connecting sides.

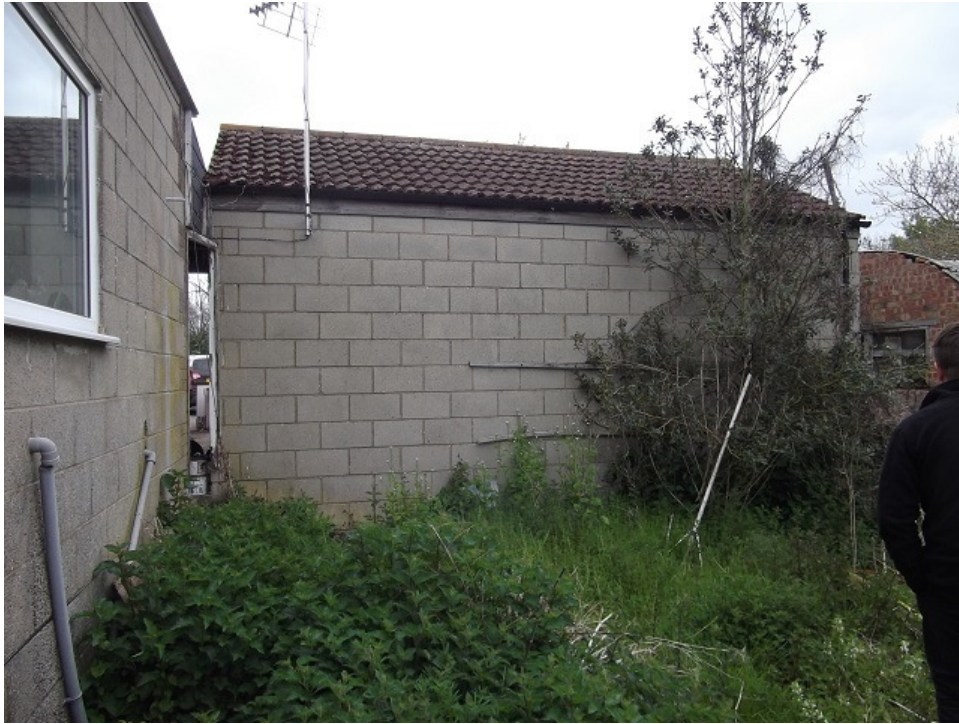
Plate 10. The south elevation of Buildings 2.

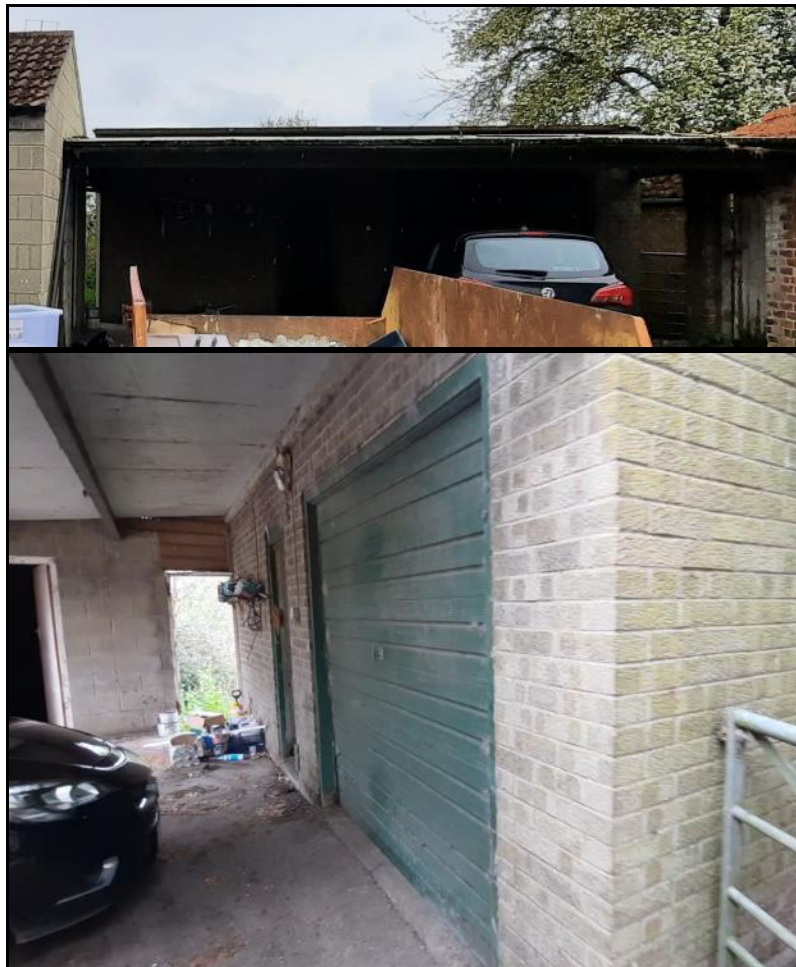
Plates 11a and b – Building 3 North Elevation showing the insulated metal box profiled roofing sheets which forms the flat roof, which runs over the carport and the full length of Building 3. Front of the garage and side pedestrian access doors which are both well fitted to the surrounding brickwork.

The flat insulated box profile roofing sheets are sat on top of a timber joist, it is underdrawn in the kitchen room with plasterboard ceiling creating a void.

There was no historical evidence of bat habitation at the time of the assessment, however from the observations made Building 3 at this stage has been assessed as having Low potential for bat habitation.

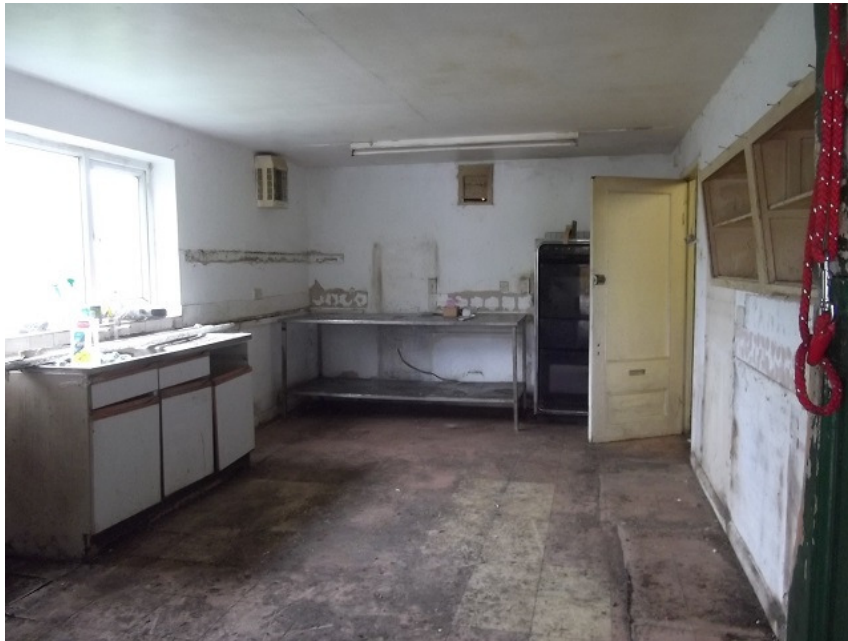
Plate 12. The interior of the kitchen area.

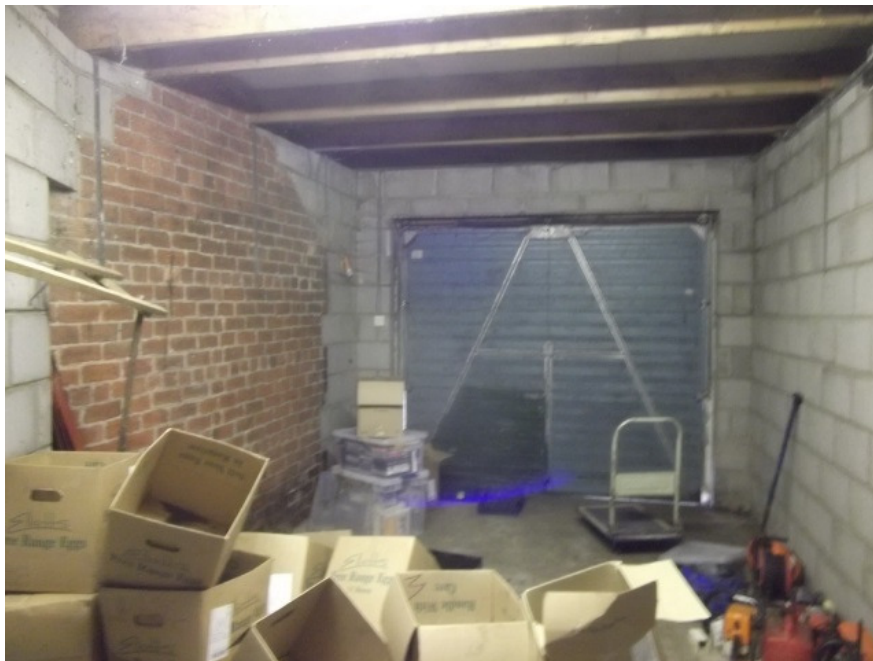
Plate 13. The interior of the garage showing the roof construction.

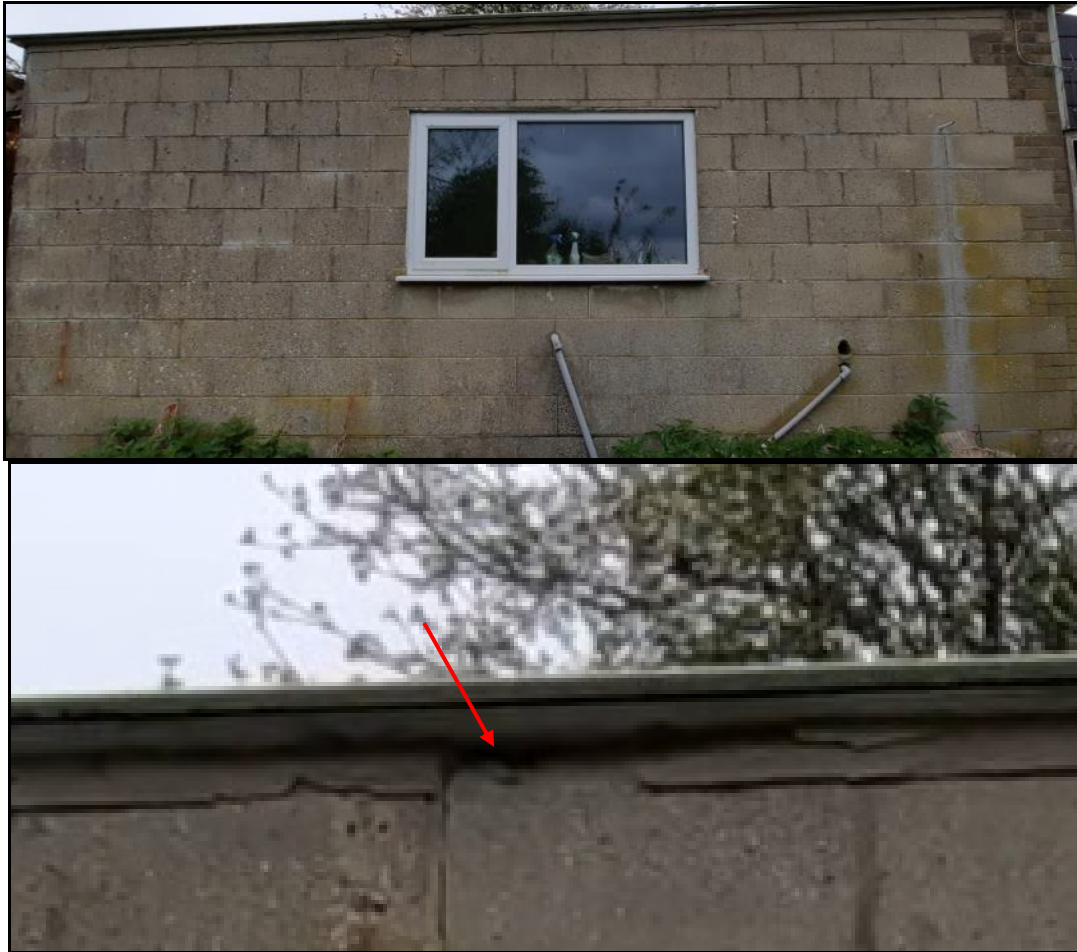
Plate 14a and b – Building 3 Eastern gable, showing the missing pointing to the flat box profile insulated roof sheets. Also a hole for a pipe that has been removed but not covered. The window unit is UPVC and double glazed, with no gaps between the wall and window frame.

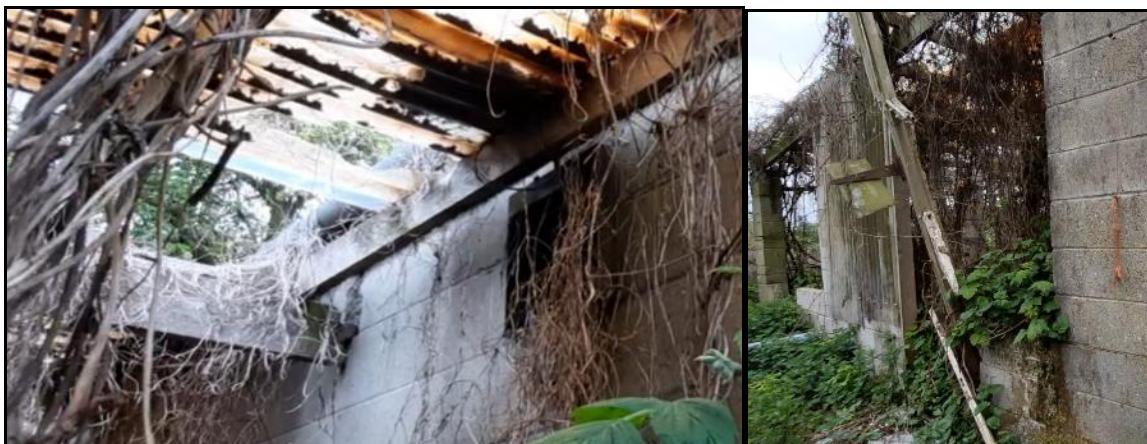
Photo 15a and b – Building 3 South elevation, has the remains of an old green house that was unstable to access, viewing from the outside it can be seen a rotten joist that has come out of the wall leaving a gap to access the block cavity. Also, the extract fan behind the old plant material has a slipped cover. The clear roofing sheet is missing allowing unhindered access for bats to these points.

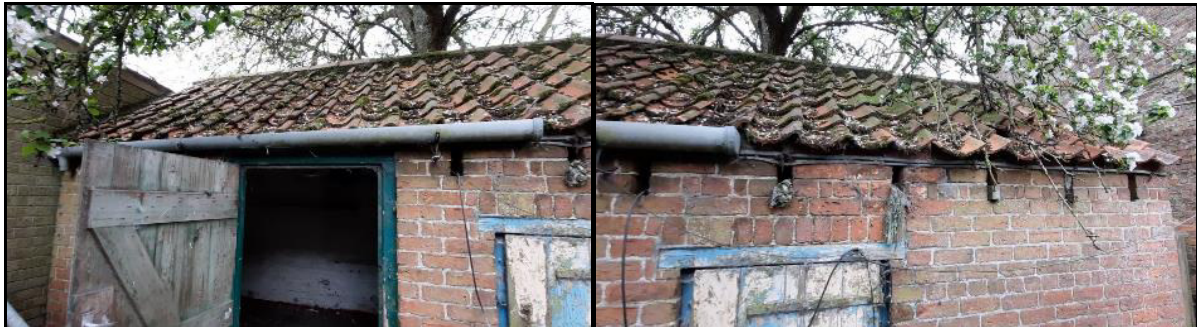
Building 4 is attached to Building 3, however it is of an earlier and similar construction to the farmhouse opposite (Building 5). The external walls are solid brick with a timber frame door and smaller window/access hatch. The building has several vent slots in the walls at gutter level allowing access to the interior. The roof covering is pantile with under felt, but additionally has a layer of hardboard fitted below. The external brick walls have occasional superficial decay along with the occasional deeper holes noted.

Plates 16a and b – Building 4 north elevation showing wall slots, pan tiled roof with a number of lifted or missing tiles allowing access between the tiles and felt/hardboard under drawing.

There was no historical evidence of bat habitation at the time of the assessment, however from the observations made Building 4 has been assessed as having Moderate potential for bat habitation.

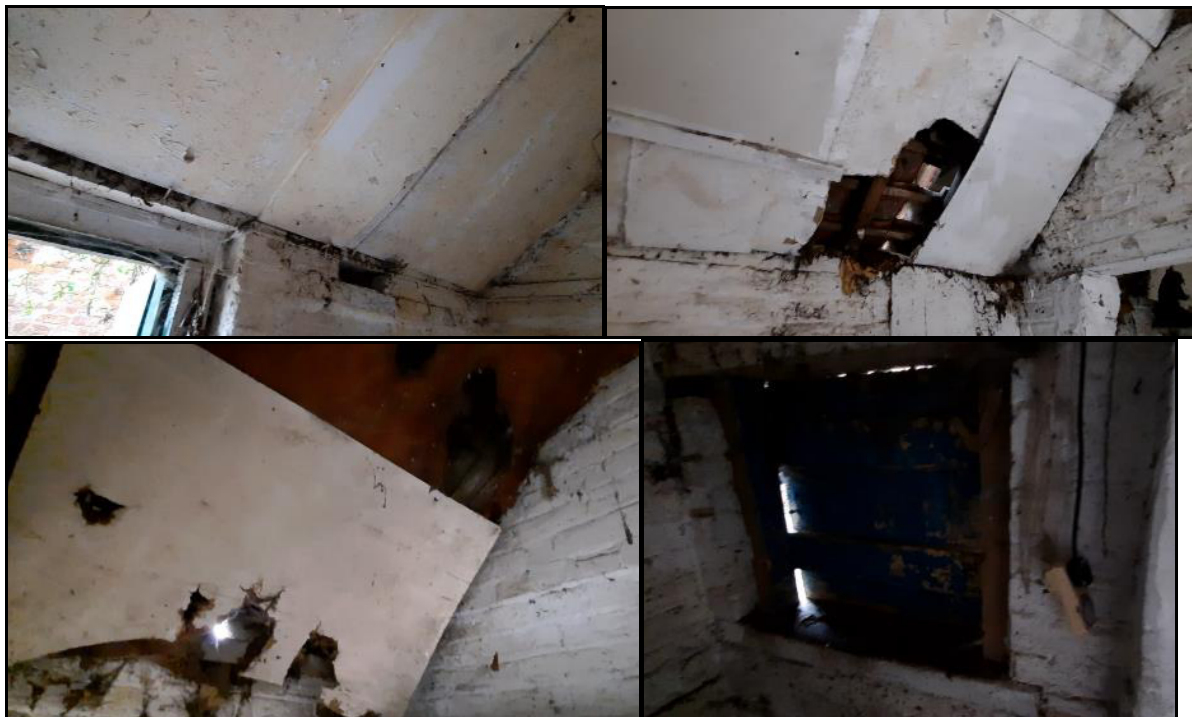
Plates 17a to d – Building 4 Interior views, illustrating the hardboard lining, daylight through the broken felt/tiles, small access hatch does not fit well with gaps around the frame.

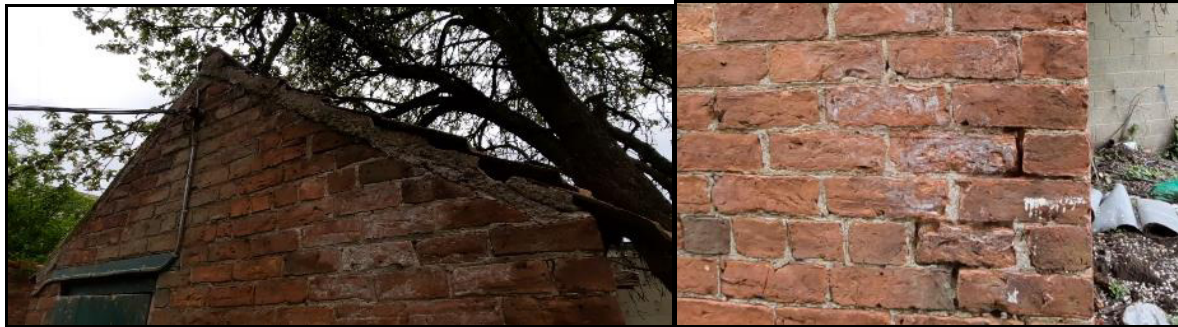
Plates 18a and b – Western gable of Building 4, verge pointing does not meet the tiles allowing access, missing mortar on the south west corner.

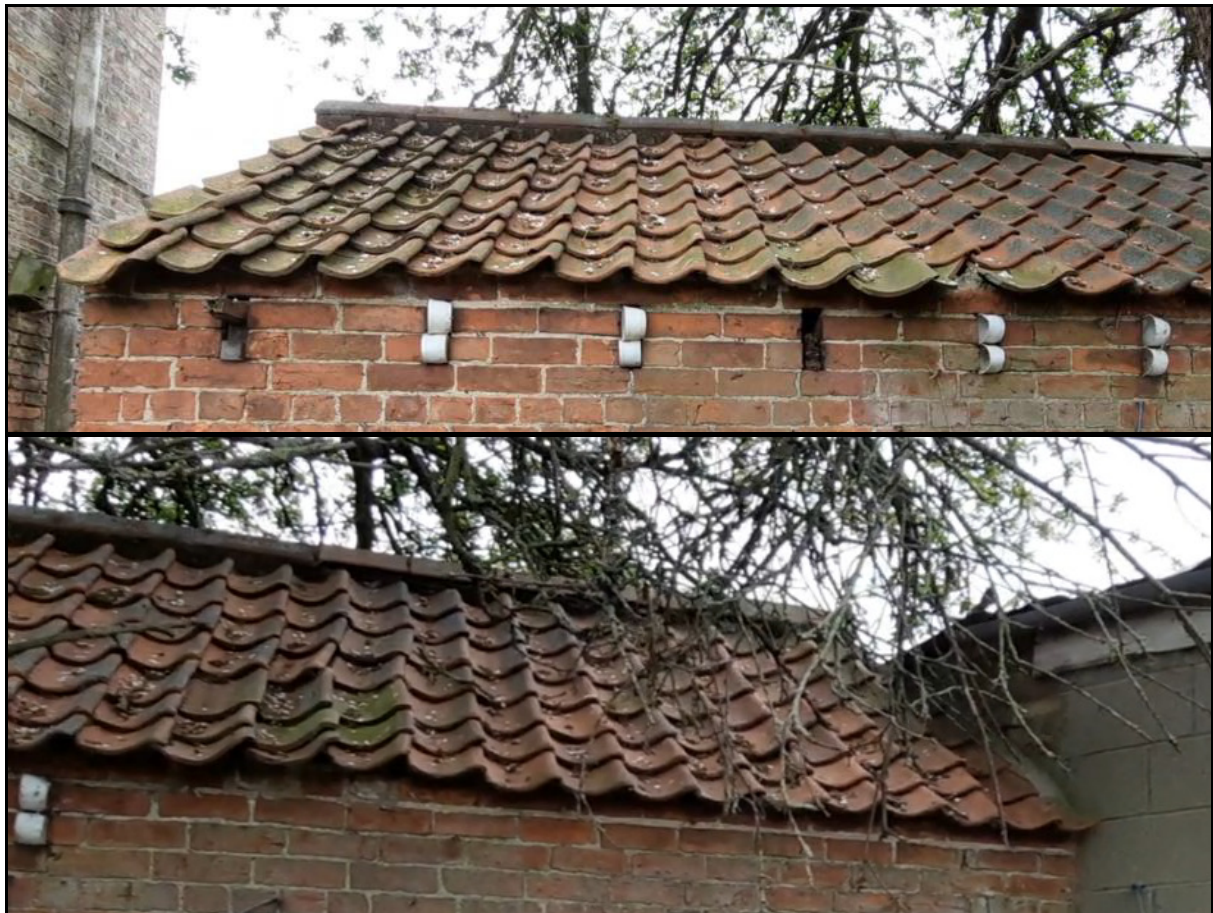
Plates 19a and b – Building 4 southern elevation, the ridge tiles are lifted/ replaced and not pointed, the vent slots within the wall are partly filled, however gaps are still present. There is a cracked pantile on the verge, along with several slipped pan tiles. Where Building 4 joins to Building 3, the joint has missing flashing, and the fascia board of Building 3 finishes short resulting in a gap with access to the rear.

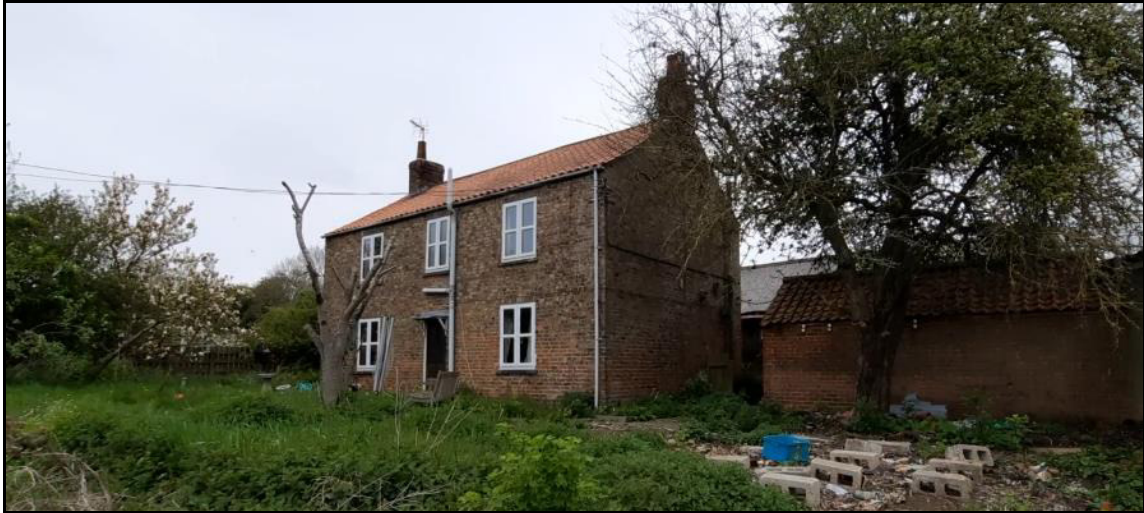
Plate 22 – South elevation of the house, all windows in the main house on this elevation are UPVC and the fitment was good, the roof is covered in a pan tile and the client confirmed this under felted.

From the observations made at this stage Building 5 has been assessed as having Moderate potential for bat habitation.

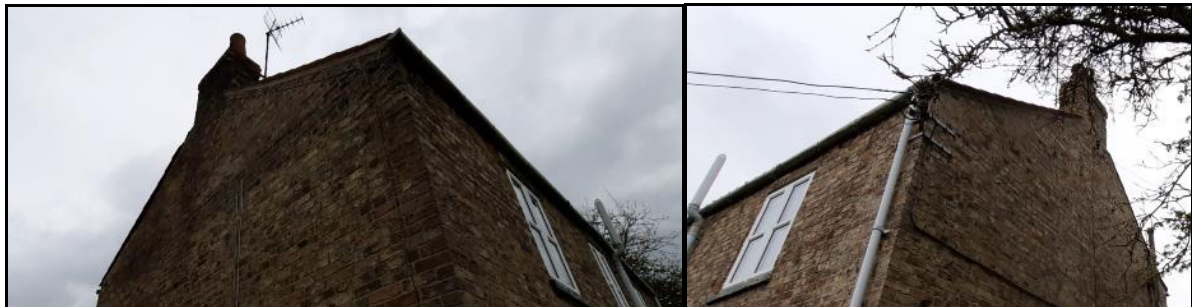
Plates 23a and b - Show both gables on the main house, the pointing and tile fitment appeared in good order and no visible gaps could be noticed.

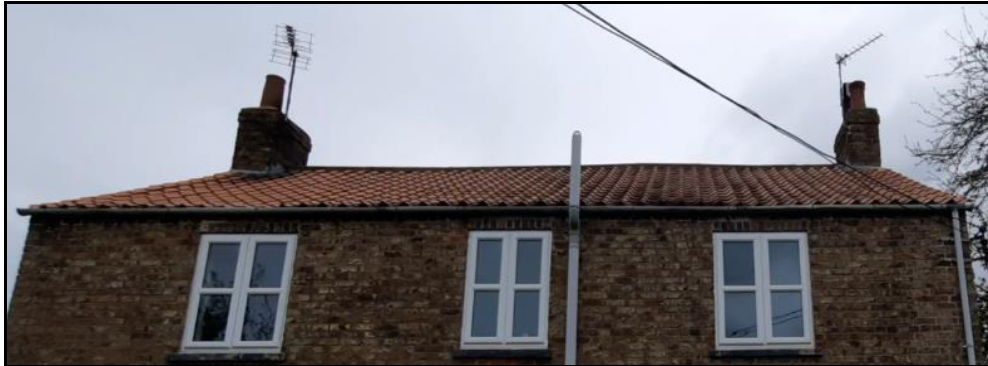
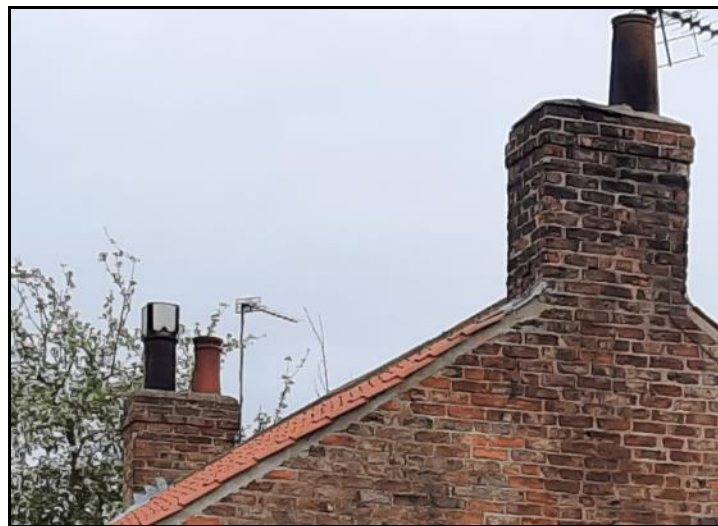
Plates 24a and b – Looking at the south elevation pantile covering, the ridge is well pointed, the tiles look to be well fitted and none appear to have slipped/broken or missing. The lead work on both chimney stacks has lifted, and mortar appears to be missing. The pantiles along the eaves levels are not pointed allowing access between the tile and roofing felt.

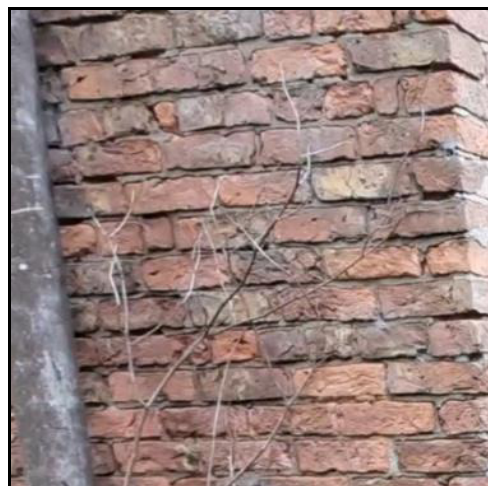
Plate 25 – Typical view on the mortar condition on the eastern gable, the property has had repointing work completed in the past, but in areas this has failed leaving a number of gaps.

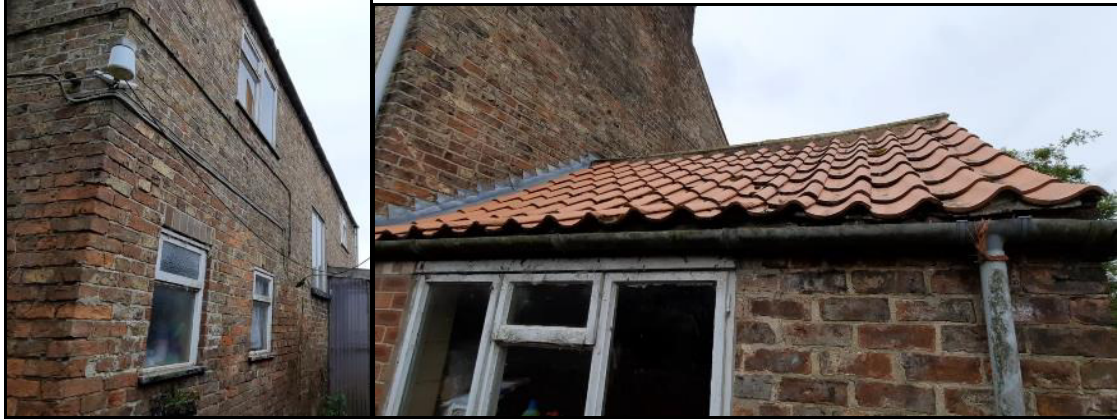
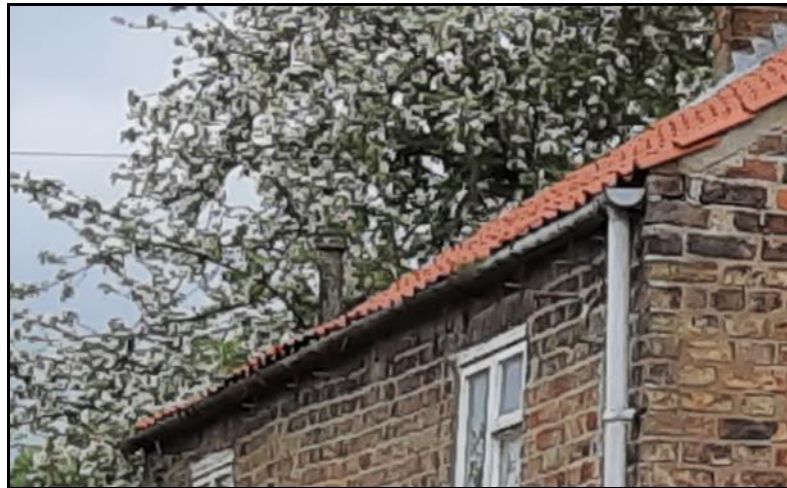
Plates 26a to c – North Elevation, due to the house being built tight up next to the barn (not part of the survey) the view was obstructed of the roof covering. It is noted on this elevation all windows are timber framed and single glazed, a number have missing or broken panes, which are boarded over internally. The eaves on the pan tiles are not pointed as the felt can be seen overhanging.

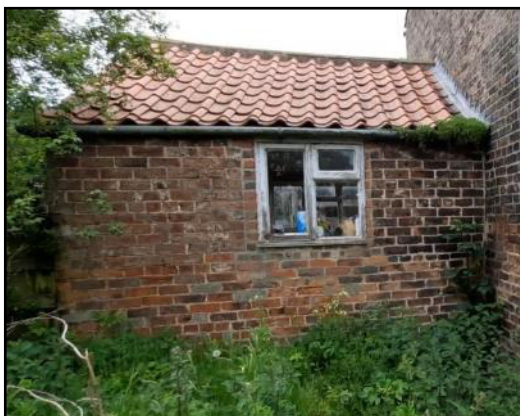
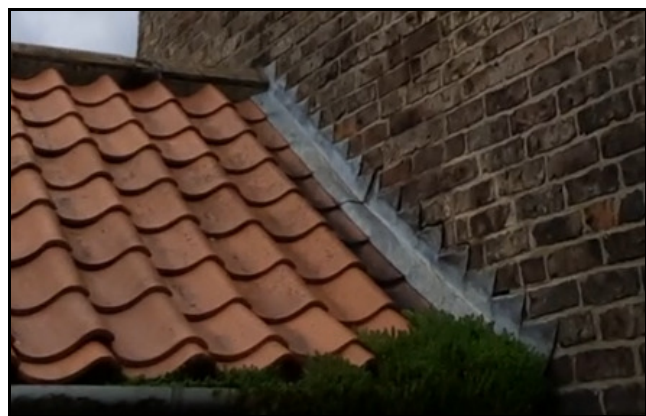
Plates 27a and b – Attached to the north gable of the house is a small extension with a pan tiled roof covering, the windows are timber framed and single glazed. Several tile are lifted or poorly fitting although the ridge tile appear to be well pointed up. The lead work to the main house has lifted with no pointing up.

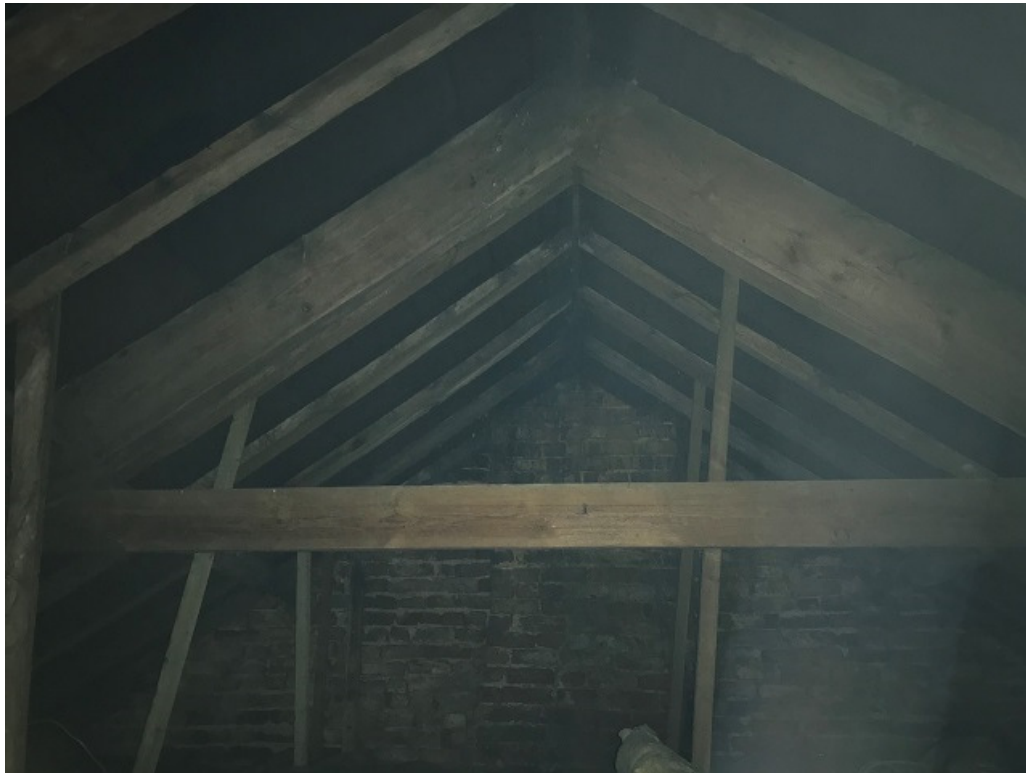
Plate 27. The interior of the roof void, with the photograph supplied by the client.
