**Garage at
Church Cottage
Morston**

**Preliminary Roost
Appraisal**

**Prepared by
Glaven Ecology**

Reference: 2192-GE-SMG

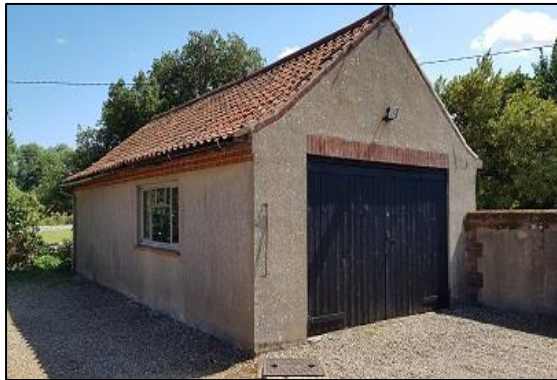
5.2.2 The garage was of brick construction with concrete rendering and a pantile roof (Figures 1 and 2).

Figure 1: The garage at Church Cottage (western and northern aspect).

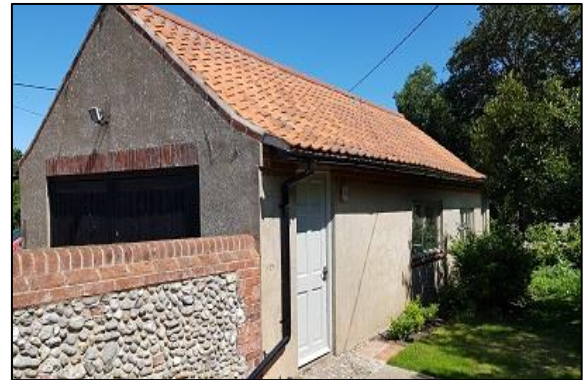
Figure 2: The garage – southern aspect.

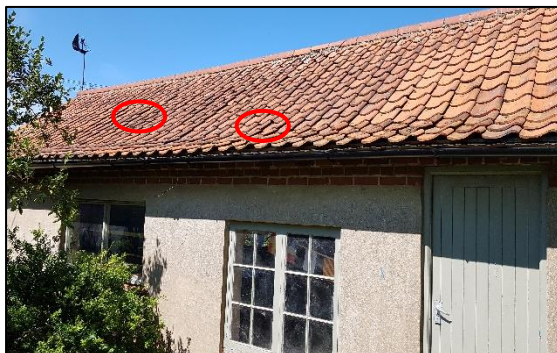
5.2.4 There were some raised tiles, predominantly on the southern aspect, but on inspection many were well cobwebbed and on careful lifting no signs of bats were noted (Figure 3).

Figure 3: Gaps under tiles on southern aspect (circled).

- Install two bat access tiles onto the southern aspect of the roof (to give access to crevice dwelling bats in between the tile and the lining). Something similar to the [Bat Access Tile Kit](#) would be suitable. Alternatively, two ridge access points can be created by using a spacer to create gap 20mm x 50mm in size in the mortar under the tiles.
- A bat box could be installed on the eastern gable end, facing the churchyard, at least 3m high where there is a clear flight path for bats entering and leaving.

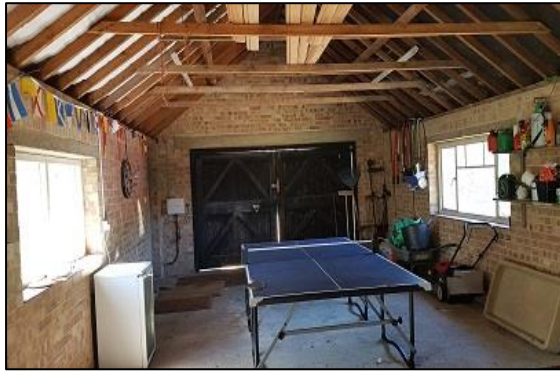
5.2.8 Internally the garage was one space, open to the roof, with no void present (Figures 4 and 5). The space was bright and airy with windows on both aspects and the eastern gable wall.

Figure 4: Garage – internal view.

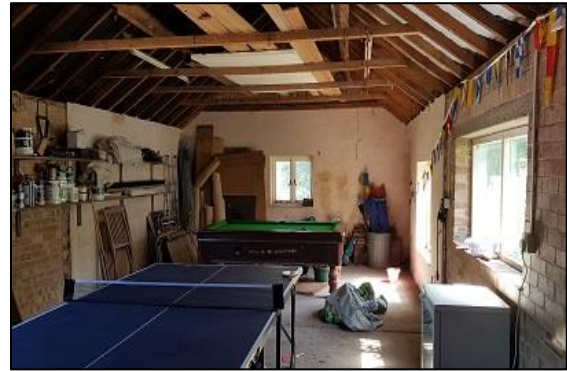
Figure 5: Garage – internal view.

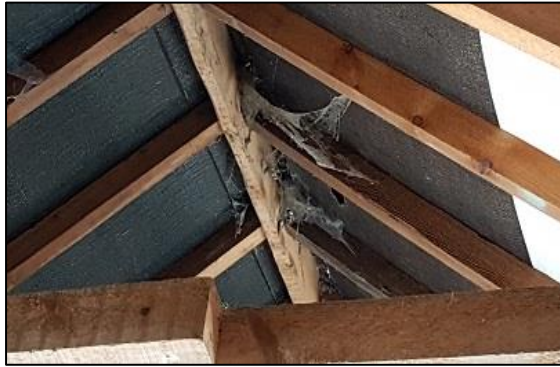
5.2.9 The roof was lined with some tears but there was heavy cobwebbing throughout (Figure 6).

Figure 7: Roof lining and cobwebs throughout.

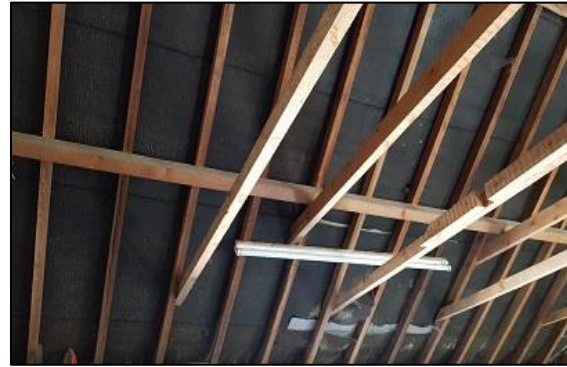
5.2.10 The beams were narrow and machine cut with no cracks or splits (Figure 7).

Figure 8: Narrow, machine cut beams.

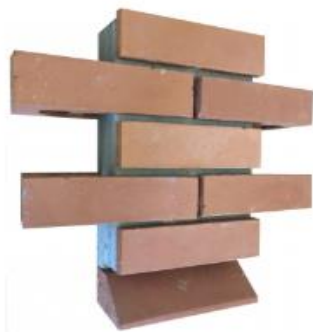
Figure 8: Habibat integrated bat box with brick finish.

- *Integrated bat box.* These are built into the fabric of a property and come in a variety of designs depending on the materials being used. For example, the Habibat bat box comes in a selection of designs to suit brick built buildings (Figure 9), whilst the Schwegler bat tube (Figure 10) is designed to be installed beneath a rendered surface. This makes it ideal for situations where you wish the box to be discrete as only the entrance hole will be visible. It can also be painted to match your building with an air permeable paint if desired.
- *Wall mounted bat box.* Fixed to the external wall of a building, the [Beaumaris bat box](#) is a popular choice as is the [Schwegler 1FQ Bat Roost](#).

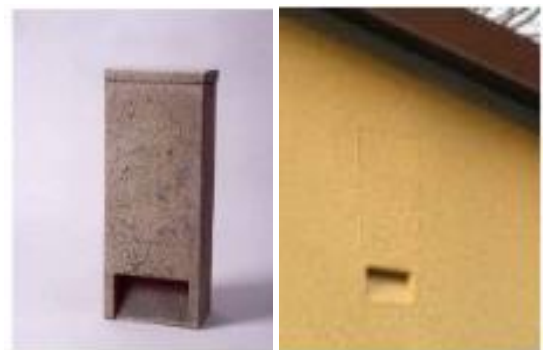
Figure 9: Schwegler 1FR bat tube
