23 Hardwick Terrace — Clumber Park

Stove Insert Details

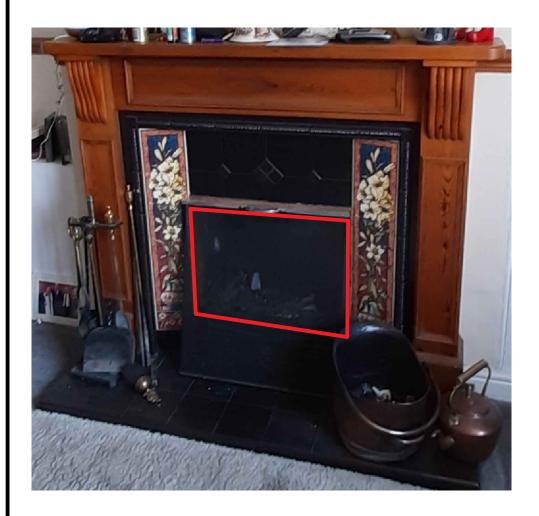
Image 1 — Existing fireplace with back boiler to be decomissioned and stove installed to existing opening. The existing grate and ash pan will be removed and the insert installed to the area shown in red. Note: The NT Vernacular Building Survey indicates that this is a 1970s installation.

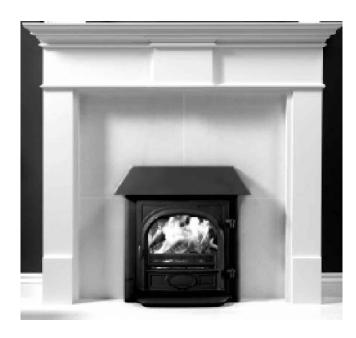
Image 2 — Indicative picture showing stove installation. Source: Stovax User Guide
