PHASE I GEOENVIRONMENTAL
ASSESSMENT

148 STATION ROAD

SIDCUP

REPORT REF: R0388/20

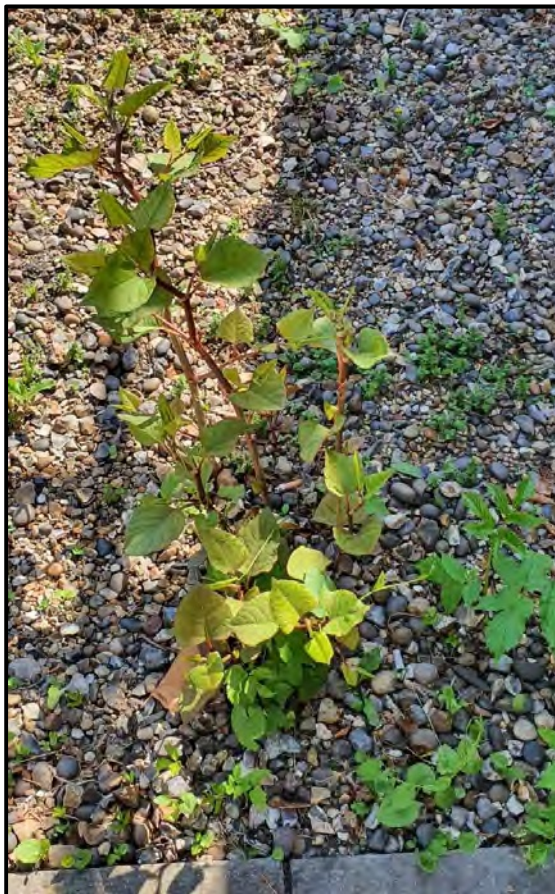
Figure 7: Photograph Showing Japanese Knotweed Located in The Rear Garden

- 3.3 The site covers an area of 0.03 hectares and is currently a two-storey property, with a former restaurant (Mariano's Pizzeria) and an office space occupying the ground floor and a 2-bed flat on the first floor. A small area of soft landscaping is present to the rear of the property.
- 3.4 The plot is generally flat and forms part of a row of terraced property's, all with commercial units on the ground floor and residential flats on the upper floors.
- 3.5 A site walkover was completed by EEGSL on the 23rd June 2020. Photographs taken during the site walkover showing the general layout of the assessment site are provided within Figures 2 - 7.
- 3.6 During the site walkover, several young plants identified as Japanese Knotweed were discovered within the soft landscaping to the rear of the property (Figure 7).

- 4.38 A detailed ecological assessment falls outside the brief of this report. However, due to the identification of Japanese Knotweed on site, advice should be sought from a specialist removal company to development.

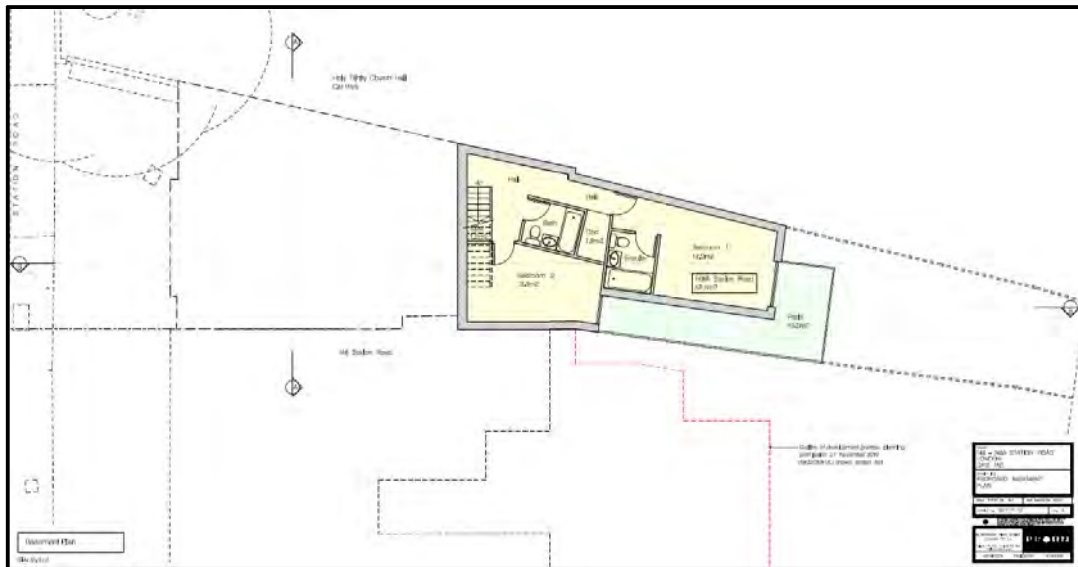
Figure 8: Proposed Basement Plan

3.8 It is understood that the site will be subject to redevelopment with a proposed ground floor and basement extension. A 3-bed flat will be situated within the basement and ground floor and two 1-bed flats will be situated on the first floor.
