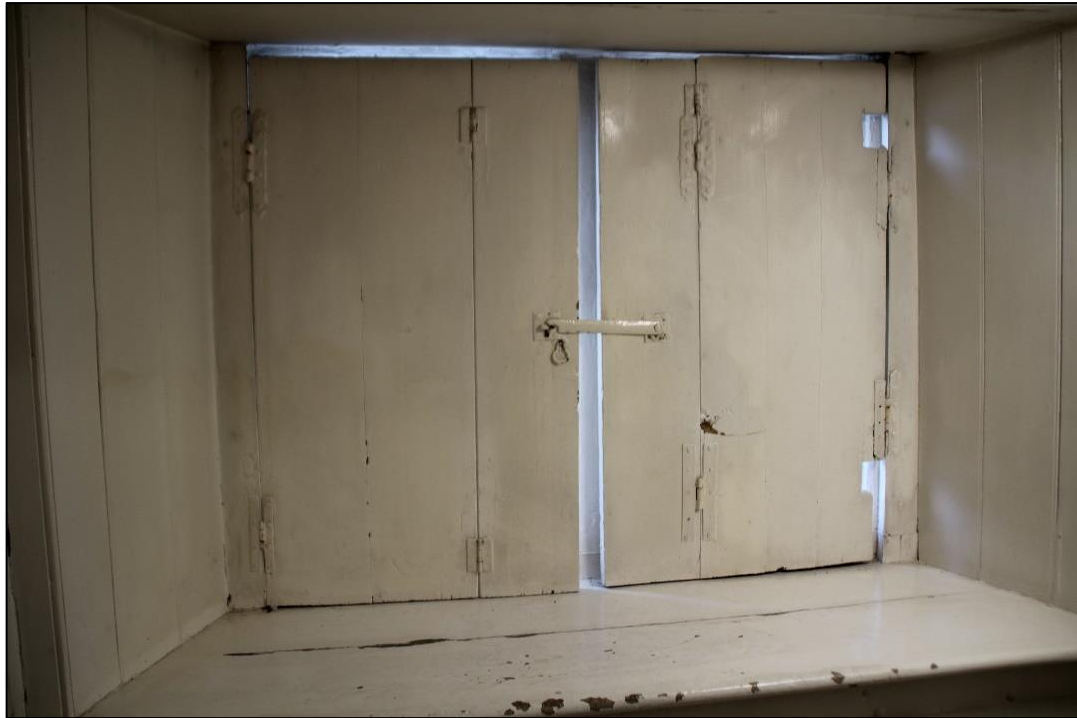
Photo 32. Plank shutters to the small window to the basement stairs, with original ironmongery

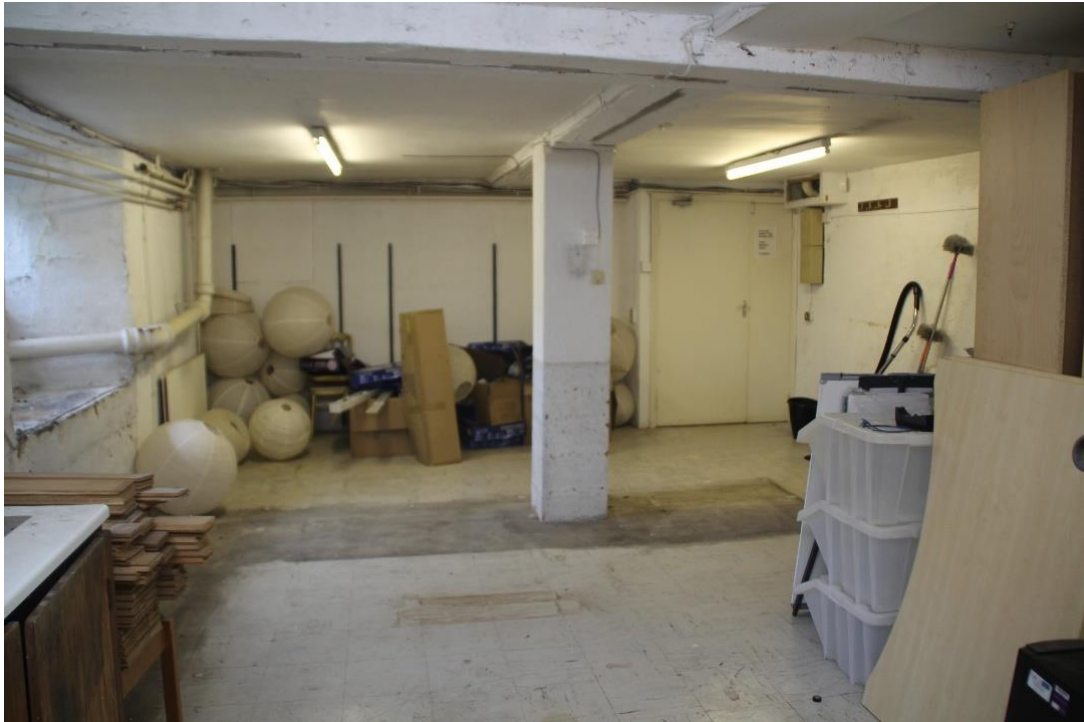
- 4.63. B1, accessed to the right at the bottom of the staircase is a rectangular room with evidence of modernisation (Photos 34 and 35) It is lit by a ground level window, which indicates that its function may well have involved activity, such as washing or preparation of food, rather than storage, which would occur in the less well lit vaulted areas. The historic floorplans in Fig.18 show a hand written note on the ground floor plan 'servant's hall below', which may indicate this room (not being vaulted) was used for this purpose.

- 4.64. Modern piers have been added to strengthen the structure of the room, which rests on two large and thick chamfer edged cross beams and there is evidence of iron strapping, possibly preceding the inserted piers. Both have interesting internal notching or mortices which suggests the room was subdivided at some point by wooden partitions. The floor has a lino covering and the walls are plastered with a pebble dash style mix in areas and painted in others.

Photo 34. Internal view of Room B1, looking east

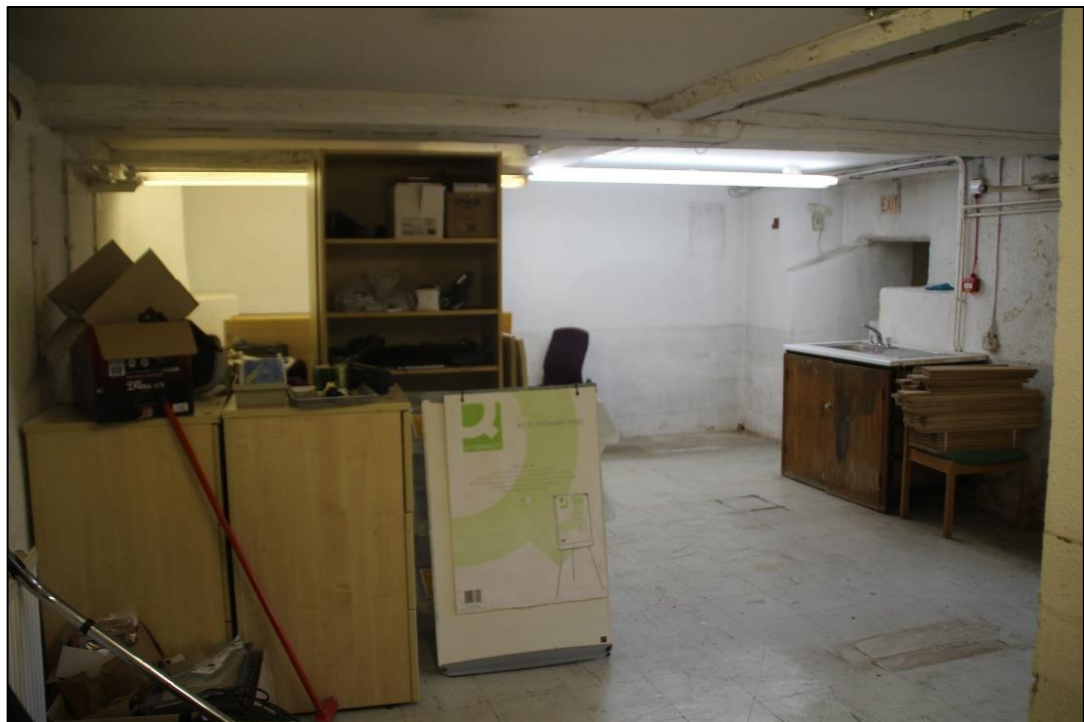
Photo 35. View of Room B1, looking west

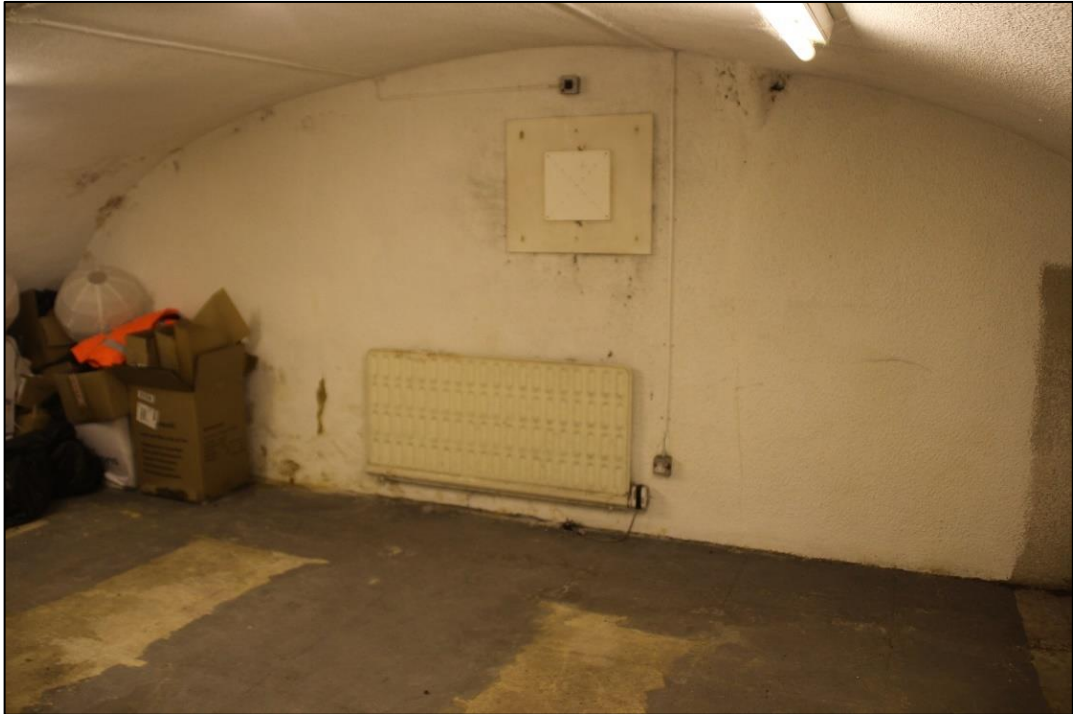
4.66. Room B2 is a barrel arched storage cellar (Photo 36) which has been rendered and cement floored but its form is otherwise discernible. A curved opening in the east wall features a blocked window (Photo 37). The window has a stone mullion and

Photo 36. View of Room B2 – arch vaulted cellar

- 4.67. Due to the presence of modern render and cement, it is not possible to ascertain the structural fabric of the cellar, though it is possibly brick, uncovering work would allow for a better picture.

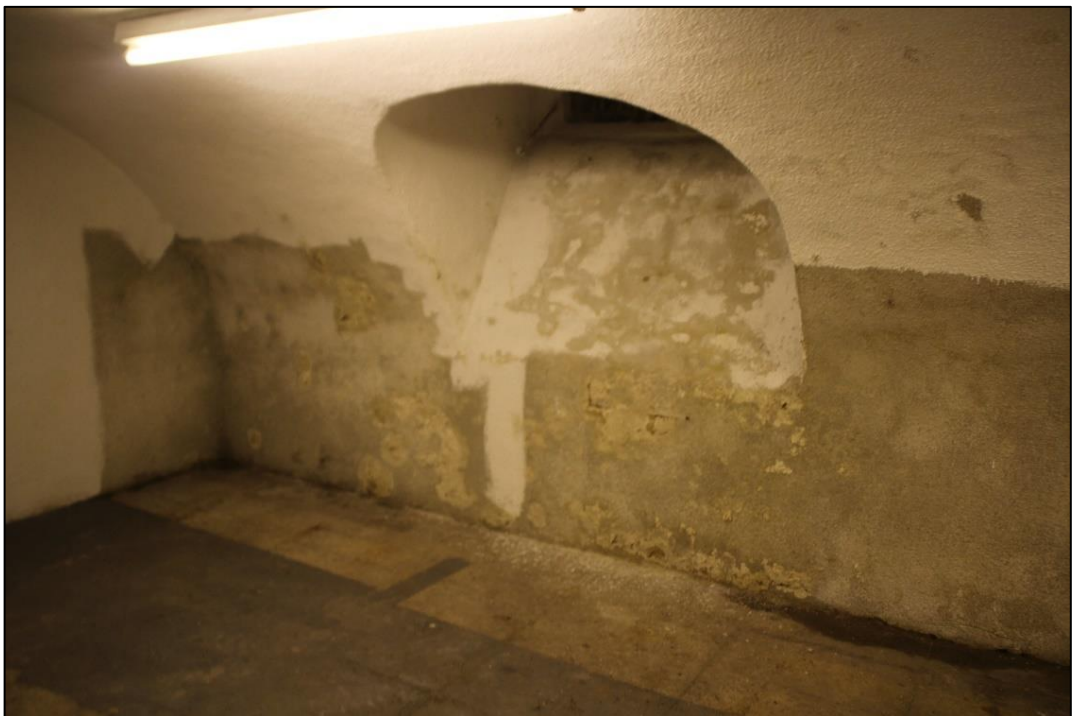
Photo 37. View of blocked window opening in B2

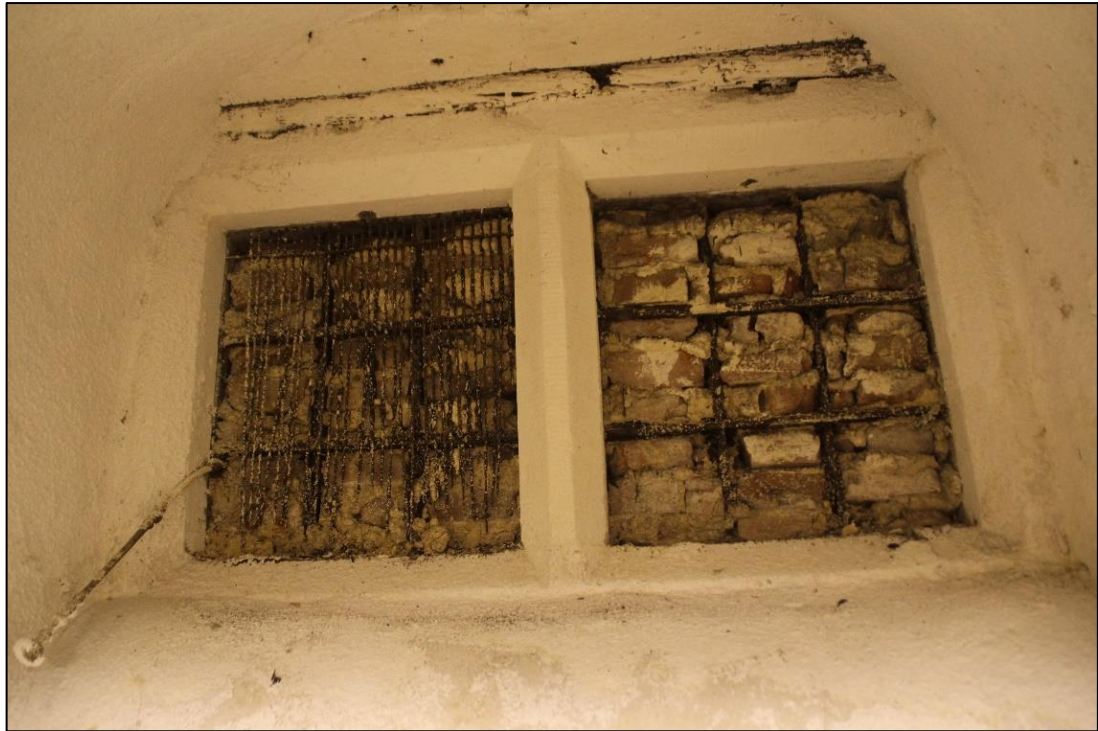
iron bars; it is infilled with brick and is directly below the 19th century extension, therefore it is assumed this window was blocked at the time of the construction of that wing (Photo 38).

Photo 38. View of blocked mullioned window with iron bars

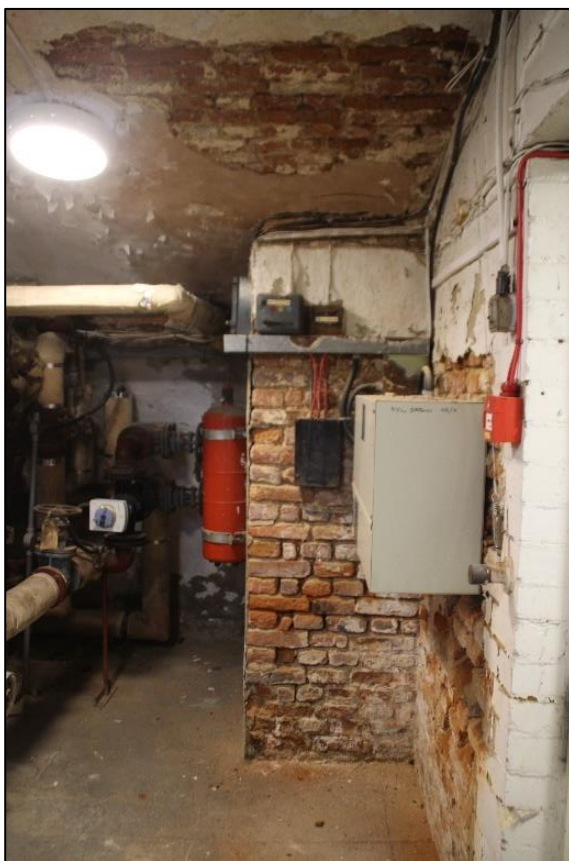
- 4.69. In B3, there is evidence of the brick construction of the vault, though the floor is now cement. There is evidence of a lime plaster or render which has failed over time to reveal the brickwork.

Photo 39. Brick construction of B3

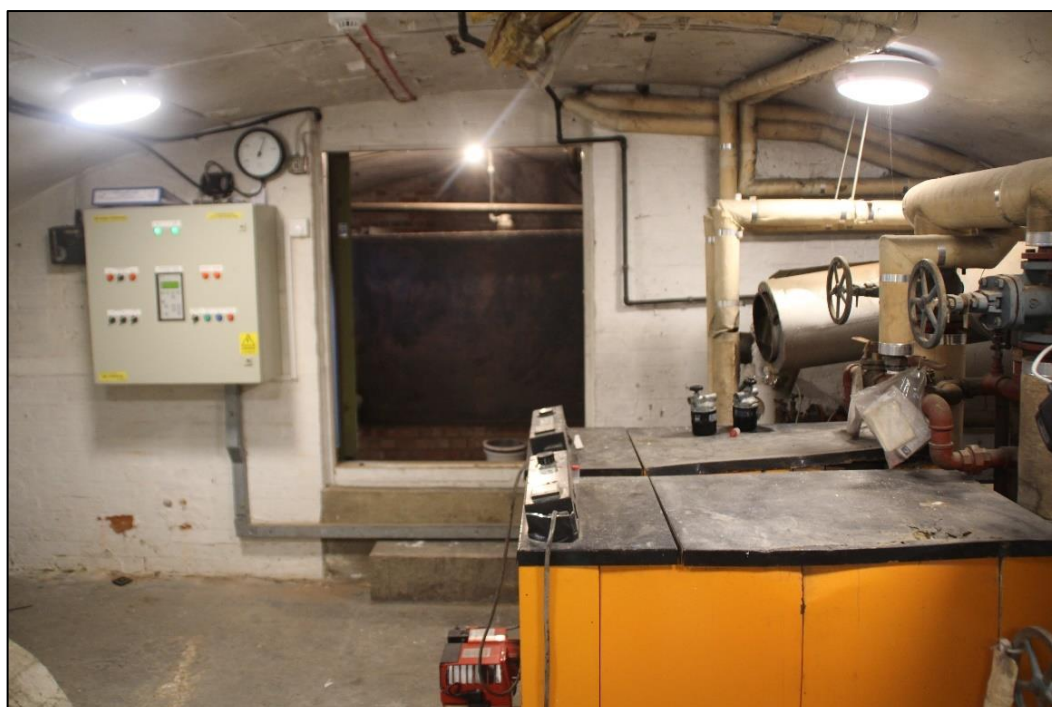
- 4.68. Moving south, B3 and B4 were once one open barrel vaulted cellars, presumably used for storage. There is evidence of subdivision in modern brickwork which may well have been structurally necessary. These rooms form the boiler room and the water tank room for the house, and have a large amount of machinery and services installed (Photos 38 and 40). Of interest is the steps leading from the east courtyard, incorporating flat slopes to each side, which may have facilitated the moving of wheeled equipment or barrels down the slope (Photo 41). Clearly these stairs indicate that this was the tradesmen's entrance, where goods, foodstuffs and materials were brought into the house for storage.

Photo 40. View of the modern brick wall between B3 and B4

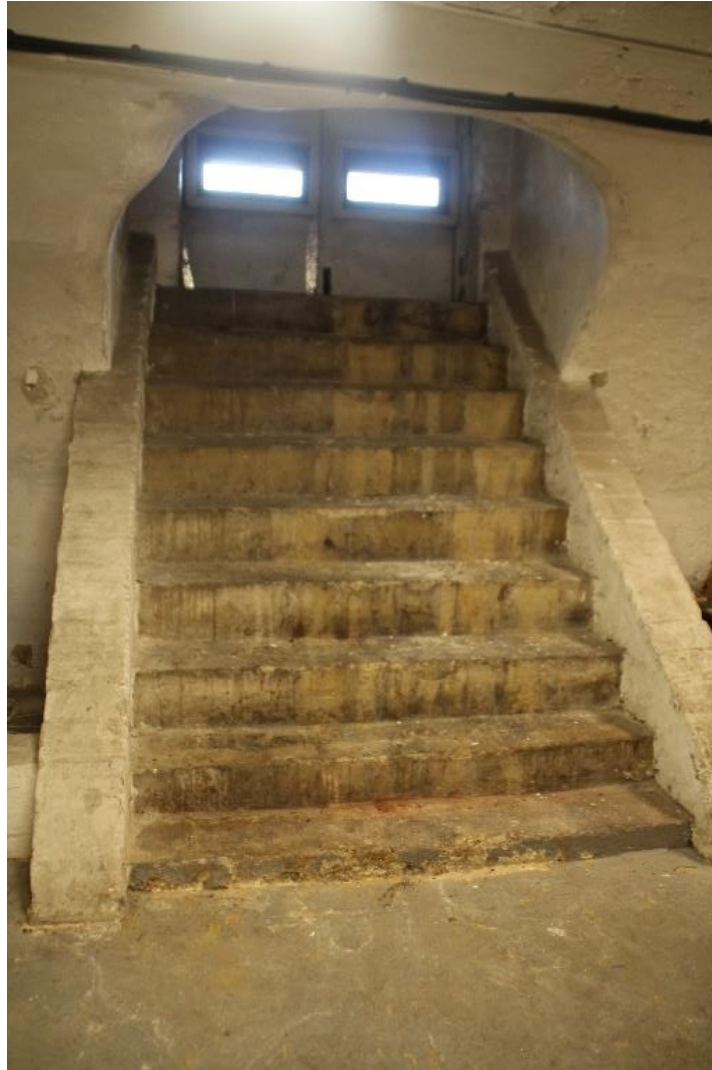
Photo 41. View of steps down from stable courtyard with sloped sides

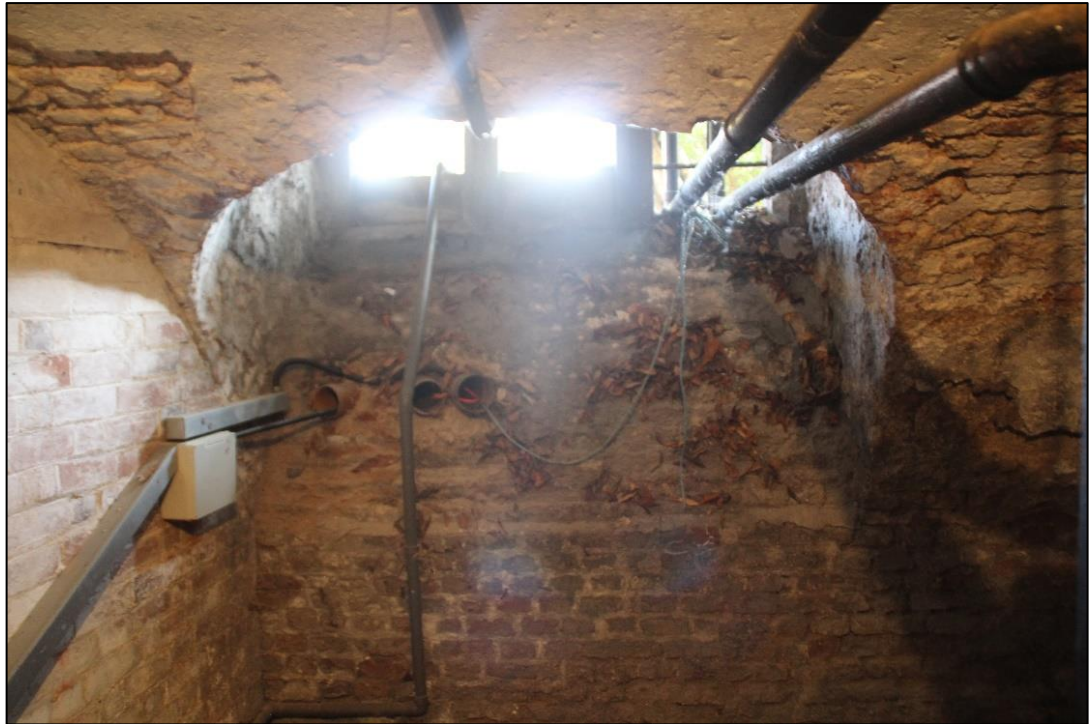
- 4.70. In B4, a large watertank dominates the space, therefore opportunities for photography were limited. Of note here is the stone window with mullions noted in within the east courtyard, which is now pierced with services . The brick construction of the space, and lime render is also evident here. Photo 42 shows the window from an internal aspect, and to the left is the modern subdividing wall, which also features a large metal door, presumably part of the necessary equipment related to the installation of the boiler. The floor in this room is formed of setts, probably the original floor material as it is hardwearing

Photo 42 Interior view of the mullioned ground level window seen in the stable courtyard, in Room B4

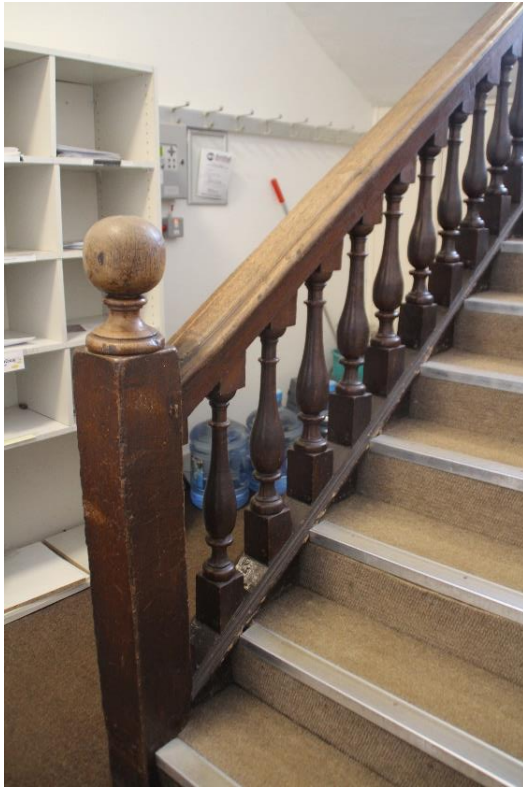
- 4.71. The first floor is accessed via both the back or secondary staircase and the grand staircase hall, The secondary stairs are much plainer than the main staircase; it has a dog leg formation featuring square newels with ball finials, closed string, turned balusters and a moulded handrail. Engaged half newel and finials finish the feature to the wall (Photos 43 and 44). The staircase hall is plain and lit with one window per landing as it rises through the house, the first floor of which has heraldic stained glass in the top lights.

Photo 43. Secondary stairs rising from the ground floor (left)

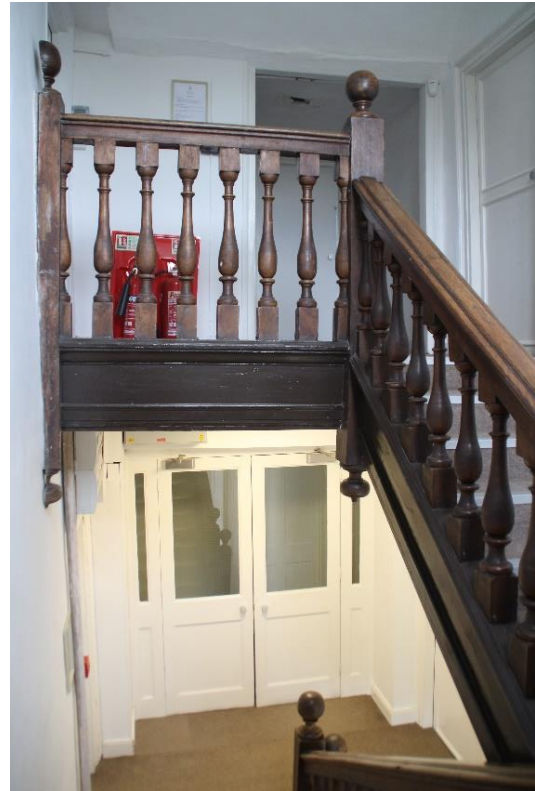
Photo 44. Secondary stairs at first floor half landing level (right)

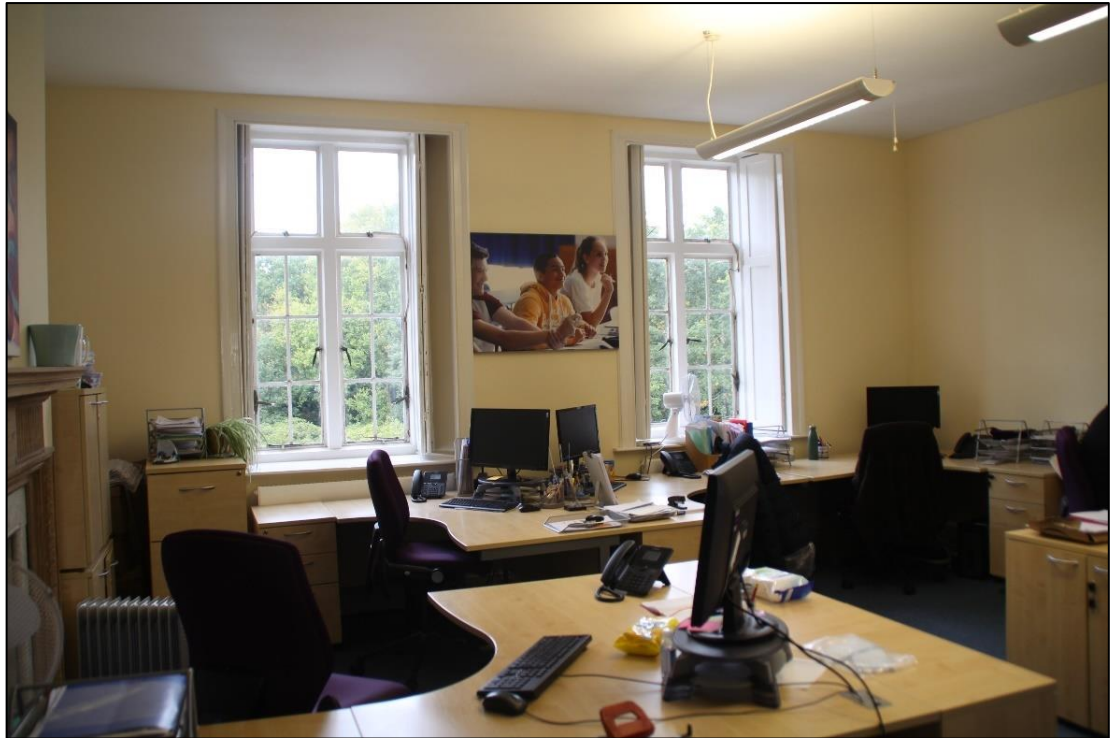
4.73. The room is plainly decorated (Photo 45), with no cornice or panelling. Whilst panelling was not always a feature of bedrooms, as it is a high status room it is likely there would have been a cornice and possibly some ceiling decoration. The mantelpiece is carved softwood, now stripped, with a marble insert and looks to be part of the 18th century schemes seen elsewhere in the house, featuring acanthus leaf, beading and arcading detail (Photo 46).

Photo 45. View of Room 7 looking south

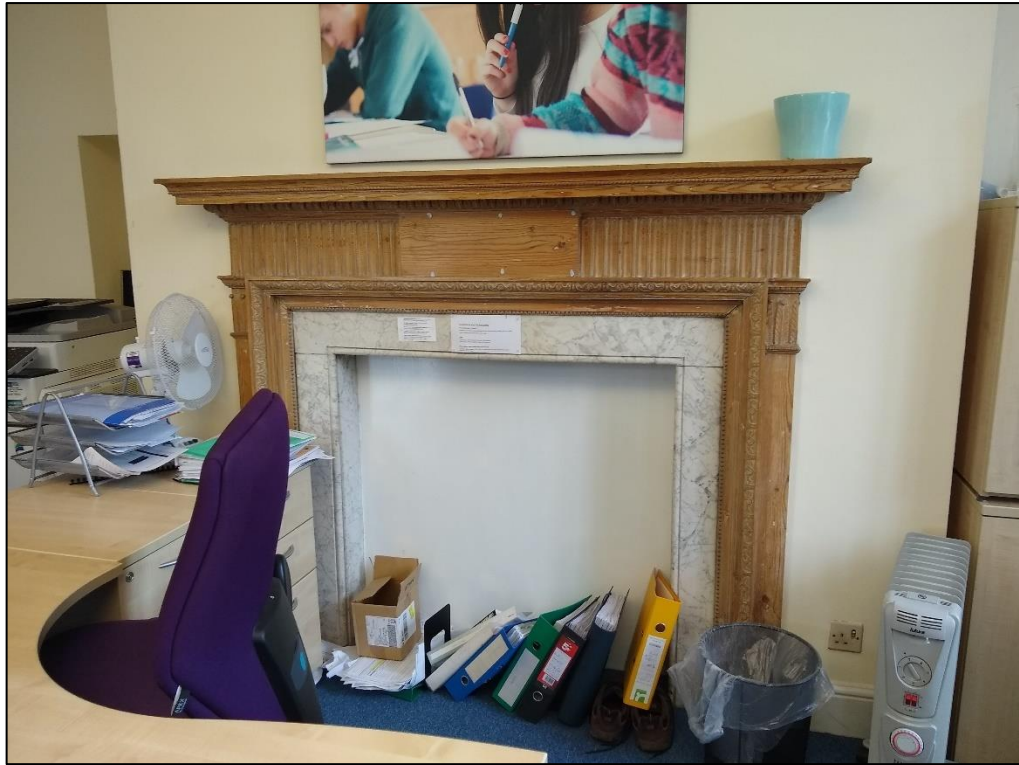
Photo 46. Fireplace in Room 7

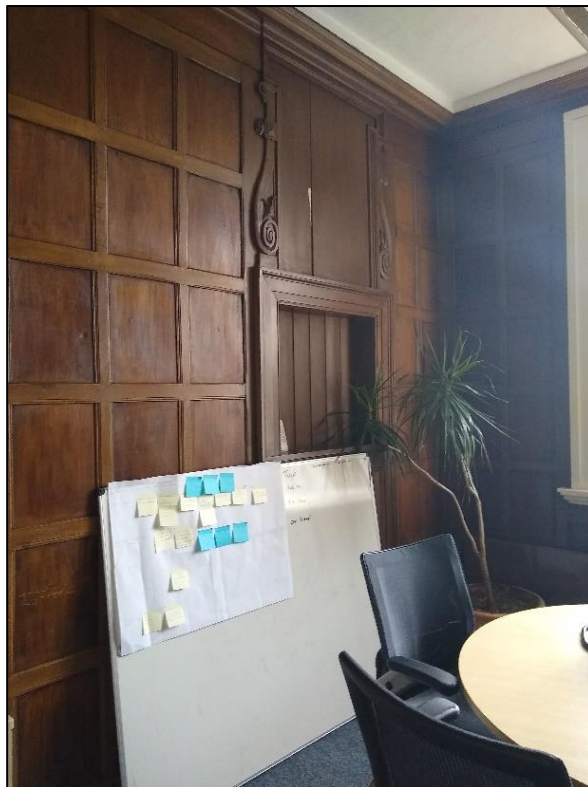
- 4.75. There are two blocked architraved doorways in the panelling, one on the north wall and one on the south wall, which access Room 7 (or cupboard thereof on the historic plans) and one Room 9. These are decorated at their headers with the recurring scroll motif (as seen in Photo 47) seen elsewhere in and on the Building.

Photo 47. Square panelling in Room 8 with the distinctive Tyttenhanger scroll motif
