REPORT ON: TYTTENHANGER HOUSE, ST ALBANS, SELECTED HISTORIC INTERIORS

CONTACT: PHIL GLADWELL, BARHALE LIMITED

RESEARCH UNDERTAKEN FEBRUARY/MARCH 2019

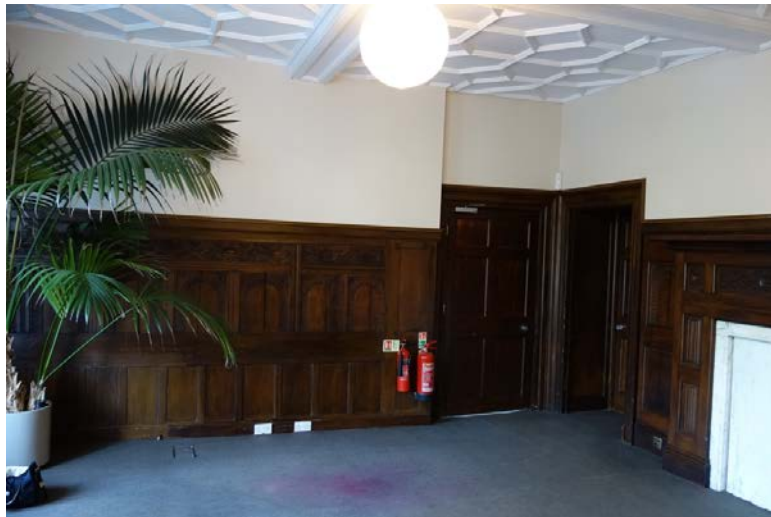
Figure 6: Room A Reception Hall

The onsite investigation within this principal entrance space indicated that there had been some extensive remodelling and tidying undertaken, presumably during the later twentieth century.

All of the wall panelling appears to date from that period with no evidence surviving of historic finishes. The earliest evidence was found on the window shutter and there was also some early evidence on the mouldings of the ceiling where it was protected above the window cornice.

Redecoration suggestion – original C17th scheme:

Ceiling cornice and upper wall faces – off-white distemper colour, or lightly tinted.
All joinery – painted C17th style mahogany woodgraining finish

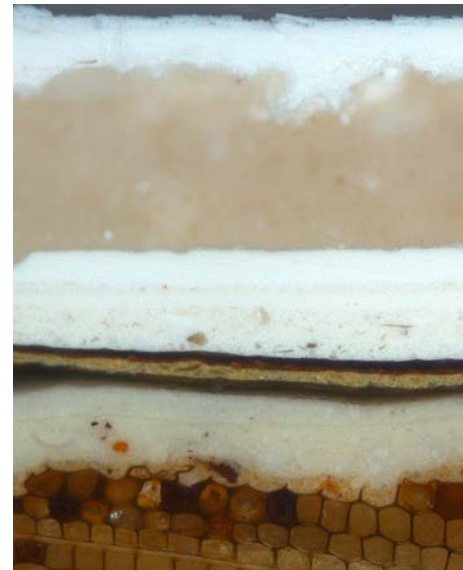
**Figure 7 Sample: Tytt.H.Ho/1.1
Ceiling moulding**

The sample in figure 7, , taken from a protected section of the timber ceiling moulding shows a deal of later intervention, filling material and repairs.

Description of layers

Schemes 5-7 White lead & alkyd oilpaints
With a thick layer of filler before the last decoration

Scheme 3 c1930's woodgraining

Scheme 1 Lead white oilpaint with varnish over

Substrate softwood

Beneath that there is a mid-oak painted grained finish in imitation of a mid-oak timber. The materials and method of execution would suggest a date of c.1930s, Beneath the graining there is an earlier scheme of lead white with a varnish over. This appears to be a nineteenth century scheme.

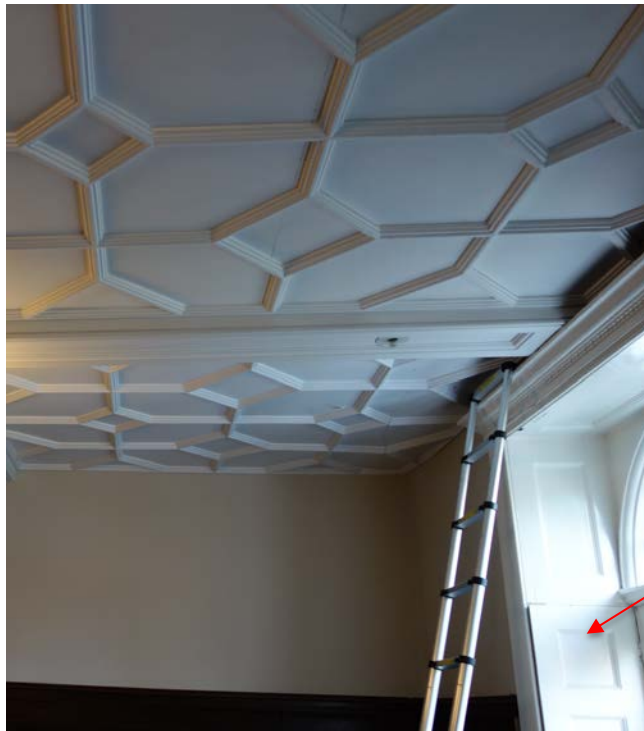
Figure 8: Window shutters

The most interesting information was identified on the window shutter, (figure 9), which retained evidence for seven separate schemes, the first of which had been repaired and re-varnished at least four-times. The repair and maintenance of a scheme to this extent indicates a high-quality finish, retained for a significant period. Possibly a century or more, not uncommon for interiors of this status.

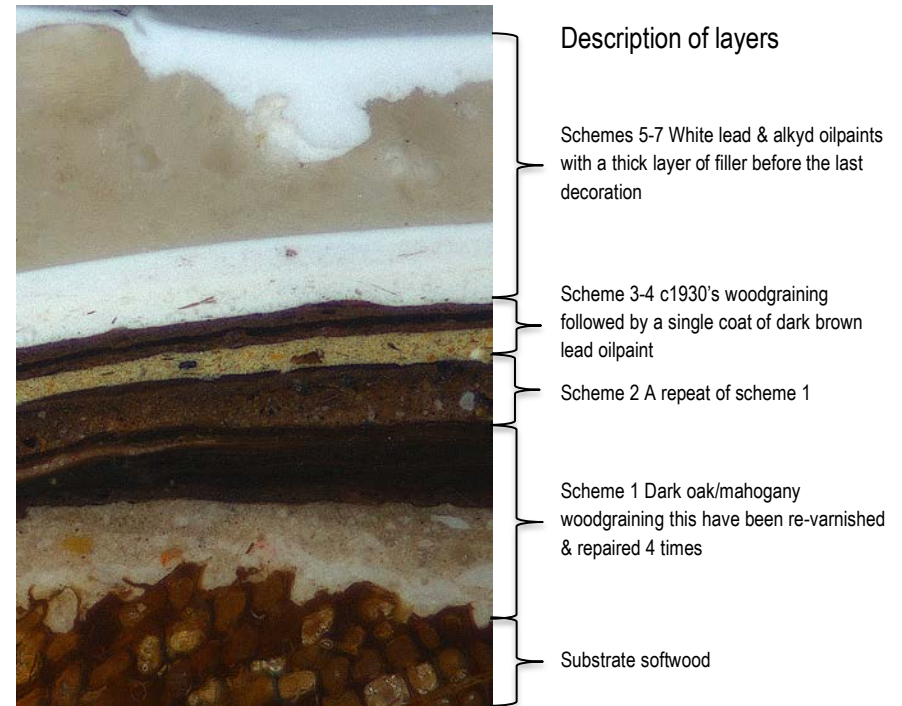
Figure 9 Sample: Tytt.H.Ho /1.2 Shutter

The earliest scheme seen on the shutters consists of a dark mahogany woodgraining. The house was built 1654/5 and it is entirely possible that this woodgrained finish is the original for this interior. The execution of a finish of this type would have been a significant financial investment at the time, reflected in the fact that it was repaired and maintained over a long period. The reinstatement of mahogany woodgraining would create an impressive entrance hall suited to the house.

Although the main wall panelling is much later it could be woodgrained to match. Seventeenth century graining is theatrical in execution, elaborate and flamboyant and would look fabulous within this grand space.

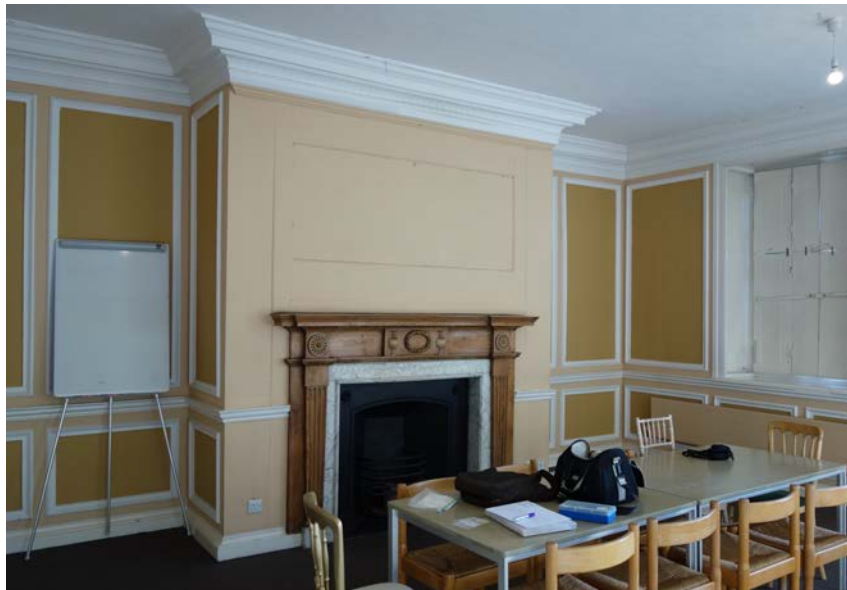
Figure 10: Room B Meeting Room

The survival of historic surfaces within this interior is quite remarkable. With minimal later alteration and repair the full height seventeenth century panelling and joinery survives intact. The cornice and ceiling however have undergone extensive repair and some replacement, removing traces of any historic finishes.

The first decoration on the panelling and joinery is quite unusual and appears to be a surviving decoration from the 1650's. The colour is extremely distinctive and has been identified previously by the researchers in other properties dating from the second half of the seventeenth century. There is a heavy dirt layer over scheme 1 indicating it was in evidence for a long time

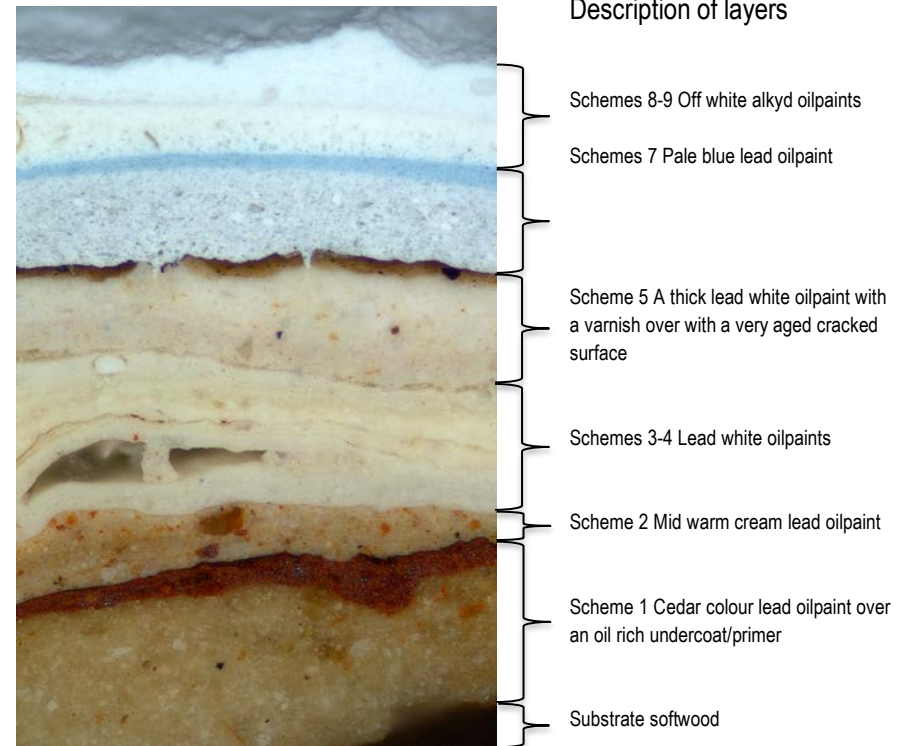
Figure 11 Sample: Tytt.H.Ho /2.7

Dado wallface panel moulding

Known historically as 'Cedar Colour', the painted scheme is not woodgraining but a solid paint colour intended to evoke an exotic hardwood without slavishly recreating it. Very high fashion in the later seventeenth century this is possibly an early example. This finish was identified by Crick Smith at the Sheldonian Theatre (1664 designed by Wren) and subsequently recreated in 2008.

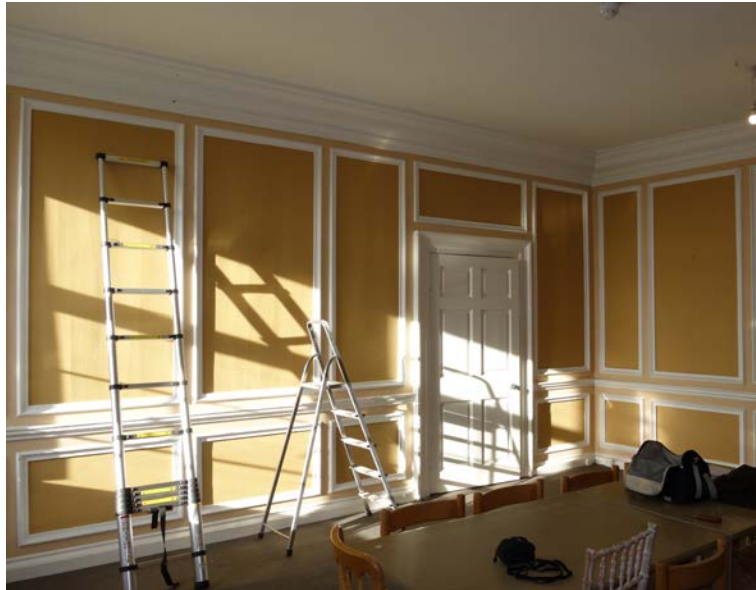
Figure 12: Door to room C

The samples removed from the doors and architraves show the same early “cedar Colour” scheme as the panelling, which would create an extremely rich and powerful interior, when originally furnished with dark oak furniture and walnut oyster veneered cabinets, blue and white Chinese ceramics and ochre coloured slipware.

The evidence is sufficiently clear to recreate the ‘Cedar Colour’ scheme, which would continue to include the cornice as part of the wall plane. The ceiling bed would have been simply painted in a soft off-white distemper. The original ceiling would most probably been heavily ornamented with mouldings and swags, but this has been replaced by a later flat finished ceiling.

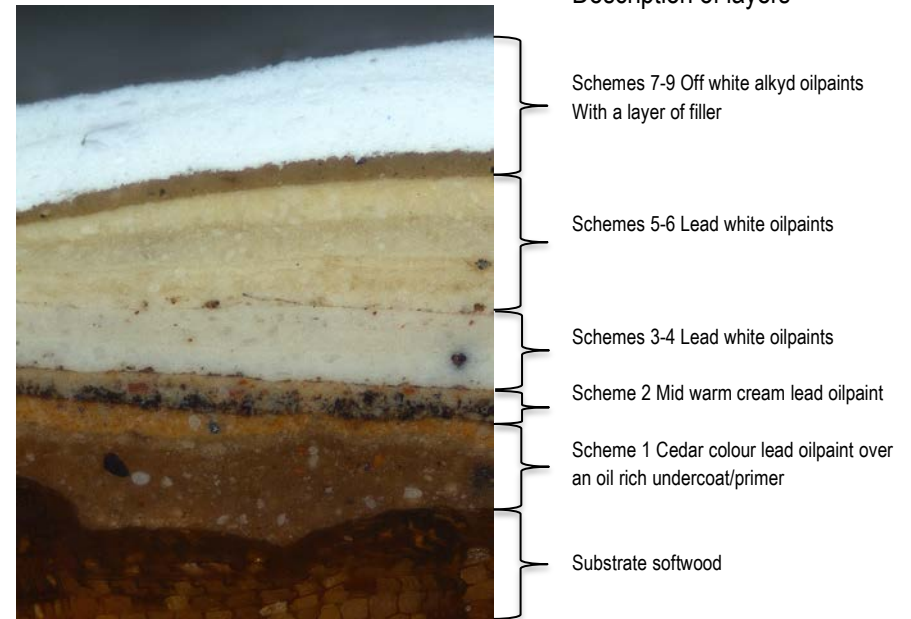
Figure 13 Sample: Tytt.H.Ho /1.2 Door architrave

The sample here shows a thin layer of the ‘Cedar Colour’ surviving at substrate level. And the later layers as seen on the wall panelling.

The second scheme was undertaken in a much paler mid warm cream oil paint and after that schemes three and four are in typical eighteenth-century Palladian tones of lead white, tinted to very soft grey. Schemes five and six are in lead white again, this time untinted and with a varnish coat added to increase the gloss of the surface.

Later layers of post 1950 alkyd resin paints have then been applied.

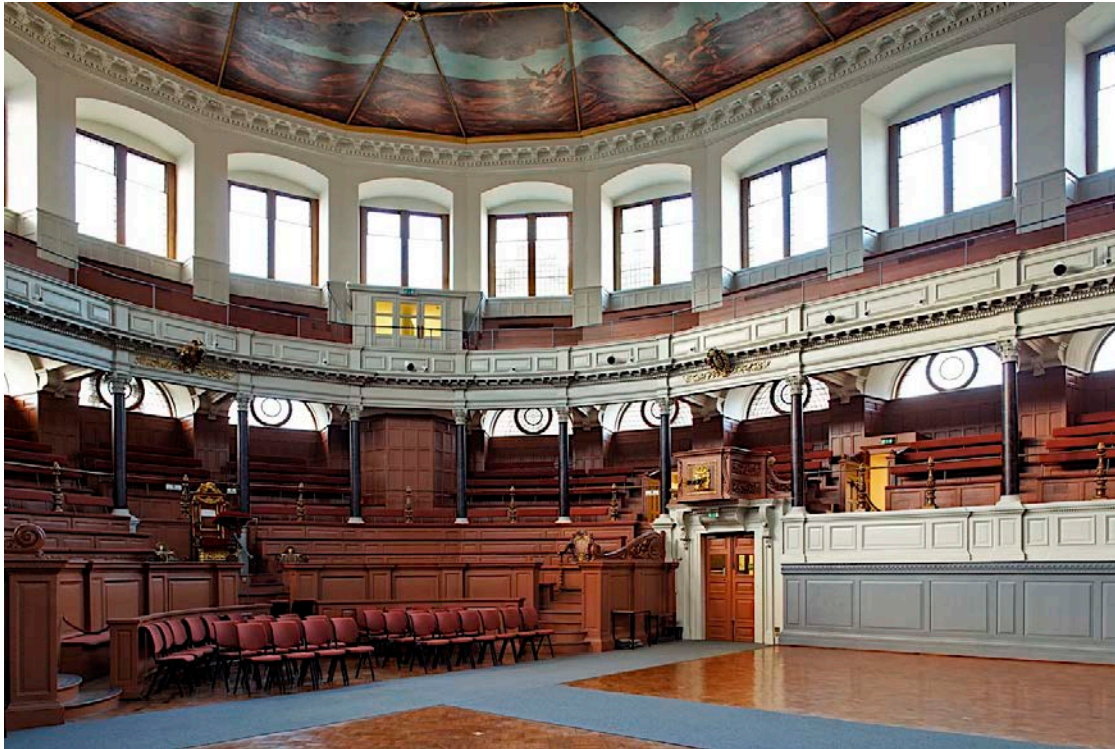
Figure 14 Sheldonian Theatre recreated 1664 Wren scheme, including the 'Cedar Colour' to the majority of the joinery.

The discovery of the 'Cedar Colour' is an exciting discovery and only the second occurrence of this treatment by Crick-Smith, the first being at the Sheldonian Theatre Oxford.

The image in figure 14, provides a good rendition of how this colour appears when used extensively

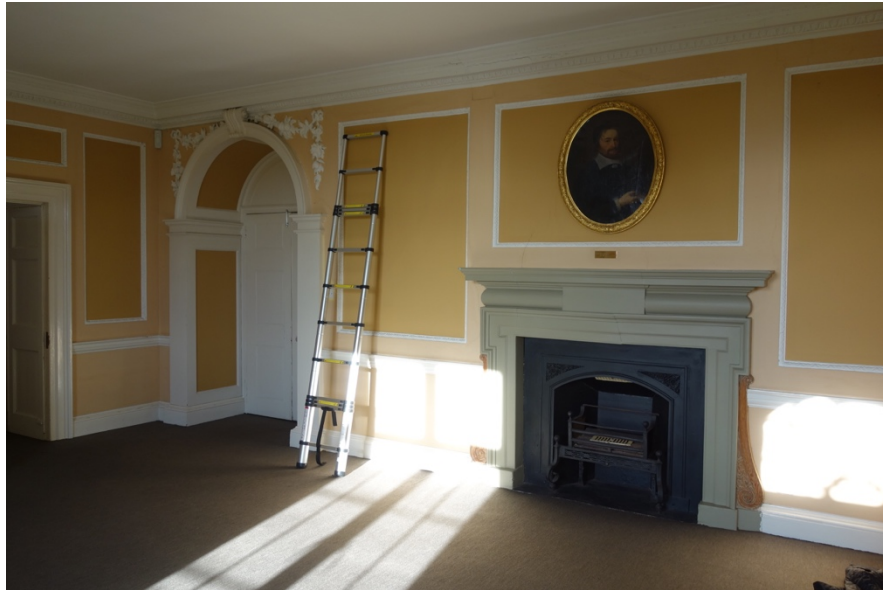
Figure 15 Room C

The evidence within this interior suggest a slightly later fitting out or a major refurbishment in the early eighteenth century. The first paint scheme is typically Palladian, in warm grey tones to the wall faces and panels, with the raised detailing picked out in a soft lead white .

An interesting detail is that the raised work in the lead white was given a light varnish coat, this would increase the gloss of these elements in contrast to the mid sheen (satin gloss) of the main wall face elements.

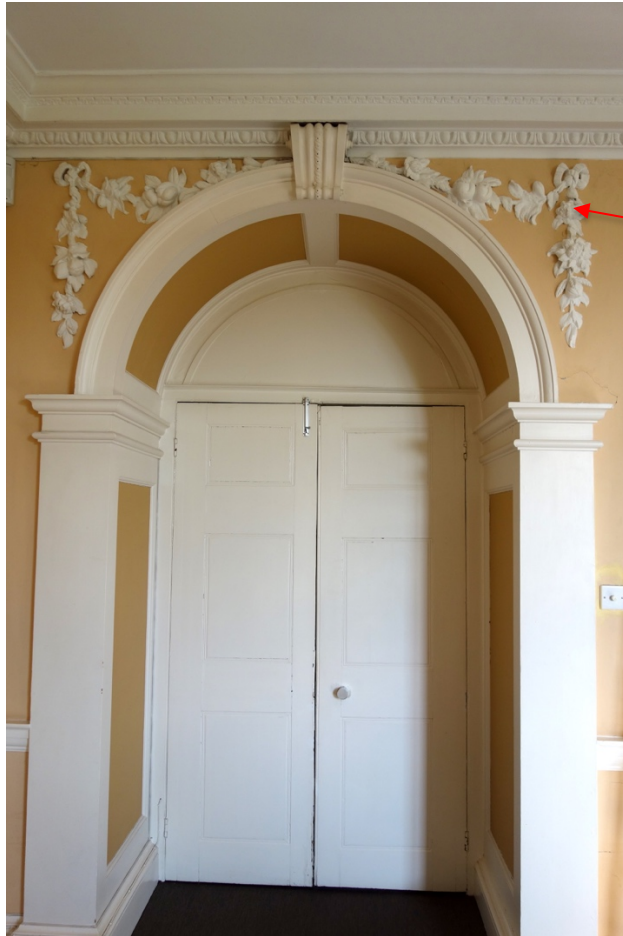
Figure 17 Room C

The original eighteenth century finish of warm grey with the raised work in lead white would look calm and yet suit perfectly the exuberant architecture of this room.

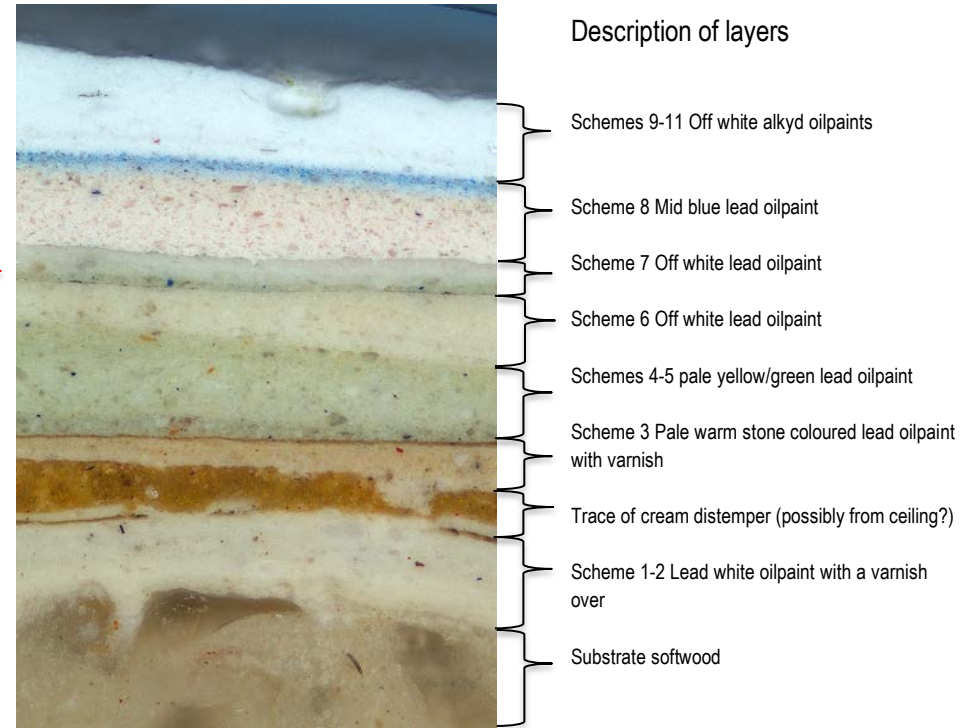
Figure 18 Sample: Tytt.H.Ho /3.4 Festoon mouldings

The warm grey palette is typical of the early to mid 18th century and the later greens very much a Regency and early Victorian colour. The later period schemes of in plain lead white throughout, possibly early twentieth century, suggesting the Edwardian move towards lighter brighter interiors.

Redecoration suggestion – original C18th scheme:

Ceiling – white distemper colour. Detailing and columns – varnished lead white oil paint
 Skirting, wall faces, all joinery and chimneypiece – pale warm grey oil paint

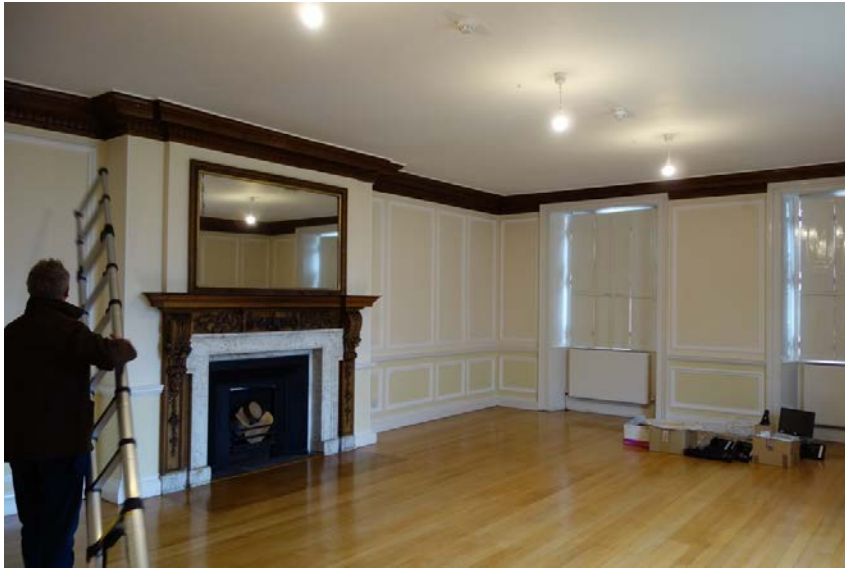
Figure 19 Room D

The Country Life photograph of 1919, adjacent, clearly shows this interior without wall panelling and full height wall surface, no sign of dado. This indicates that the wall face mouldings and dado were added after 1919. This ties in with the paint evidence, which shows that the panelling construction is made up of earliest stripped elements. The evidence suggests that the back panels of an earlier fully panelled interior had survived here and that the raised mouldings, dado etc were removed at an earlier period and the wall decorated over as a flat surface (as seen in 1919). Only the chimneypiece and cornice survived. At a later date the surfaces were stripped back to expose the earlier flat panels of the panelling

scheme. To this modern panel mouldings and dado rail were added in an attempt to recreate the earlier period

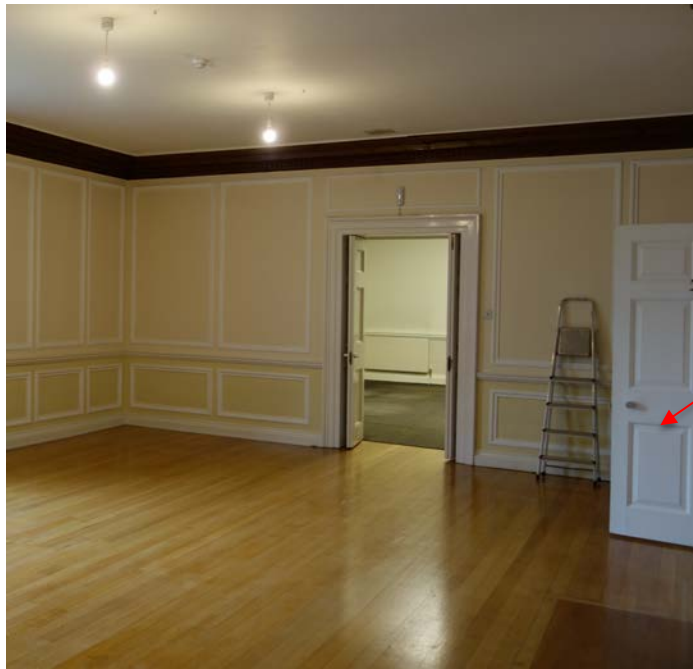
Figure 21 Room D looking towards Room E

At the time of recreating that 'lost' scheme this interior was treated in as a pair with Room E, adjacent. The evidence suggests that the panelled wall surfaces were stripped back to bare timber and then all woodgrained in imitation of a mid-oak timber.

As explained in Room C, the correct earlier convention for cornice was to treat it as wall face. This convention was not always followed during the twentieth century and that is what has happened here. The woodgraining, applied to all of the joinery, stopped below the cornice and this was painted white in with the ceiling bed.

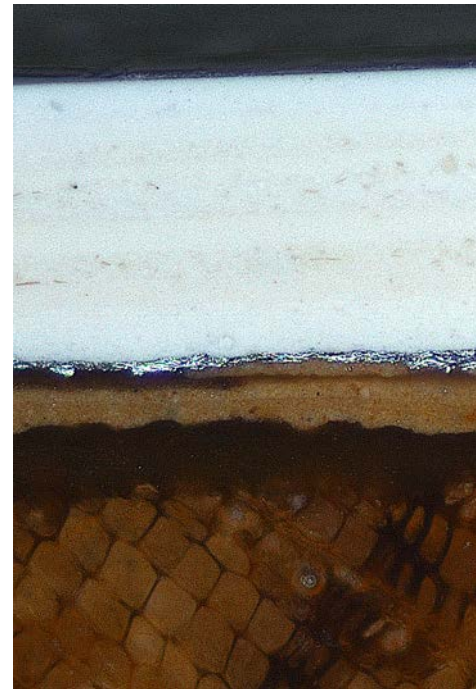
Figure 22 Sample: Tytt.H.Ho /5.6 Door

Description of layers
(Scheme numbers tie in to Room E)

Schemes 7-9 Off white alkyd oilpaints, the first has an aluminium primer as a base coat on the surface of the earlier oak woodgraining

Scheme 2 Mid oak woodgraining

Scheme 1 Varnished softwood
(C19th finish in with the flat wall surfaces)

There are two options for this area and its pair Room E.

Redecoration options –

1. **Recreate the early twentieth oak woodgrained scheme**
A complex finish, by skilled decorators
2. **Recreate the feel of a seventeenth century interior**
A plain painted scheme in period colours with period allocations

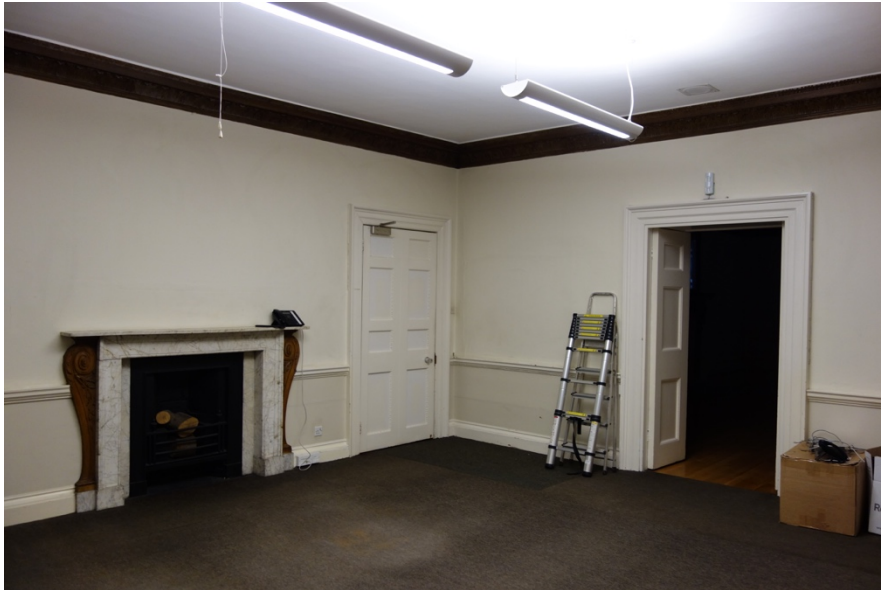
Figure 23 Room E

As with its pair Room D, the Country Life photograph of 1919, for this interior, includes indicators that help understand how it has developed. In 1919, the skirting, dado wall panels and dado rail were coated in a dark tinted oil varnish. This was also applied to the volutes either side of the chimneypiece. This type of dark varnish is very typical of the later nineteenth century through to the early twentieth century. It creates the illusion of a hardwood on a softwood substrate.

There is no evidence for earlier schemes on the softwood substrate and also no evidence for stripping or cleaning back. This indicates that the panelling is of the same date as its first varnish scheme. (late C19th to early C20th).

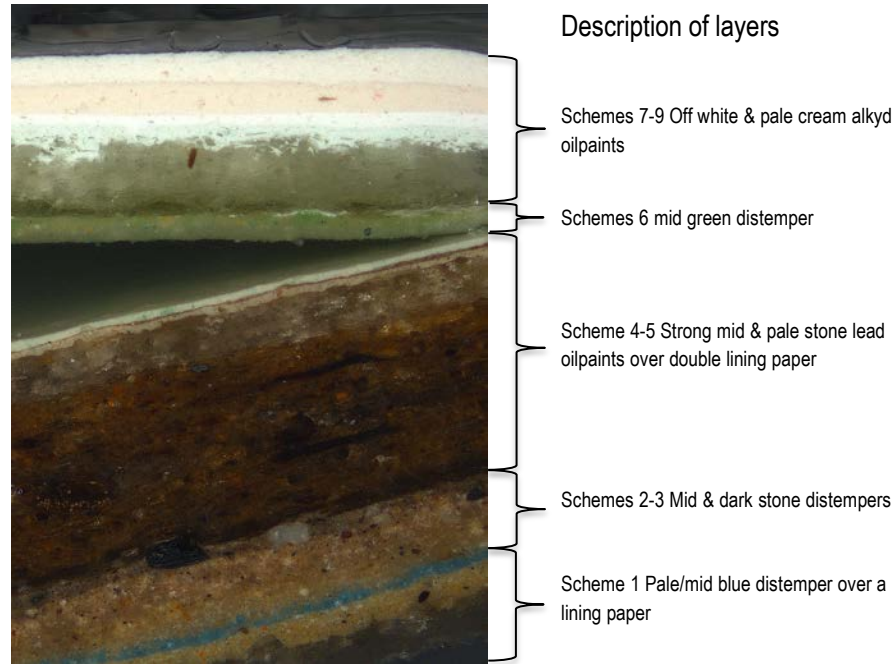
Figure 25 Sample: TH/6.1 Upper wallface

No evidence for upper wall face panelling was identified. Figure 25, shows a series of plain painted schemes with lining paper applied prior to the first scheme and then again double lining prior to scheme 4. The first lining paper is coeval to the installation of the dado panelling (dark varnish) and at that time the upper wall was painted with a blue distemper scheme. The cornice appears to have been treated in with the joinery and the ceiling bed would be plain white distemper.

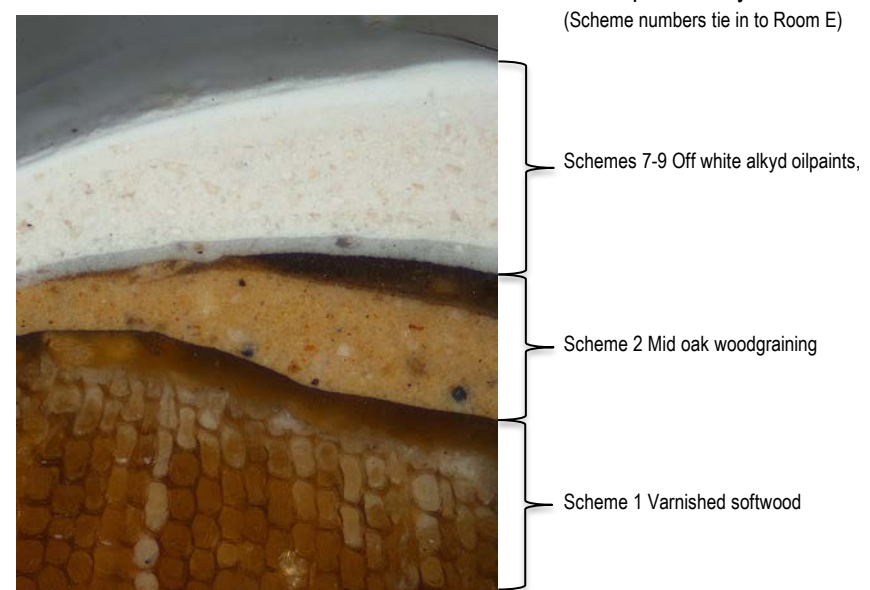
Figure 26 Sample: Tytt.H.Ho /6.4 Dado rail

The evidence on the dado joinery shows that when the wall panelling was recreated in Room D, the pre-existing nineteenth century dado joinery within Room E, which was still varnished was then also woodgrained in imitation of a mid-oak timber

Initially with the dark varnish a blue distemper was used on the walls. With the introduction of the woodgraining this was then overpainted with a series of four stone coloured schemes, before a further two schemes of mid green.

It is at scheme seven that a drastic change occurs, the woodgrained joinery is overpainted with oil paint (post 1950 alkyd) and the upper walls are painted in off whites and pale creams.

Redecoration options –

1. **Recreate the late nineteenth century dark varnished wood & blue wall faces**
Expensive to strip the timber, instead introduce a dark painted finish with varnish over, to suggest dark varnished wood.
2. **Recreate the woodgrained scheme in with Room D, with stone colour walls**
A complex finish, by skilled decorators

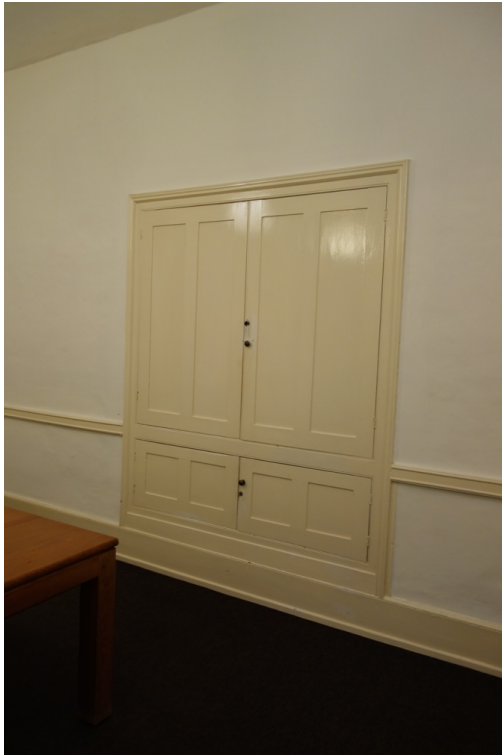
Figure 27: Room G Cupboards

Only the fitted cupboard was sampled in this interior, to give an indication of the status of the room. The scale of the interior and the cupboard suggest either a Butler's Parlour, or more probably a Housekeepers Room. The earliest evidence is of an eighteenth grey/cream, which appears to have been retained for a significant period and then two schemes of woodgraining.

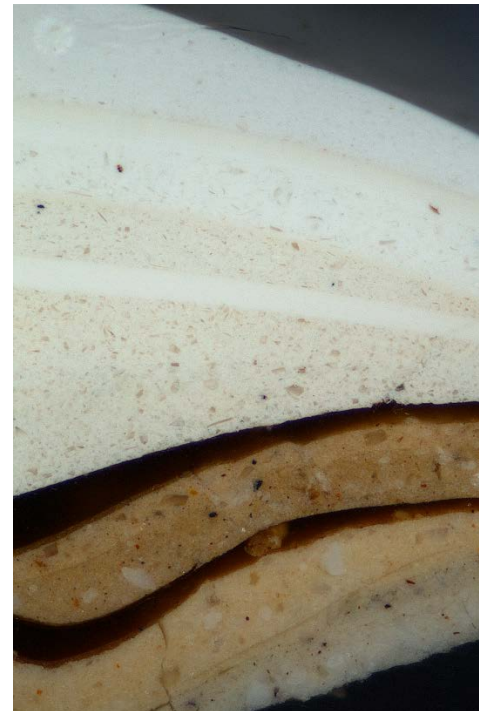
Figure 28 Sample: Tytt.H.Ho /6.1 Cupboard

Description of layers

Schemes 4-7 Pale cream & off-white lead & alkyd oilpaints

Schemes 2-3 Pale & mid oak woodgraining

Scheme 1 Pale grey/cream lead oilpaint

Substrate softwood (not shown)

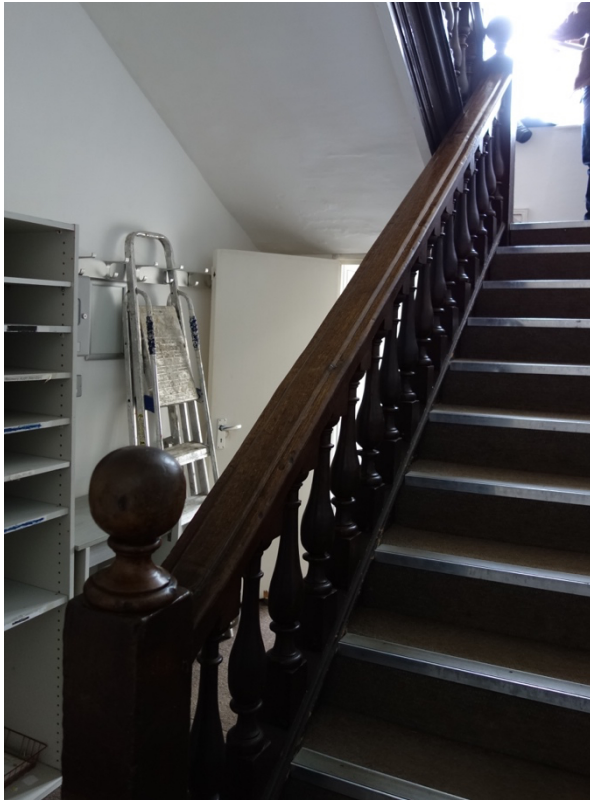
Figure 29: Room H secondary stair

This secondary staircase would primarily be used by servants. Research was focused on the walls, which have had extensive repairs, reskims and heavy application of modern embossed wallpaper. An un-papered area was sampled. The stair joinery is in its original dark varnish finish

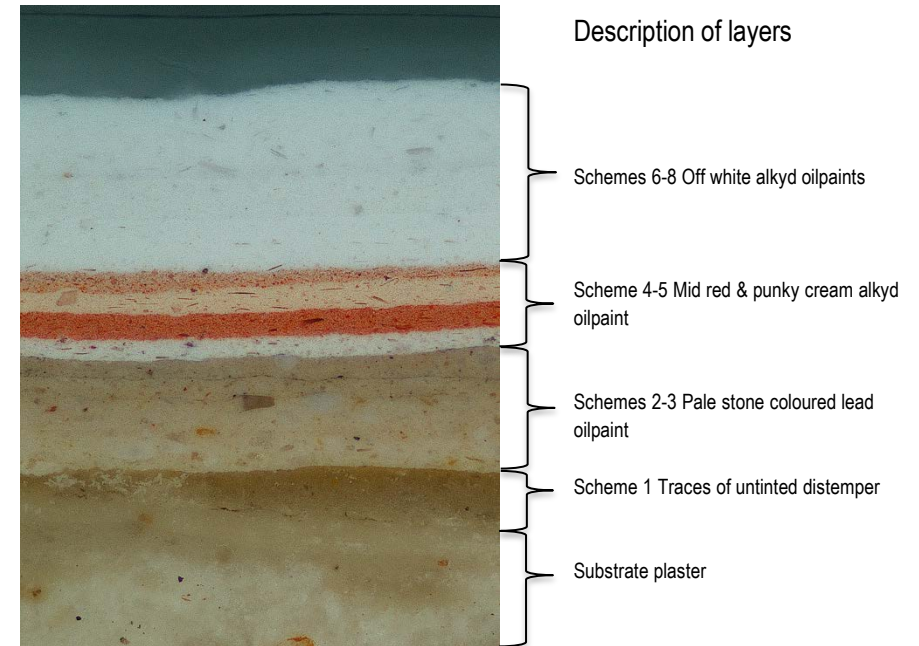
Figure 30: Sample: Tytt.H.Ho 7.2 wall face

The sample shows traces of plain soft distemper at the earliest period with stone coloured oil paints in schemes two and three. These stone colours and the coarse paint type are found in virtually every historic house during the nineteenth century period. They are easy to live with, do not fade or change over time and importantly was one of the cheapest coloured oil paints to manufacture, being tinted with ochre and umber pigments.

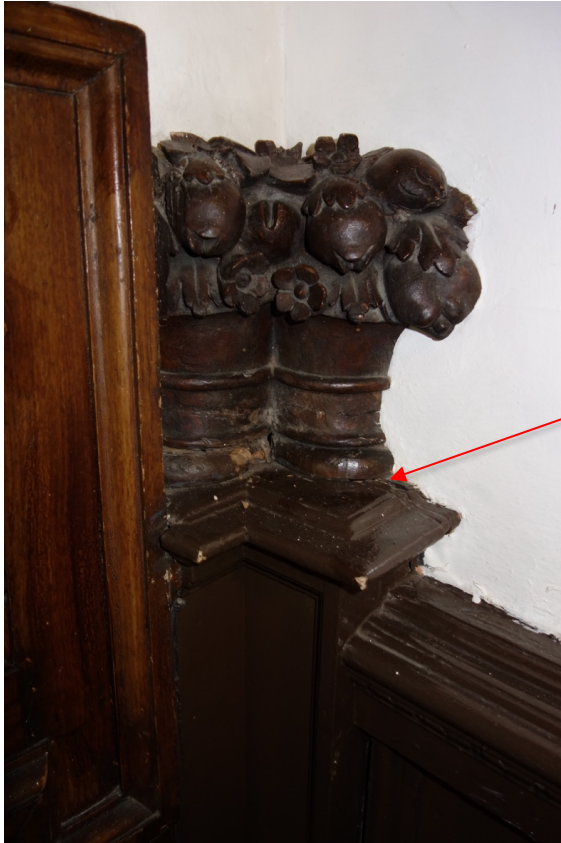
Figure 31 Main Stair carved corner detail

The Main Stair at Tythenhanger is of very high quality and status. Investigations undertaken prior to sampling identified areas of original gilding over gesso surfaces. Unfortunately, there was no evidence for early or historic wall face decoration. It appears that the area was extensively reworked at some time during the later twentieth century

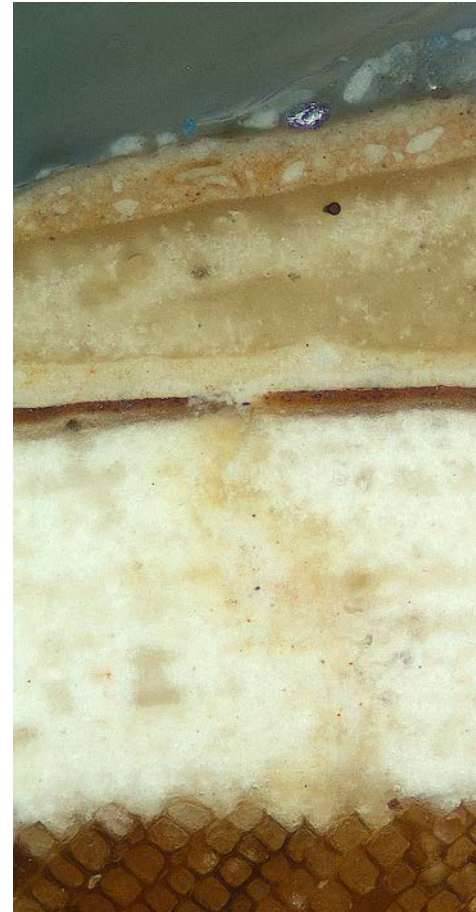
Figure 32 Sample: Tytt.H.Ho 7.1

Description of layers

Unlike the main joinery areas, which were stripped prior to scheme 3, the deep recesses of the carved detail retain evidence for the earliest decoration, including gilding.

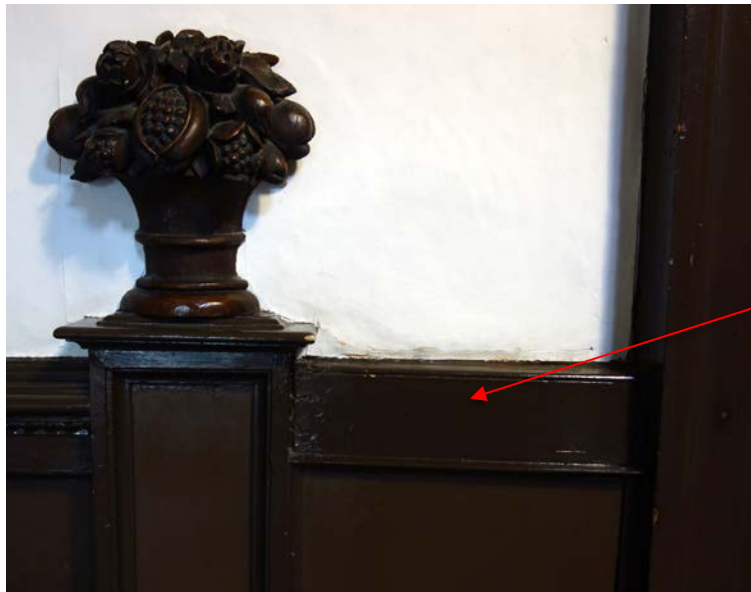
Figure 33 Dado wallface

The evidence shows that prior to the third scheme, which is a dark oak woodgraining, the stair joinery elements, including the carved work and fruit and flower baskets were extensively stripped back. This is perhaps to be expected as it appears, that the original scheme had survived for a considerable period and would have been worn and damaged reflecting that. It was painted with a single scheme of cream lead oil paint, one coat, and presumably merely to hide the degraded original finish. Scheme two was applied only a shirt while before scheme three, the dark oak woodgraining scheme. So, although referred to as a scheme here it might be an initial additional base coat for the subsequent decoration.

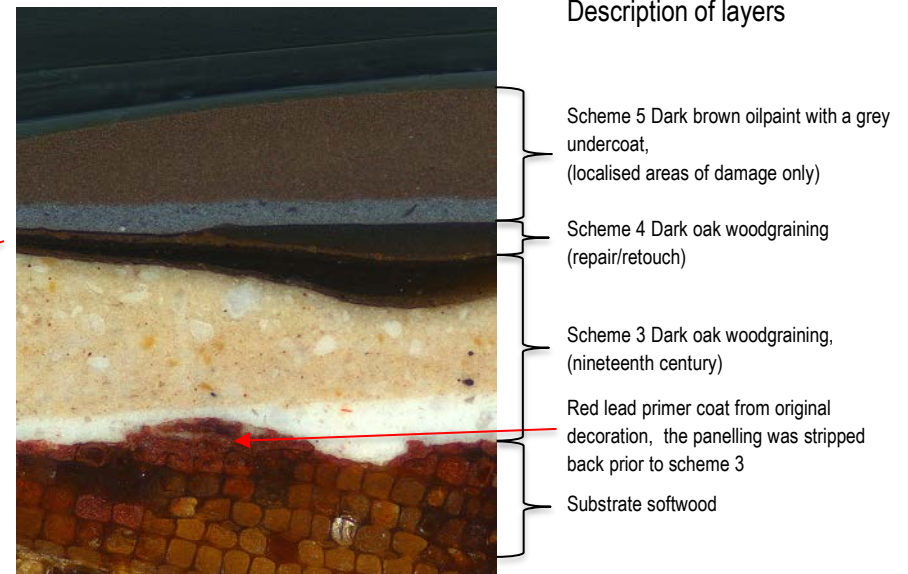
Figure 34 Sample: Tytt.H.Ho 7.1(2) Dado wall face

The presence of a red lead primer for the original finish is typical for the seventeenth century and earlier. After that period, preparation coats applied directly to substrates were of a lead white only.

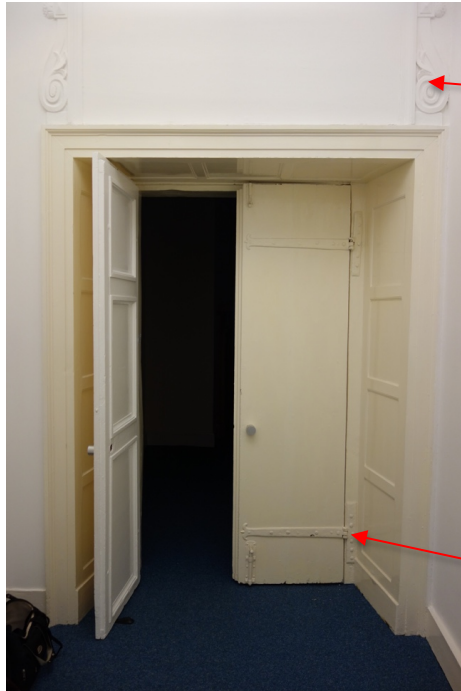
Figure 35 Room J

Within this small office/vestibule area, the research was focused on the door and its associated over door panel, with embellishments. This overdoor treatment is repeated throughout this small closet like interior.

Although the schemes on the overdoor only date from the Regency period with a woodgraining as seen in Room G, the door has a seventeenth century 'cedar Colour' as seen in the Entrance Hall, Room A.

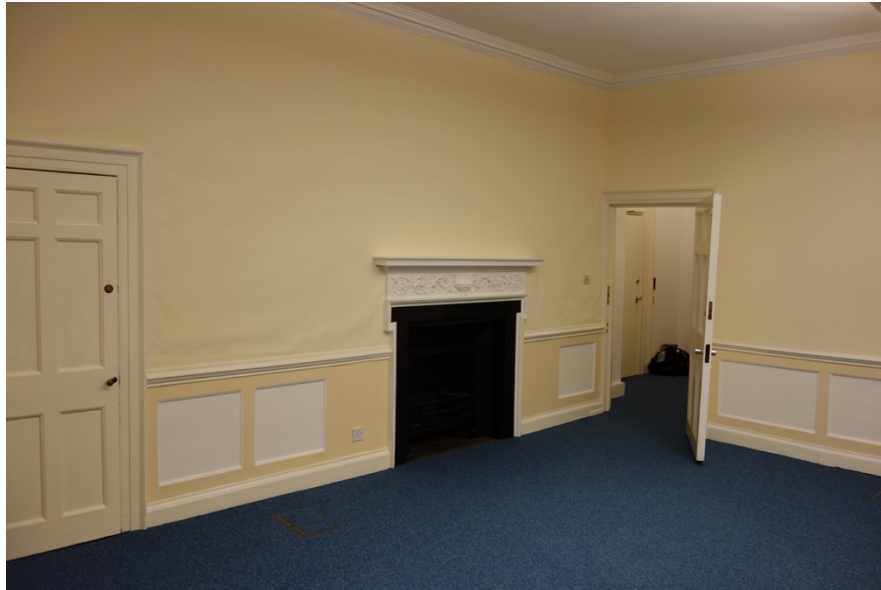
Figure 38 Room L

As identified within many of the interiors of the House, very little information survives on the wall faces within Room L. Also, the joinery elements are in a strange arrangement, indicating that there has been considerable disruption within this area. In particular the arrangement of dado panelling to either side of the fireplace, and the panel size and scale shows that the interior is a creation of a later period.

Samples removed from the cupboard to the left of the fireplace showed evidence of late nineteenth century lead white oil paint as the earliest scheme.

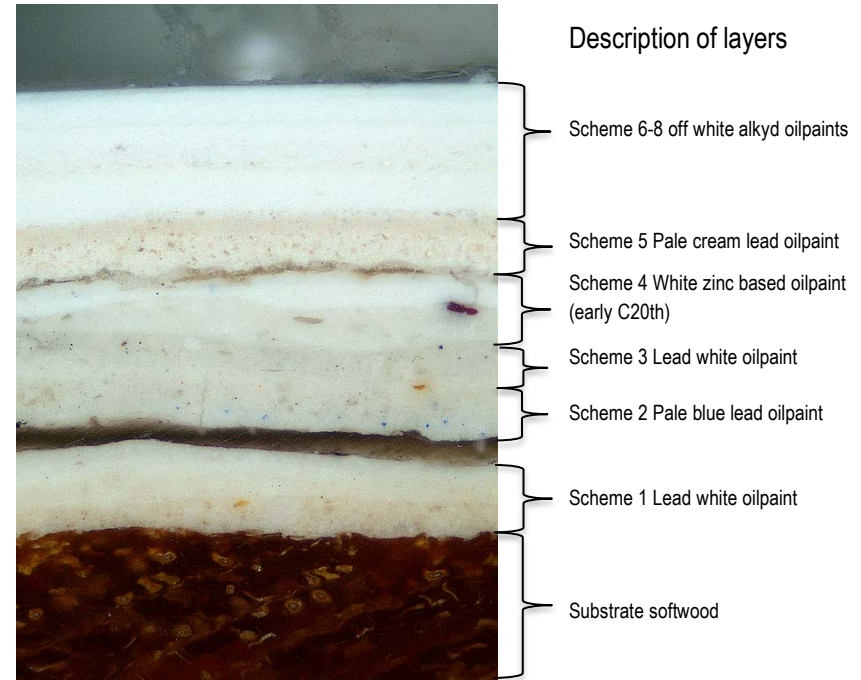
Figure 39 Sample: Tytt.H.Ho /8.1 Joinery

Two further lead white scheme were applied prior to the application of a zinc based white enamel finish. This type of finish was popular for a very short period around 1920.

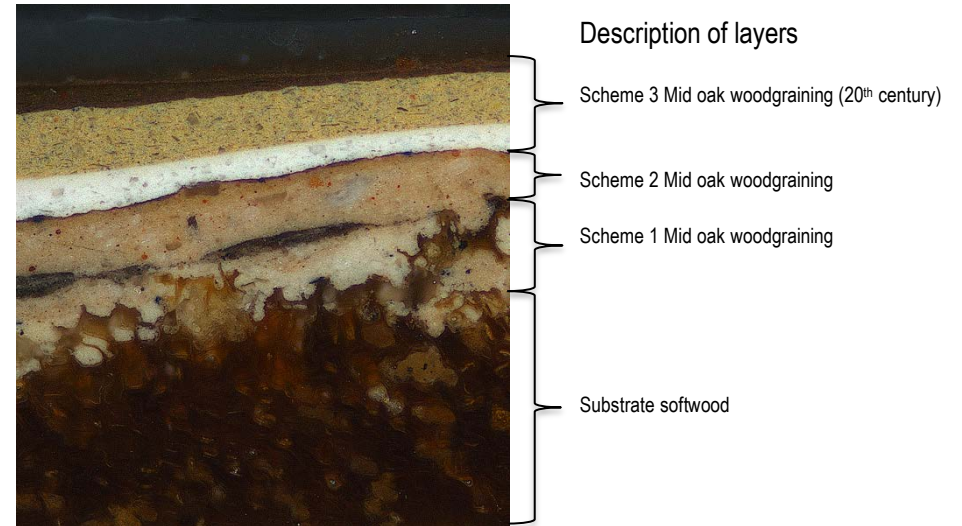
Figure 41 Sample: Tytt.H.Ho /8.1 Panelling

Three schemes of woodgraining were identified on the wall panelling and presumably this is representative for the remaining joinery within the room.

The earliest scheme of graining was obviously in evidence for a significant period of time as the surface is very dirt, eroded and degraded. In style it appears to Regency period c.1815 – 20, as seen elsewhere. The second scheme applied over it is late nineteenth century and on top of that a rather crude late twentieth century grained finish in alkyd paints (post 1950)

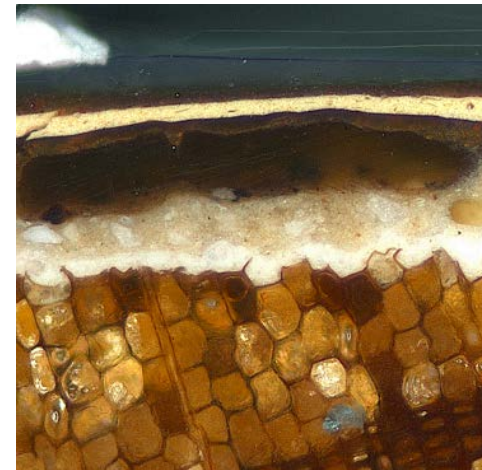
Figure 43 Sample: Tytt.H.Ho /8.1 Cupboard door

Description of layers

- Scheme 3 Mid oak woodgraining (20th century)
- Scheme 2 Mid oak woodgraining (repair/retouch)
- Scheme 1 Mid oak woodgraining
- Substrate softwood

Results as Room Q - The earliest scheme of graining was obviously in evidence for a significant period of time as the surface is very dirt, eroded and degraded. In style, it appears to Regency period c.1815 – 20, as seen elsewhere. The second scheme applied over it is late nineteenth century and on top of that a rather crude late twentieth century grained finish in alkyd paints (post 1950)

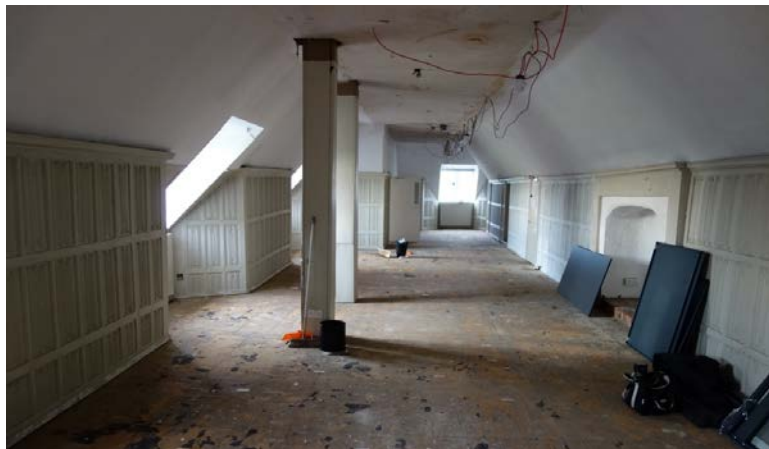
Figure 44 Room 3

The Long Gallery is a very unusual interior and the research suggests that all is not as it appears to be initially. There is no evidence for seventeenth century finishes as the earliest scheme is a typical eighteenth century, mid warm cream (or mid stone) colour. This was applied to the joinery throughout this interior.

The upper walls and ceiling retain evidence for early untinted off-white soft distempers, over which there is a blue white distemper. The blue pigment is artificial French ultramarine and therefore dates from post 1826, when it was first discovered and came into wider usage.

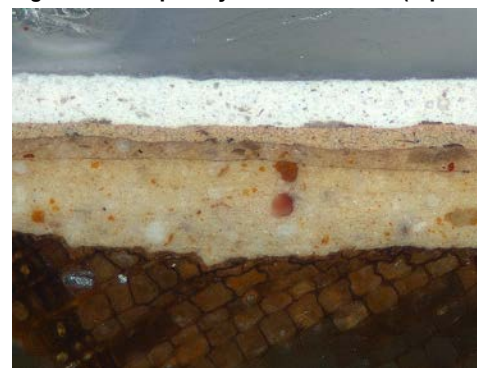
Figure 47 Sample: Tytt.H.Ho 8.3 Door (representative of wall panels also)

- Scheme 4 Grey cream alkyd oilpaint
- Scheme 3 Dark stone lead oilpaint
- Schemes 1-2 Mid warm cream coloured lead oilpaints (identical to scheme 2 Room B panelling. Early C18th mid warm cream)
- Substrate softwood
