Tyttenhanger House St Albans

Level 3 Historic Building Recording

CA Project: MK0171

October 2020

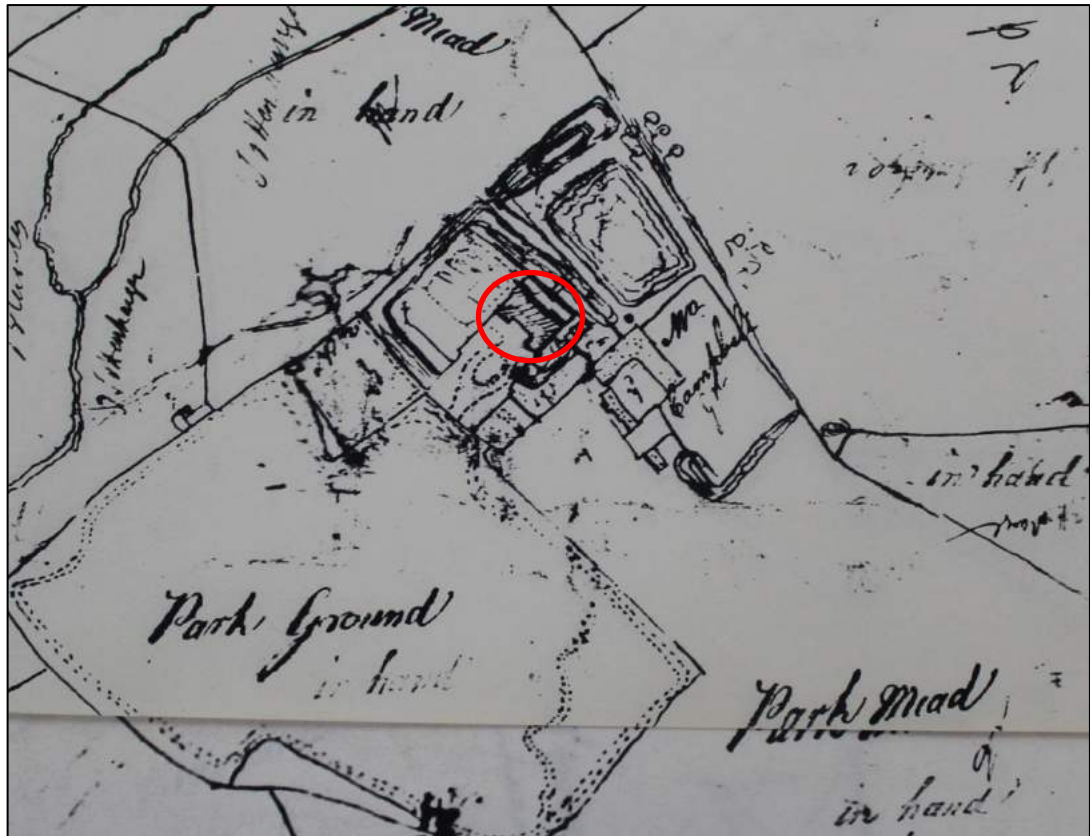
Fig. 3 Map of Tyttenhanger Estate 1777, courtesy of Hertfordshire Records Office, house circled in red

- 3.6. The next piece of cartography, a Map of Tyttenhanger Estate 1777, shows the extent of change in just 10 years (Fig.3). The map is a little difficult to interpret, as it is in sketch format, however it is possible to see the main features. The house itself is shown in a formal H-plan, which is as extant, and a turning circle drive in front of the house is visible. The 'park ground' has been established (the open landscape to the south front of the house), and some elements of formal gardens to the south-east of the house are shown. The walled garden appears to be extant as does the stable building, which also appears in the 1766 map.

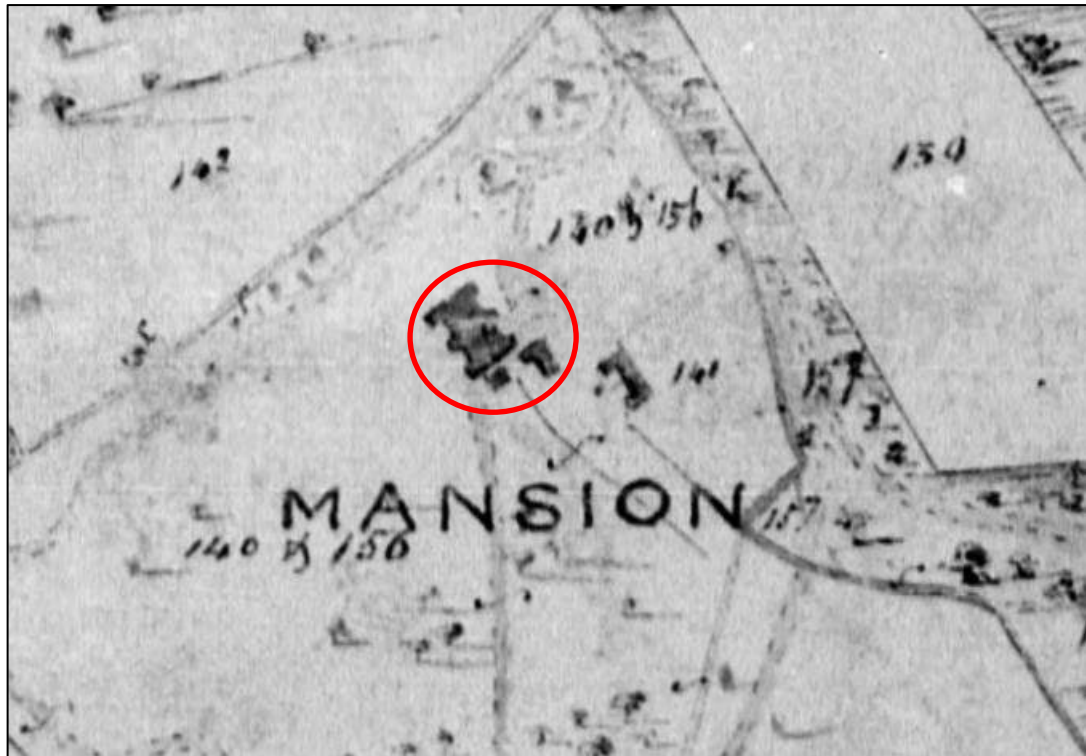
Fig.4 An extract from the Ridge Tithe map of 1828, courtesy of The Genealogist

- 3.7. The Tithe map of 1828 (Fig.4) offers a further view of the estate during the first half of the 19th century. Being primarily a record of ownership and tenancy, the map itself is a little scarce on detail, but the key features of the estate are visible. The stable block is present, and the associated apportionment details that the 'mansion, offices, yard, kitchen gardens, Old Park Ground Mead, Park Ground, Shrubby and Lawn' are all owned by the Countess of Hardwick. The house is shown in its extant H-plan formation; two protuberances are evident to both sides of the central block of the Building, these are thought to be external porches (no longer extant); the Heritage Gateway details that Lady Caledon (wife of the Earl of Caledon) renovated the house c.1834, and added porches to the north and south entrances. An outbuilding is shown to its south-east, this may be an early iteration of the later ancillary wing now extant.

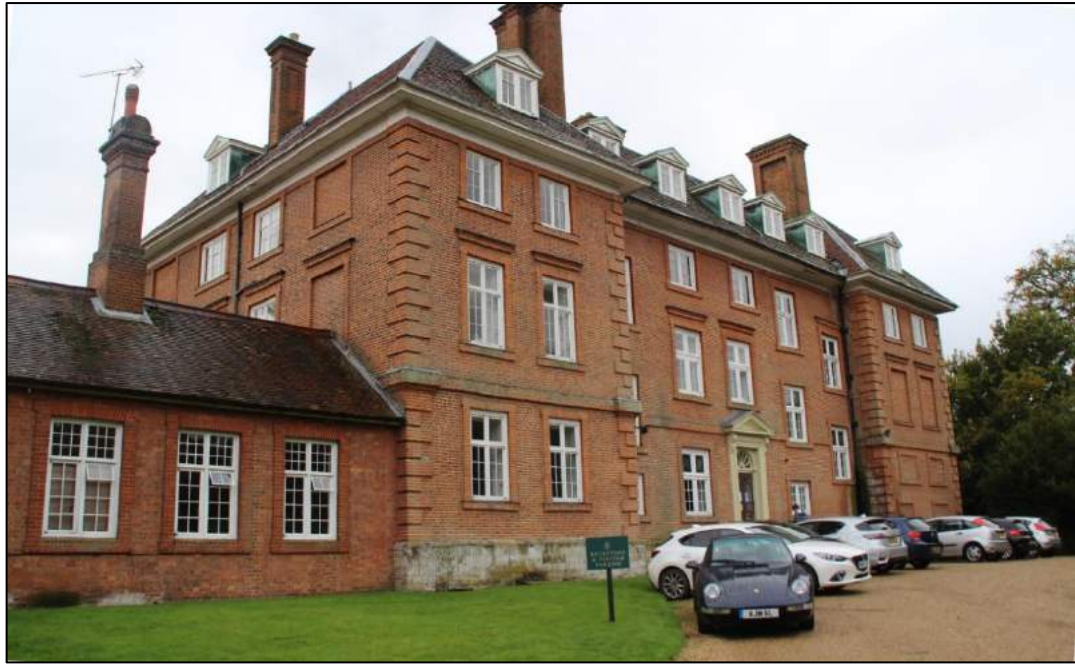
Fig.7 Front (north) elevation of the building

- 4.14. The front (north) elevation has 5 bays to the central section, with 2 bays each to the shallow wings, and a 7-bay attic storey with pedimented gables (Fig.7). A strong platband runs at first floor level. The fenestration to the central section is irregular, apparently to allow for the placement of the internal staircases. The ground, first and second floor windows of the right wing are both blind. The fenestration is largely cross windows, featuring mullion and transom with multi-pane lights to lower half, and a single glazed panel to the stop. The mullion and transoms appear to be wood, accompanied by steel, or heritage crittall style, windows. Windows to the third and attic storey are simple casements with 6 lights, similarly two to the ground floor. Window surrounds have simple lugged architraves with some floating cornices and slight fanning to the tops.

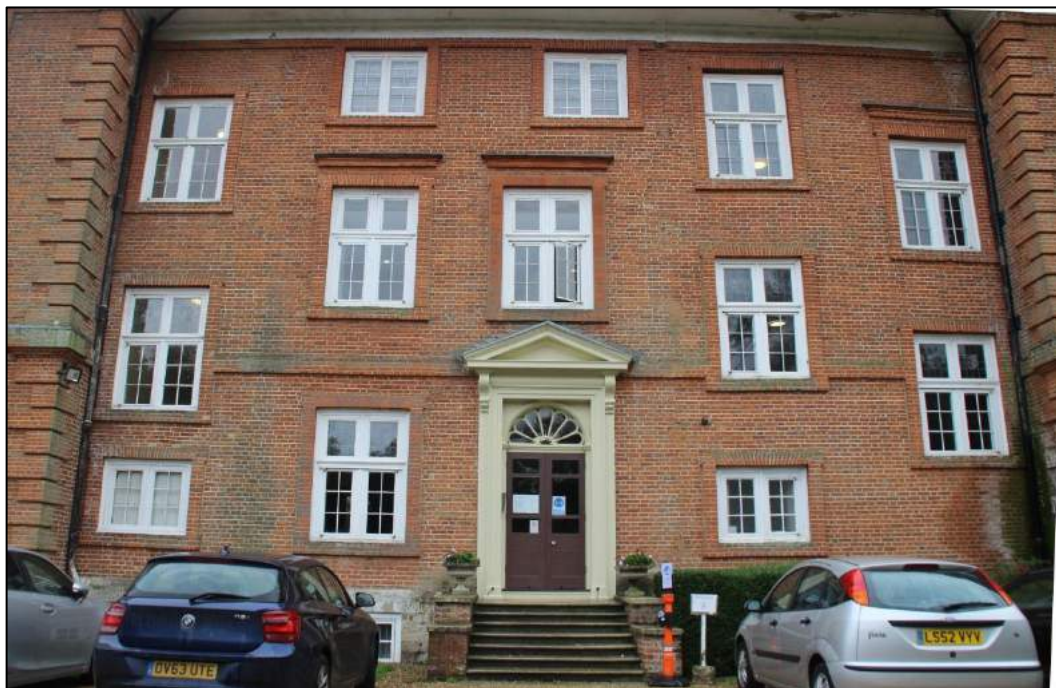
Fig.8 Front (north) middle building section showing the front door and asymmetrical fenestration

- 4.15. The current front entrance door, accessed via a short flight of steps, has a cornice pediment with decorative consoles and moulded architrave with a part glazed and panelled door with a sun adorned fanlight encircled by an engaged moulded arch and columns (Fig.8).

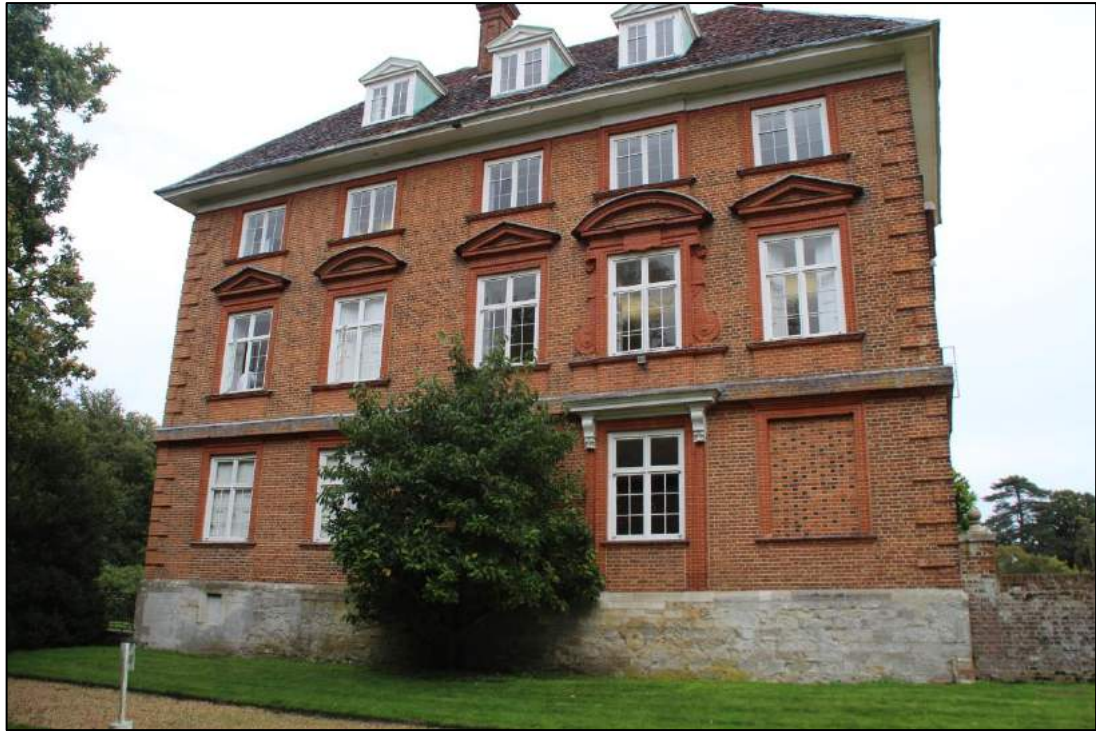
Fig.9 Western elevation, image taken looking east

- 4.17. The second-floor windows have some decorative embellishment, with alternating triangular and segmental pediment detailing in gauged brickwork and aprons below cornice cills. The 4th bay to the right is further embellished featuring a double apron, a lugged architrave with keystone detail and framed by pilasters with scrolled bases. This, and the window below with console cornice, reference the decorative work of the front (south) elevation and no doubt were designed to reference the architectural hierarchy of the pre-eminent frontage, being the first windows of the winged section returning to the front.

- 4.18. The second-floor windows have aprons topped with cornice cills and the usual arrangement of pedimented dormers. Of note is the off-centre small chimney stack on the roof slope and the deep boxed eaves.

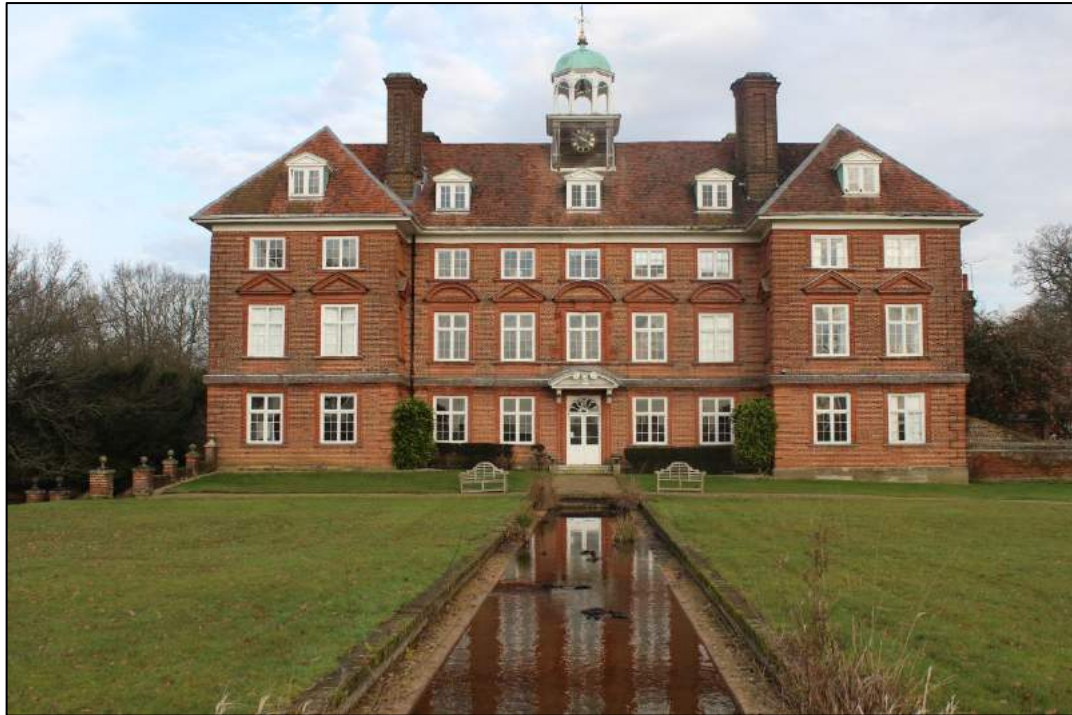
Fig.10 The south elevation of the Building, once the formal front

- 4.19. The front, south, elevation is the most decorated with moulded and gauged brick work and reflects the original intent of the design in having the Building address and grandly overlook the open landscape to the front of the house, with the long drive from Courser's Road arriving at a turning circle to this frontage of the house. The relative decorative plainness of the north front suggests that it was made a formal entrance later in the 19th century (as shown in the cartographic regression in Chapter 3).
- 4.20. This south elevation (Fig.10) features a symmetrical arrangement with 5 bays to the central block, and 2 each to the wings, which are deeper than the north elevation. Blind windows feature in the re-entrant angle of the wings. The brick quoins are chamfered. The ground floor cross windows have a plain architrave with cornice over, under a continuous moulded plat band.

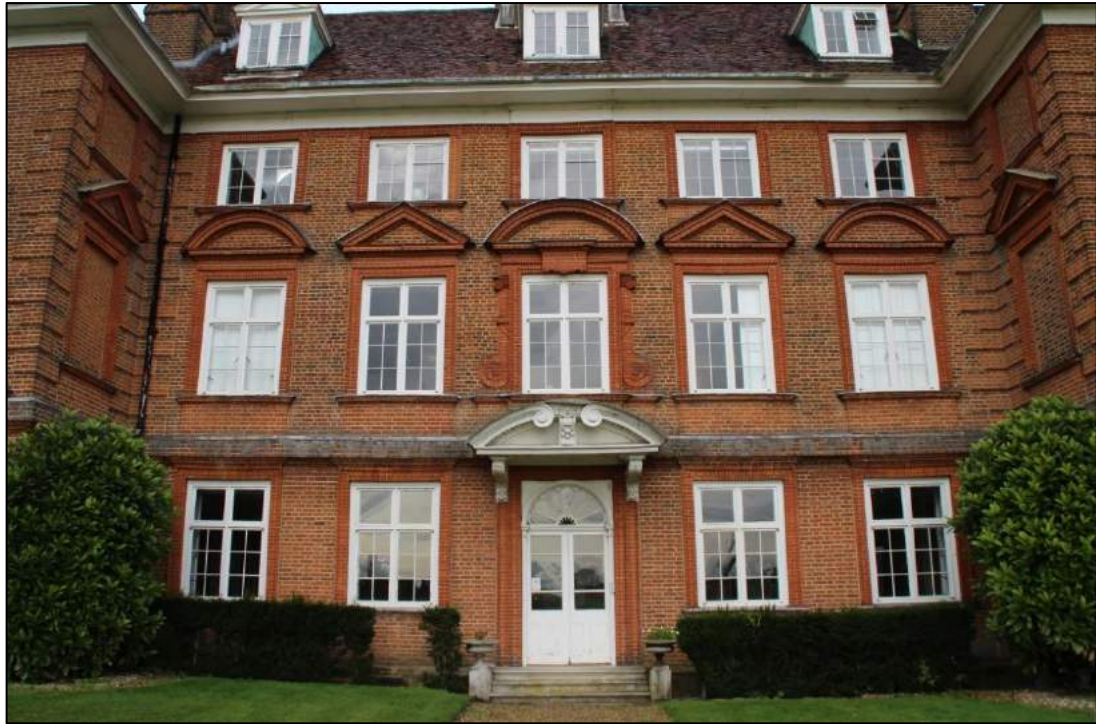
Fig.11 Central block of the southern elevation, showing the former main entrance door

- 4.21. The first-floor windows have alternating triangular and segmental arch pediments with aprons below the windows. The pediments to the wings and re-entrant angle windows are triangular. The central first floor window has the same arrangement as the west elevation, with a central segmental pedimented window with lugged architrave with keystone framed by pilasters with scrolled bases. The second-floor windows are square with 6 lights per casement and aprons below and the dormers (1:3:1) are again pedimented.
- 4.22. The main entrance has a broken scrolled pediment with brackets below, curved moulded architrave and a part glazed and panelled door with traceried circular fanlight accessed by steps from the garden (Fig.11).

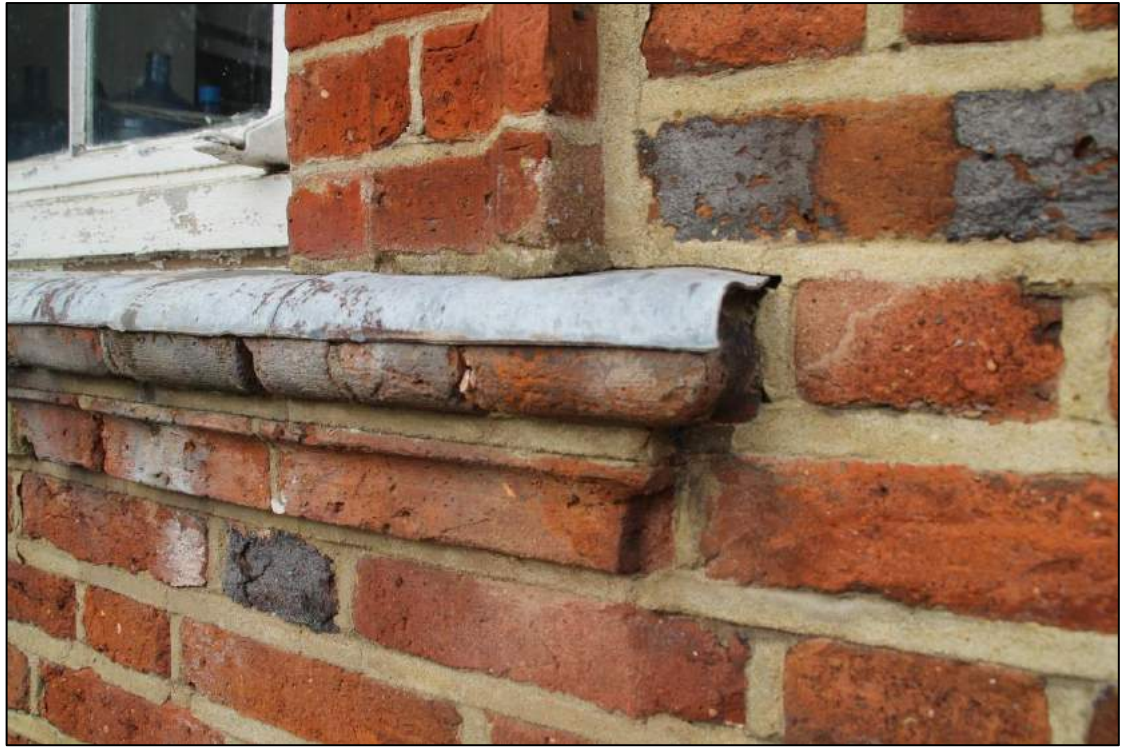
Fig.12 Detail of brickwork, showing gauged brickwork and firing marks

- 4.23. Of interest here and only discernible from above is the double span of the roof to this elevation (as compared to the north range). A clock turret sits atop the ridge of this range, surmounted by a bell cupola and weathervane finial. The finishing detail of the moulded and crafted brick is seen in Fig.12, whilst weathering has slightly deteriorated the pointing, the fine craftsmanship is still discernible. Fig.13 shows a detail of a chimney, evidencing the attention to detail even at this level.

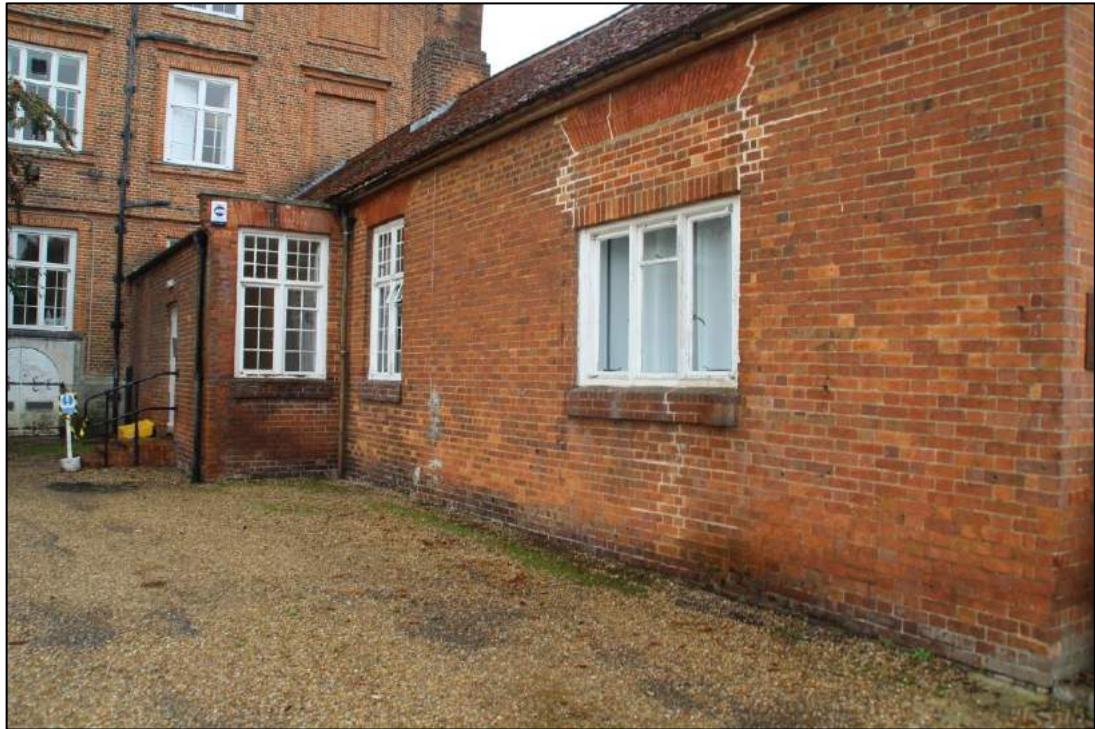
Fig.15 The southern elevation of the north-eastern servants' wing extension

-
- 4.26. The one storey 19th century ancillary extension can be seen in Fig.14 above and Fig.15 below. It is formed of a flat roofed corridor element which exits into the courtyard via some brick steps, attached to a shallow L-shaped hipped roof wing which cuts across the first-floor blind window. The windows are cross versions with multi-panes and fanned brick headers, though the far-east window has been replaced with a short 3 light casement. The bricks are uniform and appear machine cut, which would underpin the probable mid-19th century date of construction.

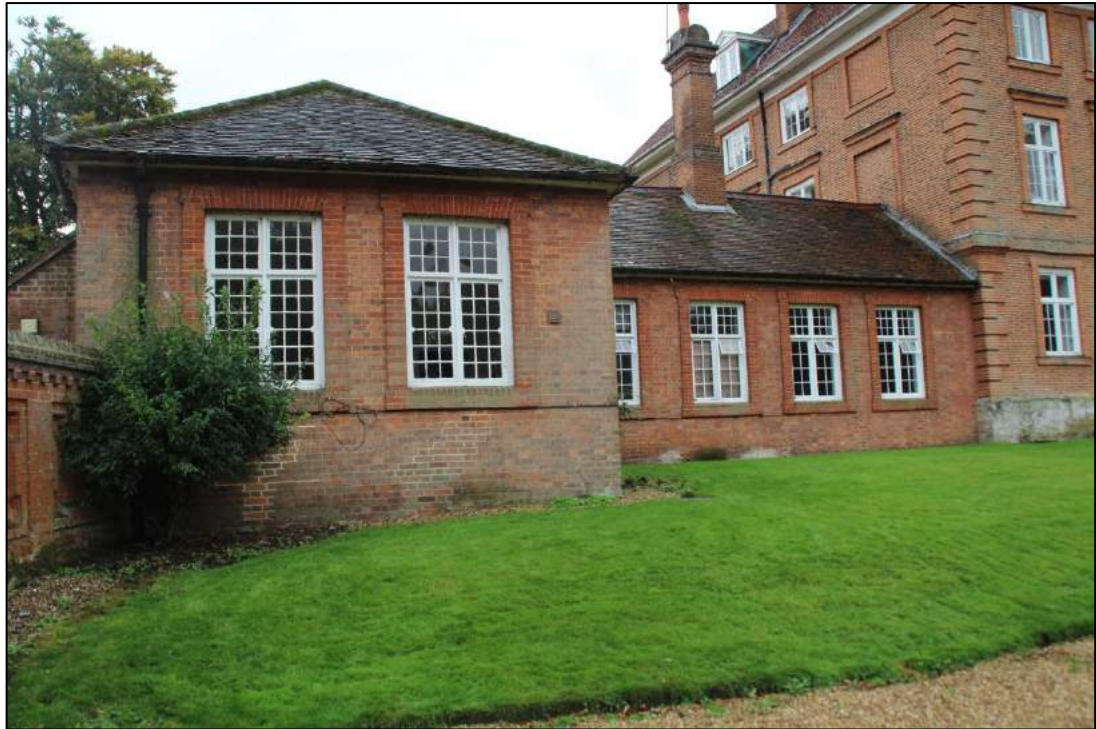
Fig.16 Northern elevation of the servants' wing extension

- 4.27. Returning to the east elevation of the extension, this has a small brick porch and back door opening out into the stable yard. The north elevation (Fig.16) is plainly detailed but references the main house, with cross multi-pane windows evenly and closely spaced and with plain lugged architraves. A tall stack with moulded cornice top and plinth sits in the middle of main wing section. This wing would no doubt have housed ancillary functions, such as stores, washing and the bakehouse the main kitchen being located in the original house near to the 'back' stairs.

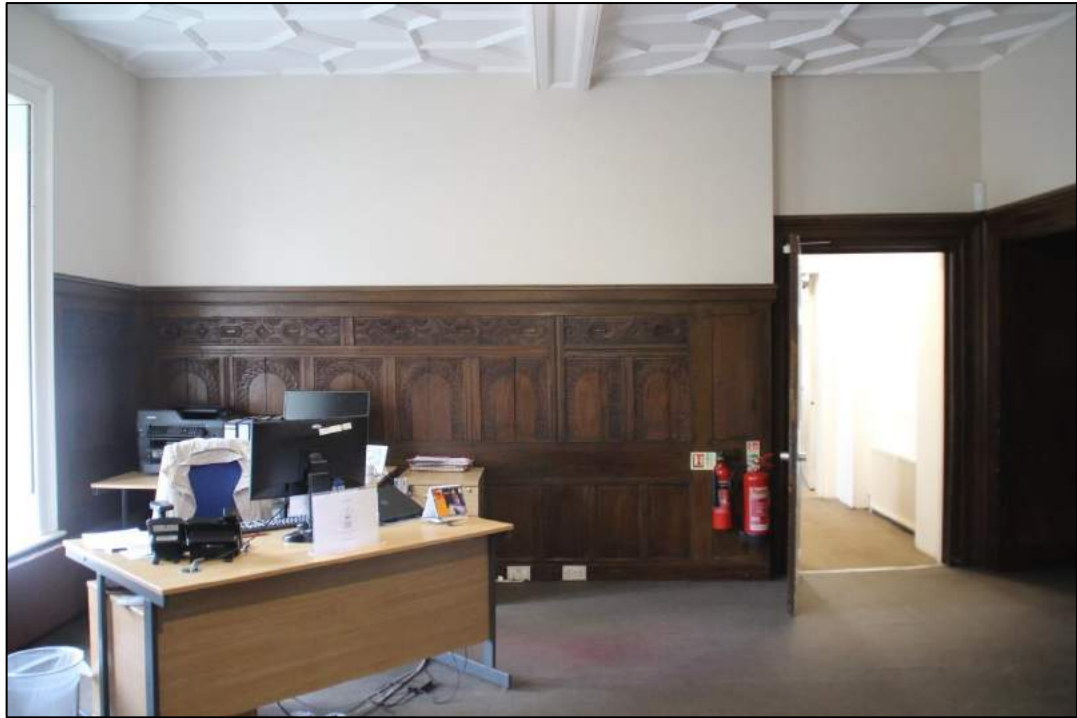
Photo 1. View of the eastern wall of the main entrance hall

- 4.31. Interestingly, Crick-Smith identifies this panelling as 'later 20th century' however it is not clear if this is correct, as the listing description, written in 1952 and updated in 1989, specifically mentions the re-used Jacobean panelling as does Pevsner (1977). Perhaps it was meant to read 'later 19th century'. Van Koughnet (1895) also mentions the re-use of panelling from the previous house on the site, though the reference to this is vague and talks of the 'materials, wainscot etc of the ancient mansion of the abbots were used for the new building'. An image of the room in the October 1919 Country Life shows the room as it is now. Further investigation of the panel fabric and carving could assist in dating these panels but it is possible that rather than re-used, they are a copy of the pew panelling in the chapel; created as part of a 19th century 'historicism' scheme.

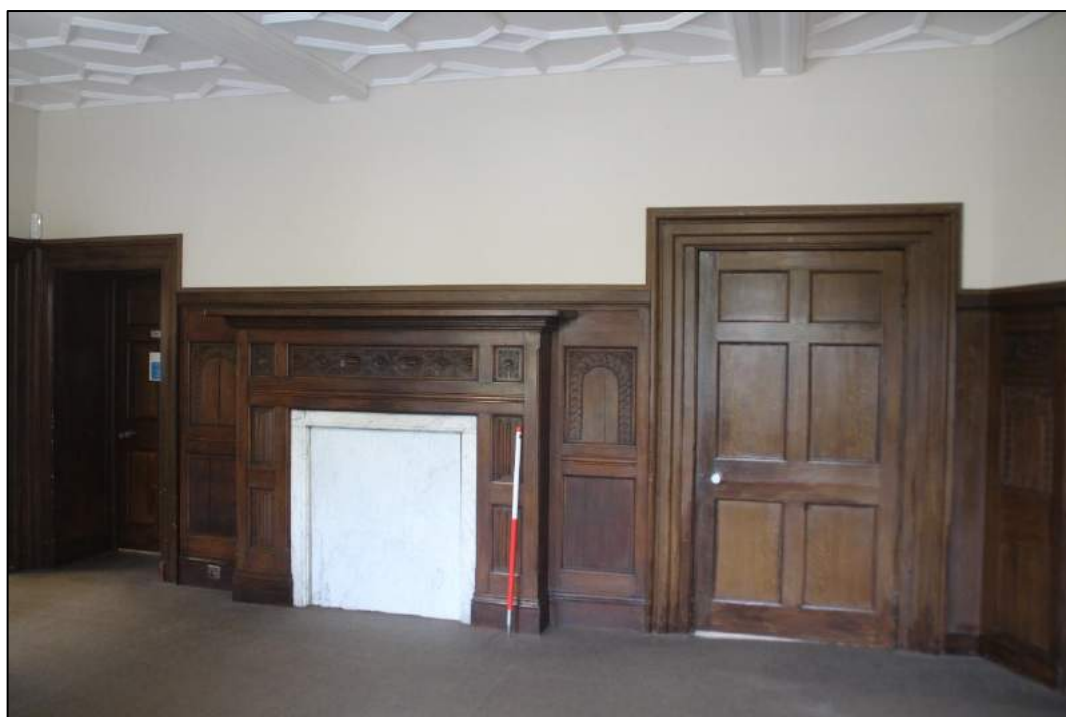
Photo 3. Southern wall of main entrance hall, image looking south

4.33. The doors themselves are largely 6 panelled (a standard pattern for the first half of the 18th century: Hall 2005) though the door to the staircase hall is a later addition, being part glazed. The type of timber used was not discernible, though staining is apparent on the door to back stair hall and this suggests softwood which is the main type of wood discovered in the house by Crick-Smith during his technical investigations. The entrance door is part glazed and the doorway is panelled with panelled shutters extending over the glazed half. This is confirmed by Crick-Smith be possibly original, based on the layering of paint, the base of which is a mahogany wood graining typical of the period of construction on a softwood fabric.

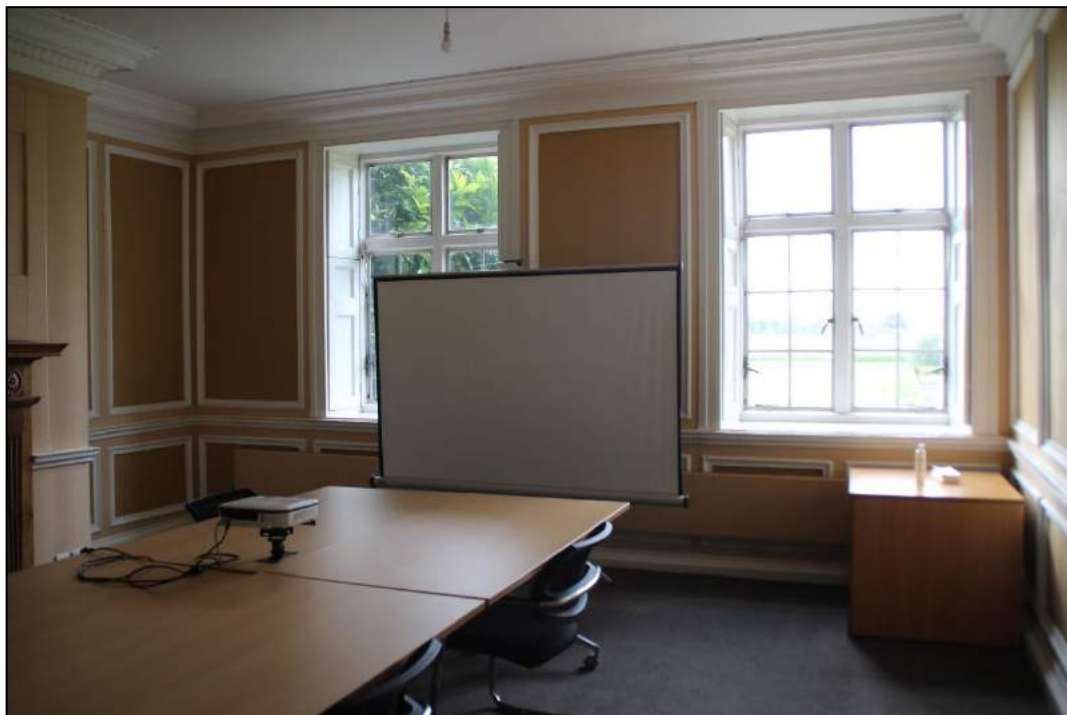
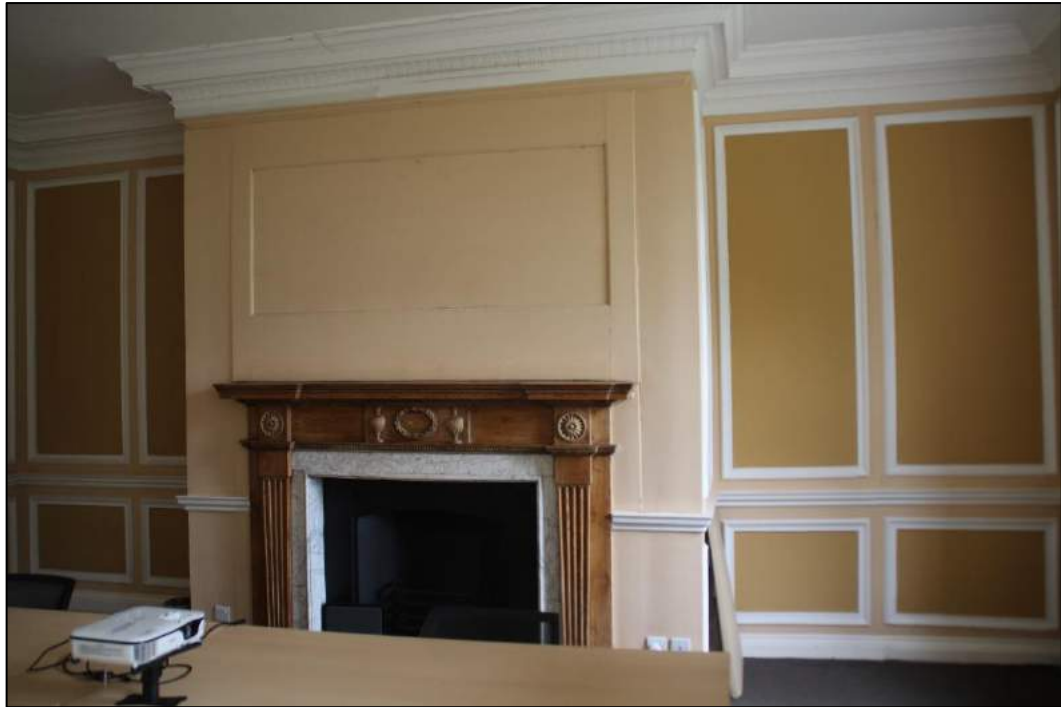
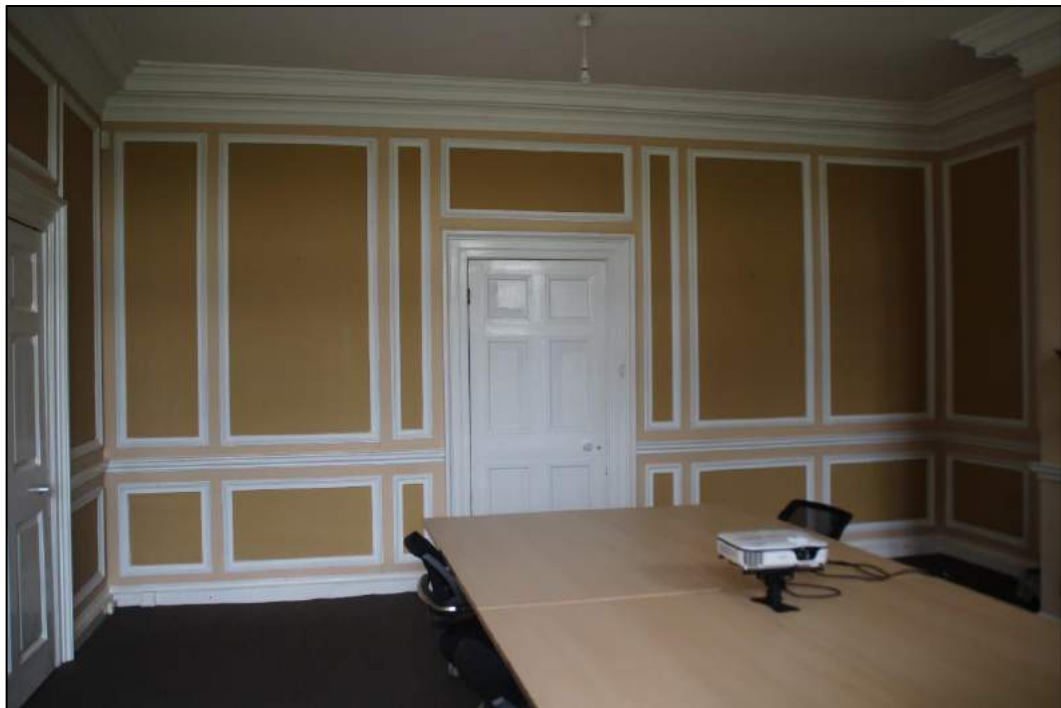
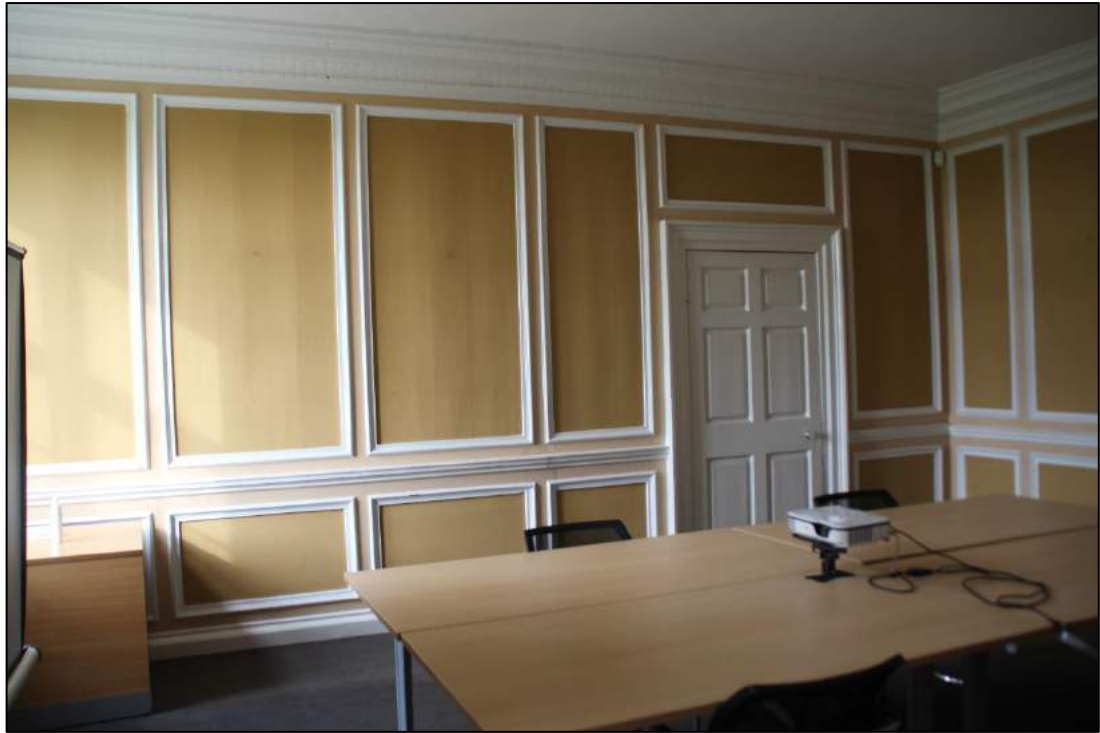
4.34. Room 2 is a former drawing room of the Building, as noted in the floor plans of c.1700. It is a rectangular plan, with two cross windows with deep shuttered reveals. The walls have original panelling and joinery as described by Crick-Smith ‘the first decoration on the panelling and joinery is quite unusual and appears to be a surviving decoration from the 1650’s. The colour (‘Cedar Colour’) is extremely distinctive and has been identified previously by the researchers in other properties dating from the second half of the seventeenth century’. Photos 4 – 7 give an overview of the room.

- 4.35. The mantelpiece in this room does not appear original; it has an Adamesque refinement that is at odds with the character of the room and may well be a later 19th or 19th century addition. The use of pine was commonplace for ease of carving, and the feature would always be painted (there is evidence of paint removal here). The fire insert is probably 18th or early 19th century, with a marble surround and with the rosettes again suggest an 18th century date. The overmantel panel, which is now blank, would have featured a painting and appears an original feature within the room composition.

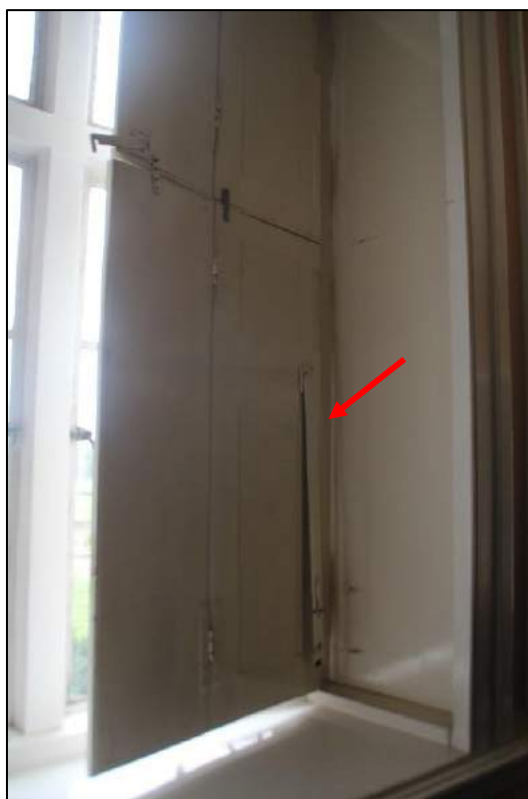
Photo 8. Detail of interior of shutter with long bracket arrowed

- 4.36. The doorcases and doors also have a 'Cedar Colour' substrate as identified by Crick-Smith and therefore are identified by him as original. They have a refined doorcase moulding and six raised and fielded panels, with an interesting multi-filleted frame to each panel which matches details on the panelling. The skirting boards are thick and short with an interesting cavetto or concave curve profile. The shutters are panelled (Photo 8) and have the original or at least historic iron-hinged bracket which clips to its opposite counterpart via the use of hooks.

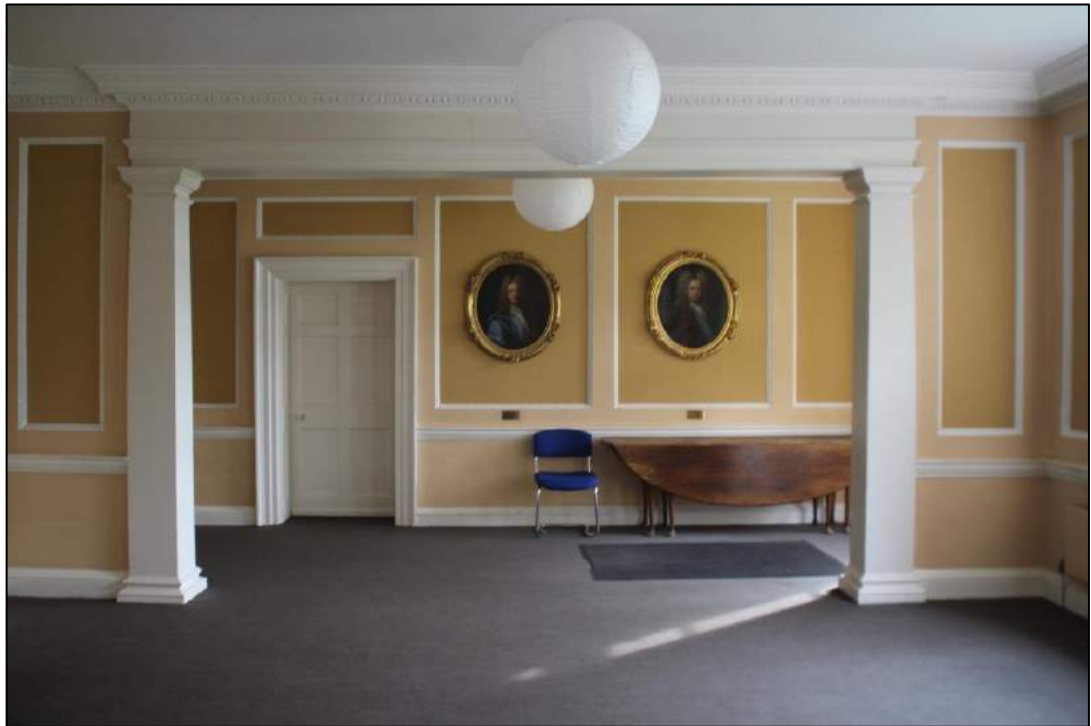
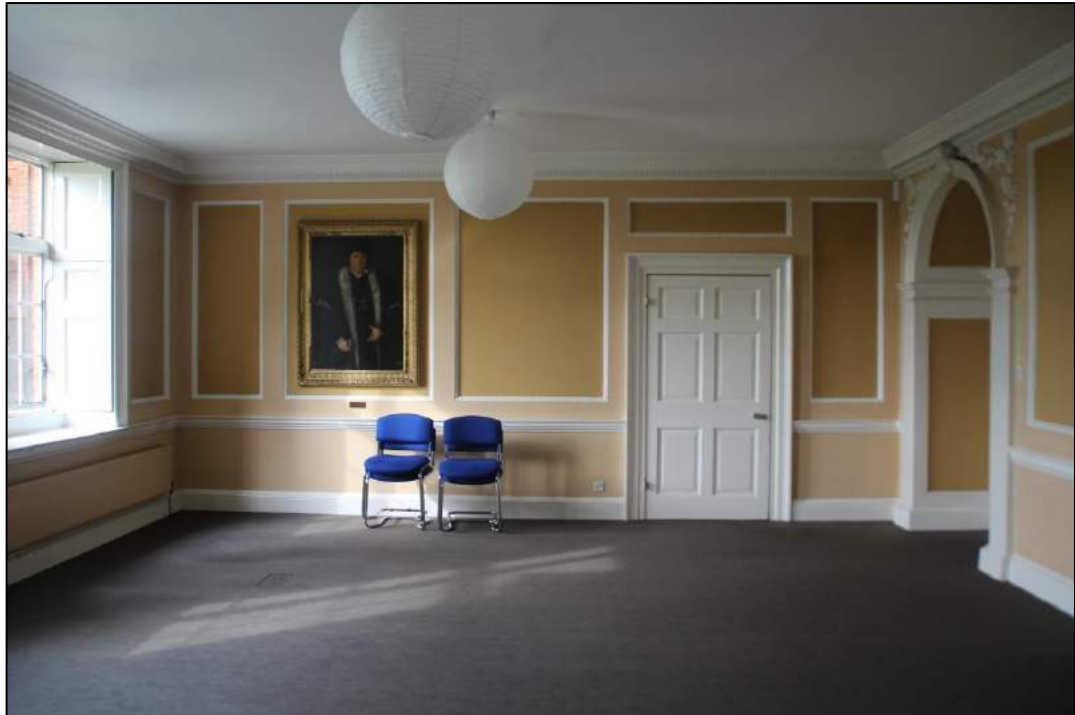
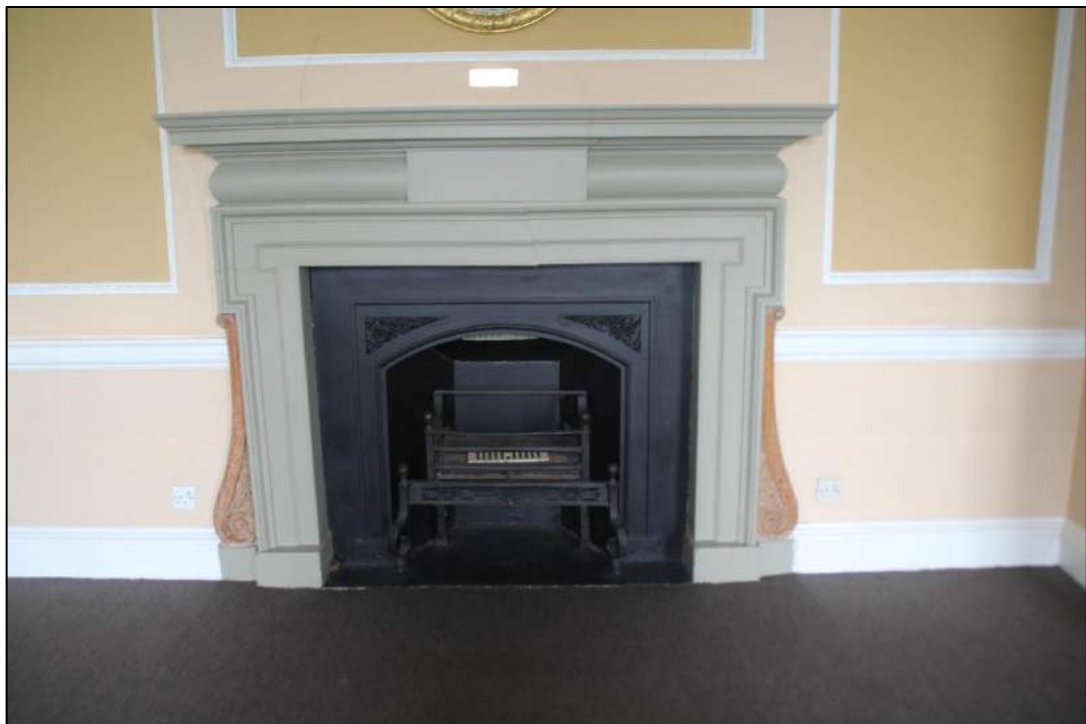
- 4.40. The room features the part glazed and fan lit door to the south gardens and has a further two windows with deep reveals and shutters. The fireplace and mantelpiece is undoubtedly original, with a typically 17th century bolection profile with the curved scroll motif seen on the principal (south) elevation. The skirting has a moulded cavetto feature (concave quarter circle) profile whilst the dado rail has a strong ledge and bolection profile. The doorcases feature the same have strong moulded profiles with the doors again being 6 panel and with the same multi-filleted framing seen in Room 2. Each doorway from Room 2 to Room 4 has two doors each, with a large panelled reveal evidencing the thickness of the structural walls. Photos 9, 10 and 11 illustrate the room.

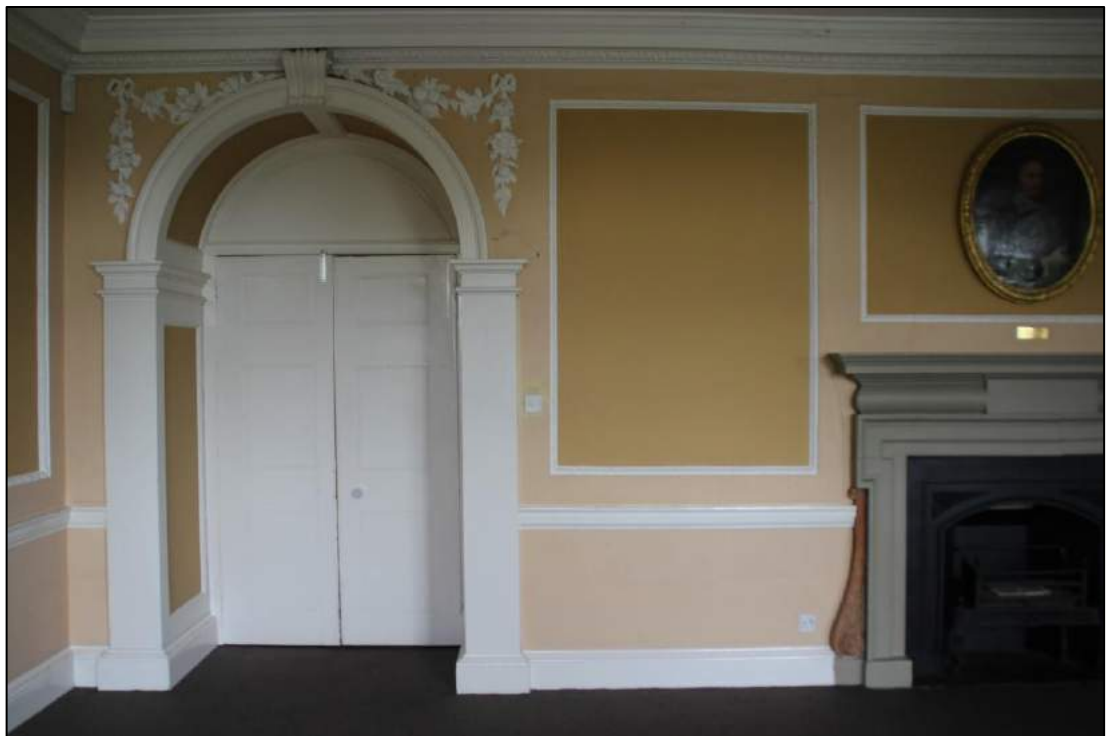
Photo 12. The arched door with swagged flower detailing in Room 3

4.41. Of particular note is the grand arched doorway to the main staircase hall, which has piers with Doric entablature, a scrolled keystone and adorned with festoons (Photo 12). Despite it having a refined Regency appearance, analysis from Crick-Smith has dated the festoon feature and upper wall face stile to early-mid 18th century which suggests a re-presentation of the decorative scheme of this room, possibly when the more old fashioned hall screen had been removed and Doric piers put in its place, thus opening the room out to the visitor as they arrived and providing a grand arrival space.

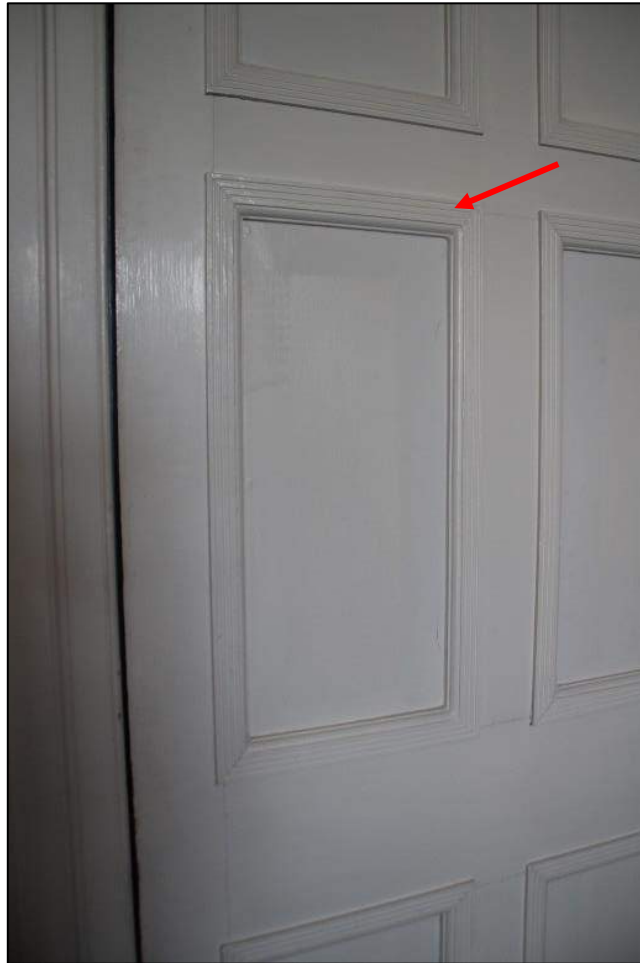
Photo 13 **Interesting ridged panel edging on door in Room 3**

4.42. The door joinery features an interesting ridging effect to the panel sides which is shown in Photo 13. This is not a usual effect seen in historic doors and suggests the work of a bespoke joiner and/or influence of an aesthetically minded owner.

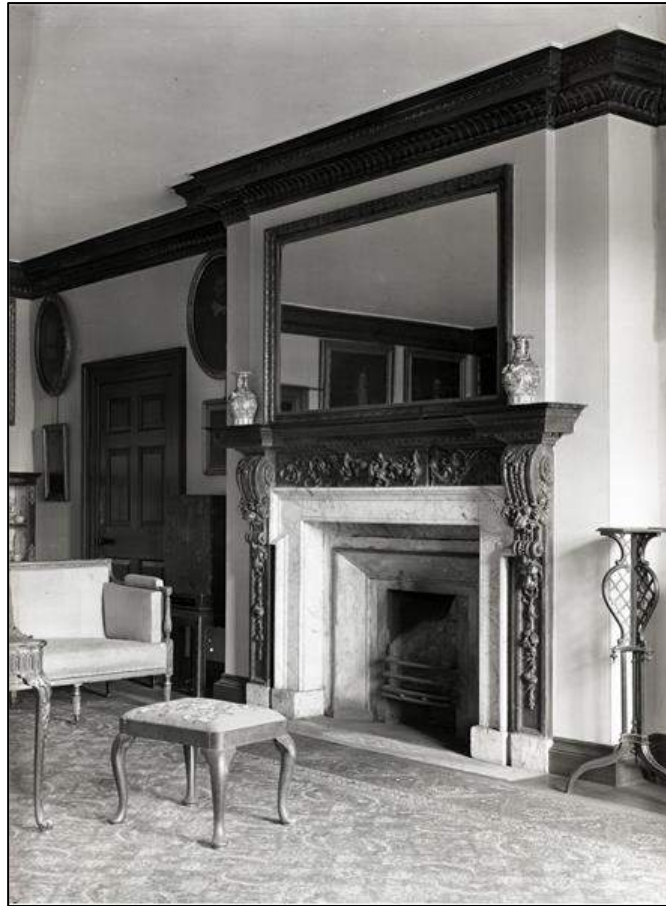
Fig.19 Image from Country Life 1919 of Room 4, then a drawing room

- 4.43. Room 4 is the former dining room of the Building and is a large space spanning two thirds of the west wing. It again has impressive panelling and joinery, some of which is identified by Crick-Smith as being largely 20th century in date. An image of the room in the 1919 *Country Life* (reproduced in Fig.19) shows the room without panelling. Crick-Smith has identified that the historic panelling in the room was probably altered at some point prior to 1919 and the joinery profiles and dado were removed, leaving just the flat timber panels which were decorated to provide a flat 'wall like' finish. Post 1919 the room was re-decorated, and the panelling scheme recreated in modern replica joinery.

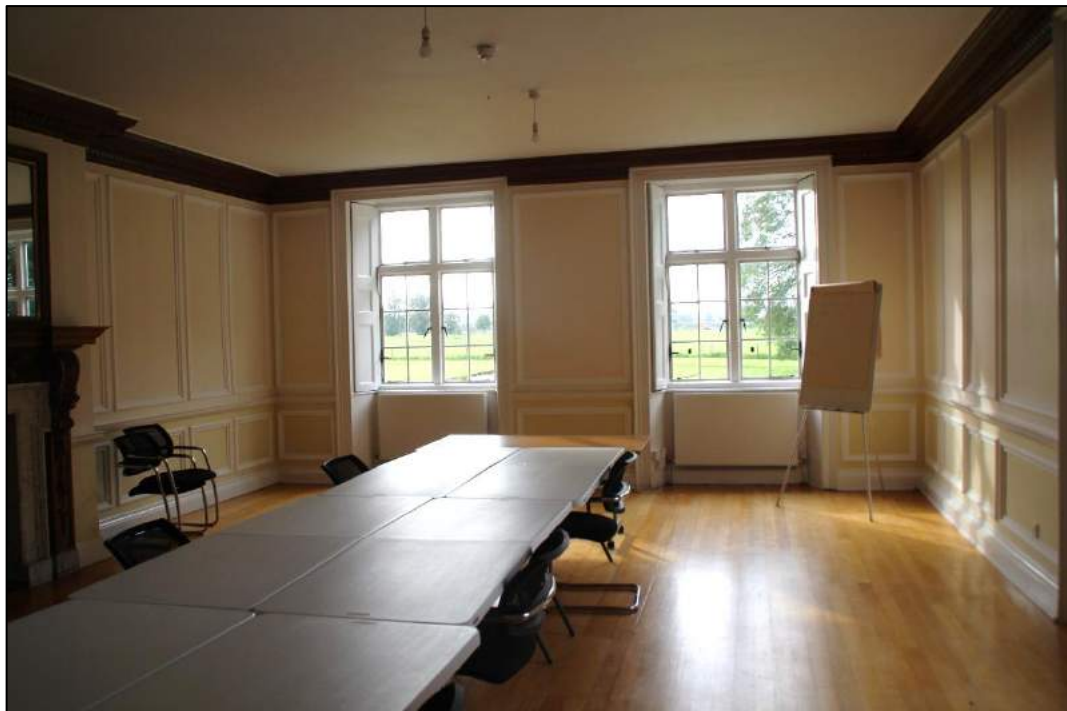
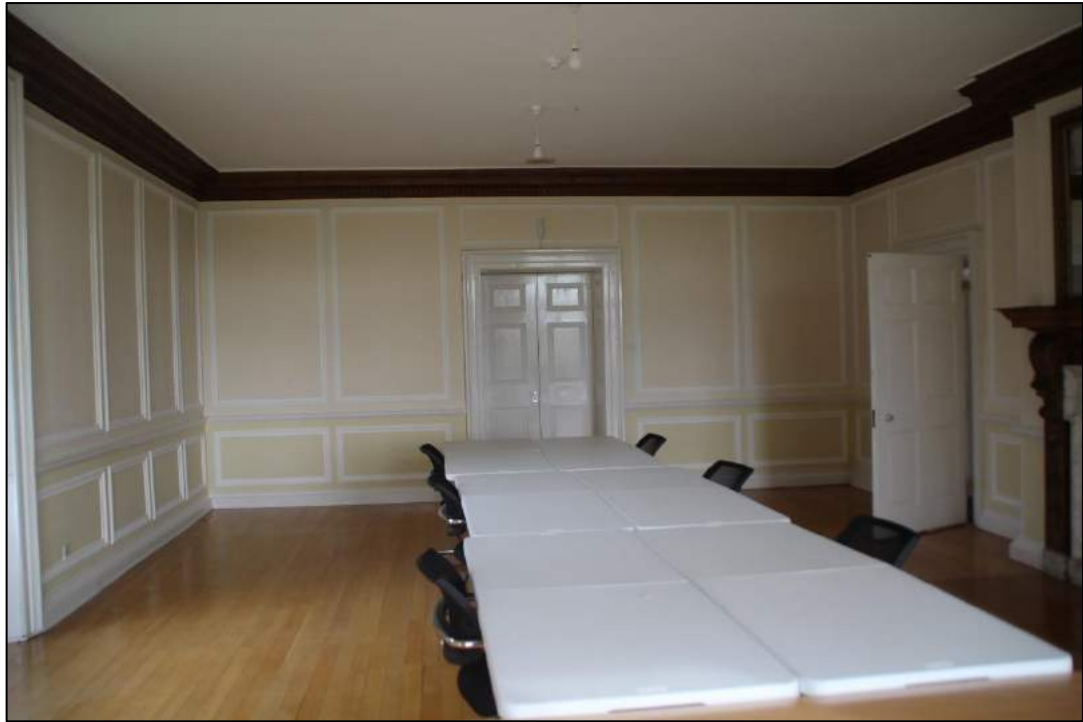
- 4.44. The room has two windows to the south, and three to the west, all with deep panelled reveals and timber shutters. The cornice is historic, and likely original or early 18th century as it matches the motifs found in the mantelpiece in the room and the cornice in Room 2. Of note and unusually the cornice is timber which further evidences its age (Photo 16). The skirtings are thick with the distinctive cavetto style moulding as seen in Room 3 and the floor is a light timber, likely softwood added in the 18th or more likely 19th centuries given the thinness of the boards.
