Tyttenhanger House St Albans

Level 3 Historic Building Recording

CA Project: MK0171

October 2020

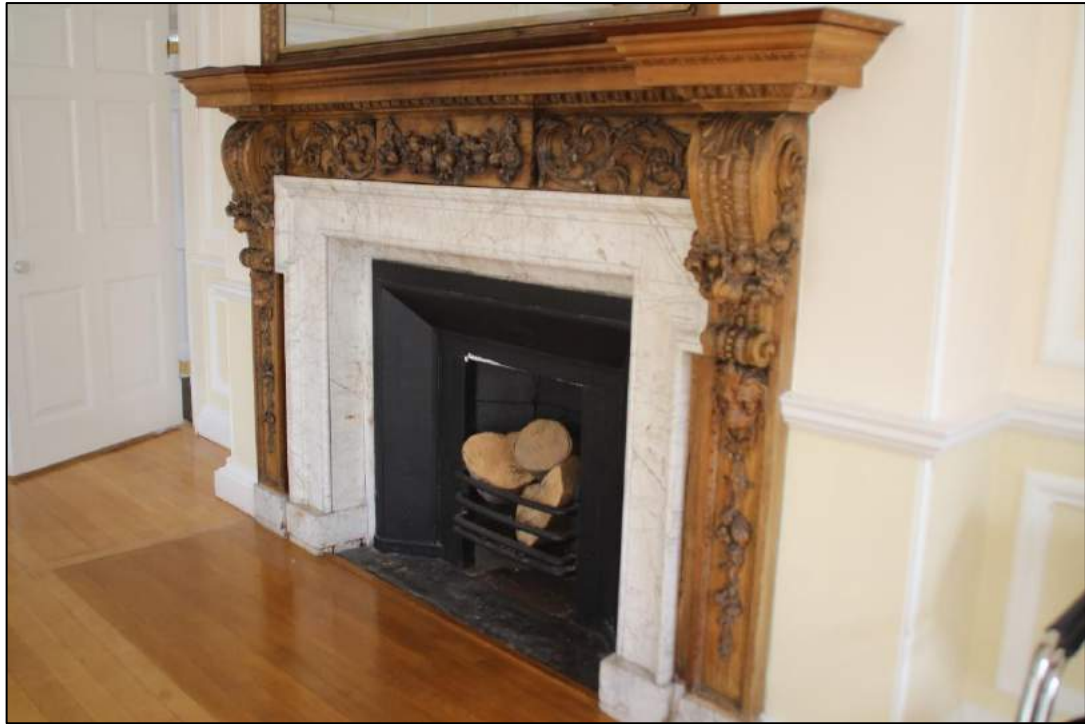
Photo 17. The fireplace of Room 4

- 4.45. The mantelpiece and insert appear original, displaying a Mannerist exuberance in carved wood that is typically 17th century in character (Photo 17). The rich carvings feature embellished bracket consoles, finely detailed foliage scrolls and swags, and two beast heads, all very typical mid-17th century decorative motifs. The marble inset is lugged, and a later fire insert has been added.

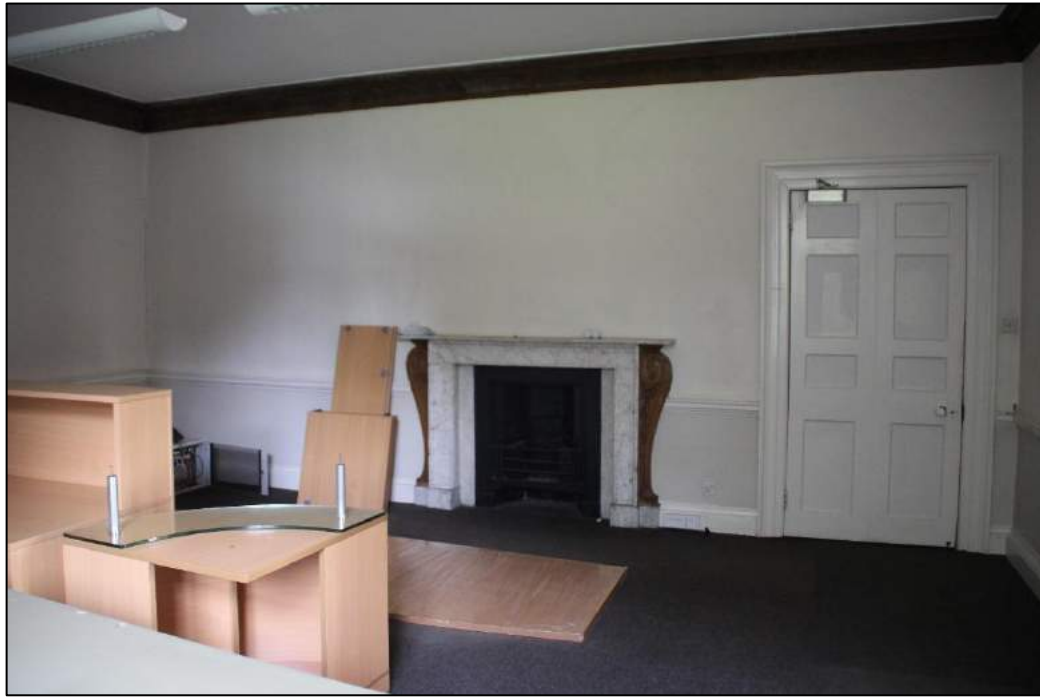
- 4.48. The mantelpiece is marble and plain with the timber scroll motif seen elsewhere in and on the house, though it is upside down, probably suggesting a later insertion (Photo 19). The door to the stair hall is an 8 panelled version which suggests it is original; the 6 panelled door being the most common during the 18th and 19th centuries. It is also tall, which references its status as being a main access point to

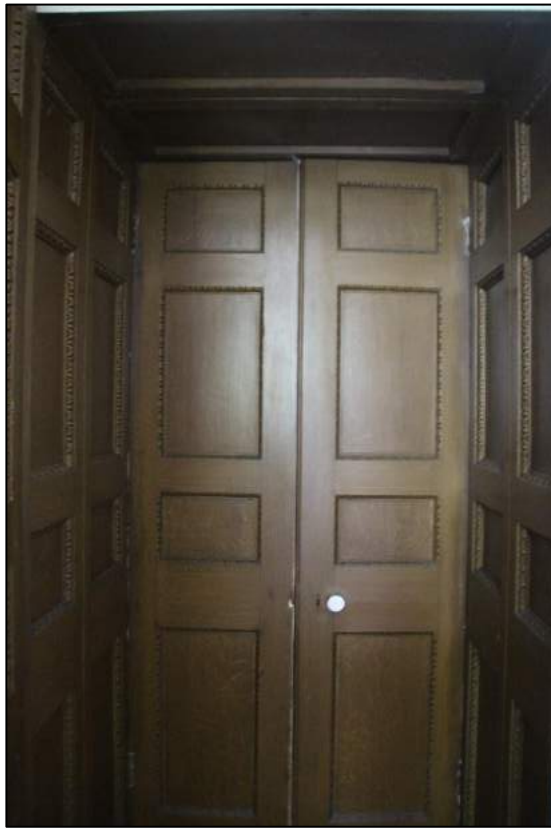
Photo 20. Interior of doors, Room 5 (left)

the grand stair hall. The stair hall side to this doorway has a grandly decorated door case (Photo 20). The door opens into a wide wood-grained panelled reveal to another door into the main staircase hall (Photo 21) This joinery all has egg and dart detailing to the inset panel sides which places it within the 18th century period.

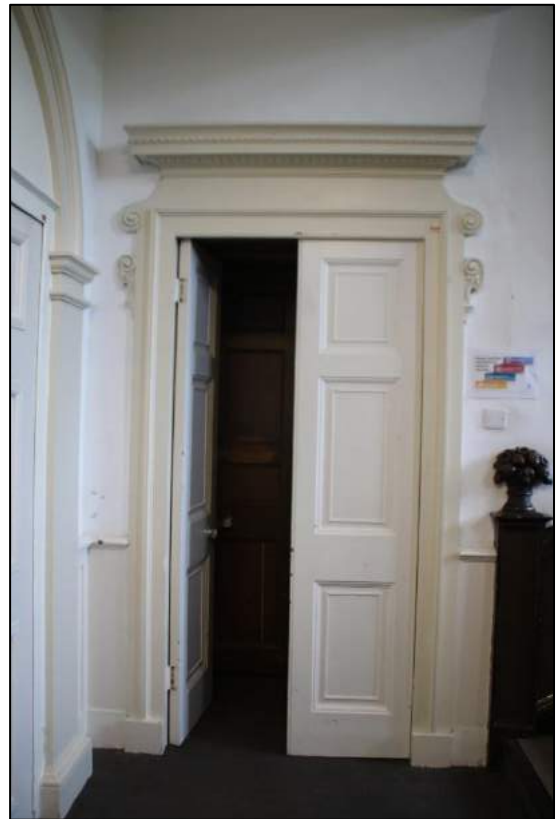
Photo 21. Stair hall view of doorcase to Room 5 (right)

- 4.49. As indicated above, the doorcase from Room 5 to the grand staircase hall has a cornice detail with scroll and features 3 panel each double doors. It has a different character to the Doric order arched door adjacent which exits from Room 3, and therefore it is likely an early if not original feature.
- 4.50. The grand staircase is original to the house and is mentioned in both the listing description and Pevsner's entry on the Building in the Hertfordshire edition of Pevsner's Guides (1977). It has an Artisan Mannerist character with rich carvings and an open well formation, rising to the top attic floor. The square newels are richly carved and topped with baskets of flowers, with an engaged half version punctuating the half panelling rising up the stairs on the wall side (Photos 22 and

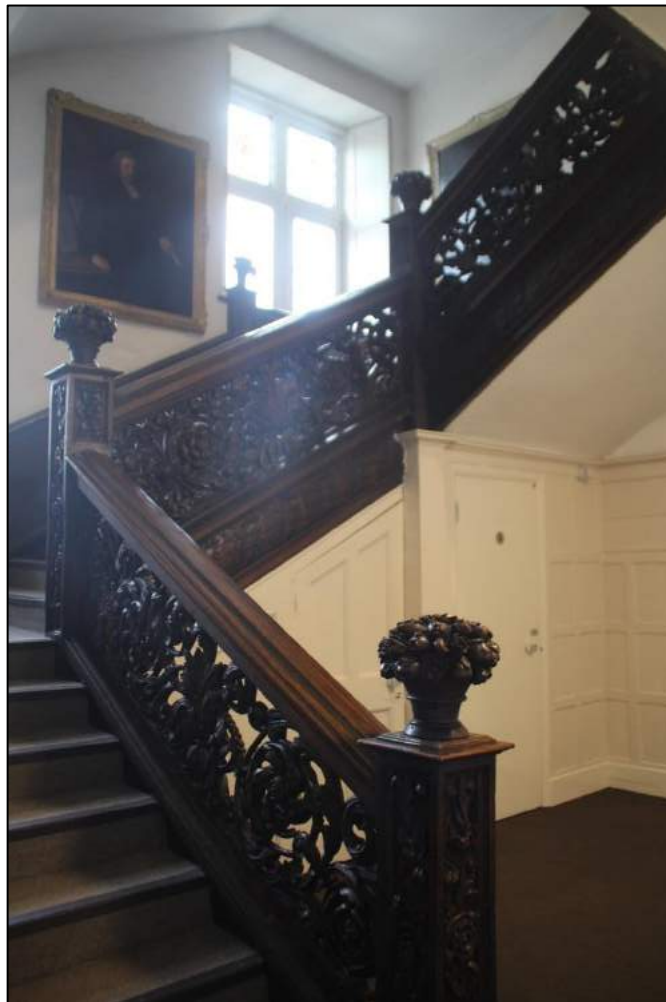
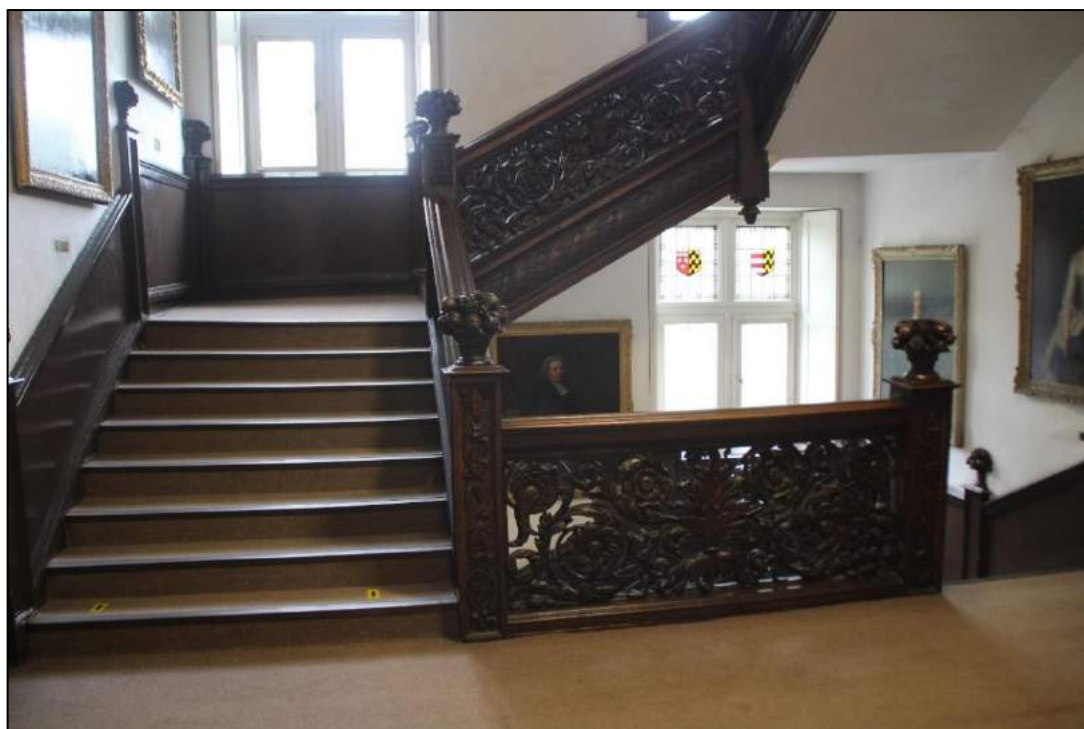
4.51. Crick-Smith has identified that the staircase would originally have been painted, as he has uncovered gesso and gilding layers within the creases of one of the bowls of flowers, suggesting the staircase was painted originally, probably in a scheme that included colours and gilding, and then stripped back to wood and given a wood grain effect at a later date (probably 19th century).

4.52. The staircase hall rises up the three storeys, and the cross windows with the usual deep panelled reveals feature some stained or etched heraldic glass in the top two lights, these are likely original to the house, given more of the same features in the second floor chapel.

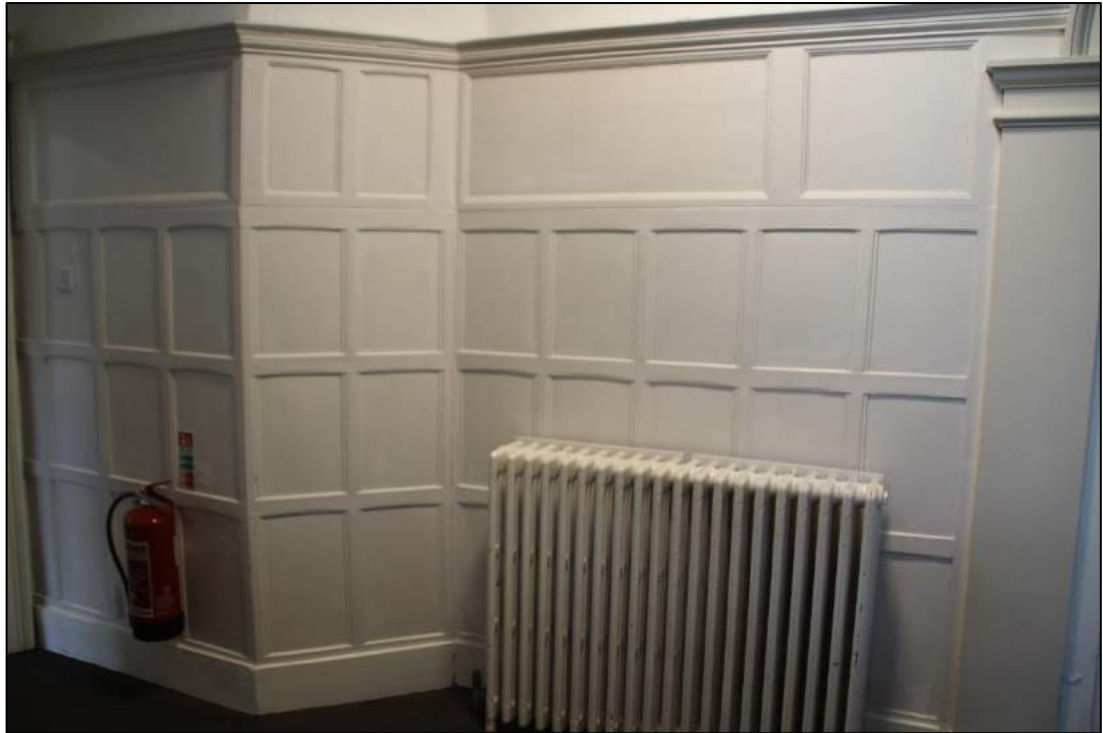
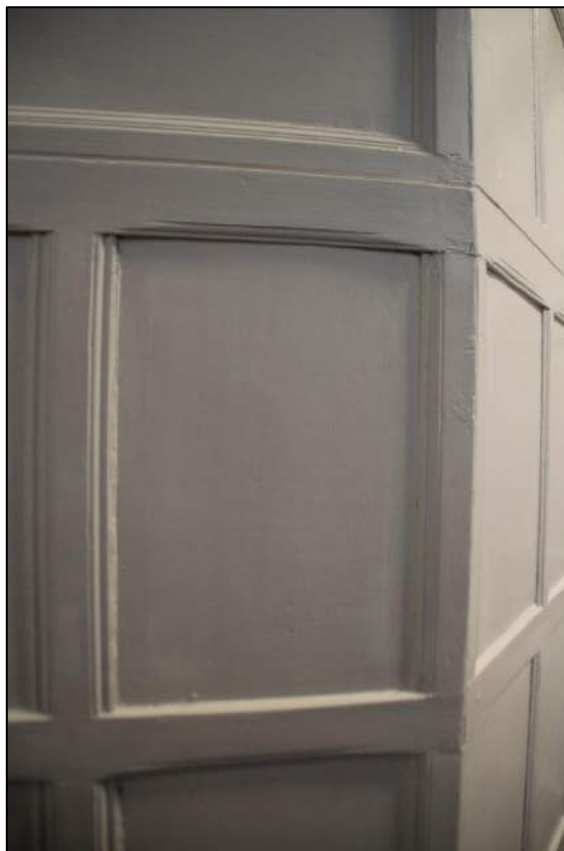
- 4.53. The ground floor stair hall is panelled in small squared panelling to picture rail height (Photos 24 and 25). Hall (2005) writes; 'small-square panelling was popular until the second half of the 17th century...after 1665 it began to be superseded by the type with much larger panels'. She also goes on to say that if skirting boards are present these have been added later. As previously discussed in relation to Tyttenhanger, the house has seen much re-working and re-use of panelling, both reproduction and historic types. It is not possible to date this panelling though it has a character and texture, despite painting, which suggests that it may be original to the house, but perhaps moved or re-used from a different room. The moulding profile does conform with a known example dating from 1658 (Hall 2005, p.140). The plain form of the panelling, and its height only to picture rail (usually it rises to the cornice) when read in conjunction with the grand staircase and doorcases is somewhat incongruous for a high-status space.

Photo 24. Panelling in the ground floor stair hall

Photo 25. Detail of panelling

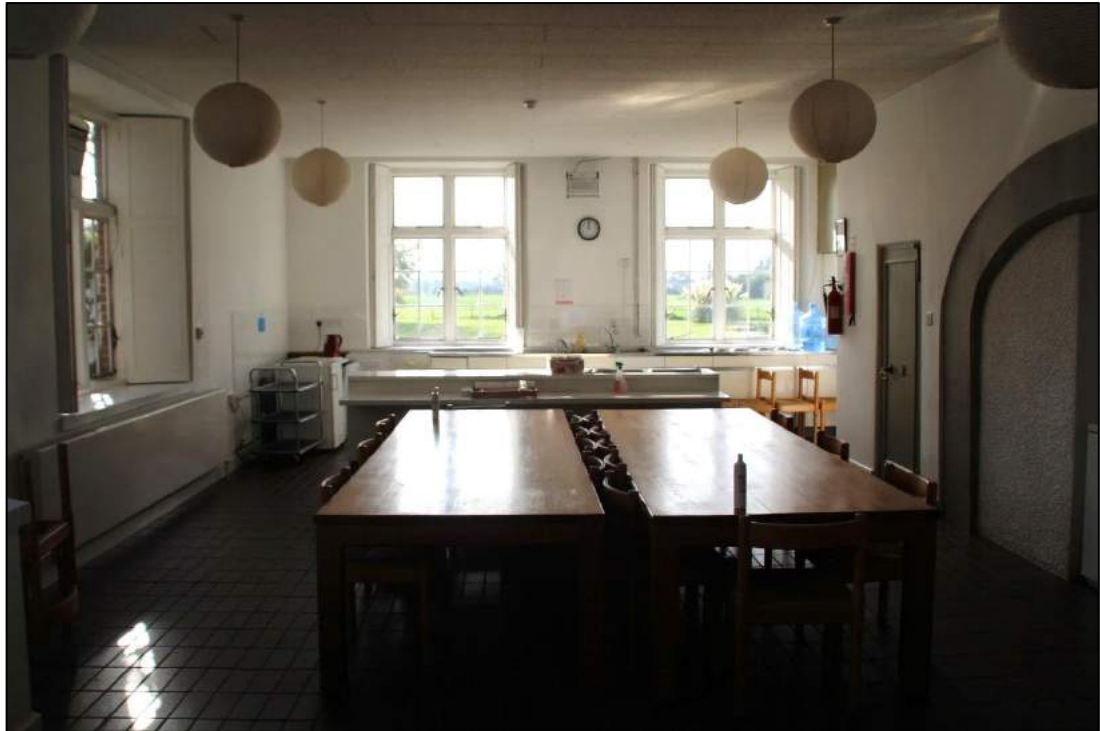
Photo 27. The kitchen (and former kitchen) in the east wing ground floor

- 4.55. The kitchen (Photo 27) is a large room with two windows each to the south and east elevations. It is annotated as a kitchen on the 1700-50 floor plans show in Fig.18, which evidences that its function has been extant since the house was constructed. This is corroborated by the very large stone surround and fireplace (now partially infilled) which would have held a number of cooking ranges and equipment (Photo 28). A metal 'safe' style larder has been inserted to the left of the fireplace, probably in the 19th century, to cold store goods and expensive items.

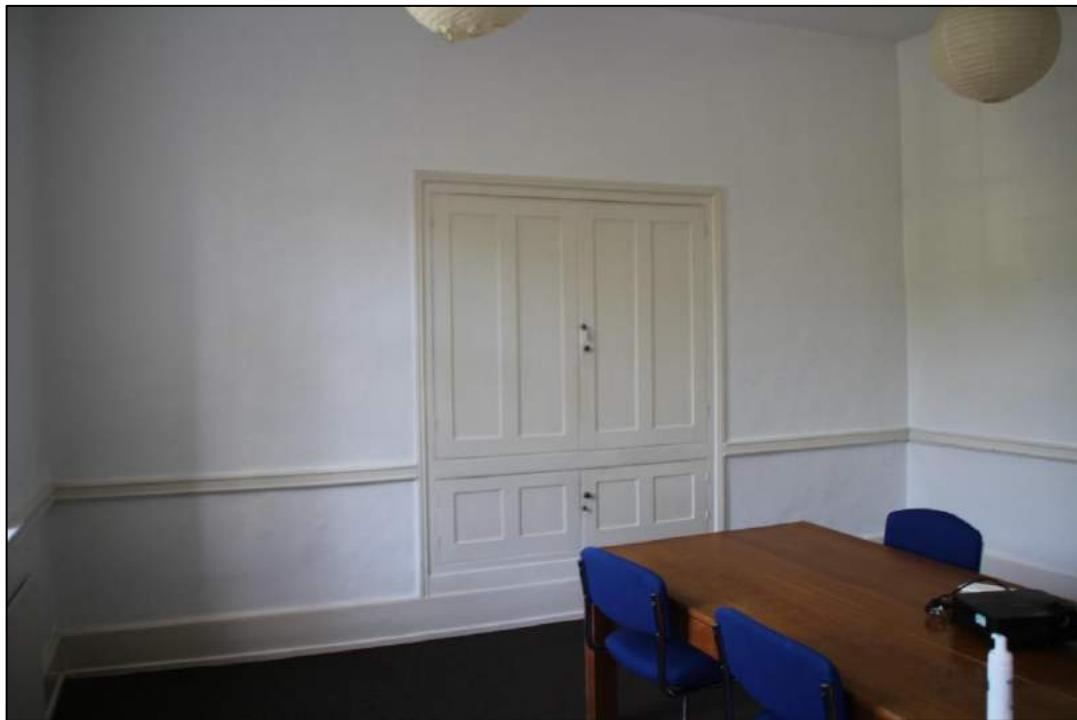
Photo 29. View of east wall of former housekeeper's room

-
- 4.57. Directly across the corridor is Room 6, in what appears to be the former housekeeper's room. It has two windows overlooking the north front and is plainly decorated, with a dado rail and built-in cupboard in what looks like the former window opening which was covered when the east servant's wing was constructed in the 19th century (Photo 29). The historic floor plans in Fig. 18 do show this room to be partially subdivided, and there is no evidence of the former fireplace or mantelpiece that existed on the west wall of the room, though it may be present and covered over.
- 4.58. Evidence of the functional nature of the room is also found in the original thick crude cut beam which spans the room north to south, no attempt has been made to cover it up as befits the low status of the room (Photo 30).

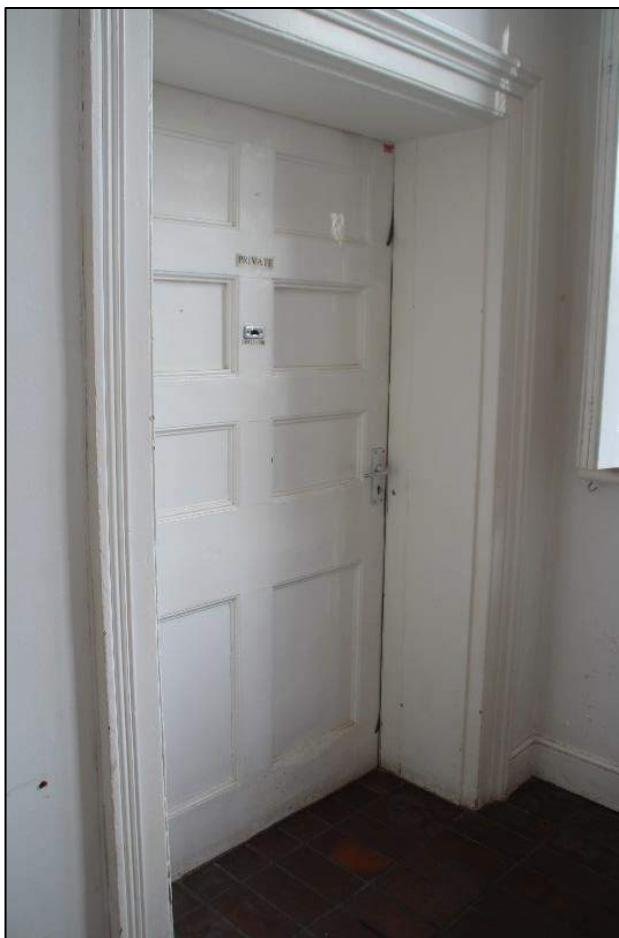
Photo 31 **Door to 19th century servant's wing**

- 4.59. Progressing further east, down to the 19th century wing, an interesting door forms the entrance point to this area (Photo 31). It has quite a raised and moulded doorcase profile, and the door itself is 8 panelled with interesting recessed panels with filleting not seen elsewhere in the house, most probably a door sourced specifically for this phase of new work to the Building.

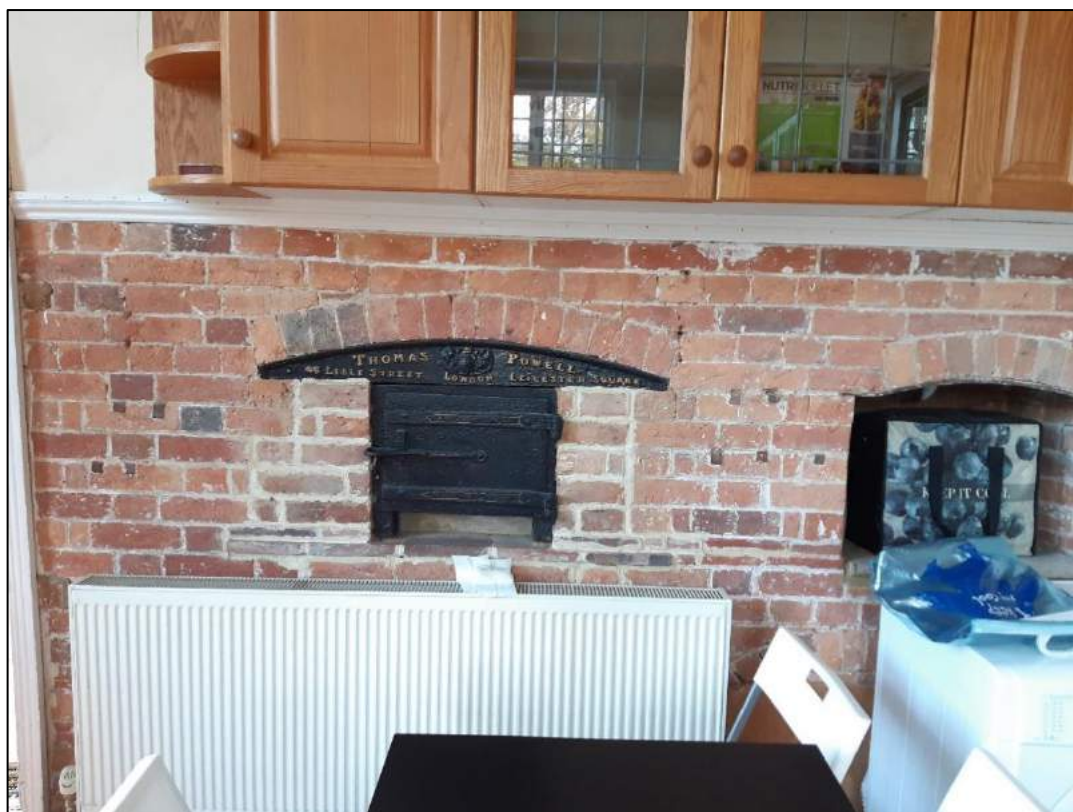
Photo 31a. Former bread ovens in servant's wing

- 4.60. These rooms now form a domestic flat within the house and the rooms have been quite extensively modernised with modern fittings such as plain cornice and skirtings throughout. However two bread style ovens were noted within the kitchen area (Photo 31a) which suggests the wing housed a bakehouse or secondary kitchen as well as other ancillary functions. The servants' hall may also have been relocated here from the basement.

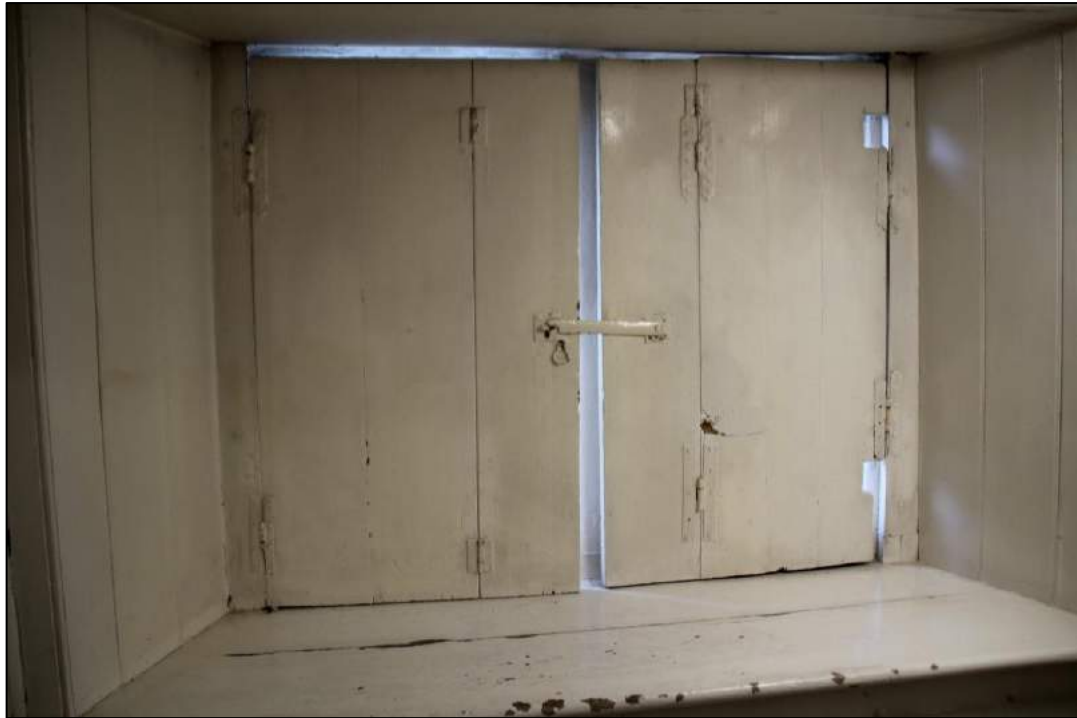
Photo 32. Plank shutters to the small window to the basement stairs, with original ironmongery

- 4.61. From the ancillary area within the east wing of the house, the 'back stairs' hall is accessed. As befits its status, this is much smaller than main stair hall, and features the doorway to the basement. A small window is present on entering the basement staircase, from the plank appearance of the shutters and the ironwork this appears to be original (Photo 32). The staircase itself is steep and narrow (Photo 33).

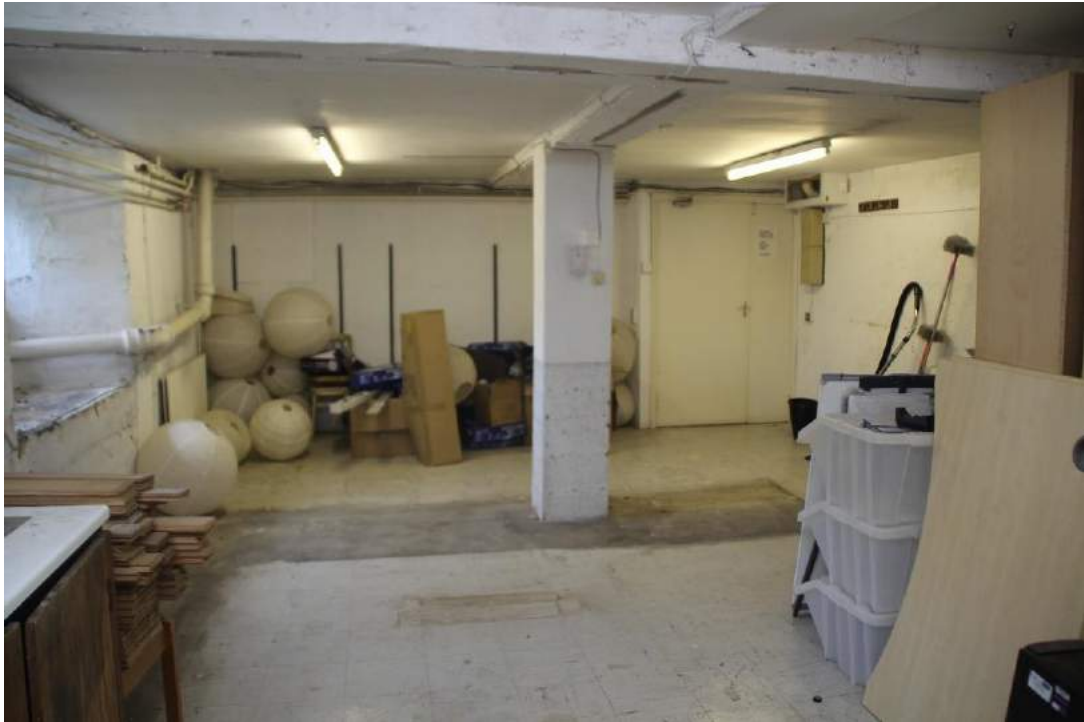
Photo 34. Internal view of Room B1, looking east

- 4.63. B1, accessed to the right at the bottom of the staircase is a rectangular room with evidence of modernisation (Photos 34 and 35) It is lit by a ground level window, which indicates that its function may well have involved activity, such as washing or preparation of food, rather than storage, which would occur in the less well lit vaulted areas. The historic floorplans in Fig.18 show a hand written note on the ground floor plan 'servant's hall below', which may indicate this room (not being vaulted) was used for this purpose.

- 4.64. Modern piers have been added to strengthen the structure of the room, which rests on two large and thick chamfer edged cross beams and there is evidence of iron strapping, possibly preceding the inserted piers. Both have interesting internal notching or mortices which suggests the room was subdivided at some point by wooden partitions. The floor has a lino covering and the walls are plastered with a pebble dash style mix in areas and painted in others.

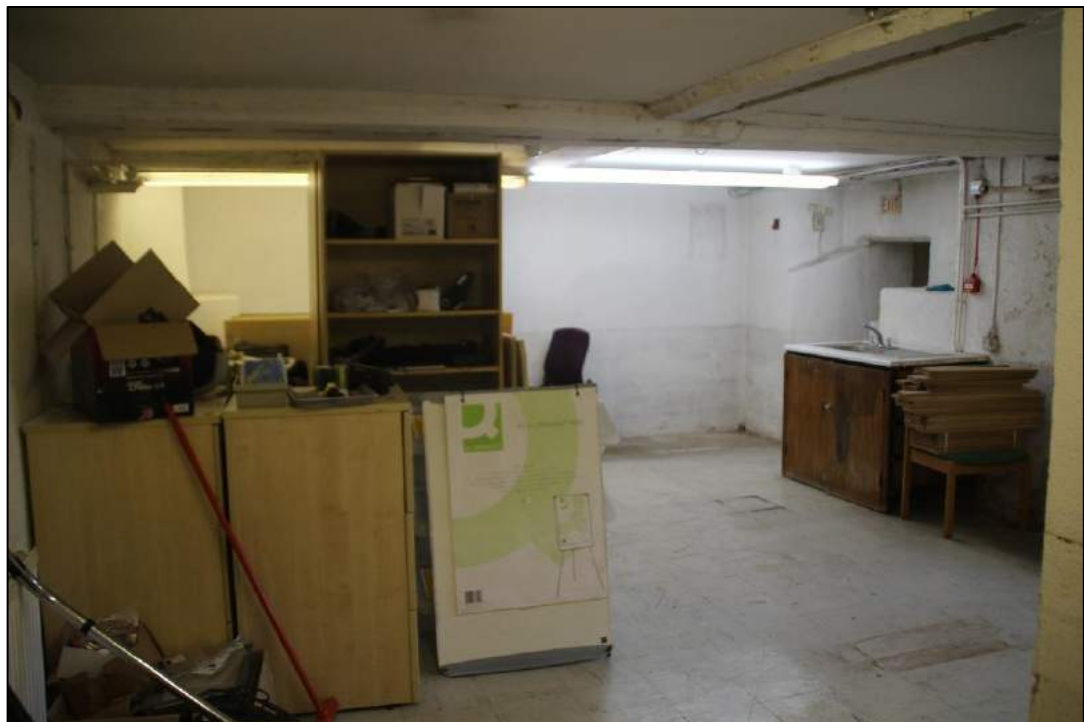
Photo 35. View of Room B1, looking west

- 4.65. A curved doorway exits the room out into a tunnel which now appears blocked. Clearly this room has been extensively altered, and offers little evidence of the historic fabric present under the modern coverings and services that have been inserted.

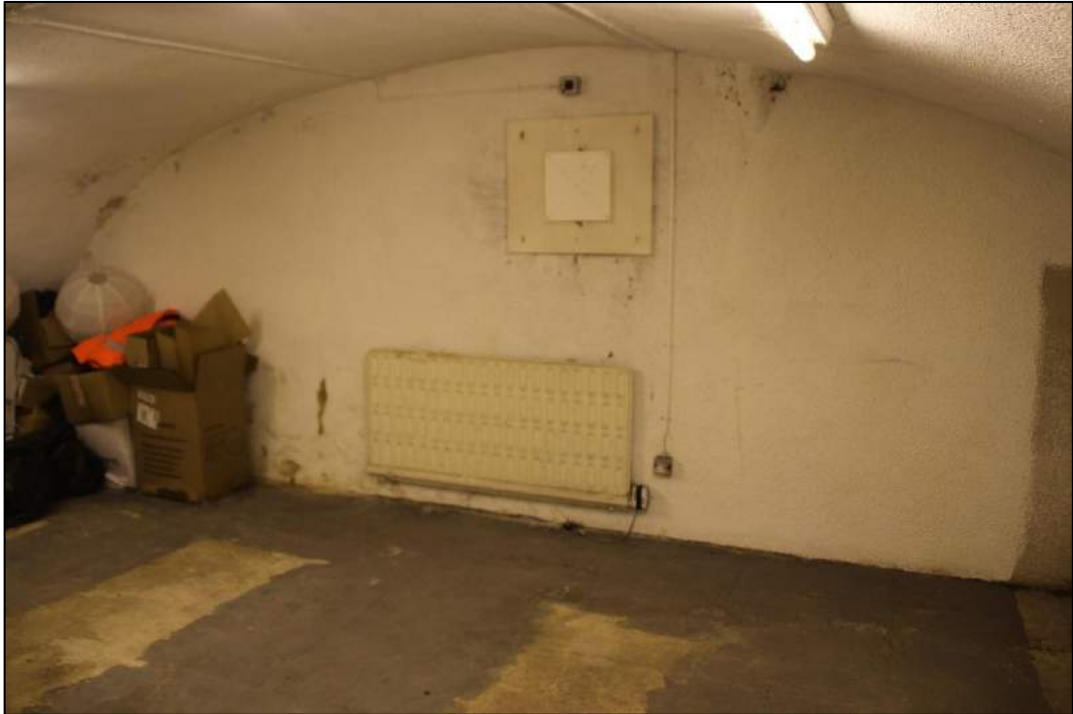
Photo 36. View of Room B2 – arch vaulted cellar

4.66. Room B2 is a barrel arched storage cellar (Photo 36) which has been rendered and cement floored but its form is otherwise discernible. A curved opening in the east wall features a blocked window (Photo 37). The window has a stone mullion and

- 4.67. Due to the presence of modern render and cement, it is not possible to ascertain the structural fabric of the cellar, though it is possibly brick, uncovering work would allow for a better picture.

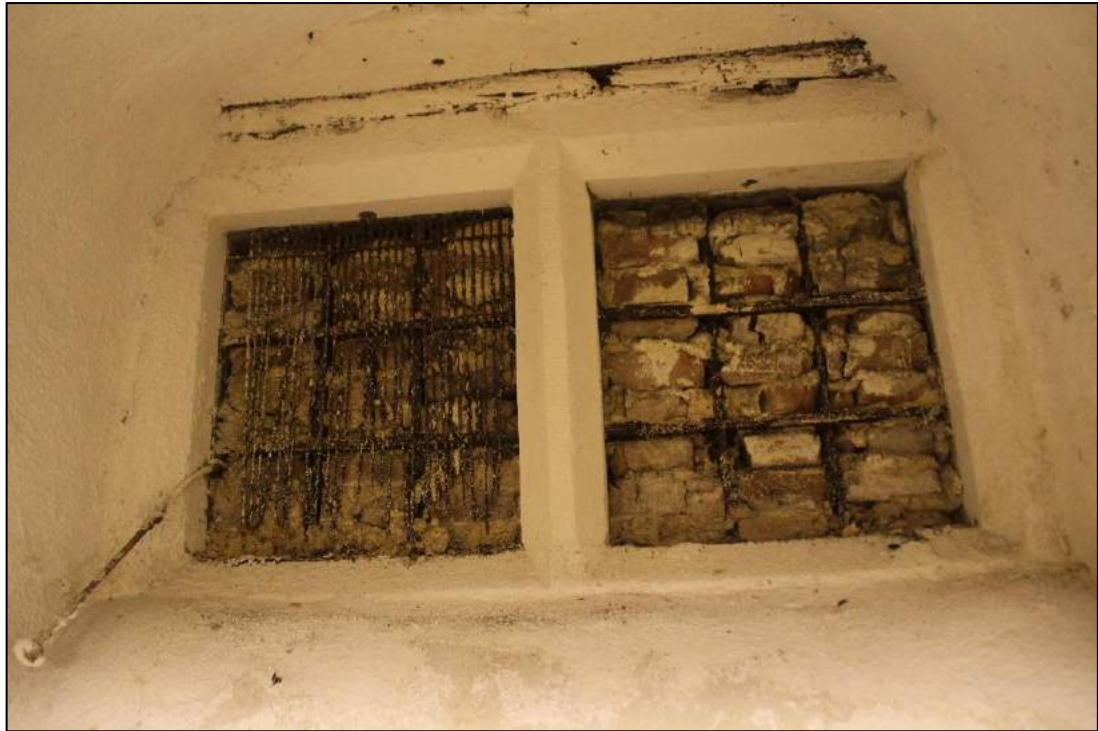
Photo 38. View of blocked mullioned window with iron bars

iron bars; it is infilled with brick and is directly below the 19th century extension, therefore it is assumed this window was blocked at the time of the construction of that wing (Photo 38).

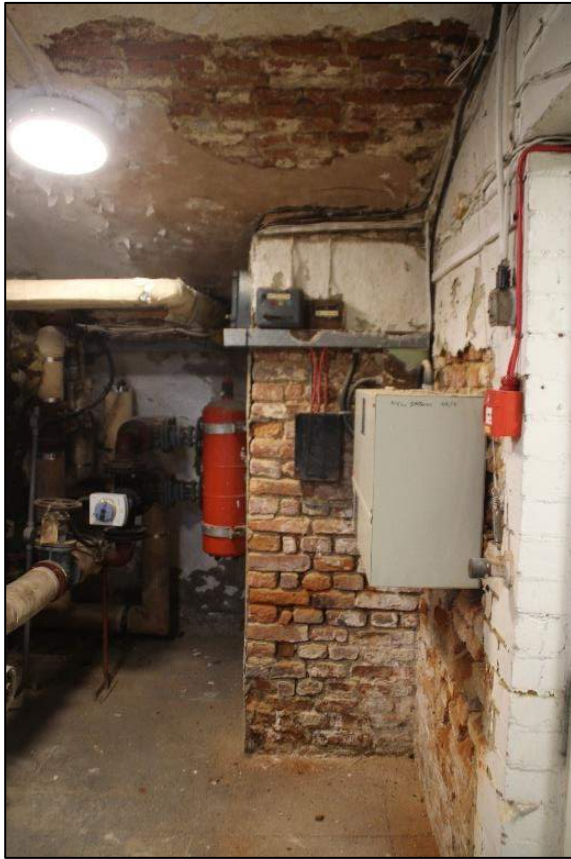
Photo 39. Brick construction of B3

- 4.69. In B3, there is evidence of the brick construction of the vault, though the floor is now cement. There is evidence of a lime plaster or render which has failed over time to reveal the brickwork.

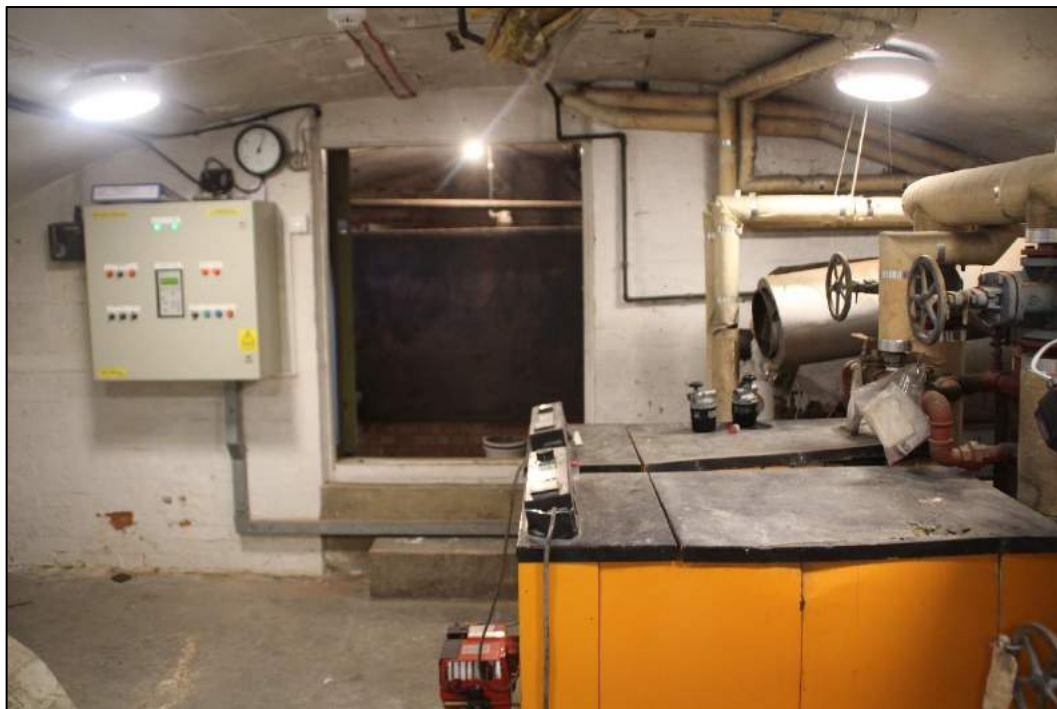
Photo 40. View of the modern brick wall between B3 and B4

- 4.68. Moving south, B3 and B4 were once one open barrel vaulted cellars, presumably used for storage. There is evidence of subdivision in modern brickwork which may well have been structurally necessary. These rooms form the boiler room and the water tank room for the house, and have a large amount of machinery and services installed (Photos 38 and 40). Of interest is the steps leading from the east courtyard, incorporating flat slopes to each side, which may have facilitated the moving of wheeled equipment or barrels down the slope (Photo 41). Clearly these stairs indicate that this was the tradesmen's entrance, where goods, foodstuffs and materials were brought into the house for storage.

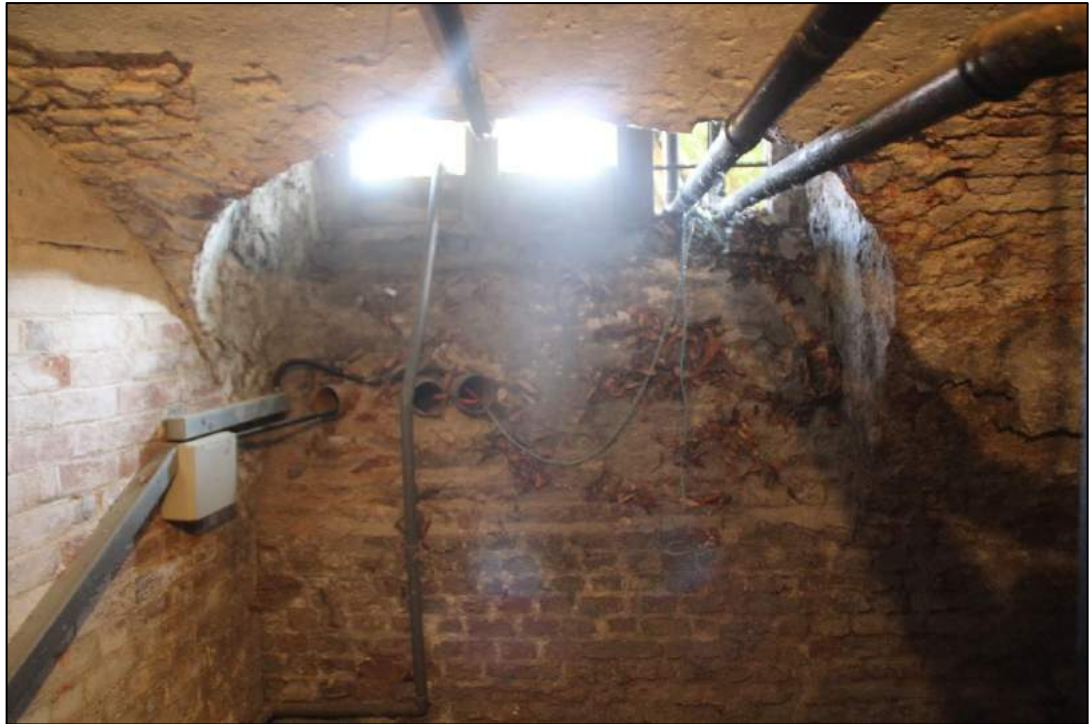
Photo 42 Interior view of the mullioned ground level window seen in the stable courtyard, in Room B4

- 4.70. In B4, a large watertank dominates the space, therefore opportunities for photography were limited. Of note here is the stone window with mullions noted in within the east courtyard, which is now pierced with services . The brick construction of the space, and lime render is also evident here. Photo 42 shows the window from an internal aspect, and to the left is the modern subdividing wall, which also features a large metal door, presumably part of the necessary equipment related to the installation of the boiler. The floor in this room is formed of setts, probably the original floor material as it is hardwearing

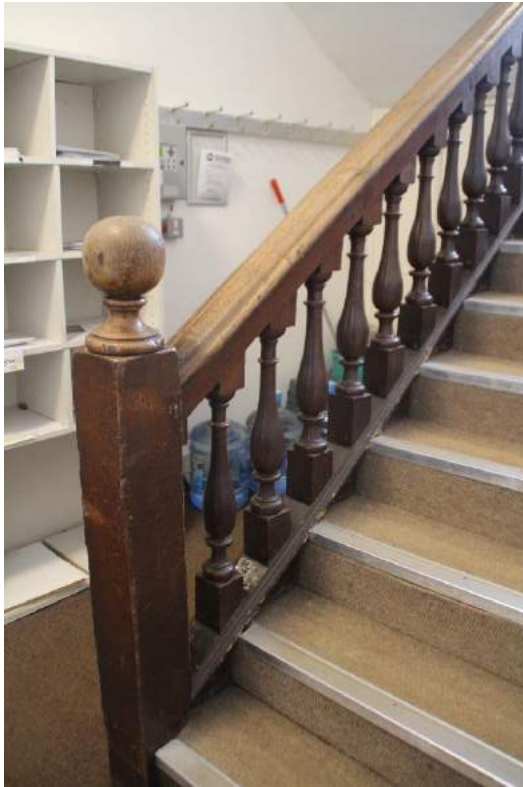
Photo 43. Secondary stairs rising from the ground floor (left)

- 4.71. The first floor is accessed via both the back or secondary staircase and the grand staircase hall, The secondary stairs are much plainer than the main staircase; it has a dog leg formation featuring square newels with ball finials, closed string, turned balusters and a moulded handrail. Engaged half newel and finials finish the feature to the wall (Photos 43 and 44). The staircase hall is plain and lit with one window per landing as it rises through the house, the first floor of which has heraldic stained glass in the top lights.

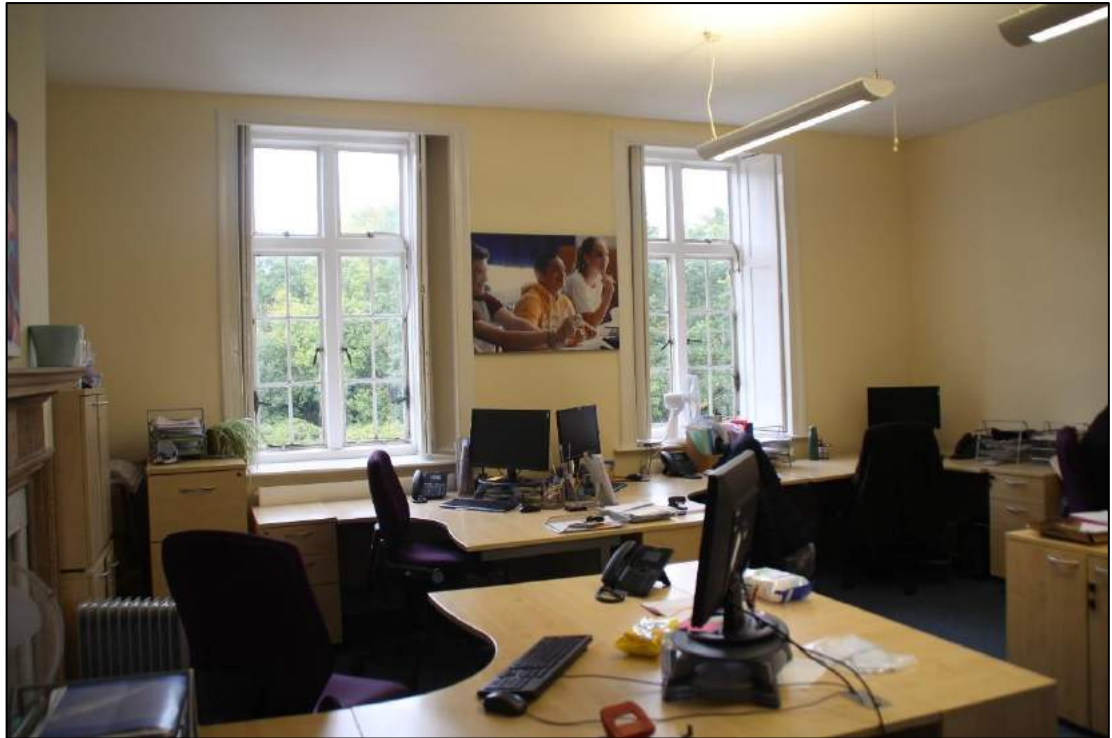
Photo 45. View of Room 7 looking south

4.72. Room 7 is accessed from the secondary staircase and is in the east wing of the Building. The historic floorplans in Fig.18 detail this room as a bedroom, though it was truncated from its extant extent, with a lobby and cupboard present on entering from the corridor. The room now has two windows (with characteristic deep reveals and panelled shutters) to the north, and one window to the east, with the north-easternmost window being blind externally (the roof of the 18th century servants wing abuts this part of the wall.).

4.73. The room is plainly decorated (Photo 45), with no cornice or panelling. Whilst panelling was not always a feature of bedrooms, as it is a high status room it is likely there would have been a cornice and possibly some ceiling decoration. The mantelpiece is carved softwood, now stripped, with a marble insert and looks to be part of the 18th century schemes seen elsewhere in the house, featuring acanthus leaf, beading and arcading detail (Photo 46).

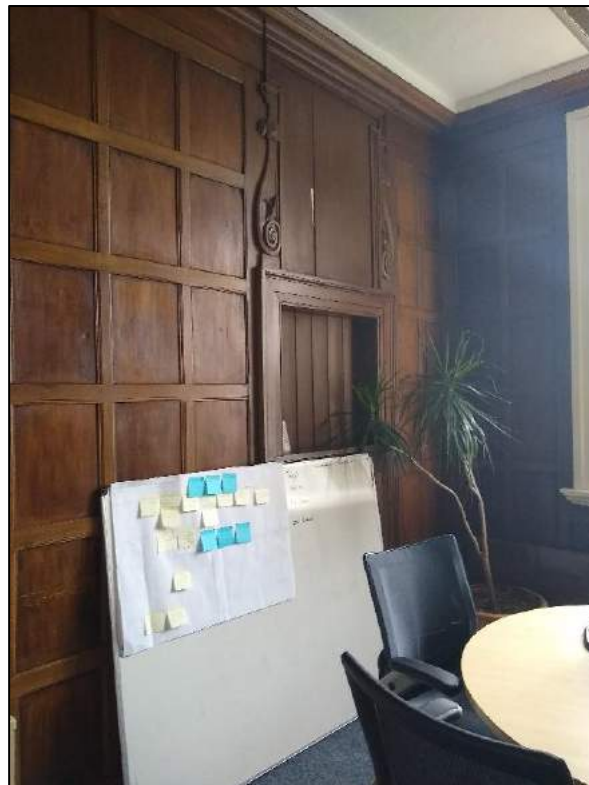
Photo 47. Square panelling in Room 8 with the distinctive Tyttenhanger scroll motif

- 4.74. Of particular interest here is the door to the room from the staircase hall, which is double panelled with a strong bolection profile; suggesting it is original to the house and not a later replacement. Double 3 panelled doors with architrave accesses Room 8. In the historic floorplans it is shown as being open to the doorcase to Room 10 and without the subdivision seen in current floor plans (marked as a later addition). The room is panelled with the same square panelling as seen in the main staircase hall on the ground floor. It is stained and not painted which is a likely survival of its original appearance. It is possible this is the original location of the panelling and that portions of its were removed in the corridor/lobby area created later and re-used elsewhere. The panelling rises to the plain moulded timber cornice, and skirtings have been added (Photo 48).

- 4.75. There are two blocked architraved doorways in the panelling, one on the north wall and one on the south wall, which access Room 7 (or cupboard thereof on the historic plans) and one Room 9. These are decorated at their headers with the recurring scroll motif (as seen in Photo 47) seen elsewhere in and on the Building.
