BiOME
CONSULTING

**2 Llanbrook
Clunton
Shropshire**

Bat Survey Report

21 July 2021

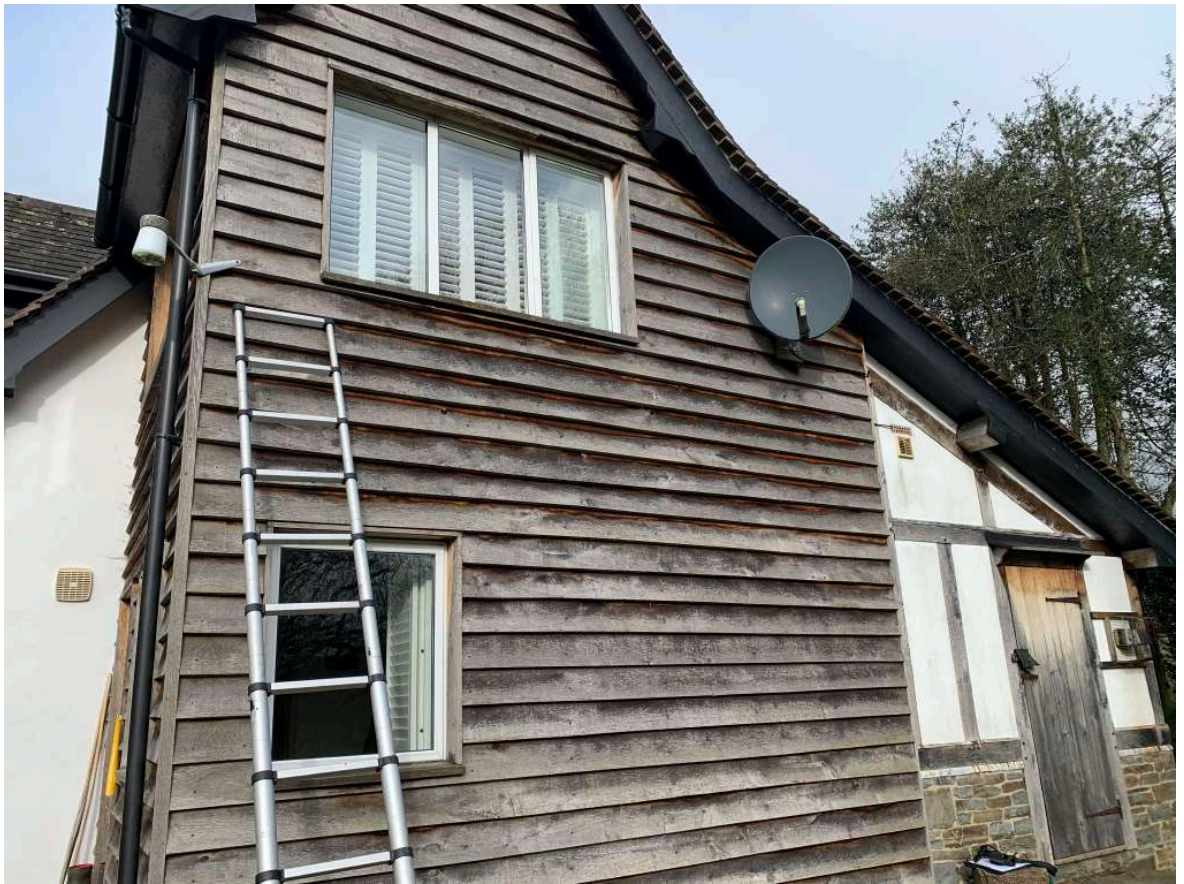
Photograph 1. 2 Llanbrook, eastern elevation (i.e. the direct impact area)

The section of the house (**Photograph 1**) to be impacted was clad with wood over rendered stone walls. Two uPVC windows were present. The roof was covered with clay tiles with facias present.

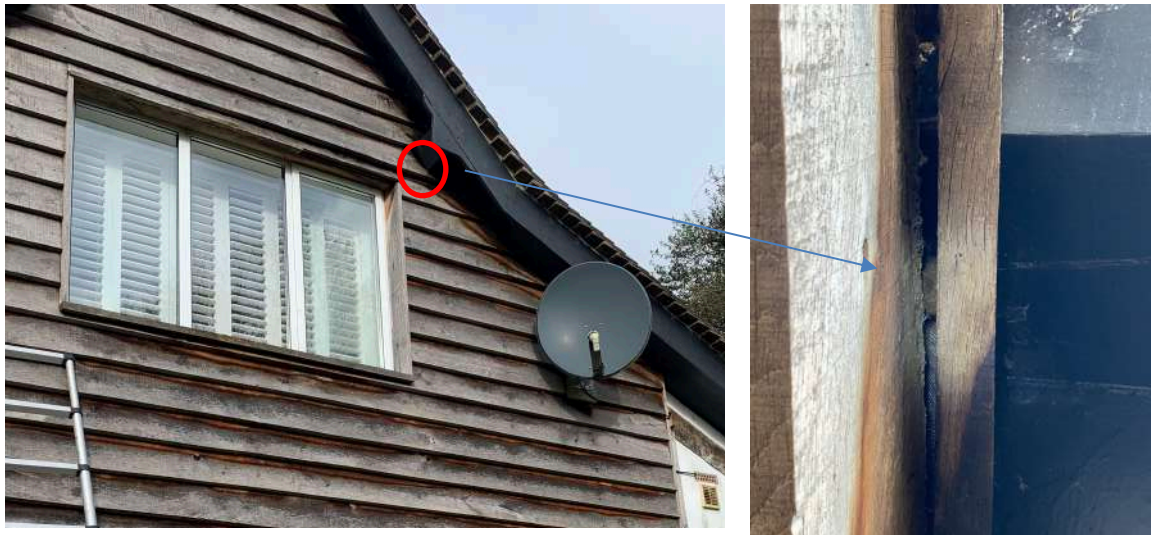
Photograph 2. Pipistrelle sp. ; Roost location 1

Inspections of the areas to be impacted was completed to the first-floor window level. A single pipistrelle sp. was found roosting behind cladding (**Roost Location 1, Photograph 2**). Various other areas of lifted cladding were also present.

No works that may disturb roosting bats, or prevent access to a potential bat roost should be completed until a mitigation licence is obtained.

The proposed works will result in the loss of the Roost Locations 1 and 3 and disturbance of Roost Location 2.

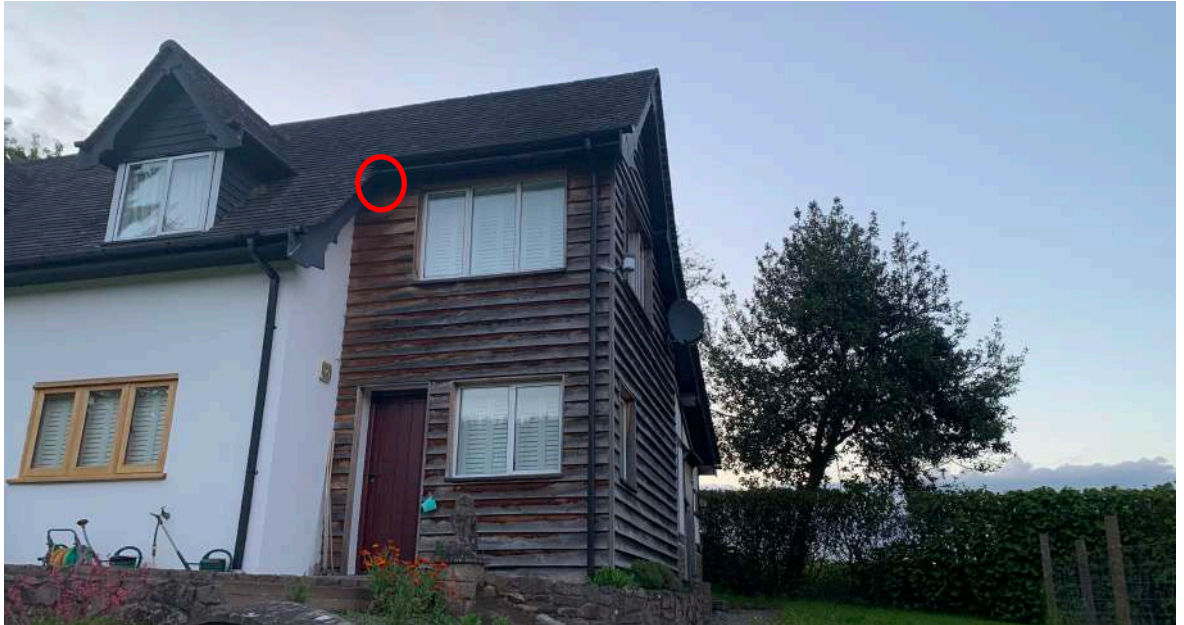
Photograph 3. Soprano Pipistrelle; Roost location 2

A single Soprano Pipistrelle emerged from a roost (at 21:36) at the eaves on the southern elevation (**Roost Location 2, Photograph 3**).

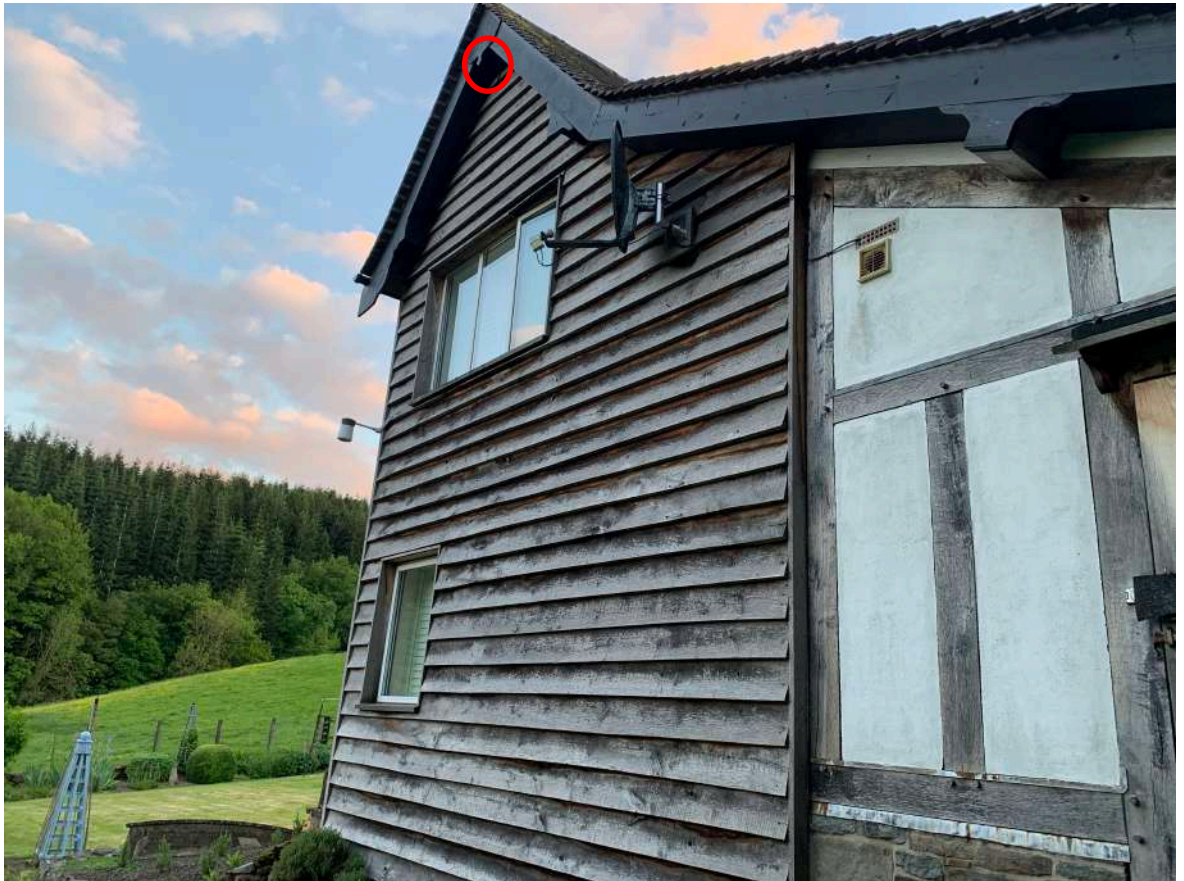
Photograph 4. Soprano Pipistrelle; Roost location 3

A Soprano Pipistrelle entered a roost at the apex of the eastern gable at 04:49. This bat was logged regularly prior to roosting.
