**Ecological Survey for  
Broomfield, Boraston Lane, Tenbury Wells  
Worcestershire**

**WR15 8RB**

**SO 59980 69071**

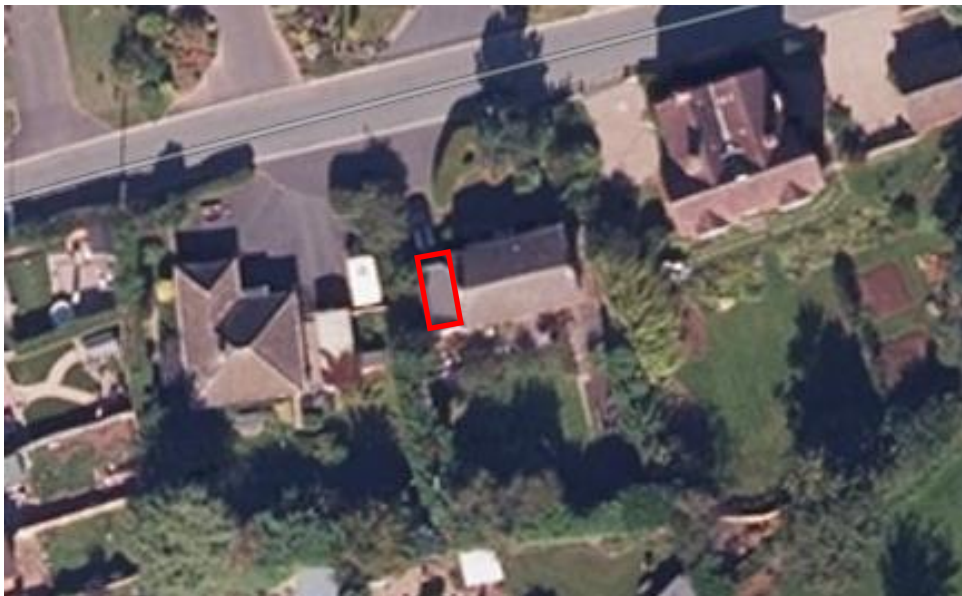
Planning permission is being applied for to add an extension to an existing building. The extension will join onto the roof at the west end above the existing garage. Some disturbance to the existing roof will occur when joining on.

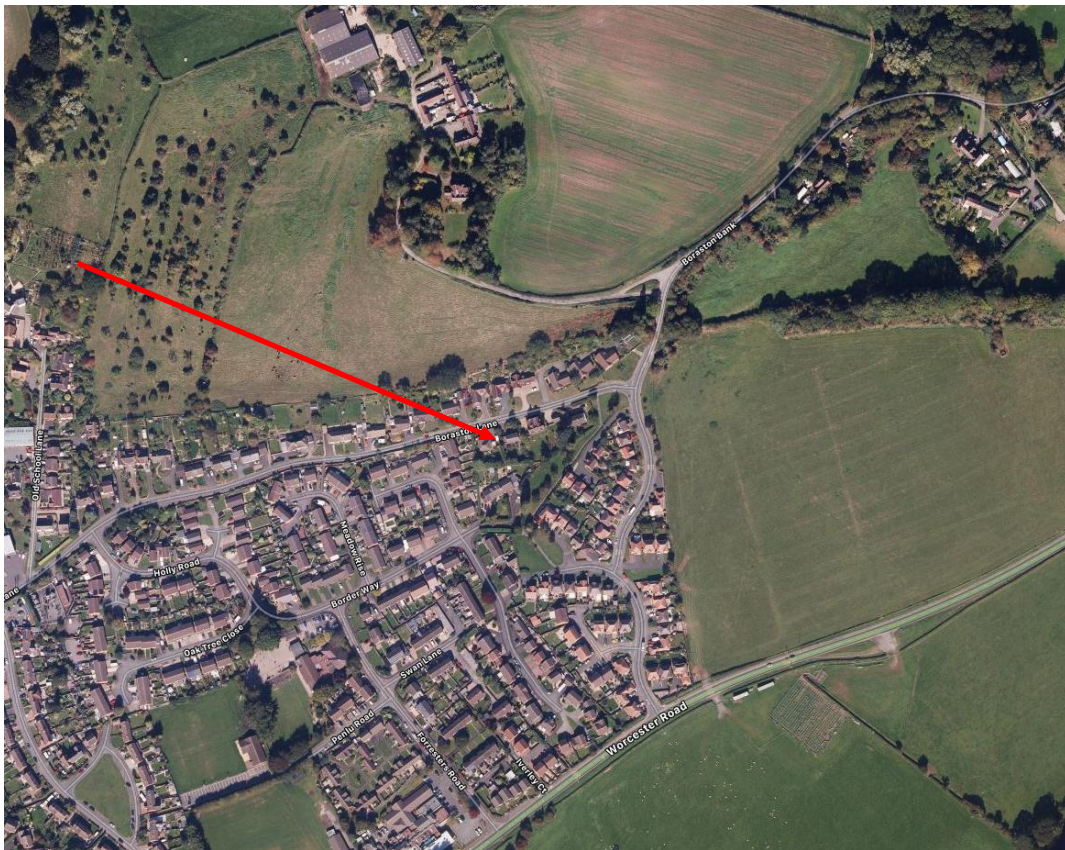
The house is situated on the north edge of the small hamlet of Burford, 1km. north of Tenbury Wells. The immediate south and west is built up housing while grass pasture lies to the north and east. No significant wooded area or water bodies are in the immediate vicinity.

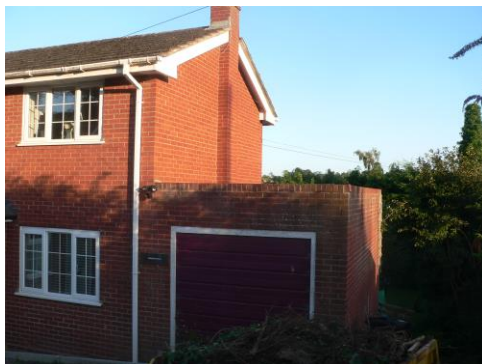
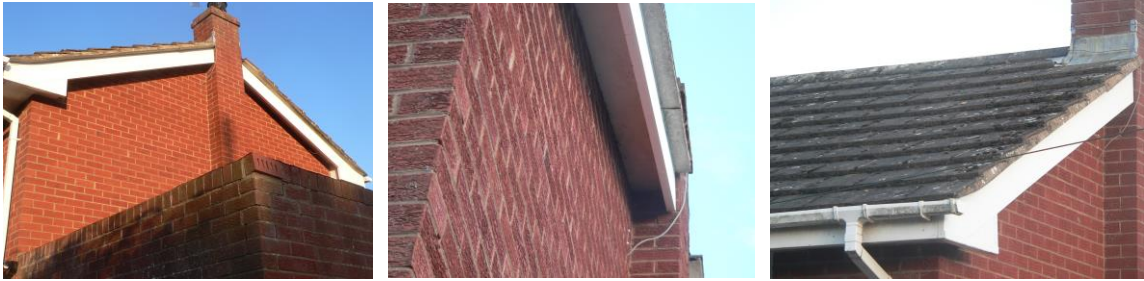
The exterior was searched for signs of roosting bats, using high powered binoculars. Bats usually leave 'grease marks' at roost entrances, caused by the natural oils in their fur rubbing off onto surfaces as they squeeze through gaps. Droppings are also deposited on walls and tiles below roost site entrances.

The roof was in excellent condition, with no missing tiles, no missing mortar at the roof ends, and no gaps below soffits. No access route for bats could be found. No external signs of nesting birds was found e.g. House Martins.

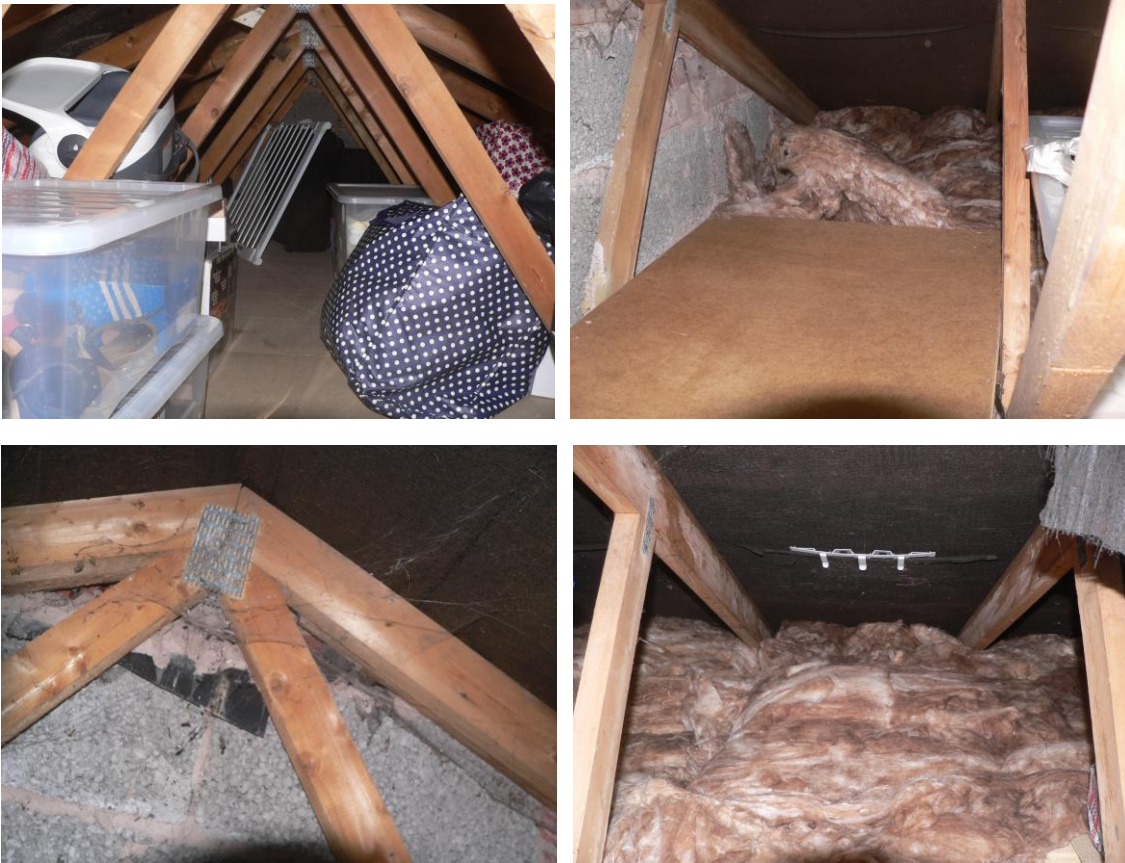
The enclosed loft was accessed via a conventional loft hatch. No bats were present, and a search of the floor revealed no bat droppings. Cobwebs were also present in the corners and the ridge areas.

No bats were using or had ever used these premises as a roost.
