# Bat survey report for Llwynderw Farmhouse, Old Hall, Llanidloes, Powys, SY18 6PW

by Simon Cope MSc MCIEEM

For: Mr Richard Becker  
Llwynderw Farmhouse,  
Old Hall,  
Llanidloes,  
Powys,  
SY18 6PW

July 2021

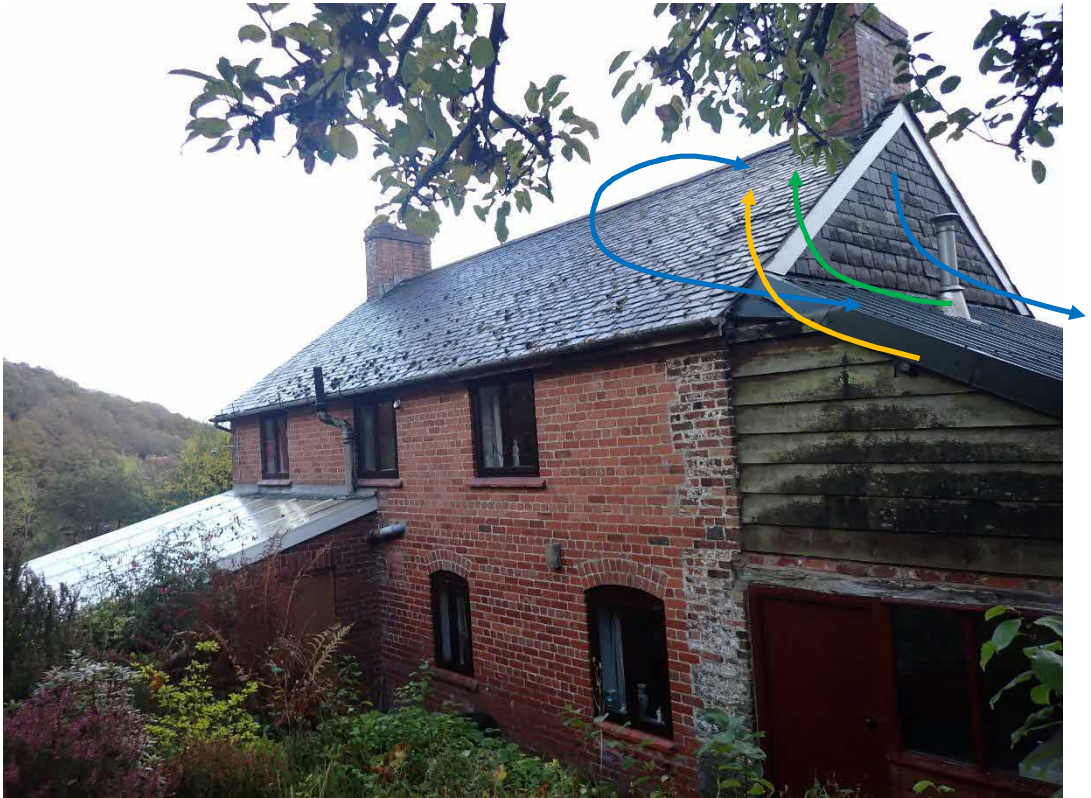
Photo 1. View from VP1 (W corner) showing bat roost access points observed during the activity surveys.

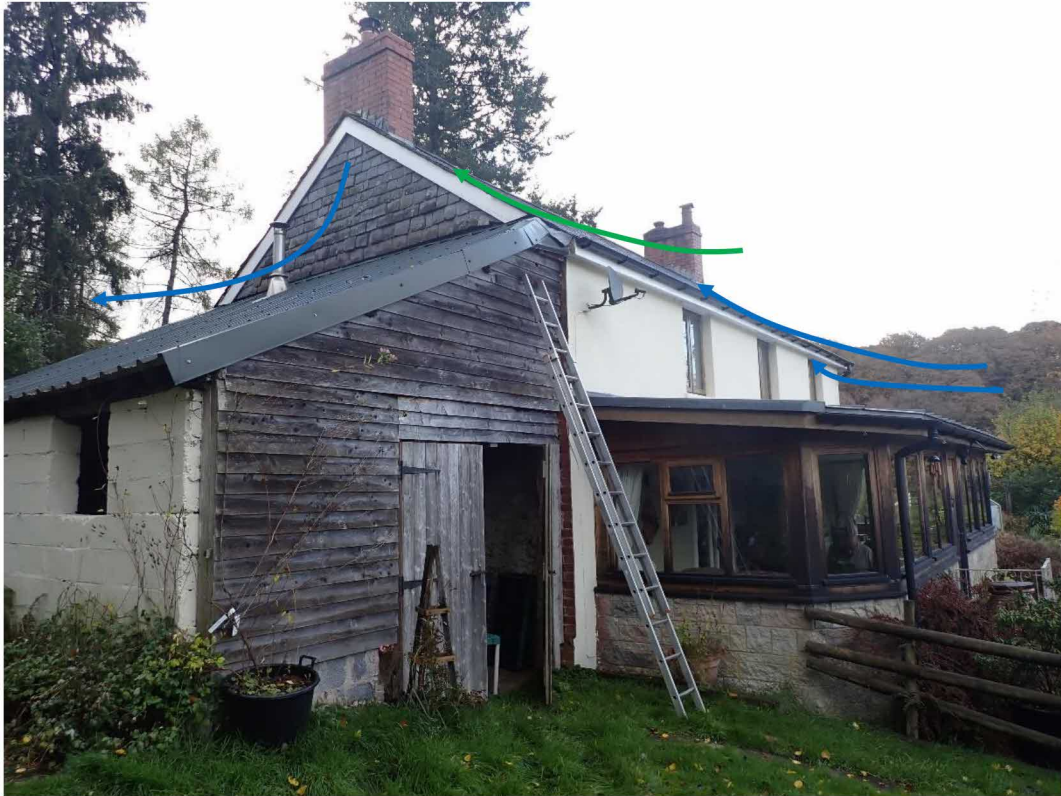
**Photo 3.** View from VP2 (S corner) showing the bat roost access points observed.

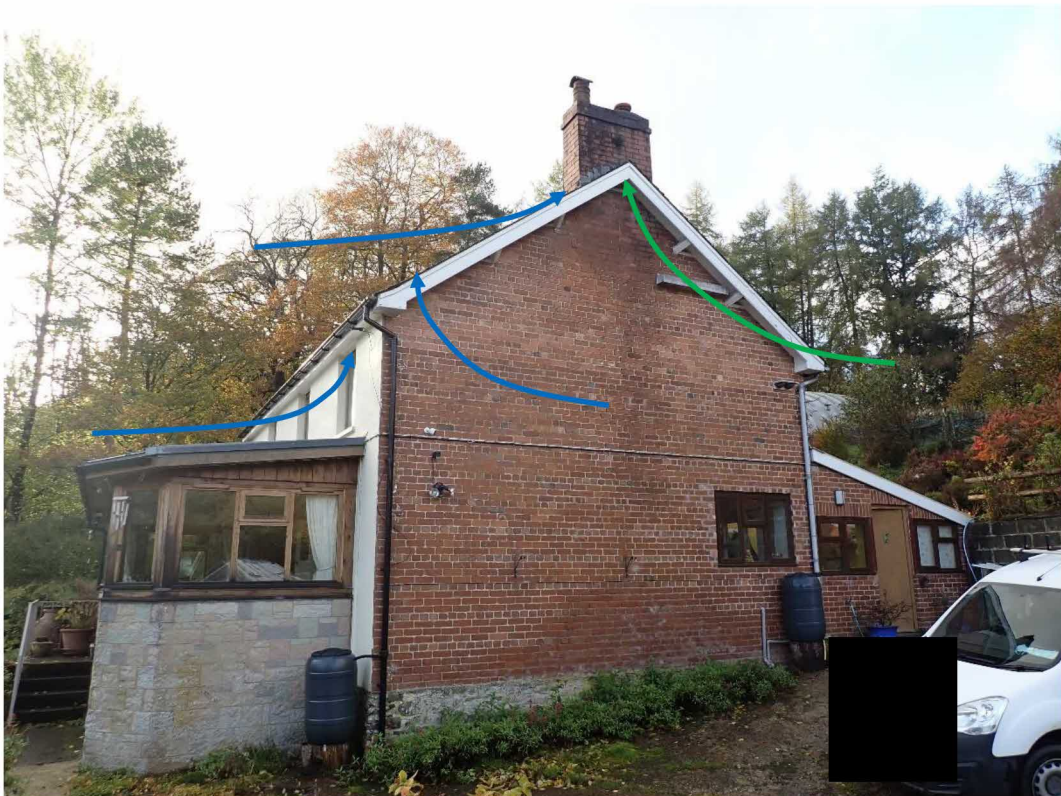
**Photo 4.** View from VP3 (NE gable) showing the bat roost access points observed.

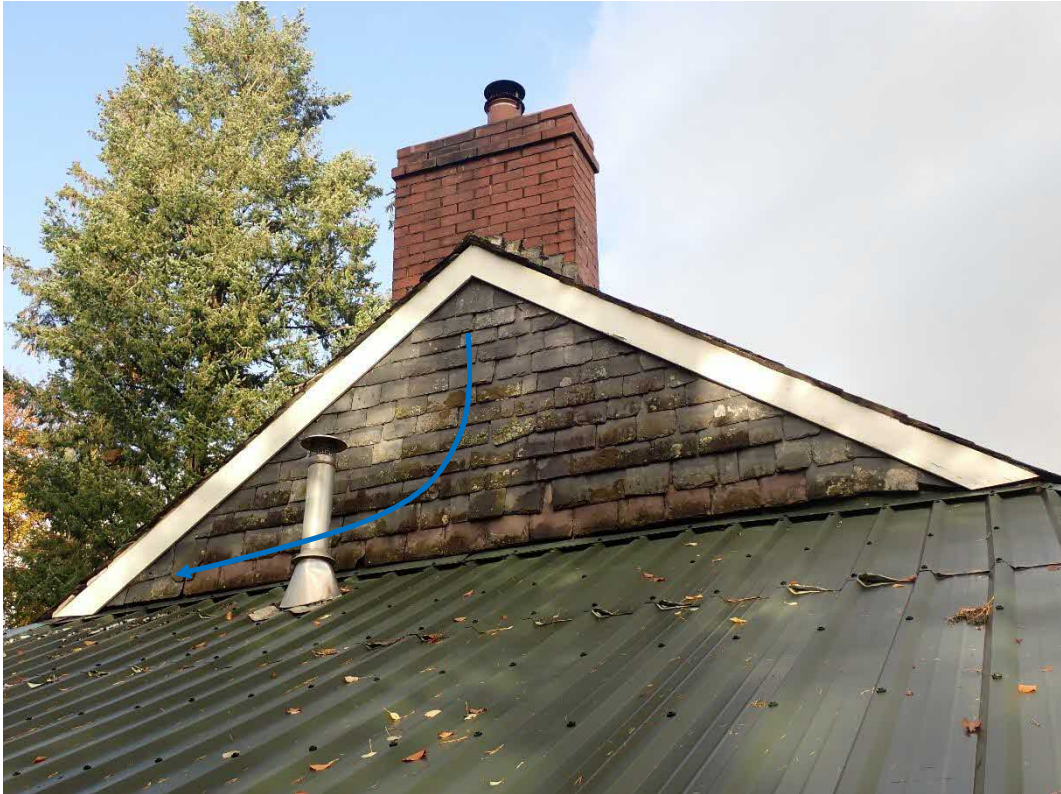
Photo 5. View of the south-west gable of the house and the junction with the roof of the lean-to shed. A single common pipistrelle emerged from under the hanging slates.

The existing roosts underneath roof coverings and/or wooden fixtures in the lean-to shed and the hanging slates on the south-west gable of the house will be dismantled gently by hand. The ECoW will be on hand to deal with any bats that are found, and these will be captured and detained during daylight hours in a suitable container, to be released at the point of capture at dusk on the same day. The current roosts will be made unsuitable in one day so that the bats cannot return to them. In general, the guidelines presented in the 'Rescue and Collection' section of the Bat Care Guidelines (Miller, 2016) will be followed for the care of any captured bats.

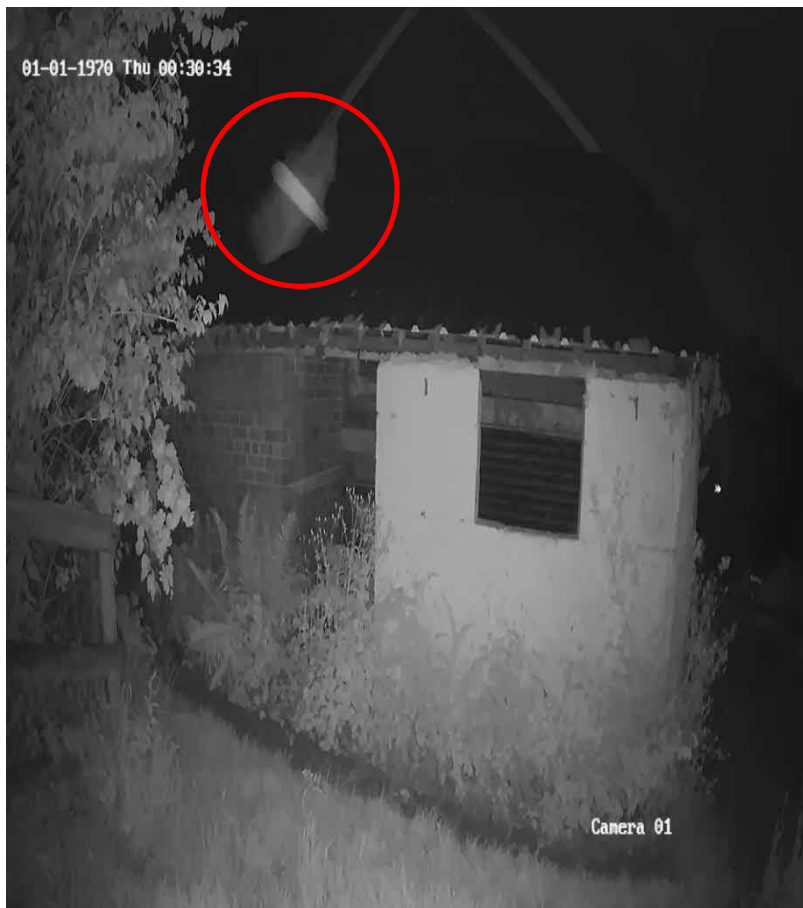
Photo 6. CCTV view of lean-to shed showing a Natterer's bat (circled, identified by sonogram) that had flown in and out of the building.

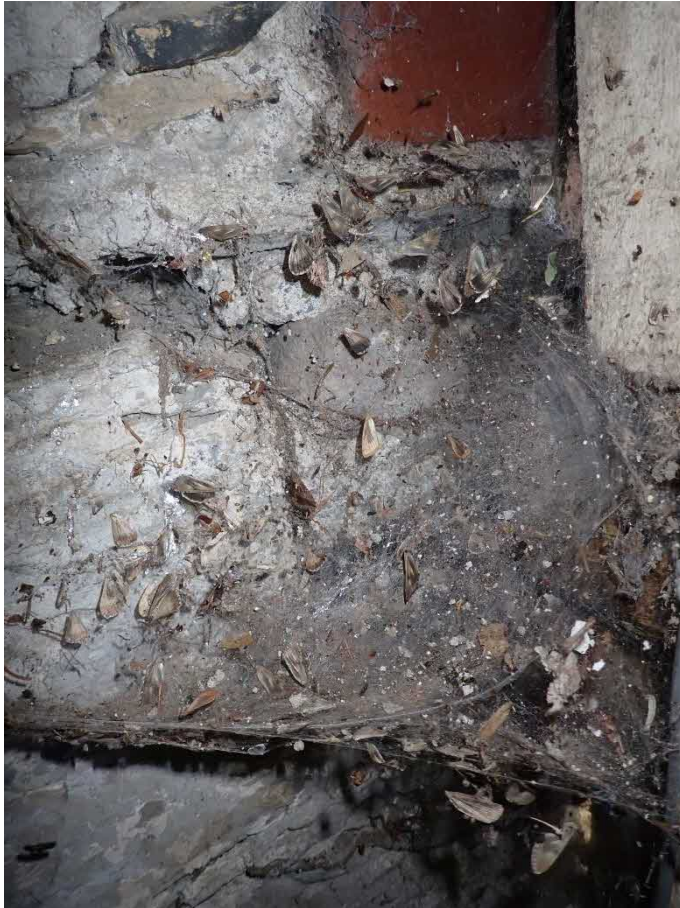
- 4.4.2 The remaining pipistrelle roosts were occupied by solitary bats (or in pairs), that were occupying day roosts.
- 4.4.3 Although *Myotis* bats were observed flying into the lean-to shed at the south-west end of the house, and brown long-eared bats passes were recorded, none were observed roosting there. The group of droppings found during the building inspection probably indicate that the lean-to probably is used as a day roost by one of these species, and the feeding remains that were also found indicate a feeding roost – a common trait of brown long-eared bats.

Photo 7. View of dismembered moth wings inside the lean-to shed representing a brown long-eared feeding roost.

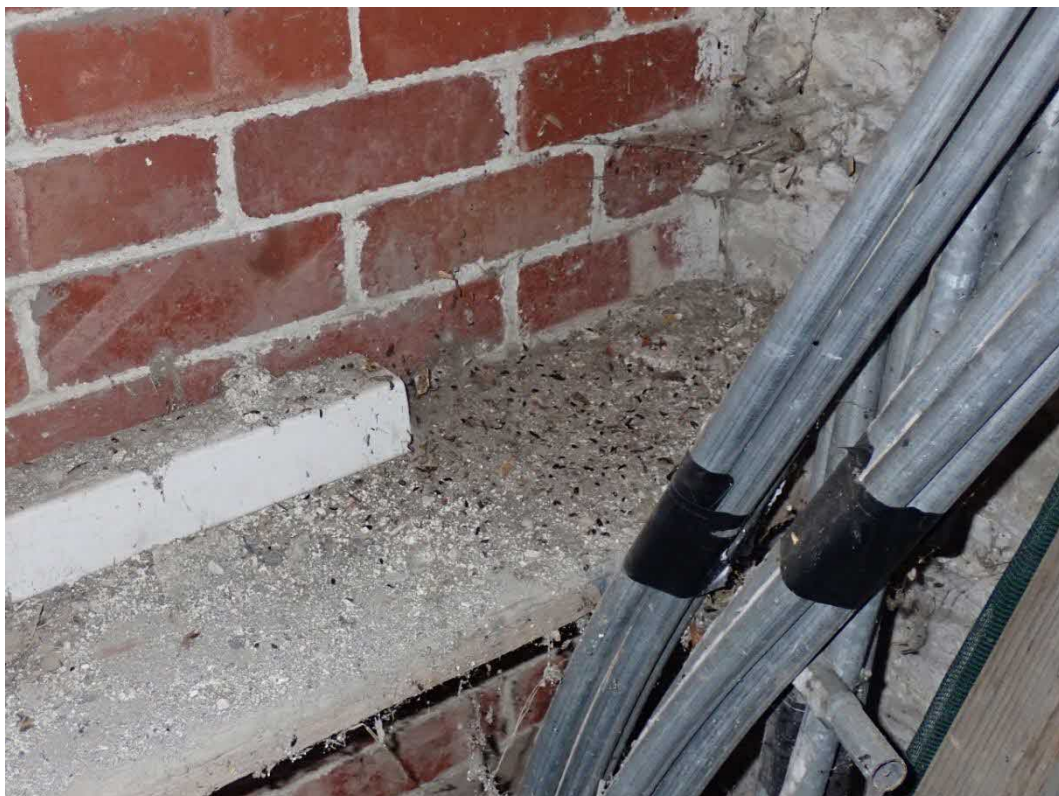
- 4.2.7 Evidence of occupation by bats found during the survey included fresh bat droppings stuck to the internal walls of the lean-to shed (Figure 6). These were mostly medium-sized, resembling those produced by a larger myotis species or a brown long-eared bat, although a few small droppings were also found (pipistrelle or small myotis-sized). A group of approximately 70 of the larger droppings were found on a shelf along the adjoining house wall in the south room of this shed, and a collection of moth wings (feeding remains) were also found on this shelf and in adjacent cobwebs.

Photo 8. Group of droppings on a shelf in the lean-to shed next to the SW gable wall of the house, probably indicating a day roost above.

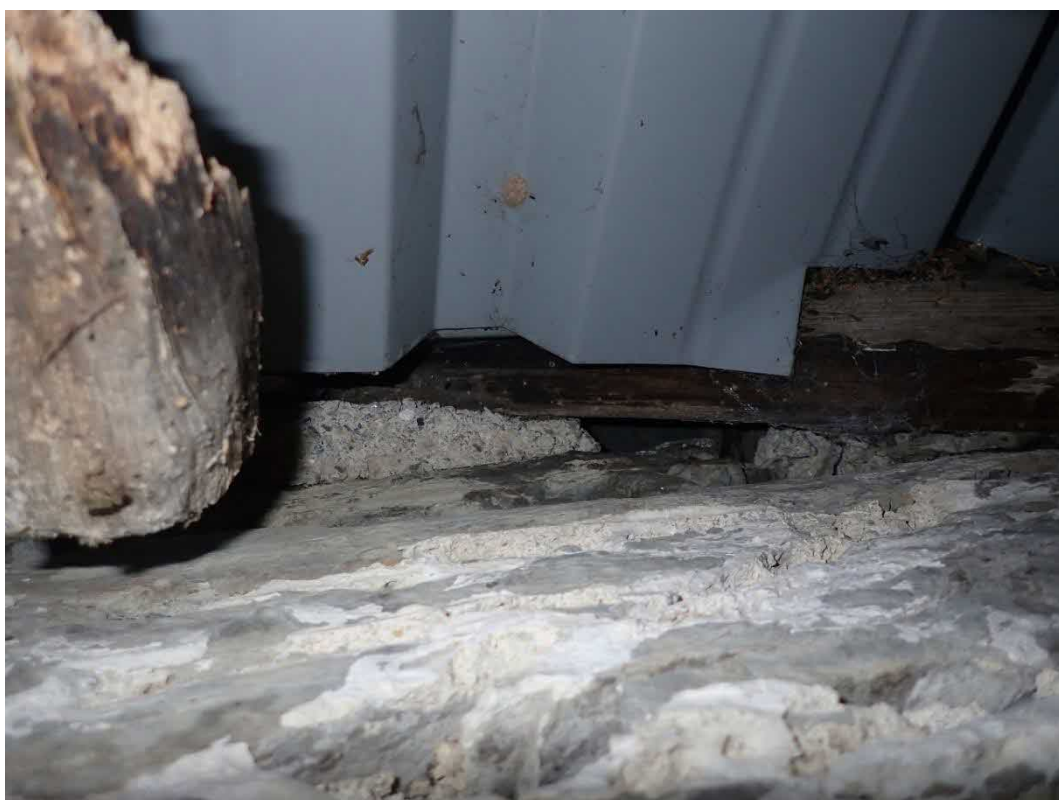
Photo 9. Example of a crevice suitable as a roost access point where the roof of the lean-to shed met the house gable wall.

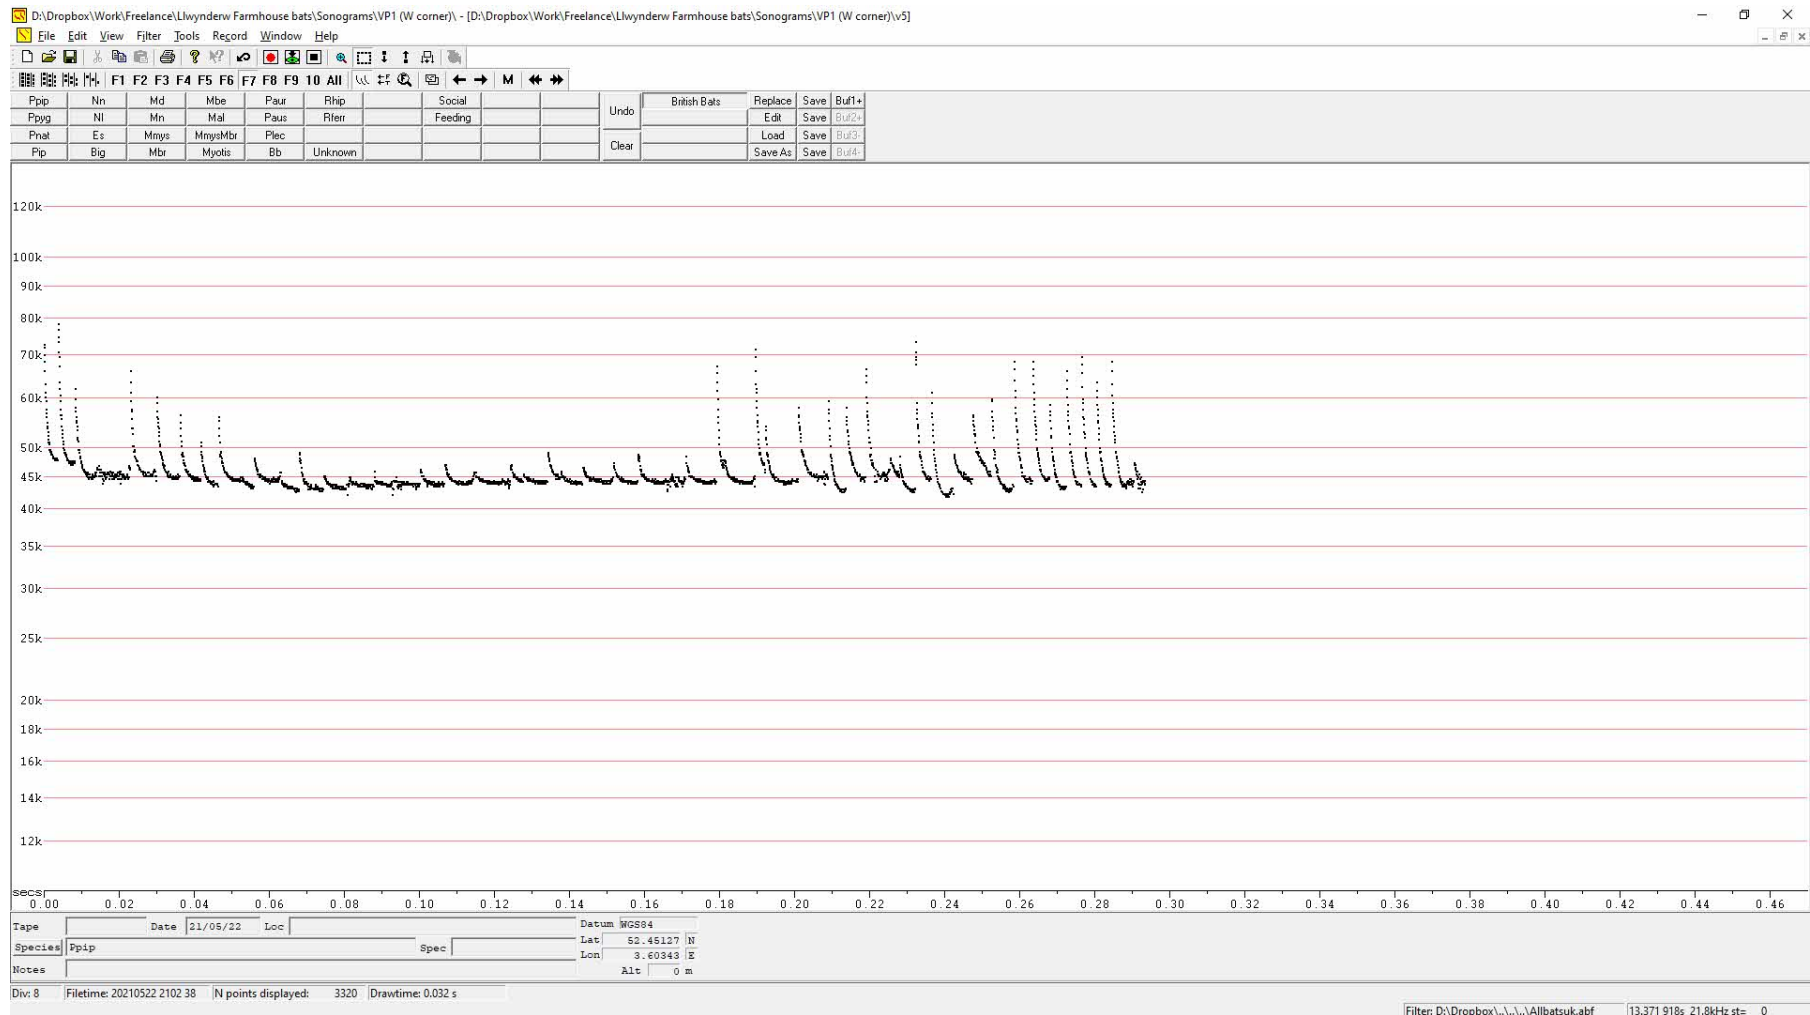
Figure 9. Screenshot of a sonogram, with frequency on the vertical axis and time along the horizontal axis. The hockey stick shaped calls are diagnostic of all pipistrelle species, and the flatter (qCF) part of the call at around 45 kHz indicates a common pipistrelle (expansion scale: F7, compressed to remove spaces between calls, filtered to remove non-bat noise).

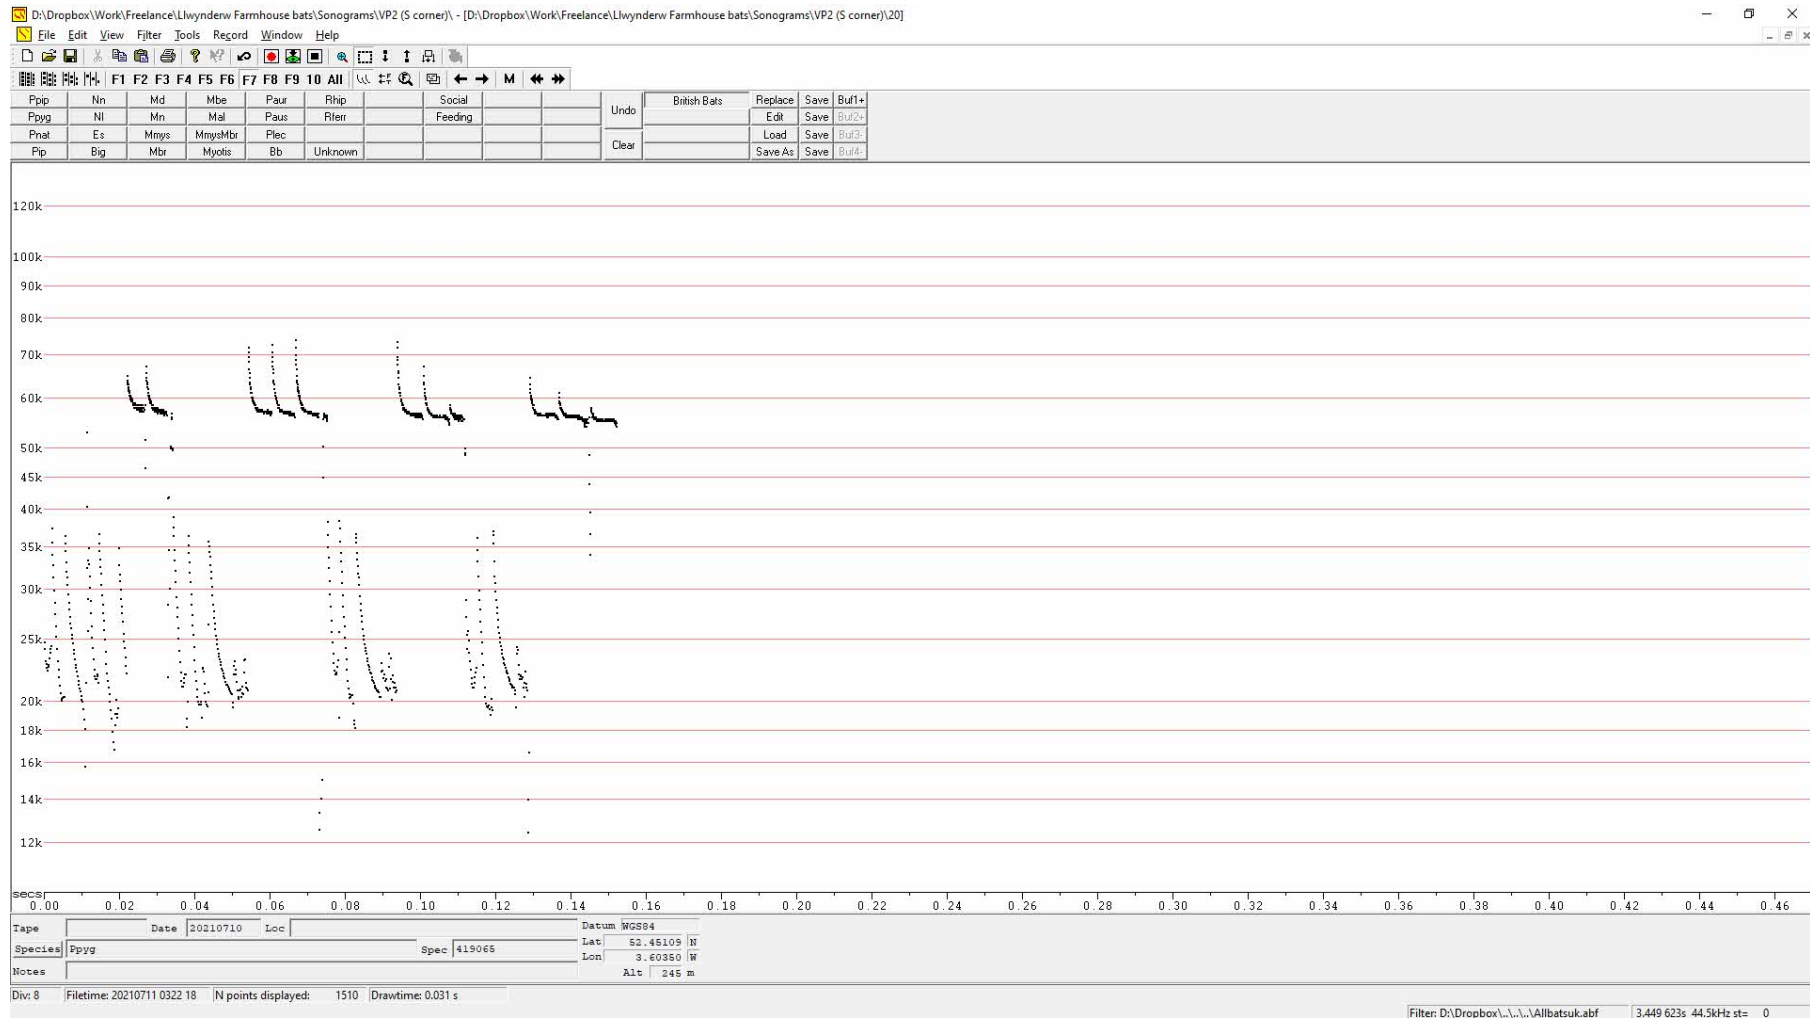
Figure 10. Sonogram of a soprano pipistrelle - echolocation calls with a qCF at around 55kHz interspersed with groups of 'social calls' at lower frequencies (F7, compressed, filtered).

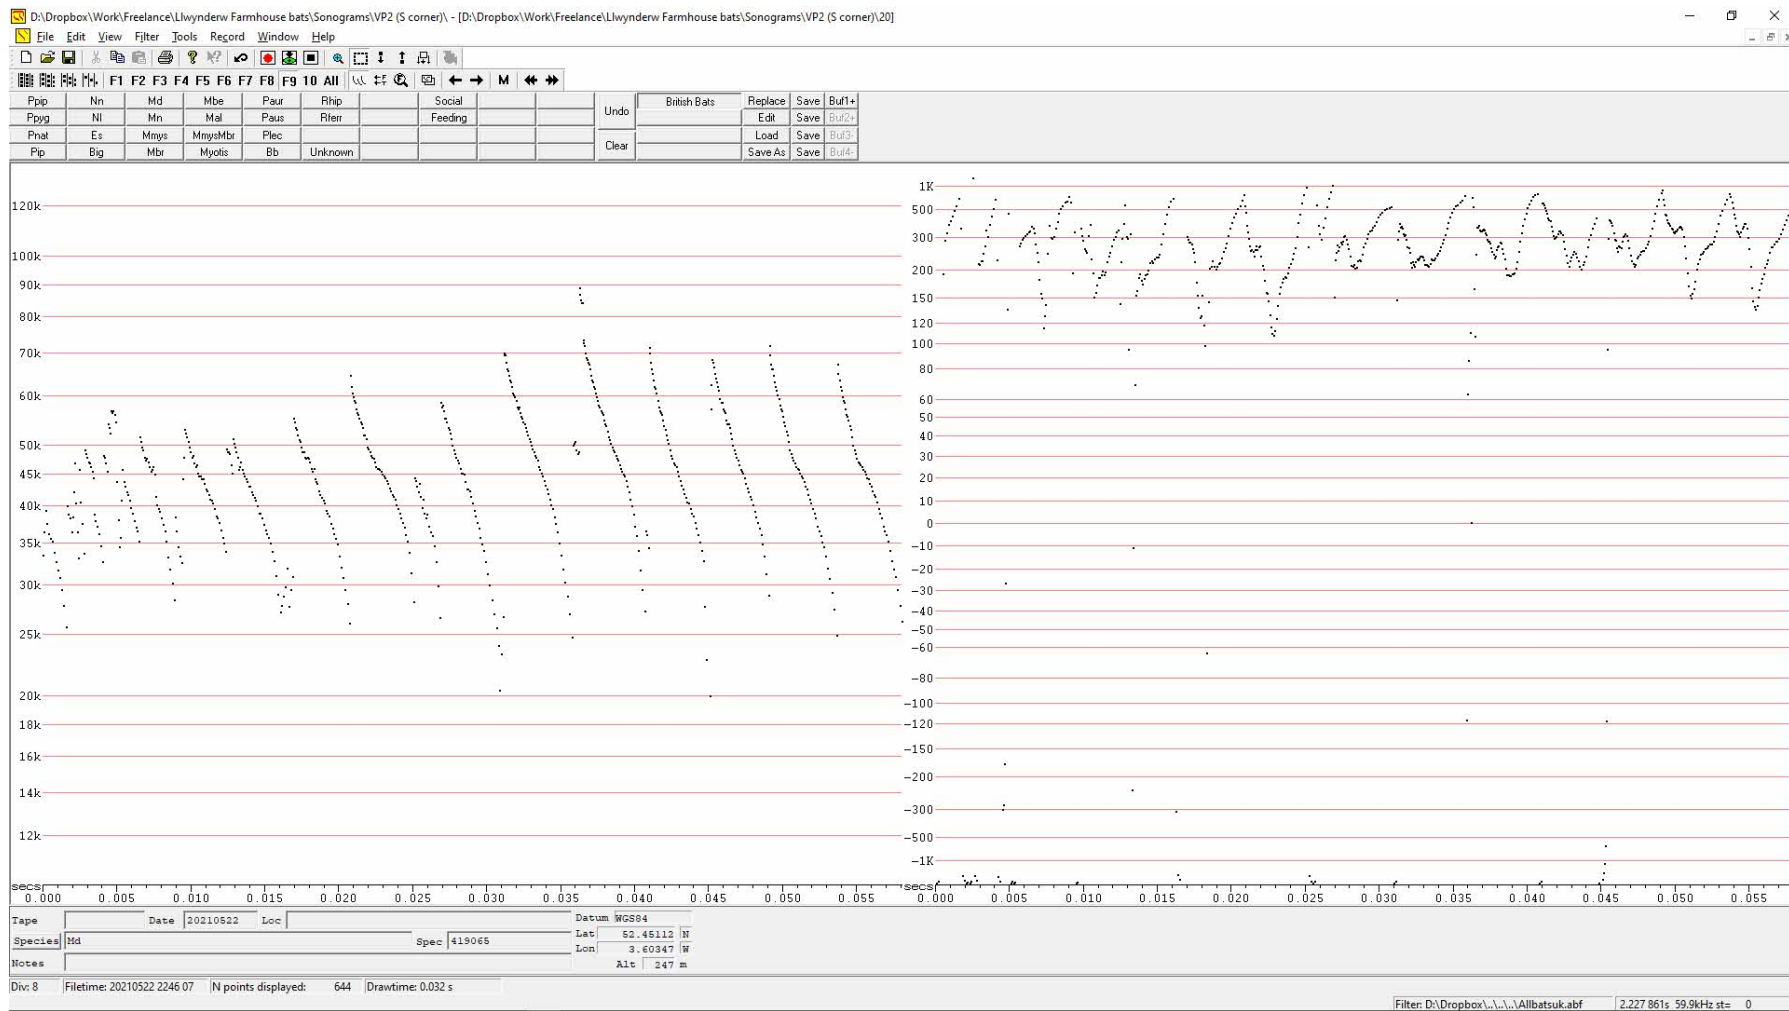
Figure 11. Sonogram of a Daubenton's Bat. The near-vertical (FM) calls on the left-hand side are indicative of a Myotis species; the split-screen on the right-hand side is an analysis of the rate of change in frequency (slope) of the corresponding calls on the left-hand side. The range of octaves per second (120 - 1000 OPS) coupled with the sigmoidal call shape (represented by the single large-scale V-shape of the slope line) is diagnostic of the species (F9, compressed, filtered).

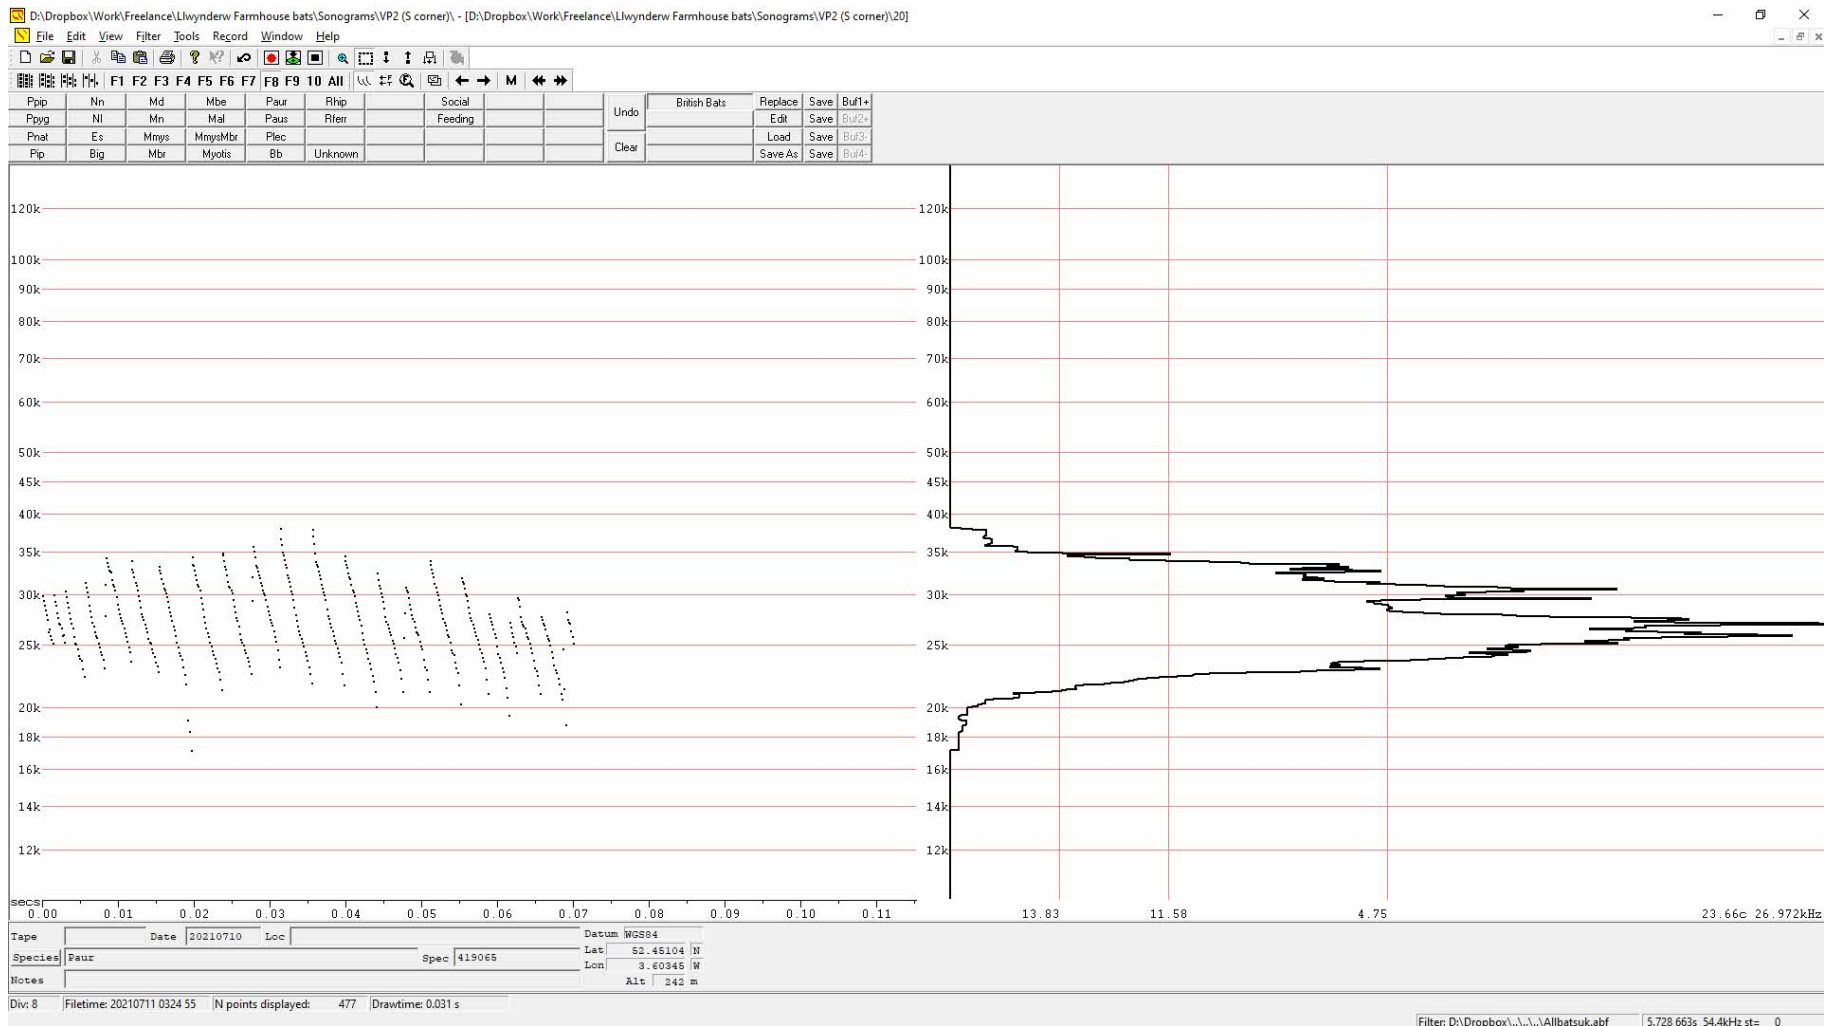
Figure 13. Sonogram of a Long-eared Bat. The calls are similar in shape to some myotis echolocation calls in that they are entirely FM, but the peak energy (shown on the right-hand split-screen) is around 30 cycles per second, which is too low for a Myotis (F9, compressed, filtered).
