# **Bat survey report for Cwm Gwyn, Llanbrynmair, Powys, SY19 7DY**

Oakwood Ecology

September 2019

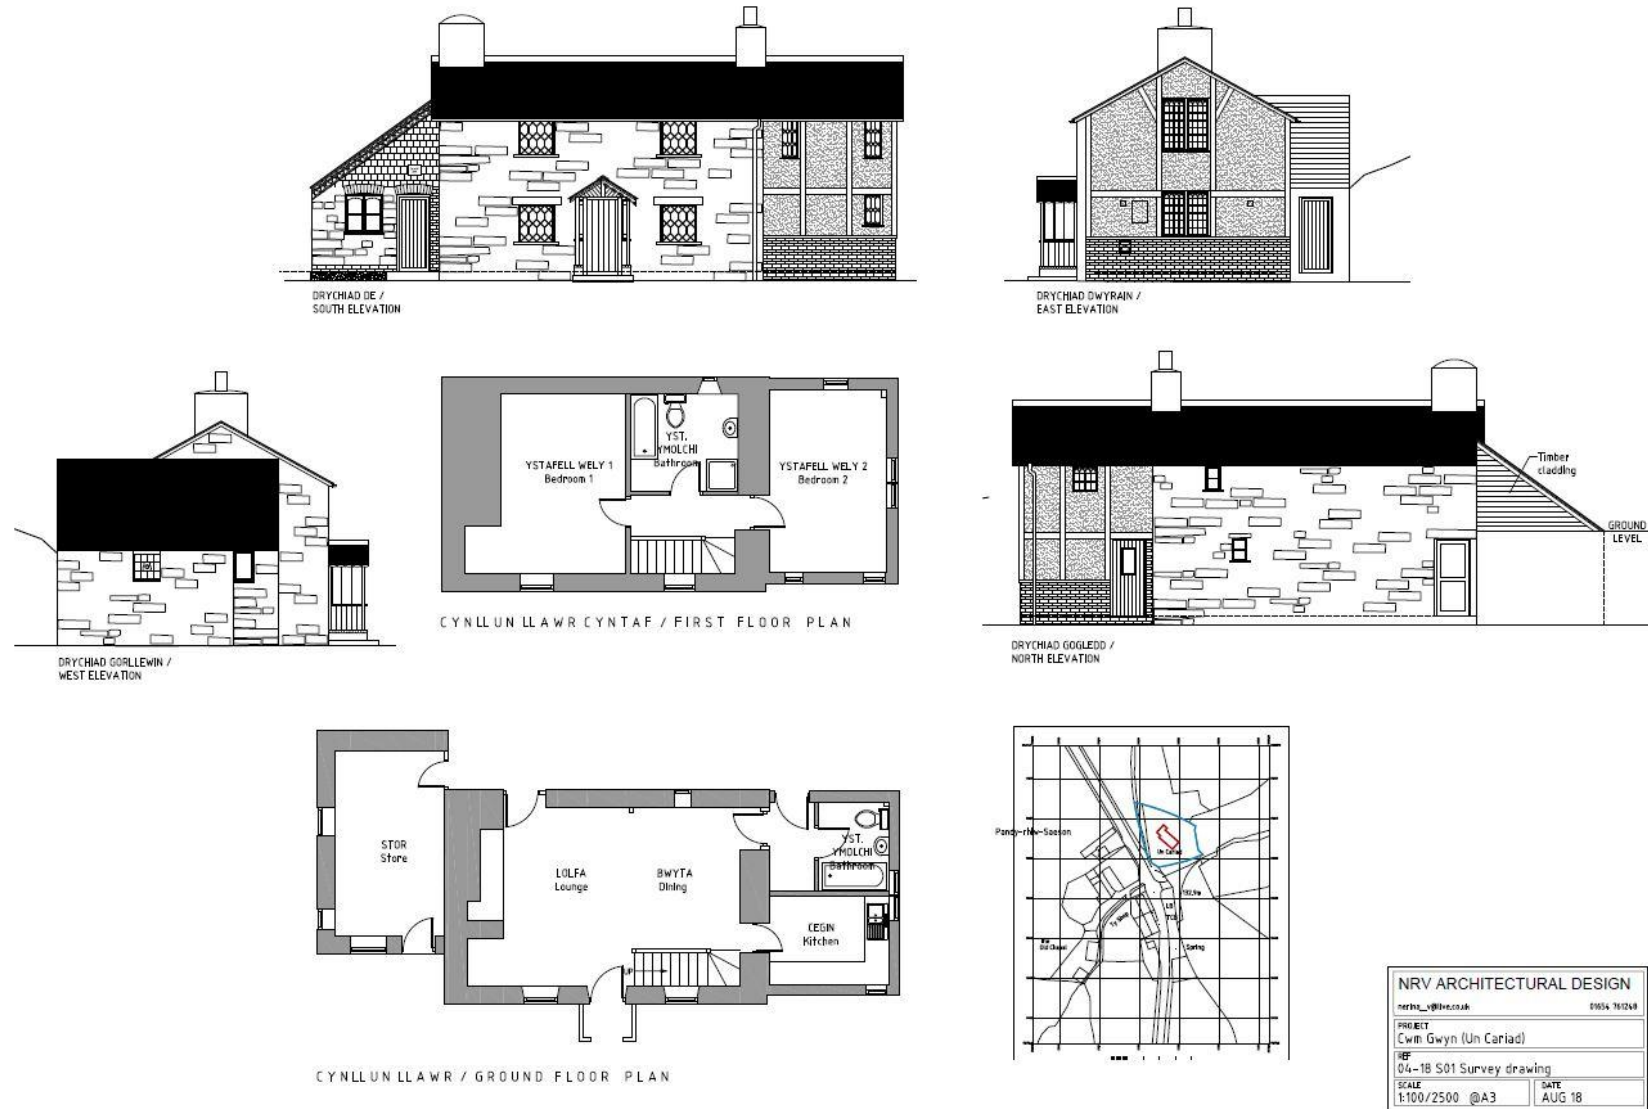
**Figure 3.** Architect's plans of the existing building at Cwm Gwyn.

- 4.2.4 There are two buildings on the site - the house and a small shed. Both are of pre-20<sup>th</sup> century origin. The house has been built in at least two phases; the oldest part has solid rubble-filled walls faced with dressed field stone. A single-storey lean-to extension has been added on to the north-western end of the house, and the north-eastern wall of this has been removed at some point. Internally, an extra layer of concrete blocks has been added to parts of the walls. A more modern two-storey extension has been added to the south-eastern end of the house, with walls constructed of concrete block (probably with an internal cavity). Internally, there has been some recent renovation work, and all rooms in two-storey part of the house are plaster-boarded and have been used as living space.

- 4.2.5 The house roof is of traditional timber frame construction, with trusses and purlins supporting rafters and battens. The entire roof is covered with slates and is pitched to a central ridge. The eaves are mostly closed by boarding, although this has collapsed in places. The second-floor room extends to the apex of the roof, and there are no lofts.

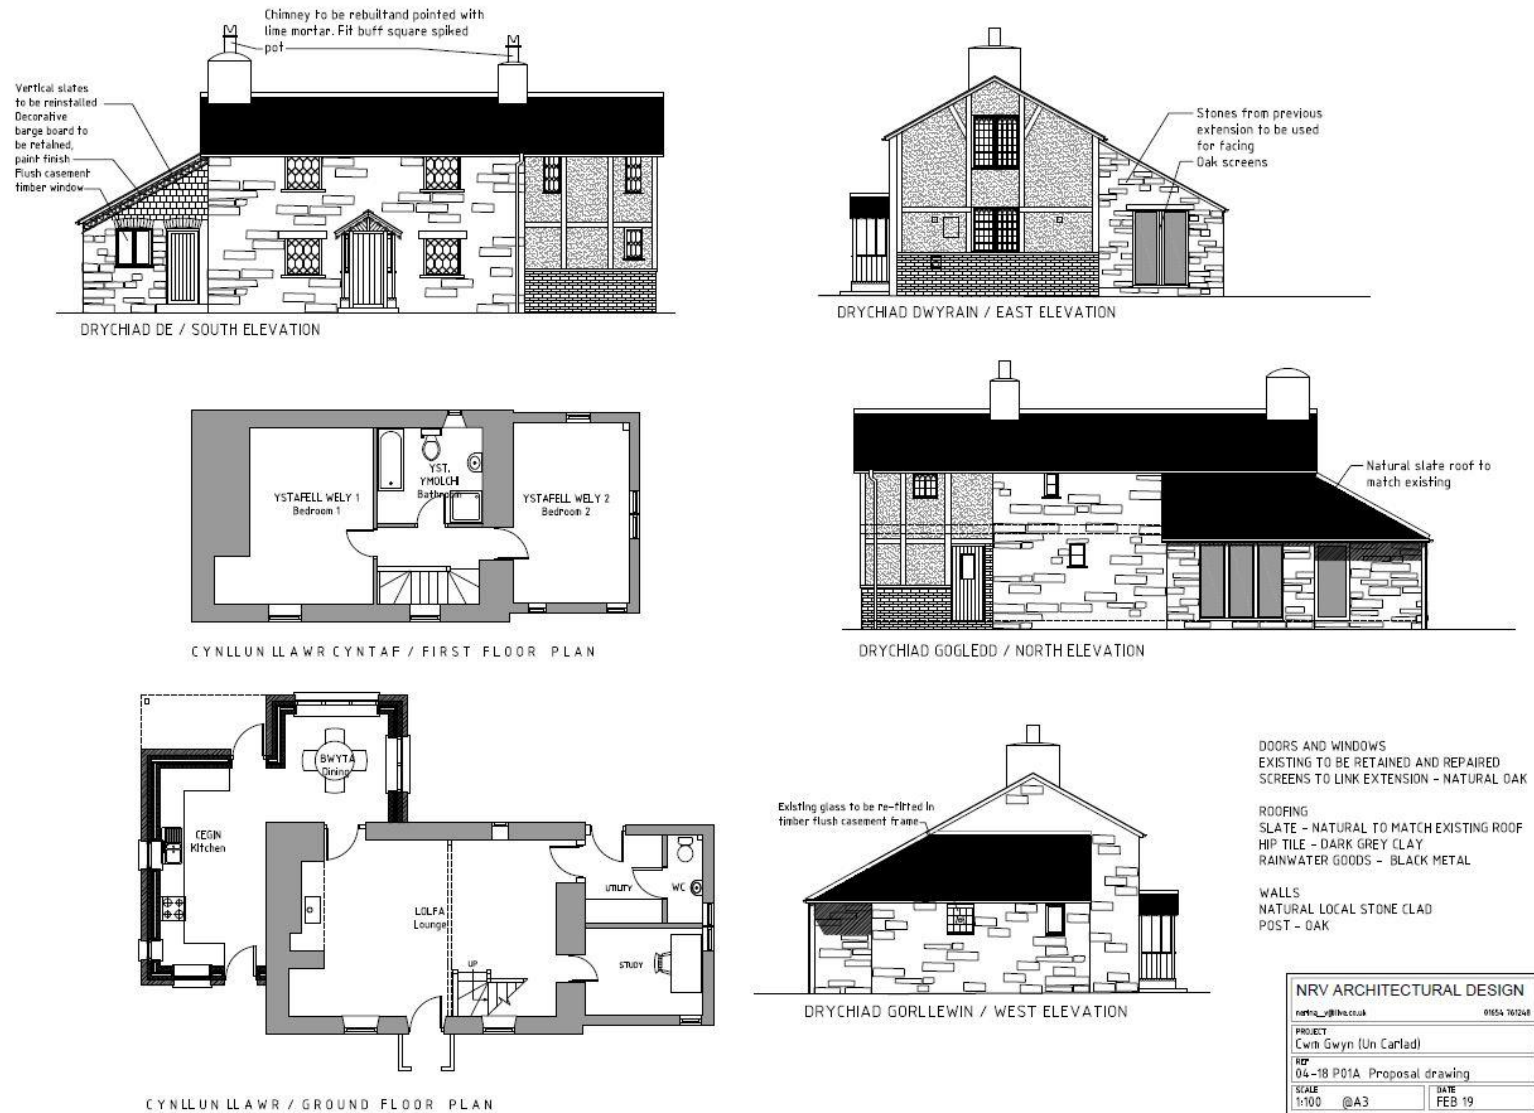
**Figure 4.** Architect's plans of the proposed development at Cwm Gwyn.

- 1.1.2 The proposed development involves the demolition of part of the dwelling, the erection of an extension, the excavation of land and all associated works (part retrospective) (**Figures 3 & 4**). The majority of the site has recently been completely cleared of vegetation, including some large trees, and significant earthworks have already taken place. It is not possible to comment on the potential for roosting bats that may have existed in this vegetation before clearance. Renovation work has also already started inside the house, and scaffolding was erected around the two chimneys of the house at some point between the building inspection and the start of the activity surveys.

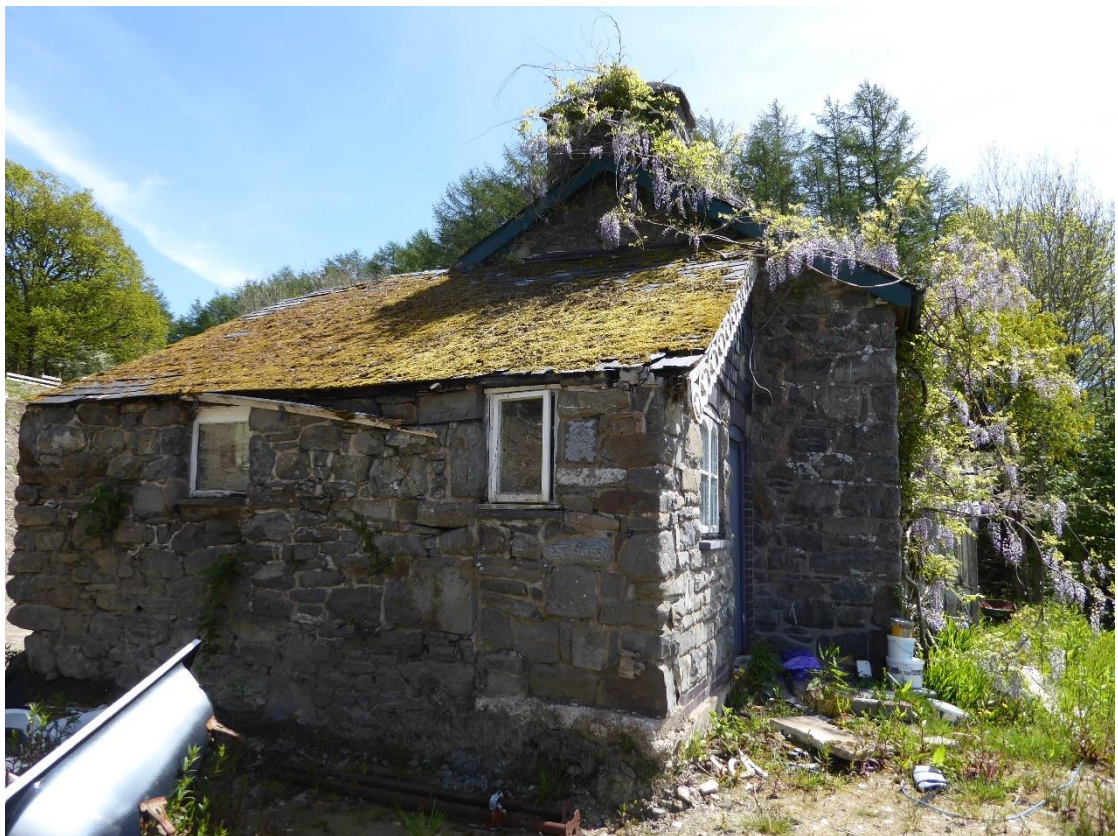
**Photo's 1 & 2.** Views of the buildings at Cwm Gwyn from VP1 (above) and VP2 (below). Emergences and re-entries of bat are indicated with arrows.

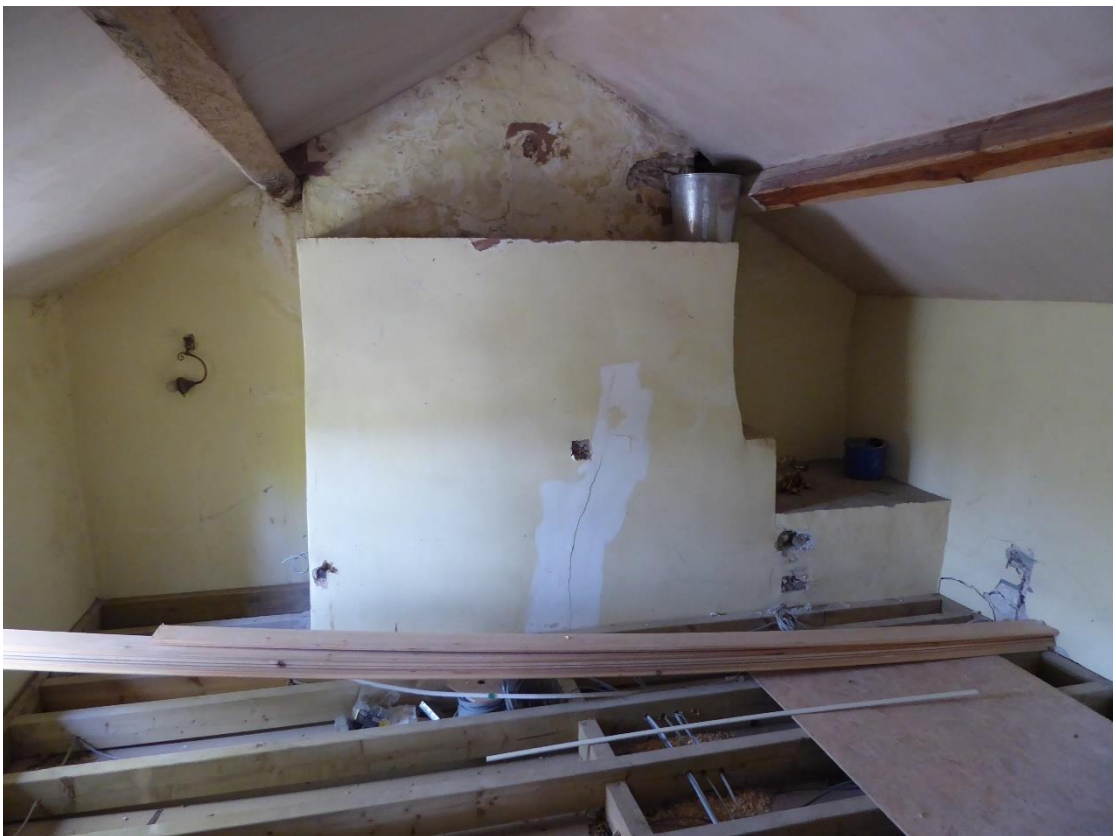
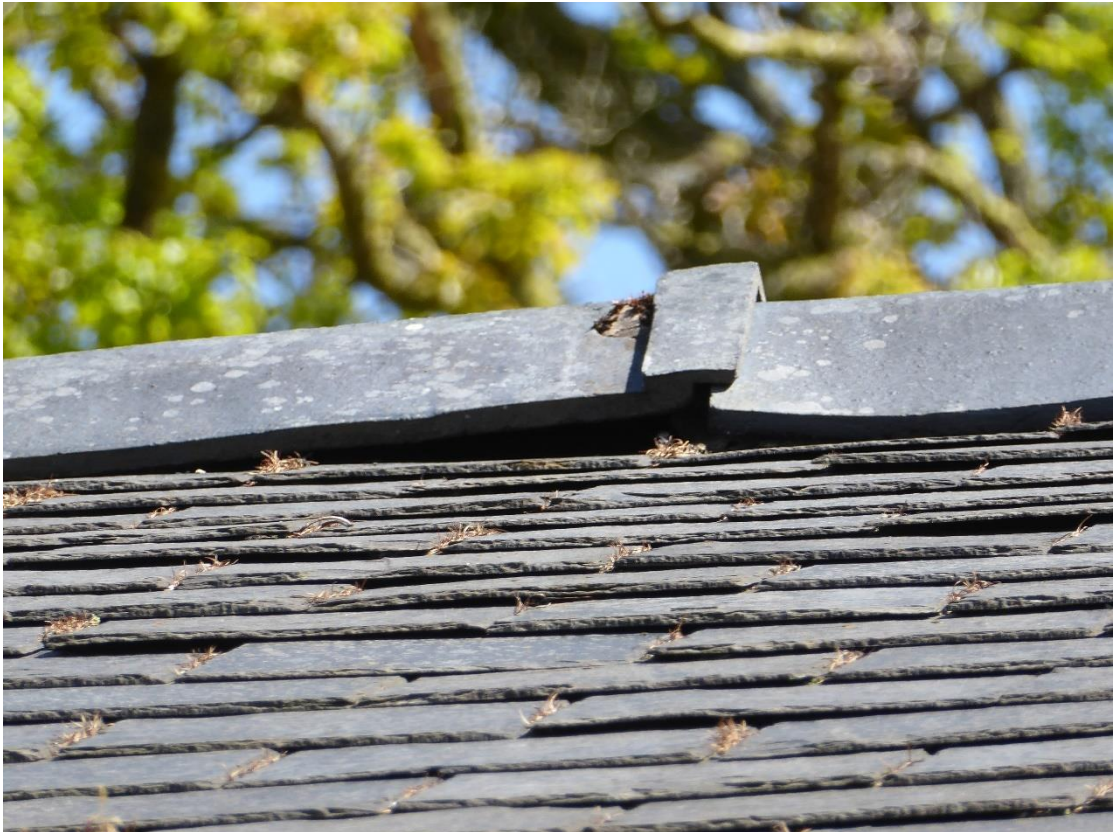
- 4.2.7 In terms of potential roost features for bats, there were raised ridge tiles and slates, holes in some of the coverings over the eaves, gaps in the stone walls where mortar had fallen out, and a gap between the original wall and the new concrete block wall inside the north-western lean-to extension, all of which formed crevices suitable for roosting bats. The back door of the house, the door of the shed and the north-eastern wall of the north-western lean-to were all missing, which would allow fly-in access inside these rooms for bats.

**Photo's 7 & 8.** Potential roost features were located under raised ridge tiles (above) and where boxed soffits had come adrift (below).

- Replacement roosts will be integrated within the renovated buildings. In the spirit of a ‘like-for-like’ provision, most of these will be small crevices that replicate those previously occupied by small numbers of bats (**Figures 9 & 10**), following the principles outlined in Gunnell *et al.* (2013). Crevices will be formed behind all fascia and barge boards, and underneath four raised ridge tiles.

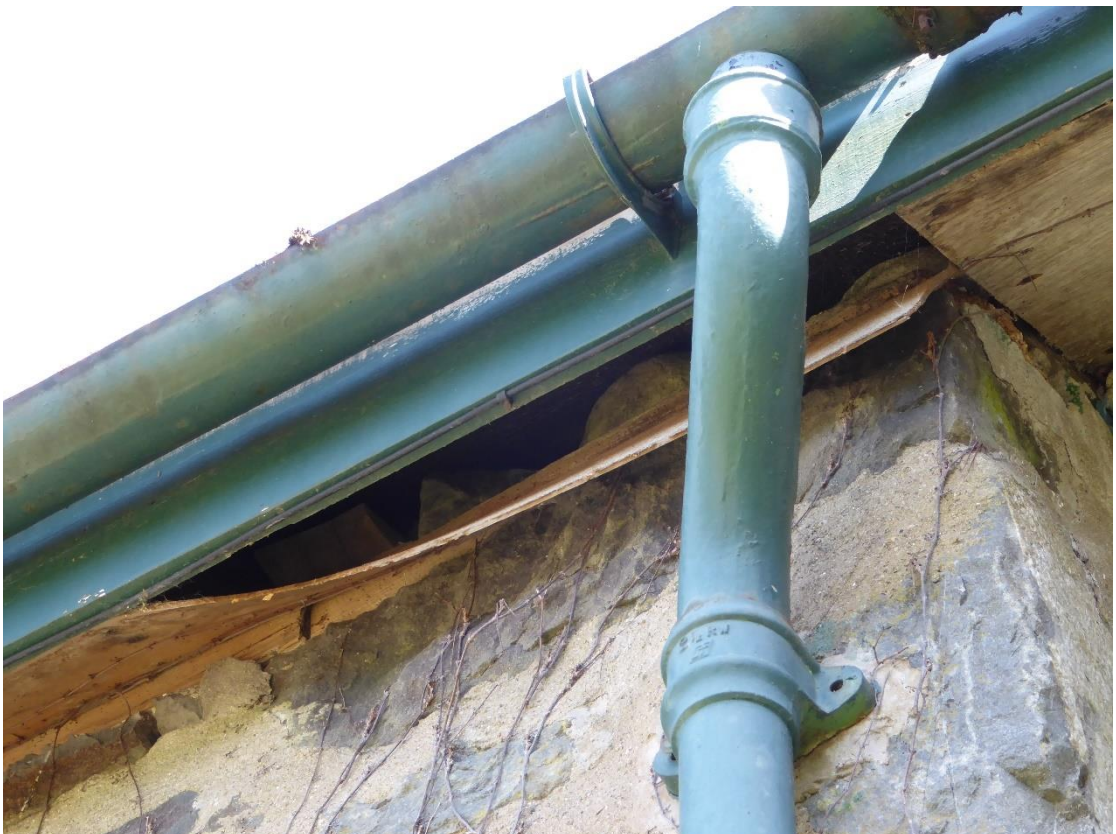
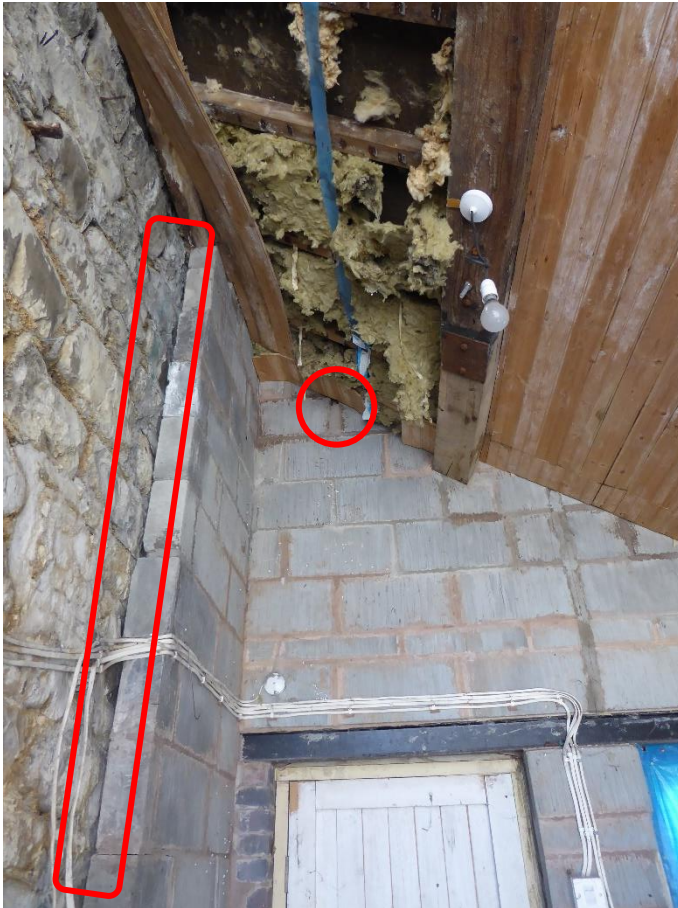
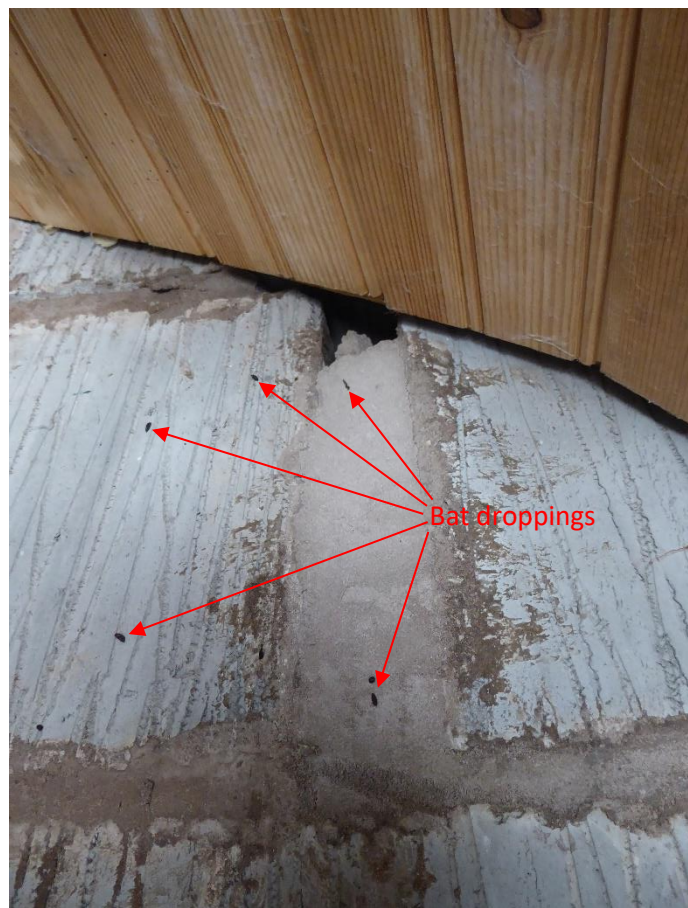
- 4.2.8 The only evidence of bat-roosting encountered during the inspection was 12 fresh droppings found stuck to the concrete block wall inside the north-western lean-to extension. The size and shape of these indicated that they were produced by a small species of bat (*Pipistrelle* or small *Myotis*). They were located under an obvious crevice in the top of the wall, partially covered by a rafter.

**Photo's 9 & 10.** During the building inspection, potential roost features were identified inside the lean-to extension on the north-west end of the house.

A suitable gap was identified behind the concrete block wall and the original house wall (left). Droppings resembling those produced by pipistrelle bats were recorded stuck to the wall below a suitable roost access point (left and below), and a common pipistrelle was recorded entering and emerging from this access point (below).

- The stonework will only be re-pointed during the bats active season (March – November). To exclude the bats, all crevices in the stonework (and behind the concrete block wall in the lean-to extension) will be investigated using an endoscope by a suitably qualified ecologist to ensure the absence of bats. If no bats are present, the entrance will be blocked with a removable rag until it is re-pointed. If a bat is present in a crevice, or if the cavity cannot be fully observed, a one-way door will be installed on the entrance (in accordance with guidance given in Mitchell –Jones & McLeish, 2004) and work will be delayed for up to four suitable flying nights or until the bat is observed to leave the roost. A suitable flying night is one that has a temperature above 6°C, with light winds and little or no rain.

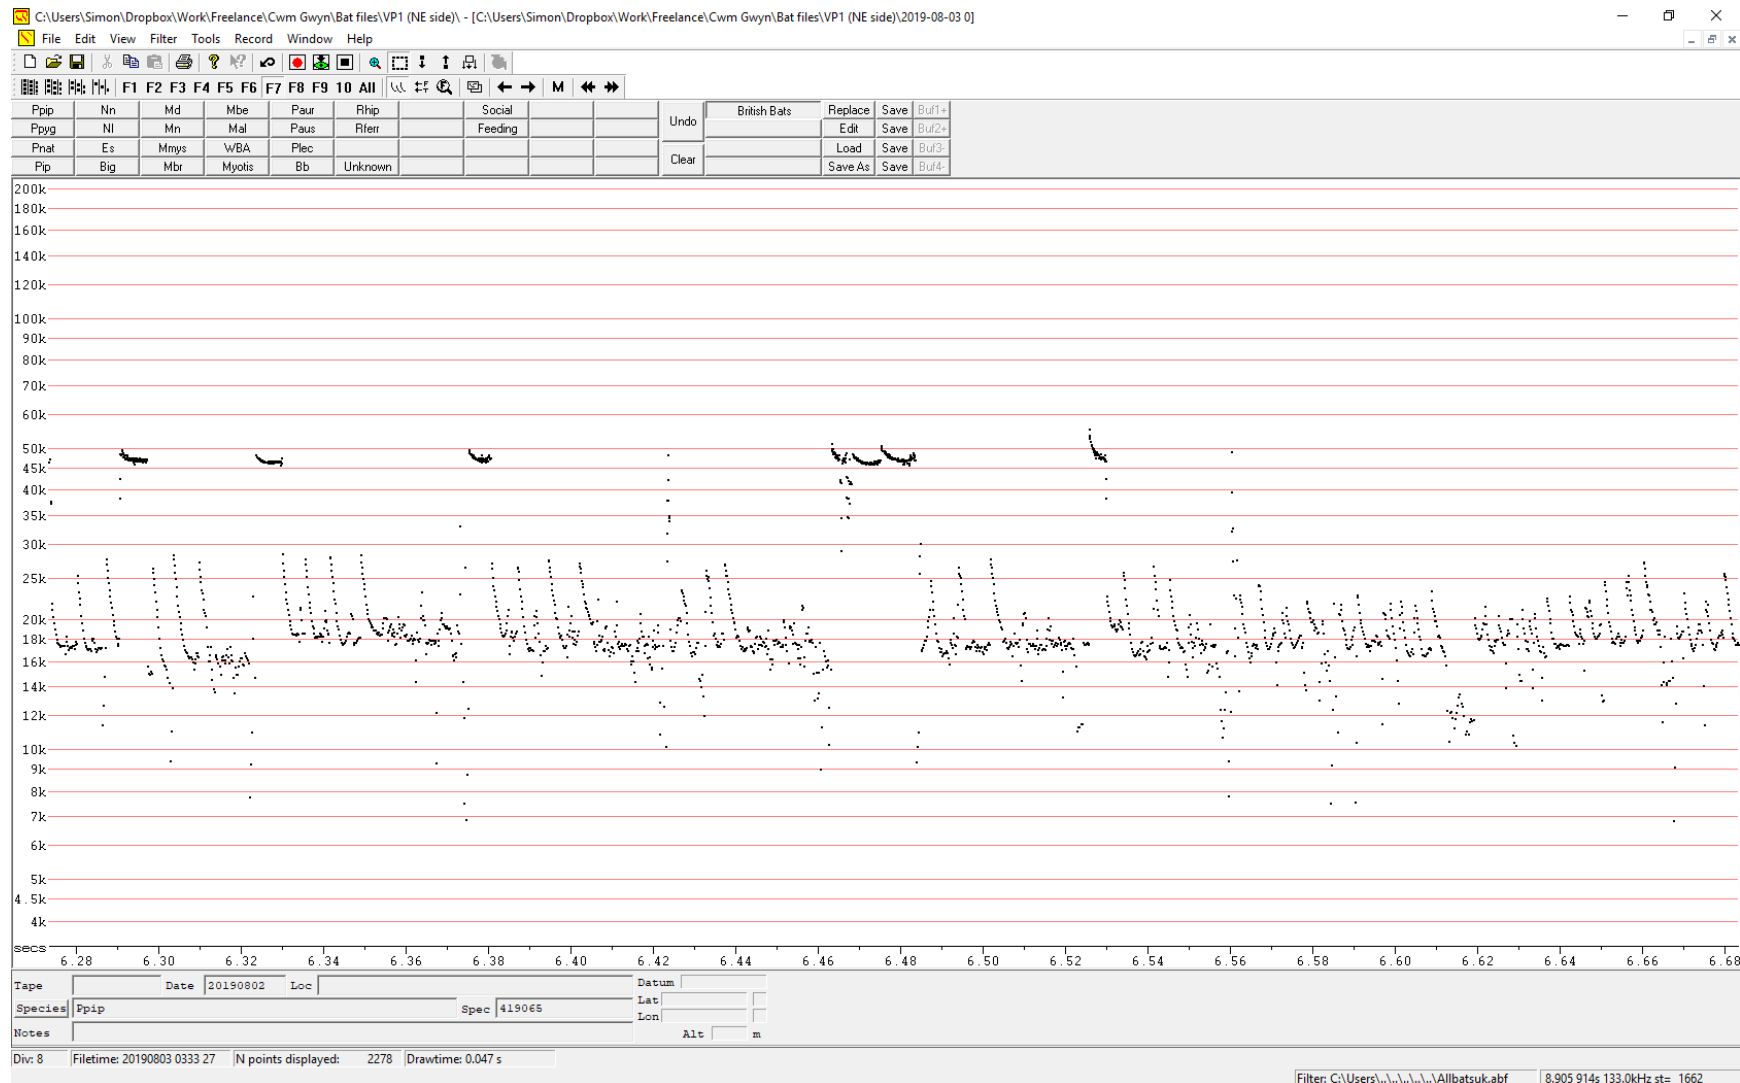
**Figure 12.** Sonogram of common pipistrelle, showing echolocation calls with qCF at around 45kHz. The lower frequency calls are social calls produced by the same bat (F7, compressed, filtered).
