Preliminary Bat & Bird Assessment

Higher Treavars, Longdowns, Penryn, Cornwall

23rd May 2018

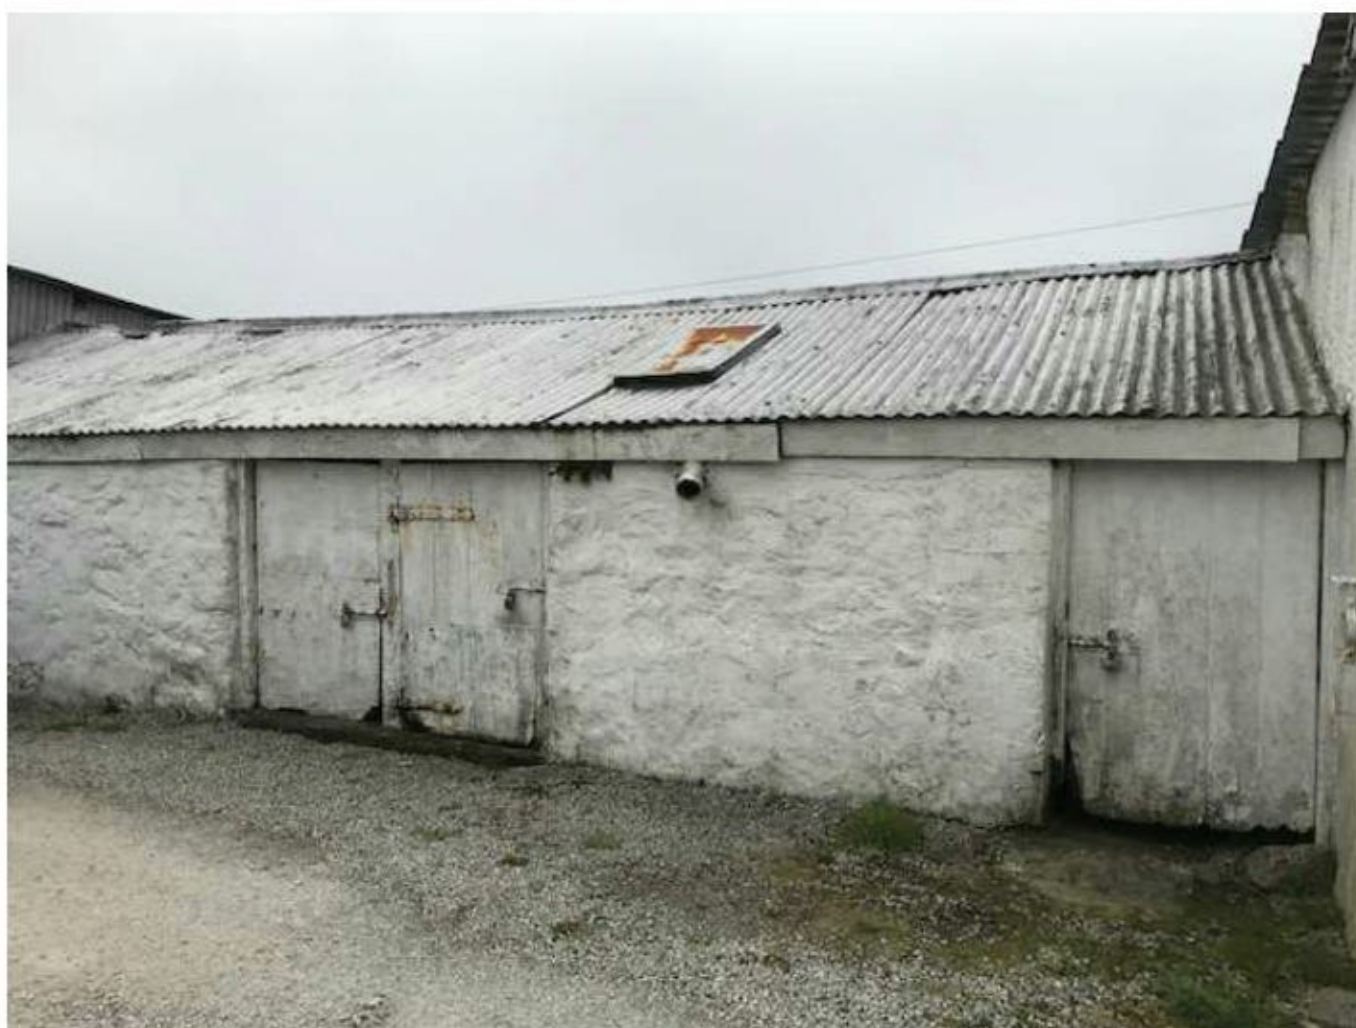
The old piggery is a single storey building of stone construction, with a pitched, corrugated metal roof, wood fascias and wood doors (Figures 1 and 3).

Figure 1: View of north elevation of the old piggery.

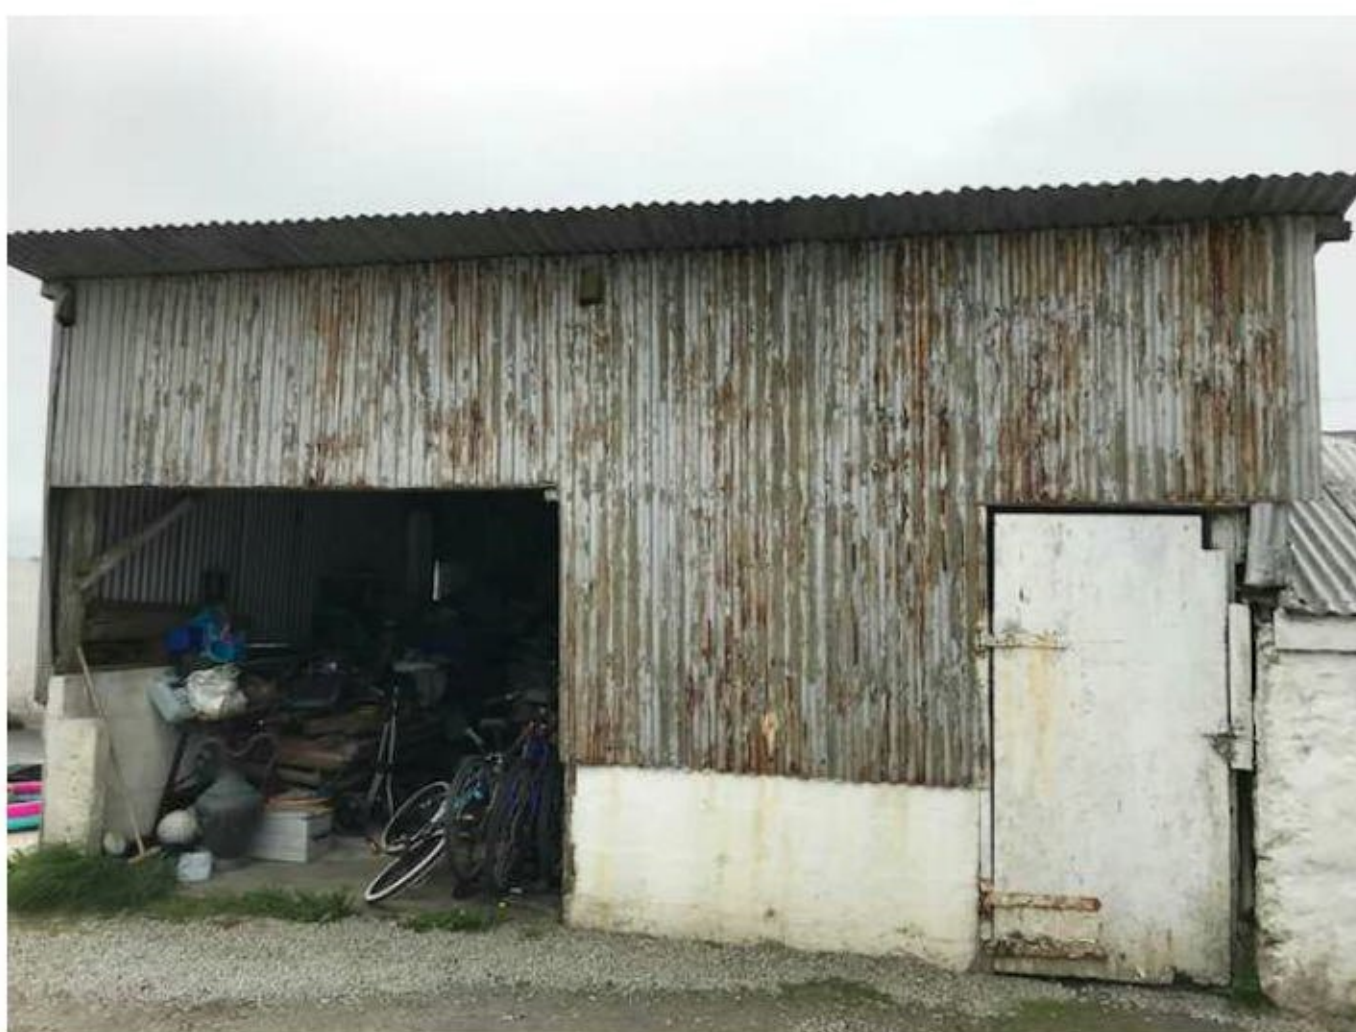
Adjoining the old piggery is a garage of corrugated metal construction with a corrugated metal mono-pitched roof (Figure 2). The garage is used for storage and has a concrete floor. The corrugated metal roof is open to the rafters and unlined (Figure 5). No evidence of bats was observed within the interior of the garage and there are no visible external features that provide potential for roosting bats. The garage is assessed as being of **negligible suitability** for roosting bats.

Figure 2: View of north elevation of garage.

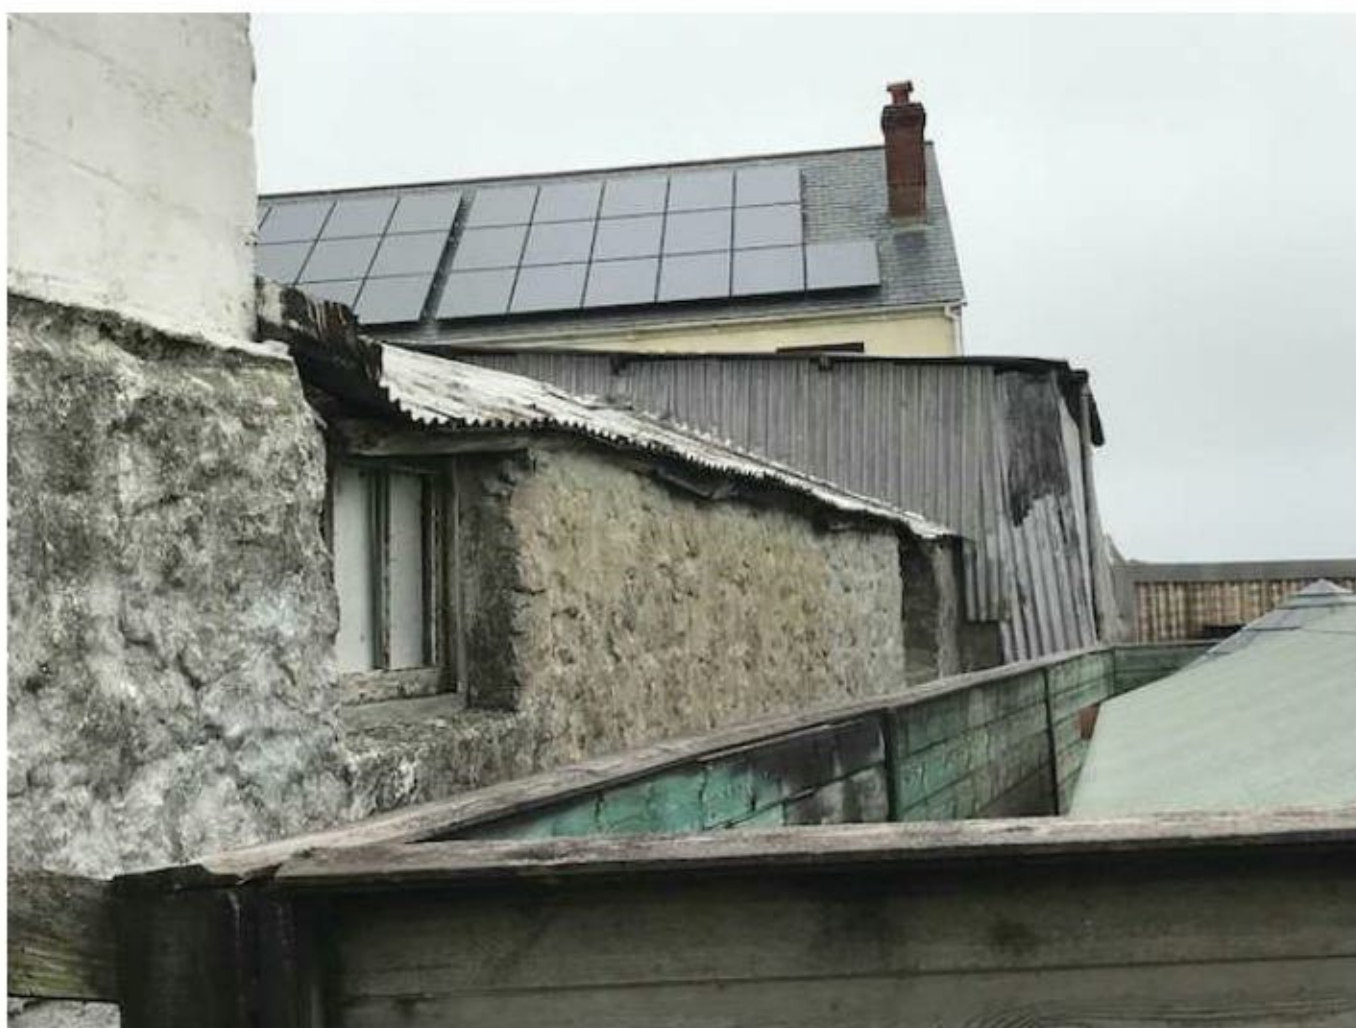
Figure 3: View of south elevation of the old piggery.

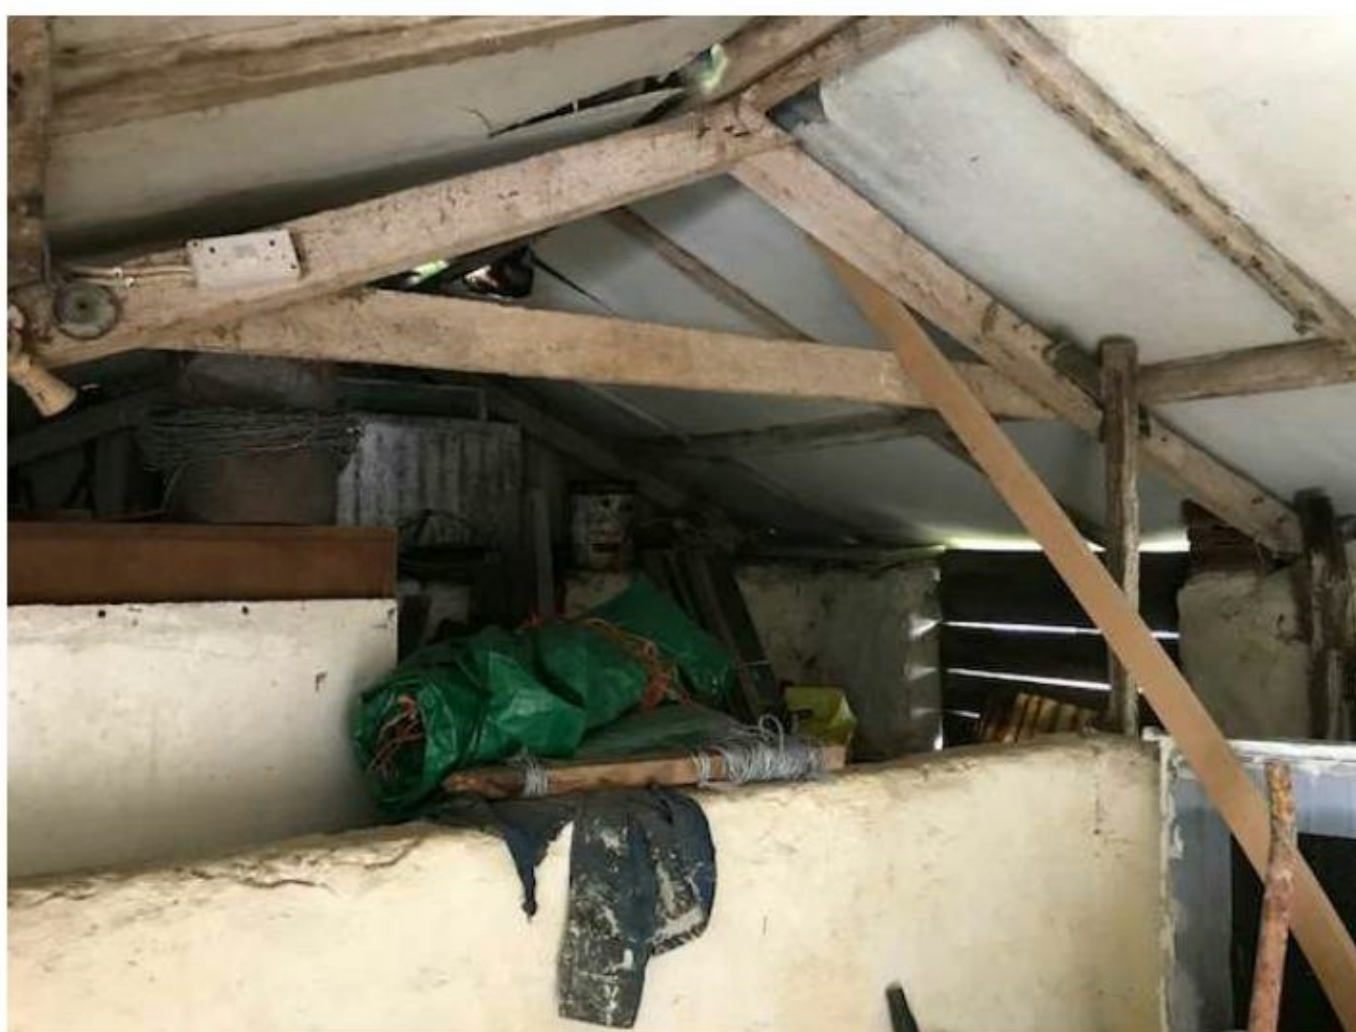
Internally the building is divided into three sections, by half block walls. The old piggery is now used for storage, with a concrete floor. The roof is open to the rafters with timber beams and unlined, exposing the corrugated metal sheeting. The central section is boarded out (Figure 4). There are large gaps within the metal sheeting and gaps below the wooden doors making the building draughty. No evidence of bats was observed within the interior of the old piggery and there are no visible external features that provide potential for roosting bats. The old piggery is assessed as being of **negligible suitability** for roosting bats.

Figure 4: View of interior of the old piggery, showing dividing half block walls.

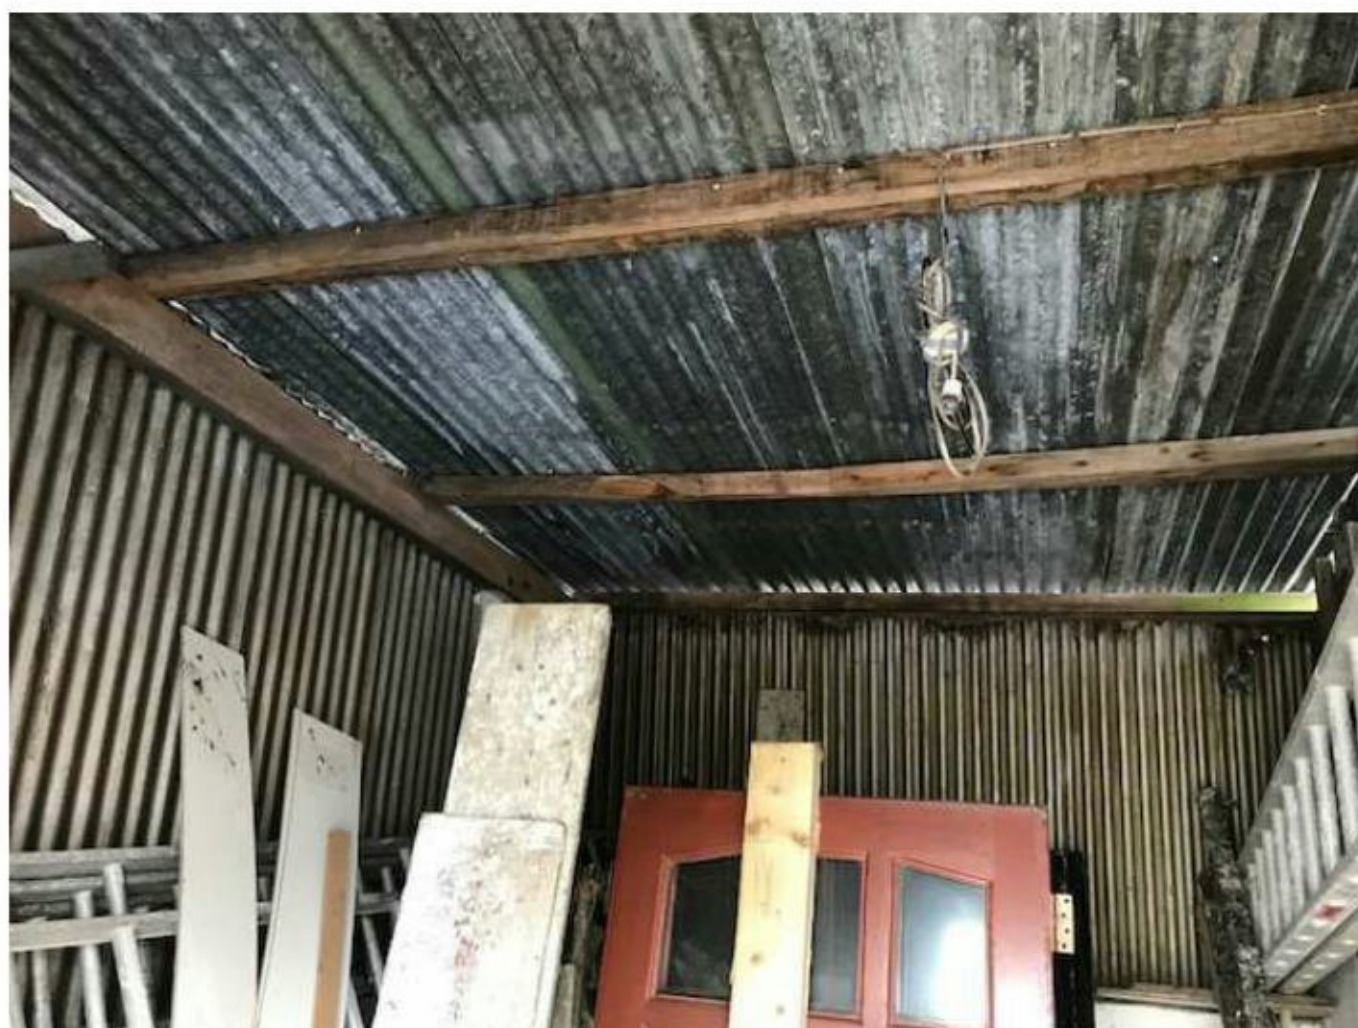
Figure 5: View of interior of garage.
