## **INITIAL SITE APPRAISAL** Flat 4, 129 Camberwell Road, SE5 OHB

## **Revision A**

Prepared by Sarah Nevin 21 May 2021

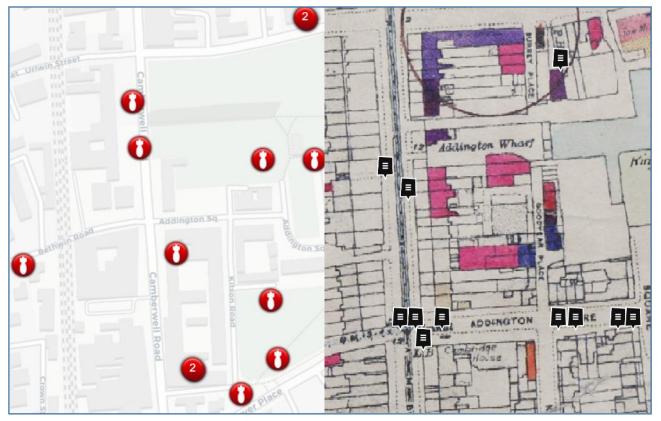
FIGURE 9

The site had blast damage described as 'minor in nature'. (Figure 9)

Other buildings nearby were damaged beyond repair.
