Caldbeck Road		
Bromborough		
Utilities Survey		
Client : Redsun Developments		
Surveyed By : CS	Date : 09/04/21	A1 @
Drawn By : CS	Drawing No : 8181/02	1:500
Checked By : SH	Amendment : ****

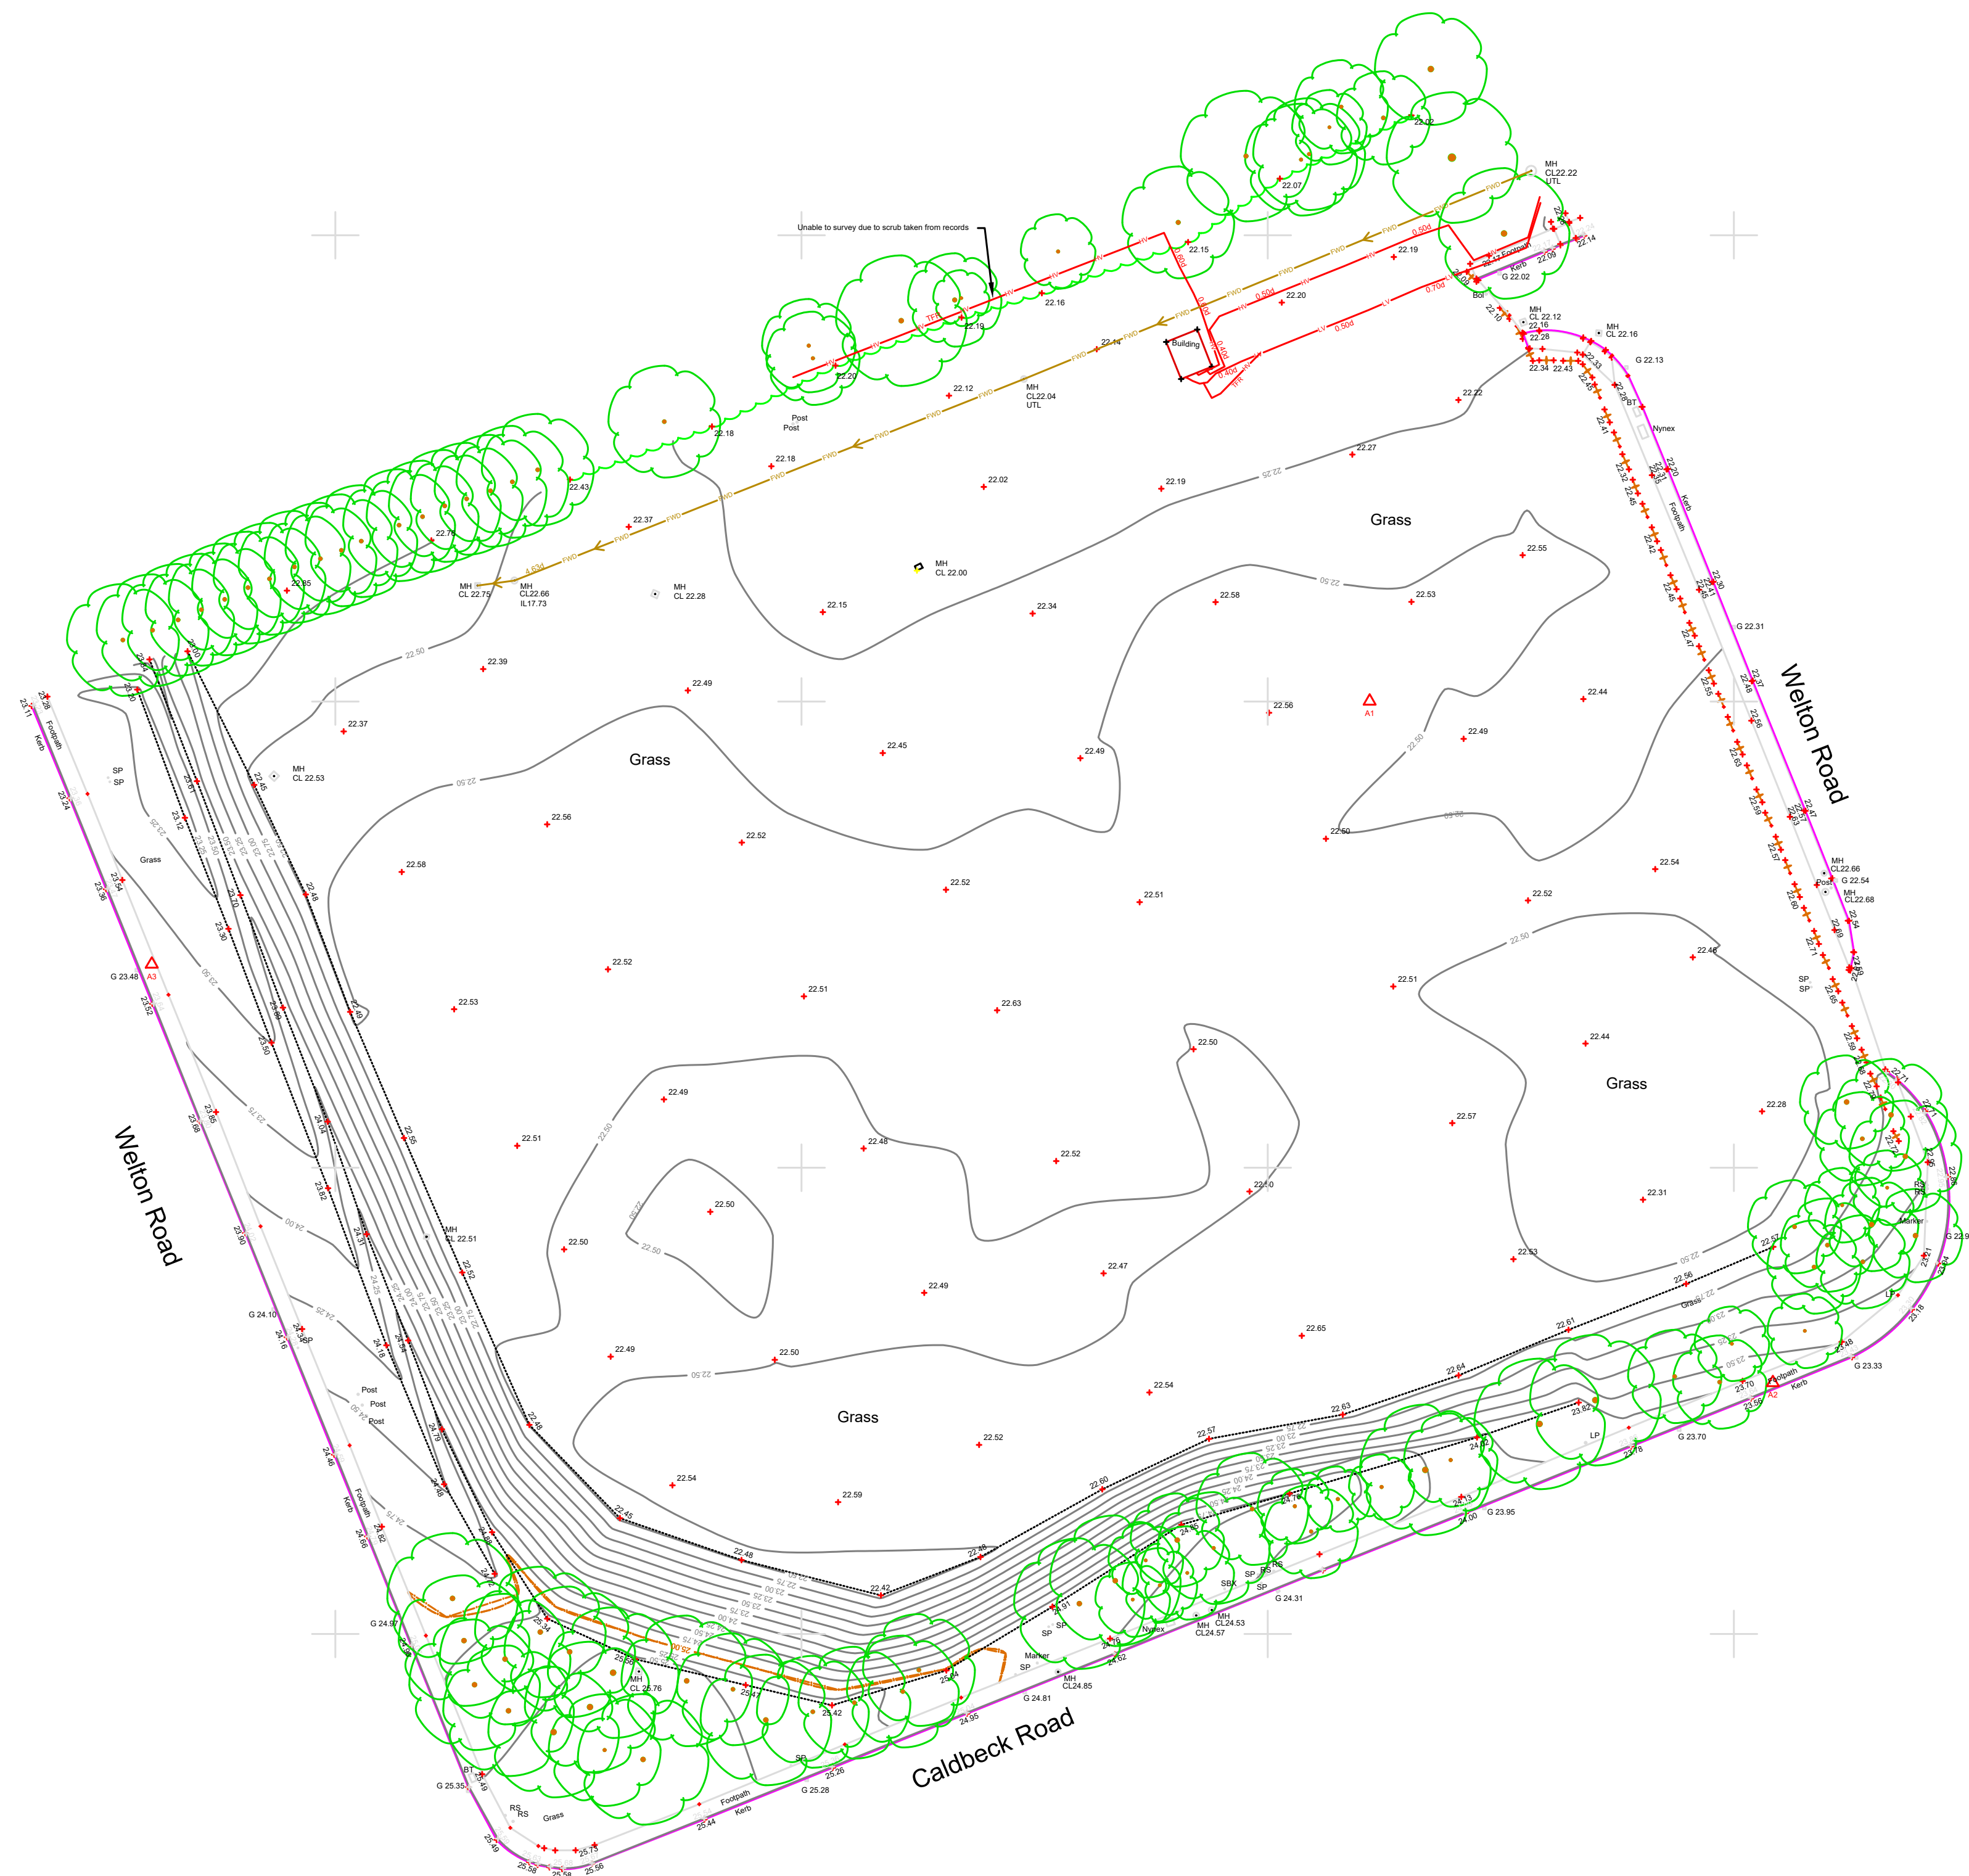
The drawing has been derived from the amalgamation of several data sets: utility service provider buried asset plans, visual confirmation by way of lifting manholes, and measuring depth, type and location of services, electromagnetic detection, and GPR scans.

BURIED ASSETS DETECTED ON SITE:

ONLY DRAINAGE DISCOVERED WHILST ON SITE IS DISPLAYED ON THIS DRAWING. FURTHER INVESTIGATIONS MAY NEED TO BE CARRIED OUT TO ASCERTAIN THE FULL EXTENT OF THE DRAINAGE FOR THE SITE.

Care should be taken by designers when utilising the findings within this drawing, and should confirm depths by visual confirmation/verification using vacuum excavation or slit trench technology if a higher degree of accuracy is required to meet the design brief specification.
