PHASE II GEO-ENVIRONMENTAL SITE ASSESSMENT

**The Croft
Welton Road
Birkenhead
Wirral
CH62 3PL**

Report Ref: 12-999-r1
Date Issued: February 2019

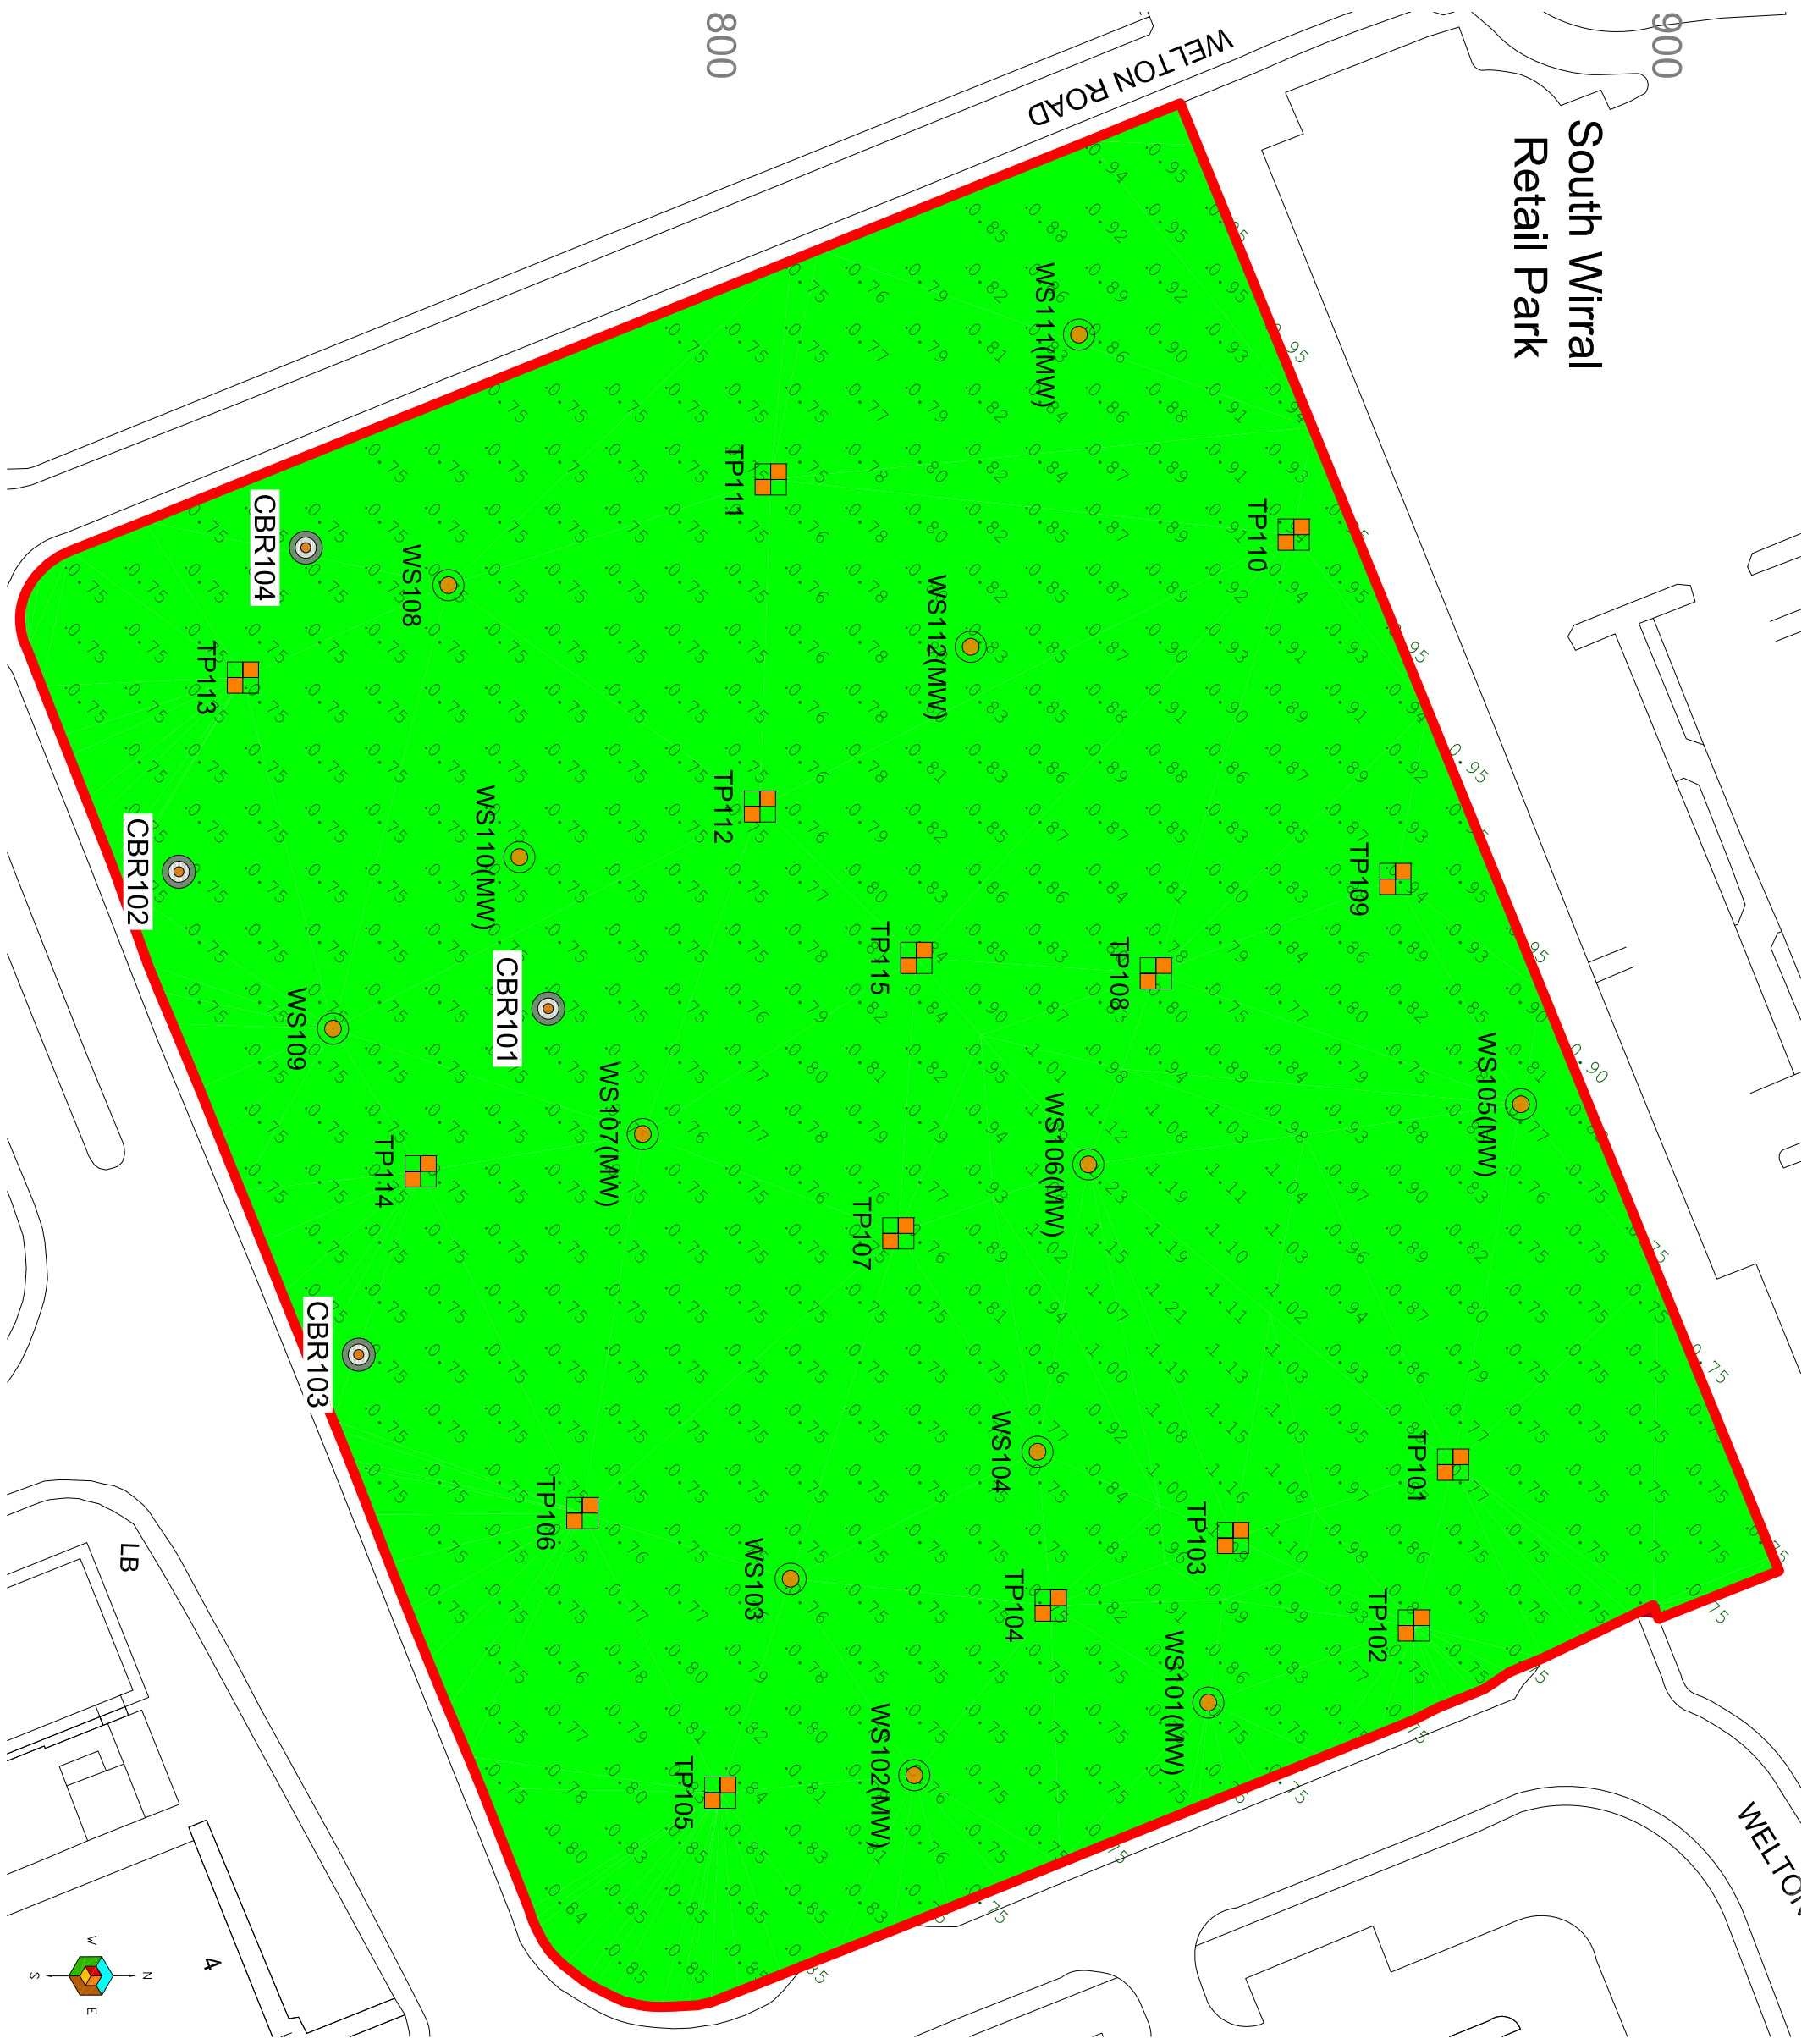
Location Symbols

- Approximate Window Sample Probehole Location with Insiall
- Approximate Trial Pit Location
- Approximate California Bearing Ratio Test Location

The sampling locations are illustrated in Drawing 12-999-004 (Appendix III). The ground conditions encountered are indicated on the logs which are provided in Appendix IV.

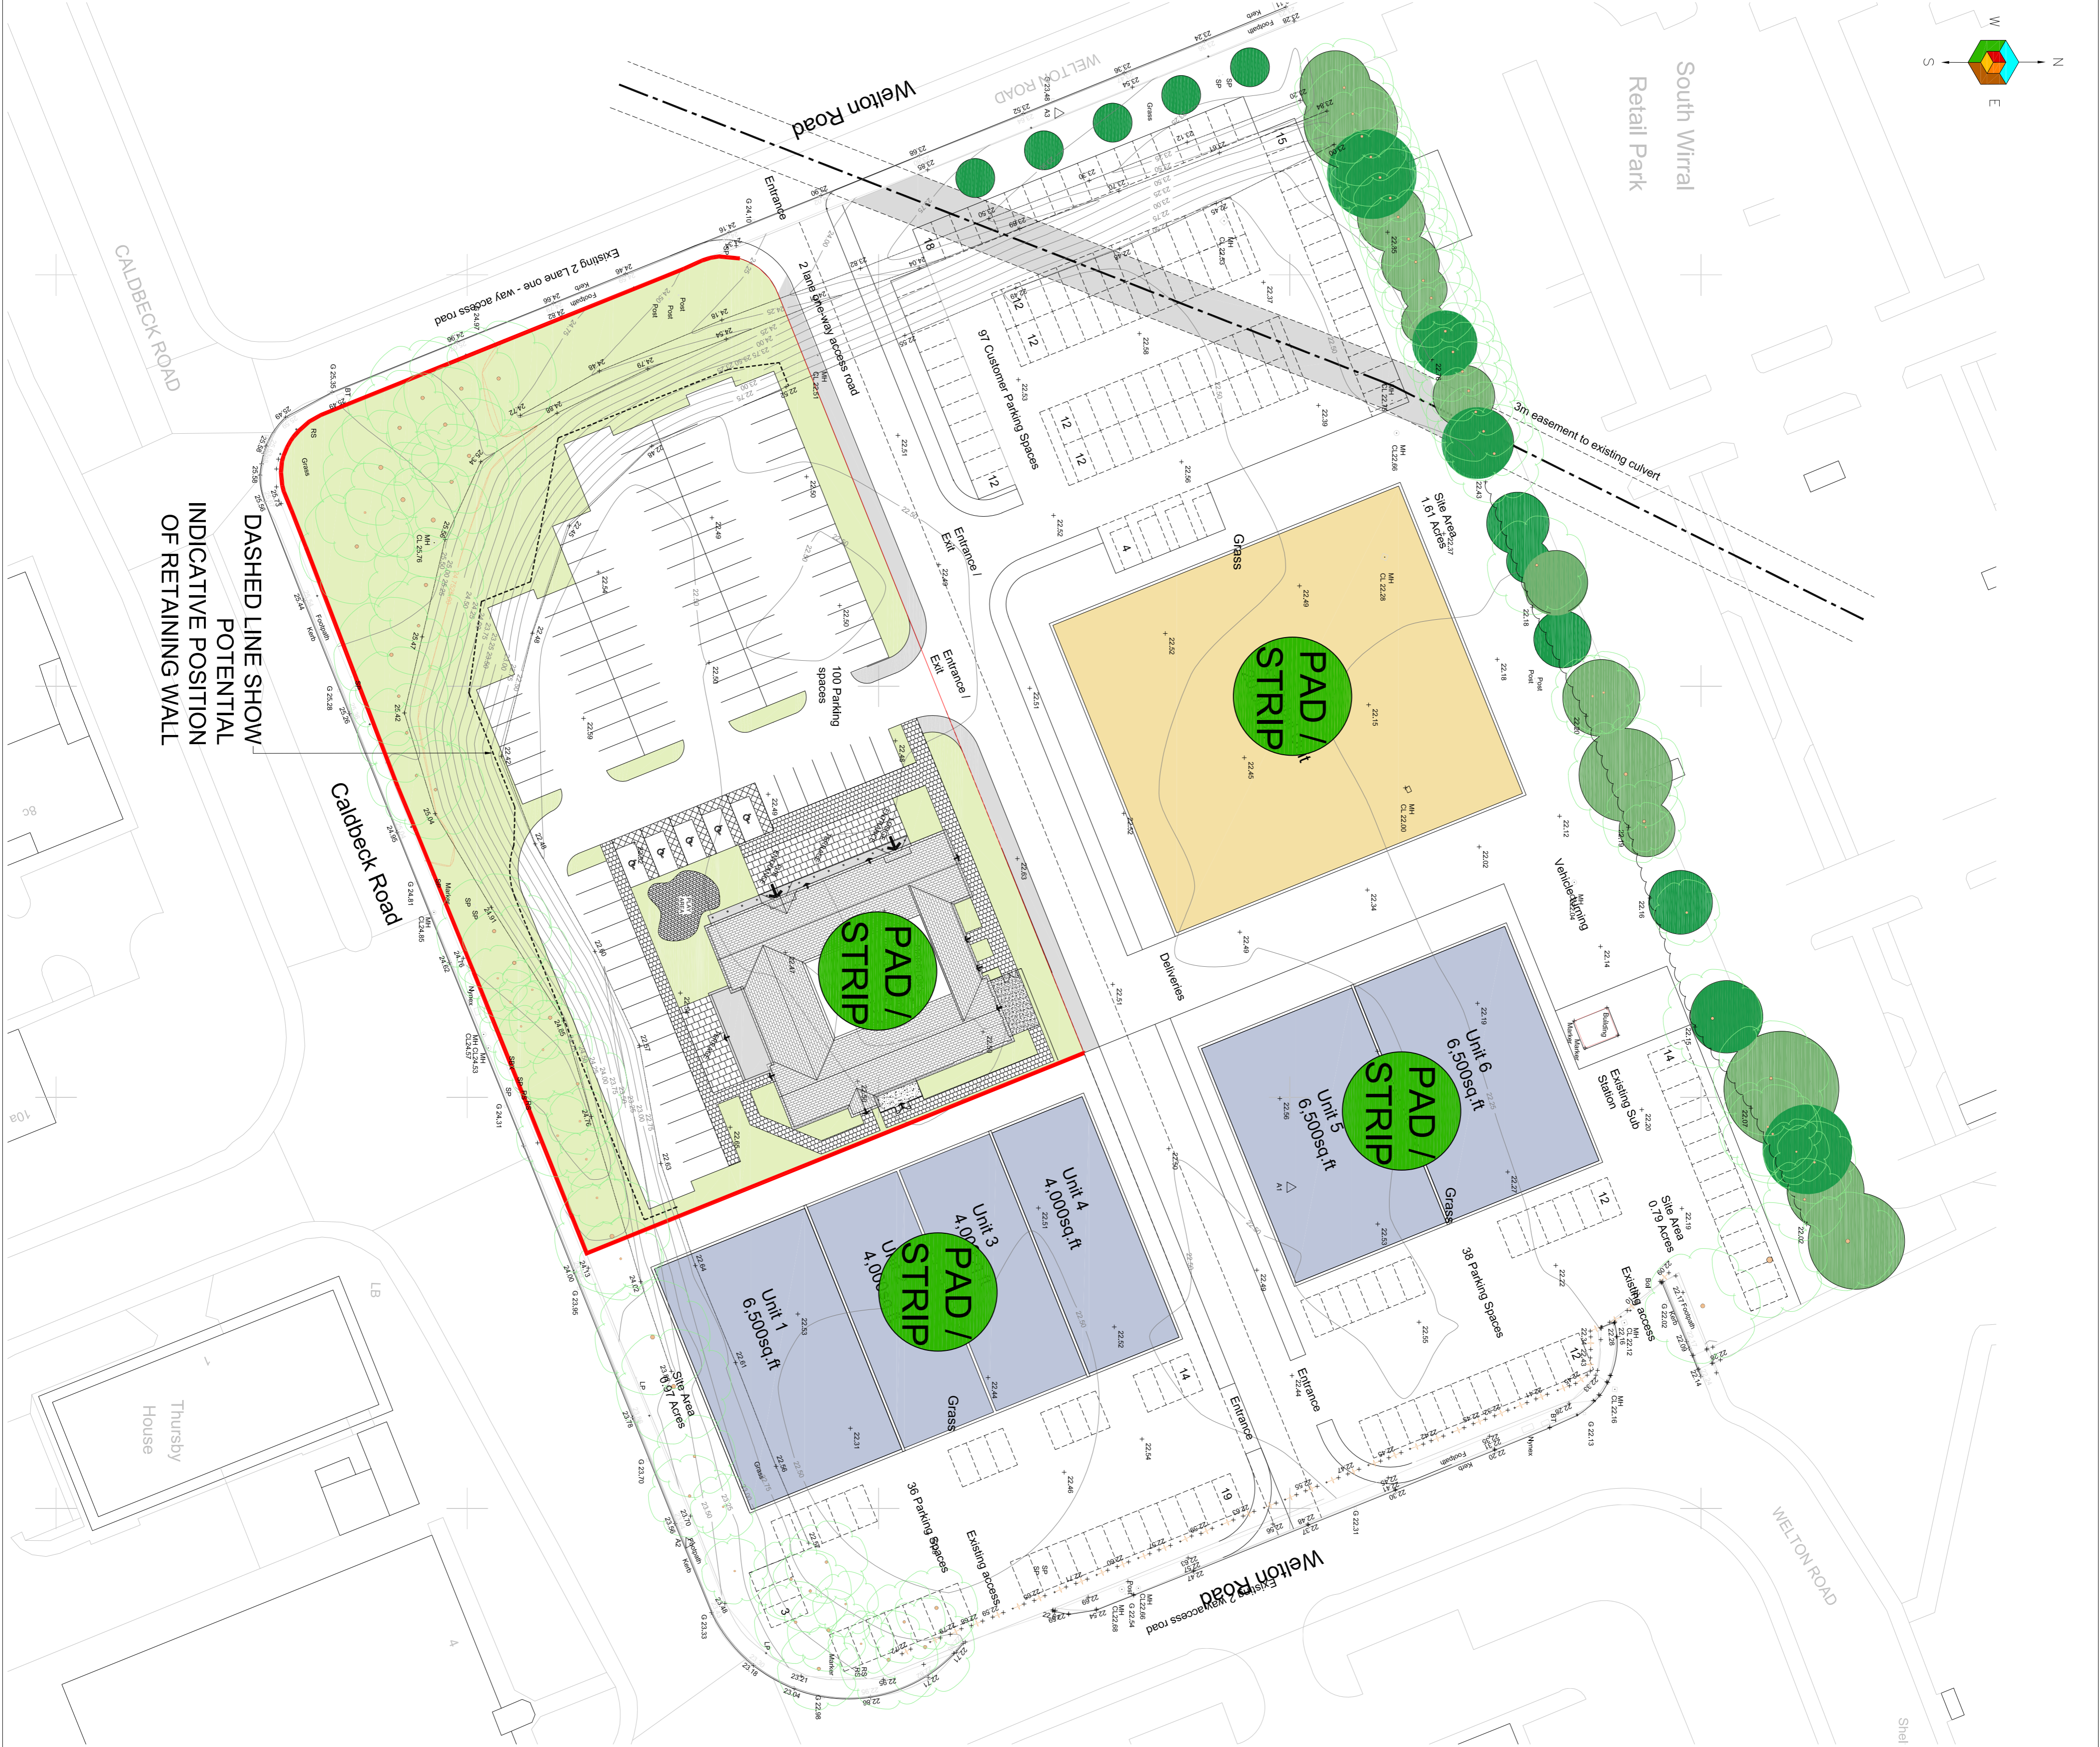
DASHED LINE SHOW POTENTIAL INDICATIVE POSITION OF RETAINING WALL

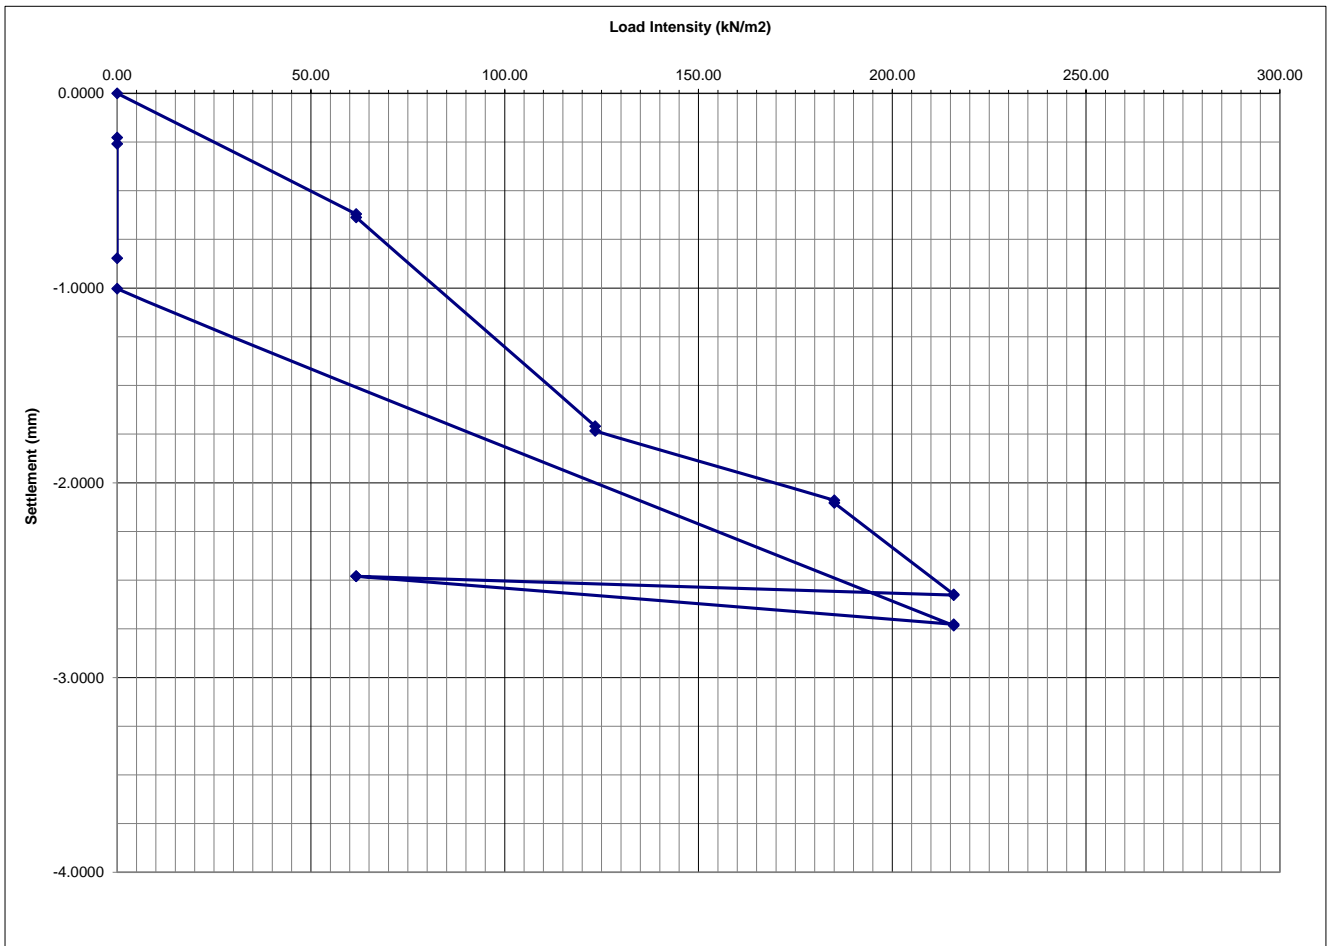
| Strata Description: | Red Sand/Bedrock | | |

Equivalent CBR Value of 8%
