Detailed Unexploded Ordnance (UXO) Risk Assessment

| Project Name | Croft Business Park |
| Site Address | Croft Business Park, Carrock Road, Birkenhead, Wirral, CH62 3RA |
| Report Reference | DA7696-00 |

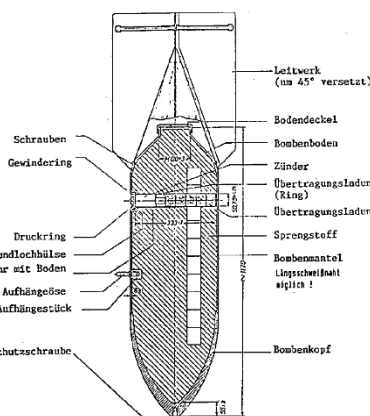
SC 250kg High Explosive Bomb

| Use | Against railway installations, embankments, flyovers, underpasses, large buildings and below-ground installations. |
| Remarks | It could be carried by almost all German bomber aircraft, and was used to notable effect by the Junkers Ju-87 Stuka (Sturzkampfflugzeug or dive-bomber). |

SC250 bomb being loaded onto German bomber

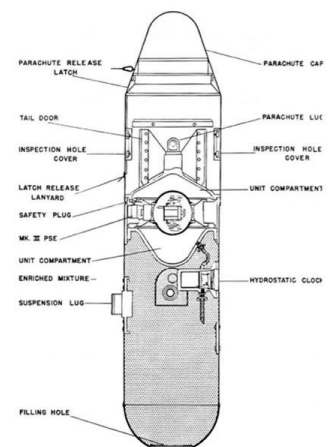
Parachute Mine (Luftmine B / LMB)

| Remarks | Deployed a parachute when dropped in order to control its descent. Had the potential to cause extensive damage in a 100m radius. |

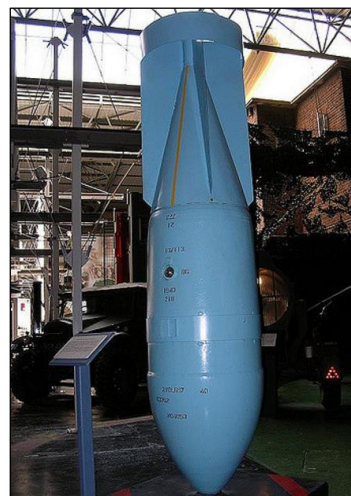
SC 1000kg

| Use | SC type bombs are General Purpose Bombs used primarily for general demolition work. Constructed of parallel walls with comparatively heavy noses. They are usually of three piece welded construction |

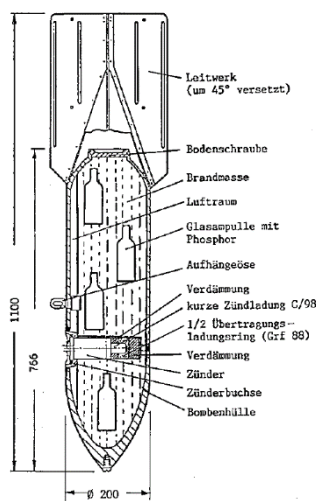
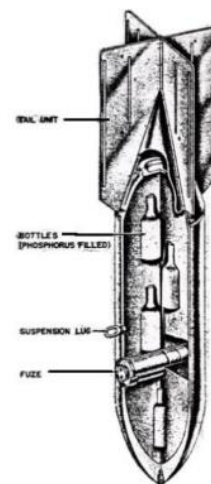
C50 A Incendiary Bomb

| Remarks | Early fill was a phosphorous/carbon disulphide incendiary mixture |

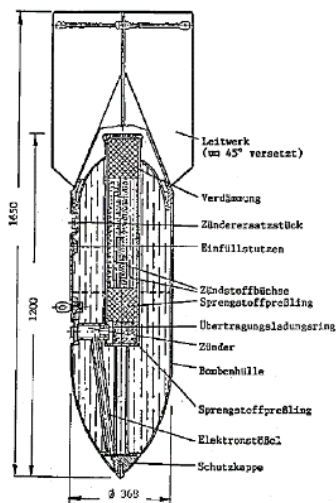
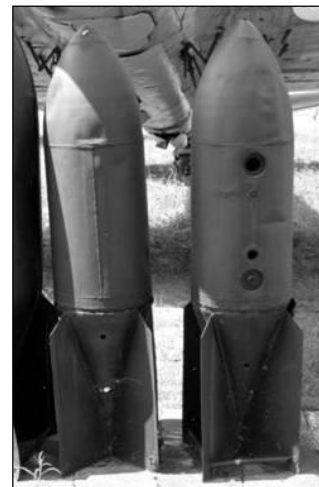
Flam C-250 Oil Bomb

| Use | Often used for surprise attacks on ground troops, against troop barracks and industrial installations. Thin casing – not designed for ground penetration |

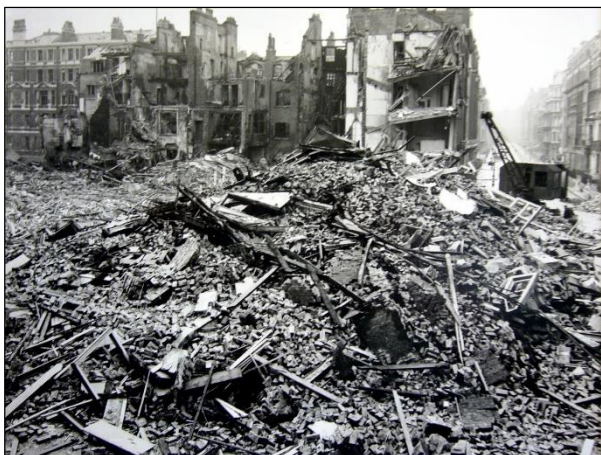
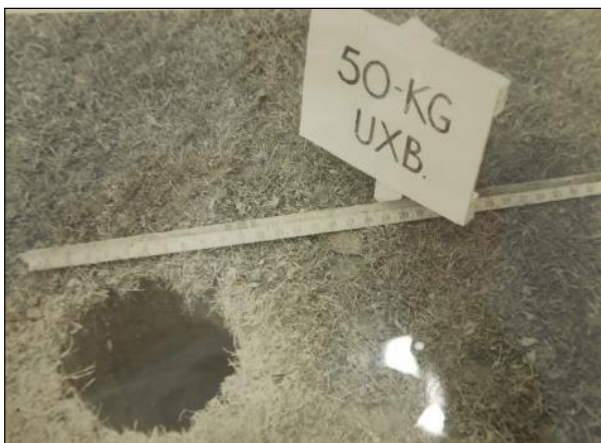
'J-Curve' Effect

Top: J-curve Effect - Due to angle of entry, unexploded bombs would often end their trajectory at a lateral offset from point of entry, often ending up beneath adjacent extant structures/sites. The photograph above shows 250kg bomb found in Bermondsey pointing upwards, demonstrating 'J-curve'

One of the most common scenarios for UXO going unnoticed was when a UXB fell into a 'bomb site' (such as the area shown **Top Left**), the entry hole of the bomb obscured by any debris and rubble present. Note that the entry hole of a 50kg UXB could be as little as 20cm in diameter (**Left**).

J-curve is the term used to describe the characteristic curve commonly followed by an aerial delivered bomb dropped from height after it penetrates the ground. Typically, as the bomb is slowed by its passage through underlying soils, its trajectory curves towards the surface. Many UXBs are found with their nose cone pointing upwards as a result of this effect. More importantly however is the resulting horizontal offset from the point of entry. This is typically a distance of about one third of the bomb's penetration depth, but can be higher in certain conditions (see **Annex G**).

For example, the largest common German bomb (500kg) had a likely concluded penetration depth of 6m in sand or gravel but 11m in clay. The maximum observed depth for a 500kg bomb was 11.4m and for a 1,000kg bomb 12.8m. Theoretical calculations suggested that significantly greater penetration depths were probable.

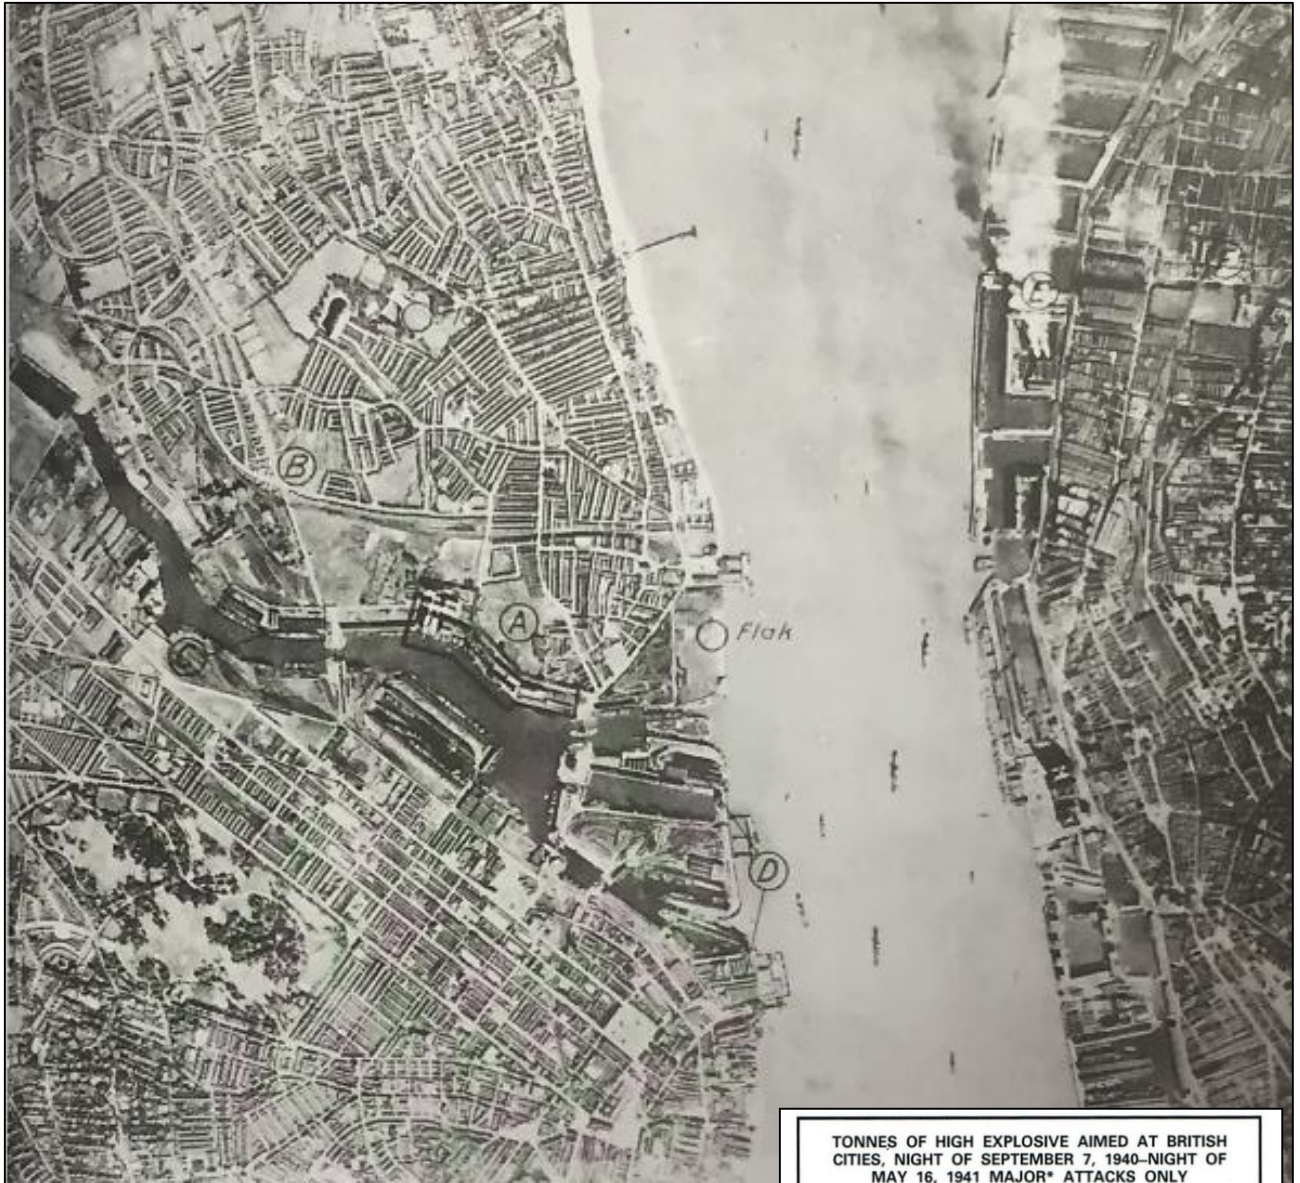
Above: Luftwaffe target photography of the Wallasey/Birkenhead Docks, dated 9th July 1943. The site is situated approximately 7km to the south of the docks.

Right: air raid statistics indicating the number of raids and metric tonnes of bombs dropped on Britain between September 1940 and May 1941.

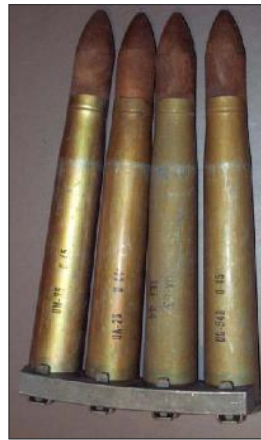
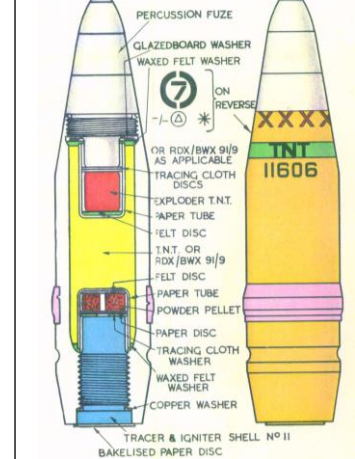
40mm Bofors Projectile

| Remarks | Light quick fire high explosive anti-aircraft projectile. Each projectile fitted with small tracer element. If no target hit, shell would explode when tracer burnt out. Designed to engage aircraft flying below 2,000ft |

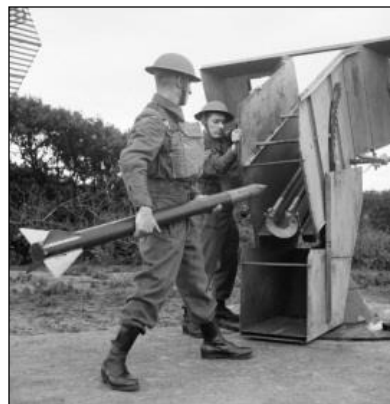
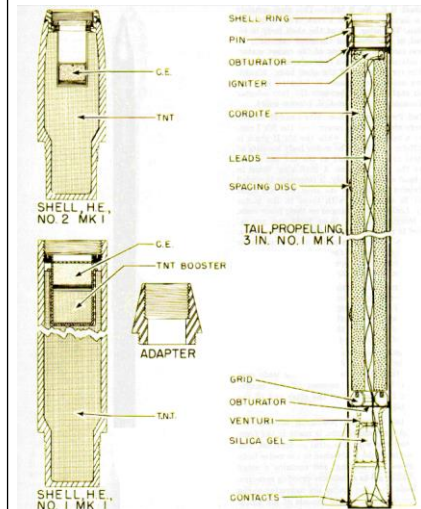
3in Unrotated Projectile (UP) Anti-Aircraft Rocket ("Z" Battery)

| Remarks | As a short range rocket-firing anti-aircraft weapon developed for the Royal Navy. It was used extensively by British ships during the early days of World War II. The UP was also used in ground-based single and 128-round launchers known as Z Batteries. Shell consists of a steel cylinder reduced in diameter at the base and threaded externally to screw into the shell ring of the rocket motor |
