Project and Project No:	HABERDASHER'S SCHOOL			Job No: 9756-1	Drawing No:	9756-1 P(0)1000	Revision:	Drawn:	GILES QUARME ARCHITECTS	
Title:	EXISTING TERRACE STEPS 01 - REPAIRS				Date:	May 2021	Scale:	1:500, 1:20, 1:50@A3	Checked:	7 BISHOP'S TERRACE LONDON SE11 4UE
								NCB	CGQ	Tel: (020) 7582 0748 Fax: (020) 7593 8807 E-mail: mail@quarme.com

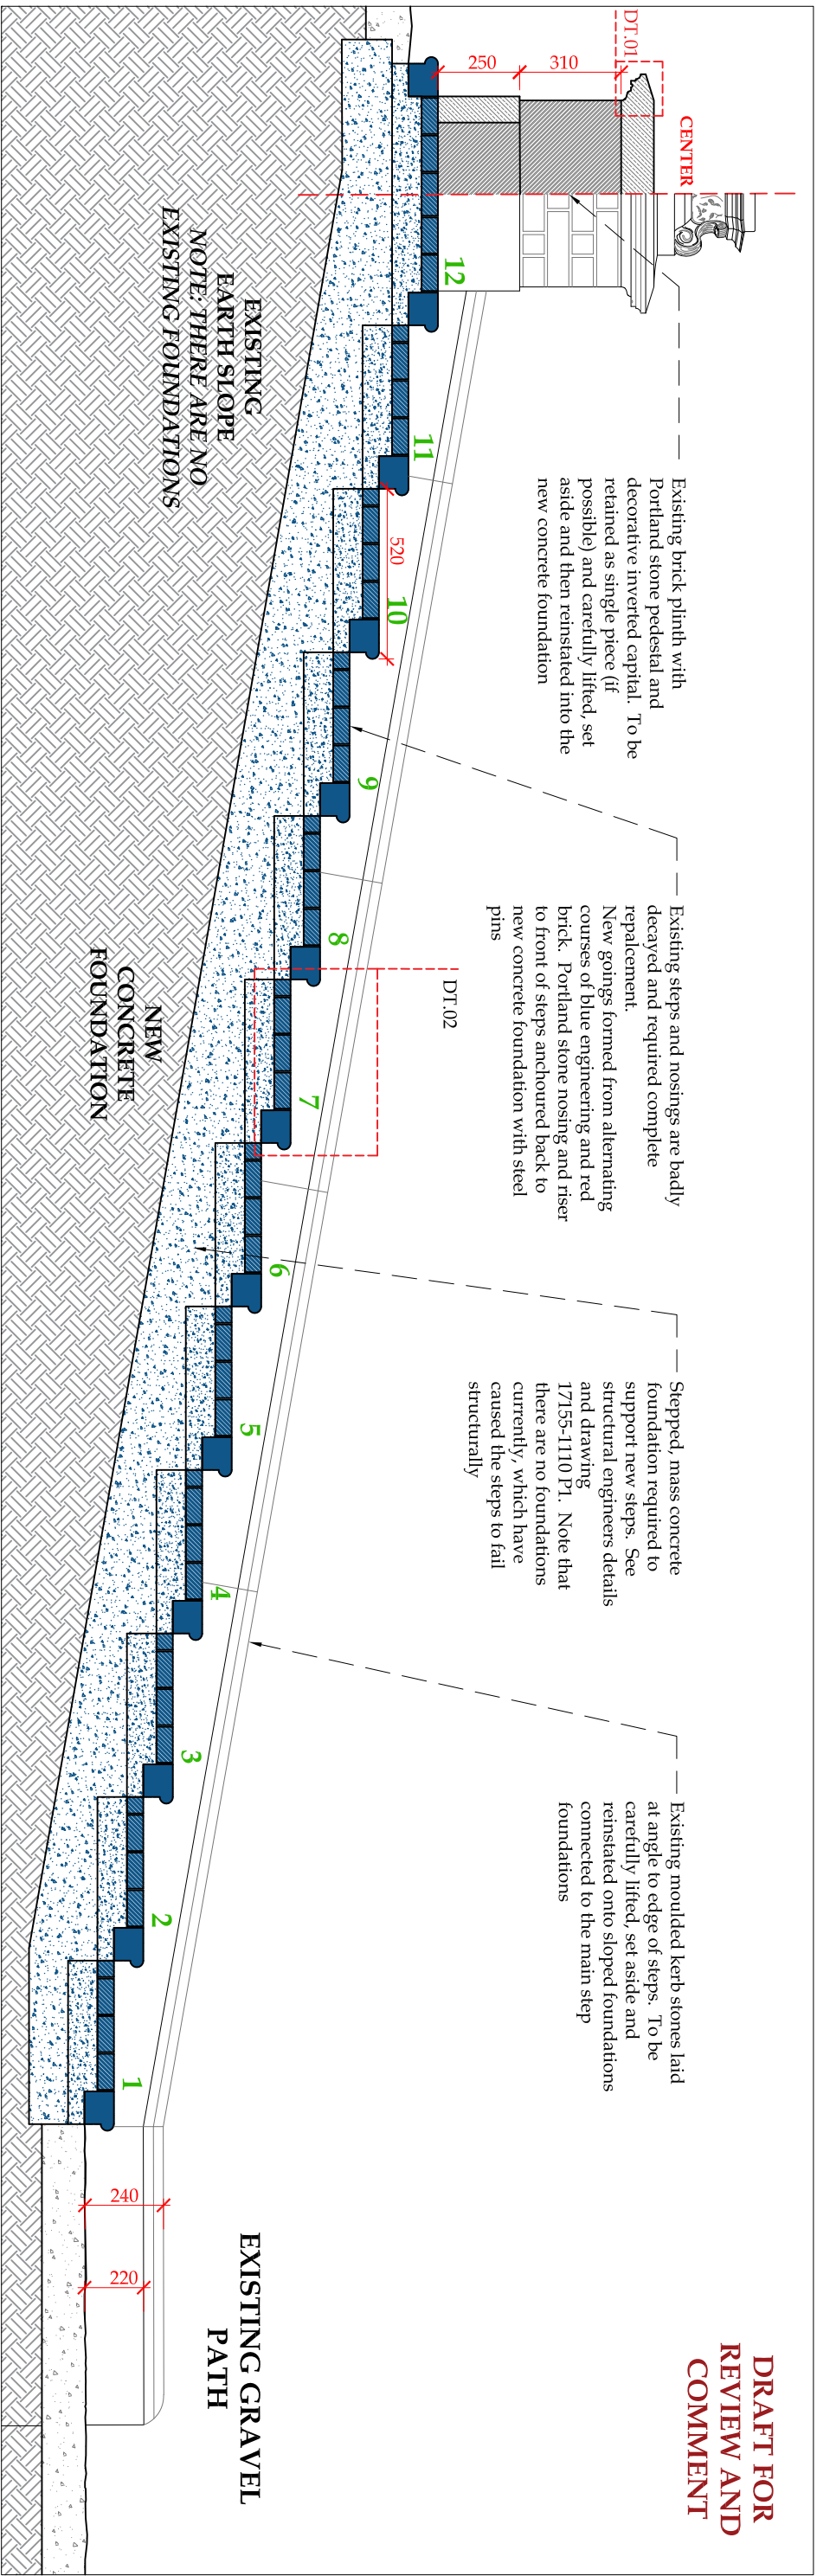
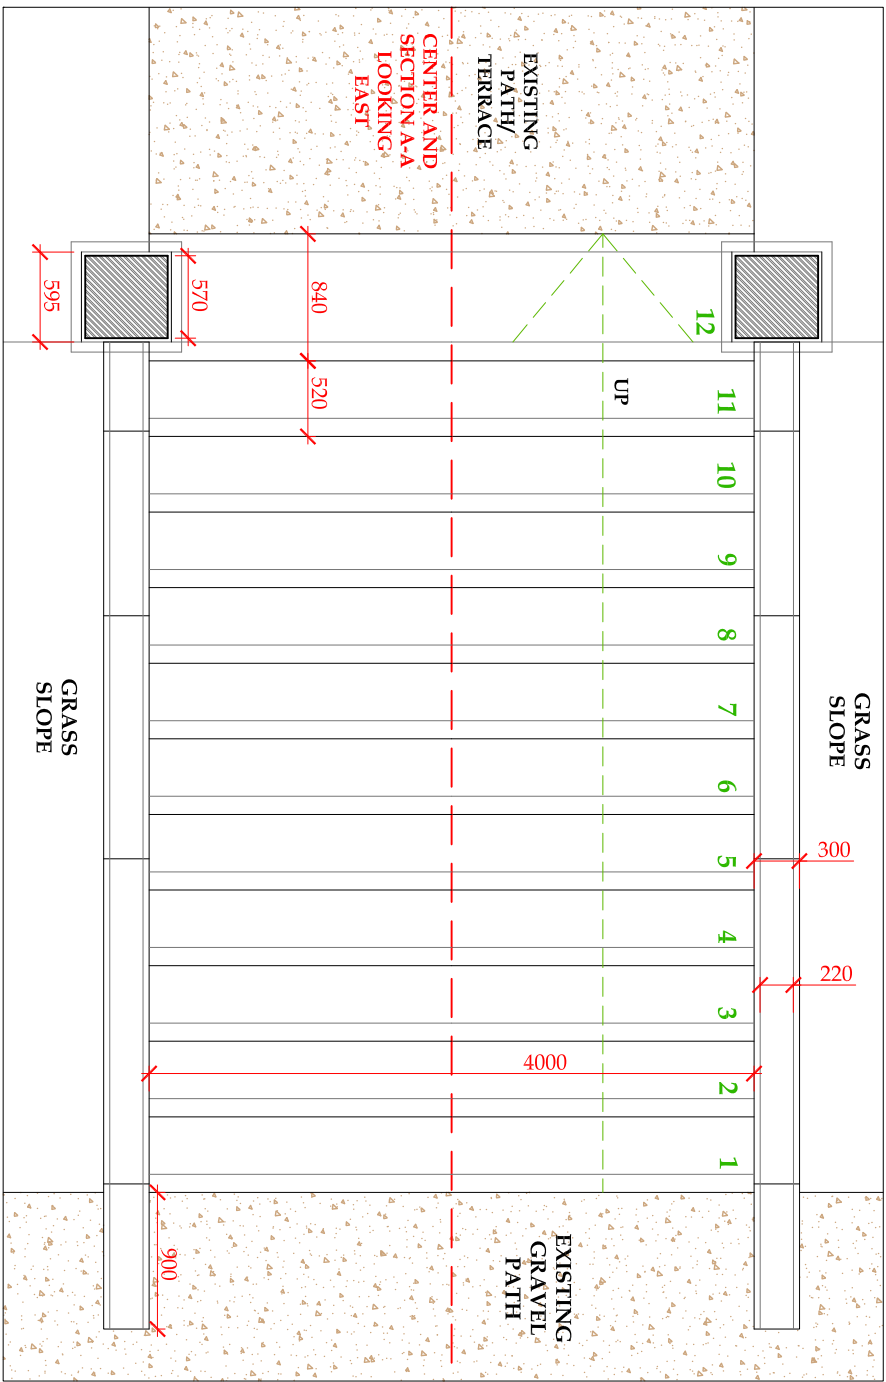
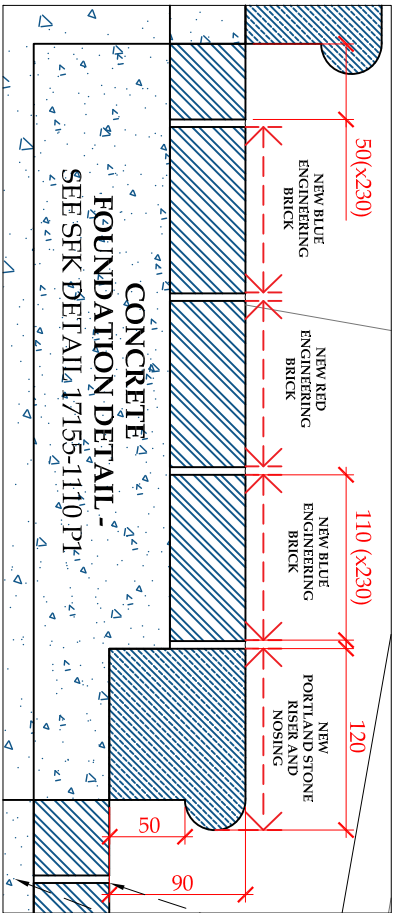
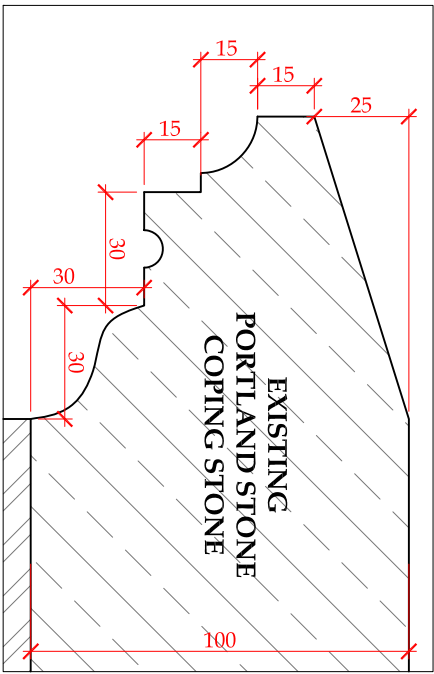
- GENERAL NOTES:**
- To be read in conjunction with GQA Heritage, Design Access Statement Outline Scope of Works Document;
 - To be read with general location plan 9756-1 P(0)1000 and all structural engineers documents;
 - Existing Steps 01: Principal steps to terrace formed from 12 treads, with limestone kerbs, nosings and dressings to 2x brick piers. The steps are generally in poor condition with evidence of settlement that has caused them to split roughly in two, roughly along the middle axis. The treads and nosing are also badly spalled and cracked and therefore require complete replacement with new sections. The structural engineer has recommended that the steps are rebuilt on a new foundation in order to mitigate future movement. The limestone kerbs and piers (with inverted capital finials) can be retained in their entirety and reinstated once the foundation have been installed.
